Structural evaluation of axial and rotational flexibility and strength of web-flange junctions of open-web pultruded composites

Composites Part B: Engineering, 66

Structural evaluation of axial and rotational flexibility and strength of web–flange junctions of open-web pultruded composites

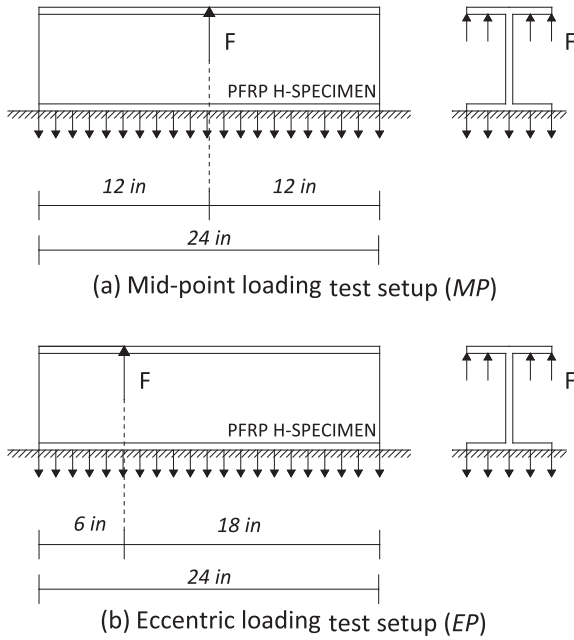
Fig. 3. (a, b) Schematic setup of web-flange junction pullout test.

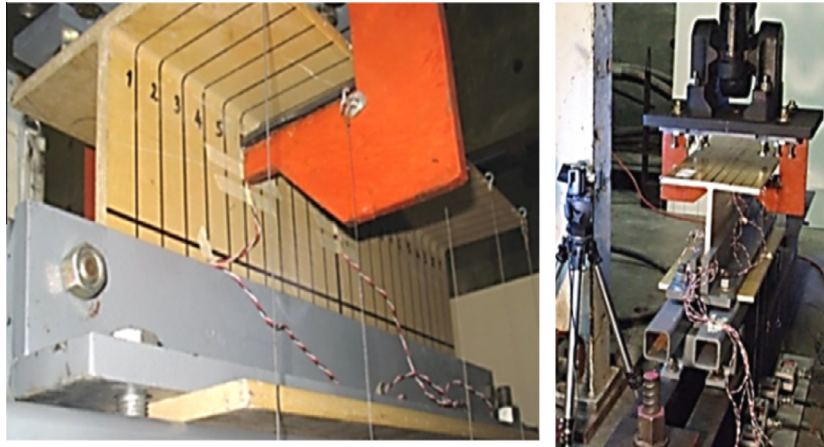
Fig. 6. Typical pull-out web/flange test setup.

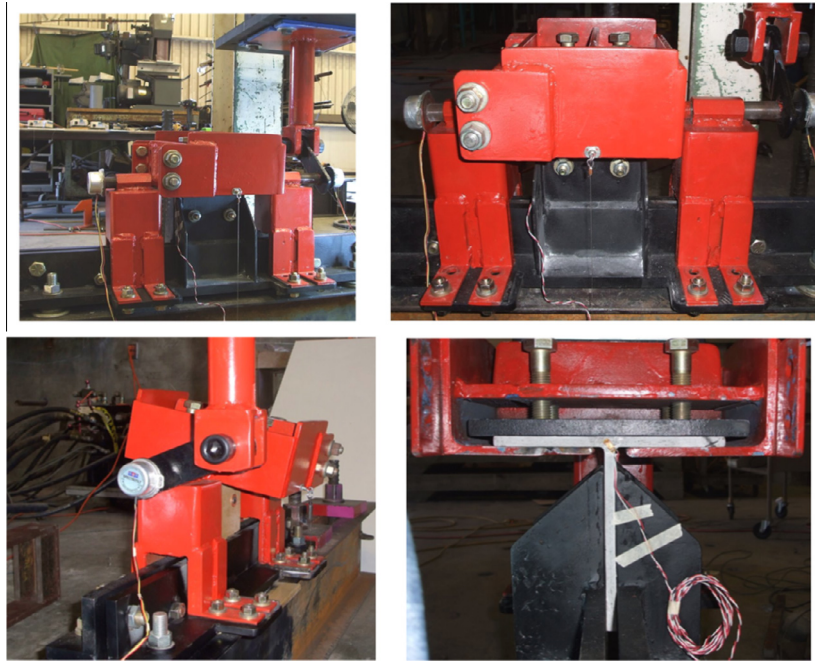
Fig. 8. Views from rotation test setup.

In all tests, moment was applied via an eccentric axial load through a calibrated MTS 55-kip (245 kN) servo-hydraulic

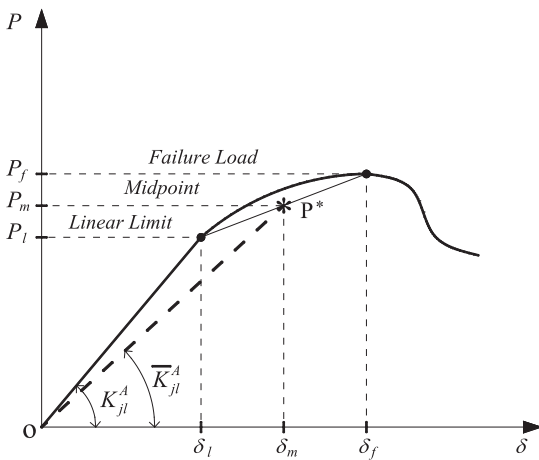
Fig. 13. Linear axial stiffness, K_{jl}^A , and average linear axial stiffness, \bar{K}_{jl}^A .

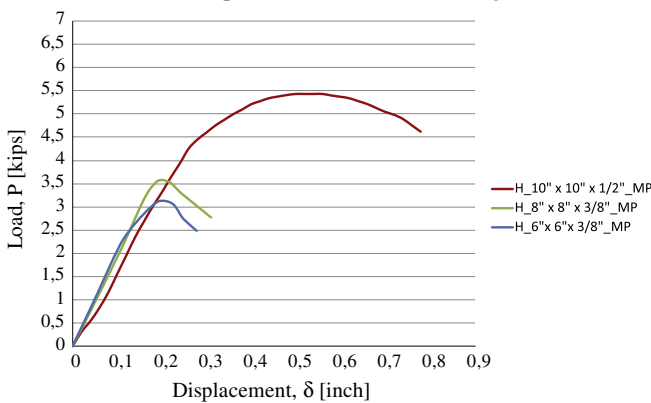
Fig. 14. Load (P) versus displacement (δ) curve for H-specimens in mid-point loading (Group 1).

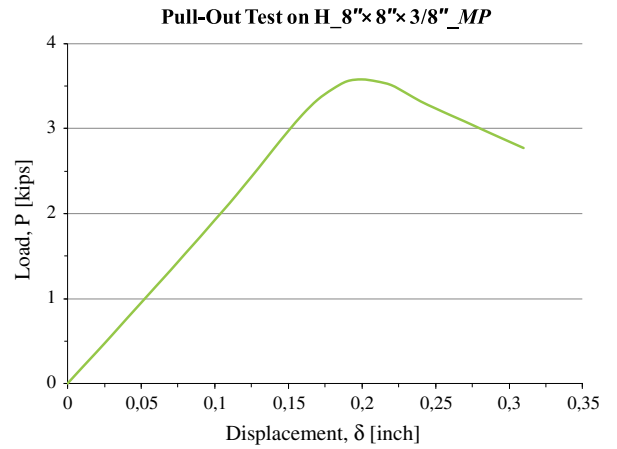
Fig. 19. Load–displacement curve for H₈'' × 8'' × 3/8'' (203.2 mm × 203.2 mm × 9.5 mm)_{MP} specimen at loading-point.

For this specimen, the P – δ behavior was similar to the previous one where linearity continued up to a displacement of 0.20" (5.08 mm) corresponding to a pull load level of 3.58 kips (15.93 kN). Beyond this load level, signs of failure were observed leading to a complete total separation of the flange from the web that was initiated at the location of the pull load line and propagated to the rest of the junction length. Fig. 19 shows the load–displacement curve at the specimen's mid-point. Equivalent linearized P – δ relation at mid-point of this specimen is presented in Fig. 20. Fig. 21 shows the displacement pattern along the upper flange length drawn at 1.0 kip (4.448 kN) loading steps.

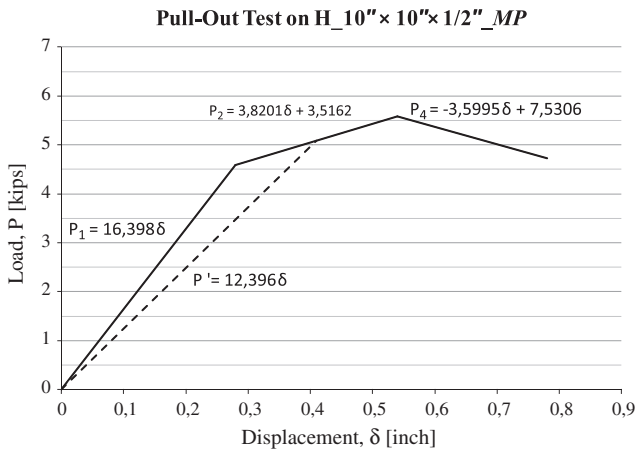
Fig. 17. Linearized load–displacement curve for H₁₀'' × 10'' × 1/2'' (254.0 mm × 254.0 mm × 12.7 mm)_{MP} specimen at loading-point.

specimen's mid-point is shown in Fig. 17. Fig. 18 shows the displacement pattern along the upper flange length at 1.0 kip (4.448 kN) loading steps.

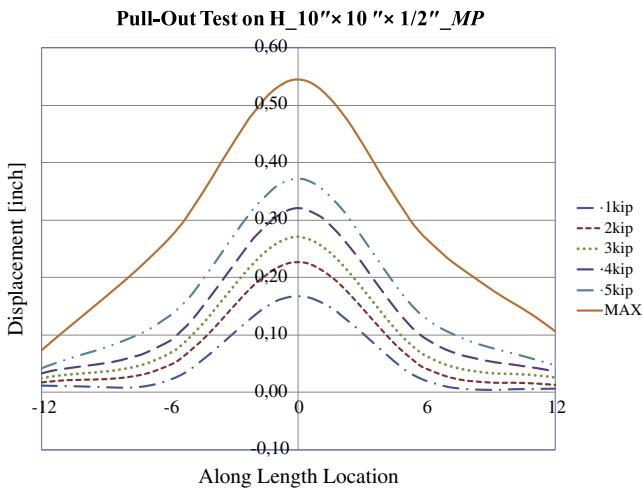
Fig. 18. Displacement pattern along upper flange length for H₁₀'' × 10'' × 1/2'' (254.0 mm × 254.0 mm × 12.7 mm)_{MP} specimen at loading-point.

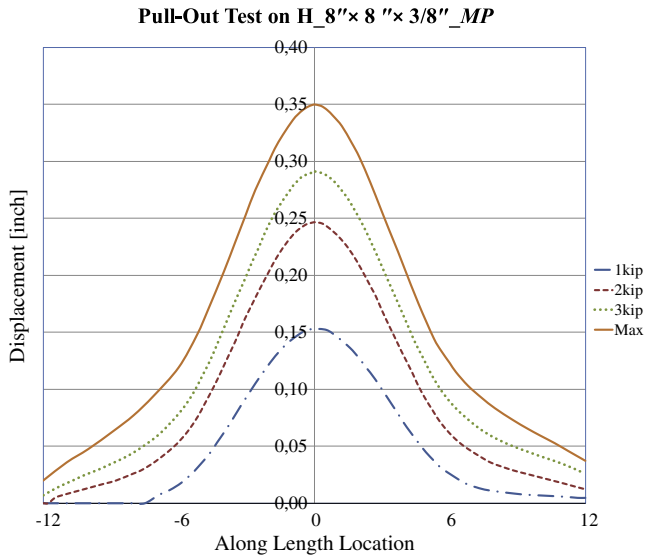
Fig. 21. Displacement pattern along upper flange length for H₈'' × 8'' × 3/8''_{MP} specimen at loading-point.

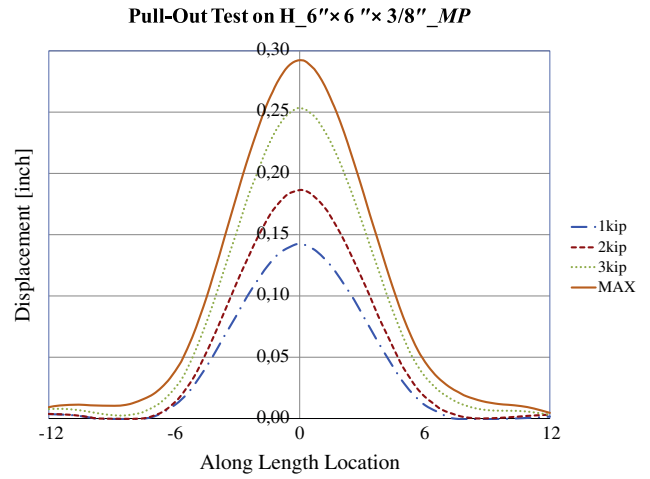
Fig. 24. Displacement pattern along upper flange length for H₆'' × 6'' × 3/8''_{MP} specimen at loading-point.

ment level of 0.20'' (5.08 mm) that corresponds to a load of 3.14 kips (13.96 kN). Beyond this load level, localized junction failure was initiated. The load–displacement curve at mid-point is shown in Fig. 22, and the proposed trilinear idealized behavior is presented in Fig. 23. Fig. 24 shows the displacement pattern along the upper flange length at 1.0 kip (4.448 kN) loading steps.

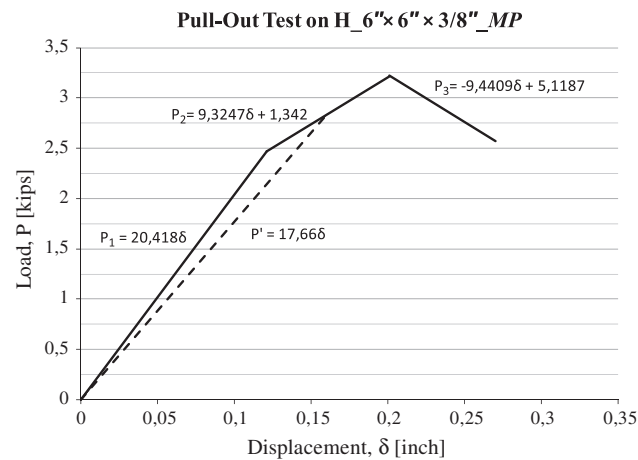
Fig. 23. Linearized load–displacement curve for H₆'' × 6'' × 3/8''_{MP} specimen at loading-point.

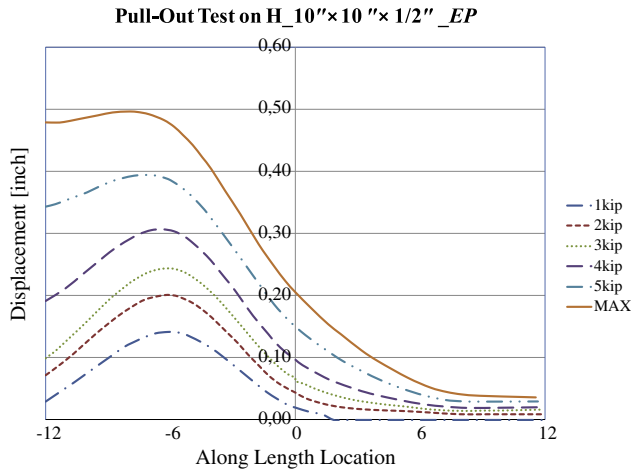
Fig. 27. Displacement pattern along upper flange length for H₁₀'' × 10'' × 1/2'' (254.0 mm × 254.0 mm × 12.7 mm)_{EP} specimen at loading-point.

For this specimen, the displacement was increased linearly with increasing load up to 0.44'' (11.09 mm) displacement and 5.73 kips (25.51 kN) axial load. After which, failure started to occur. Fig. 25 shows the load–displacement curve at loading-point. Equivalent linearized load–displacement at loading-point is shown in Fig. 26. Fig. 27 shows the displacement pattern along the upper flange length at 1.0 kip (4.448 kN) loading steps.

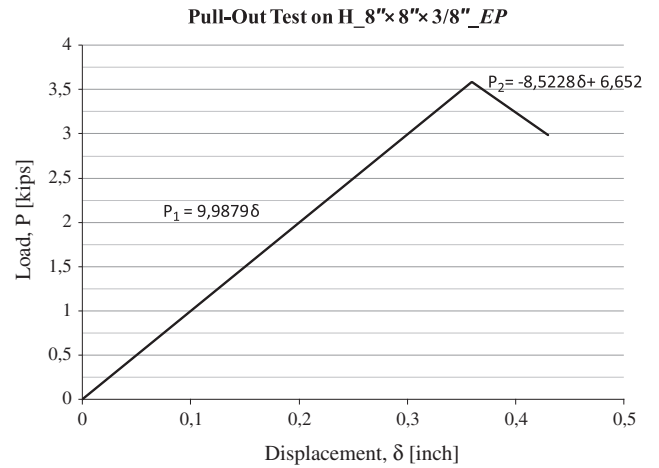
Fig. 29. Linearized load–displacement curve for H₈'' × 8'' × 3/8'' (203.2 mm × 203.2 mm × 9.5 mm)_{EP} specimen at loading-point.

level, localized junction cracks were observed. Fig. 28 shows the load–displacement curve at loading-point while Fig. 29 shows the equivalent linearized load–displacement at loading-point.

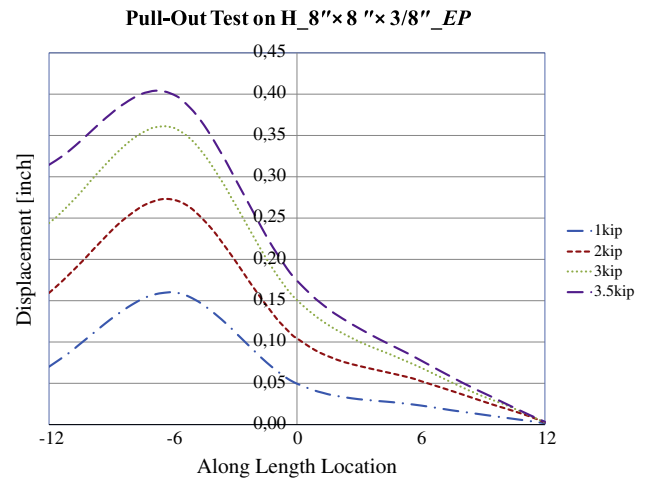
Fig. 30. Displacement pattern along upper flange length for H₈'' × 8'' × 3/8'' (203.2 mm × 203.2 mm × 9.5 mm)_{EP} specimen at loading-point.

Displacement pattern along the upper flange length at 1.0 kip (4.448 kN) loading steps is shown in Fig. 30.

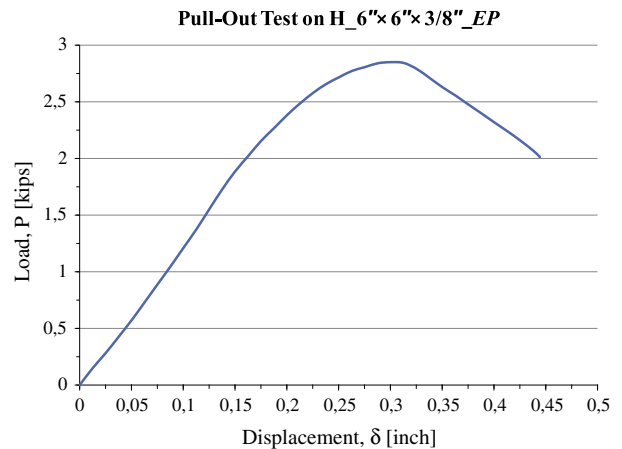
Fig. 31. Load–displacement curve for H₆'' × 6'' × 3/8'' (152.4 mm × 152.4 mm × 9.5 mm)_{EP} specimen at loading-point.

For this specimen, the displacement and the load was linearly proportional up to a displacement equal to 0.15'' (3.81 mm) and load equal to 1.88 kips (8.40 kN). As the load increased, stiffness degraded even though the *P*– δ relation remained linear up to 0.3'' (7.62 mm) displacement that corresponds to a load of 2.85 kips (12.69 kN). After this load level, local failure started to occur. The load–displacement curve at loading-point is shown in Fig. 31, and the equivalent linearized curve is shown in Fig. 32. Fig. 33 shows the displacement pattern along the upper flange length at 1.0 kip (4.448 kN) loading steps.

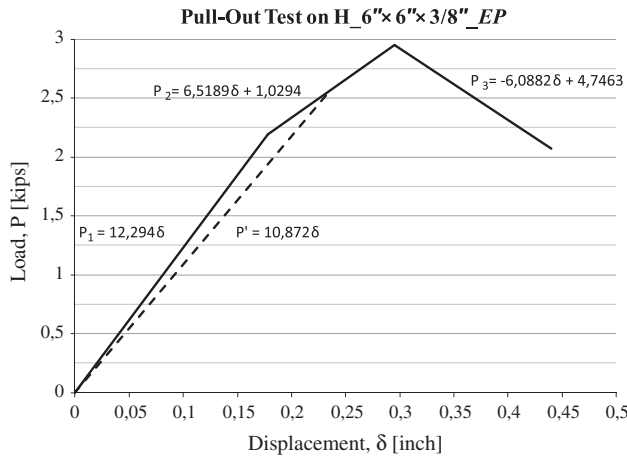
Fig. 32. Linearized load–displacement curve for H_{6''} × 6'' × 3/8'' (152.4 mm × 152.4 mm × 9.5 mm)_{EP} specimen at loading-point.

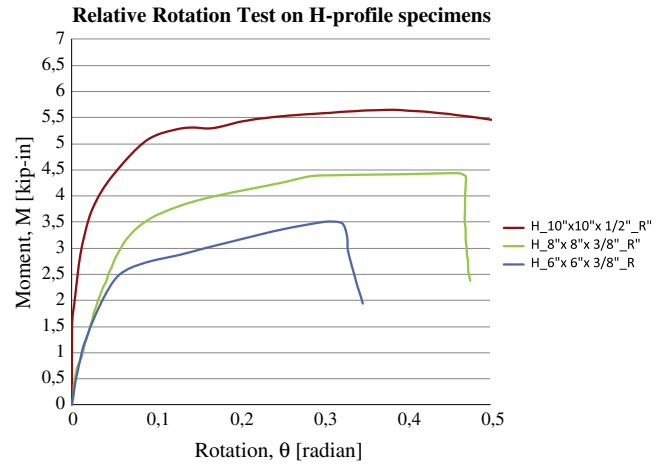
Fig. 34. Moment–rotation ($M-\theta$) curves for H-profile specimens in relative rotation test.

The main experimental results obtained from the relative rotations tests are summarized in Table 5. Fig. 34 presents the moment–rotation (*M*– θ) curves for all three pultruded H-profile specimens while Figs. 35 and 36 show the *M*– θ curves for the two pultruded L-profile specimens in both open-mode (*R_{OM}*)

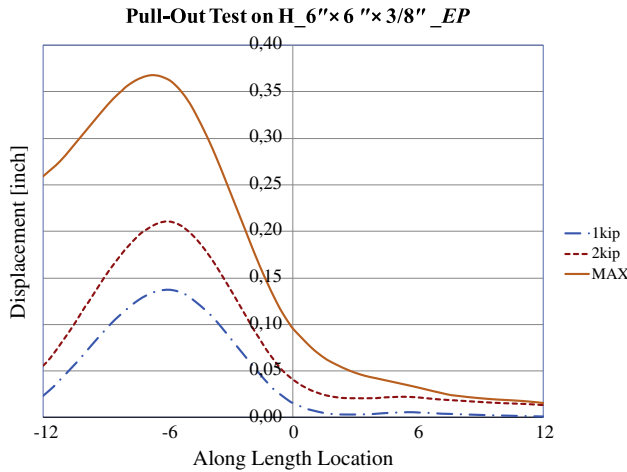
Fig. 33. displacement pattern along upper flange length for H_{6''} × 6'' × 3/8'' (152.4 mm × 152.4 mm × 9.5 mm)_{EP} specimen at loading-point.

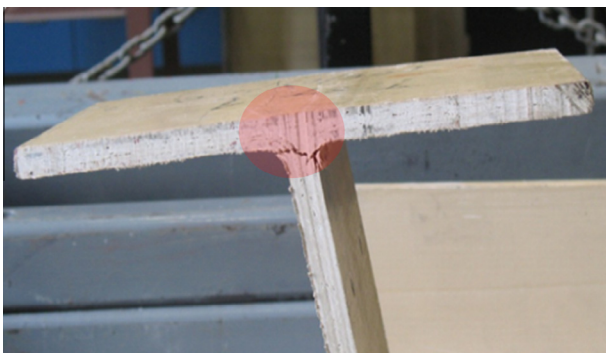
Fig. 37. Failure of $10'' \times 10'' \times 1/2''$ (254.0 mm \times 254.0 mm \times 12.7 mm) H-profile.

even though the relation between moment and rotation stayed linear up to 5.22 kip.in (589.79 kN mm) moment and 0.11 radian rotation angle. From here, large increases in rotation angle were observed with very small changes in moment up to 0.4 radian rotation angle. After this point, failure started to occur (Fig. 37). Fig. 38 shows the moment–rotation curve for the H-profile, while the linearized curve is shown in Fig. 39.

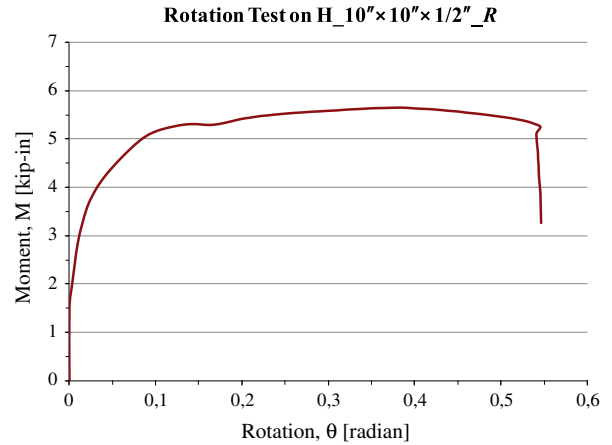
Fig. 38. Moment–rotation curve for H_{10''} \times 10'' \times 1/2'' (254.0 mm \times 254.0 mm \times 12.7 mm)_R specimen.

For this specimen, it was observed that the rotation was very small up to moment less or equal to 1.5 kip.in (169.5 kN mm). The relation between moment and rotation angle remained linear up to 3.56 kip.in (402.65 kN mm) moment and 0.02 radian rotation angle. After that level degradation in the stiffness started to occur,

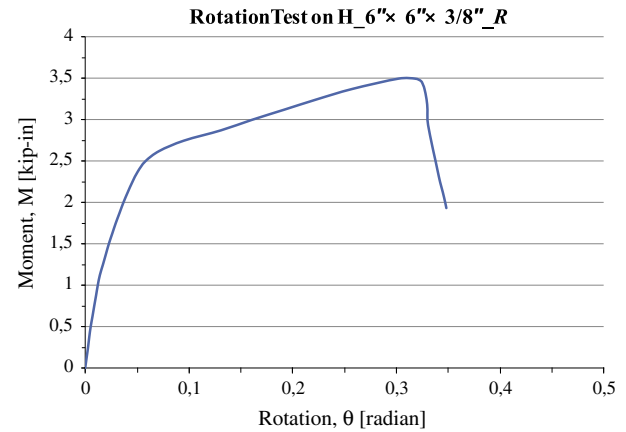
Fig. 44. Moment–rotation curve for H_6'' × 6'' × 3/8'' (152.4 mm × 152.4 mm × 9.5 mm)_R specimen.

For this specimen, identical behavior was noticed. The rotation was very small up to moment equal to 0.7 kip.in (79.1 kN mm); after which, the relation between moment and rotation angle was linear up to 2.63 kip.in (296.70 kN mm) moment and 0.07 radian rotation angle. Beyond this point degradation in the stiffness started to occur but the relation between moment and rotation remained linear up to 3.50 kip.in (395.62 kN mm) moment and 0.30 radian rotation angle, at which time failure occurred (Fig. 43). Fig. 44 shows the moment–rotation curve for the $6'' \times 6'' \times 3/8''$ H-profile, while the linearized curve is shown in Fig. 45.

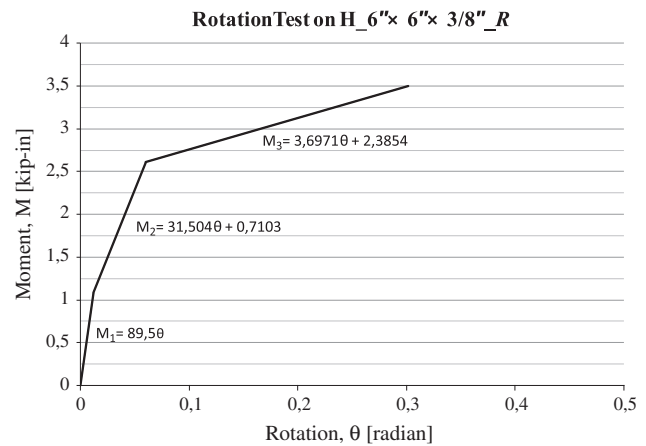
Fig. 45. Linearized moment–rotation curve for H_6'' × 6'' × 3/8'' (152.4 mm × 152.4 mm × 9.5 mm)_R specimen.

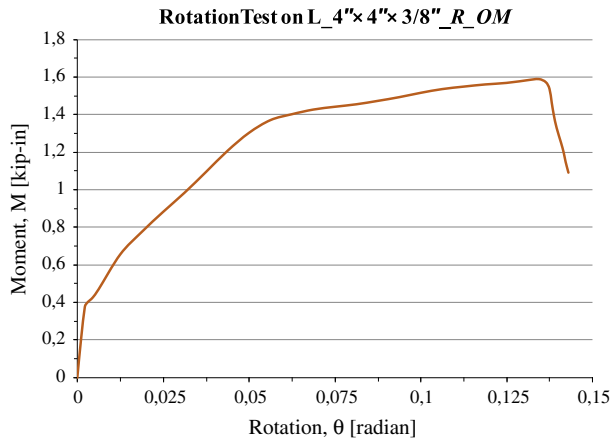
Fig. 51. Moment–rotation curve for $L_4'' \times 4'' \times 3/8''$ (101.6 mm \times 101.6 mm \times 9.5 mm) $_R_{OM}$ specimen.

For this specimen in open mode, it was observed that the rotation was very small up to a moment equal to 0.4 kip.in (45.21 kN mm). The relation between moment and rotation angle was linear up to 1.30 kip.in (147.47 kN mm) moment and 0.05 radian rotation angle. After that, increases in rotation angle were observed with small increases in moment till 0.13 radian rotation angle. After this point, the failure suddenly occurred (Fig. 46). Fig. 51 shows the moment–rotation curve for open mode of 4'' × 4'' × 3/8'' (101.6 mm × 101.6 mm × 9.5 mm) L-profile, while the linearized curve is shown in Fig. 52.
