Ecological History of Los Laureles-Goat Canyon

Ld Arch 227: River Restoration

Maria Lopez Vazquez

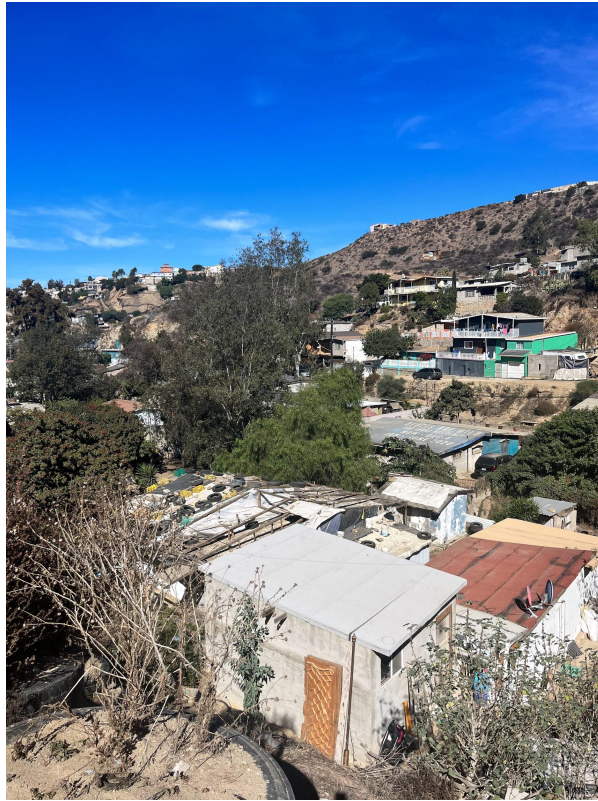
Figure 1-12 Aerial view showing dense vegetation. Figure 1-13 Above the channel looking down at the encroaching urban settlements (32.505925, -117.083453)

As I continued to track the stream upwards, there was a point where the channel changed direction and was no longer visible from the street, looking at an aerial view of the region, I realized the stream was not culvered because there was dense vegetation forming a corridor between houses Figure1-12.
