Understanding wood-pool dynamics using long-term monitoring data from the Gualala River Watershed: What can we learn?

A thesis submitted in partial satisfaction of the
requirements for the degree of

Master of Landscape Architecture

Spring 2012

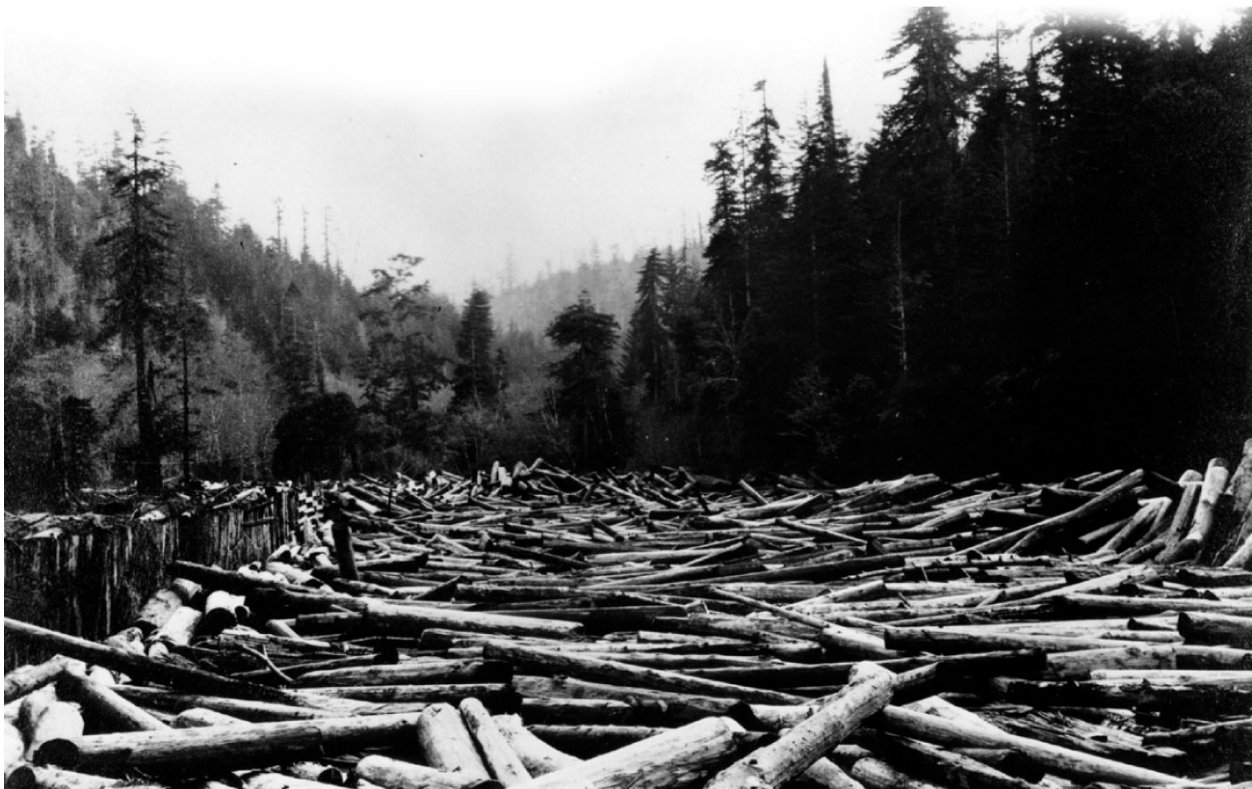
Wood jam on Big River. Historical photo courtesy of Klamath Resource Information System (KRIS).

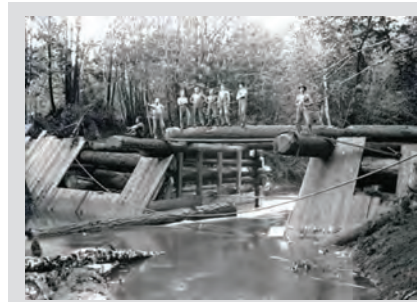
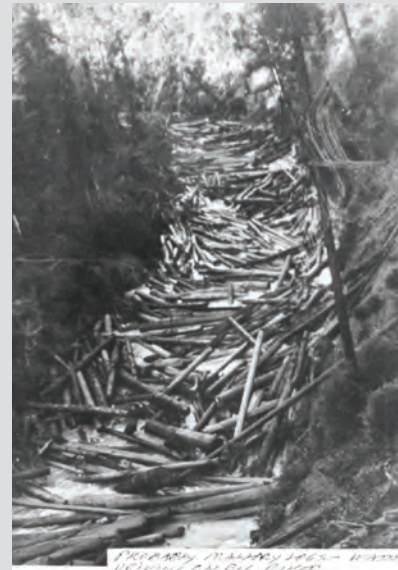
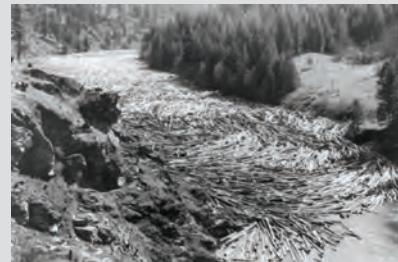
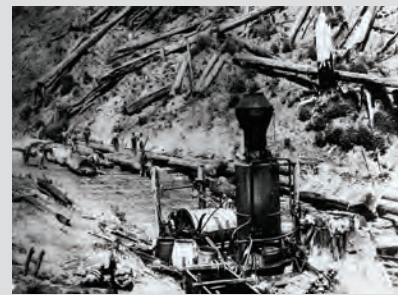
Legacy effects of destructive forestry practices. (top) Splash dams were used to transport logs during low flows or in smaller channels. (middle) Repeated log drives and log jams scraped away at the banks and streambed. (bottom) Instream roads and skids “paved over” the streambed.

“Splash damming” was a common practice used when natural flows were insufficient to transport logs, or where streams were too small to transport large logs (Bisson et al. 1987). Loggers would create a temporary dam across the stream to store wood and water until sufficient head was attained. By breaching the dam, the deluge would transport harvested logs to areas downstream where they could be easily transported and processed. The constant barrage of logs and water scraped away at the streambed and banks causing the channel to widen and severely modifying aquatic habitat. In extreme cases, the repeated impact of thousands of logs would scour the channel down to bedrock (Sedell and Luchessa 1981, Opperman et al. 2006, Harmon et al. 1986).

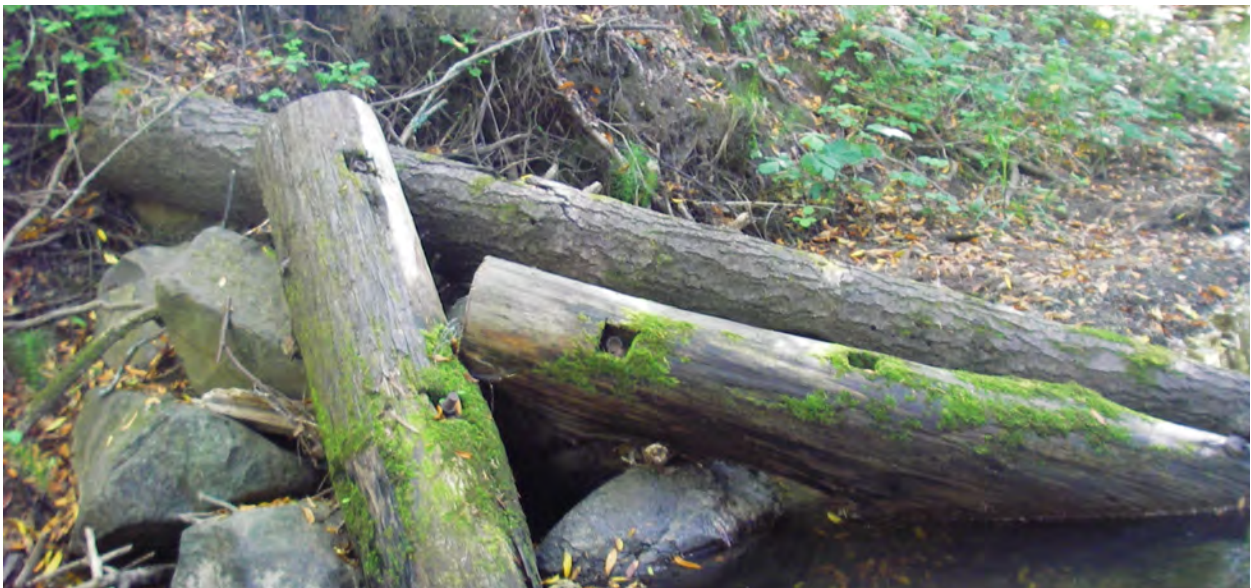
Artificial large wood structure bolted into boulders (Napa County).

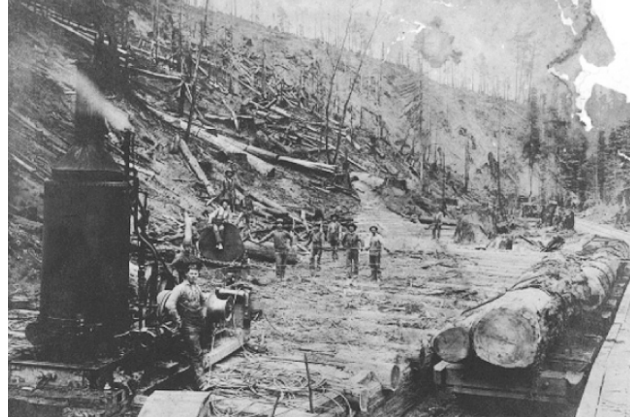
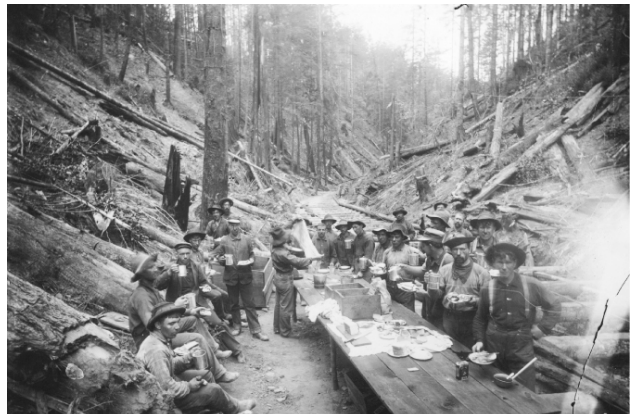
Historical photos of the deforestation and in-stream modifications imposed by timber harvest operations in the Gualala River Watershed. (top) Railroad landing and “steam donkey” circa 1902. (bottom) Logging crew circa 1905 and a streambed near the upper center paved with log sections. Photos provided courtesy of the Mendocino Historical Society and the Held Poage Memorial Home and Research Library.

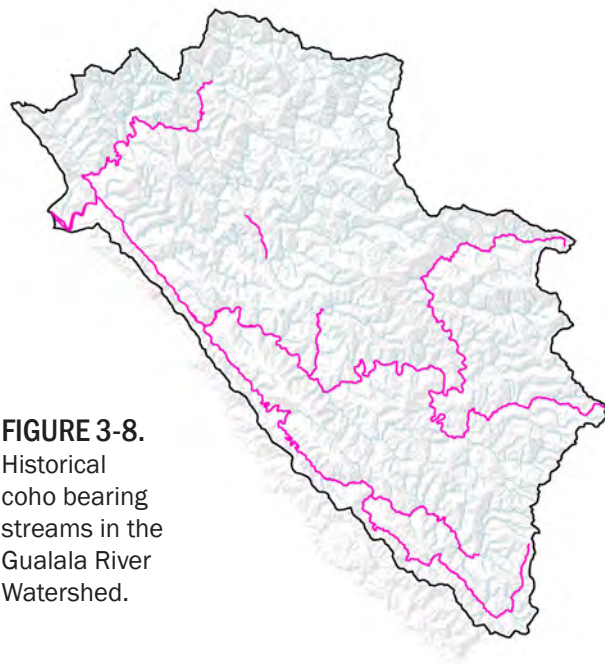
FIGURE 3-8.
Historical
coho bearing
streams in the
Gualala River
Watershed.

Coho and steelhead were historically abundant in the Gualala River watershed (LeDoux-Bloom 2002) (Figure 3-8). Coho salmon naturally inhabited the streams flowing from coniferous forests, but likely were sub-dominant to steelhead trout in interior areas due to the more open nature of the channels, less suitable habitat, and naturally warmer stream temperatures (the interior is largely grassland with scattered oaks).

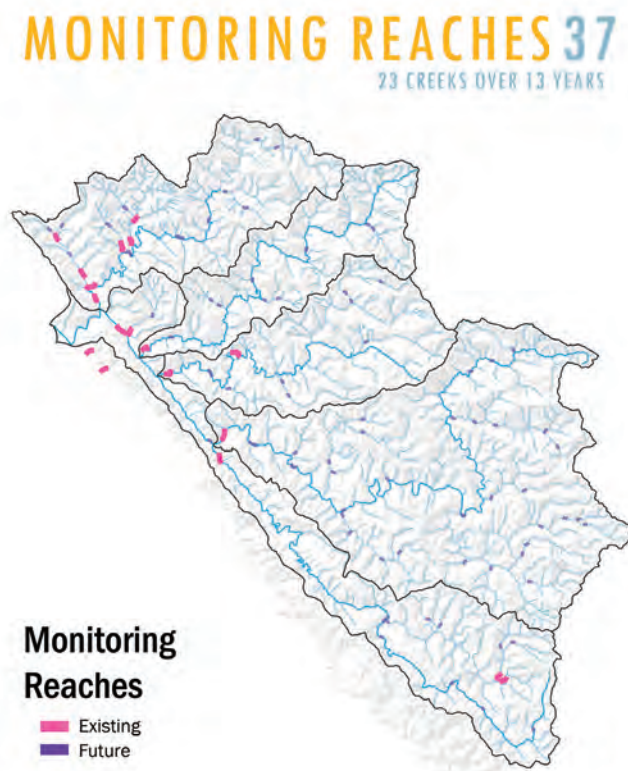
FIGURE 3-9. Location of current (pink) and future (purple) GRWC monitoring reaches in the Gualala River Watershed.

The Gualala River Watershed Monitoring Program was designed to examine and understand watershed conditions through the collaboration of private landowners, community groups and public agencies. Since 1998, GRWC has installed 37 monitoring reaches distributed throughout the watershed (Figure 3-9).

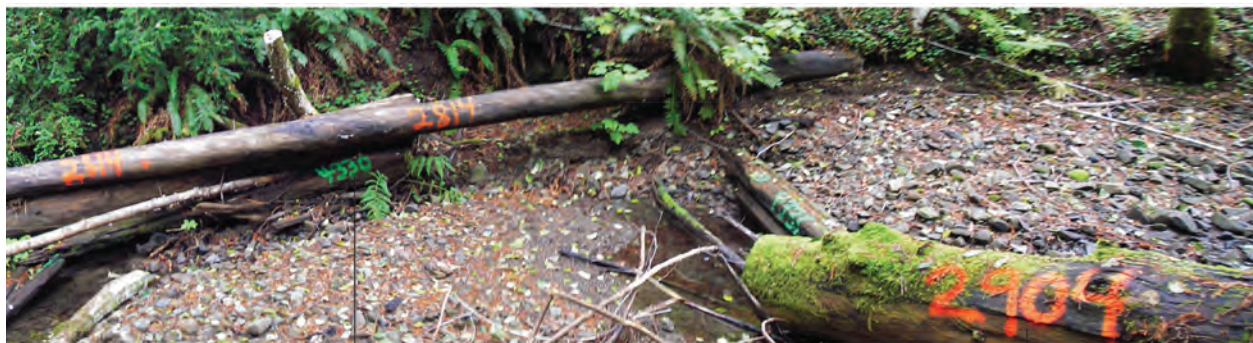
Large wood accumulation cause by wood pieces introduced by the GRWC (orange numbering) as well as naturally recruited wood (green numbering) [left bank looking toward right bank].

ID: #4330
 Installed: n/a
 Type: Log Jam
 Species: Red Alder
 Diameter: 12 in
 Length: 12 ft

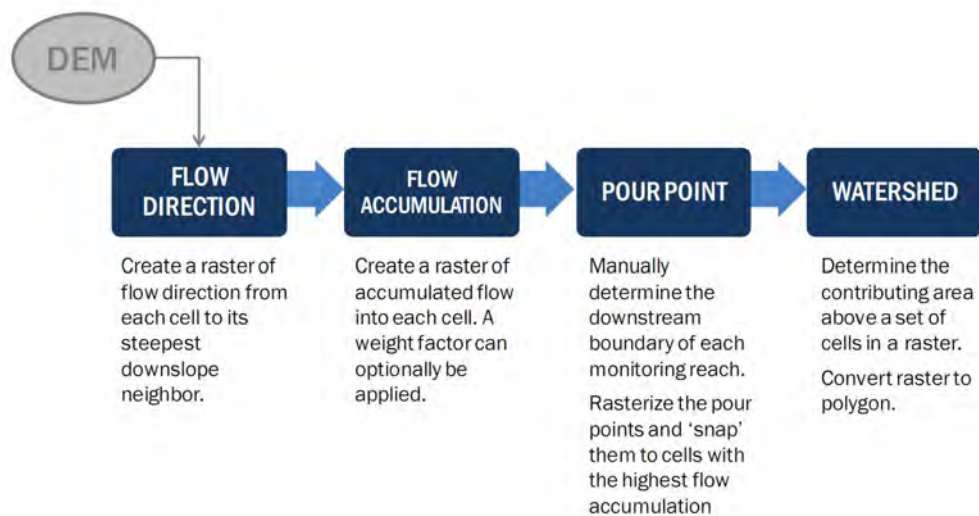
FIGURE 5-1.
Process for determining contributing watershed area.

The subbasin-scale analyses required delineating the upstream drainage area (contributing watershed area) of each of the four reference reaches (Figure 5-1). The delineated subbasins were used to determine the area draining to each reference

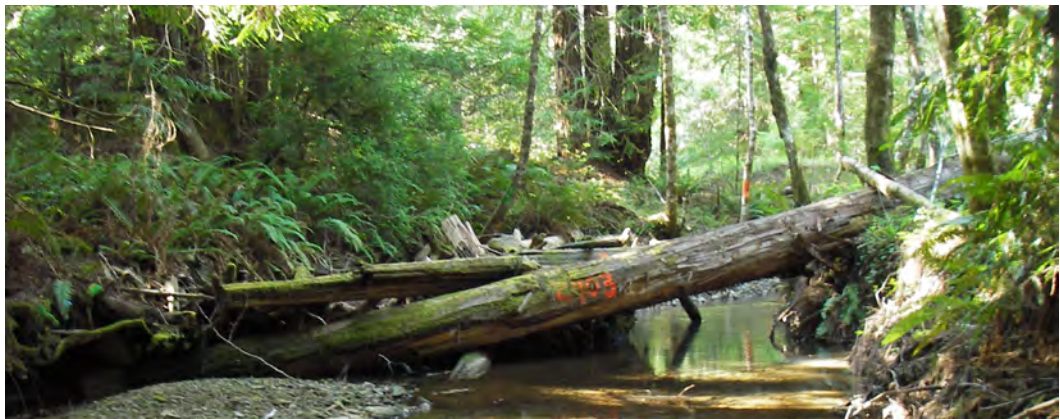
FIGURE 6-1.
Wood density
(number of pieces
per 1000 ft) at all
four references
reaches, 1998 to
2010.

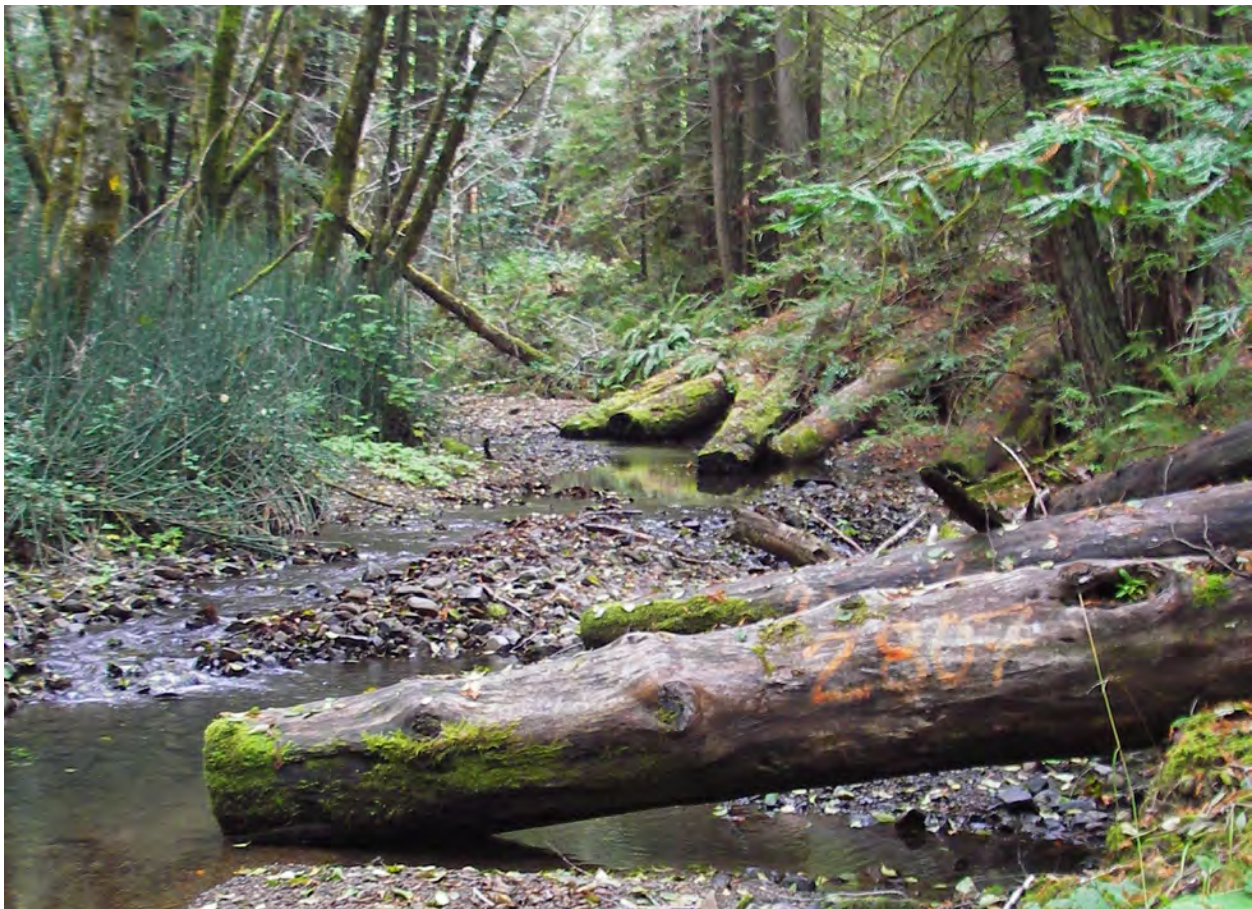
Wood volume (cu. ft. of wood per 1000 ft) in the in the bankfull channel at all four reference reaches, 1998 to 2010.

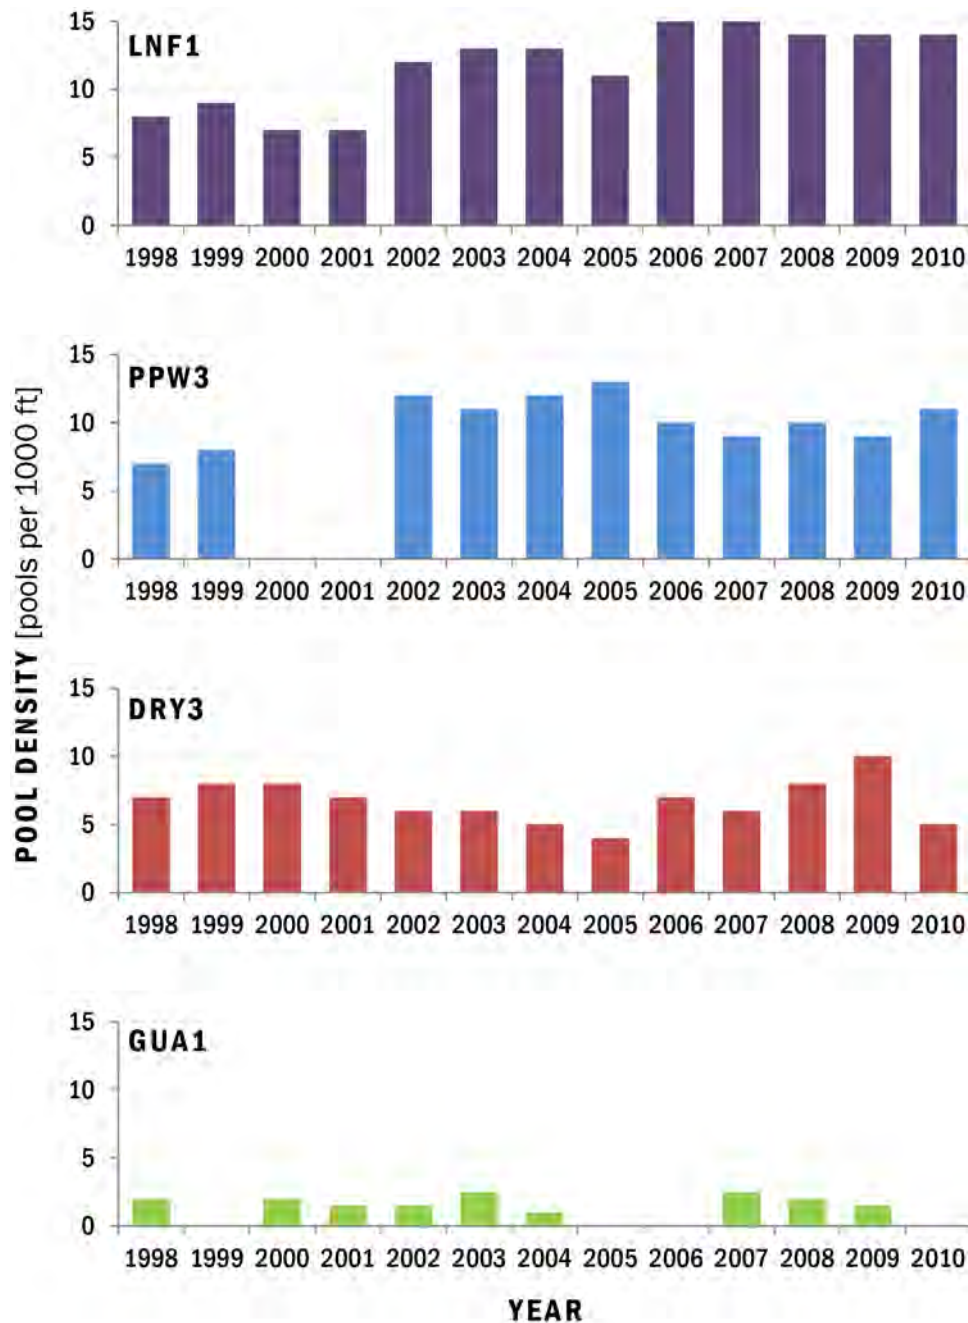
FIGURE 6-5. Pool density (number of pools per 1000 ft) at all four reference reaches, 1998 to 2010.

Pool density (number of pools >1 ft deep per 1000 ft) increased overall at LNF1 from 8 to 14 pools per 1000 ft (Figure 6-5). Pool density was more variable at PPW3, DRY3, and GUA1. PPW3 increases from 7 pools per 1000 m in 1998 to peak at 13 pools in 2005, but then declined in subsequent years. Conversely, DRY3 increased from 7 pools in 1998 to 8 pools in 2000, before declining to a low of 5 pools in 2005 and then peaking at 10 pools in 2009. Pool density at GUA1 remained consistently low throughout the period of record, never exceeding 3 pools per 1000 ft.

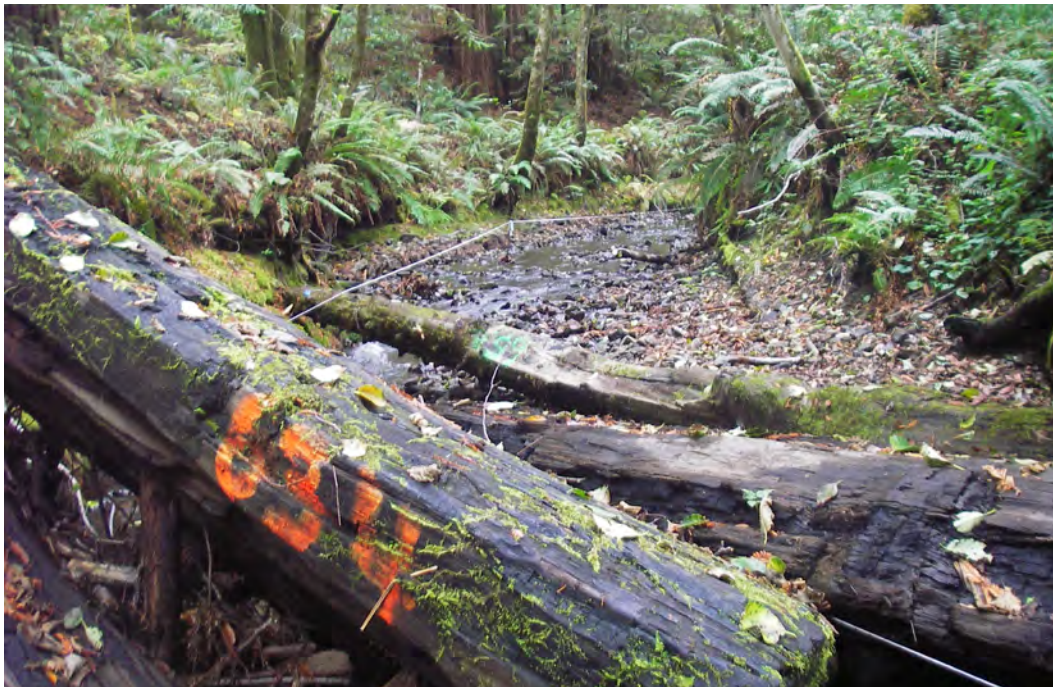
2011 thalweg survey in progress at Big Pepperwood Creek.

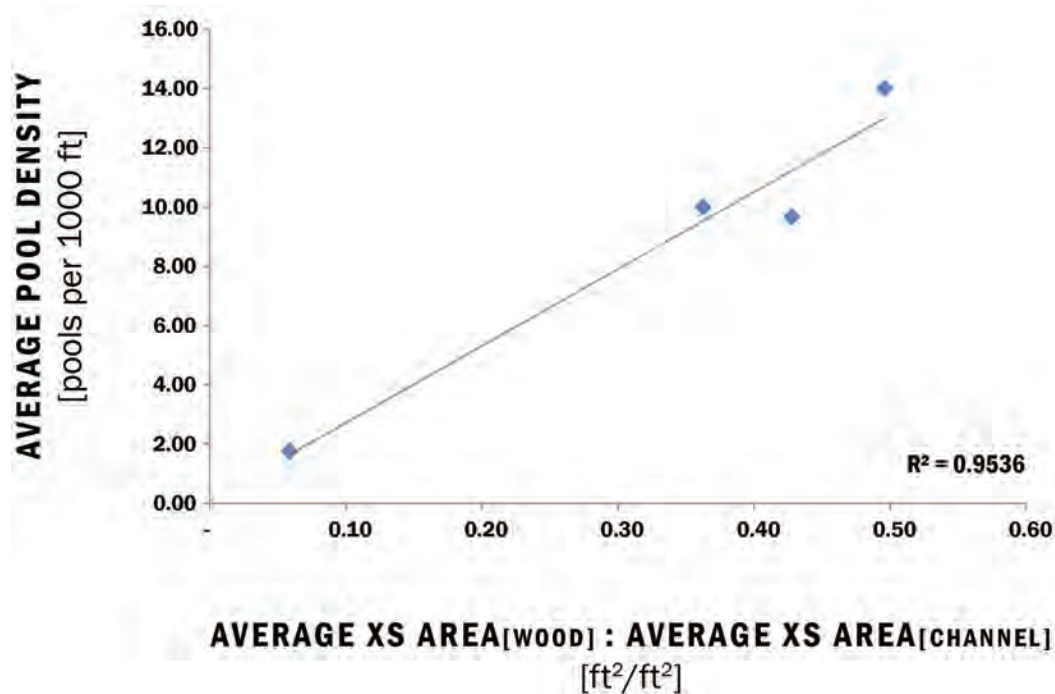
FIGURE 6-17. Average pool density relative to the portion of the bankfull channel, 2008-2010.

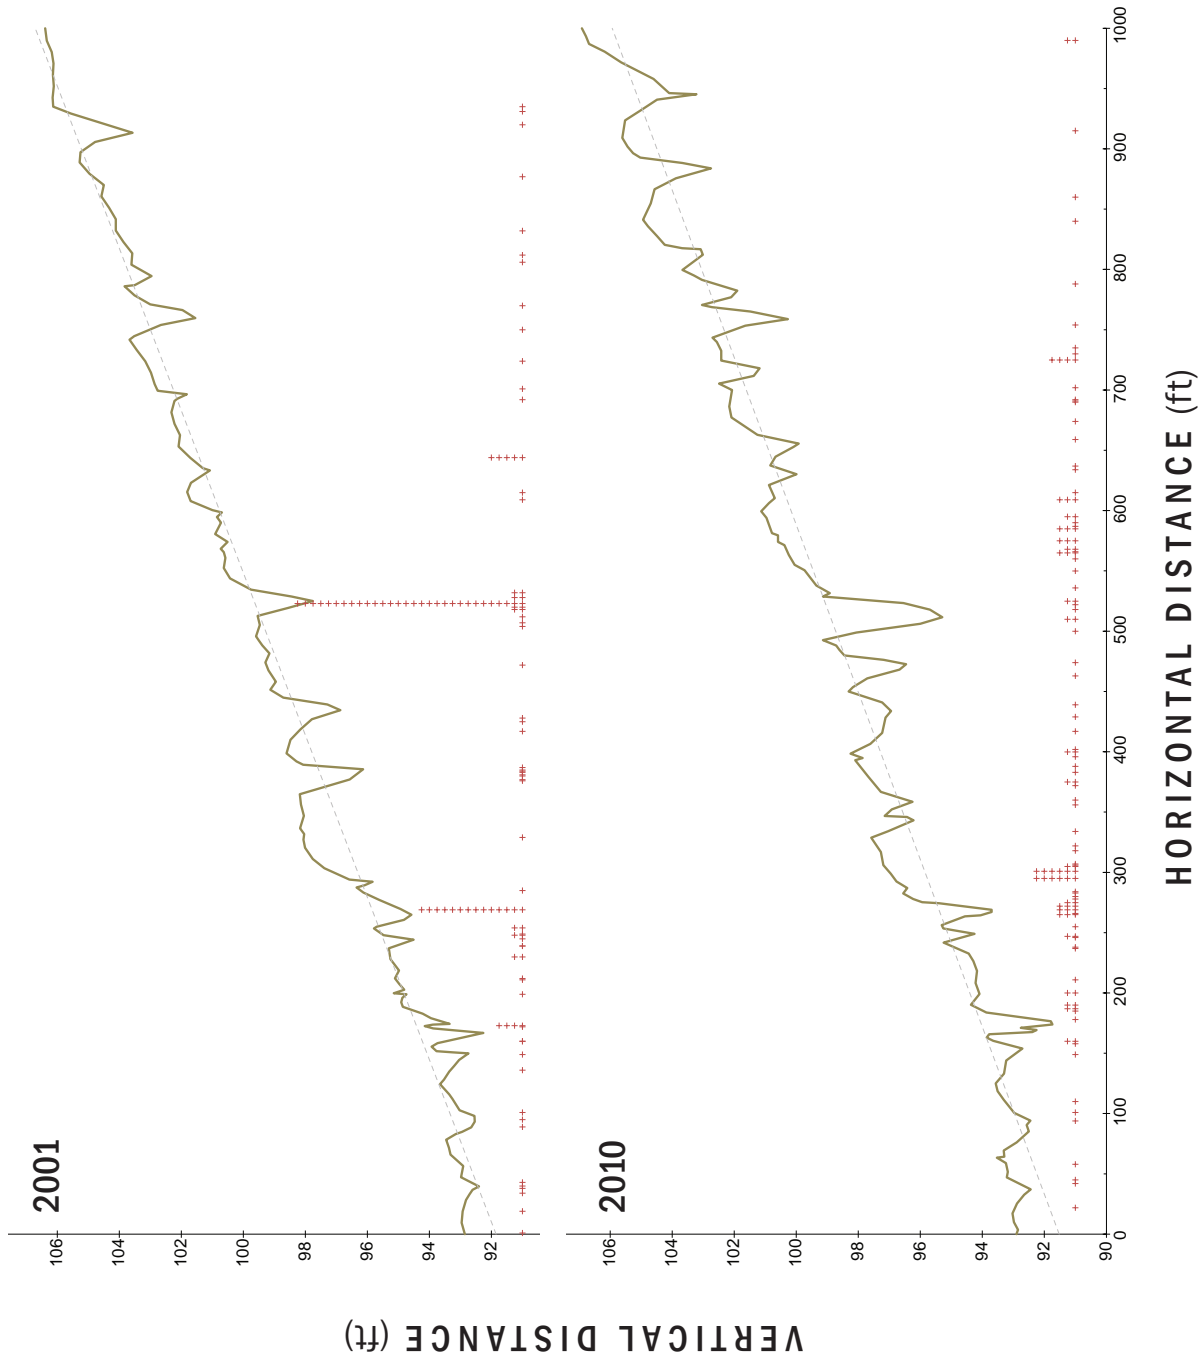
FIGURE 6-19. Concentration of wood pieces along the thalweg profile for LNF1 for 2001 (top) and 2010 (bottom). Red markers indicate wood pieces along the profile.

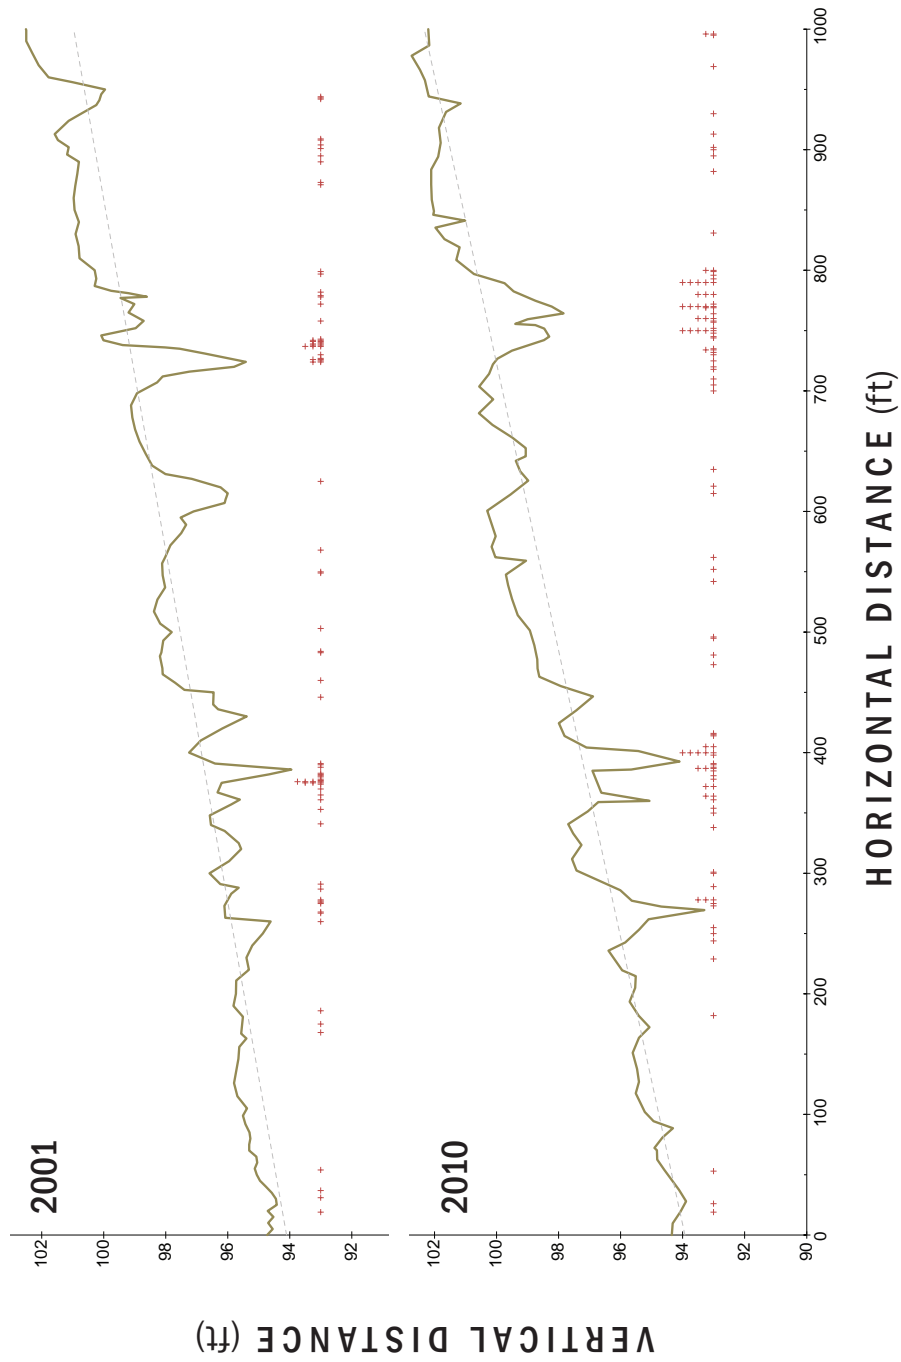
FIGURE 6-20. Concentration of wood pieces along the thalweg profile for DRY3 for 2001 (top) and 2010 (bottom). Red markers indicate wood pieces along the profile.
