Pedogenic Process in Engineered Soils for Radioactive Waste Containment

Doctor of Philosophy

Geography

Fall 2019

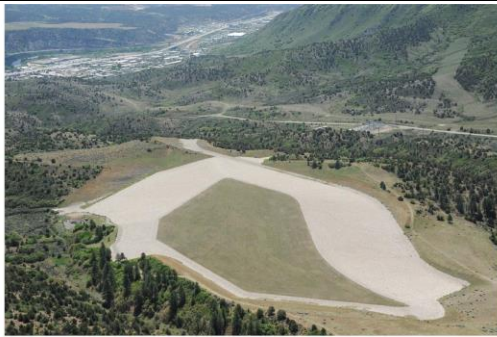
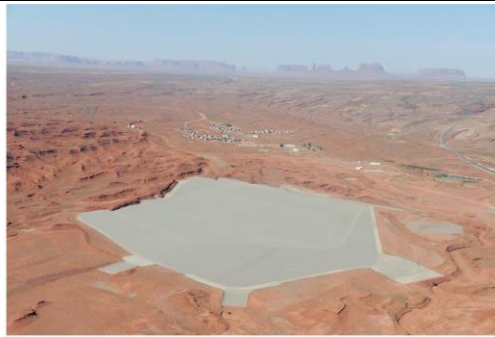
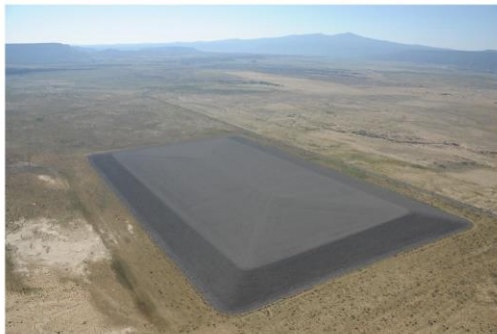
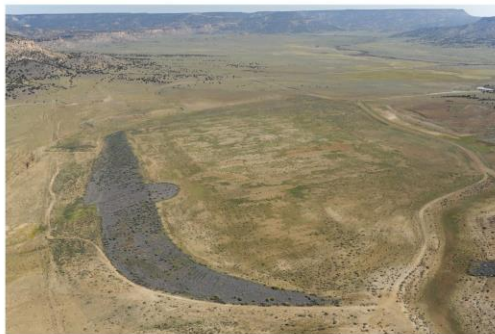
Figure 1.1: Engineered disposal cells of the UMTRCA program

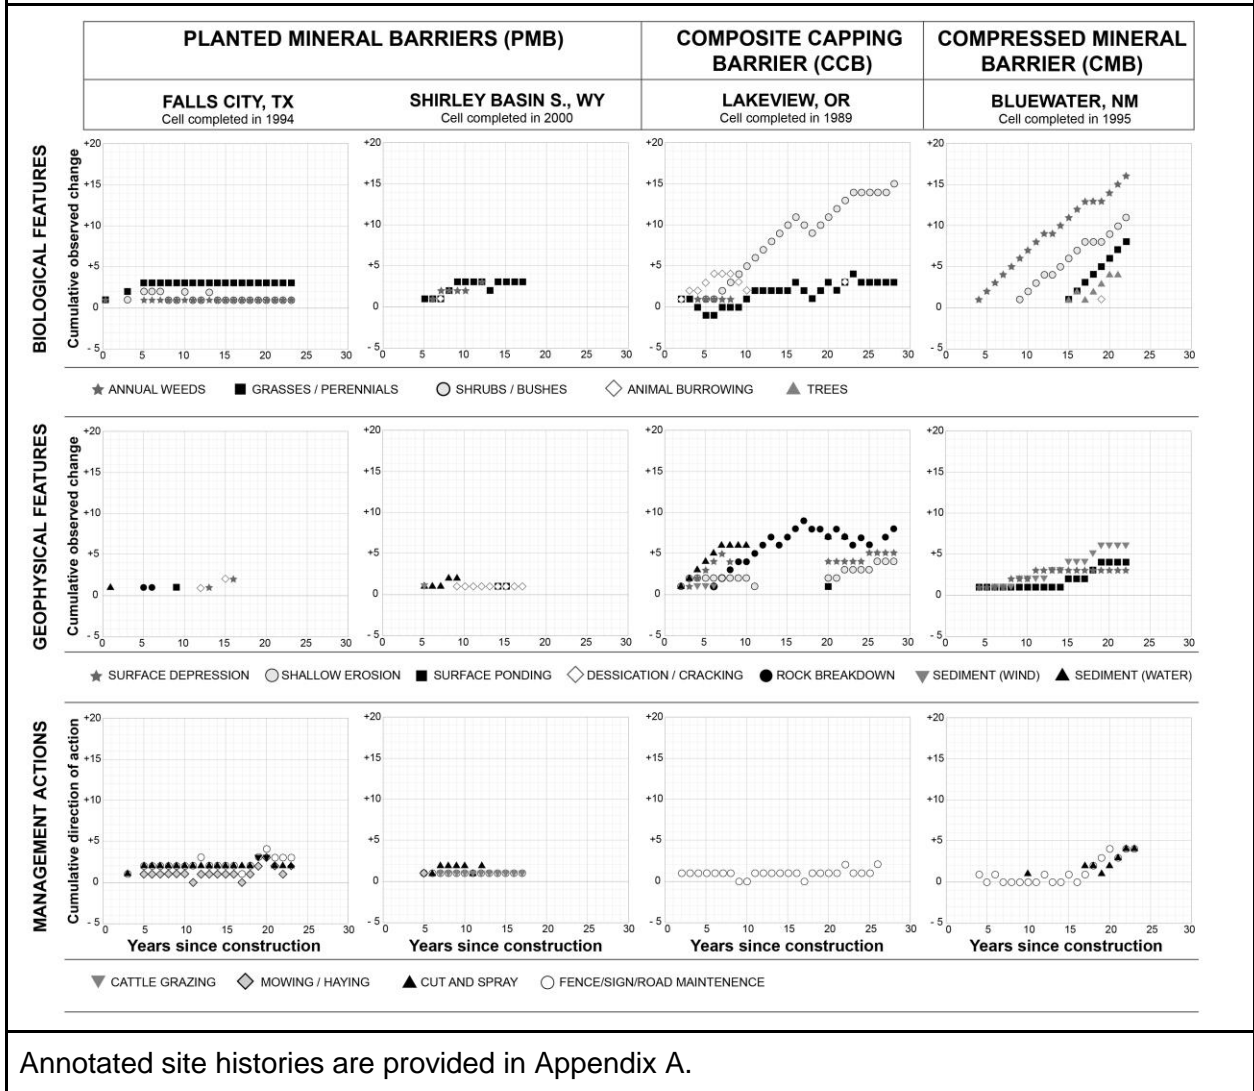
Figure 2.1: Delta graphs of biological and geophysical surface feature development and management actions

The site-to-site variation in observed biological and geophysical surface features largely corresponds with original design and ongoing surface management strategy. Delta graphs that track the cumulative direction of biological and geophysical surface feature development (Figure 2.1) show that the deep Planted Mineral Barriers (PMB) at Falls City and Shirley Basin behaved most evenly over space and time with the fewest increases or decreases to observed surface condition. Conversely, the shallow Composite Capping Barrier (CCB) at Lakeview and the shallow Compressed Mineral Barrier (CMB) at Bluewater are characterized by the cumulative, and patchy, emergence of both biological and geophysical surface features through time. With exception to an increase in average daily minimum and maximum temperature at the Shirley Basin site, temperature and precipitation anomalies have remained largely consistent (with episodic seasonal variation), and any connection between surface feature occurrence and climate appear to be negligible at this time interval. A time sequence of surface process and management events, for each site, can be found in Appendix A.

Delta graphs for both Bluewater and Lakeview show that cumulative change has occurred across almost all monitored categories. A total of 42 annual changes (41 increases, and 1 decreases) across all biological surface features, in addition to 12 annual changes (12 increases) across all geomorphic features were observed at the Bluewater site between construction in 1995 and 2017 (21 years). At the Lakeview site, a total of 41 annual changes (30 increases, and 11 decreases) across all biological surface features, in addition to 41 annual changes (32 increases, and 9 decreases) across all geomorphic features were observed between construction in 1989 and 2017 (28 years). The emergence of novel landform features is clear in the time series photographs for these sites (Figure 2.2).

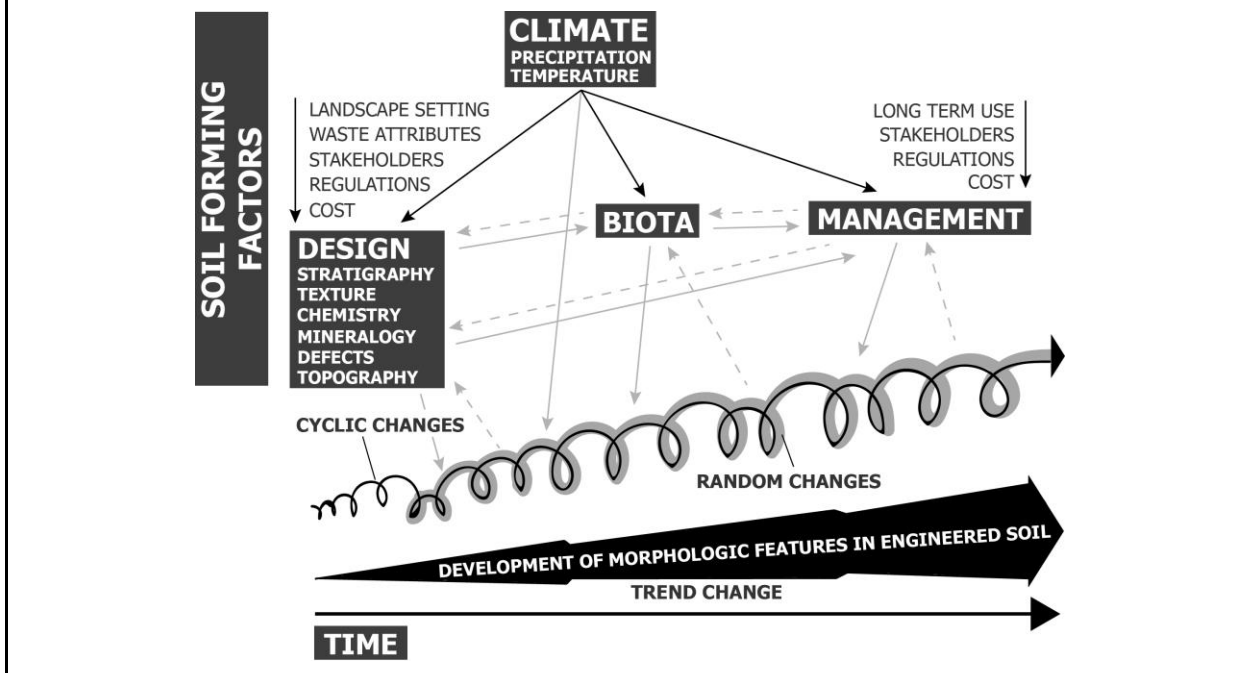
Figure 3.1: Soil forming factors in engineered soils for waste containment

Solid black arrows represent the dominant direction of influence. Solid gray arrows represent interactions. Dashed arrows represent a feedback between factors and cyclical, random and trend changes. Based on Lin, (2011).

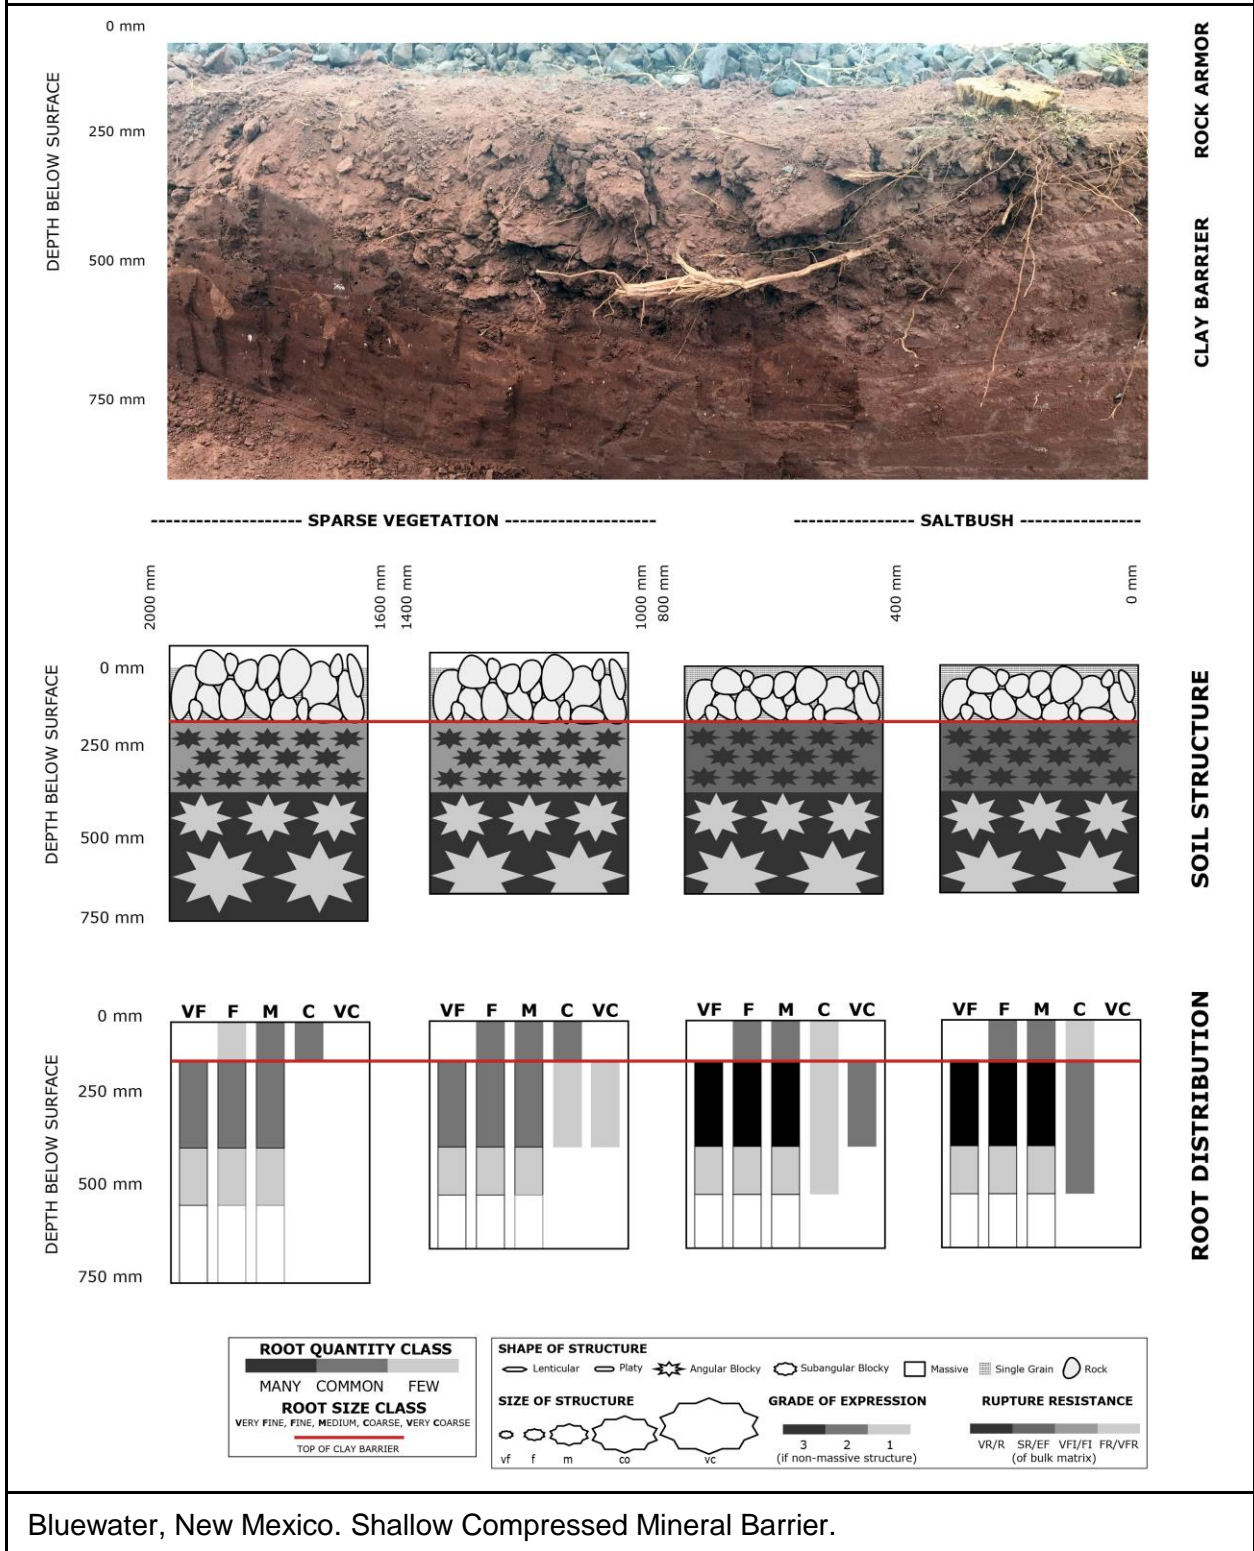
Figure 4.8: Fourwing saltbush soil morphology impact gradient.

Bluewater, New Mexico. Shallow Compressed Mineral Barrier.

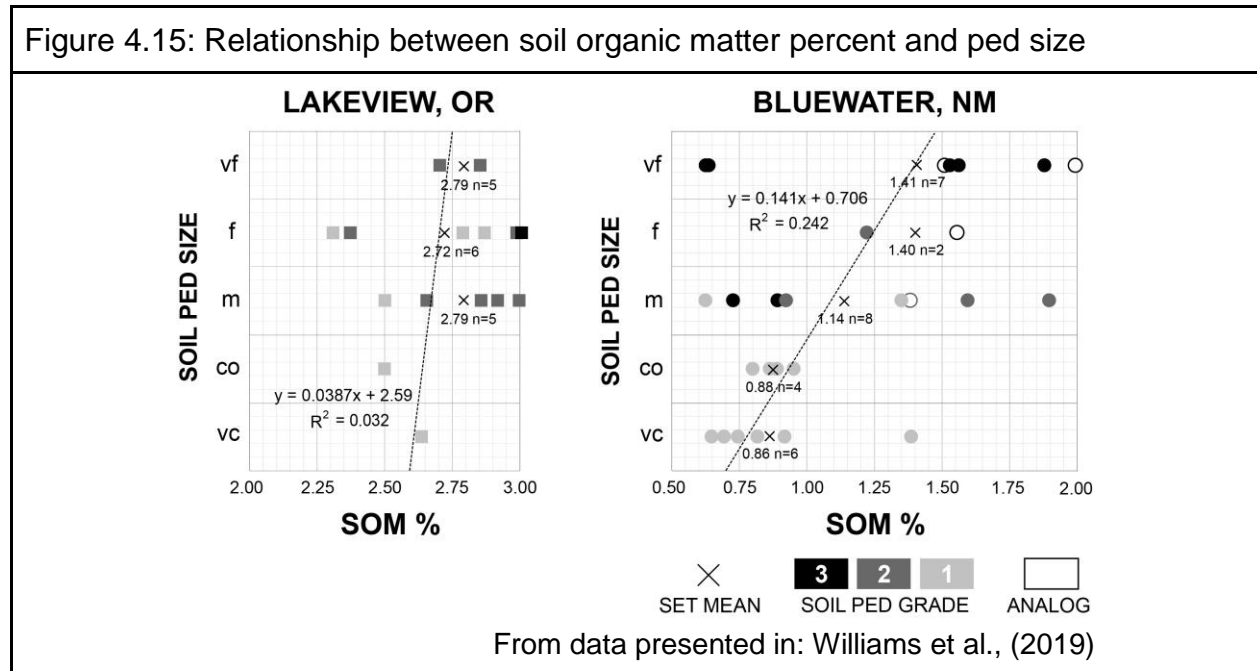
The relationship between the soil organic matter fraction and soil ped (structural unit) size in the clay barriers at Lakeview and Bluewater show weak trends (Figure 4.15). As soil organic carbon content increases, ped size tends to decrease at Bluewater ($R^2 = 0.242$). The trend is insignificant at Lakeview ($R^2 = 0.032$). Ped size contributes to the regulation of hydraulic conductivity (Benson et al., 1994; Lin et al., 1999a) with potential impacts to long term cover performance. As such, feedbacks between vegetation establishment, soil organic carbon deposition, and evolved soil ped size in bioturbated clay barriers is of

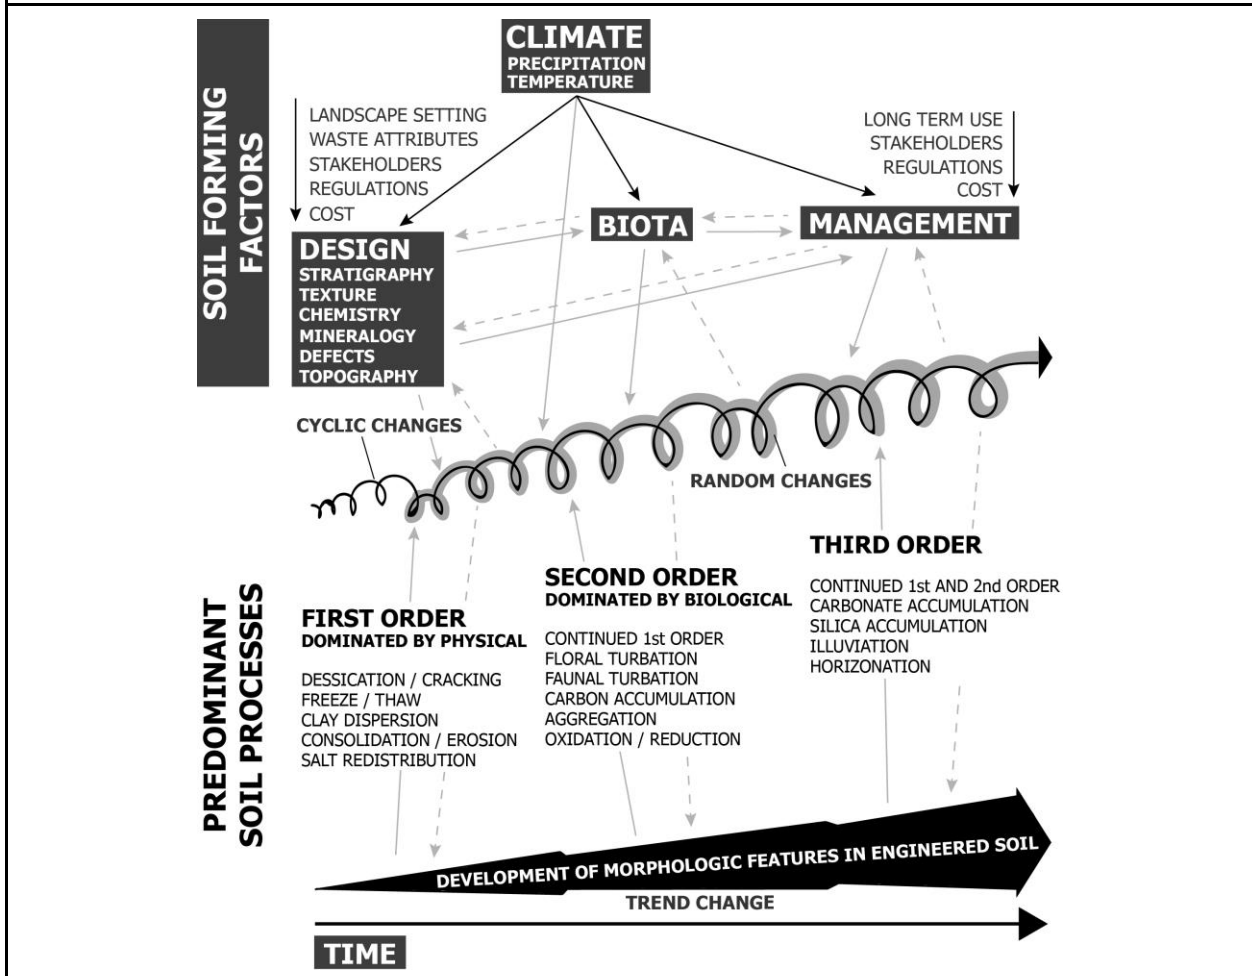
Figure 4.18: Site factors, soil process, and morphological development in engineered soils for waste containment

Conceptual model of the co-evolution of soil process and morphology in engineered clay barrier systems based on Lin, (2010). Solid black arrows represent the dominant direction of influence. Solid gray arrows represent interactions. Dashed arrows represent a feedback between factors, change, soil processes, and morphology. The time step evolution of soil process is based on Targulian and Krasilnikov, (2007).

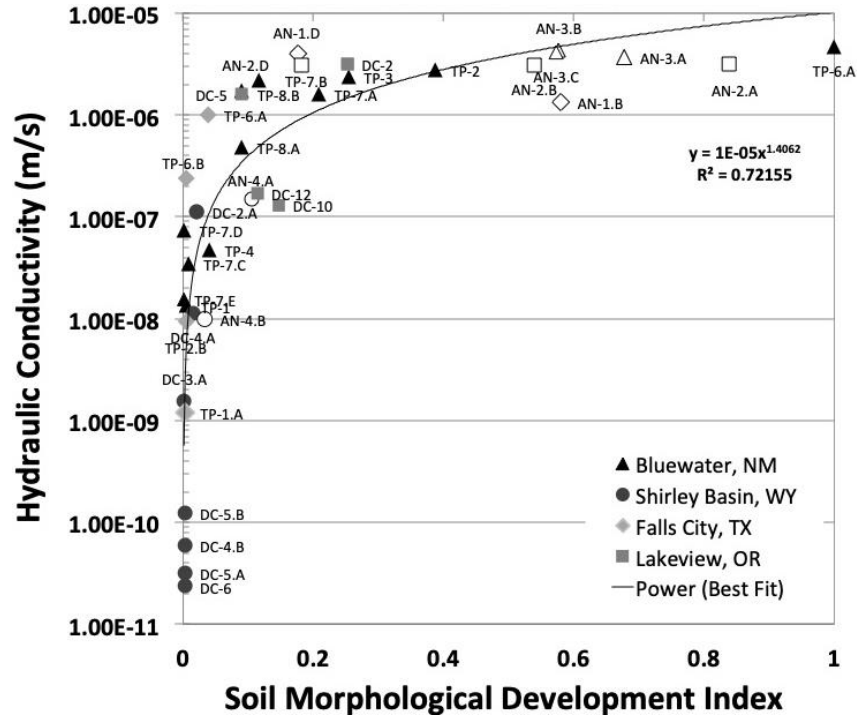
Figure 5.5: Impact of soil morphological development on saturated hydraulic conductivity, across all profiles and sites

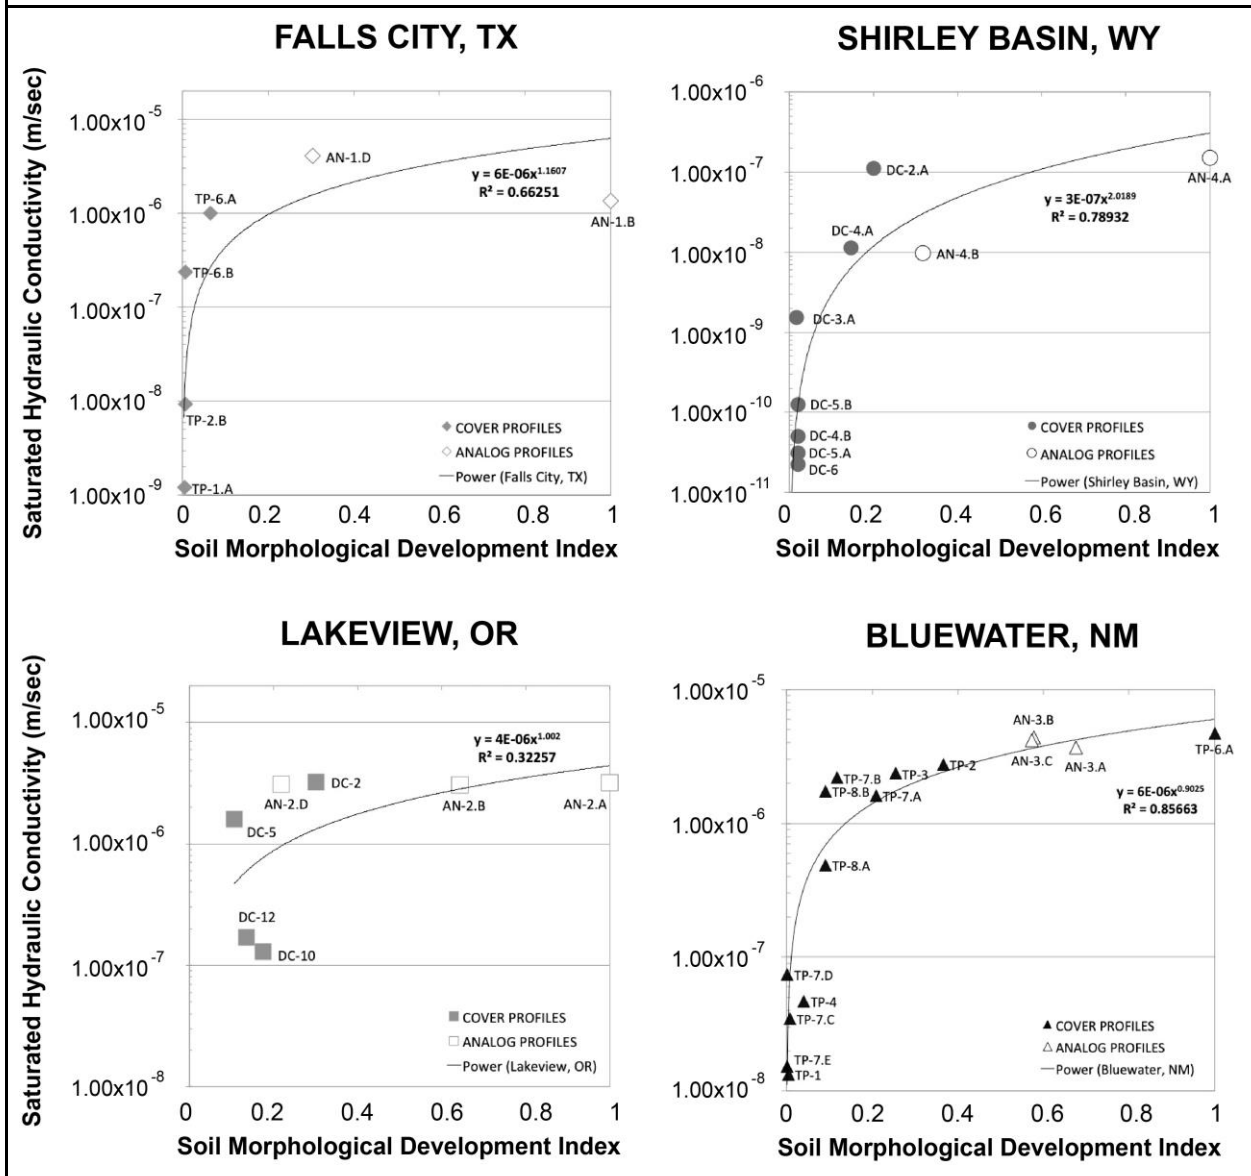
Figure 5.6: Impact of soil morphological development on saturated hydraulic conductivity, within sites

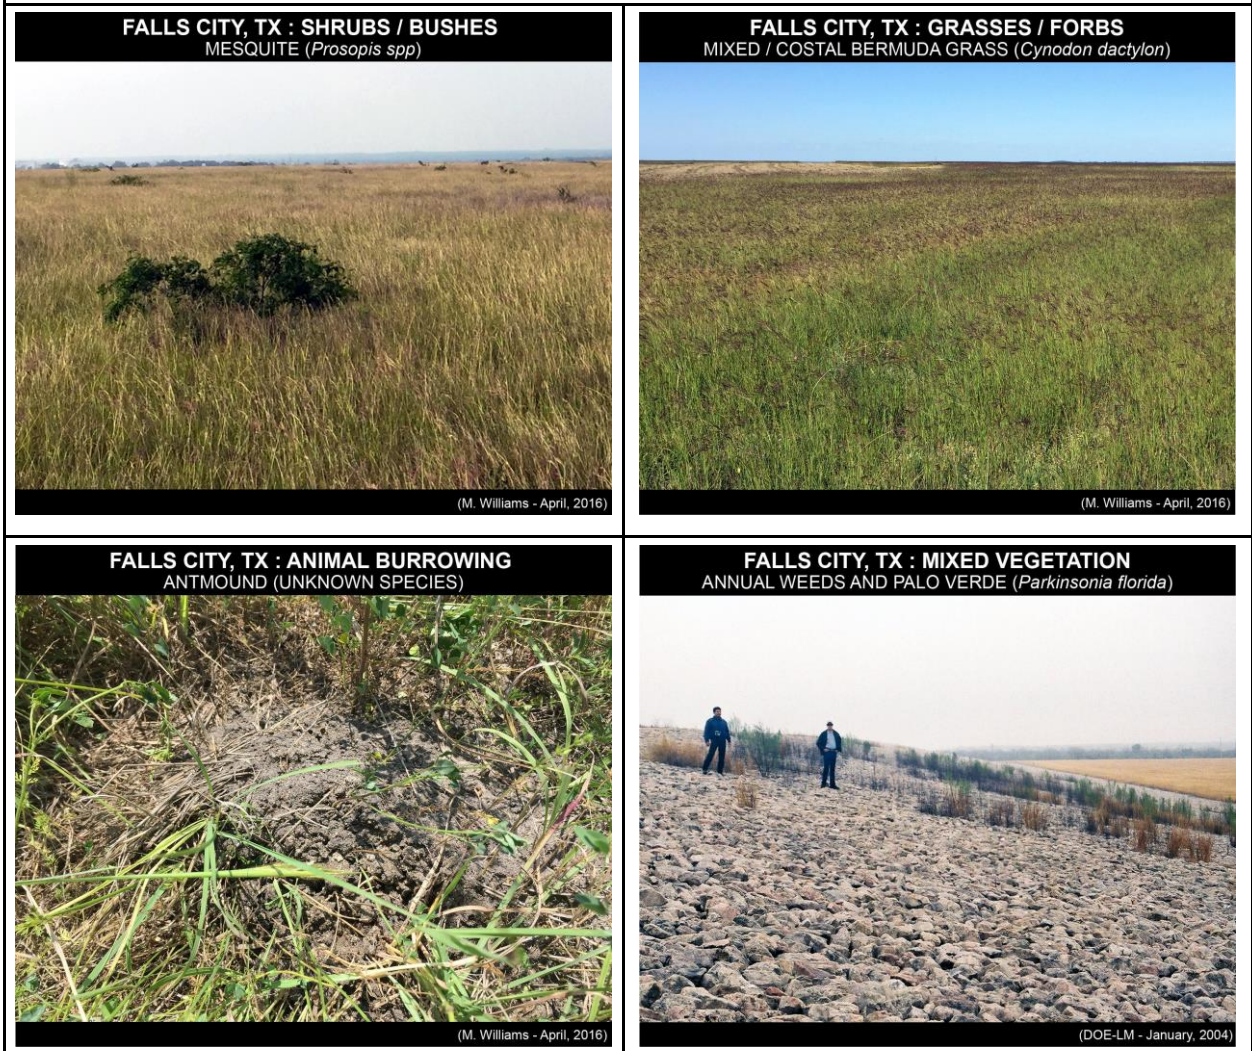
Figure A.2. Falls City, TX : Surface Features Characteristic of Biological Processes

burrowing by ants at Falls City (Appendix A. Figure 2: Animal burrowing), the deposition of sediment by water at Bluewater (Appendix A. Figure 6: Sediment collection), and the incidence of a sporadically emergent shrub (saltbrush) at the Shirley Basin site. While animal burrowing was observed during annual inspections at Bluewater (Badgers in 2014), Lakeview (Badgers across several years; rodents in 2011), and Shirley Basin (Badgers in 2007), site inspections did not document the incidence of harvester ant mounds at Bluewater (Appendix A. Figure 5: Animal burrowing), the incidence of rodent burrowing at Bluewater (Appendix A. Figure 5: Rodent burrowing), ant mound burrowing at Lakeview (Appendix A. Figure 7: Animal burrowing) or rodent burrows at Shirley Basin (Appendix A. Figure 11: Animal excavation).

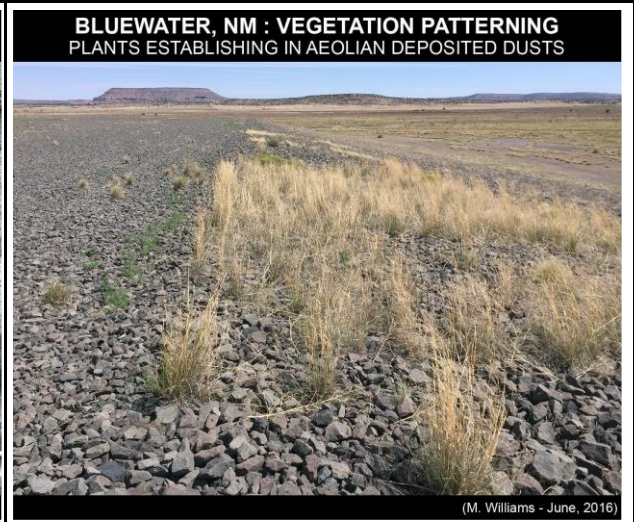
Figure A.5. Bluewater, NM : Surface Features Characteristic of Biological Processes

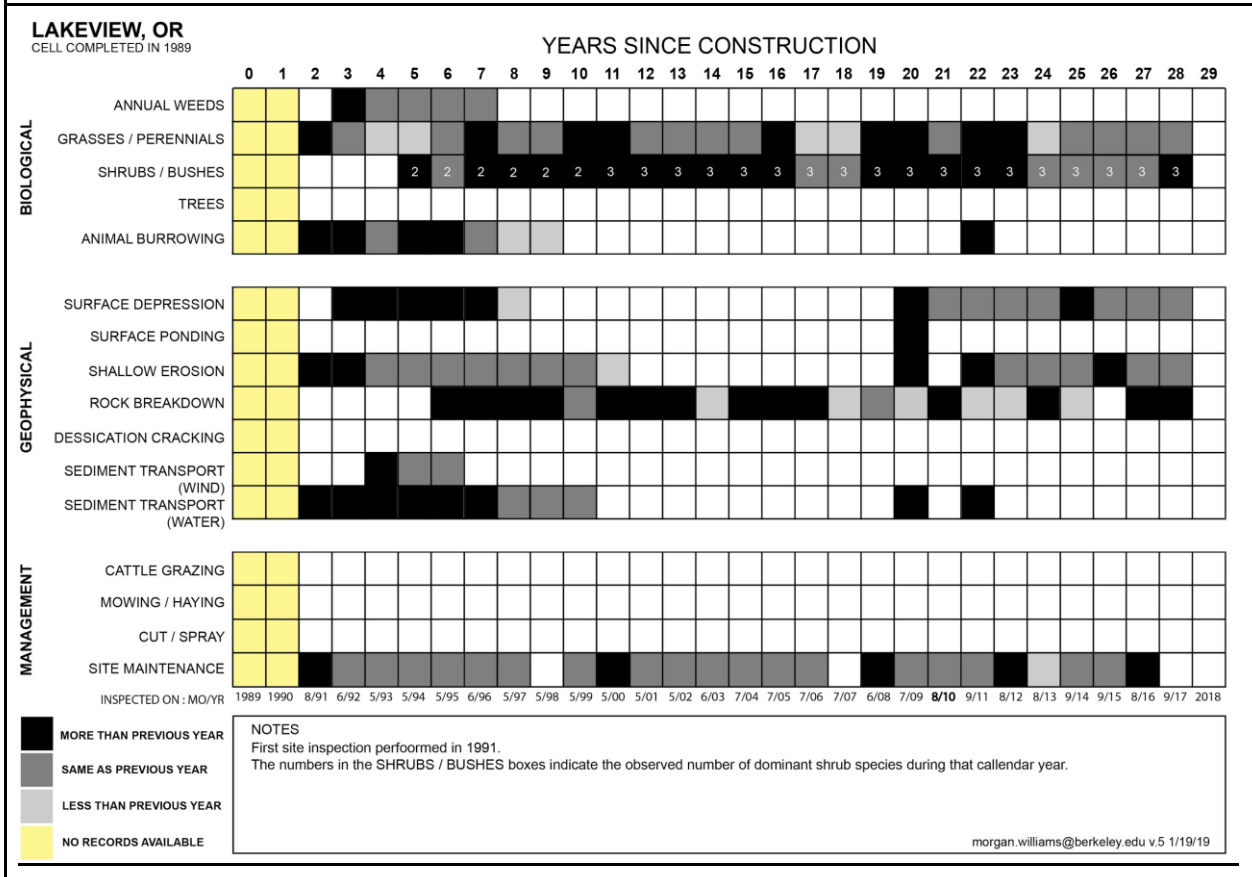
Figure A.7. Lakeview, OR : Surface Process History

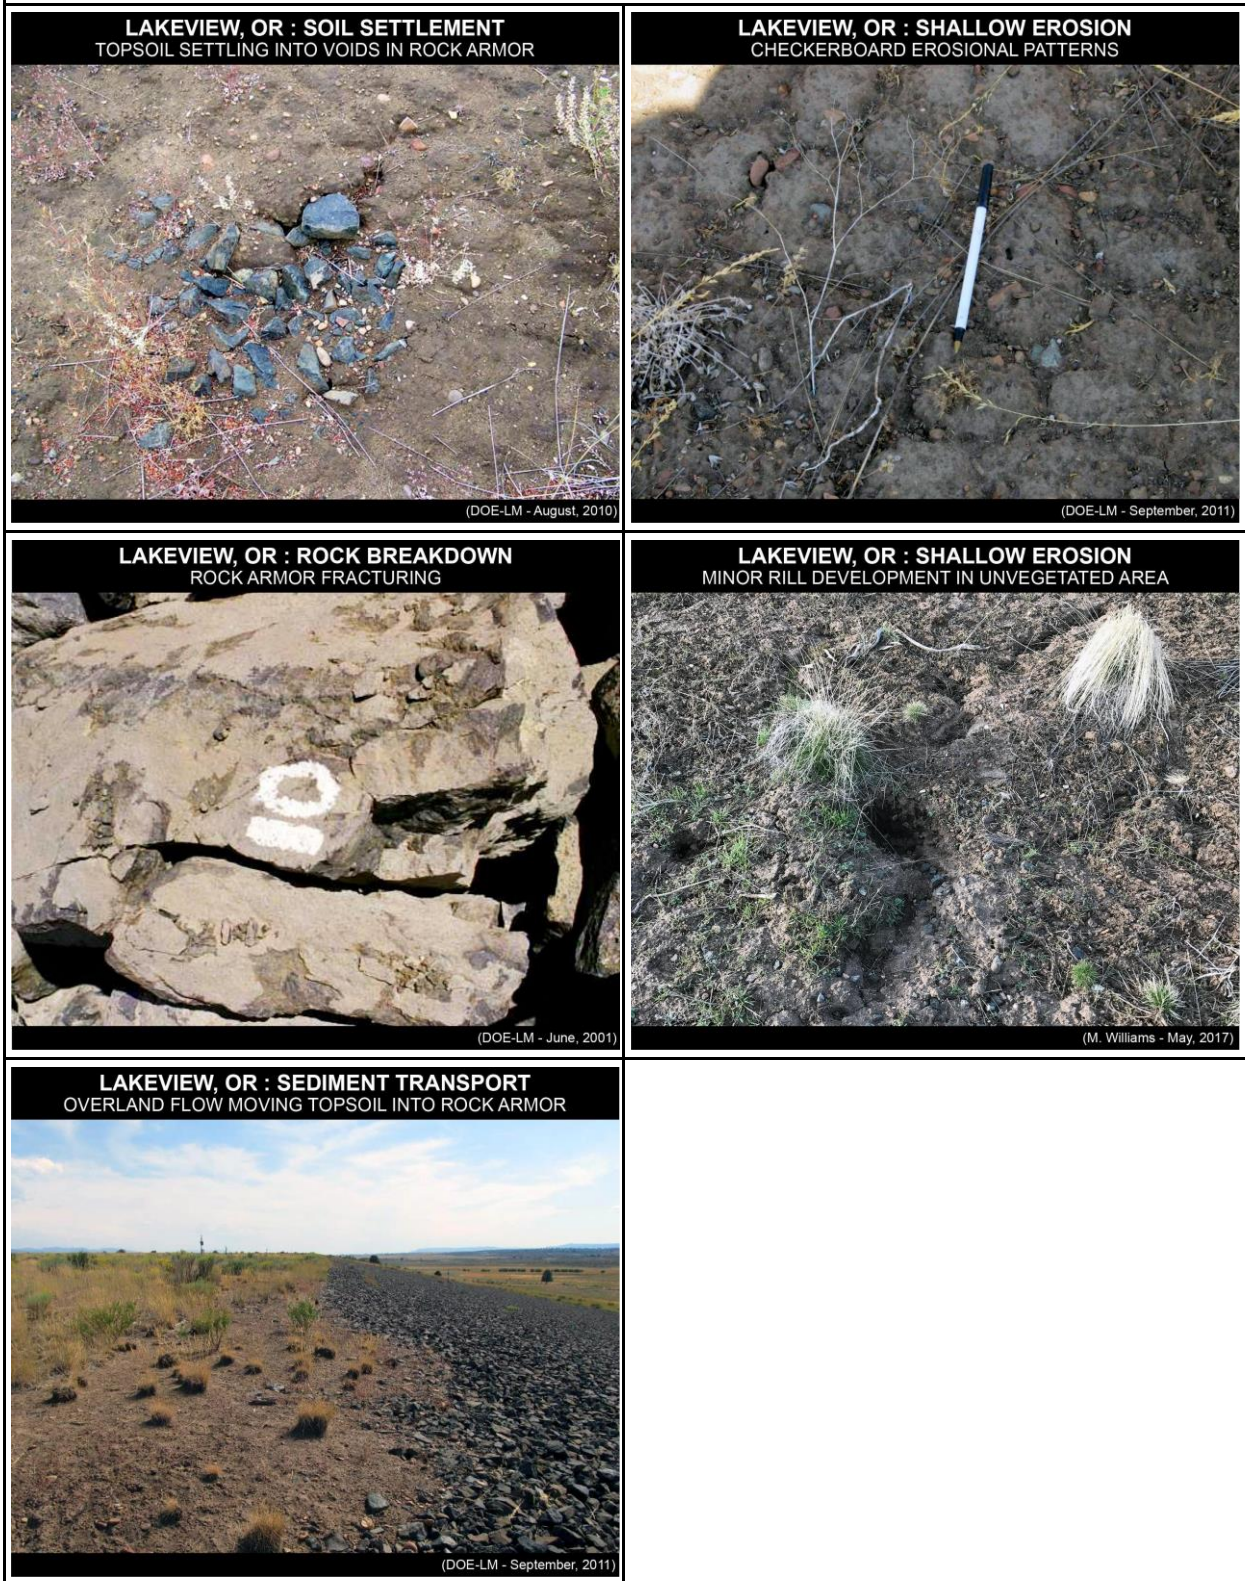
Figure A.9. Lakeview, OR : Surface Features Characteristic of Geophysical Processes

The emergence of various geophysical features including shallow erosion, rilling, wind scouring, and the transport of topsoil into side slope rock armor (Appendix A. Figure 9: Sediment Transport) have been observed, to varying degrees of significance, since monitoring began at Lakeview. With exception to the time period between 2000 and 2008 (a time that site inspection reporting contained far less language relevant to surface feature observations, generally), these erosional features were commonly tracked. In 1995 (six years after cell construction), rock armor on the side slope was observed to be deteriorating, with 10-15% of rocks crumbling in some areas (Lakeview Annual Site Inspection Report, 1995). A rigorous annual monitoring effort was then implemented. Between 1997 and 2017, rock armor monitoring indicated that mean diameter (D_{50}) was below the original design range in 14 of the 20 years sampled, however a trend analysis of D_{50} values determined, at the 95% confidence level, that mean rock diameter has not significantly decreased since monitoring began (Lakeview Annual Site Inspection Report, 2017). Rock breakdown at Lakeview has been attributed to the presence of microfractures present in some of the basalt materials and physical processes including shrink/swell and freeze/thaw. In 2002, concerns about rock breakdown lead NRC to direct LMS and the U.S. Army Corp of Engineers to pursue additional Hydrologic Modeling. Based on these analyses, the minimum D_{50} required to protect the disposal cell during probable maximum precipitation events were found to be 1.8 inches. This compares to the original D_{50} of 2.7-inches and was substantially greater than the D_{50} of 2.35-inches measured in 2002. The recalculation was included in a revised Long-Term Surveillance Plan for Lakeview later adopted by the NRC.

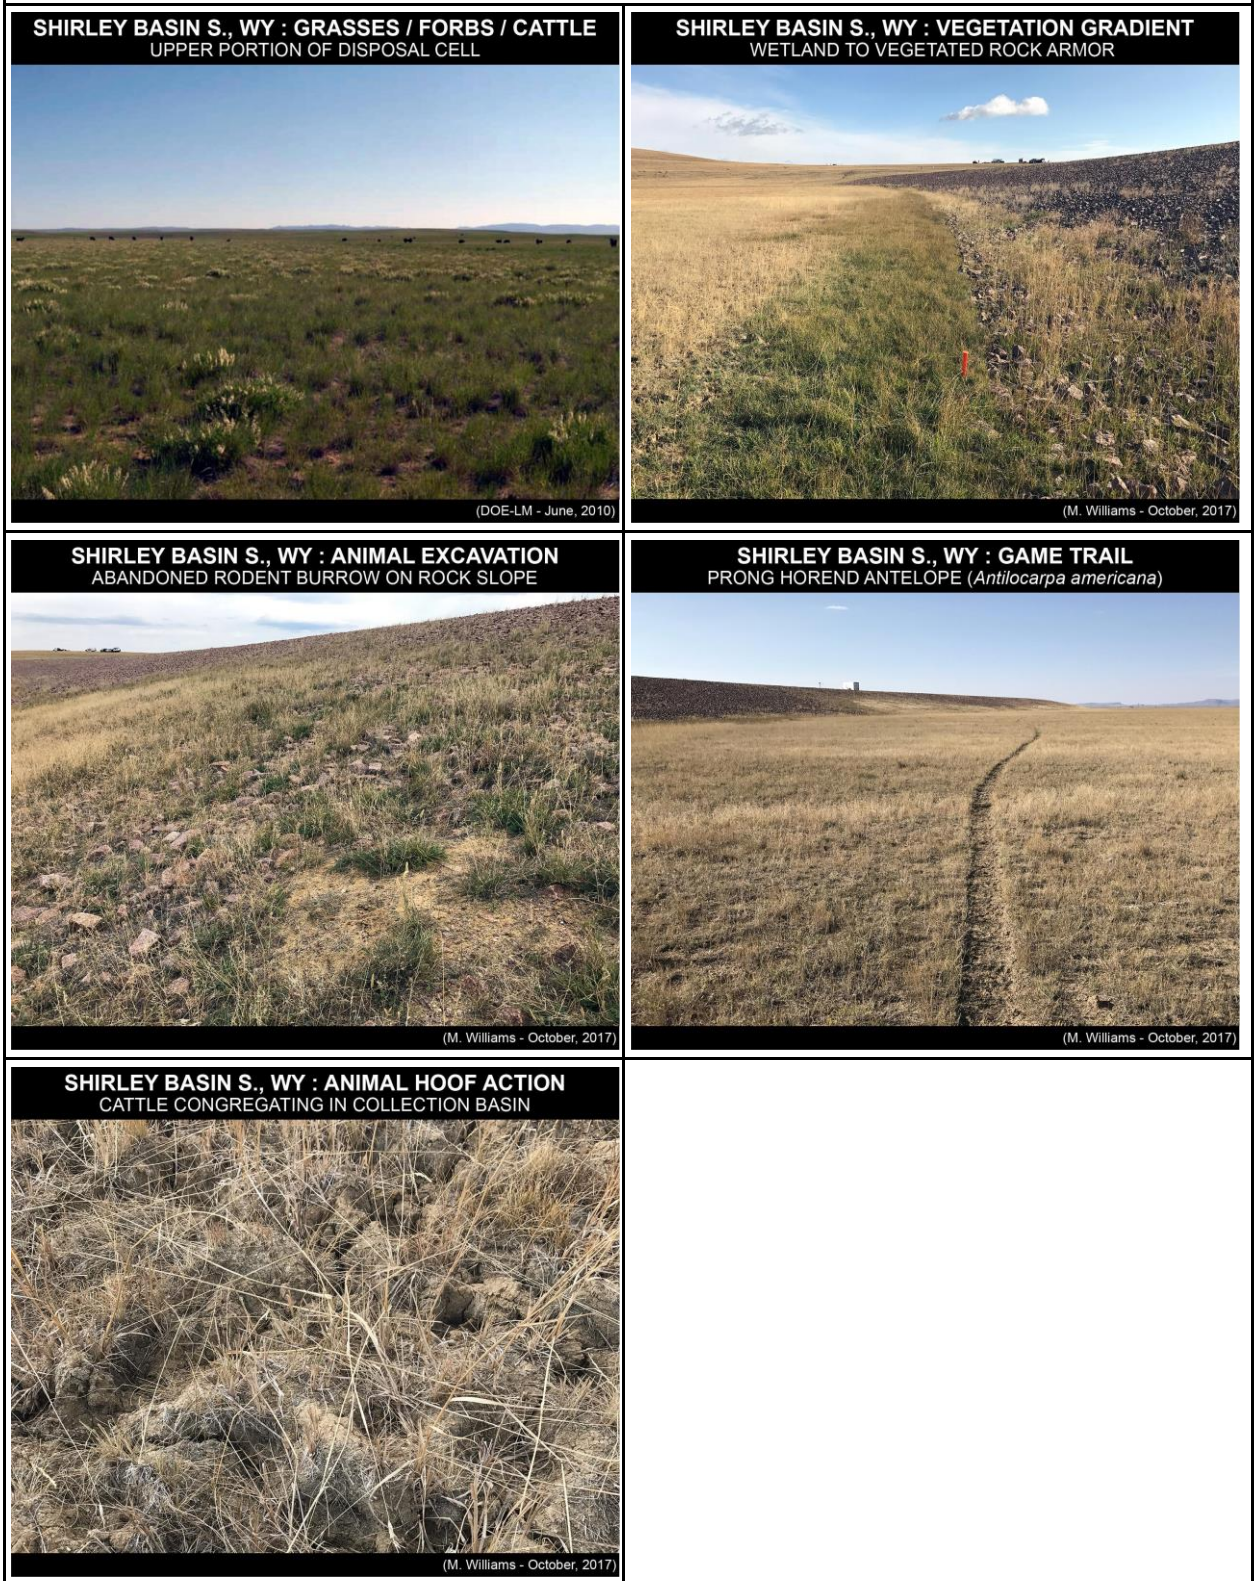
Figure A.11. Shirley Basin, WY : Surface Features Characteristic of Biological Processes

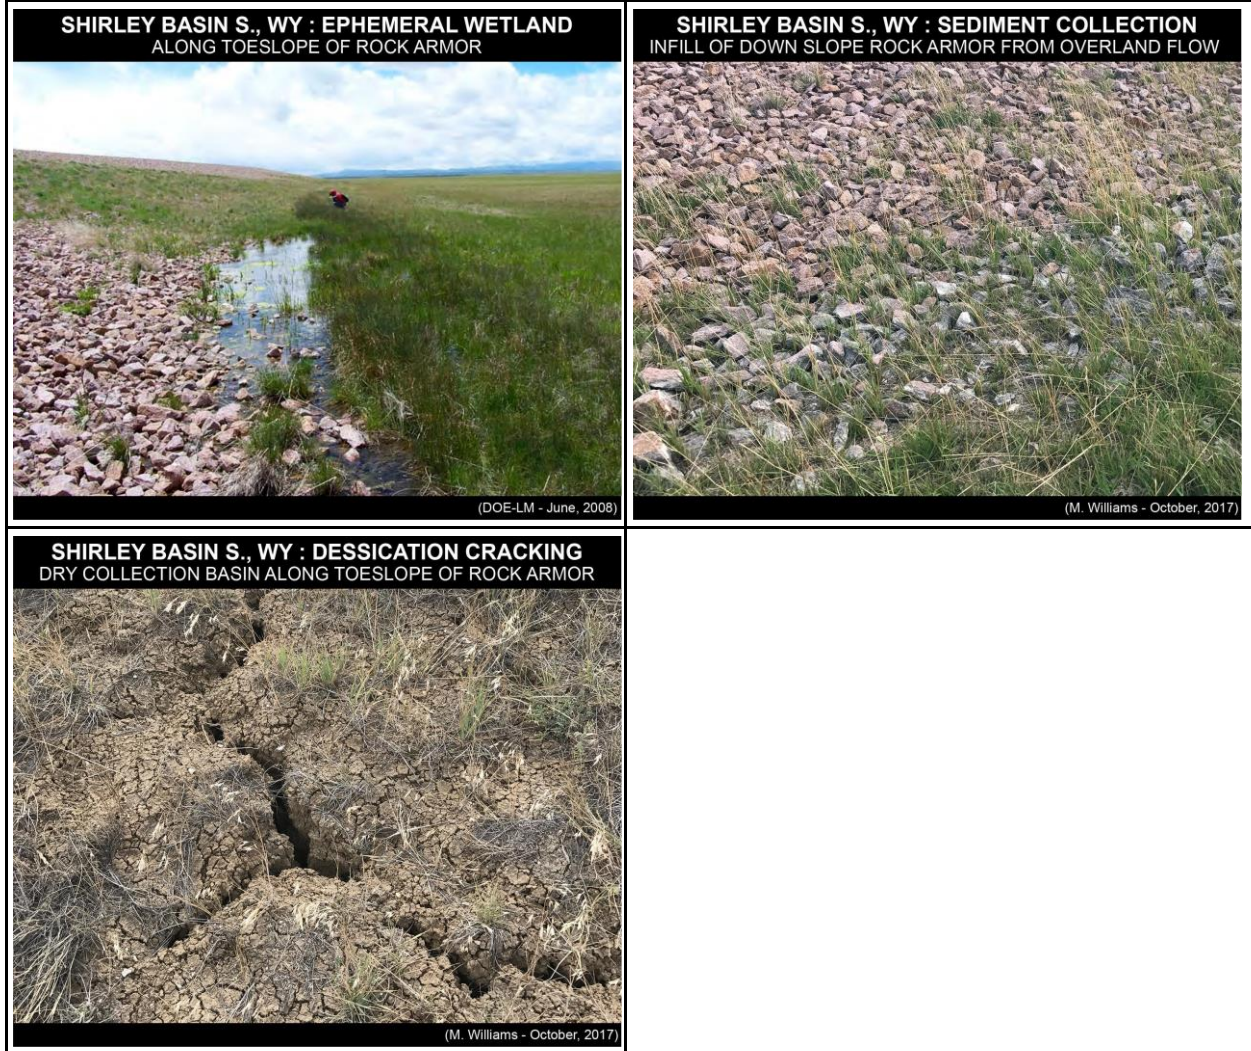
Figure A.12. Shirley Basin, WY : Surface Features Characteristic of Geophysical Processes
