700 MHz window R & D at LBNL

## 700 MHz Window R&D at LBNL

This document describes the R&D activities at LBNL under contract # 06261-001-99 2A "700 MHz RF Window" from LANL. The Conceptual design, numerical modelling, cold-testing, and manufacturing steps are described. Recommendations for assembly and testing procedures are included. Some possible future developments are discussed. A drawing package and cost estimate for volume production are also included.

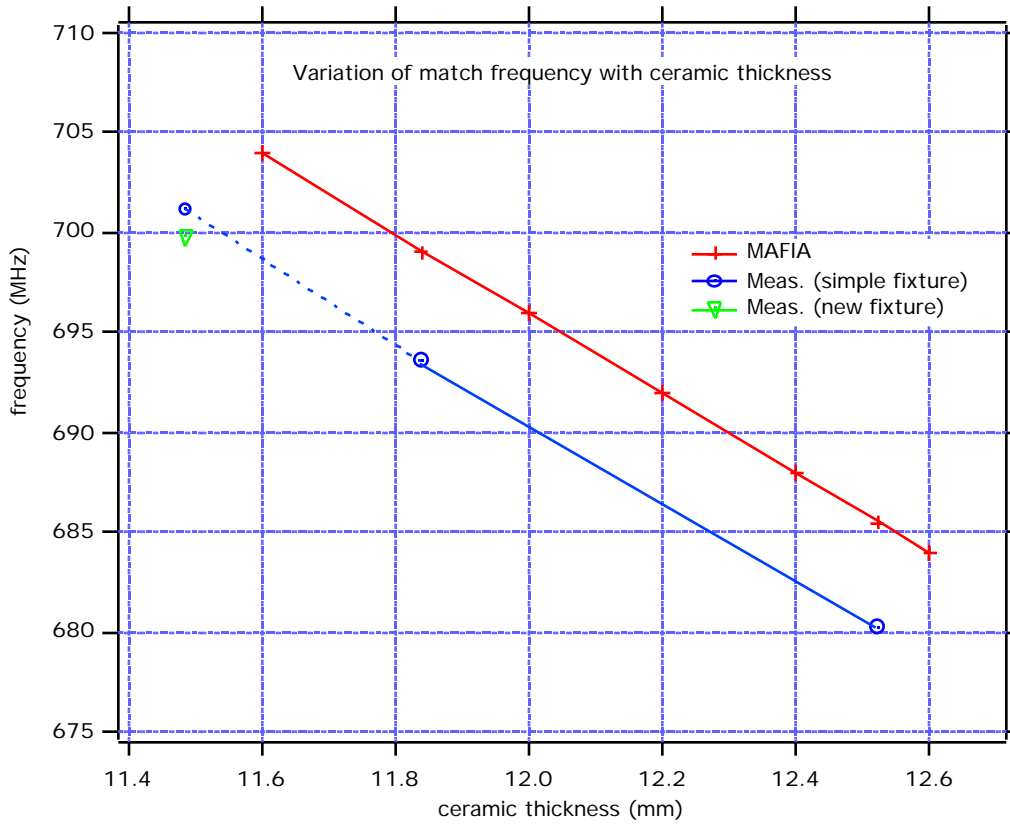
one a little thicker. The two ceramics were measured in a simple fixture and the frequencies compared with the MAFIA predictions. Figure 7 shows the calculated and measured match frequency verses ceramic thickness. There is a small offset between the two curves, which can be accounted for by the actual dielectric constant being slightly different from that assumed in the MAFIA calculations. The slope of the curve predicted by MAFIA is  $-19.9$  MHz/mm, while that from the measurements is  $-19.5$  MHz/mm. The slope of the measured data was used to extrapolate to estimate the ceramic thickness which should yield a match frequency of 700 MHz. Note that there is a second slight offset in the plots because the simple fixture was slightly thicker than the final flange thickness. This was accounted for in the tuning and the ground ceramic when remeasured came out very close to the expected frequency (701.1875 measured vs 700.537 expected). Figures 8,9 show the measured Transmission and reflection coefficients for the tuned window in the simple test fixture. Figure 10 shows the reflection coefficient on a linear scale to compare with figure 3. When the ground ceramic was measured in a new fixture with the correct thickness the frequency dropped to 699.6875, which is within the measurement accuracy of the desired value.

Figure 7. Variation of match frequency with ceramic thickness.

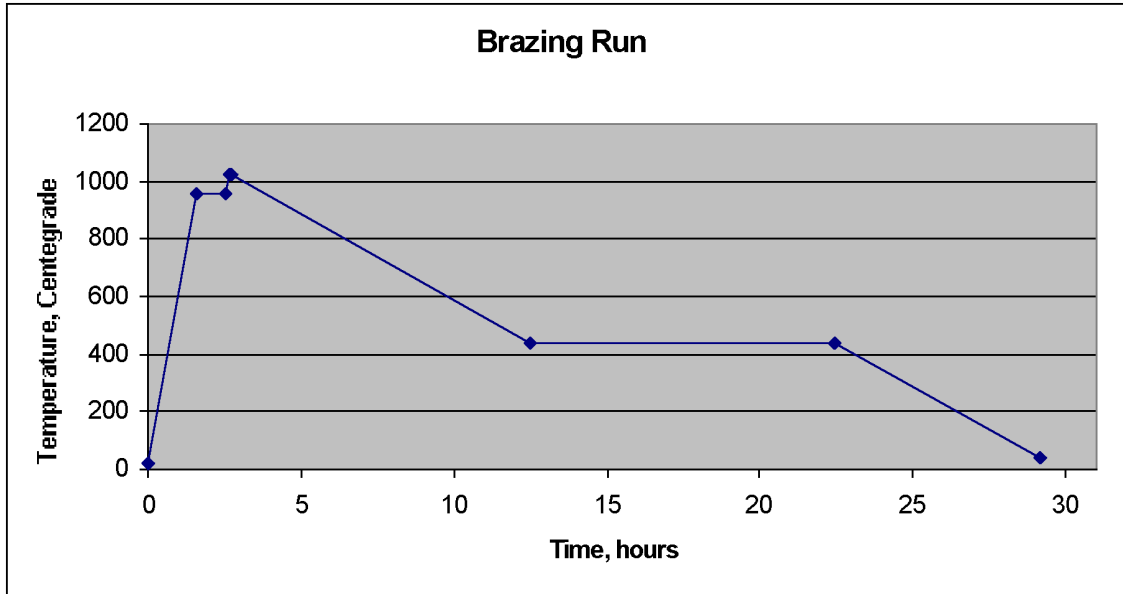
Figure 18. Braze furnace temperature profile

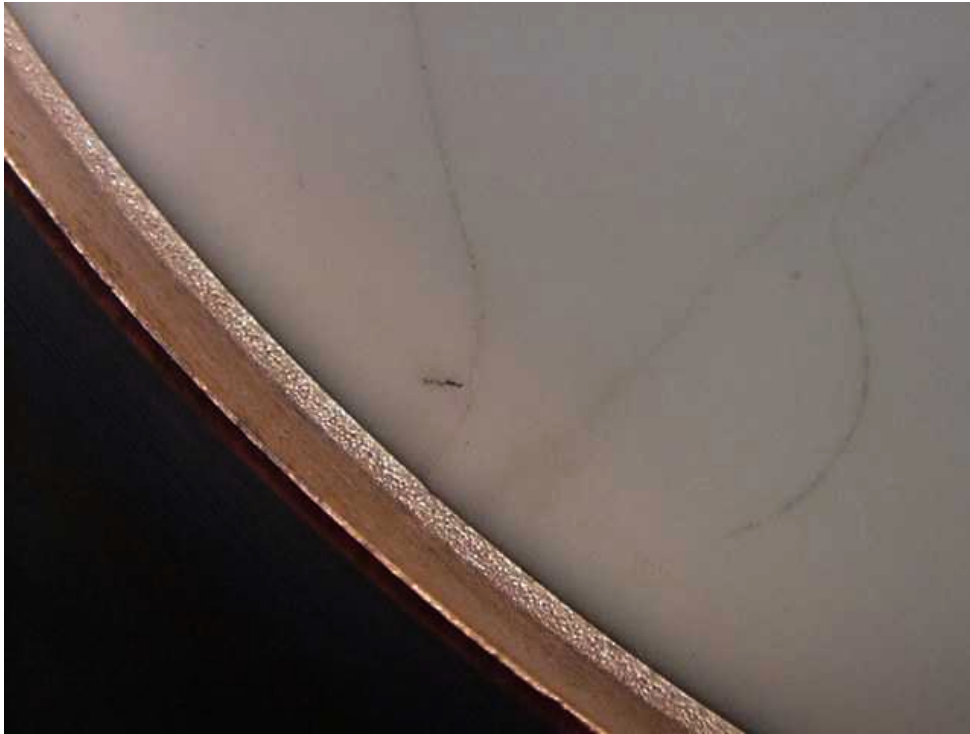
Unfortunately the first brazement ended with a cracked alumina window. The braze looked smooth and uniform, but there was a crack running from the braze interface into the window. The first centimeter of the crack was relatively straight and went through the entire window. The crack continued from there in an almost complete circle along one of the surfaces. The radius of the circle corresponded almost exactly with the circle that intersected the three ball bearings that supported the weight of the alumina window. Additionally, upon removing the assembly from the

Figure 20. Crack at edge of ceramic after first braze test.

There are a number of possible scenarios that could explain the failure. The hertzian contact stresses at the interface between the window and the ball bearings may have approached the yield strength for the ceramic. Rough hand calculations confirmed that this could be the case. The allowable hertzian contact stress (calculated) for this alumina was  $\sim 1200\text{MPa}$ , the calculated stress from the weight of the stainless steel ring and the ceramic window sitting on the three ball bearings was  $\sim 1000\text{MPa}$ . This was proposed to explain the circular path taken by the crack. It did not completely address the issue of crack initiation. Changing from ball bearing supports to ceramic disc supports was proposed.

The ceramic could have broken due to direct and uneven heating from the infrared radiation from the unbaffled heating elements. SLAC had some experience with this problem when baking out ceramics during the PEP-II project. The fact that the Vacuum Industries furnace had a rectangular element profile could add to the uneven heating. Putting a stainless steel baffle around the braze assembly was proposed to eliminate this possibility.

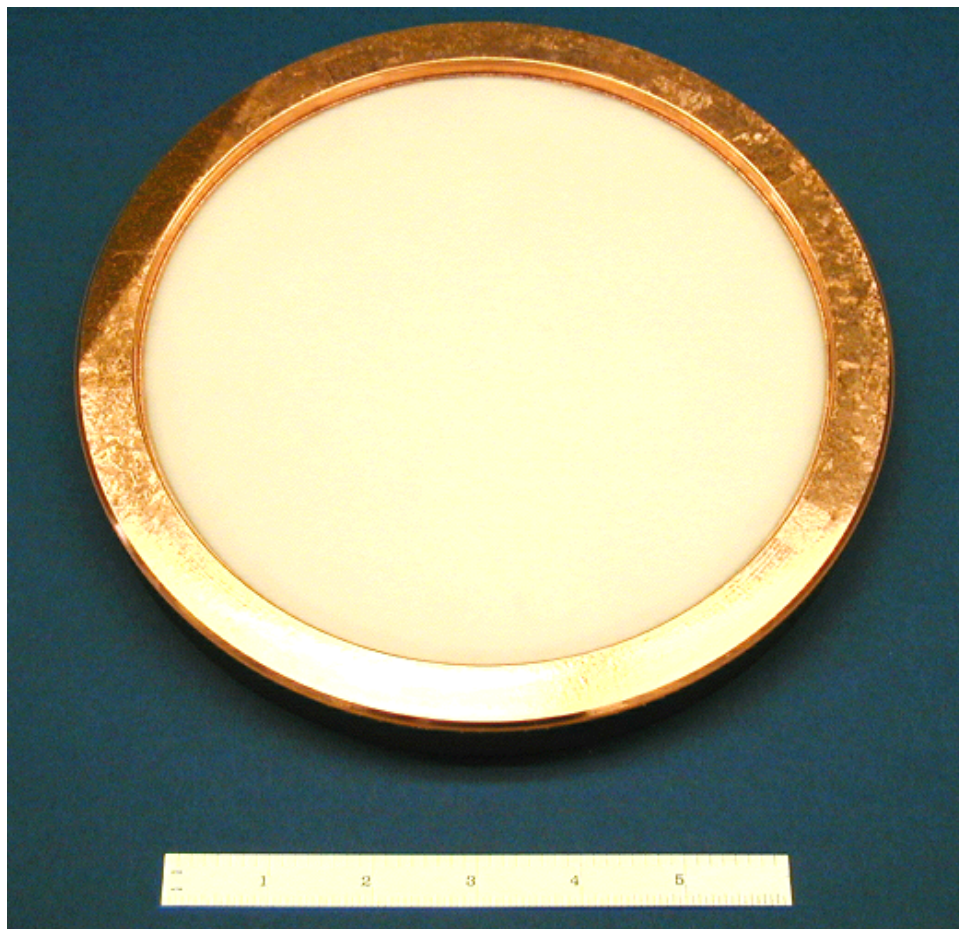
Figure 23. Window #2 as brazed.

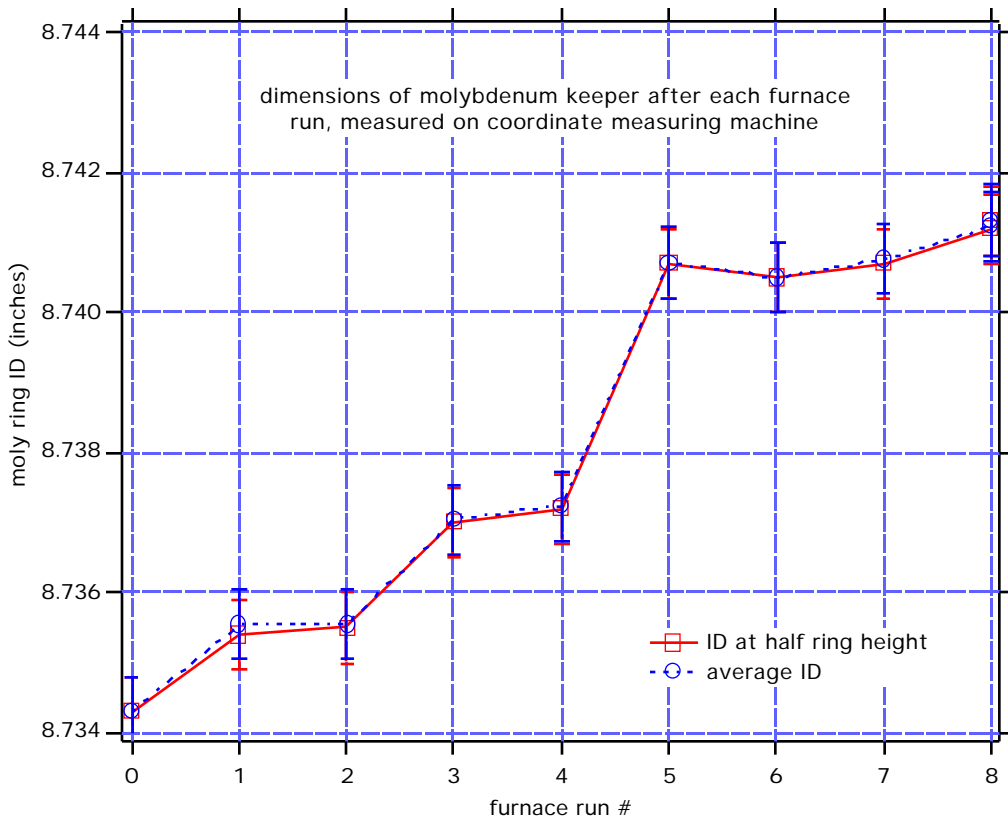
Figure 23a. ID of molybdenum keeper ring after each furnace run.

The instability of the molybdenum ring proved to be one of the more frustrating aspects of the brazement. Over 6 furnace cycles the ring grew .008” in its inner diameter. There are several possible theories that might explain this growth:

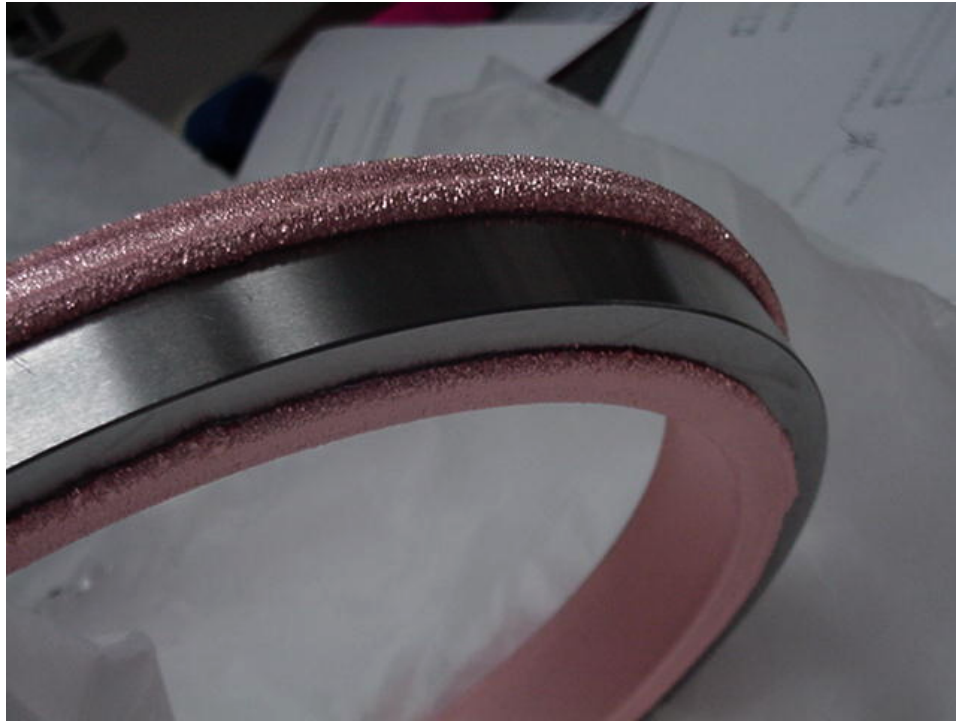
Figure 26. Copper build-up on the corner of the cooling ring.

The additive free copper solution does not apply very smoothly, especially around corners. In order to get a 0.025" final smooth layer of copper, at least 0.010" additional machine stock must be coated over the entire piece. In order to get a 0.035 copper layer over the low spots on the flats, we found that as much as 0.080-0.100" must be plated on the corners. Custom fixtures were made for the plating so that the rings rotated around an anode inside the ID of the ring. Even with these measures, the ring needed to stay in the plating bath for the better part of a week.

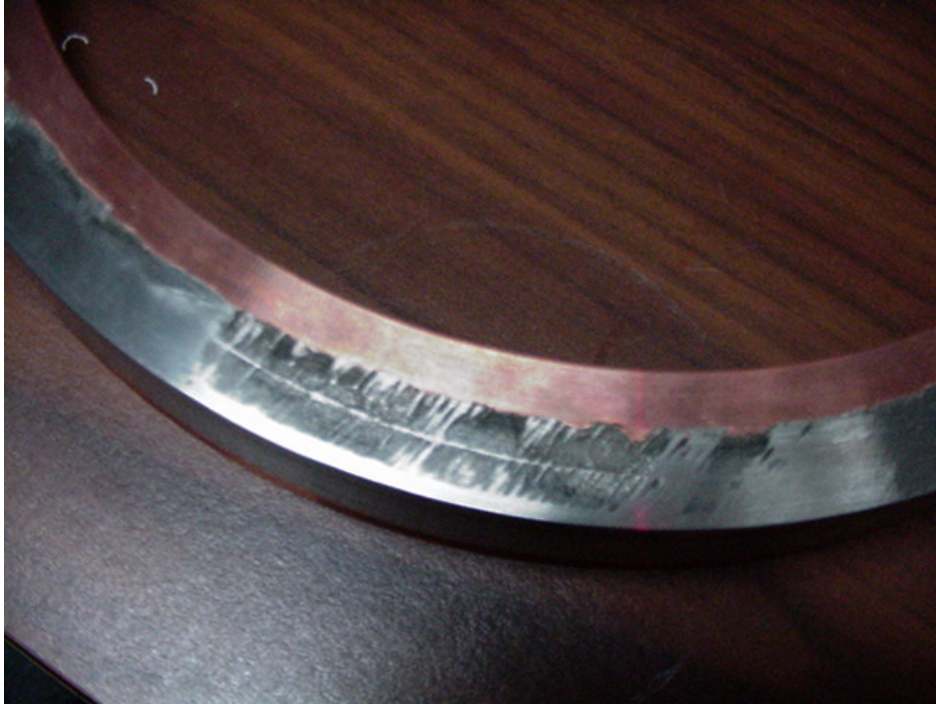
There was a recurring problem during the initial copper coating runs. When a ring was removed from the plating tank and the masking removed from the ring, etching damage in the stainless steel was noticed on 3 or 4 of the initial rings.

Figure 27. Etching damage on the stainless steel ring.

It was thought that during the initial strike, which prepared the stainless steel surface for copper plating, the hydrochloric acid in the solution may have leaked under the masking tape. The HCl solution may have sat against the stainless steel surface for the

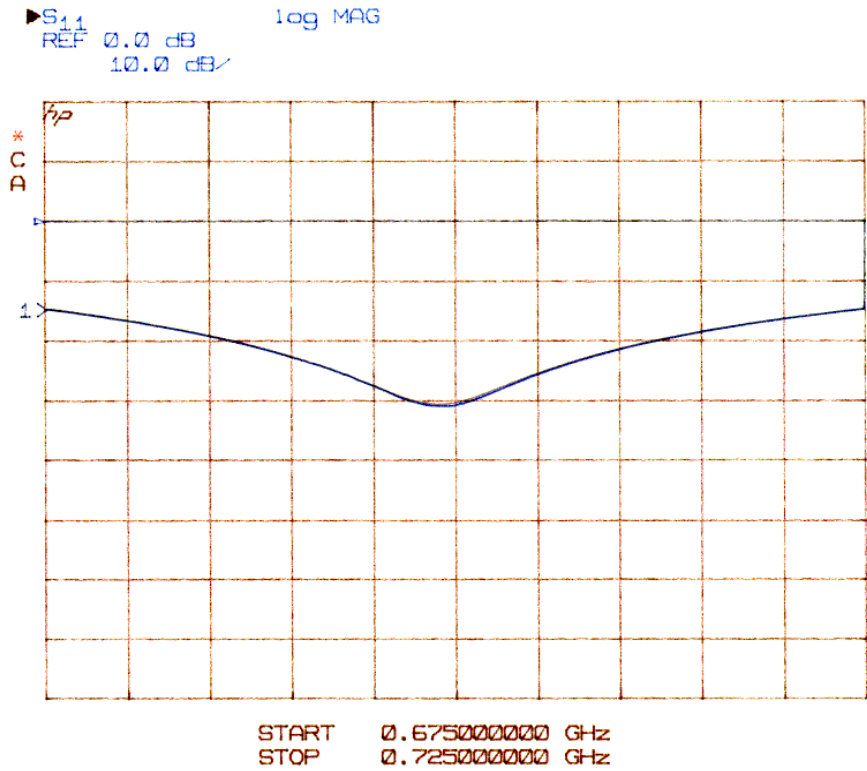
Figure 29 shows the reflection measurement of the first (cracked) window. The match frequency is close to 700 MHz although the best measured reflection coefficient is not as low as the other windows. This is probably due to a small drift in the calibration or other measurement error. (Note that even in this case the measured match is better than -30dB which is acceptable) Window #2, the first good window, showed a slightly lower match frequency, see figure 30 The measured reflection coefficient was better than window #1, suggesting a better calibration. Despite the frequency offset the match at 700 MHz is almost -35dB (the best match is almost -47 dB). Figure 31 shows how the match frequency varies with iris thickness as spacers are inserted to raise the window or the clamping ring.

Figure 29. Window #1 (cracked) as brazed (6 shims on top)

The graph shows four data points at each height; two reflection measurements and two in transmission, along with the average. The average value seems to vary as expected with thickness, the deviation of individual data points gives an idea of the measurement uncertainty. Note that even at the full height the frequency does not quite reach the ideal value (700 MHz) expected from previous cold-test measurements. This could easily be corrected in series production by a small change in the ceramic thickness.

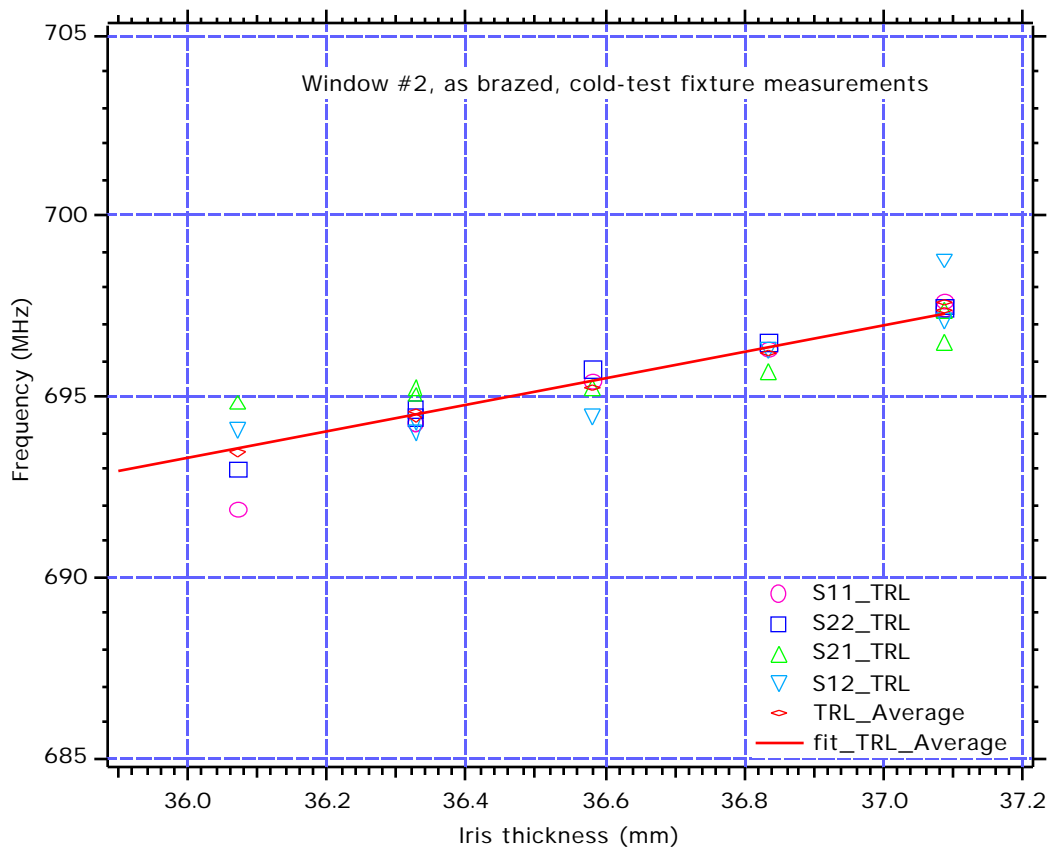
Figure 31. Window #2, frequency dependence on iris thickness

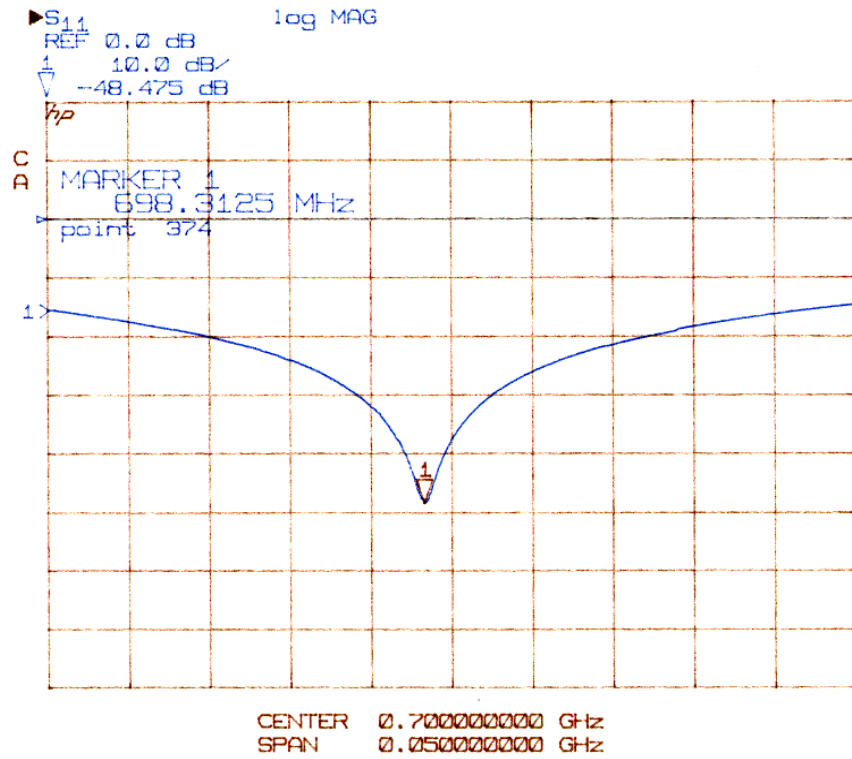
Figure 32. Window#4 as brazed (8 shims underneath)

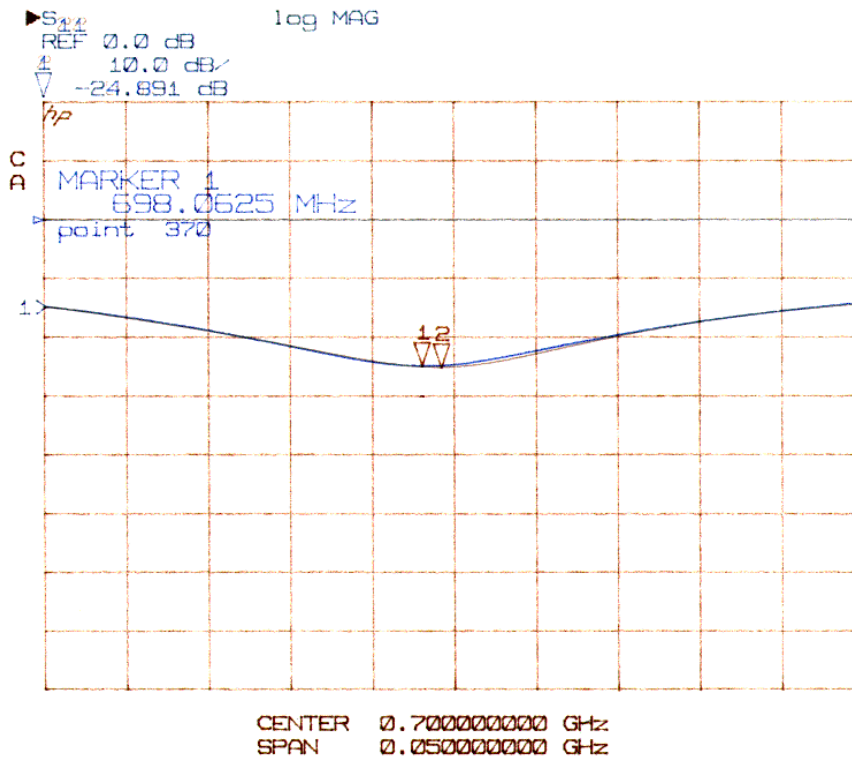
Figure 33. Window #5 as brazed (10 shims on top)

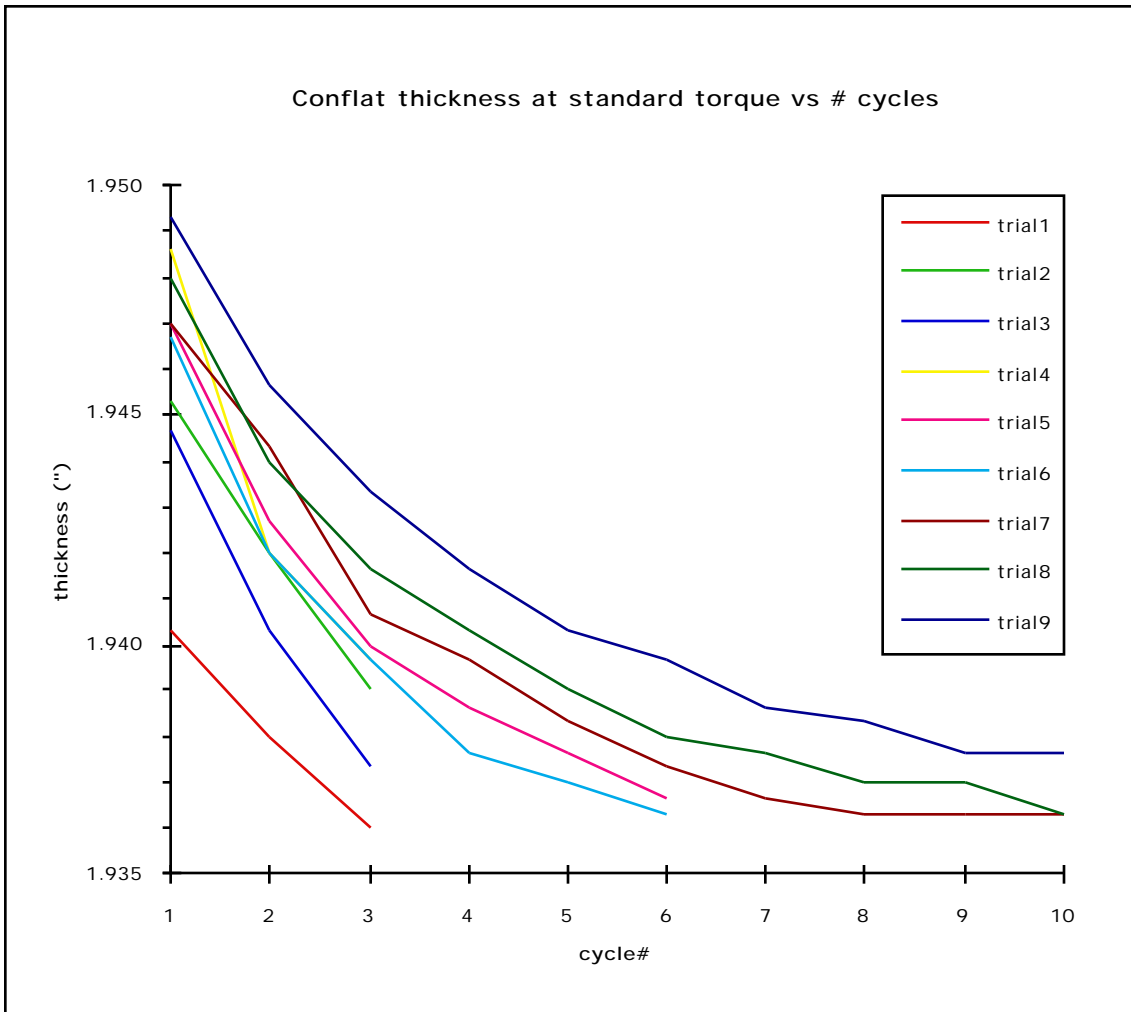
Figure 41. Compression of flange pair with repeated torquing
