Development of Quartz Substrate Circuit Boards for nEXO

A Thesis submitted in partial satisfaction of the requirements
for the degree Master of Science

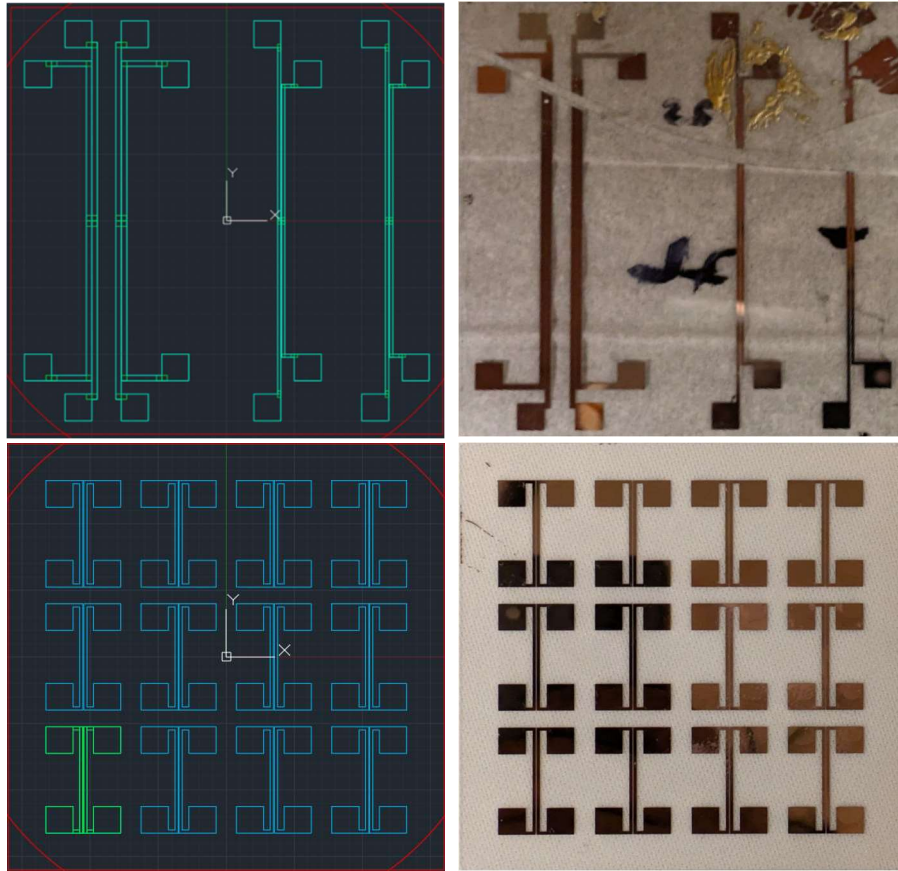
Figure 1.1: Schematic diagram of the initial paired trace test circuit (top left). The deposited traces are in blue, the substrate dimensions are outlined in red. Actual microfabricated sample 2 after round of silver epoxy thermal cyclic testing (top right). Schematic diagram of the final paired trace test circuit (bottom left). The final deposited traces are in blue, the target deposition zone is outlined in red. Actual microfabricated sample 3 (bottom right).

In the Nano3 cleanroom, the wafers were first cleaned through 10 minutes of ultrasonic agitation each in acetone, ethanol, and 70% isopropyl alcohol before being rinsed with deionized water and dehydration baked at 180°C for 10 minutes. Following this, AZ 12XT-20PL-5 positive spin-on photoresist was applied with the procedure provided by the Nano3 facility. The photoresist was then exposed with the desired circuit pattern in a Heidelberg MLA 150 laser writer at 375nm with a dose of 500mJ/cm². Then, in a solution of AZ300 MIF developer, the exposed photoresist was removed, leaving behind the desired circuit pattern shown in figure 1.1.

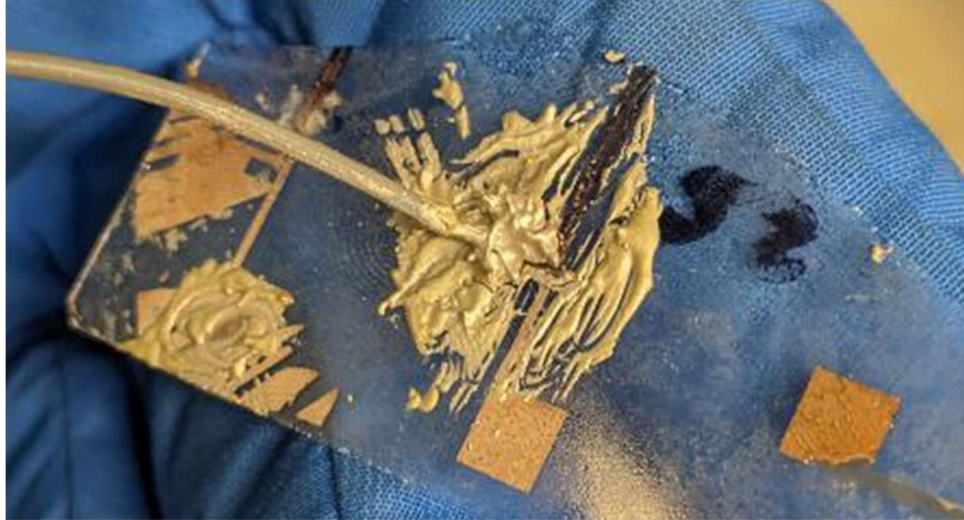
Figure 3.3: Sample 2S after the attachment of the 16 gauge copper wire using silver epoxy after one liquid nitrogen dunk cycle. Note the epoxy with no attached wires or leads on the bottom-leftmost test pad.

Regarding the silver epoxy, it formed a bond with the copper traces and maintained low resistances across the board. The precise values obtained will be discussed further when discussing the results of thermal cycling. Sample 2S was the first to be tested for this, with an excess of epoxy being used to attach the stranded 16 gauge wire to the test pad. Though not pretty, the result was a strong bond that could be used to hold up the sample, a property which was then used to subject it to a liquid nitrogen dunk test. Sample 1L was the next to have leads bonded using silver epoxy, this time with much thinner strands of copper extracted from the larger 16 gauge wire (Fig. 2.1). Once again, the resistance across each trace was unchanged initially, making it a promising candidate for cycling via the environment chamber.

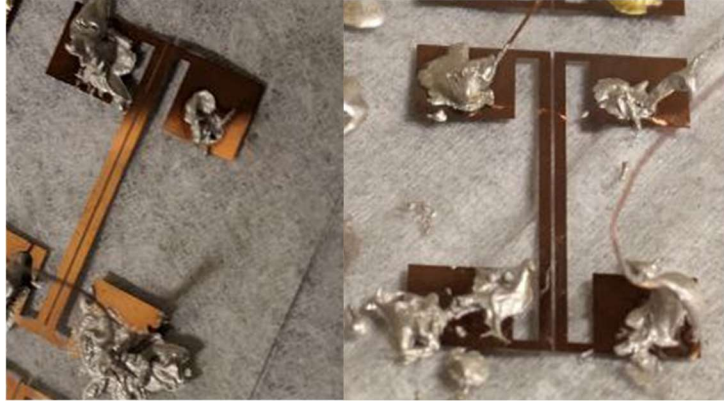
Figure 3.4: Pair 14 (left) and pair 34 (right) on sample 3. Note the lack of attached leads on the top two test pads of pair 14 and the bottom test pad of trace 34L.

The last two samples to have epoxy applied were samples 3 and 4. Although the initial goal was to attach multiple individual copper strands to several of their test pads as in sample 1L, sample 3 saw the strands attached to the top two pads of pair 14 and the bottom pad of trace 34L break away. The former saw mechanical failure of the copper itself, as the strands snapped into pieces shortly after the sample was moved. The latter saw a mechanical failure of the epoxy, as the strand slipped out of the epoxy without any damaged sustained by either (Fig. 3.4).

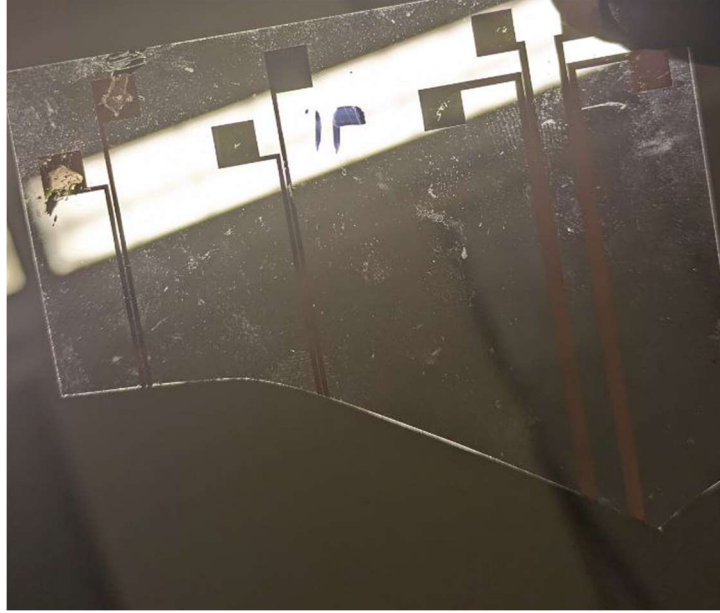
Figure 3.12: Sample 1L after all thermal cycling tests. The large damaged sections of copper are visible on traces 1 and 2 to the left. Traces 3 and 4, as well as all of the control traces, had small but visible gaps in the test pads compared to before any tests as seen in figure 2.1.

After the first cycle, the epoxy on traces 1 and 2 was already loose. After the second, the epoxy on trace 1 partially peeled away from the trace, bringing a substantial amount of copper with it. Pushing it back into position and leaving it overnight remedied this issue. However, after the third cycle, the epoxy peeled away entirely, bringing a substantial amount of the copper underlayer with it. The same happened in trace 2 after the fourth cycle. In both cases, after the epoxy peeled away, the space where it once was became either discontinuous or maintained a resistance on the order of $M\Omega$. Thus, all further resistance measurements were taken on the surviving copper around the missing epoxy.

After the thermal cycling of sample 1L, aside from the epoxy already peeled away from traces 1 and 2, visible damage at the point of contact with the multimeter leads was confirmed on all other traces, including the control traces (Fig. 3.12). Notably, the chromium underlayer in all cases appears to be undamaged on sample 1L, indicating a mechanical weakness in the Cu-Cr interface rather than the Cr-SiO₂ interface.
