Structural performance of RC shear walls with post-construction openings strengthened with FRP composite laminates

Composites Part B: Engineering, 115

# EXPERIMENTAL INVESTIGATION ON STRUCTURAL PERFORMANCE OF RC SHEAR WALLS WITH OPENINGS RETROFITTED WITH ADVANCED COMPOSITES

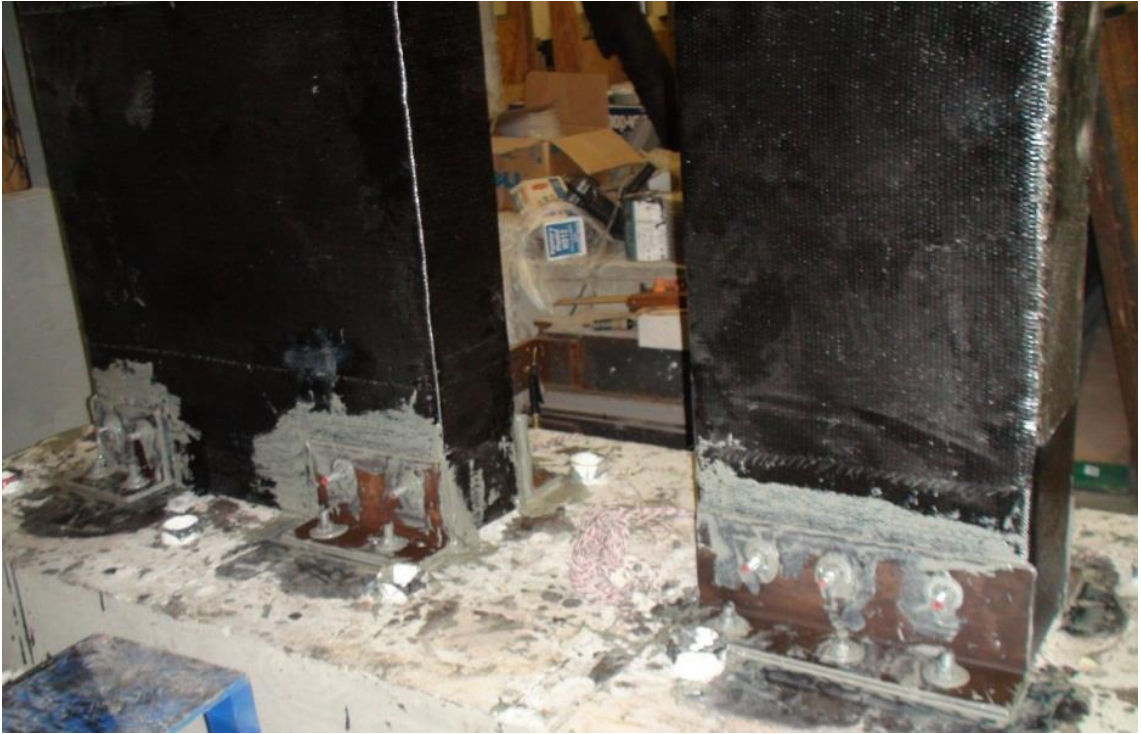
**Figure (6):** Wall (R-DO) Anchorage System

As stated earlier, both wall specimen (R-WO) and (R-DO) were retrofitted in both flexure and shear. Due to the existence of direct connection between the left and right piers and the wall footing, a special anchorage system was installed for wall specimen (R-DO) to ensure the transfer of forces **between the wall base and the vertical FRP laminates**. The anchorage system consisted of steel angles and high-strength steel threaded rods. Figure (5) shows the details of the retrofit systems for both retrofitted walls (R-WO) and (R-DO) and the anchorage system for wall specimen (R-DO).

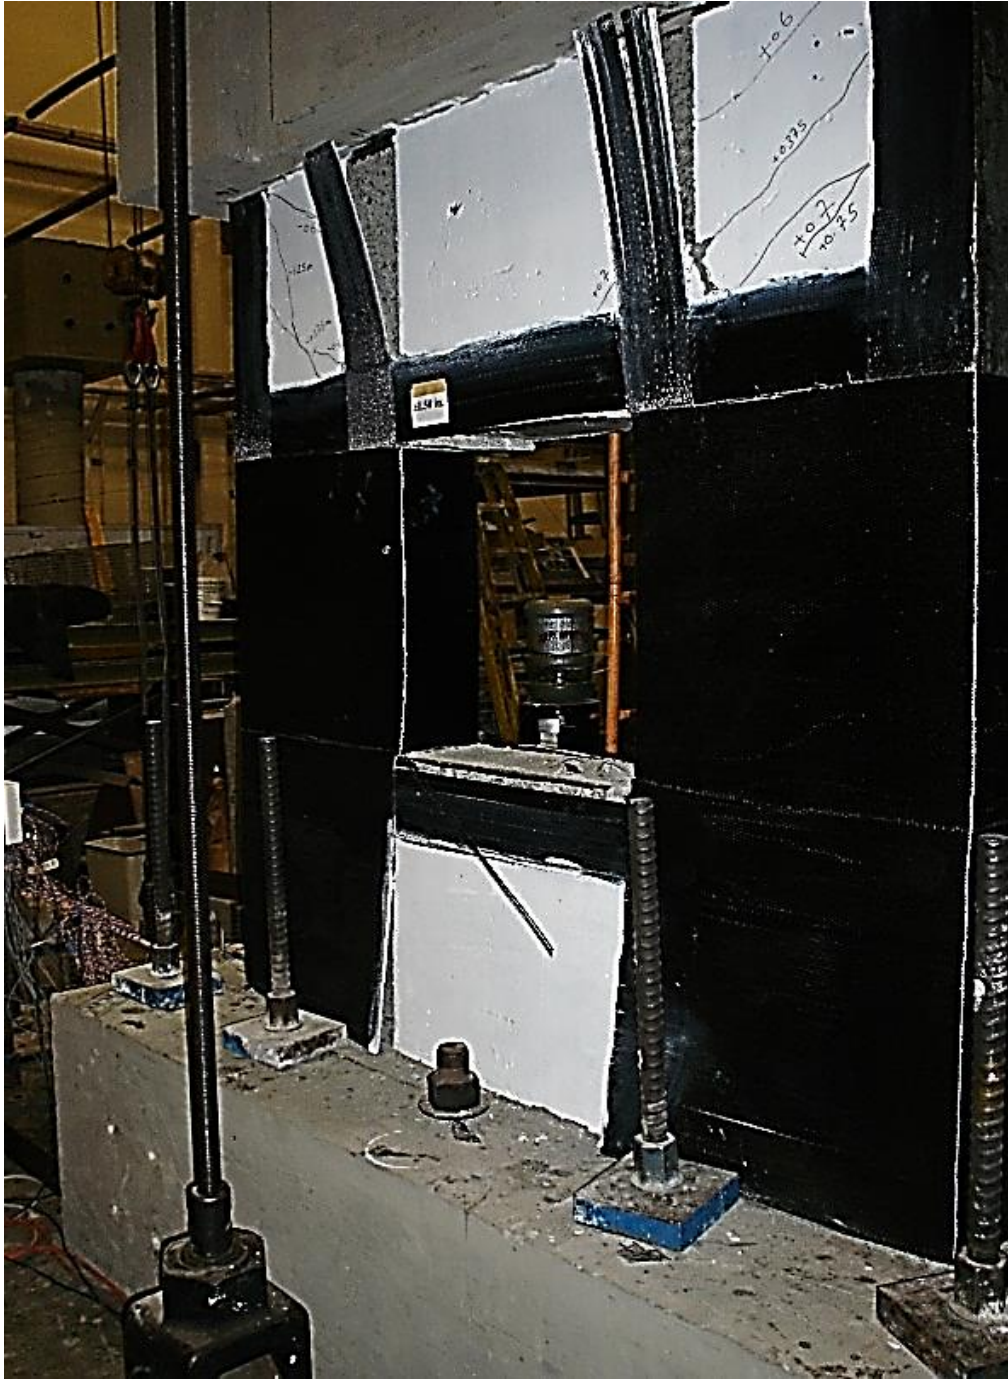
**Figure (13):** Failure of Wall Specimen (R-WO)

At a ductility level 1.50 (corresponds to a lateral displacement of 9.5 mm/0.375") during both the pull- and push- cycles, two cracks were observed at the two top corners of the window opening, however, no damage to the CFRP laminates was observed. During the first cycle of ductility level 3.0 (corresponds to a lateral displacement of 19.00 mm/0.75"), a minor debonding started to occur at the horizontal CFRP laminates located at bottom of the window opening at both sides of the wall. A partial debonding of the horizontal U-shaped CFRP composite laminates located between the bottom spandrel and both left and right wall piers. No additional cracks were observed up to the ultimate failure of this wall specimen, however, debonding of the bottom CFRP U-shaped laminates at both the left and right wall piers continued to grow. Loading continued beyond this point in order to determine the wall's ultimate load. The maximum load in the push-direction was 956.40 kN (215.00 kips) that occurred at a lateral displacement of 31.80mm (1.25"), while the maximum load in the pull-direction was 898.60 kN (202.00 kips) that occurred at a lateral displacement of 31.80mm (1.25"). At a displacement level of 38.10mm (1.50") and during both the pull- the push-cycles, fracture at the edges of the horizontal laminates at both the top and bottom of the opening was noticeable. At the same time, the horizontal CFRP U-shaped laminates at the bottom of the wall piers suffered from severe debonding and started to dilate resulting in concrete crushing as shown in Figure (13). The load-displacement and load-drift ratio hysteresis curves are shown in Figure (14).

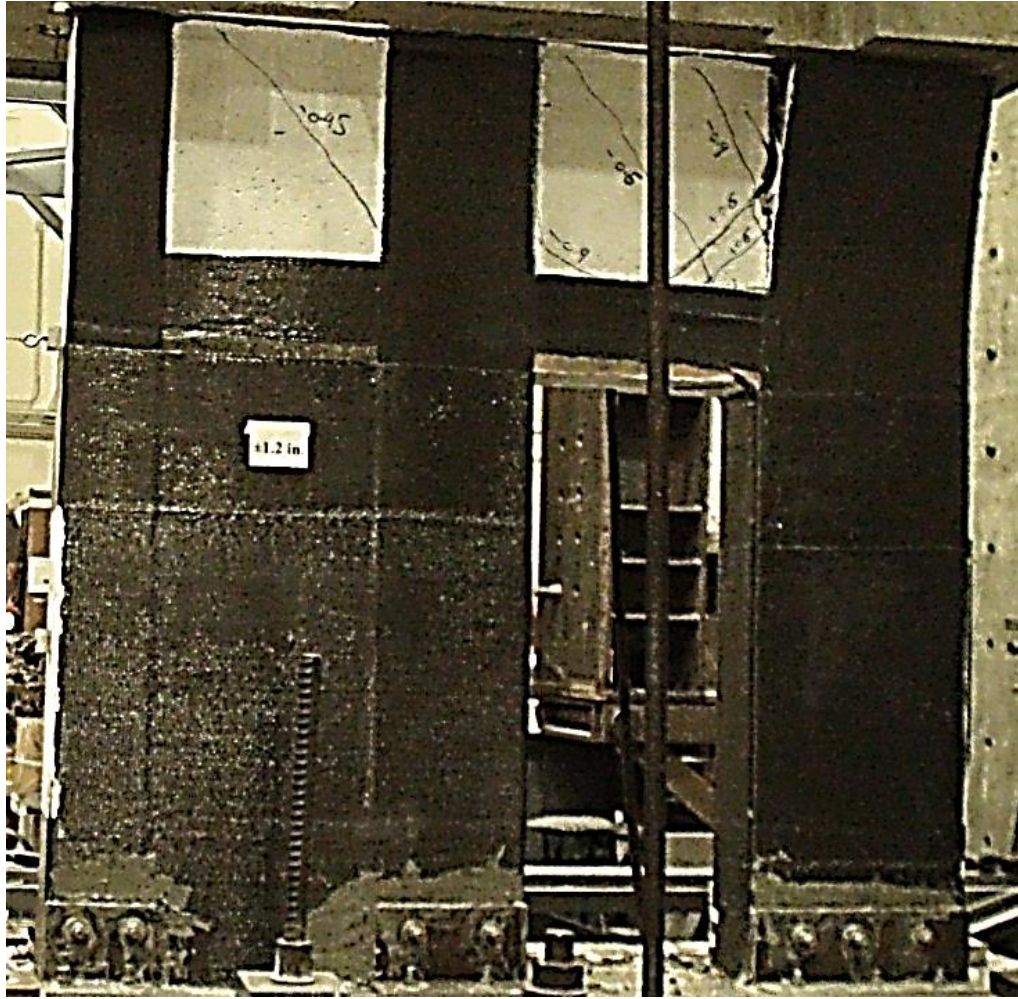
**Figure (15):** Failure of Wall Specimen (R-DO)

protocol similar to the one used for wall specimen (R-WO) was applied until yield is detected. After the yield was detected, the displacement control protocol with the following steps  $\pm 0.30''$ ,  $\pm 0.60''$ ,  $\pm 0.90''$ ,  $\pm 1.20''$ ,  $\pm 1.50''$  equivalent to ductility level of 1.00, 2.00, 3.00, 4.00, 5.00, respectively was applied to the specimen up to failure. At the third cycle of ductility level 2.0 of displacement 15.20mm (0.60'') partial debonding of vertical CFRP laminates on right narrow pier at wall top at 15.20mm (0.60''). At the first cycle of ductility level 3.0 of displacement 22.90 mm (0.90'') another crack occurred at the top of the opening and at the same time debonding of vertical CFRP laminates on wide left pier next to the opening has initiated at wall top. In The first cycle of ductility level 4.0 of displacement 31.80mm (1.20'') the debonding of vertical CFRP laminates on right narrow pier at wall top began to grow up to a displacement 25.40 mm (1.00'') resulting in severe splitting of the concrete cover exposing the wall rebars and resulting in significant drop in the wall load capacity. The test was stopped at this point and the wall specimen at the end of the test is shown in Figure (14). The maximum load in the push was 1,005.30 kN (226.00 kips) at displacement of 22.90mm (0.90'') and the maximum load in the pull was 791.80 kN (178.00 kips) at displacement of 22.90 mm (0.90''). Figure (15) shows the load-displacement hysteretic curve for shear wall specimen (R-DO).

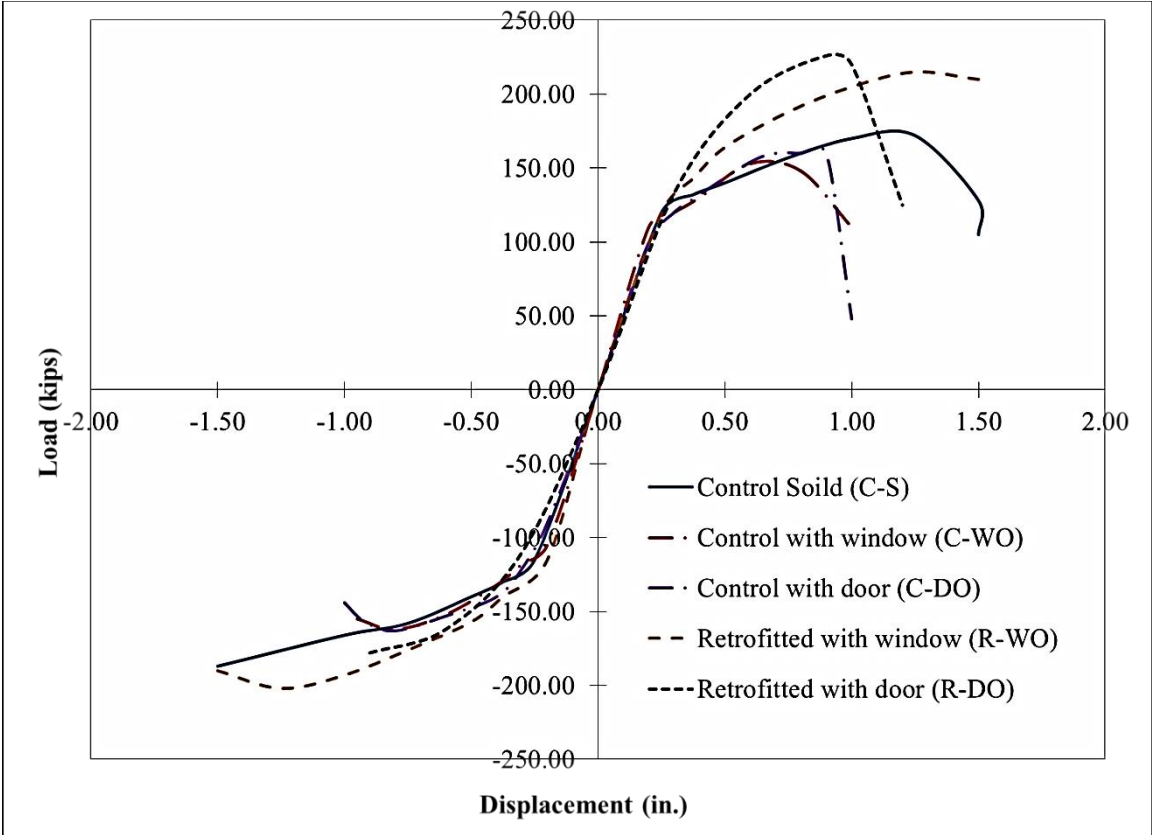
**Figure (17):** Comparison of Load-Displacement Envelopes of All Wall Specimens

shear cracks followed by diagonal shear failure of the wall due to excessive displacement. For the control wall with window opening (C-WO), the behavior of the wall was ductile up to failure but the mode of failure was different the left and right piers of the wall failed at the end of the test in diagonal shear rather than flexure failure by concrete crushing. Control wall with door (C-DO) had different modes of failure in each pier. The left wide pier experienced shear failure while the right narrow pier had diagonal shear cracking but at the end of the test failed in flexure by crushing of concrete at the top and bottom sections. For the retrofitted specimen, retrofitted wall with window (R-WO) and retrofitted wall with door (R-DO) no shear failure occurred. The failure sequence for both specimens was the debonding of the CFRP laminates from the concrete surface specially the vertical inner laminates on the side of the opening at the top of the wall and then towards the end of the test flexure failure at the zone between spandrels and the wall piers. A comparison of the failure mode for all the specimens is presented in Table (5). The load-displacement envelopes for all specimens are compared in Figure (16). Figure (17) shows a comparison of the average load capacities of all tested walls. It can be seen from the graphs that the retrofitted specimens had higher capacities than the solid control wall (C-S). Comparison between the different ductility levels achieved by different specimens up to failure is shown in Table (6).
