Monitoring erosion control strategies of vineyards in Napa County

## **Monitoring erosion control strategies of vineyards in Napa County**

Paul Rogé  
proge@berkeley.edu  
Landscape Architecture 222  
Spring 2004

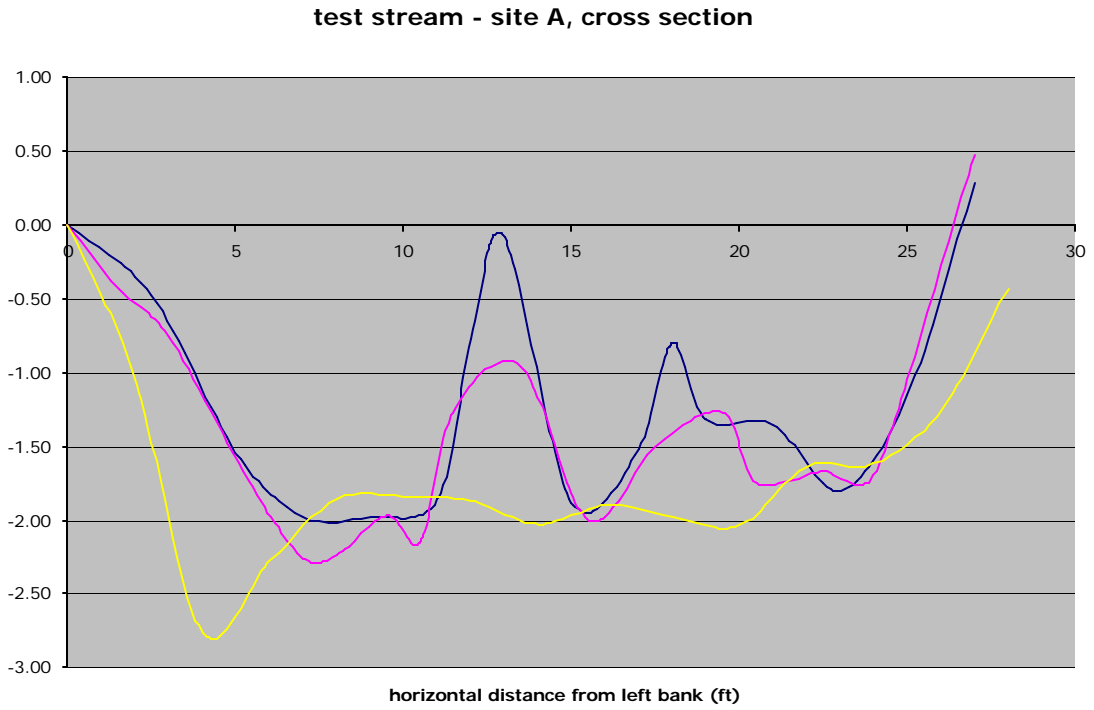
Figure 1a. Cross section of site A on the test stream looking downstream with vertical exaggeration.

My measurements were made using a Topcon automatic level, a stadia rod, and a measuring tape. I measured cross sections from the left banks. My cross sections include the approximate bank height at each site. I tried to capture the most obvious variation in stream channel morphology.

Although I located sites A and B successfully, the longitudinal profiles and cross sections are not accurate enough to draw inferences about changing stream morphology over four years. Lutrick (2000) also concluded that topographic surveys from October 1999 and April 2000 were not accurate enough to compare. I concord with Lutrick (2000) that sites A and B have a complex topography of boulders. This may cause relatively large differences in topographic measurement depending on the placement of the stadia rod. Future surveys should consider using small measurement intervals. Also, triangulating locations using clear and permanent markers should be integrated into survey projects that expect follow-up work by other investigators.
