Journal of Orthopaedic Research®, 36(1)

Structure-Function Relationships at the Human Spinal Disc-Vertebra Interface

Britta Berg-Johansen, Aaron J. Fields, Ellen C. Liebenberg, Alfred Li, Jeffrey C. Lotz

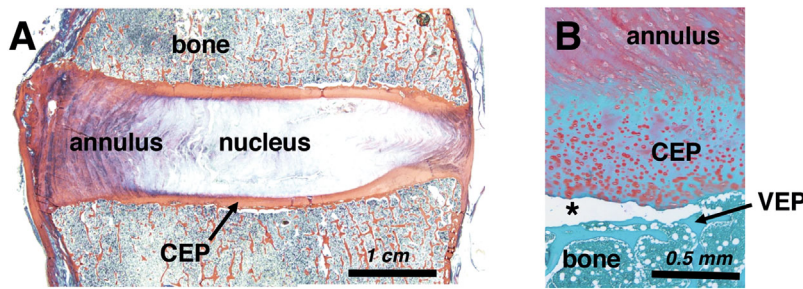
Figure 1. Histologic sections from human cadaveric lumbar spines. (A) Tri-chrome Mallory-Heidenhain stained section depicting the annulus fibrosus, nucleus pulposus, vertebral bone, and cartilage endplate (CEP). (B) Safranin-O stained section illustrating an in situ CEP avulsion (at asterisk) from the underlying vertebral endplate (VEP).

The intervertebral disc-vertebra interface is structurally complex as it serves as the junction for multiple tissue types (Fig. 1A). Injury at this site has received growing interest due to its clinical significance. For instance, avulsion of the cartilage endplate (CEP) from bone at the cartilage-vertebral endplate junction (EPJ) may be the most common form of disc injury since it is reportedly the initial site of failure in over 60% of intervertebral disc herniations (Fig. 1B).^{1,2} Damage at the disc-vertebra interface is highly innervated³ and is a specific imaging predictor of low back pain.⁴ The EPJ is intrinsically prone to failure because of stress concentrations that occur where material properties change abruptly.^{5,6}

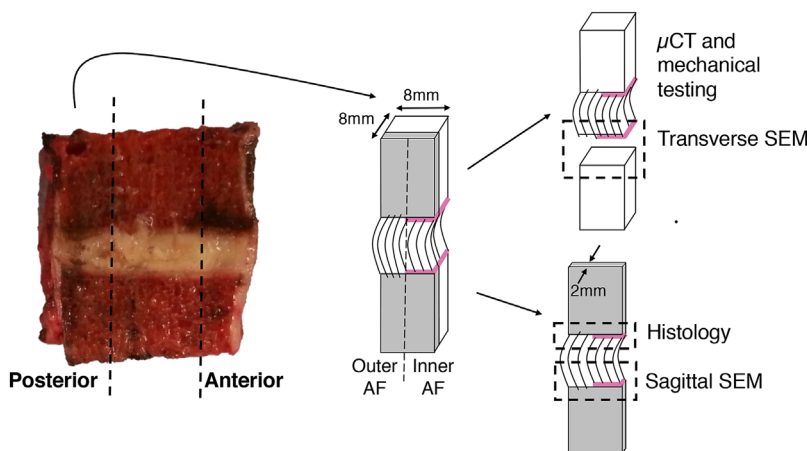
Figure 2. Sample preparation and allocation. Bone-disc-bone specimens were cut from the posterior and anterior annulus regions to include both outer and inner annulus fibrosus (AF). A thin sagittal slice was cut for sagittal-plane histology and SEM, while the bulk sample was scanned with μ CT and mechanically tested. Failure surfaces were scanned with SEM. Note that annulus fibers of the outer AF attach directly to the vertebra, while those in the inner AF attach to the cartilage endplate (denoted by pink line).

within 72 h post-mortem (UCSF Willd Body Program). Each motion segment was sectioned on a band saw into ~ 8 mm-thick parasagittal slabs, which were visually classified by two raters using the Thompson grading scheme (Grade 1 = healthy; Grade 5 = severely degenerated),¹⁴ with good inter-rater reliability ($\kappa = 0.69$). Images from one spine (three motion segments) were unavailable for Thompson grading. From the central-most parasagittal slab of each motion segment, cuboidal bone-disc-bone specimens including both outer and inner annulus ($\sim 8 \times 8$ mm² in cross-section) were extracted from the posterior annulus (PA) and anterior annulus (AA) regions. Specimens were held in place with wooden blocks while cutting. No visible tears were caused by the sectioning process. Tissue was kept hydrated by spraying with phosphate-buffered saline (PBS) throughout preparation. Six specimens showed existing fissures in the annulus or separations at the EPJ, and were not used for subsequent analyses. One 2 mm-thick parasagittal slice from each sample was fixed in 10% formalin for histology and scanning electron microscopy (SEM). The remainder of each specimen was designated for μ CT and mechanical testing (Fig. 2).

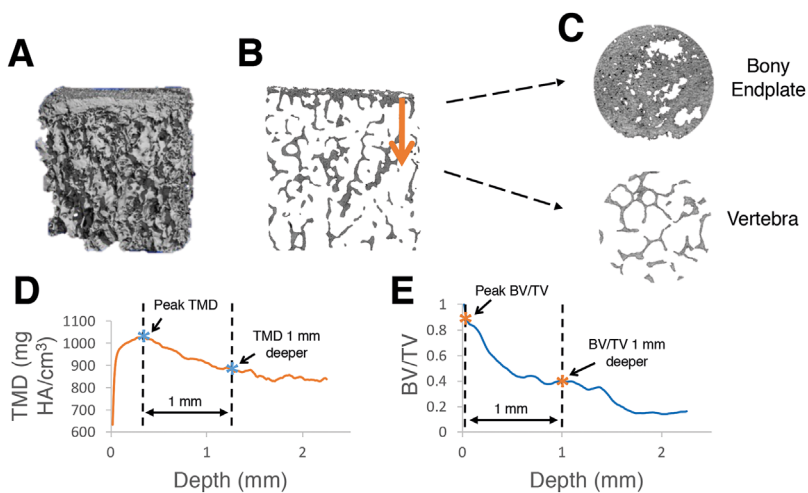
Figure 3. Process of calculating gradients in tissue mineral density (TMD) and trabecular bone volume fraction (BV/TV) at the endplate junction regions. (A) Three-dimensional μ CT data is loaded into custom IDL algorithm, (B and C) algorithm traverses from the dense bony endplate into the deeper vertebral bone, and average values of (D) TMD, and (E) BV/TV are plotted by depth. Differences between peak values (first asterisk) and values 1 mm deeper (second asterisk) were used to assess local gradients in TMD and BV/TV. Note that (B) and (C) are slices in the sagittal and transverse planes, respectively.

Next, a custom script was written in Interactive Data Language (IDL) to quantify TMD and BV/TV at the inferior and superior vertebral endplate regions for each specimen. The algorithm performs the following steps: (i) reads in TMD data; (ii) thresholds and masks the bone; (iii) crops the central 2.6 mm-diameter core of the sample; (iv) marches in the axial (Z) direction—beginning above the endplate—and identifies the endplate surface by finding the first non-zero pixel for each X-Y position; and (v) stores TMD values at every pixel for the next 2.25 mm depth. Then, the average TMD and BV/TV across the specimen were calculated and saved at every 0.015 mm from the endplate to the 2.5 mm depth. A custom MATLAB script was then written to calculate endplate TMD and BV/TV (defined as the average TMD and BV/TV in the first 0.2 mm-thick region from the surface) and gradients in TMD and BV/TV (defined as the difference between (i) the peak TMD and BV/TV, and (ii) the TMD and BV/TV 1 mm deeper). The 1 mm distance spans the thickness of the vertebral endplate, which is typically between 0.4 and 1.0 mm thick.¹⁵⁻¹⁷ This process is outlined visually in Figure 3.

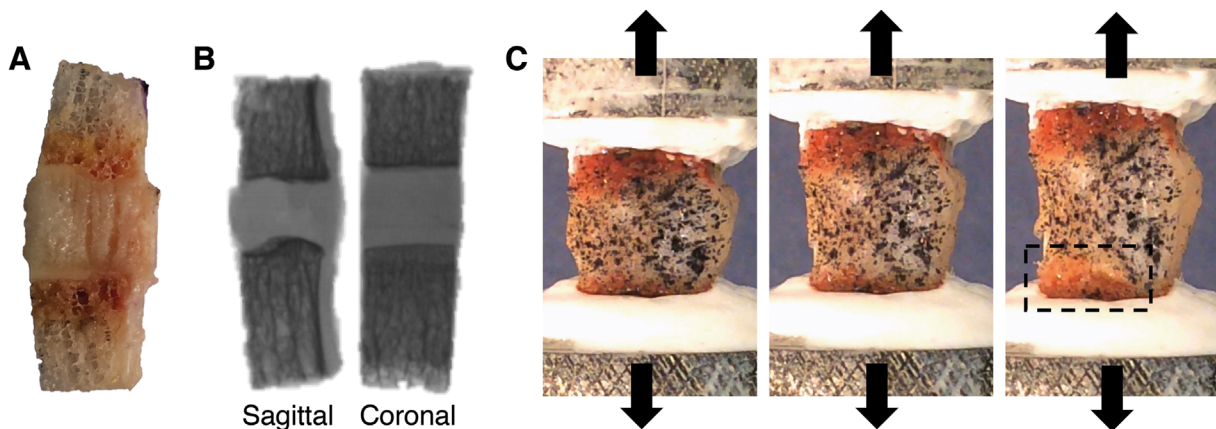
Figure 4. Specimen is (A) cleaned of bone marrow, (B) X-rayed in two orthogonal planes to calculate geometry, and (C) speckle-coated on parasagittal surface, mounted in custom-designed aluminum pots, and pulled in tension to failure. Box in (C) shows location of endplate junction failure. A, B (left), and C are all sagittal views with the inner annulus on the left and outer annulus on the right.

area, speckle-coated on one parasagittal surface with Verhoeff's tissue stain for DIC, and affixed to a custom testing fixture using casting resin (Fig. 4). Specimens were kept hydrated by spraying with PBS throughout preparation. Specimens were preconditioned for five cycles between 0 and 5% tensile strain, then loaded to failure in tension at 0.01 mm/s on a mechanical load frame (ElectroForce 3200; Bose, Eden Prairie, MN). The side of the disc where each specimen failed (inferior or superior) was recorded. Force-displacement data were normalized into stress-strain data using cross-sectional area (measured on X-rays as an average of cross-sectional area at the inferior endplate and superior endplate) and initial specimen height (measured with calipers as the average length between the two endplates along the center axis of the specimen's four faces). Measured cross-sectional areas and initial specimen heights were used to normalize the force-displacement data into stress-strain data. A MATLAB algorithm was written to calculate (i) toe region strain, defined as the strain where the stress-strain curve transitions to the linear portion ($R^2 > 0.99$); (ii) tensile modulus, defined as the slope of the stress-strain curve during the linear portion; and (iii) and (iv) failure strength and strain (Fig. 5). The toe region has been previously reported,^{18,19} and results from viscoelastic straightening of initially curved annulus collagen fibers. Mechanical tests were unreliable for seven specimens (i.e., casting resin

Failure locations were observed visually during testing (Fig. 4C). Videos captured during tension tests at 30 frames/s were watched in slow-motion to confirm initial failure location and observe failure progression. Failed specimen surfaces were visualized after testing to confirm precise failure locations (as determined by tissue types on either side of the failure).

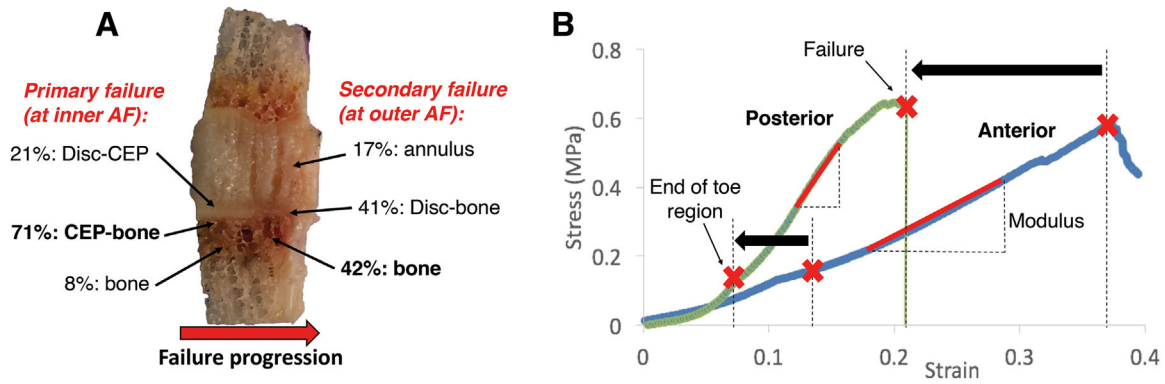
Figure 5. (A) Distribution of failure locations at inner annulus fibrosus (AF) and outer AF regions, with red arrow showing typical direction of failure progression from inner to outer AF. CEP, cartilage endplate; (B) Stress-strain curves for representative posterior annulus and anterior annulus specimens. Posterior specimens had a shorter toe region and lower failure strain (denoted by black arrows) than anterior specimens, as well as a higher modulus than anterior specimens ($p < 0.01$). Strains on x-axis are grip-to-grip strains along the loading axis.

Mechanical failures initiated near the disc-vertebra interface for all specimens (52% at the inferior side and 48% at the superior side). Failure initiated at the inner annulus region and progressed toward the outer annulus region. A total of 71% of primary failures (at the inner annulus region) occurred at the CEP-bone interface, with CEP being stripped from the underlying bone. A total of 21% occurred at the disc-CEP interface, and 8% occurred within the subchondral bone. Following primary failure at the inner annulus region, failure progressed to the outer annulus region, where 42% of secondary failures occurred mid-bone, 41% at the disc-bone interface (note: no CEP is present between the disc and bone in this out annulus region), and 17% within the annulus (Fig. 5). The average modulus, strength, and failure strain were

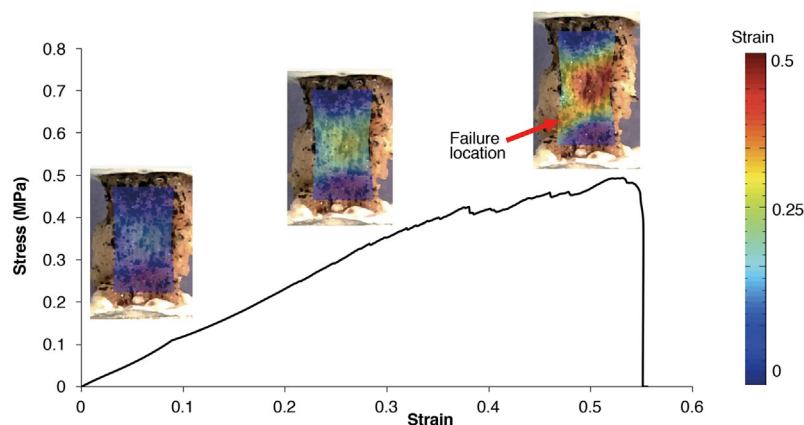
Figure 6. Stress-strain curve for a bone-disc-bone specimen. Strains on x-axis are grip-to-grip strains along the loading axis. Principal strain maps are overlaid on specimen images acquired at corresponding levels of applied strain.

the range of 10–100 μm . Strain maps were overlaid on specimen test videos (Fig. 6). A MATLAB algorithm was written to plot principal strain at each central axial location across the specimen. Principal strains were analyzed—rather than axial strains—due to the nonhomogeneous nature of the tissue samples. Strain gradients were calculated as the difference between the maximum strain (in the annulus) and minimum strain (in the bone), as a surrogate measure of functional grading across the interface.

Across all specimens, the highest principal strains occurred mid-annulus, while the lowest occurred in the bone. The strain gradient (measured as the difference between the maximum and minimum principal strains) became steeper with higher applied strains. At very high applied strains (near failure), high local strains were observed at the failure location (Fig. 6).

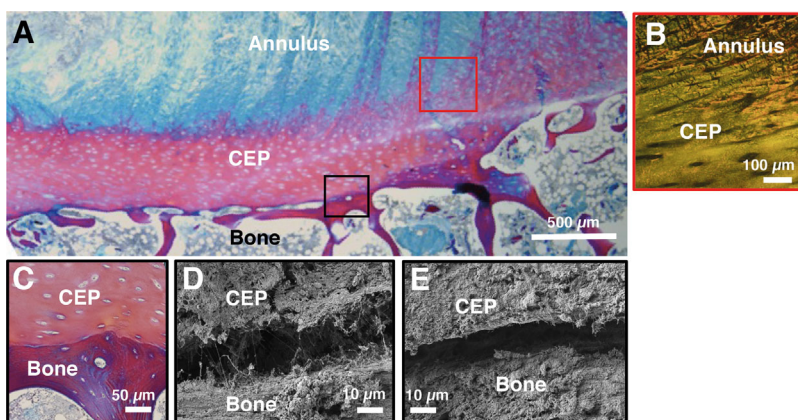
Figure 7. Sagittal histology (A,B,C) and SEM (D,E) images of the endplate junction. (A,C) are stained with trichrome stain, and (B) is stained with picrosirius red and visualized under polarized light. (B) shows annulus fibers integrating with the cartilage endplate (CEP), while (C) shows a clear demarcation between CEP and bone with no integration. (D and E) show small gap between CEP and bone using SEM. Black and red boxes on (A) are color-coded to correspond with approximate regions of (B–E).

SEM scans in the sagittal plane indicated a lack of structural integration between the CEP and bone. Many specimens showed a physical gap (5–30 μ m thick) between the CEP and bone (Fig. 7D and E). The gap typically either had sporadic thin collagen fibrils showing evidence of a weak connection (Fig. 7D) or was void of collagen fibers altogether (Fig. 7E). Transverse failure surfaces showed a bed of collagen fibers oriented in the plane of the failure interface (Fig. 8). For specimens that appeared to fail at the CEP-bone interface, the vertebral endplate surface displayed cartilage-like fiber morphology, indicating that the specimen failed between the CEP, and the calcified cartilage layer.

Histologic sections also indicated a lack of structural integration between the CEP and adjacent bone (Fig. 7). Inner annulus fibers joined at oblique angles with the CEP (Fig. 7A and B), but did not anchor into the subchondral bone (Fig. 7C). The outer annulus region did not contain CEP, and fibers anchored directly into the vertebral rim as previously described. The average CEP thickness was 0.85 ± 0.21 mm, as

Microstructural imaging showed very little structural integration between the disc and vertebra. SEM showed 5–30 μm discernible gaps between the CEP and bone with no ligament-like bridging other than thin individual collagen fibrils (Fig. 7D and E). These gaps may be a result of interlaminar delamination caused by scanning under vacuum (low pressure), which is a known artifact of electron microscopy and has been observed in previous studies.^{34,10} Delamina-

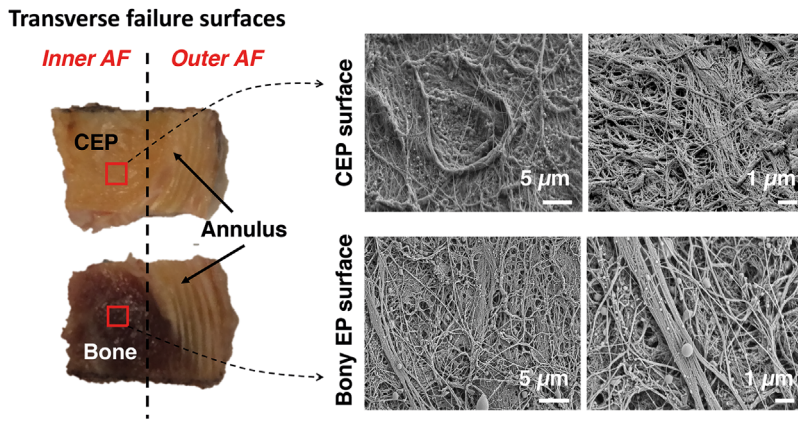
Figure 8. (Left) Transverse failure surfaces for specimen that failed at cartilage endplate (CEP)-bone interface at inner annulus fibrosus (AF) region and failed in mid-annulus at outer AF region. Red squares indicate location of SEM scans; (Right) SEM scans of failure surfaces imaged for CEP; and opposing bony endplate surface.

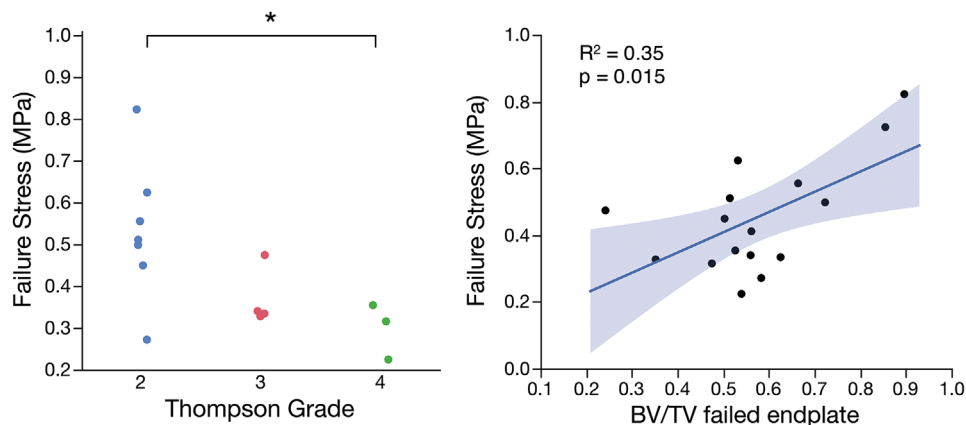
Figure 9. (Left) Failure stress was significantly lower in samples from discs with Thompson Grades 4 versus 2 ($*p=0.026$, t -test); (Right) Failure stress was positively correlated with trabecular bone volume fraction (BV/TV) in the vertebral endplate that failed during mechanical tests ($R^2=0.35$, $p=0.015$).

Various relationships were found between structural and mechanical properties. Failure stress was significantly lower in specimens with a Thompson Grade of 4 than those with a Thompson Grade of 2 ($p=0.026$, t -test; Fig. 9). Interestingly, failure stress significantly increased with BV/TV in the failed endplate ($R^2=0.35$, $p=0.015$; Fig. 9). Within each specimen, the endplate (inferior or superior) that remained intact during mechanical tests had 8% higher BV/TV and 3% higher TMD than for the endplate that had failed ($p<0.05$). The intact side also tended to have a 5% lower (less steep) BV/TV gradient ($p=0.08$).

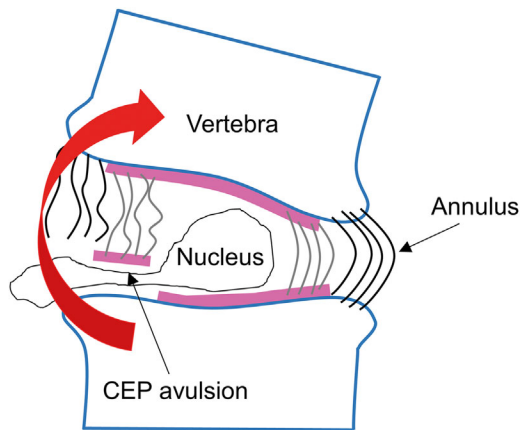
Figure 10. One proposed mechanism of disc herniation, in which cartilage endplate (CEP) is avulsed from bone, allowing disc material to escape. Endplate junction failure is the most common cause of clinical disc herniations¹ and may occur during spinal movements involving bending motions that place the CEP-bone interface in tension.

Our findings indicate that the CEP and vertebra at the inner annulus region are not well-integrated, which is supportive of previous findings^{24–26} and may explain the weakness of this zone. Because the CEP and inner annulus are structurally integrated, tension at the CEP-bone interface generated during certain spinal movements can avulse the cartilage from the underlying bone (Fig. 10).

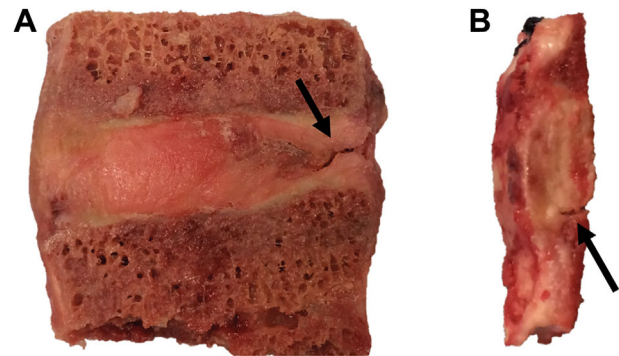
Figure 11. Un-tested lumbar specimens. Specimens are often too degenerated for mechanical testing and show (A) annular fissures and (B) separation at the CEP-bone interface.

A significant limitation of this study is that we tested only thoracic levels because most lumbar levels of the donor spines contained annular fissures and existing defects at the CEP-bone interface that precluded harvesting intact specimens for analysis (Fig. 11). The majority of clinical disc herniations occur in the lumbar spine.⁴¹ Although we tested only lower thoracic levels (T10-L1), we expect that our conclusions regarding the importance of structural integration applies to lumbar specimens, which have similar endplate morphology. Moreover, the annular fissures and defects at the CEP-bone interface in the lumbar levels further evidences the weakness of this interface *in vivo*.
