North Campus Open Space Restoration Project Annual Monitoring Report: Year 2 (2019)

# North Campus Open Space Restoration Project

## Annual Monitoring Report: Year 2 (2019)

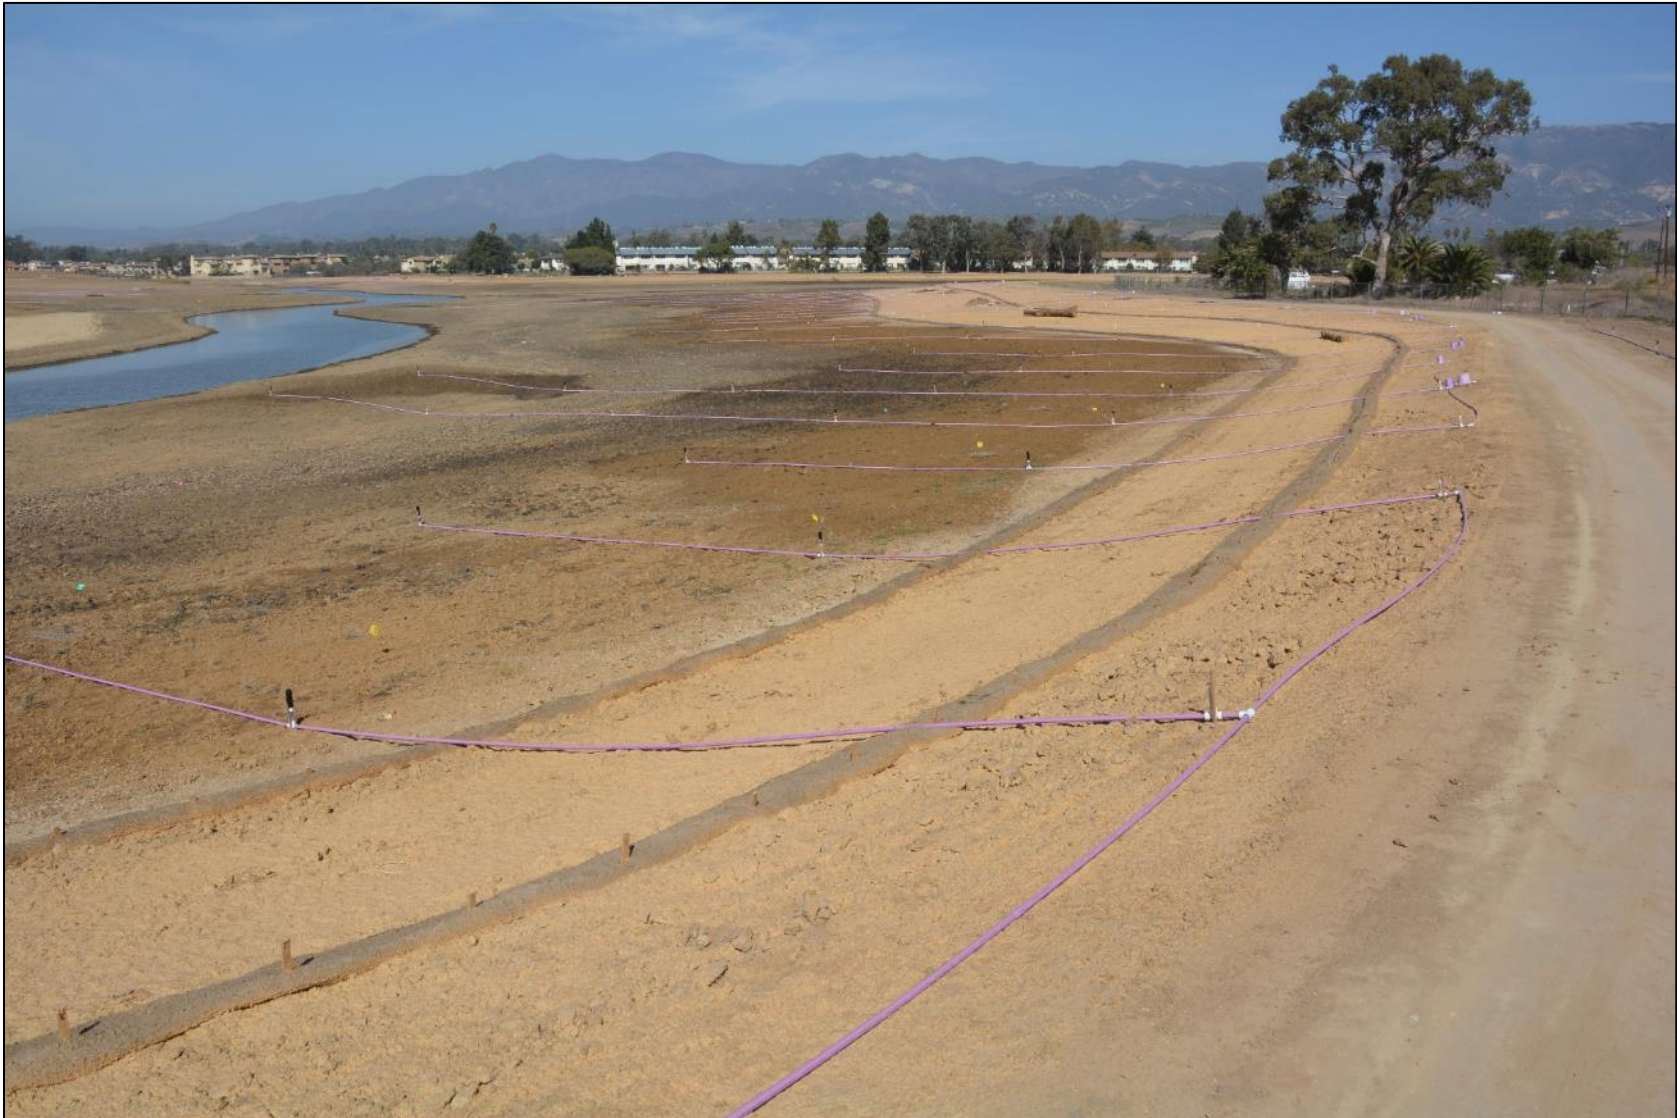
**Photo point 20-NW – looking northwest from the southeast corner of the NCOS project site.**

**Baseline photo – post-grading, October 10, 2017.**

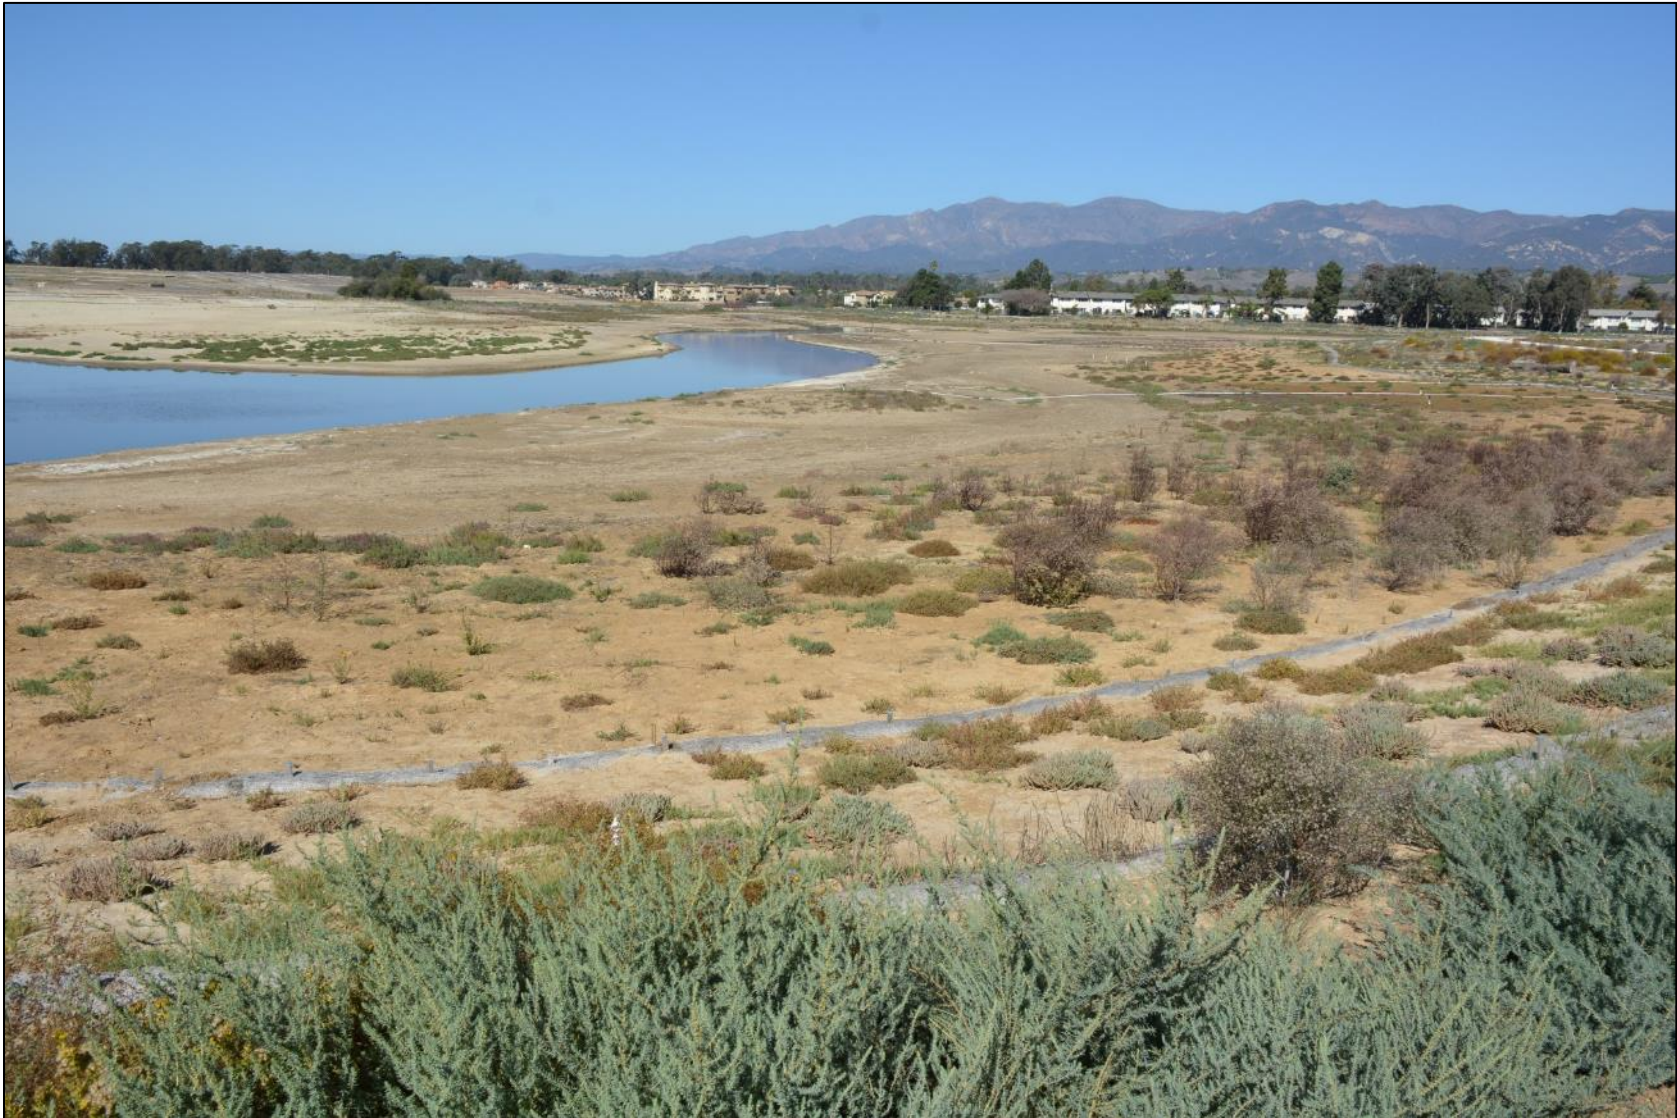
**Year 1 photo – October 16, 2018.**

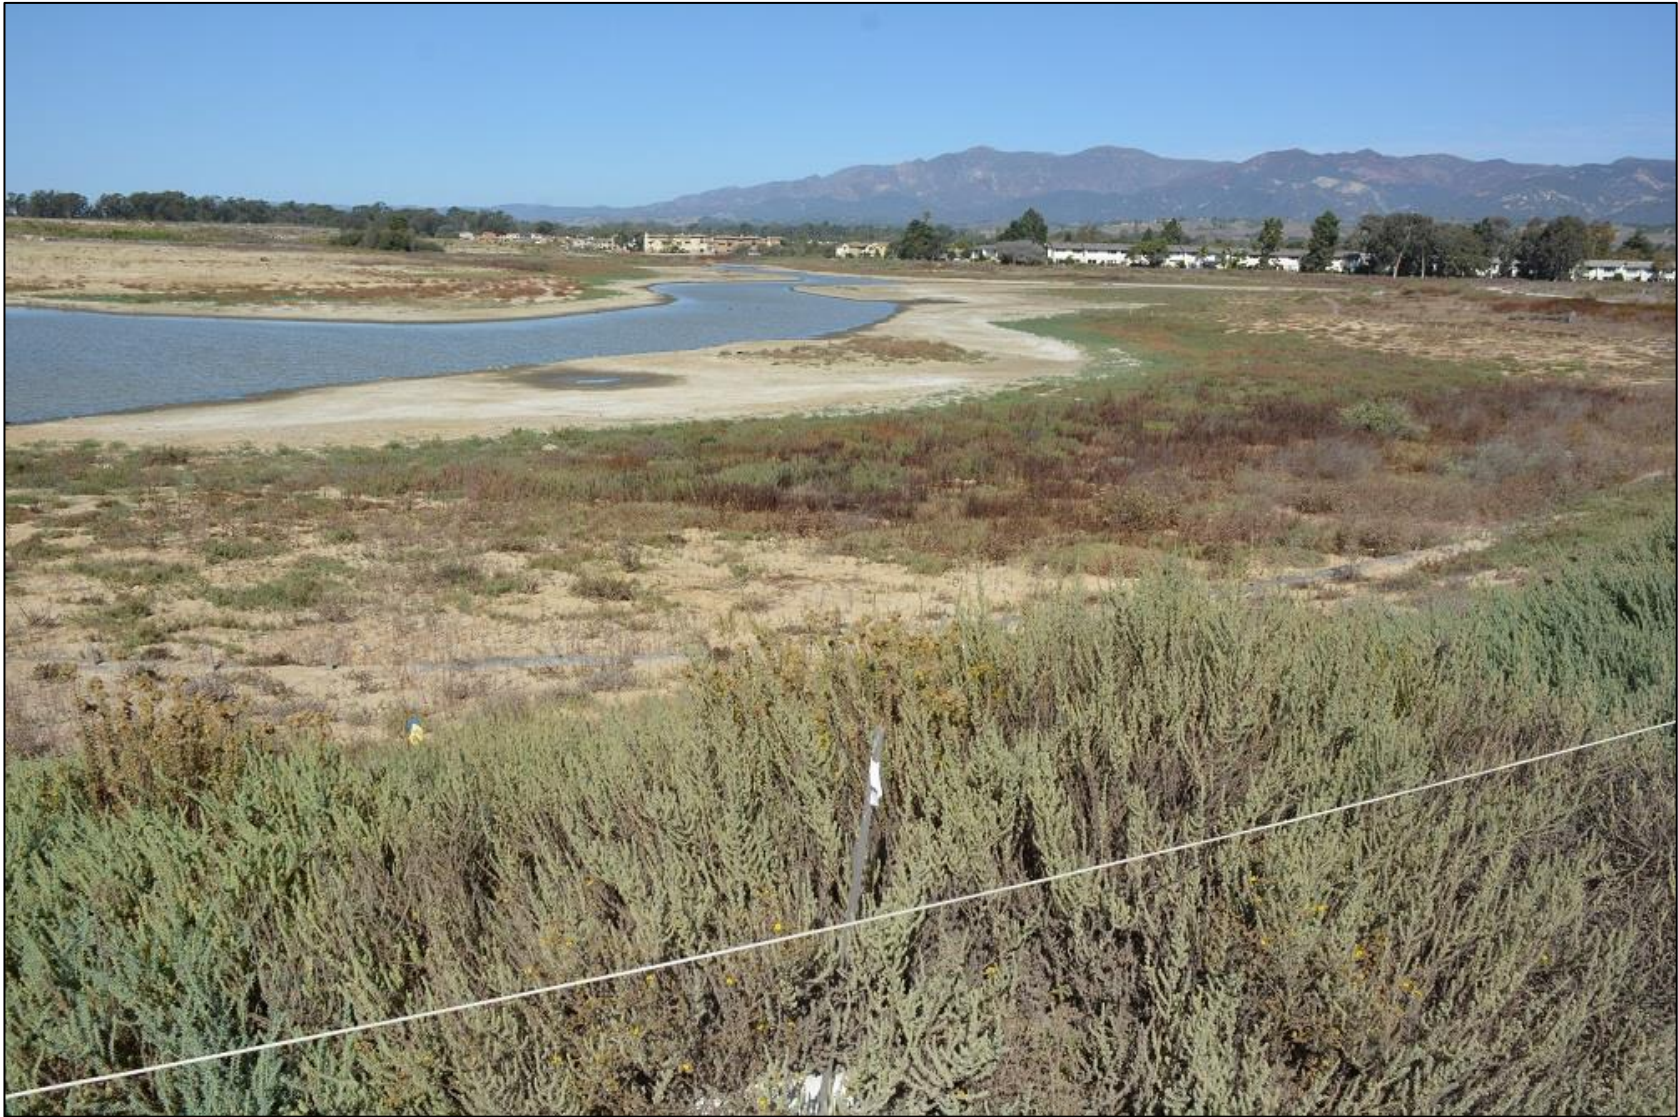
**Year 2 photo – October 11, 2019.**

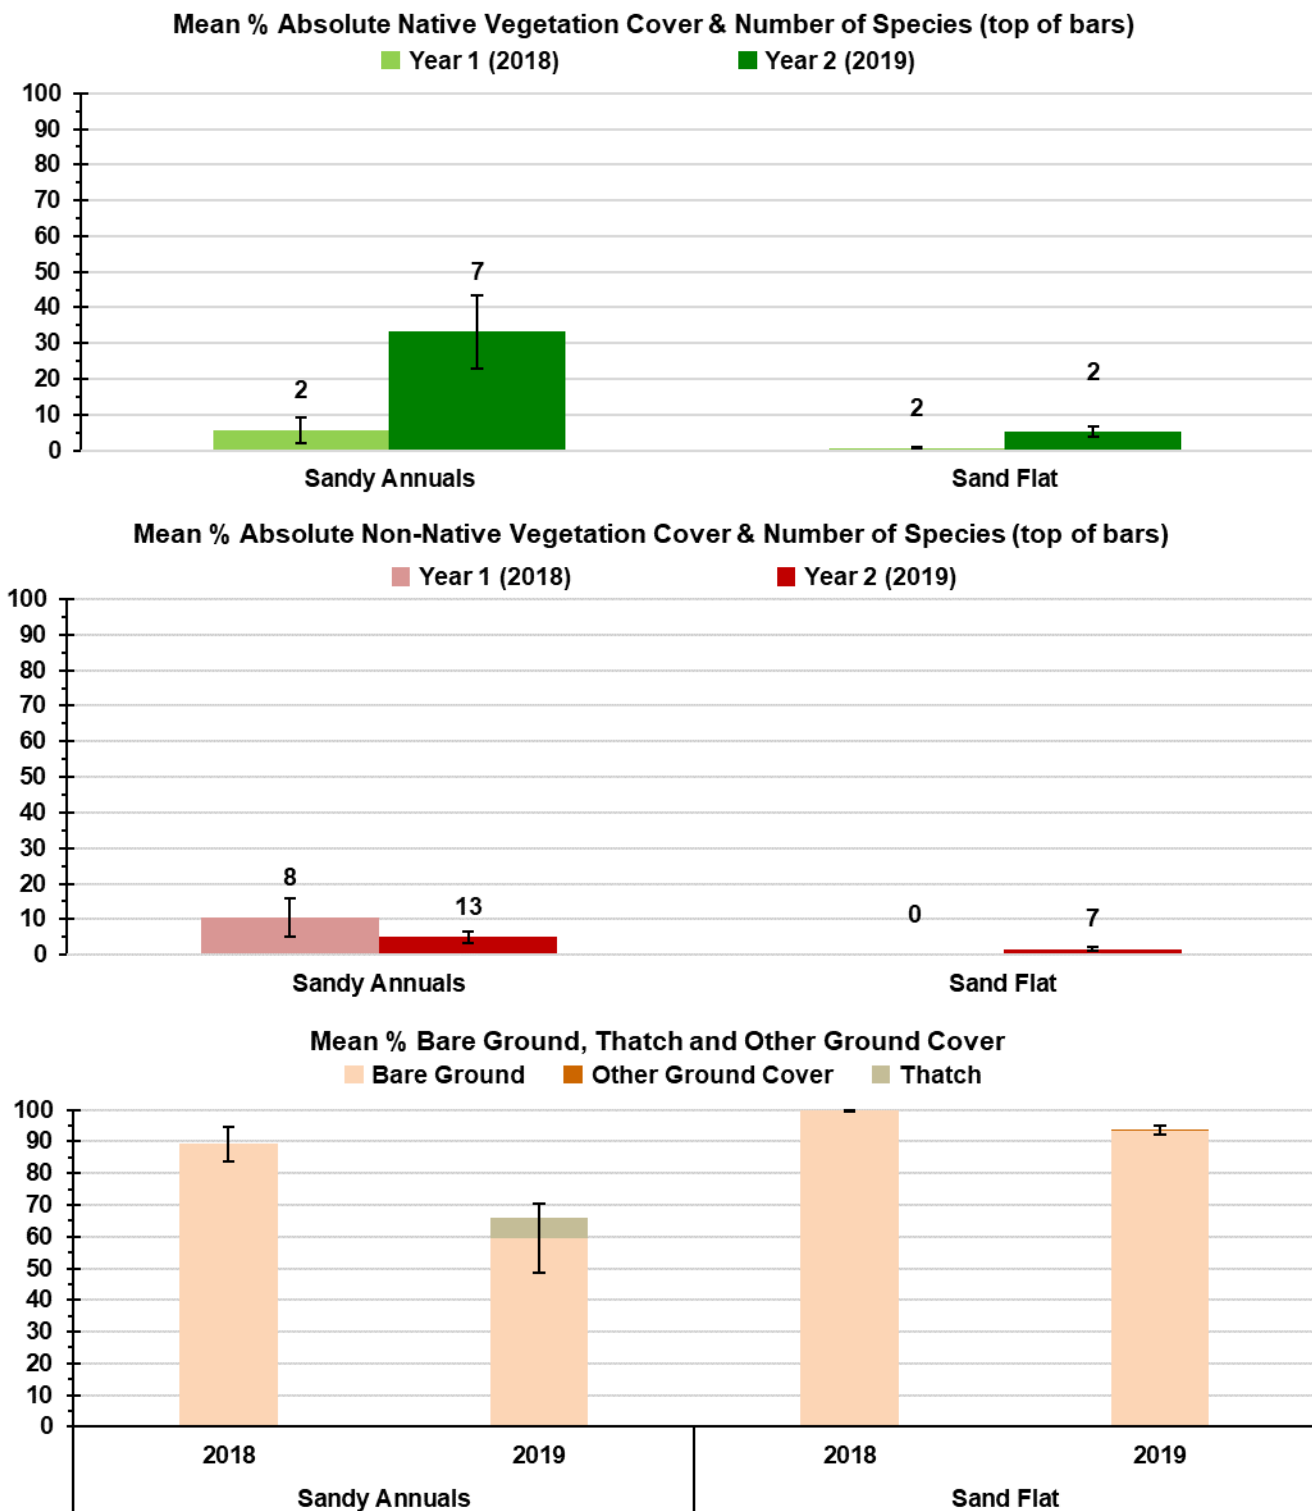
Figure 5. Charts of the mean percent and standard error of absolute native (top) and non-native vegetation (middle) cover, and percent bare ground, thatch and other ground cover (primarily mulch/woodchips or dried algae) quantified from monitoring transects in the Sandy Annuals and Sand Flat habitats at NCOS in year 1 (2018) and year 2 (2019). The number of native and non-native species recorded from the monitoring are on the top of the bars that represent percent cover.

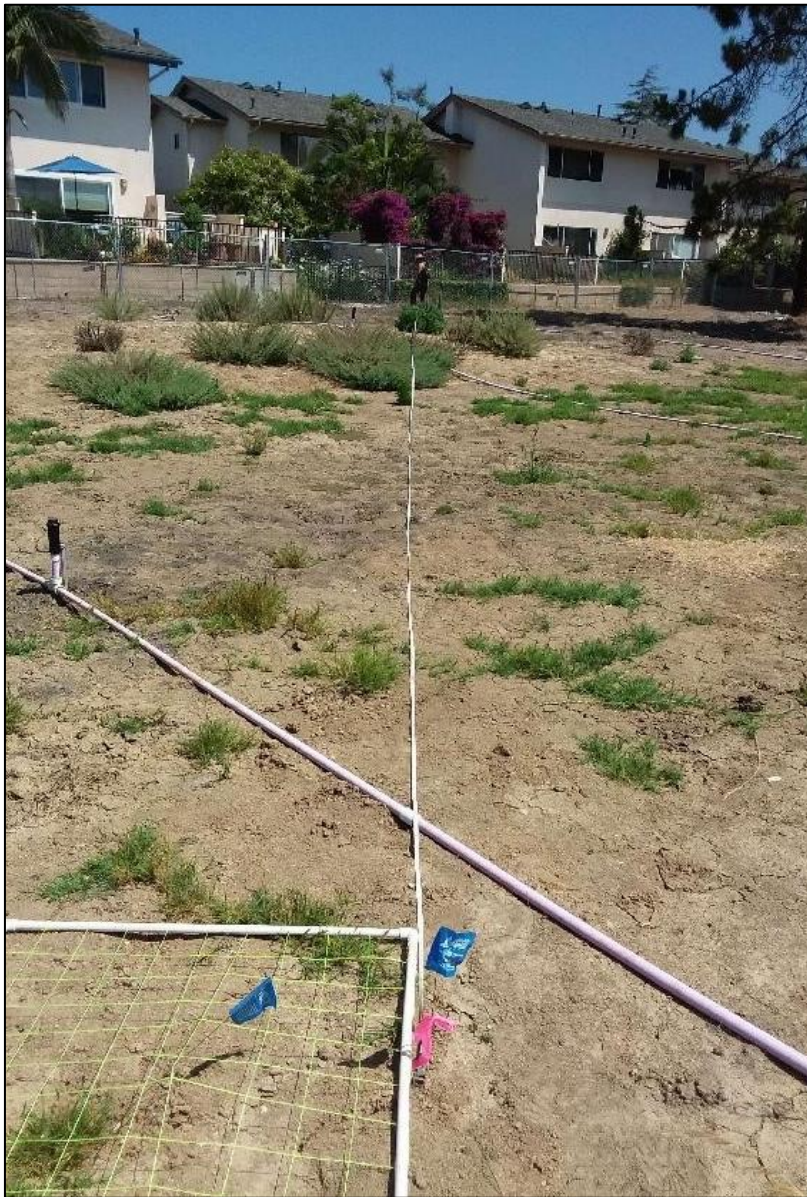
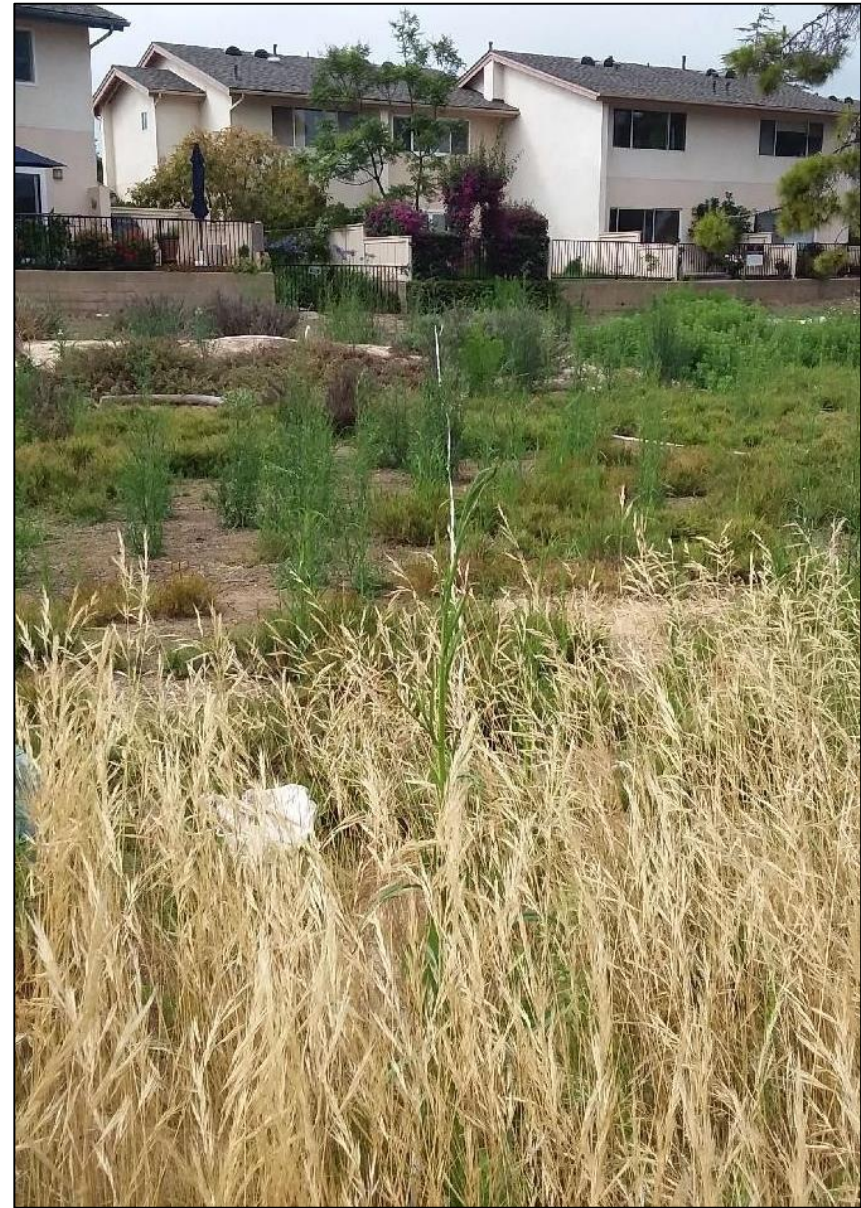
Figure 7. Photographs of monitoring transect PU-04 in the Peripheral Uplands taken in year 1 (left image) and year 2 (right image).

The second year of monitoring showed increases in native vegetation cover in all habitats, a decrease in the amount of bare ground in most habitats, and variable yet mainly insignificant changes in the amount of non-native vegetation cover. In many habitats, the average percent of absolute native vegetation cover more than doubled since the first year, with the greatest increases observed in the Native Grassland, Peripheral Upland Mosaic, Salt Marsh and Transition/High Salt Marsh ([Figure 4](#)), as well as the Sandy Annuals ([Figure 5](#)) and the sub-canopy of the new Riparian habitat ([Figure 6](#)). This positive result also meant that these same habitats saw a significant reduction in the amount of bare ground between the first and second year of monitoring, particularly in the Salt Marsh habitat where the overall percent of bare ground decreased by more than half ([Figure 4](#)). The increase in vegetation cover and decrease in bare ground is also evident in a comparison of photos of transects from the first and second years of monitoring ([Figure 7](#)).

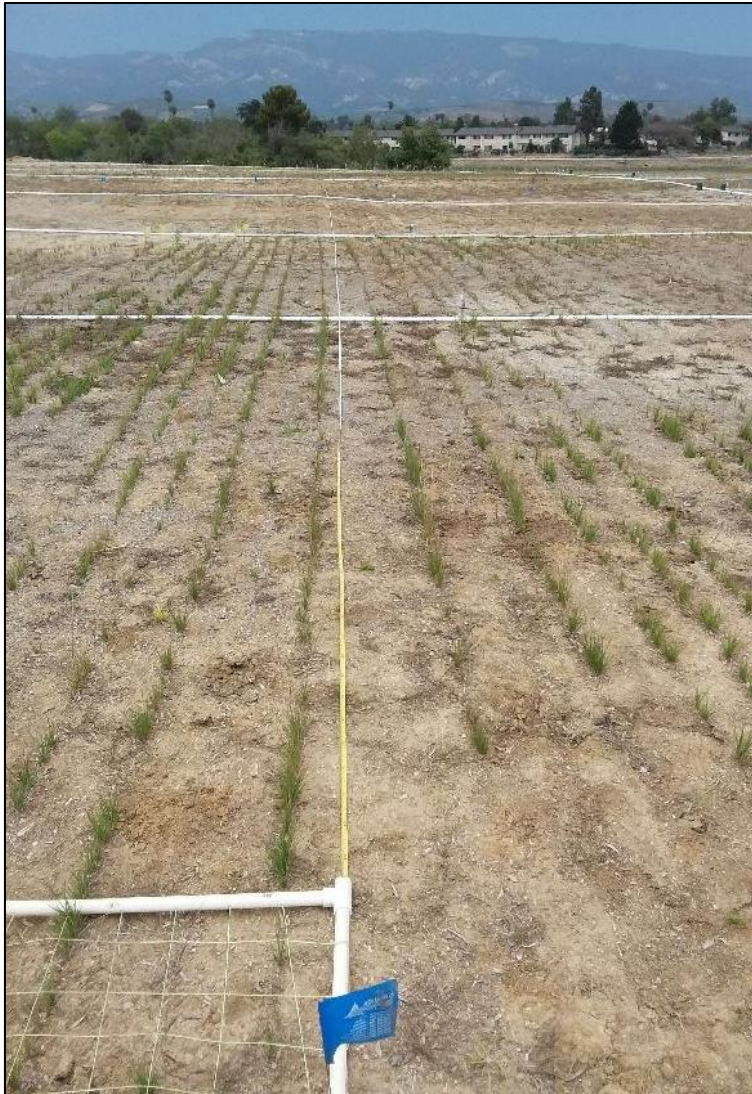
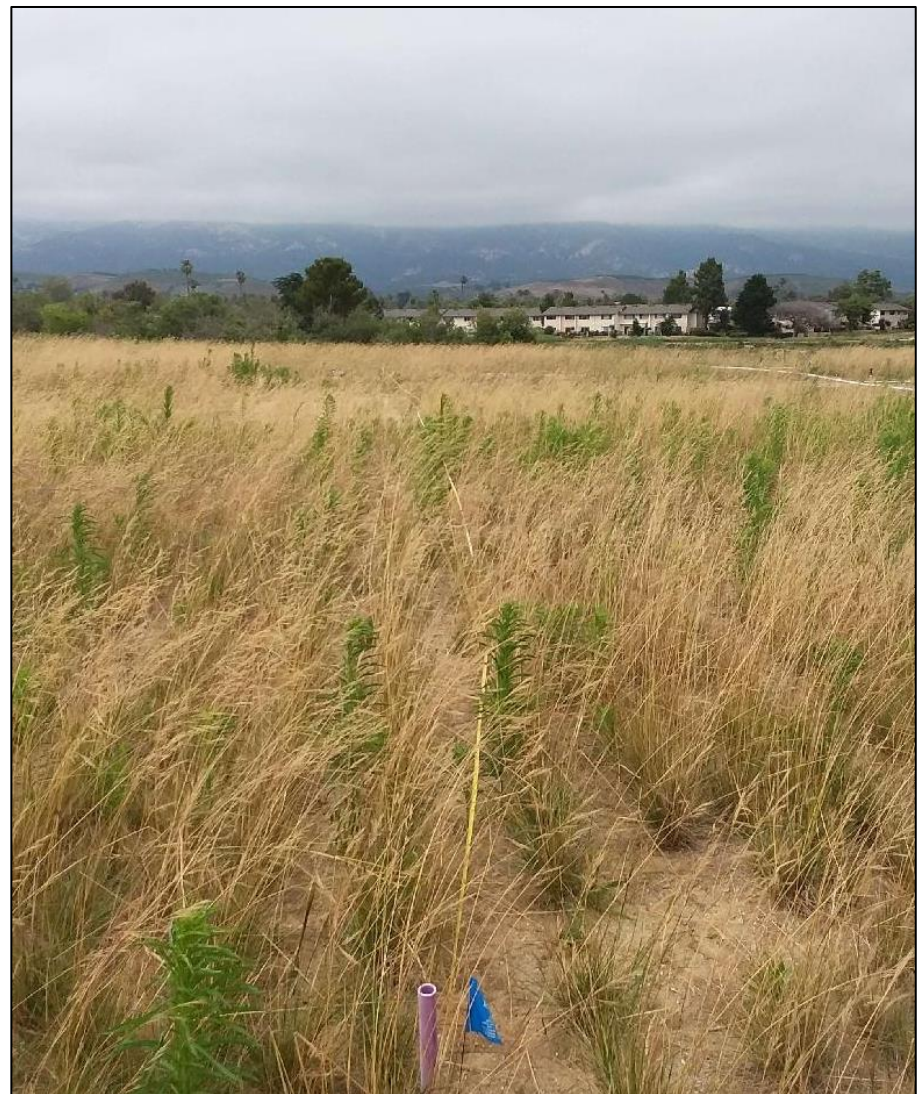
**Figure 8. Photographs of monitoring transect GL-10 in the Native Grassland taken in year 1 (left image) and year 2 (right image).**

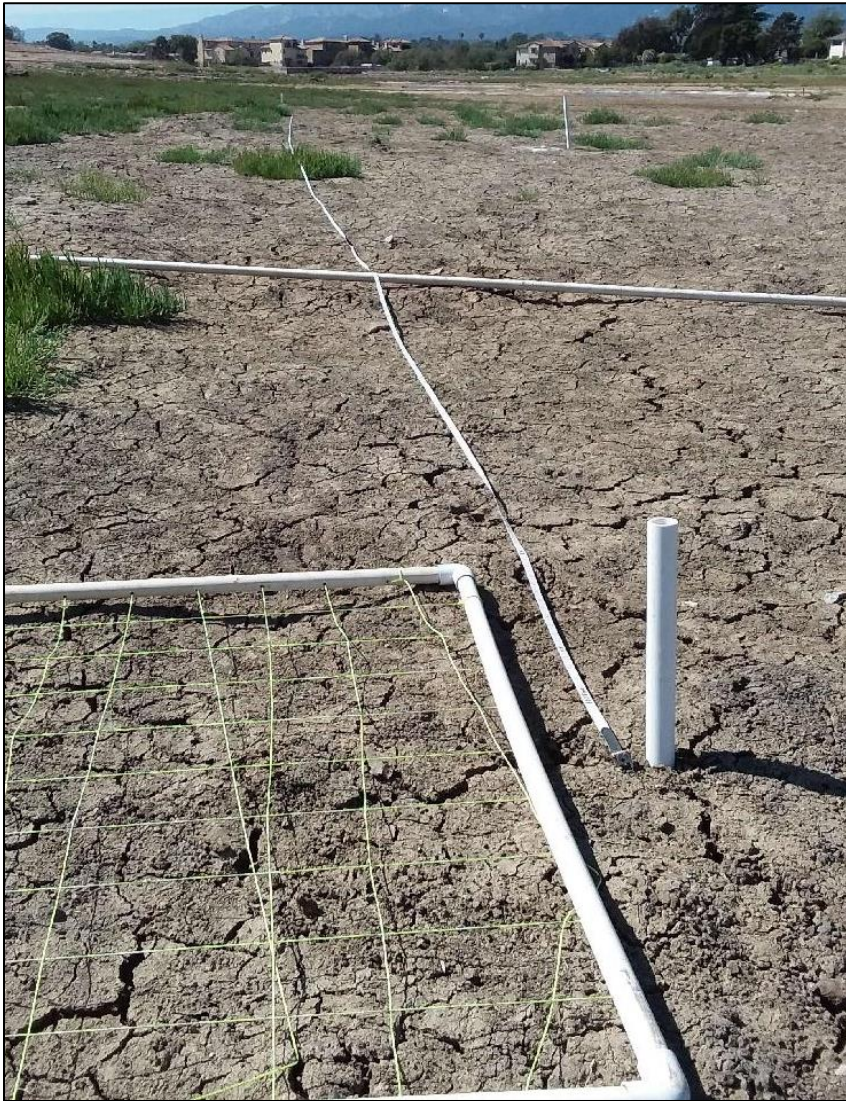
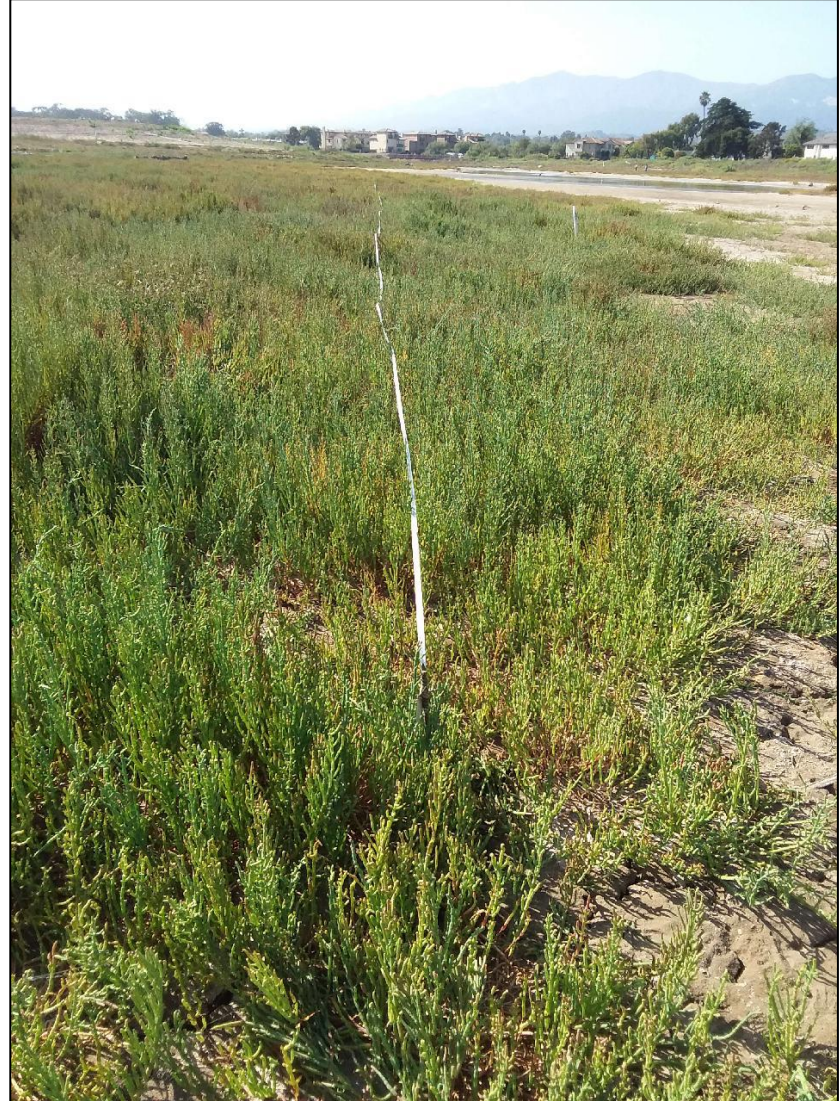
**Figure 9. Photographs of monitoring transect SML-05 in the Salt Marsh taken in year 1 (left image) and year 2 (right image).**

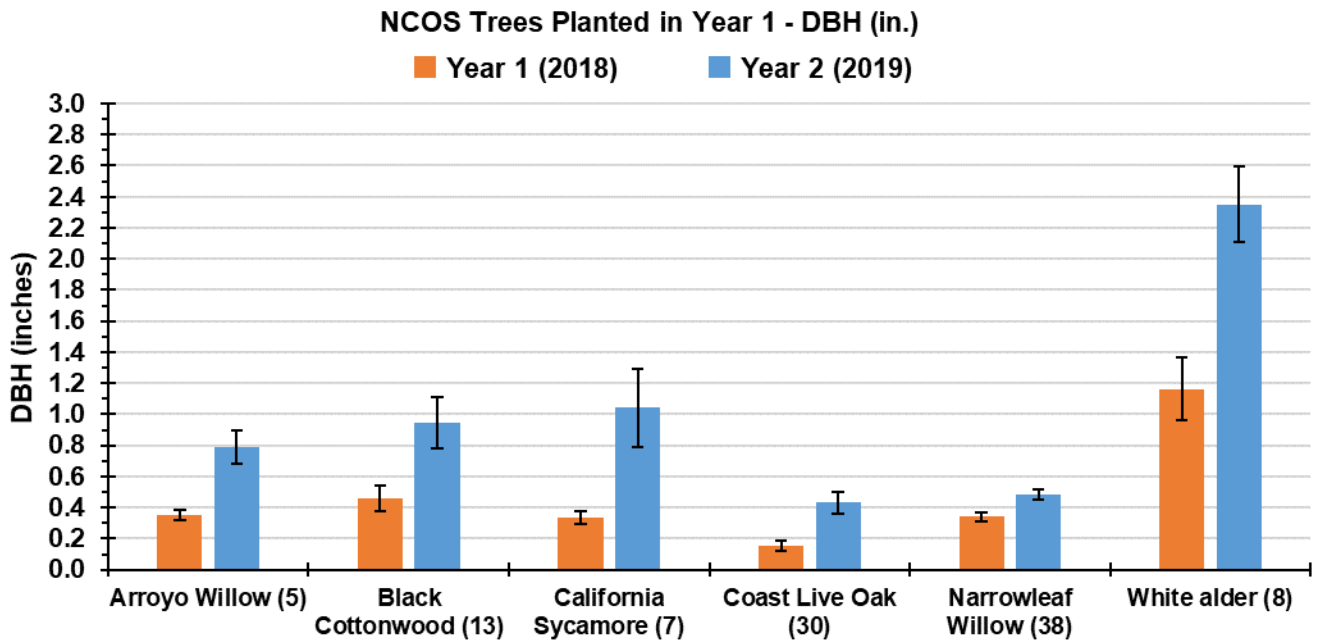
Figure 14. Bar chart of the mean diameter at breast height (inches) in year 1 (2018) and year 2 (2019) of six tree species planted in the first year of restoration at NCOS. The number of trees planted is in parentheses next to the name of each species. Error bars are +/- standard error of the mean.

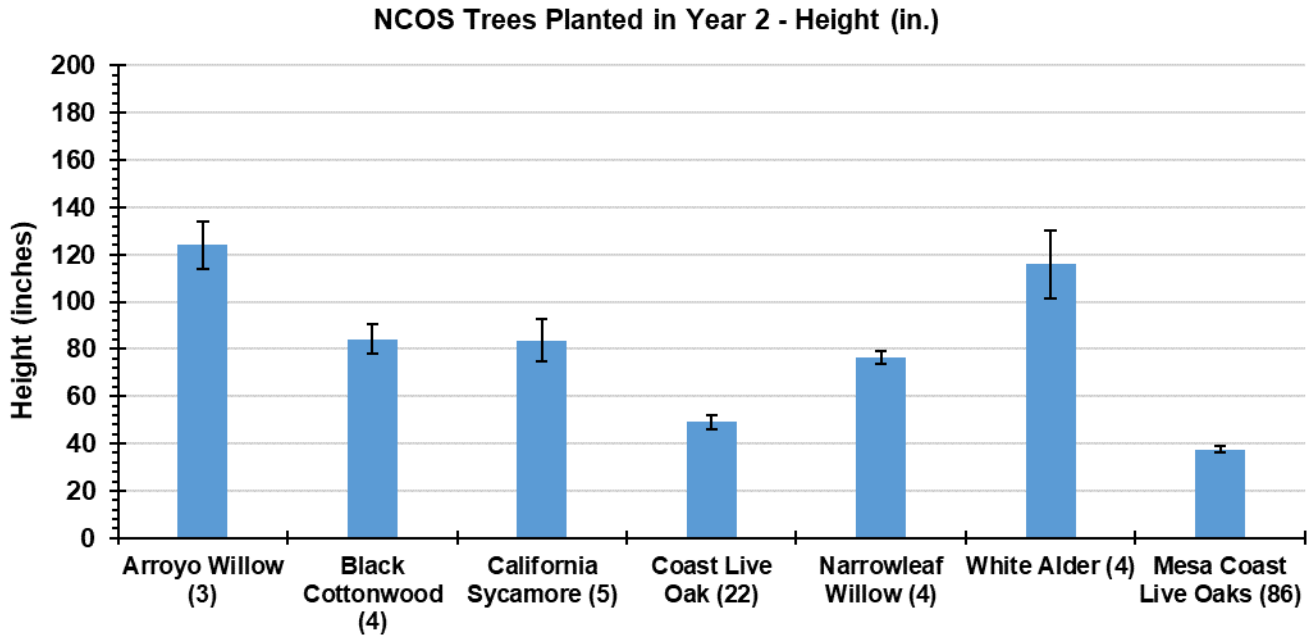
Figure 16. Bar chart of the mean height (inches) of six tree species planted in the second year of restoration at NCOS. Coast live oak trees planted to create oak woodlands on the slopes of the Mesa are shown separately from other oak trees. The number of trees planted is in parentheses next to the name of each species. Error bars are +/- standard error of the mean.

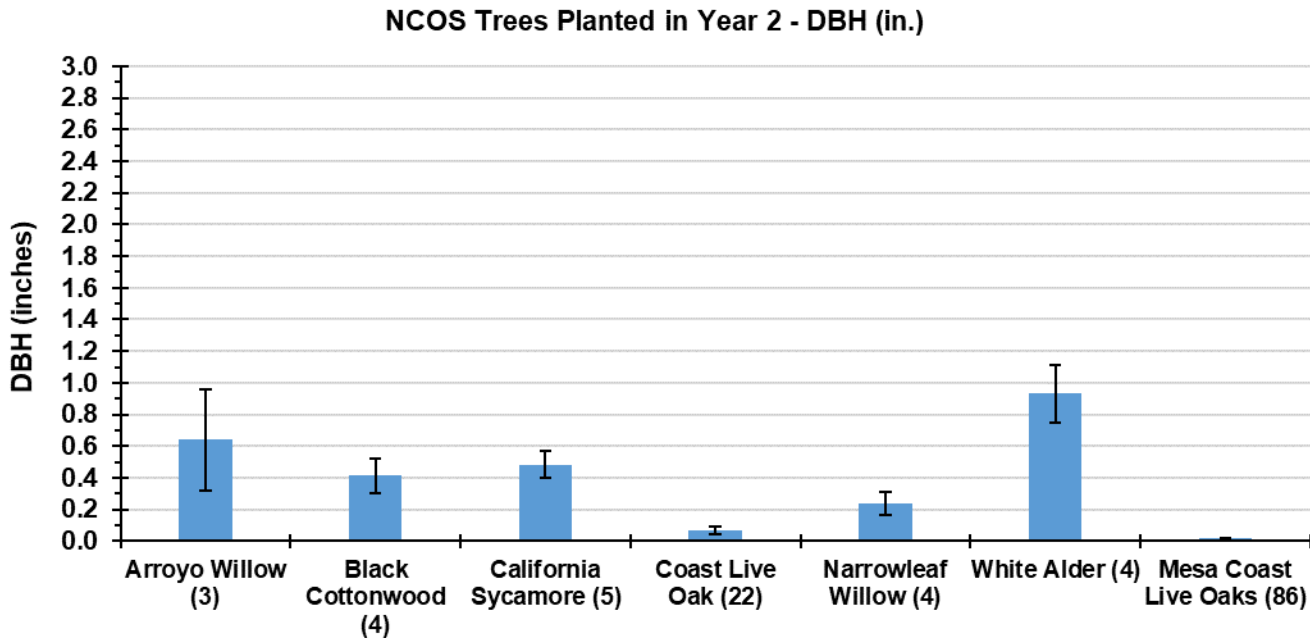
Figure 17. Bar chart of the mean diameter at breast height (inches) of six tree species planted in the second year of restoration at NCOS. Coast live oak trees planted to create oak woodlands on the slopes of the Mesa are shown separately from other oak trees. The number of trees planted is in parentheses next to the name of each species. Error bars are +/- standard error of the mean.

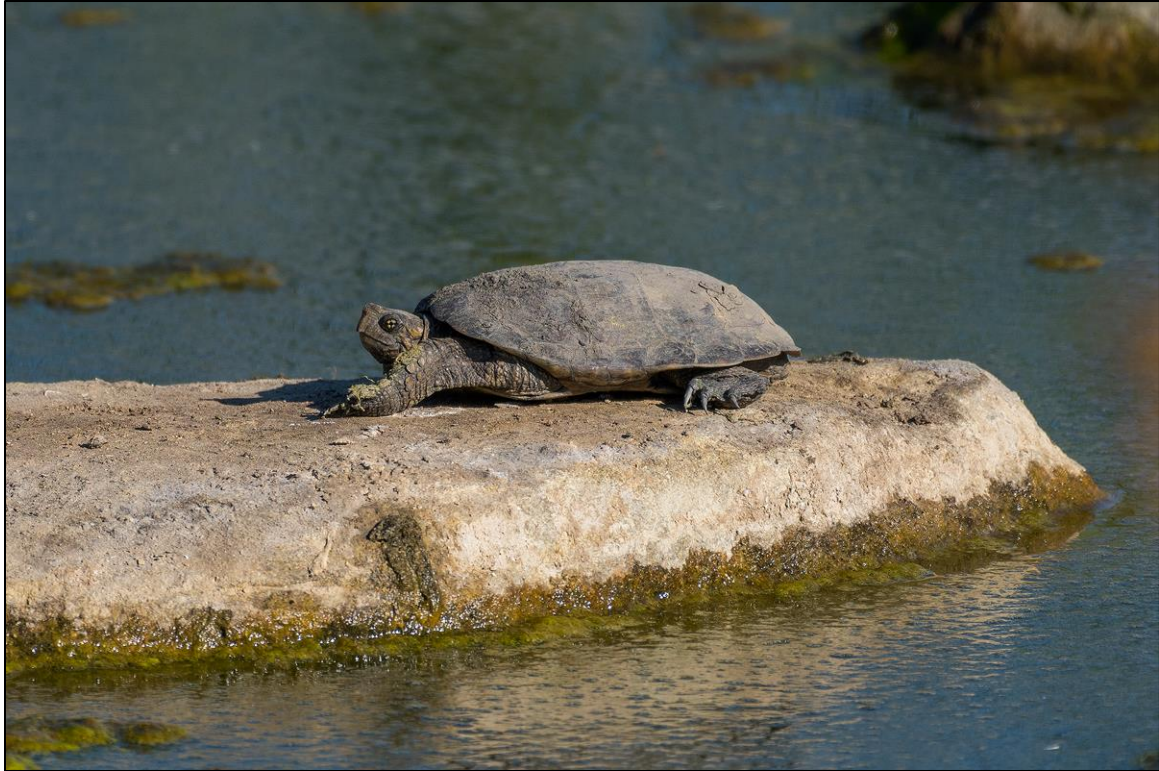
**Figure 20. Photograph of a Southwestern Pond Turtle in the area where Phelps Creek enters NCOS, November 18, 2018.**

Surveys for the sensitive and special status species California Red-legged Frog, Tidewater Goby and Southwestern Pond Turtle have been conducted by permitted biologist, Rosemary Thompson (federal permit TE-815144-9, state permit SC-002731), with the assistance of CCBER staff. Pre-construction surveys conducted in 2016, and post-construction surveys conducted in the fall of 2017 and in August 2018 found no presence of the three species. Outside of these surveys, CCBER staff have observed a Southwestern Pond Turtle in Phelps Creek prior to construction, and periodically in the same area since the first post-construction sighting in November 2018 ([Figure 20](#)).

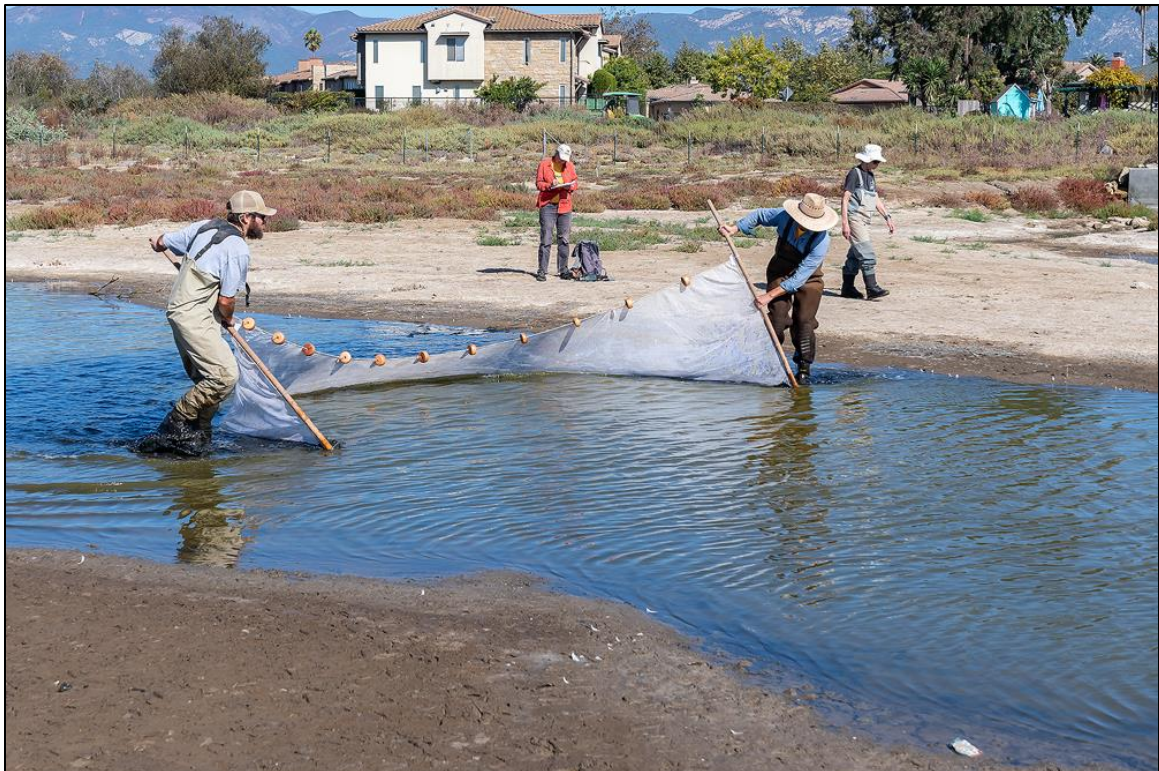
**Figure 21. Photograph of CCBER staff and permitted biologist, Rosemary Thompson, conducting a survey for Tidewater Goby in the upper Devereux Slough, October 2019.**

A third post-construction survey for Tidewater Goby conducted on October 17, 2019 found the presence of five individuals of the endangered fish in the lower most area of Devereux Slough ([Figure 21](#)). This was the first observation of the species in Devereux Slough in several years. The survey also found several individuals of three other native fish species, as well as hundreds of individuals of two non-native fish and a few non-native crayfish. The slough was connected to the ocean for several weeks in January and February of 2019, which may have allowed some Tidewater Goby to enter and remain in the slough. It is also possible that a small population has persisted in the slough for the past few years and not been captured in prior surveys. Tidewater Goby have been found in Phelps Creek in the past, and the results of this most recent survey are promising for the future presence of the species in the upper slough and tributaries of NCOS. A Technical Memorandum on the results of the October 2019 survey is provided in [Appendix 3](#) of this report.

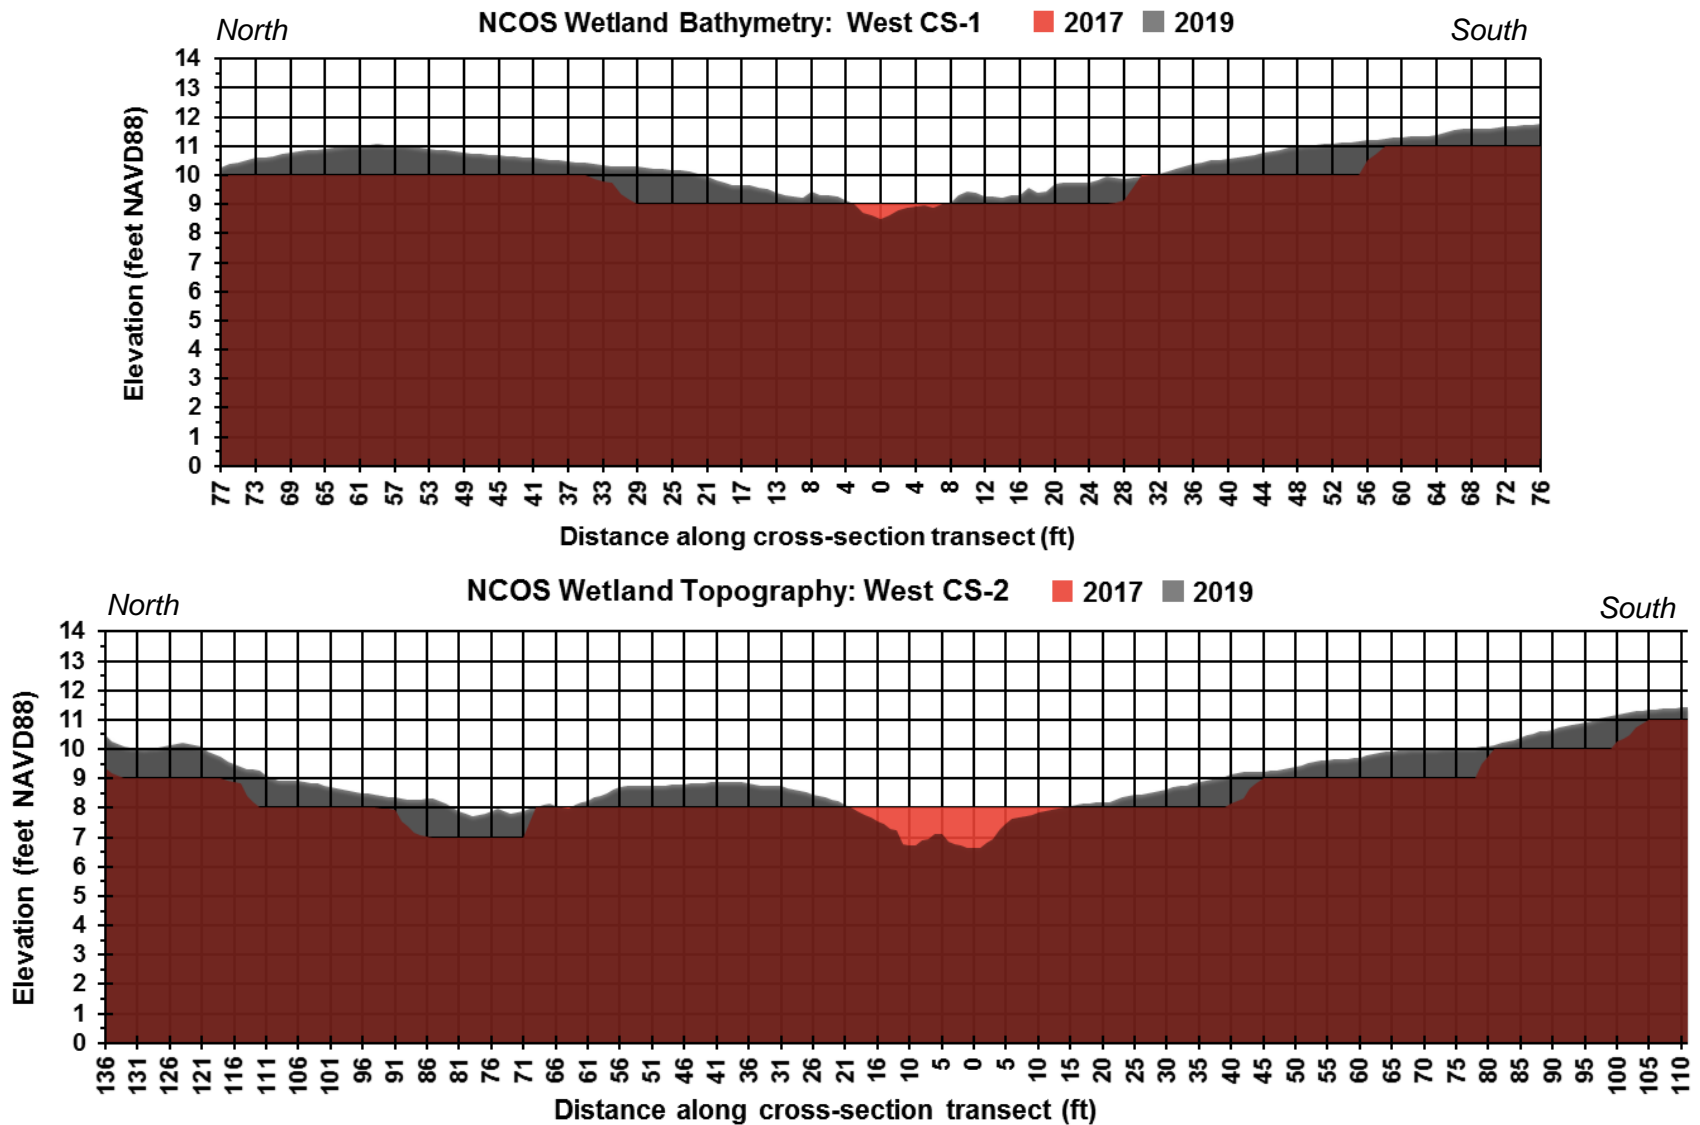
Figure 24. Profiles of the two NCOS wetland bathymetry cross-section transects west of the confluence with Phelps Creek that were added in 2019. The 2017 profiles for these transects are derived from a digital elevation model of the as-built grading, which explains the abrupt, step-wise change in elevation by 1-foot intervals. See [Figure 23](#) for a map of the transects.

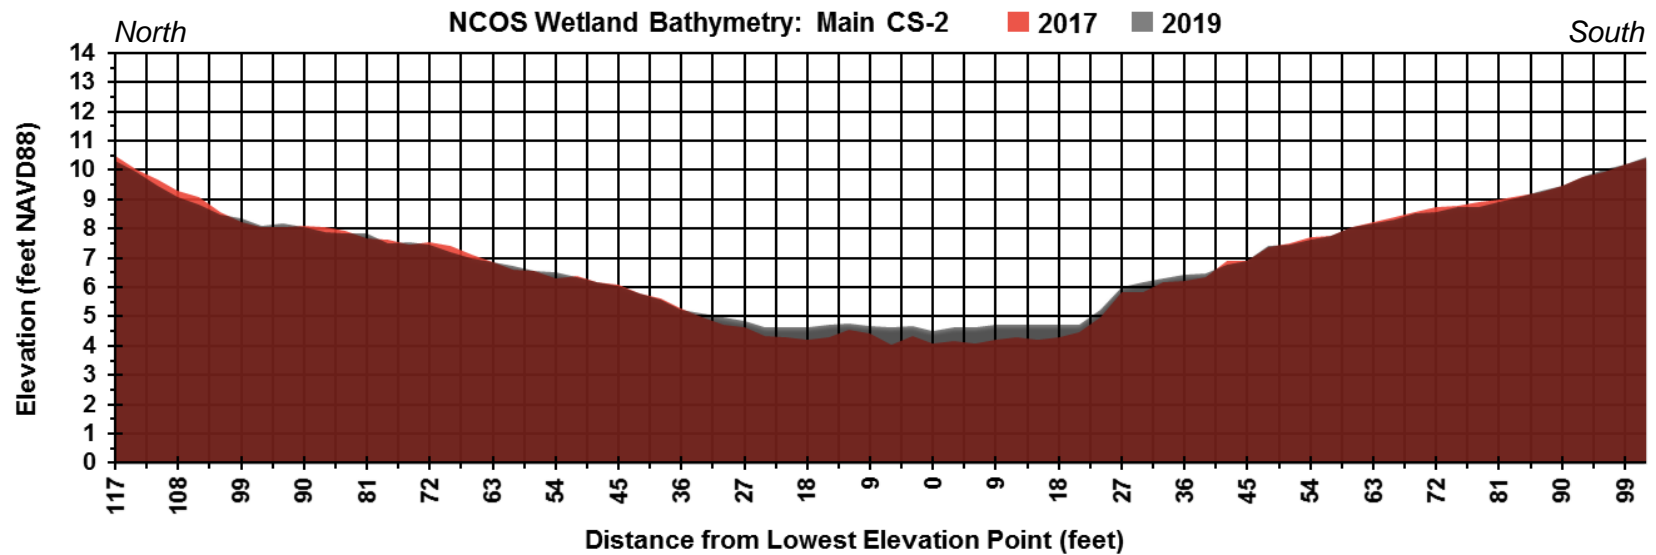
Figure 25. Profiles of the wetland bathymetry cross-section transects measured in 2017 (as-built) and 2019 in the upper portion of the Main Channel (Main CS) of NCOS. See [Figure 23](#) for a map of the transects.
