North Campus Open Space Restoration Project Annual Monitoring Report: Year 2 (2019)

# North Campus Open Space Restoration Project

## Annual Monitoring Report: Year 2 (2019)

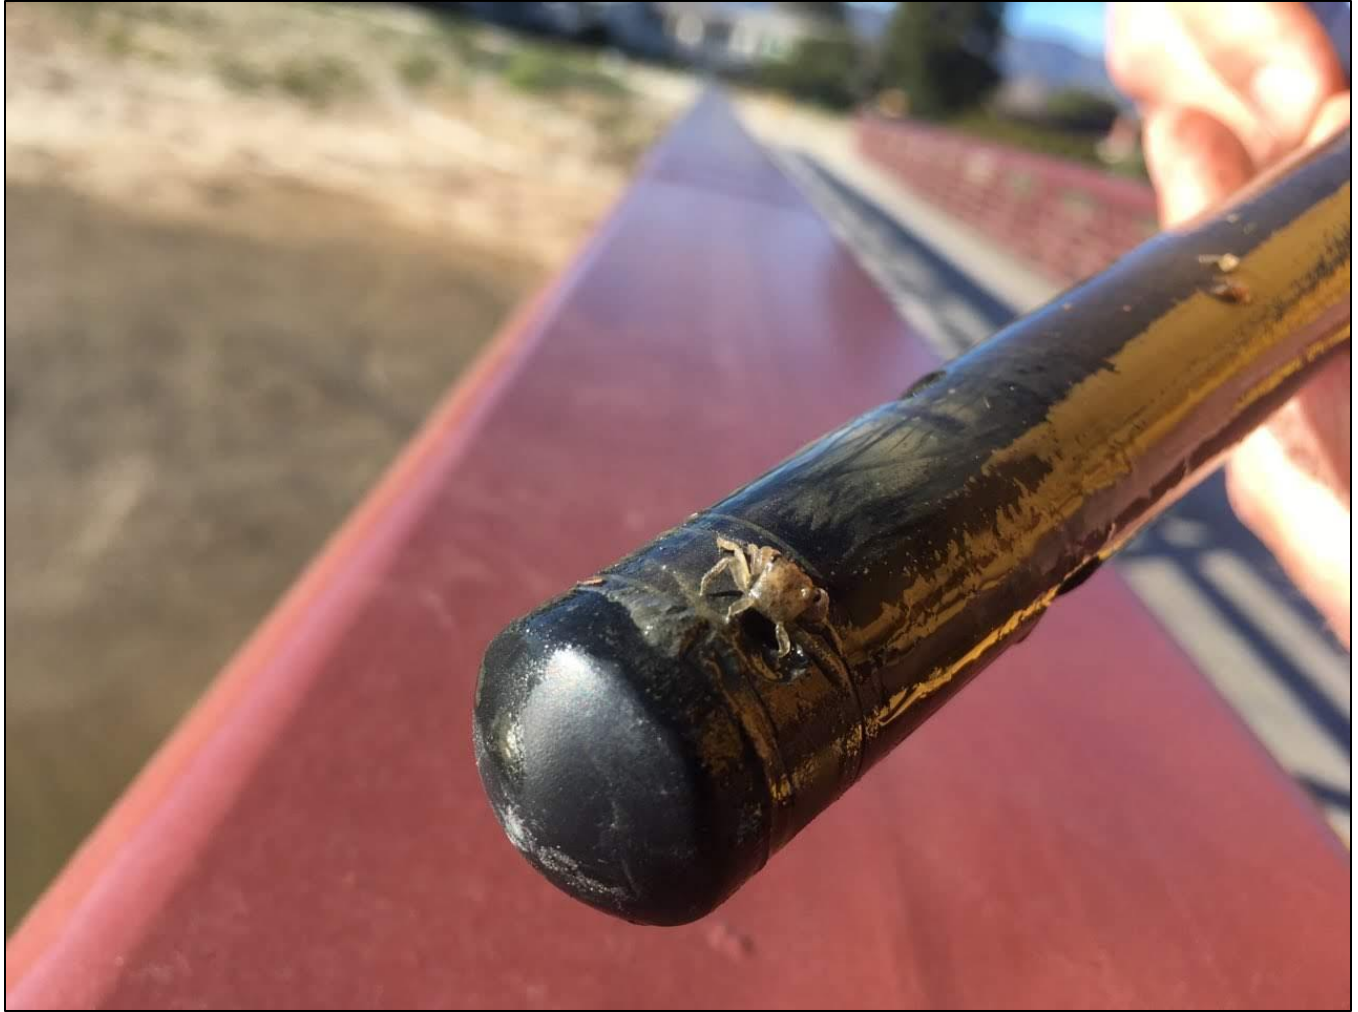
**Figure 36. A small crab found on a Solinst Levellogger in the restored upper east arm of Devereux Slough indicates that sea water infiltration during tidal connectivity likely deposited marine invertebrates.**

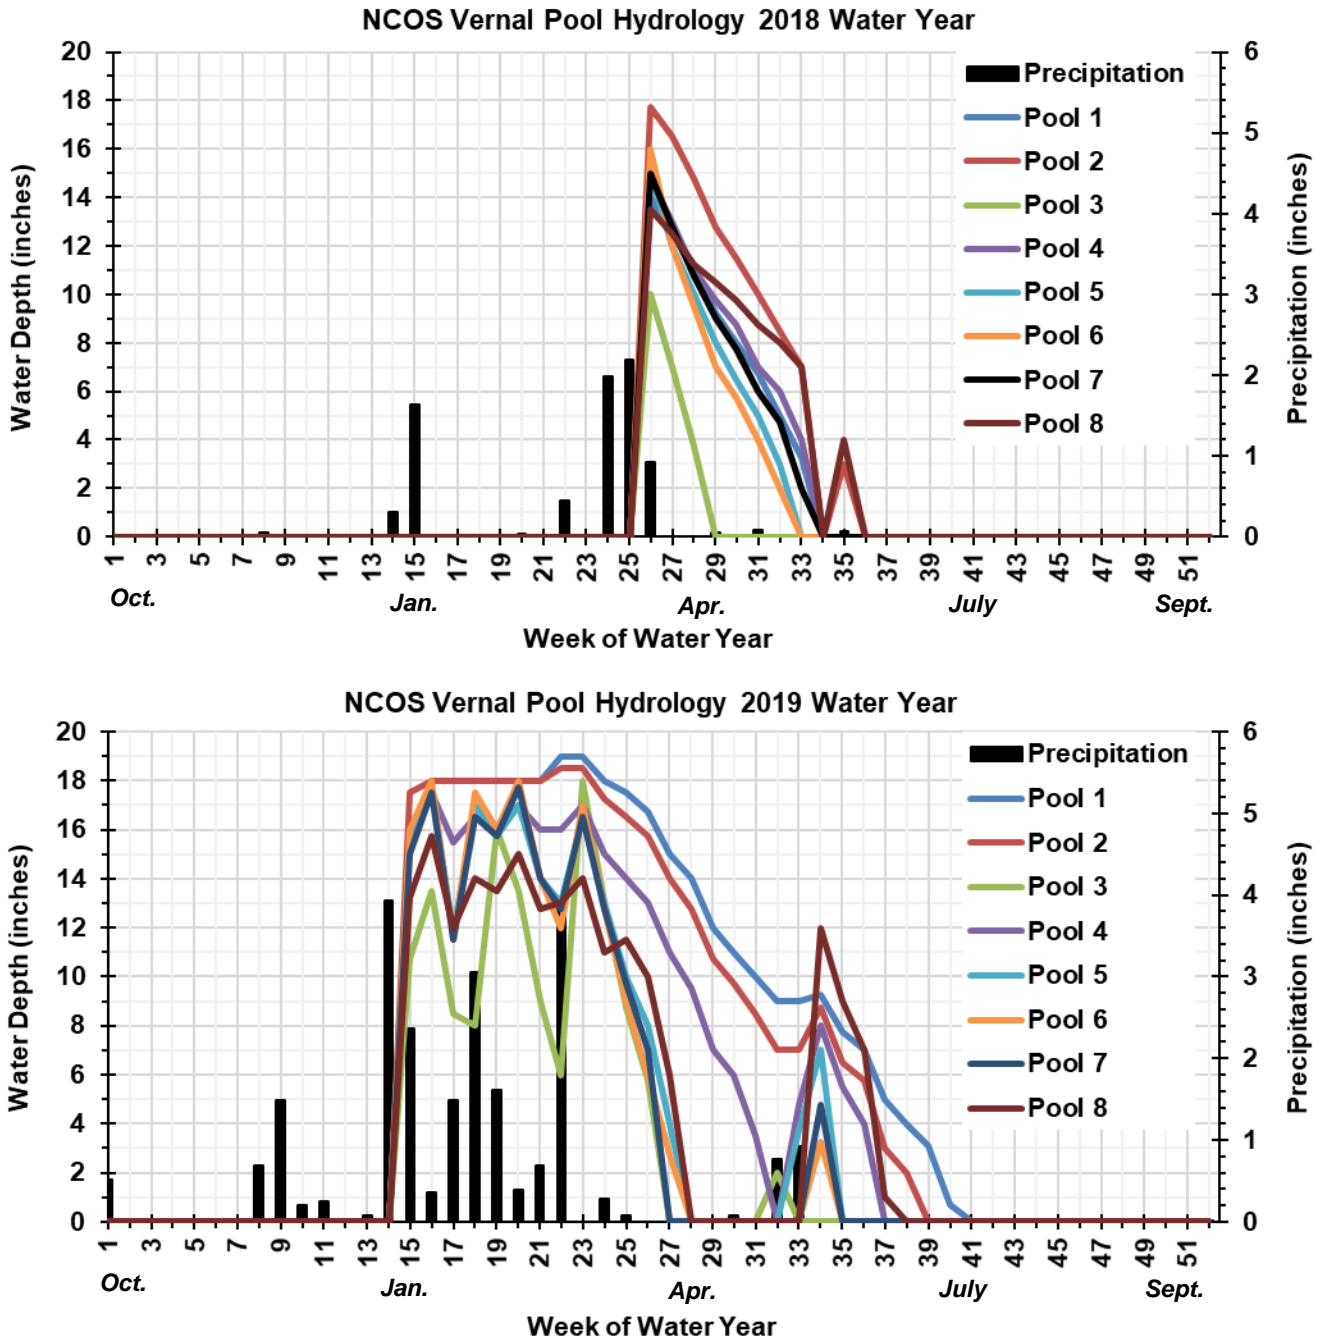
Figure 37. Hydrographs of weekly water depth (inches) in the eight restored vernal pools on the NCOS Mesa in the 2018 (top chart) and 2019 (bottom chart) water years (October 1<sup>st</sup> to September 30<sup>th</sup>). Black bars represent weekly precipitation in inches recorded at a nearby NOAA climate data station.

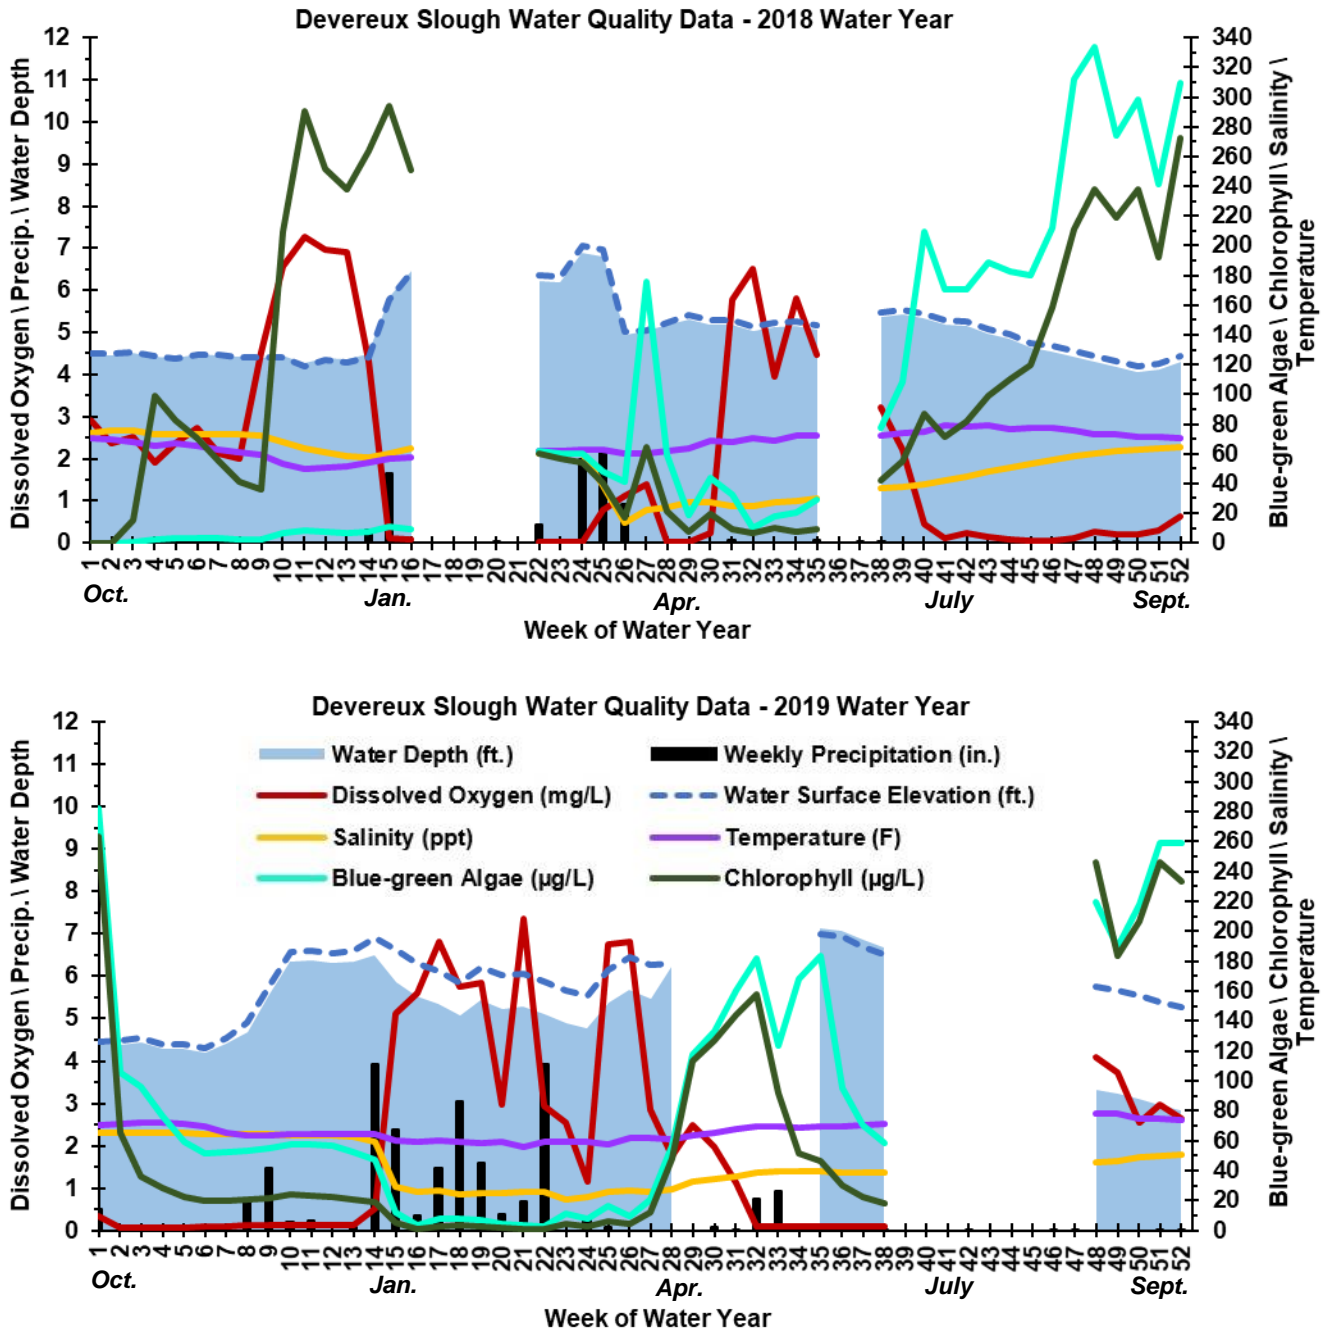
Figure 43. Weekly average water quality data recorded in the 2018 (top chart) and 2019 (bottom) water years (October to September) with a YSI EXO1 sonde in the lower section of Devereux Slough (see map in Figure 28). The sonde also records water depth, which is represented in the charts as the depth of water above the sensors. A dashed blue line indicates the water surface elevation in feet (NAVD 88), determined from comparing staff gauge measurements with the sonde's depth measurements. In August 2019, the fixed position of the sonde was raised by approximately 2.5 ft, which decreased the depth of water above the sensors. Gaps in the data are during periods when the sonde malfunctioned and/or was out for repair. Precipitation data was recorded at a nearby NOAA climate data station.

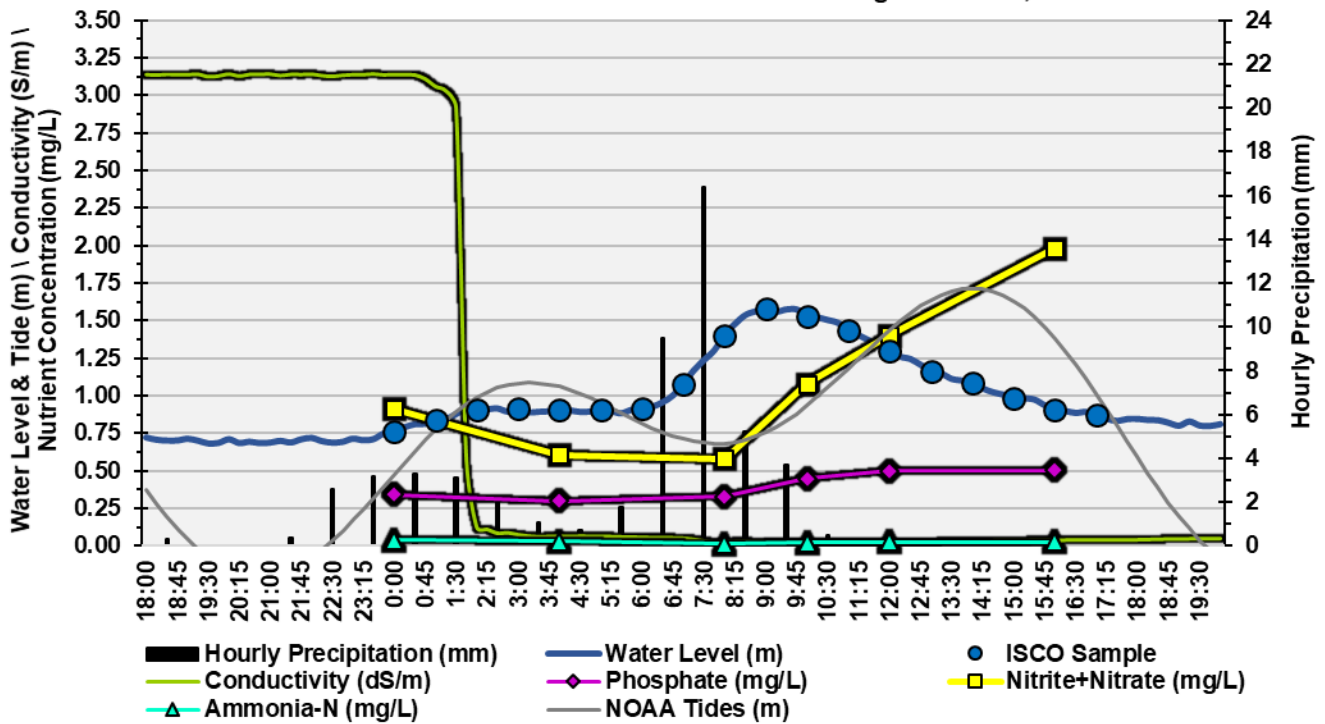
Stormwater Suspended Solids - Venoco Bridge: Feb. 1-2, 2019

Figure 49. Top chart: inorganic nitrogen (nitrate+nitrite), phosphate, and ammonium (from nitrogen) concentrations (mg/L), and (bottom chart) suspended solids concentration (g/L) in stormwater samples collected hourly (blue circles) with an ISCO auto-sampler during a storm on February 1<sup>st</sup> to 2<sup>nd</sup>, 2019 at Venoco Bridge, North Campus Open Space. The conductivity (in Siemens/meter) indicates when freshwater from storm flows reached the sampler. Precipitation data was recorded at a nearby NOAA climate data station.

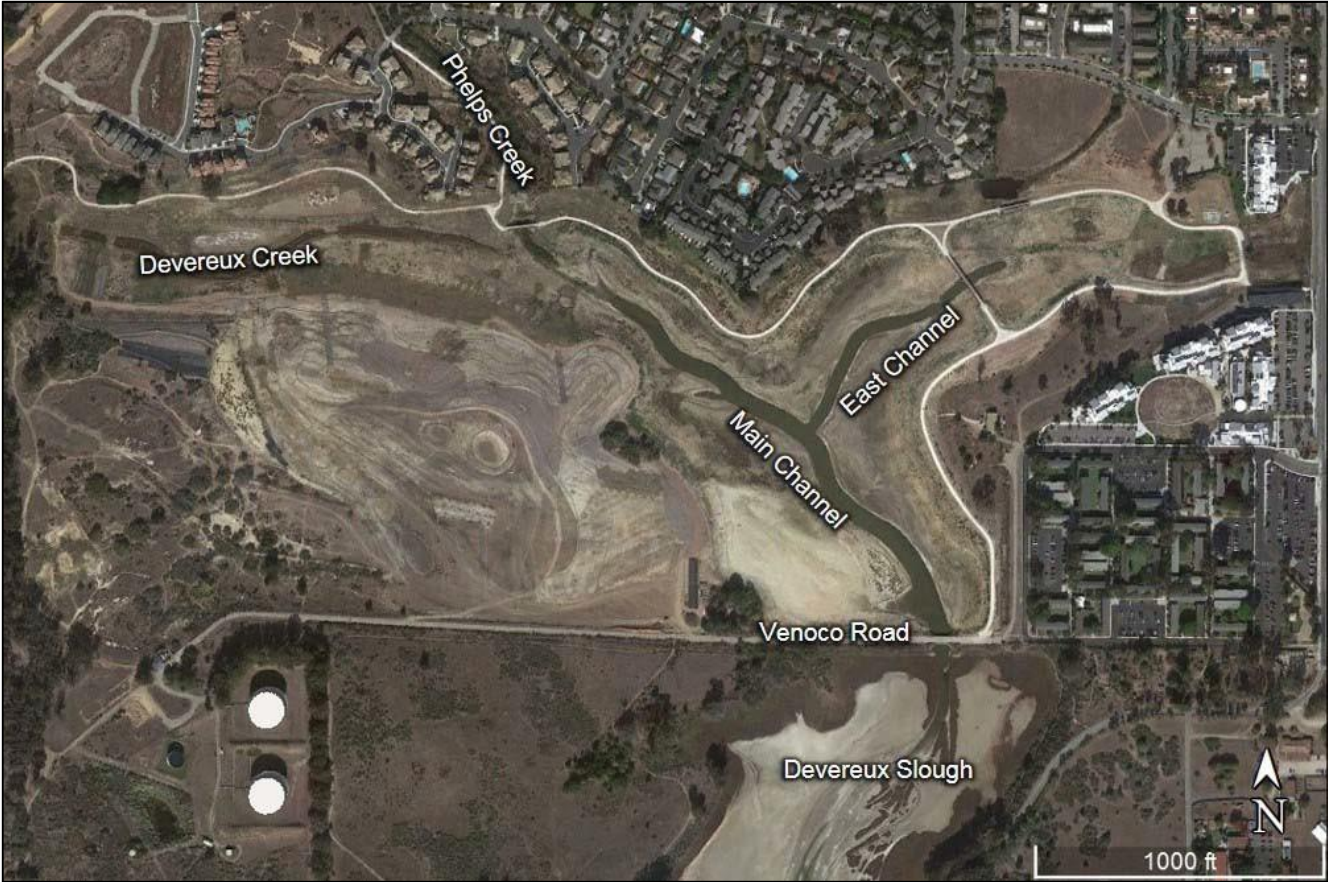
Figure 1 Creeks and channels at NCOS.

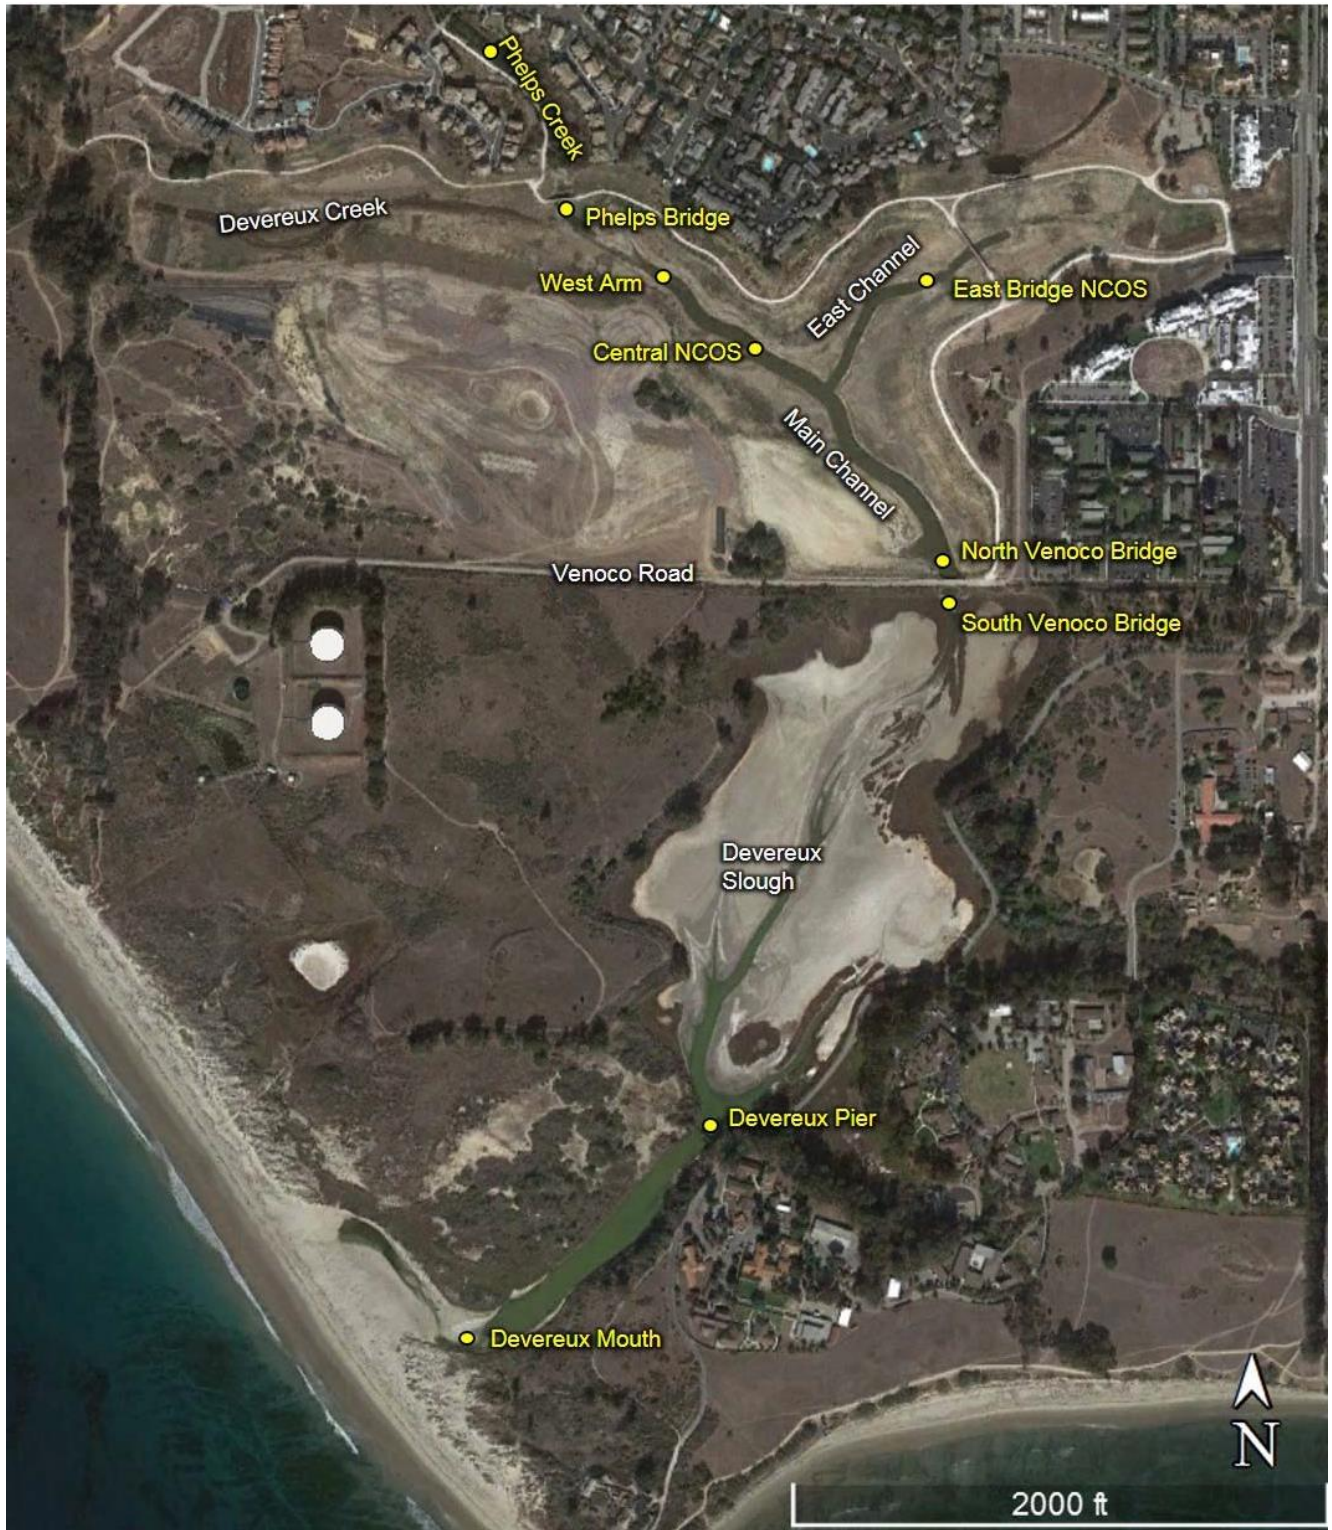
Figure 2 Fish sampling and water quality locations (yellow labeled points).
