Road-crossing restoration on alluvial creeks in the Klamath National Forest, California

Term Project for Restoration of Rivers and Streams – LD ARCH 227

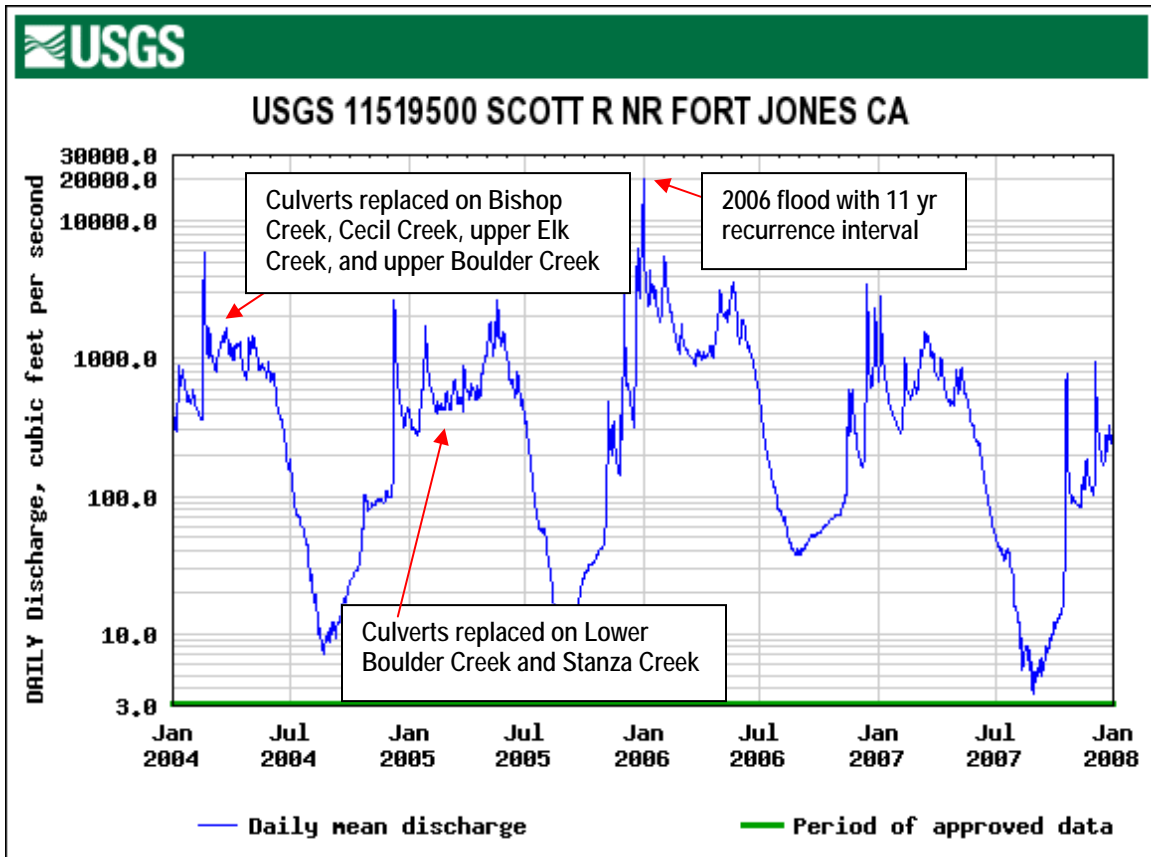
Figure 2. Hydrograph from the Scott River, a nearby site in the Klamath River Basin, showing the magnitude of the floods during the study, and a timeline of when the 6 culverts were replaced.

The first 4 creeks listed above were reconstructed by contractors in summer 2004, and the last two in summer 2005 (Figure 2). At each site, consultants established 5 cross-sections downstream of the road-crossings and 7 upstream of the crossings to monitor short-term changes in fine-sediment, grain-size distributions, channel-shape, and aquatic invertebrate communities. The consultants delivered the raw data to UC Berkeley researchers to prepare the final report.

Because construction did not start in the same year on all 6 creeks (Figure 2) the hydrologic regime was potentially a significant confounding factor, but it probably was not significant because the largest flood in 2005 was very small. If most fine-sediment movement during the study occurred during the same floods in all 6 creeks, I would expect the hydrologic regime to be a significant factor. The largest changes in fine sediment between upstream and downstream occurred from 2004-2005 in Bishop Creek (9.8%) and Upper Elk Creek (25.3%), 2005-2006 in Cecil Creek (8.2%), Lower Boulder Creek (0.96%) and Upper Boulder Creek (8.7%), and 2006-2007 in Stanza Creek (13.7%). These changes coincided with different floods.

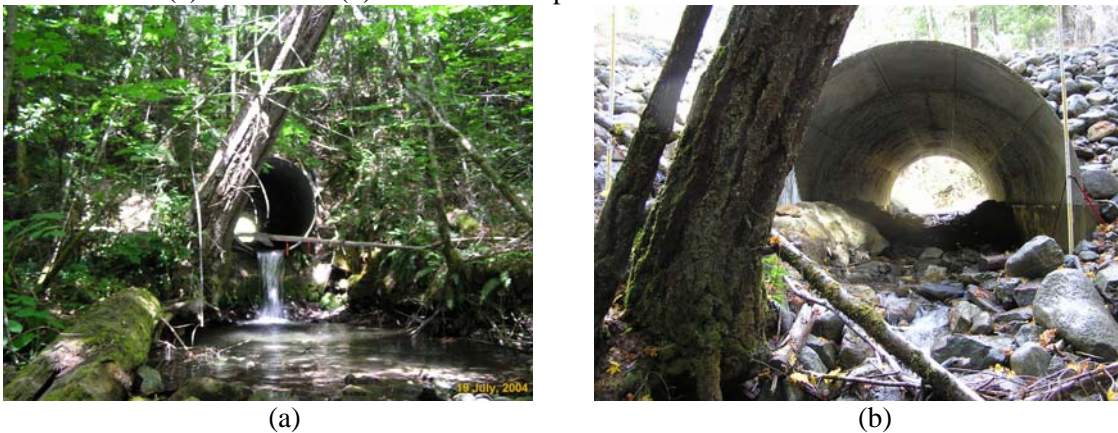
Figure 3. Example of fish-passage improvement and reduction in risk of catastrophic failure at Stanza Creek (a) before and (b) after culvert replacement.

The study site was the Klamath National Forest, which is located in Siskiyou County in northern California. This site covers an area of 1.7 million acres and includes 388 miles of waterways. The study focused on 6 creeks (Figure 1) – Cecil Creek (CEC), upper Boulder Creek (UBO), upper Elk Creek (ULK), Bishop Creek (BIS), lower Boulder Creek (LBO), and Stanza Creek (STA) – with culverts replaced in either 2004 or 2005 (Figure 3). The largest annual flood

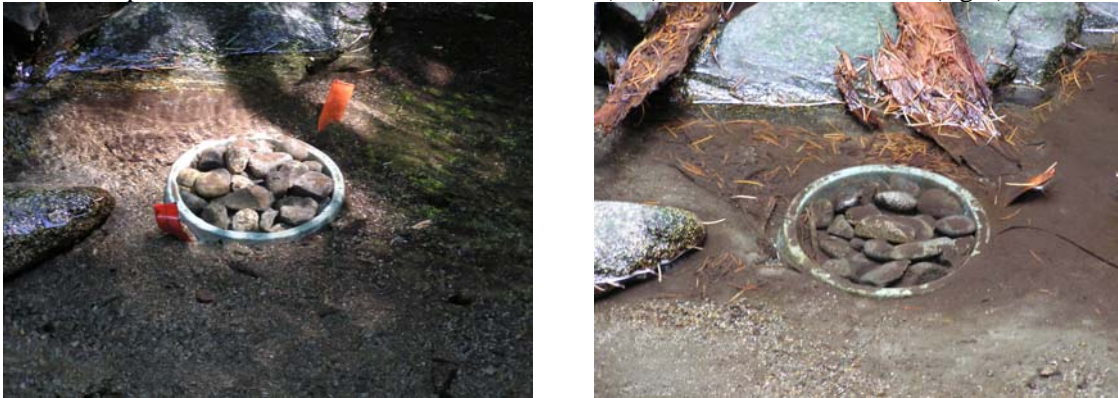
Figure 4. The dogbowl traps collected colonizing invertebrates in the months after construction. This example is from Stanza Creek in 2005 before (left) and after construction (right).

I used a Before-After-Control-Impact study design (e.g., Smith et al. 2003). The data included 1 set of monitoring in the weeks or months just before construction, 1 set in the summer just after construction, and 1 set in each of the following 2 summers. The control was the reach directly upstream of the road crossings and the impact was the reach directly downstream. In addition, in-stream traps were installed in the stream-bed to monitor invertebrate colonization upstream and downstream of the road-crossings over the first yr after construction (Figure 4).

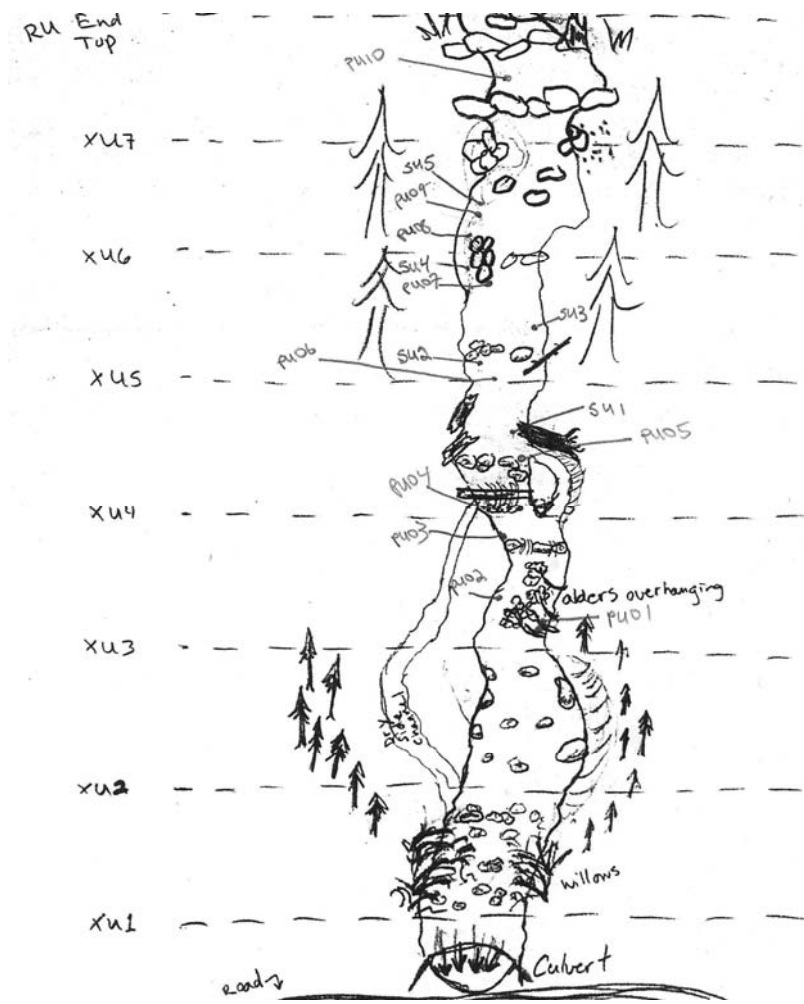
Figure 5. The facies map for upper Boulder Creek in 2004 shows that the channel was not significantly stratified geomorphically, therefore the grain-size information could be aggregated.

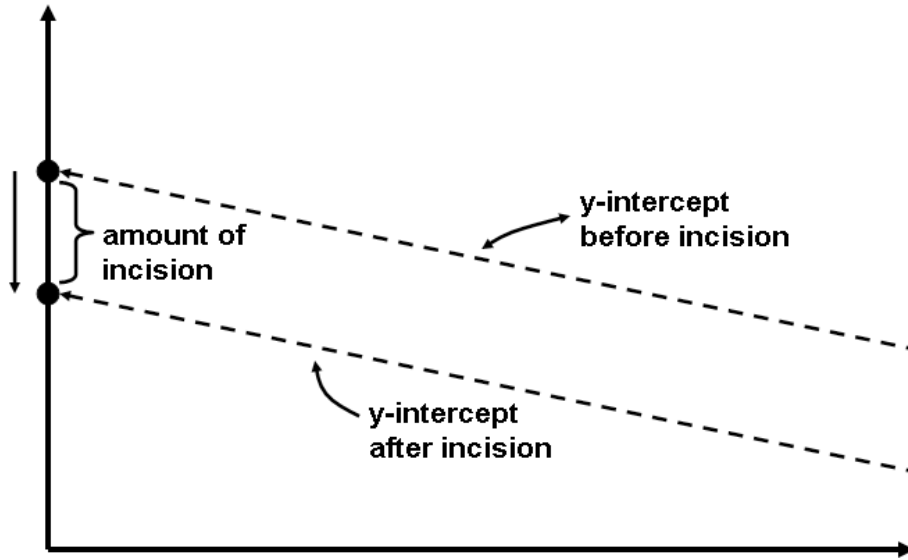
Figure 6. This cartoon shows how the drop between y-intercepts is related to incision.

I used longitudinal-profiles and cross-sections to examine patterns in channel aggradation and incision. For example, I used linear-regression as a tool to analyze the longitudinal-profiles. An increase in the y-intercept of the trend-line through the longitudinal-profile would indicate aggradation and a decrease would indicate incision (Figure 6). Further, change from a lower to a higher magnitude slope in the trend-line would indicate that the channel is steepening (Figure 7).

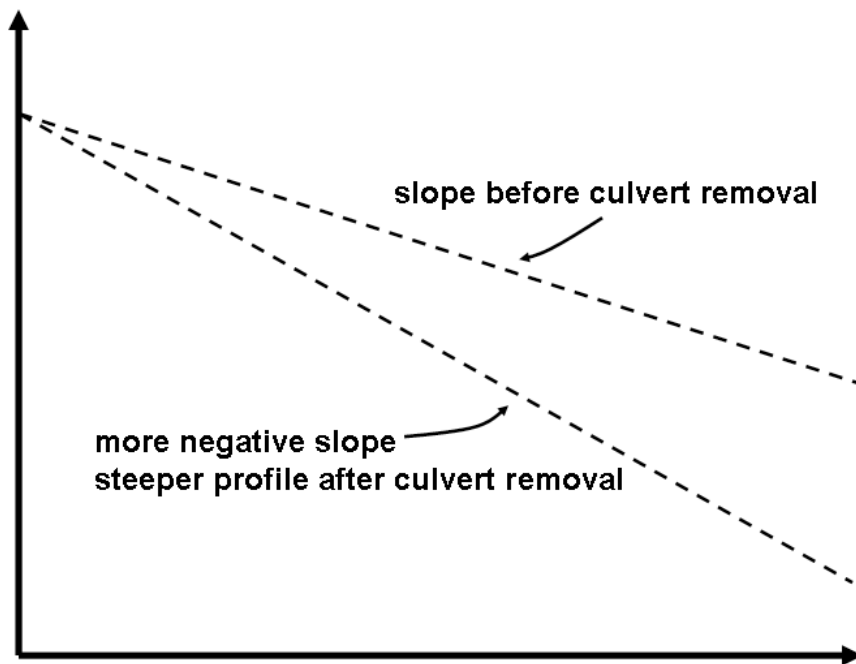
Figure 7. This cartoon shows what a more negative slope looks like on the longitudinal-profile.

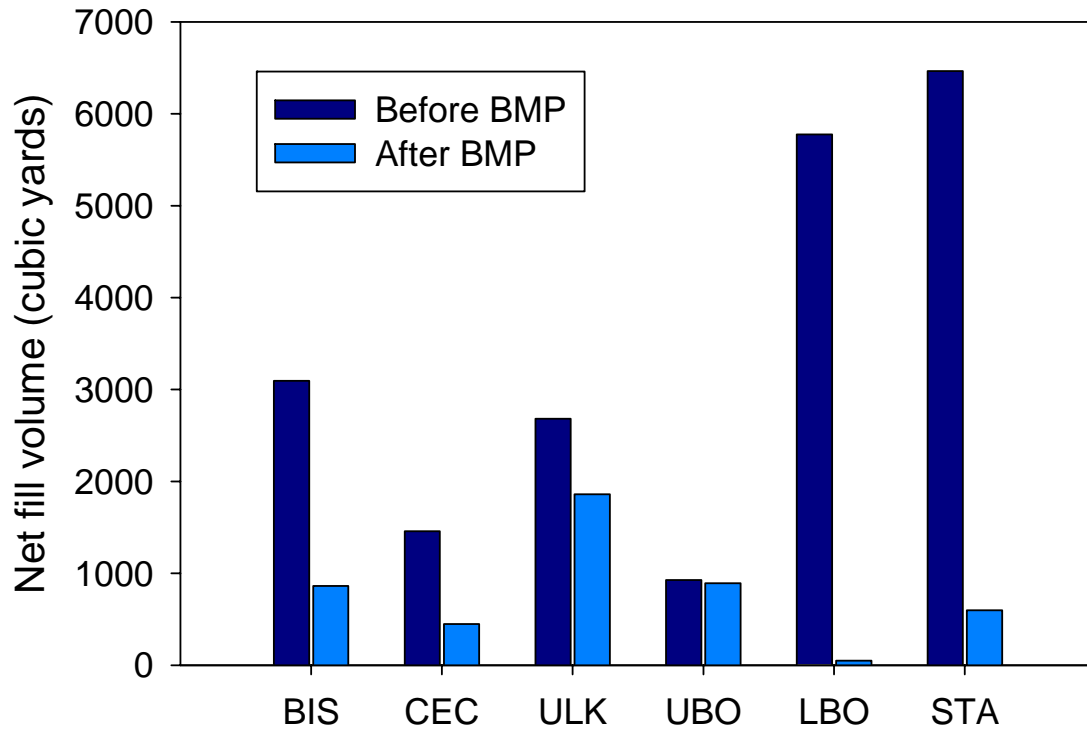
Figure 8. The fill-volume was reduced by more than half in the majority of the creeks.

The culvert replacements achieved the long-term goals of removing barriers to upstream salmonid migration and reducing the risk of catastrophic failures. For example, the median drop at the end of culverts before the replacements was 1.5 m (Table 1) and a drop of this size is impassible for most juvenile salmonid species (Table 2). This drop was smoothed-out in all the creeks as a result of the re-constructions. In addition, the fill volume was reduced by more than half in the majority of the creeks (Figure 8), thereby reducing the risk of catastrophic failure.

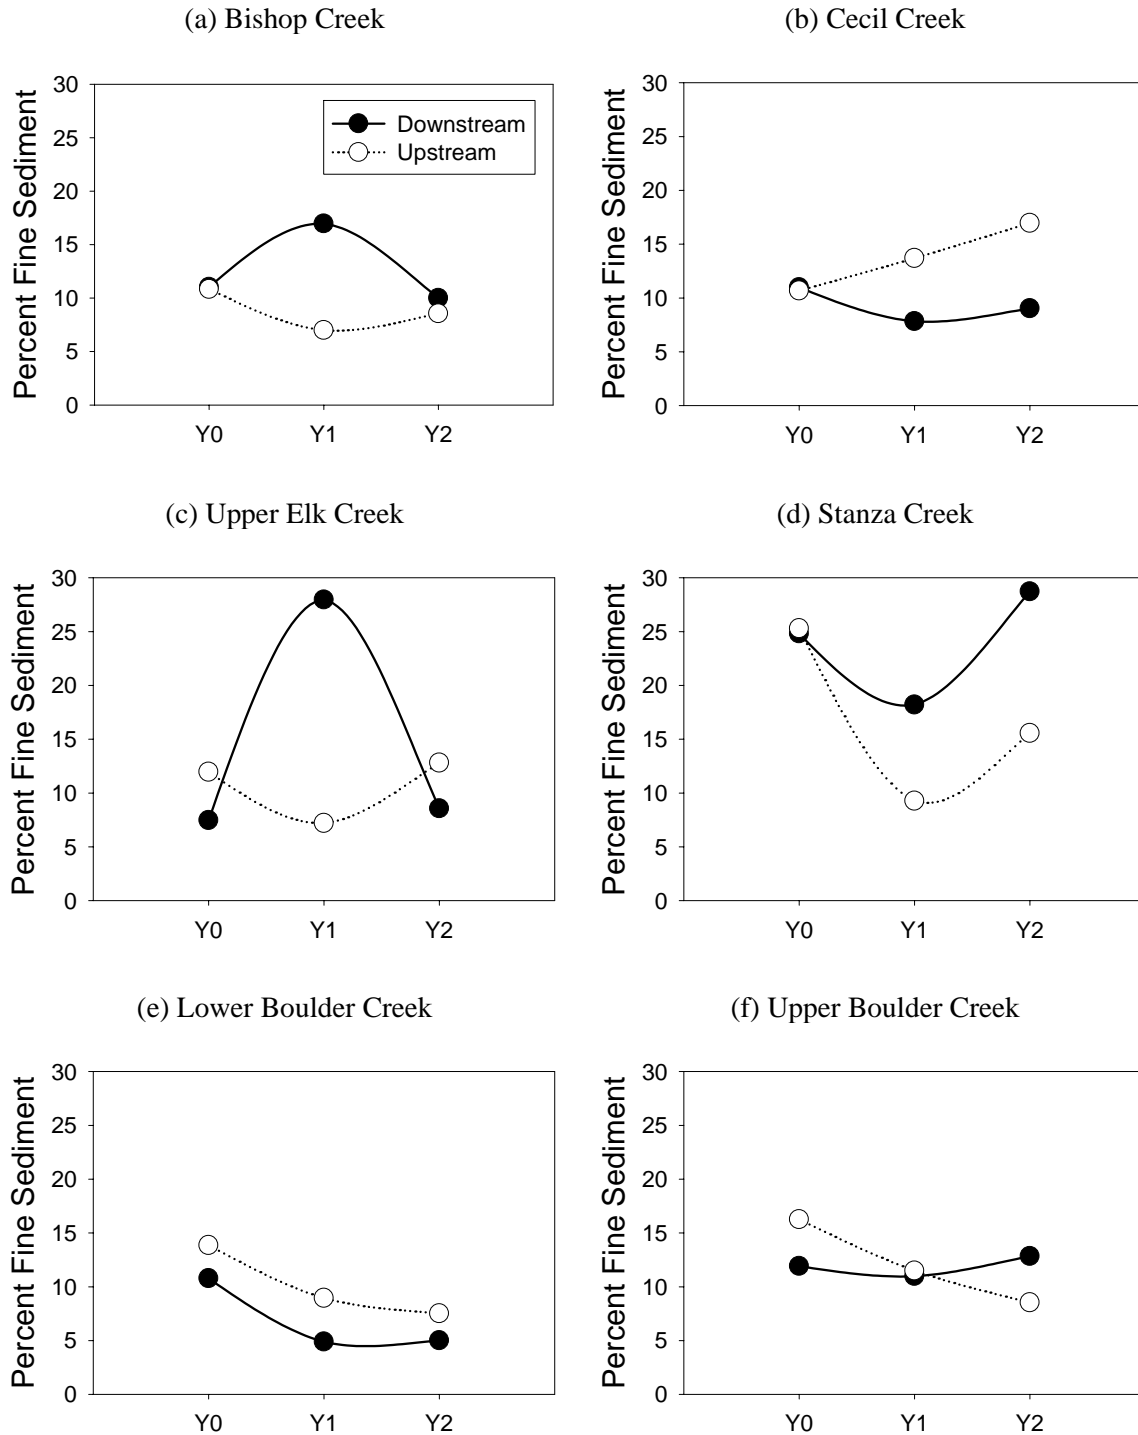
Figure 9. The BMPs had no significant short-term impacts on fine-sediment deposition ( $\text{Prob} > F = 0.30$ ) in the 6 creeks before (Y0) and after (Y1 & Y2) construction.

\* Percent Fine Sediment is the composite sum of all the fine particles, defined as particles with diameters less than 2mm, measured in cross-sections upstream or downstream of the road crossings divided by the total number of particles, times 100. The cross-sections were not treated as replicates, hence no error bars.

Although fine-sediment levels in several creeks (e.g., Upper Elk and Lower Boulder) were much higher in the 1 yr after construction (Figure 9), I found no significant difference between control and impact (with  $\alpha = 0.05$ ) in the percent of the creek beds covered by fine-sediment when accounting for all 6 creeks before and after construction ( $\text{Prob} > F = 0.30$ ). The difference between the yr before construction and the yr after construction was not significant ( $p = 0.13$ ), nor were the differences between the yr prior to construction and the 2 yr after construction ( $p = 0.54$ ), and the 1 yr after construction and the 2 yr after construction ( $p = 0.35$ ).

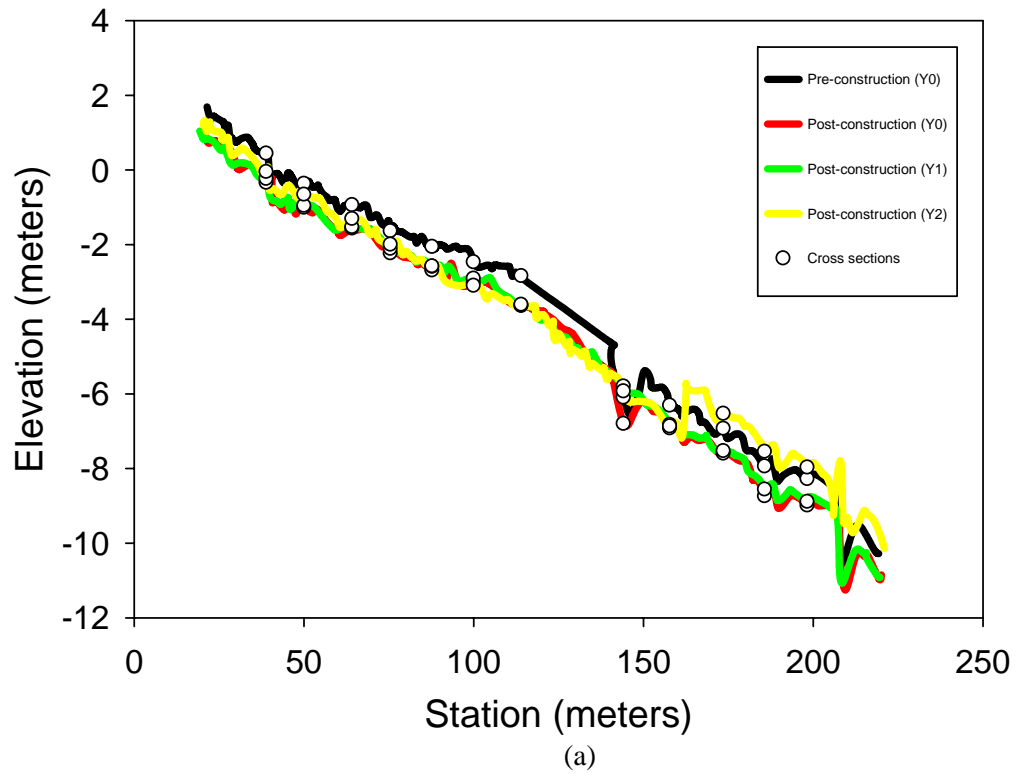
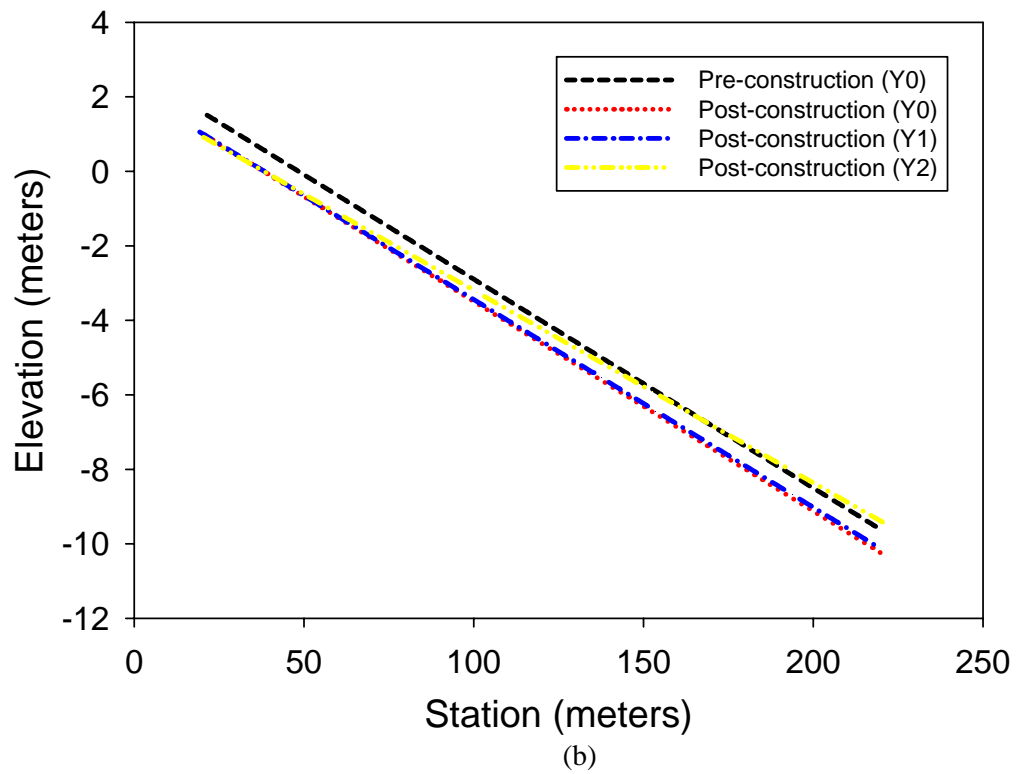
Figure 10. Example of (a) longitudinal-profiles and (b) linear regressions for Bishop Creek.

lines tended to be more-negative, indicating that the channels steepened slightly (Table 4). For example, the regression-lines fit through the longitudinal-profile of Bishop Creek show a 0.7 m drop in the y-intercept from Y0 to Y2, and a 0.01 change in slope (Figure 10). Furthermore, the largest changes in bed-grade and channel-shape coincided with the 2006 flood.

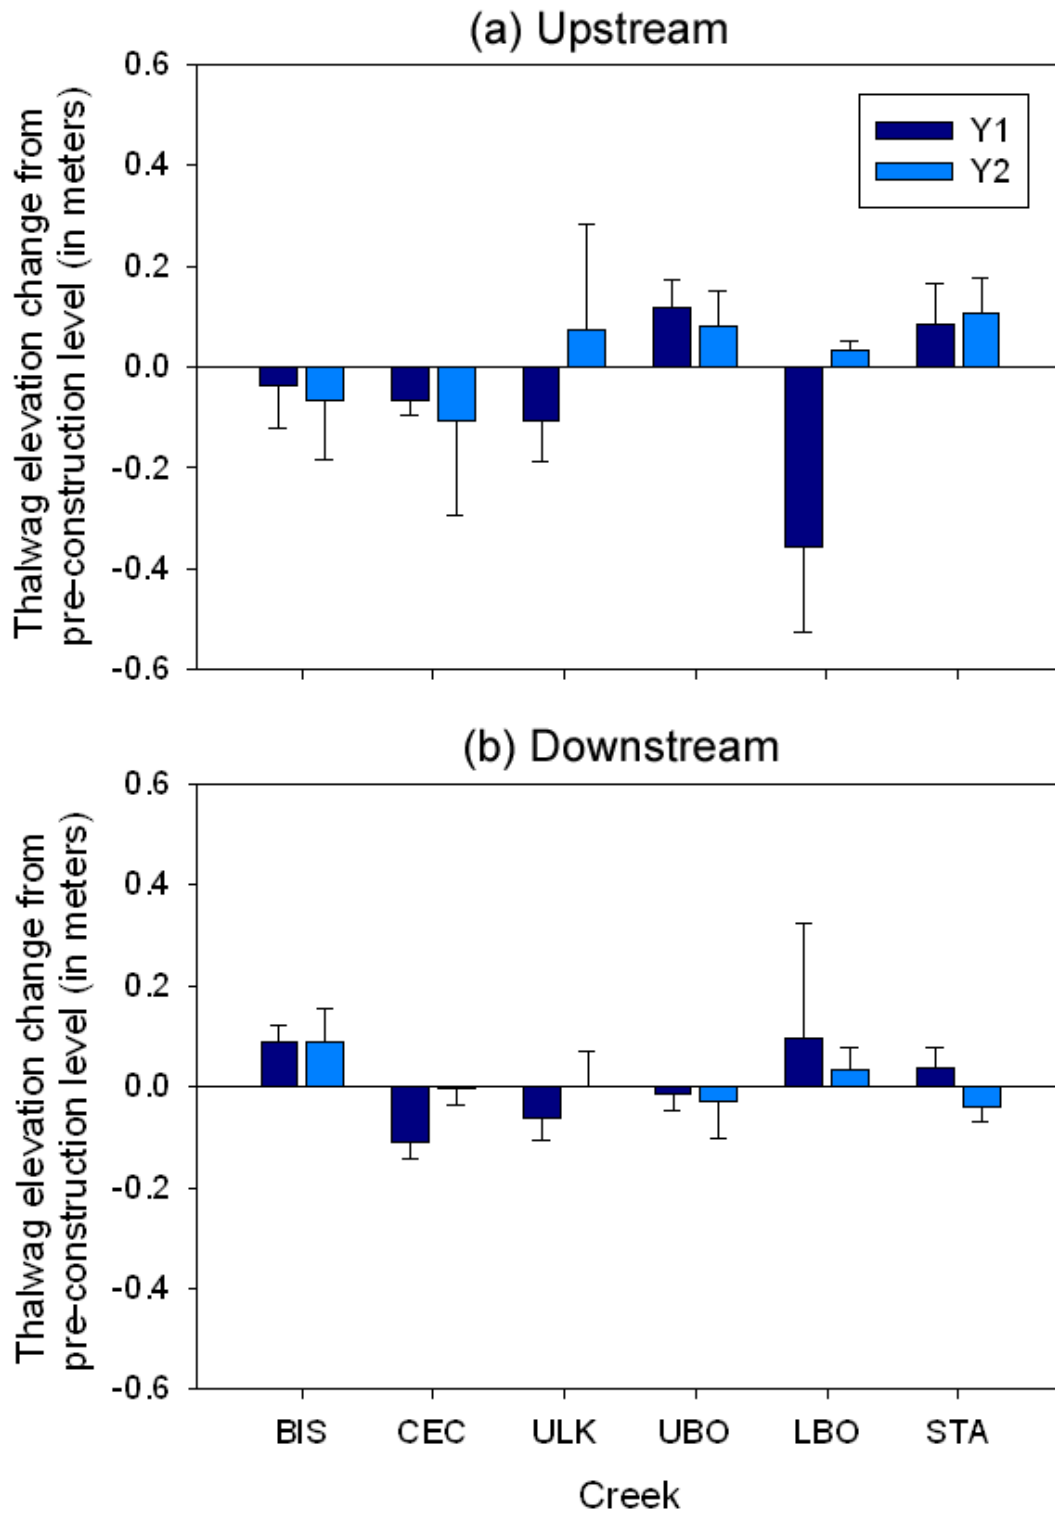
Figure 11. The thalweg elevation change from pre-construction to post-construction was highest in Lower Boulder Creek in the 1 yr after construction; error bars are SE among the cross-sections.

The thalwags tended to incise more downstream than upstream, which is evident in the longitudinal-profiles and cross-sections that are included in the appendix. For example, the cross-sections in Lower Boulder Creek incised upstream more than 0.25 m in the 1 yr (Figure 11). Out of 4 creeks that incised a lot upstream in the 1 yr, only 2 of them remained incised after the 2 yr, indicating that channel adjustments may smooth out the impacts of culvert replacement over time.

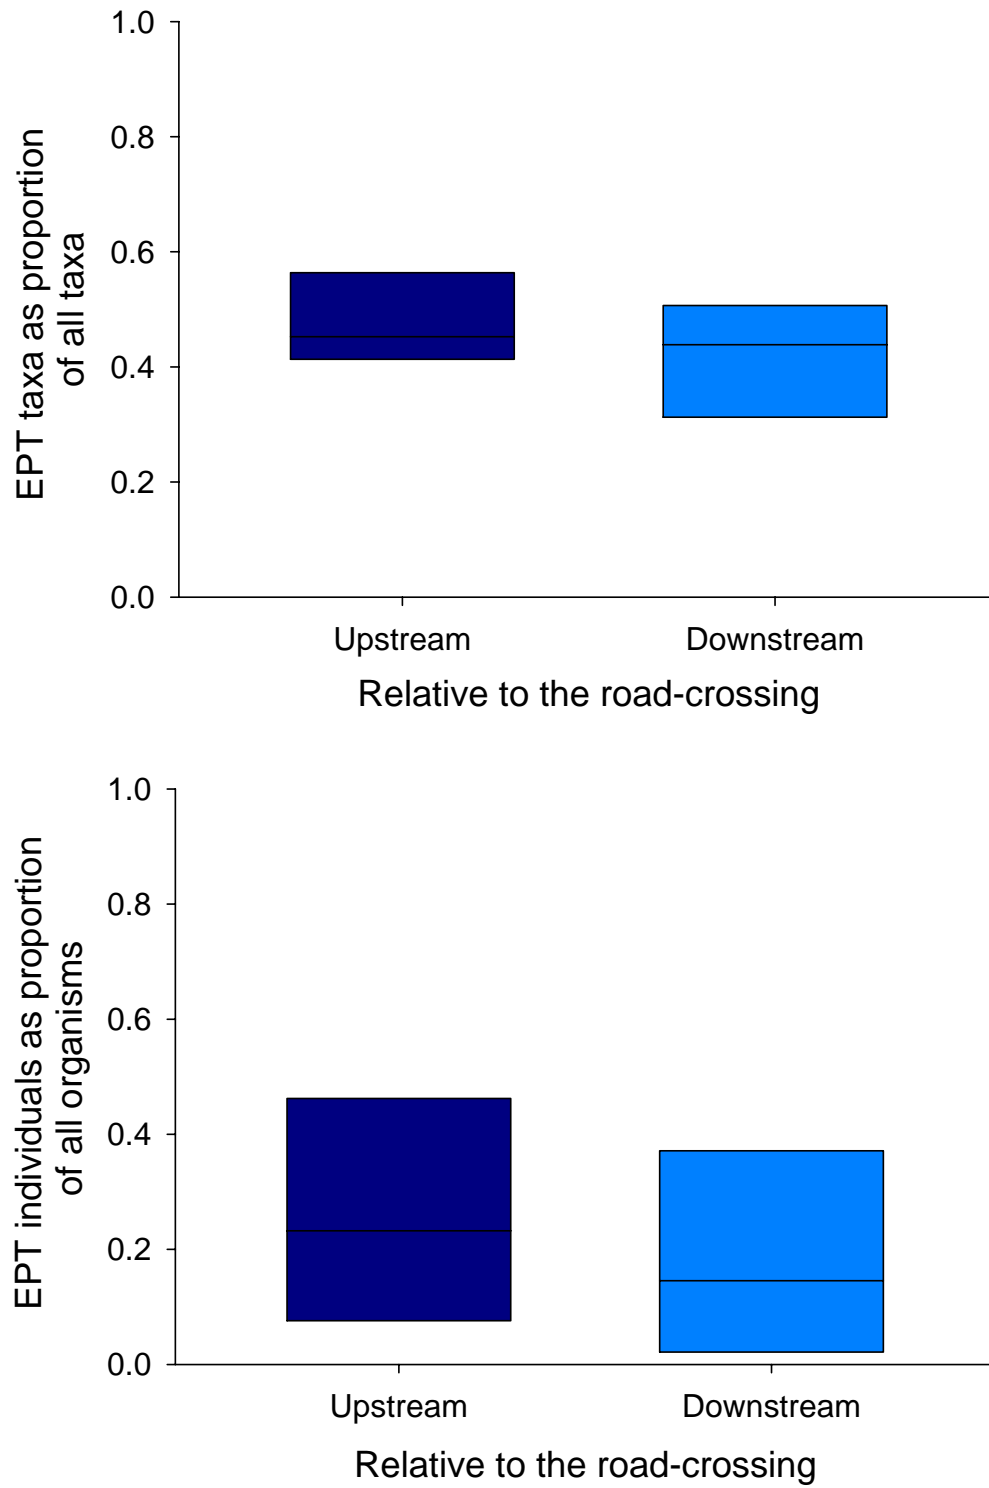
Figure 12. Proportion EPT taxa and Proportion EPT individuals with upper and lower quartiles.

Most biological measures were not significantly different ( $P > 0.05$ ) between upstream and downstream samples, with the exception of the EPT-proportion indices (Figure 12). The proportion was significantly higher in the upstream samples of the EPT taxa (48.6% vs. 42.1%; t

= -3.19, 5 df,  $P = 0.02$ ) and the EPT individuals (27.3% vs. 19.5%;  $t = -4.76$ , 5 df,  $P = 0.005$ )<sup>2</sup>, indicating that the construction may have exerted some negative influence on these disturbance-sensitive orders of mayflies, stoneflies, and caddisflies. However, the impacts were small.

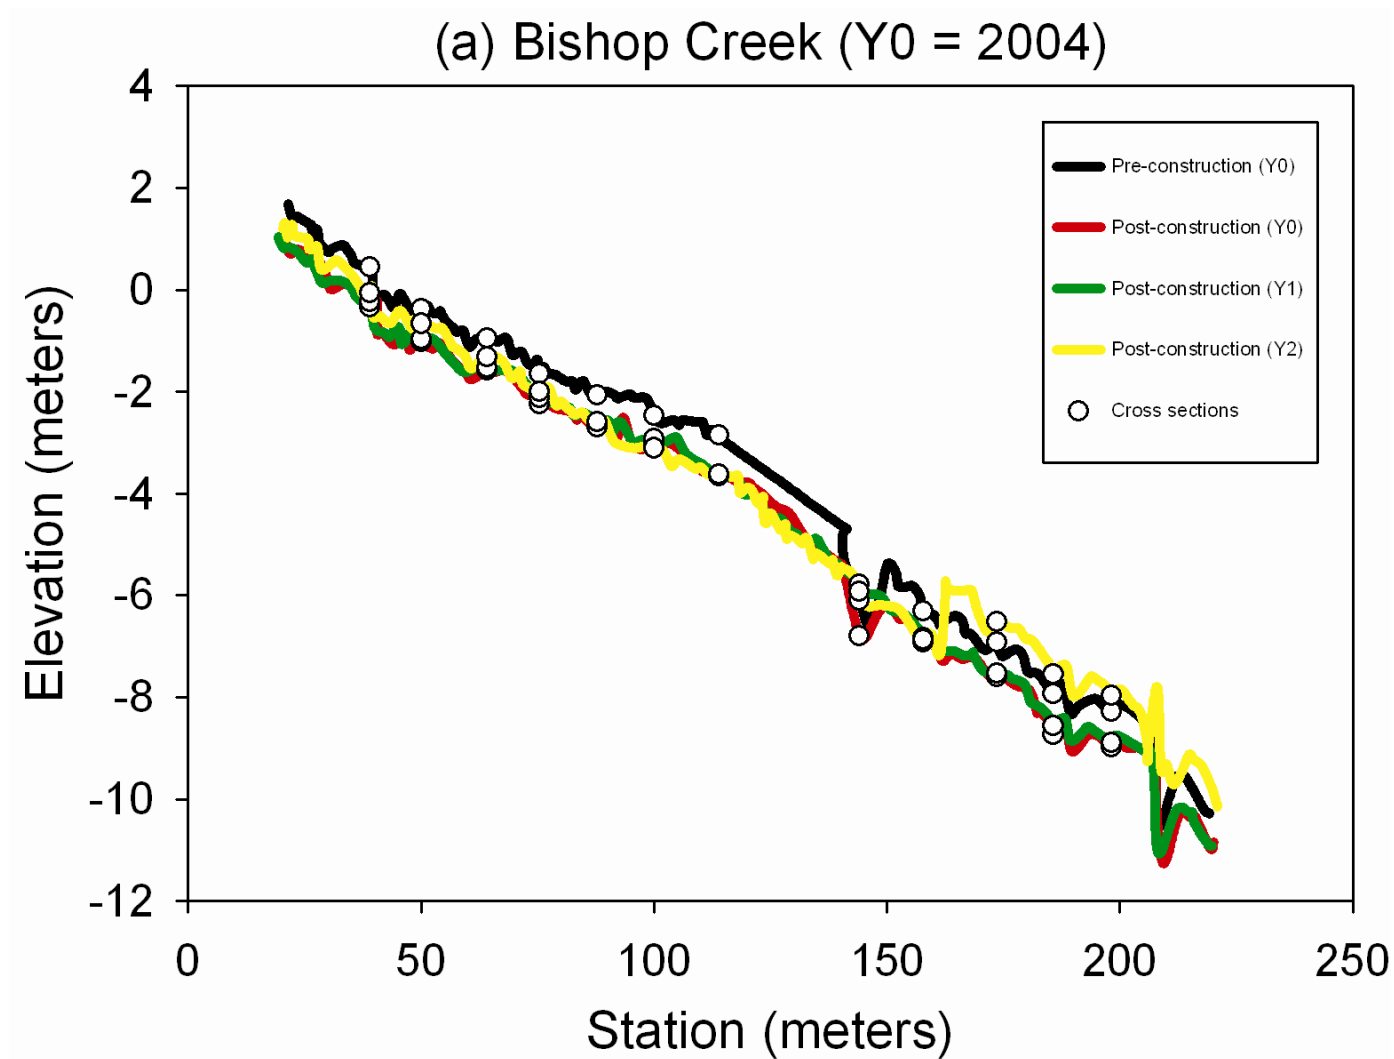
A1. Bishop Creek was most active in flood year 2006 and predominately incised during the study.

Many of the largest changes in the channel morphology occurred during the flood in 2006. For example, this flood caused about 1 m of incision in the second-upstream cross-section at Bishop Creek. Furthermore, the changes in morphology that occurred with the 1 yr recurrence-interval flood in 2005 were negligible compared to the changes that occurred in 2006.

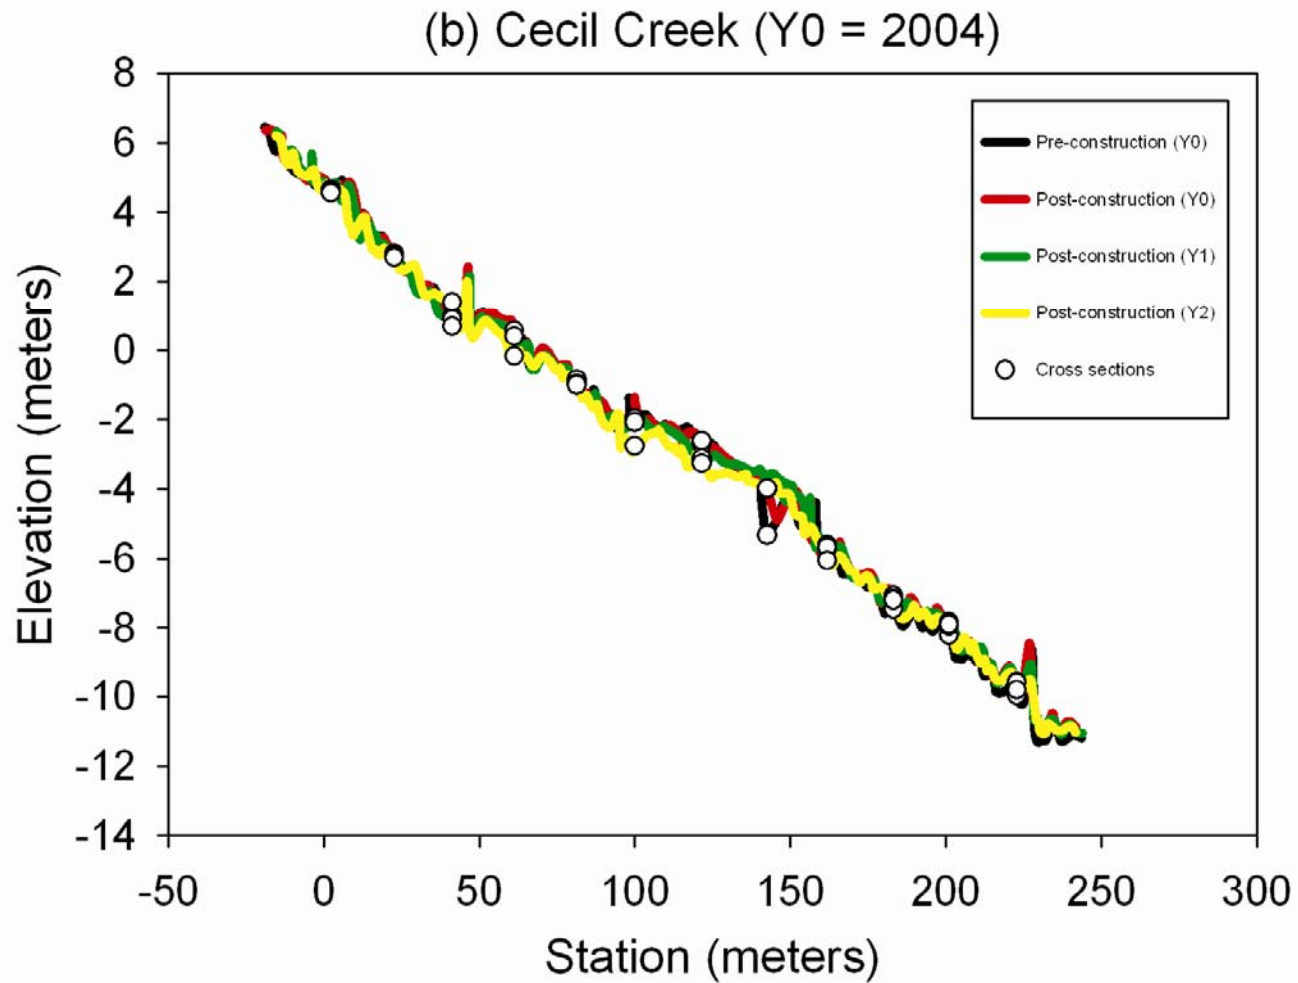
A2. The plunge pool after the culvert in Cecil Creek disappeared in the years after construction.

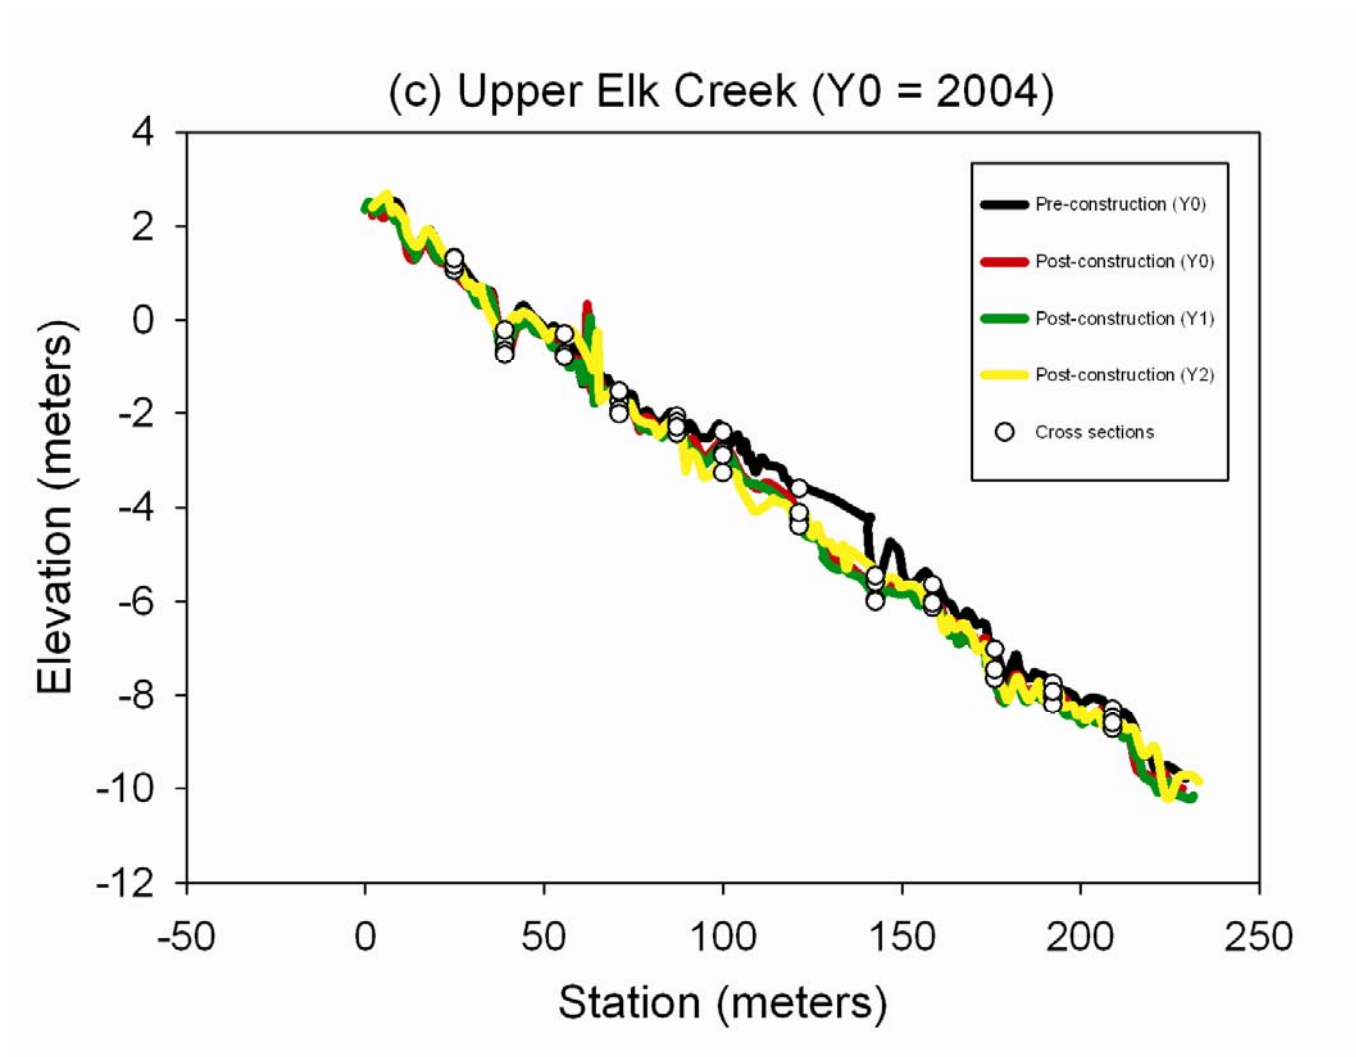
A3. Upper Elk Creek assumed a more even grade after the culvert was replaced.

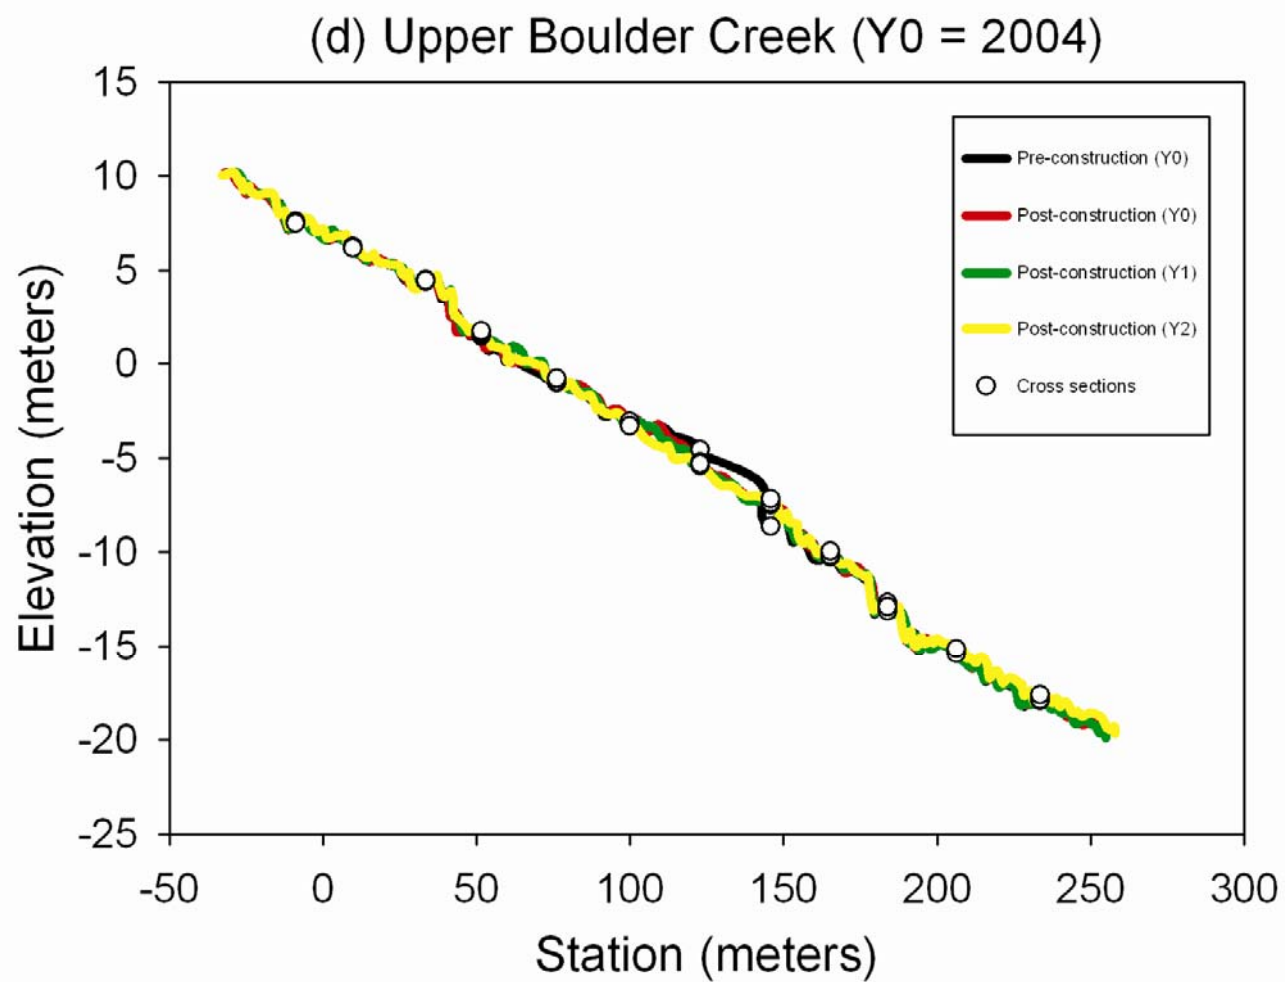
A4. Changes in the longitudinal profile in Upper Boulder Creek were minimal over the course of the study.

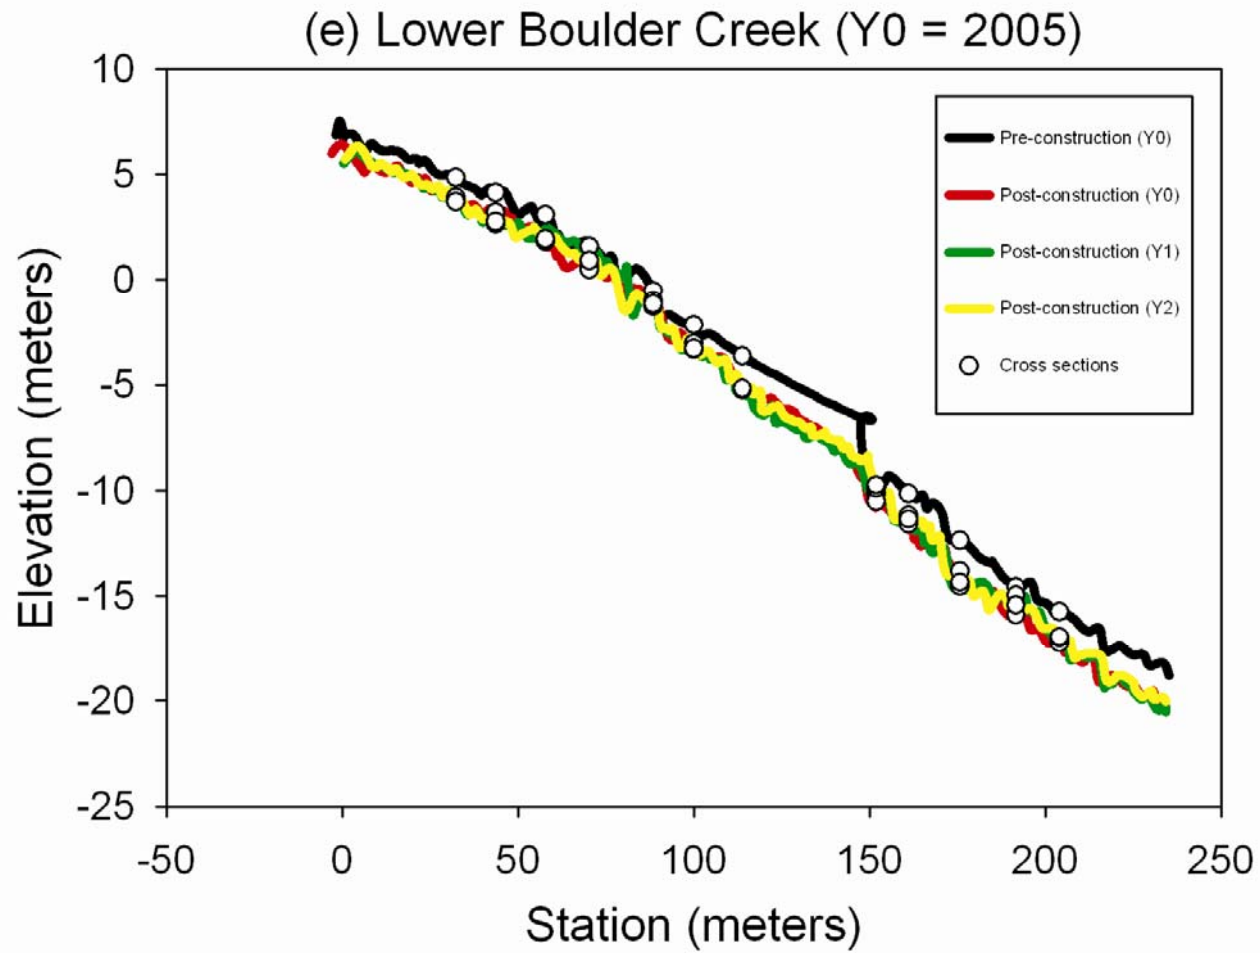
A5. Lower Boulder Creek incised and the 2.7 m drop after the culvert was smoothed-out.

The channels responded site-specifically to the road crossing reconstructions by smoothing out the grade. For example, the 2.8 m vertical-drop in the longitudinal-profile of Lower Boulder Creek caused by the culvert was smoothed-out by the 1 yr after construction. The maximum jumping ability for adult coho is on the order of 2.5 m (Whyte et al. 1997). Thus, this smoothing-out of the grade should have some benefits for the threatened salmonid populations.

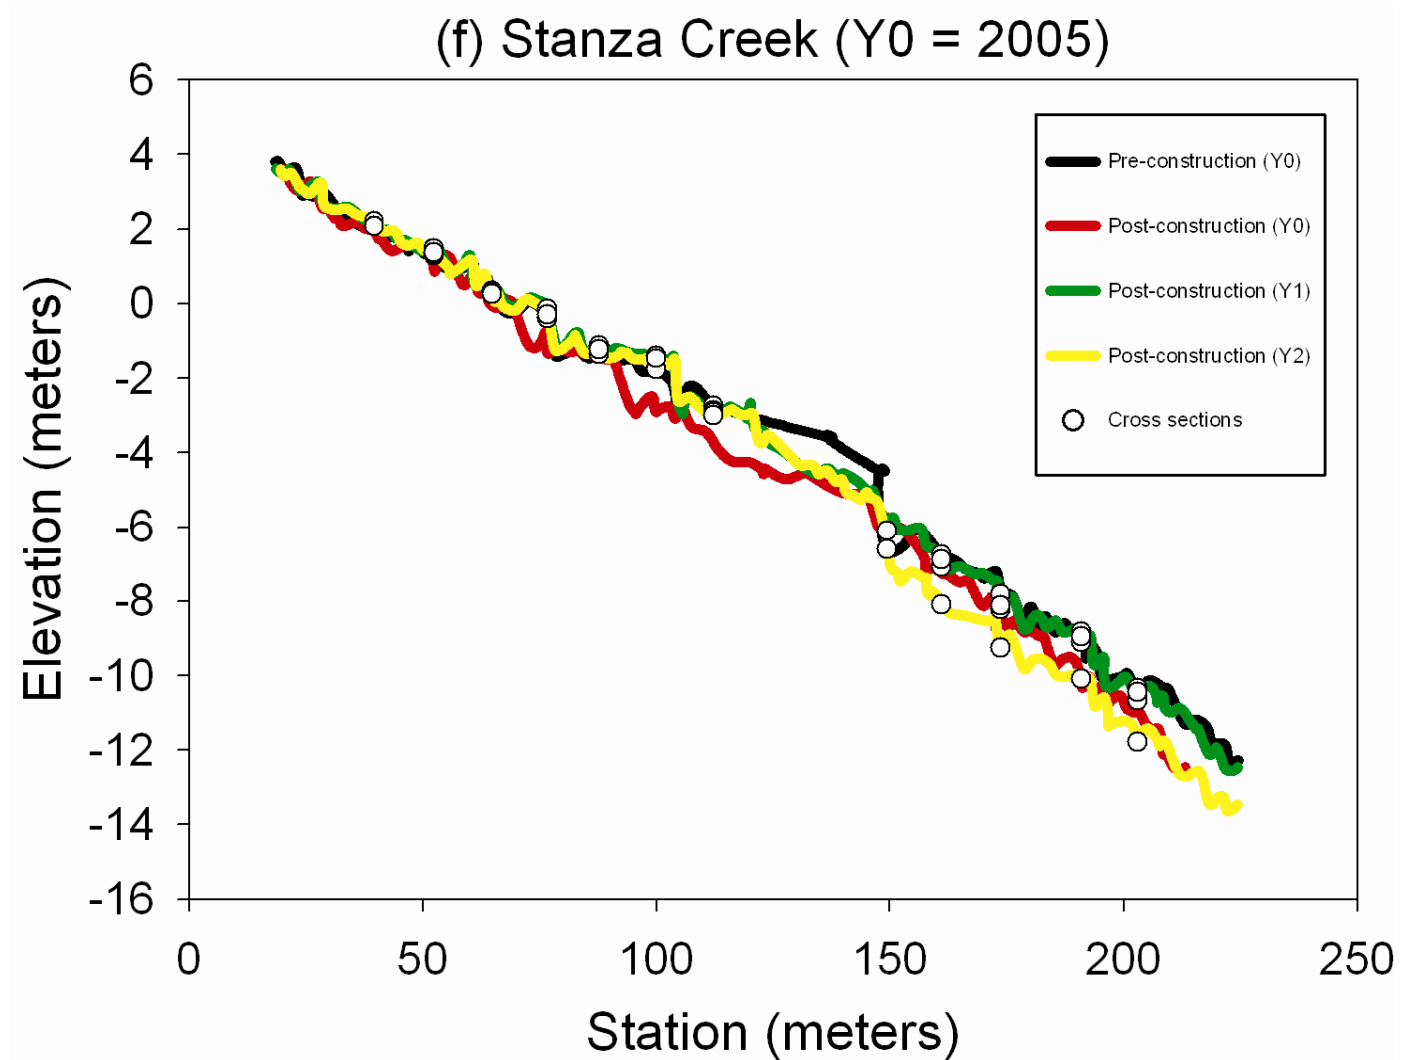
A6. Stanza Creek was most active in flood year 2006 and the channel incised in the years after construction.

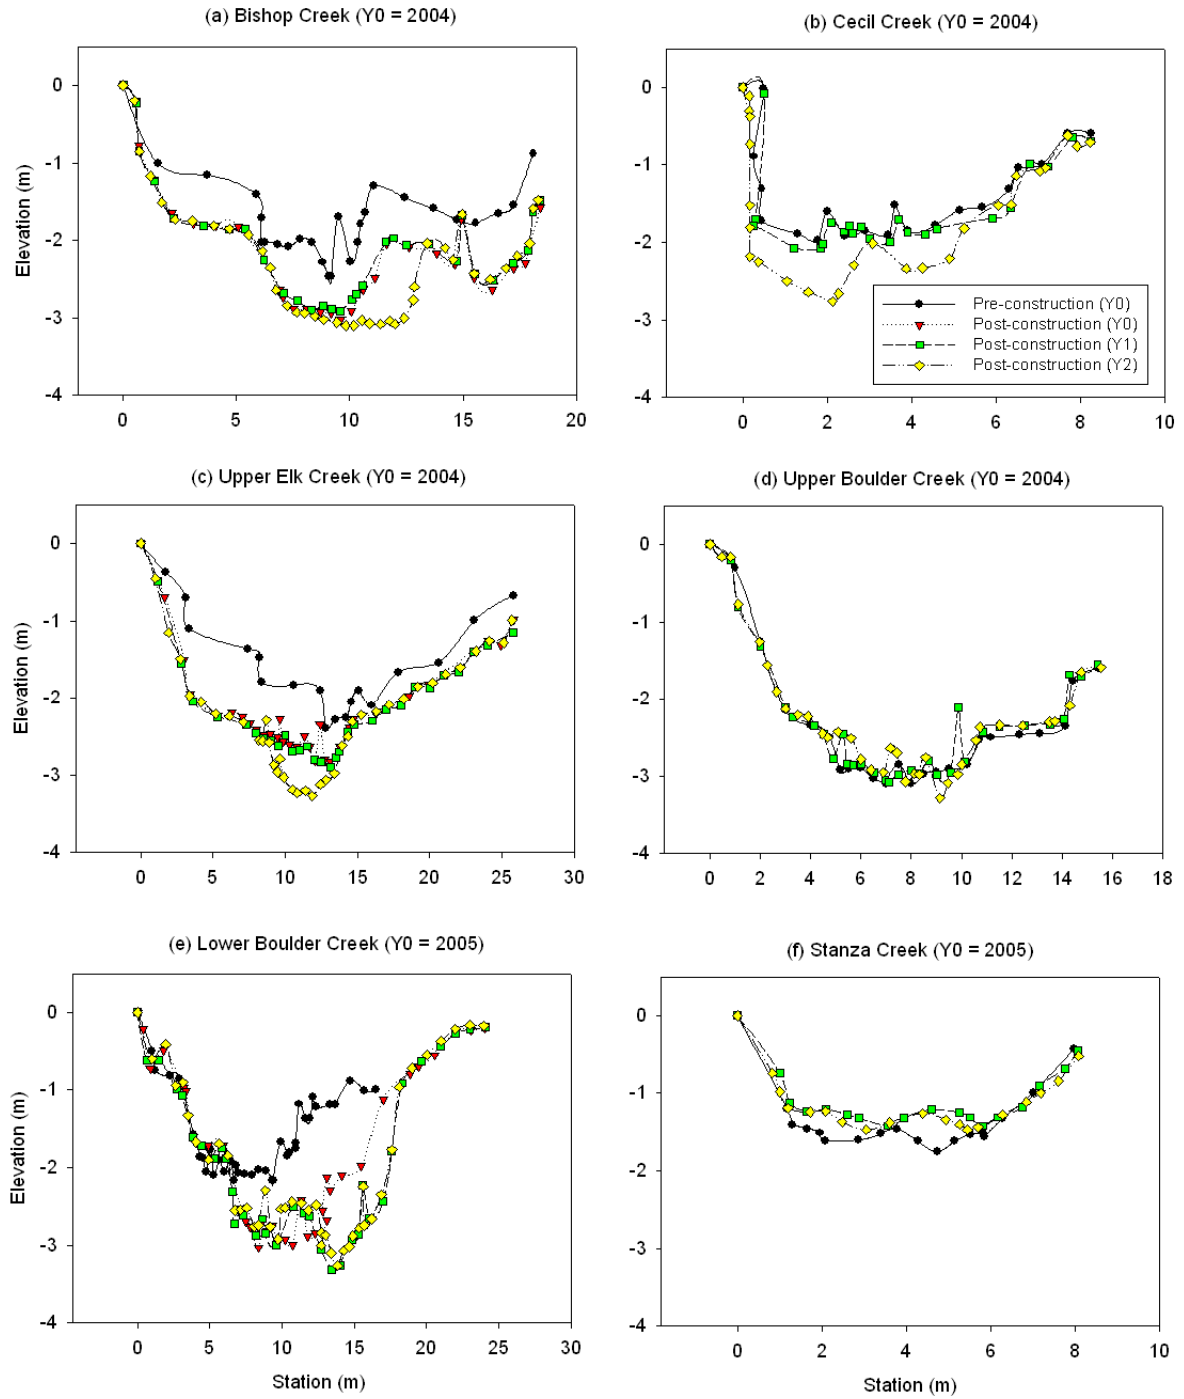
## 7. Channel adjustments at upstream cross-section (XU2) throughout the study.
