Road-crossing restoration on alluvial creeks in the Klamath National Forest, California

Term Project for Restoration of Rivers and Streams – LD ARCH 227

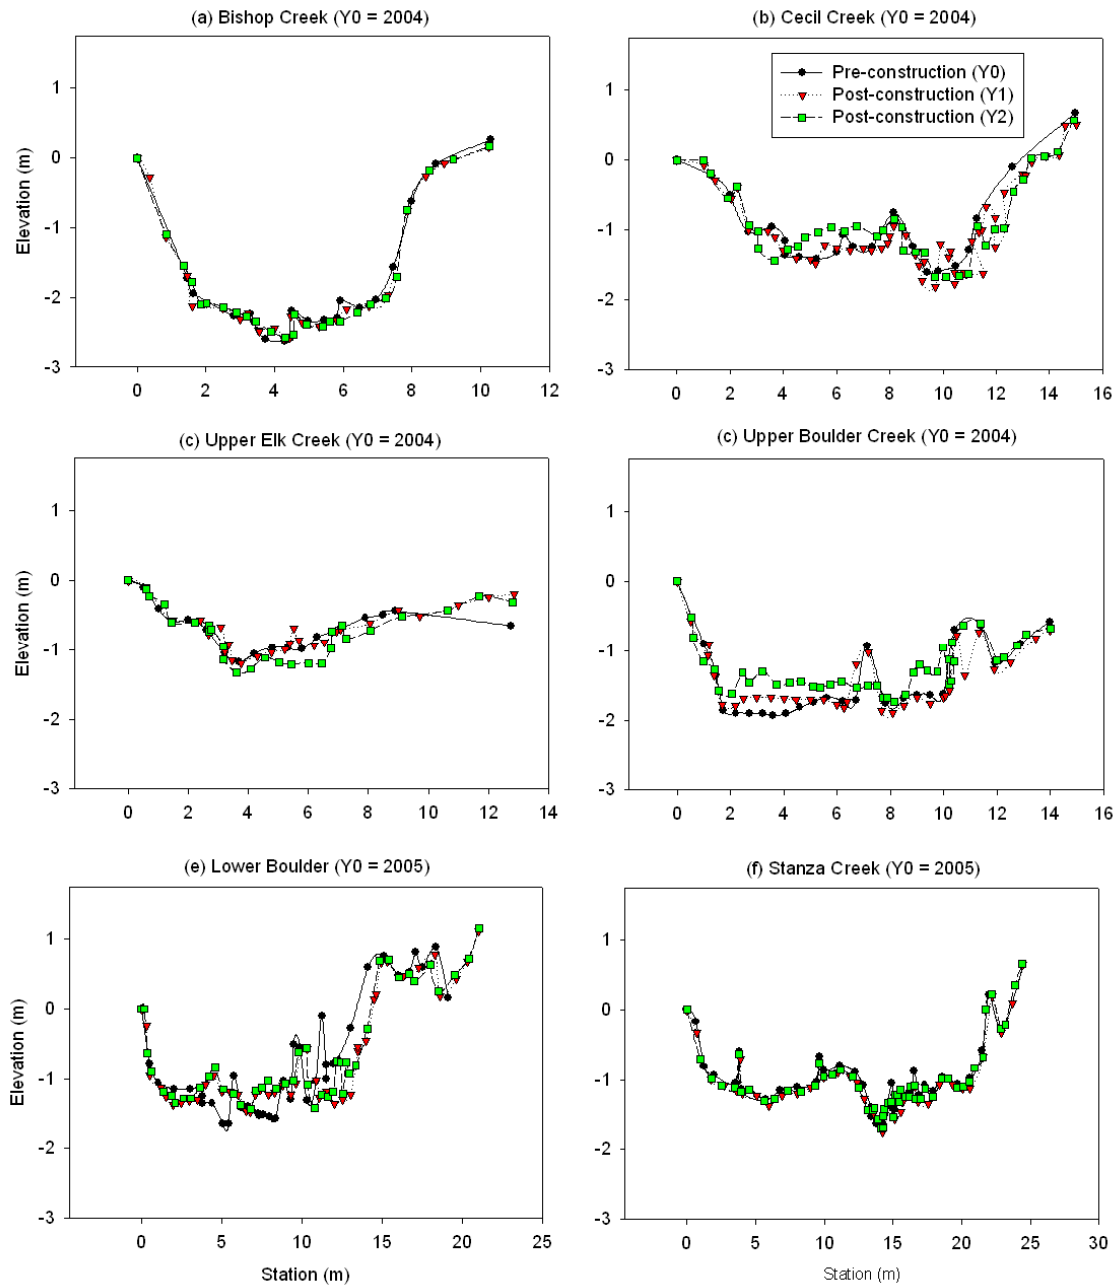
### A3. Channel adjustments at downstream cross-section (XD2) throughout the study.
