Occupant Response to Window Control Signaling Systems; Appendix C: Mixed-mode Signal Case Study Summary

Window Signaling Systems: Case Study Summaries

Appendix C

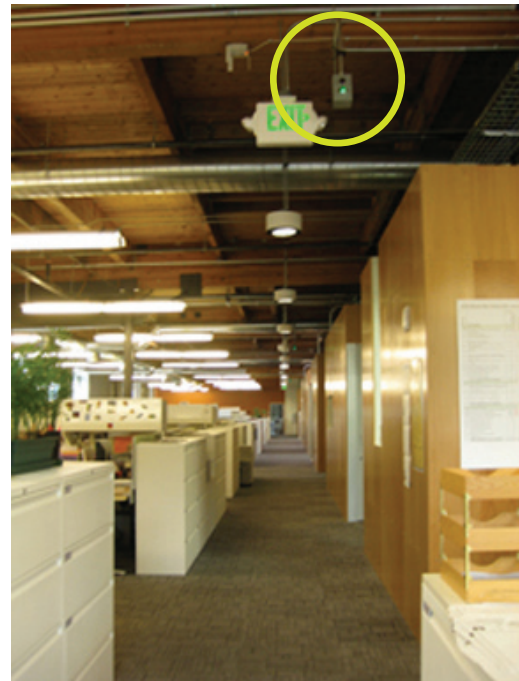
Red/green signals are located overhead in corridors, with other utilities

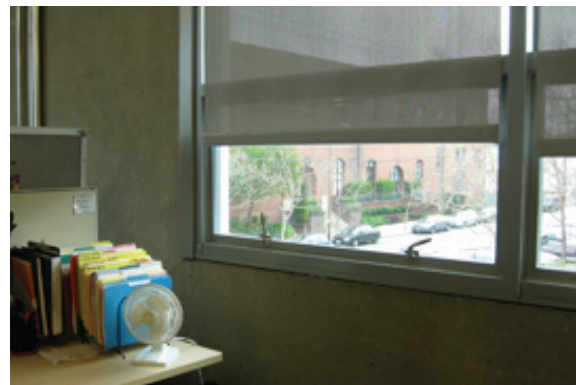
Typical operable window adjacent to workstation.

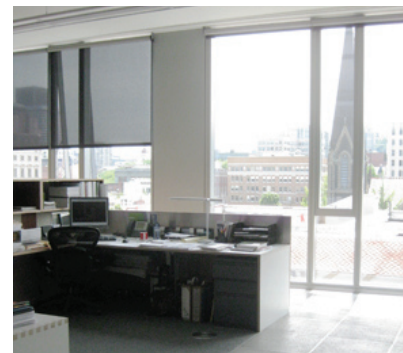
Operable slender awning windows are removed a few feet from workstation clusters

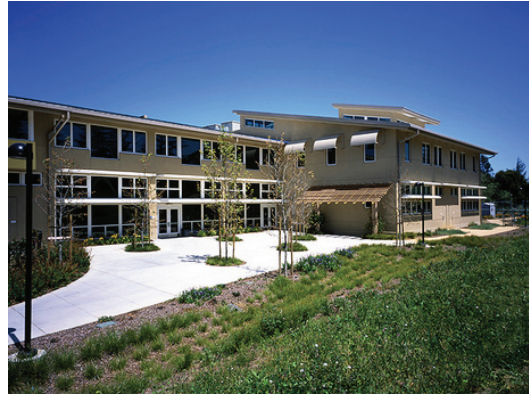
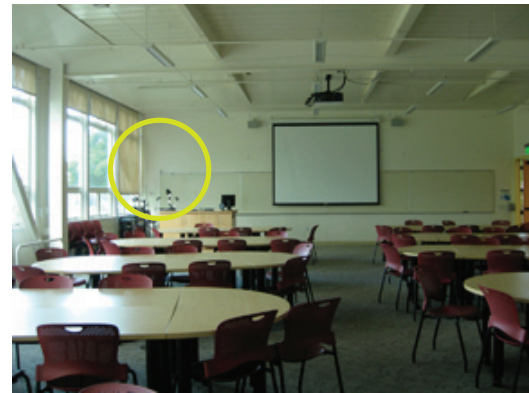
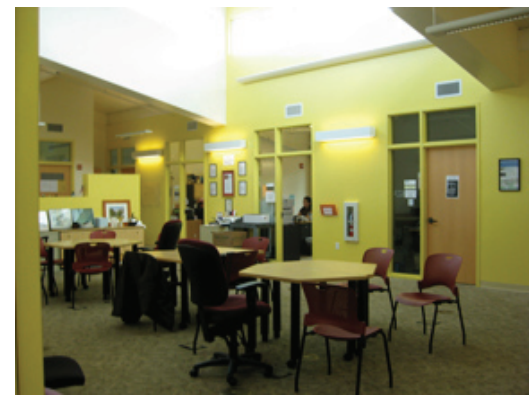
A red/green light with instructional text is mouted at eye level on the wall next to each window in private offices, classrooms, and shared worspaces. In the classrooms, they are mouted next to the thermostat and blind controls.

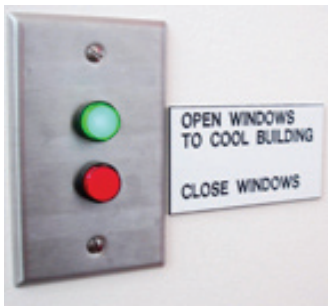
SEQUENCE OF OPERATION

THE INDICATOR LAMPS ARE INTENDED TO ASSIST THE BUILDING OCCUPANTS AND MAINTENANCE STAFF TO KNOW WHEN TO OPEN THE BUILDING UP FOR VENTILATION AND WHEN TO CLOSE IT DOWN. ILLUMINATE THE UPPER GREEN LAMP WHEN ANY OF THE FOLLOWING ARE TRUE:

1. BETWEEN THE HOURS OF [6pm] AND [6am] THE INSIDE TEMPERATURE IN THE PARENT SPACE IS HIGHER THAN THE OUTSIDE TEMPERATURE AND THE OUTSIDE TEMPERATURE IS [50°F] OR GREATER.
 2. BETWEEN THE HOURS OF [6am] AND [6pm]
 - A. THE INTERNAL TEMP IS ABOVE THE MAXIMUM ADAPTIVE COMFORT TEMP AND OUTSIDE TEMP IS BELOW INDOOR TEMP.
 - B. THE INTERNAL TEMP IS BELOW THE MINIMUM ADAPTIVE COMFORT TEMP AND OUTSIDE TEMP IS ABOVE INDOOR TEMP.
- ILLUMINATE THE LOWER RED LAMP WHENEVER THE UPPER GREEN LAMP IS NOT ILLUMINATED.

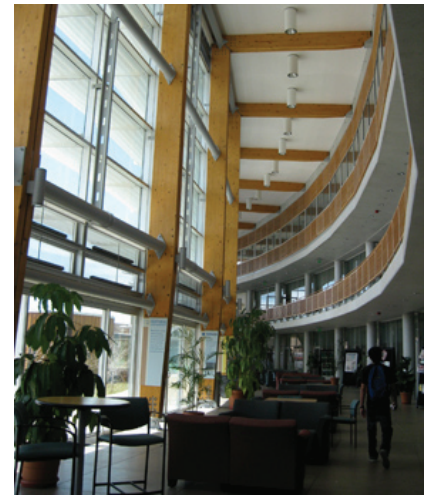
The atrium provides a thermal buffer for the north-facing offices

Because the atrium and the office areas are served by independent systems, the windows serve different functions: in the atrium, they are primarily for night ventilation, while in the offices they are intended for local supplemental cooling and ventilation. In theory, using the windows would offset fan energy by allowing the demand-controlled VAV system to modulate air supply in response.

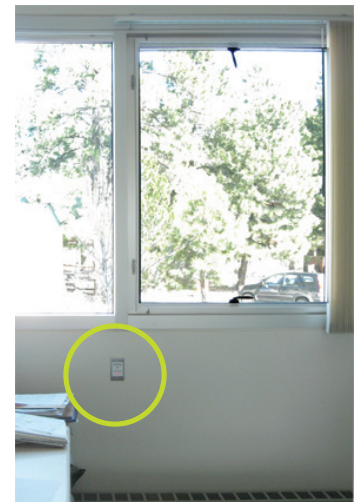
Signals are located below the window in each private office

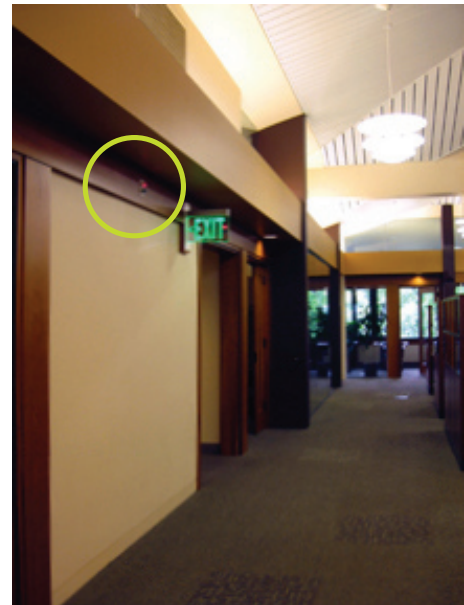
Signals are installed in the circulation areas between perimeter and core offices

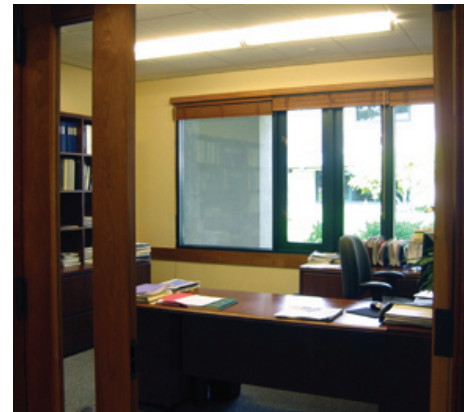
Typical perimeter office

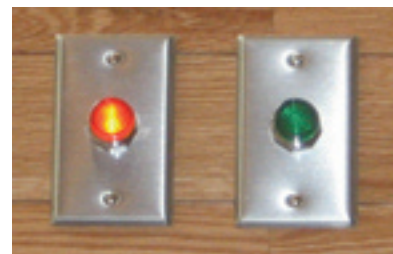
Signals are installed at either end of each floor in public circulation areas.

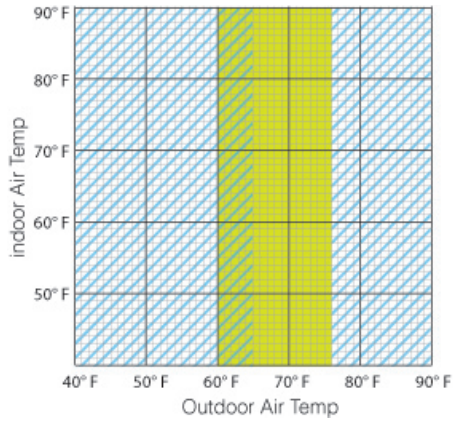
Excerpt from Sequence of Operations, 2005

"open" signal is on
 air is being supplied to zone

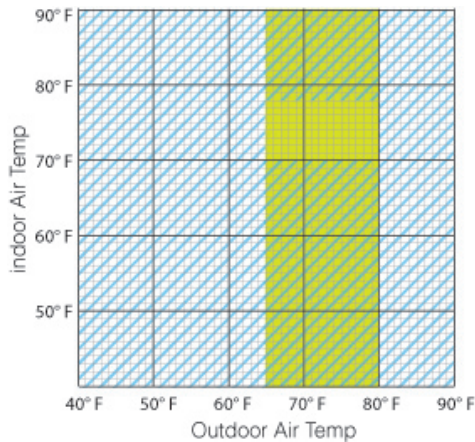
"open" signal is on
 air is being supplied to zone
