Case Study of Urban Concrete Pavement Reconstruction and Traffic Management for the I-10 (Pomona, CA) Project

RESEARCH REPORTS & FINDINGS

University of California, Berkeley
Institute of Transportation Studies
Pavement Research Center
Berkeley, California

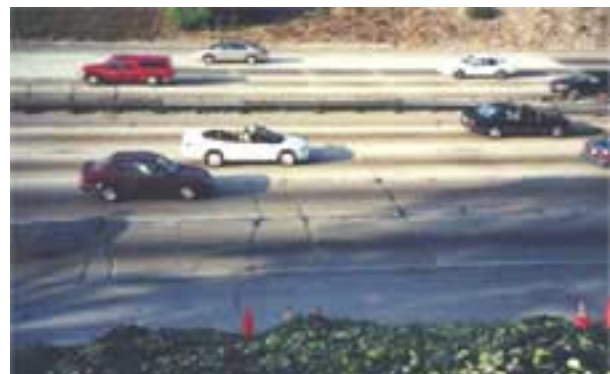
Figure 2. Typical failure of concrete pavement on U.S. Interstate 10.

Interstate 10, one of the most important arterial roads connecting the east and west coasts, begins in Jacksonville, Florida and extends throughout the southern United States and terminates in Santa Monica, California. The segment of the I-10 running through Southern California, commonly called the "San Bernardino Freeway," was built in the early 1960s with a 20-year design life. I-10 has a high concentration of deteriorated concrete pavement with extensive concrete slab failures due to transverse and longitudinal cracks and faulting, as illustrated in Figure 2. Traffic

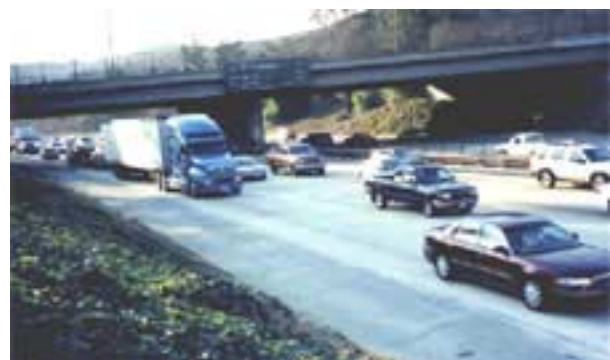
Figure 3. Typical traffic volume on U.S. Interstate 10.

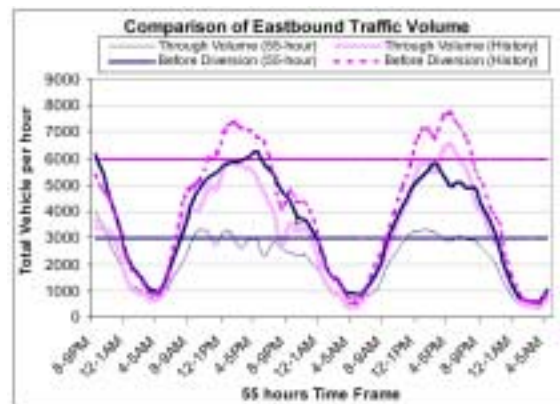
Figure 15. Net through traffic volume compared with total volume before diversion.

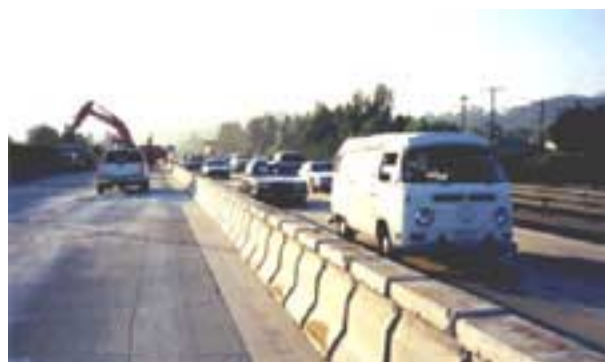
Figure 18. MCB installed as safety barrier during the weekend closure.

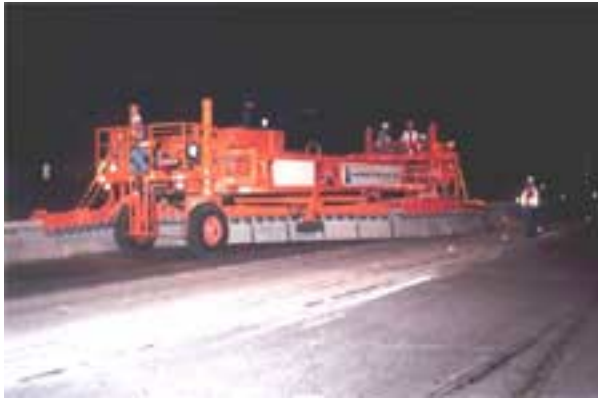
Figure 19. Installation MCB using transfer and transport machine.

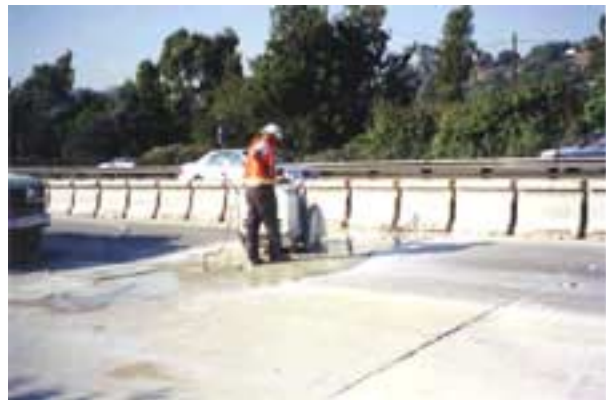
Figure 20. Slab cutting for non-impact demolition method.

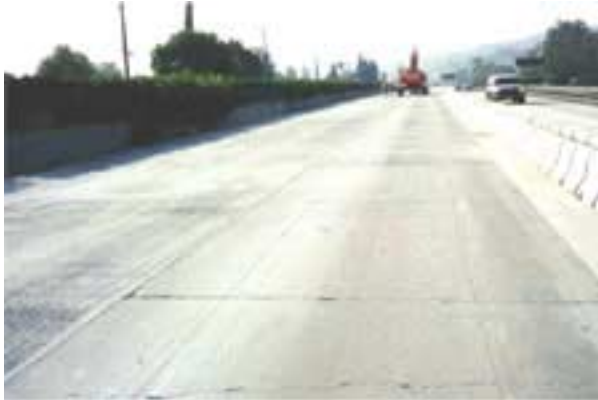
Figure 21. Slab panels cut into three pieces longitudinally.

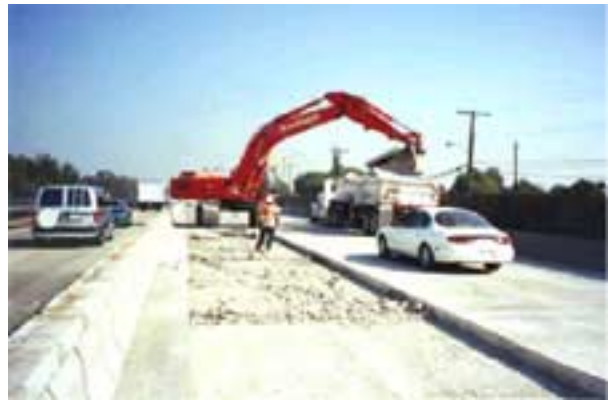
Figure 23. Non-impact demolition.

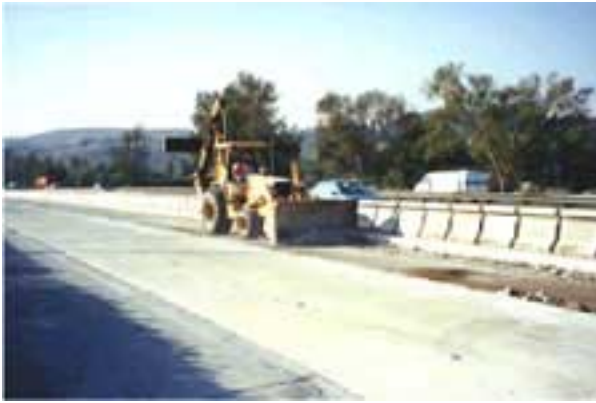
Figure 28. Cleanup of base with a small loader for “slab replacement” case.

For the slab replacement only case, cleaning up the base with a front-end loader followed right after the slab demolition, as shown in Figure 28. For most of the project, the existing CTB layer had loose debris on top of it from erosion of the base or materials washing underneath the slab. In many places, the CTB could be scraped away by the heel of a shoe. The overall condition of the existing base was not very good for a pavement section expected to last for 30 years.

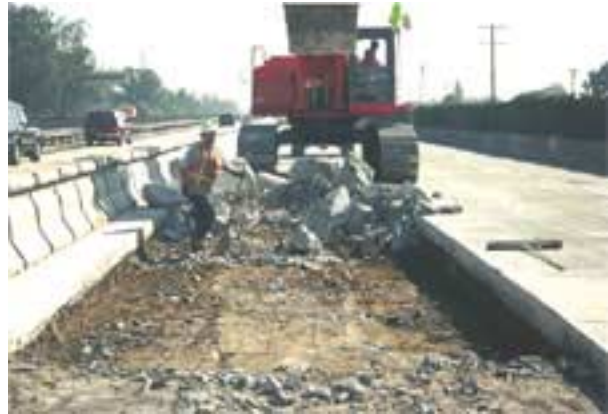
Figure 30. Removal of PCC slab, CTB, and part of aggregate base for full depth replacement.

the guillotine hammer was finished, the whole section was taken out with an excavator, as shown in Figure 30. FSHCC was used for the placing the new CTB layer to quickly achieve early strength with the purpose of placing the slab as soon as the CTB achieved the minimum required strength. Placement of the fast-setting hydraulic cement treated base can be seen in Figure 31.

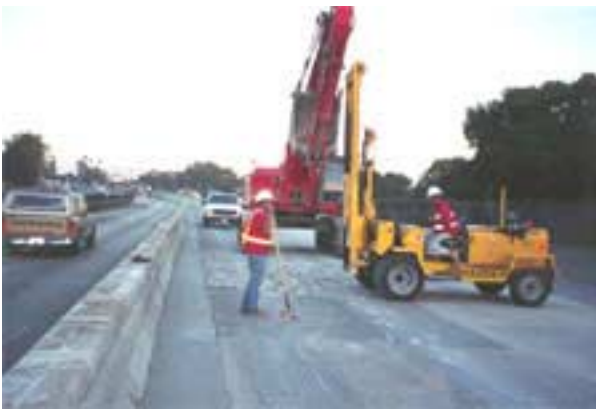
Figure 29. Impact demolition with a breaker for full depth replacement.

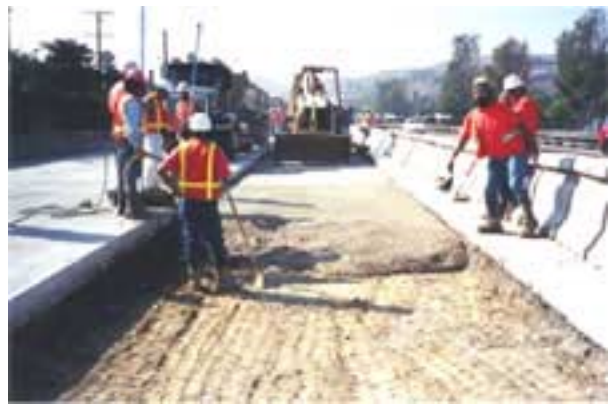
Figure 31. Placement of FSHCC CTB.

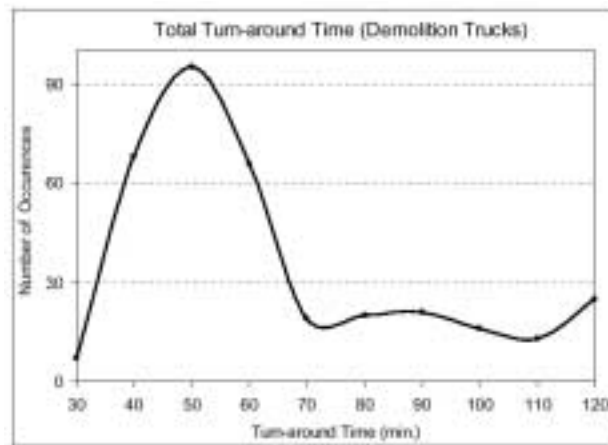
Figure 34. Distribution of turnaround time of demolition trucks.

- The average turnaround time of demolition trucks was measured as approximately one hour (64 minutes with a five-minute standard deviation), as shown in Figure 34. Due to the turnaround time averaging more than one hour and the average number of demolition trucks per crew of 9, the total required demolition trucks to be mobilized needed to be more than the 21 originally planned. The contractor had 32 demolition trucks available for the 55-hour weekend.

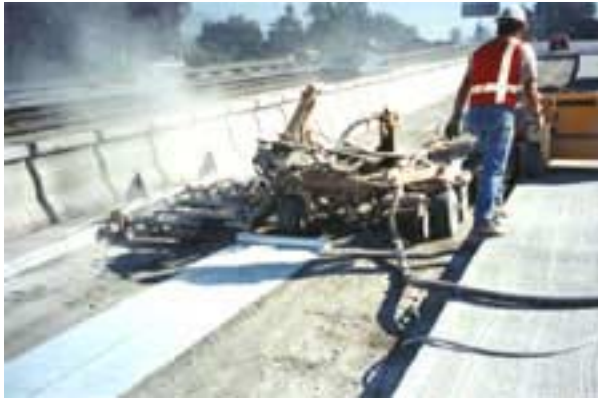
Figure 36. Self-propelled gang drill unit for drilling the bar holes to the existing slab.

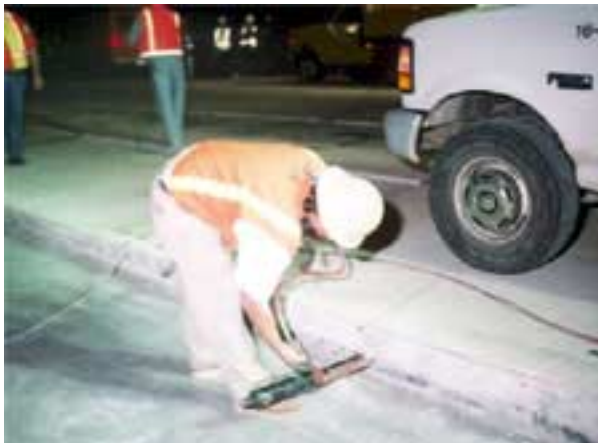
Figure 37. Injection of epoxy into the bar holes.

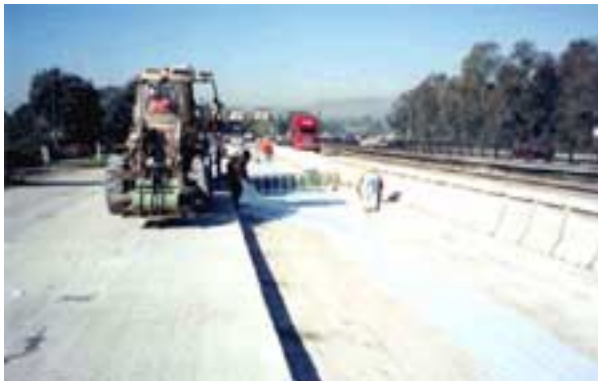
Figure 38. Placement of polyethylene sheet as a bond breaker between CTB and new slab.

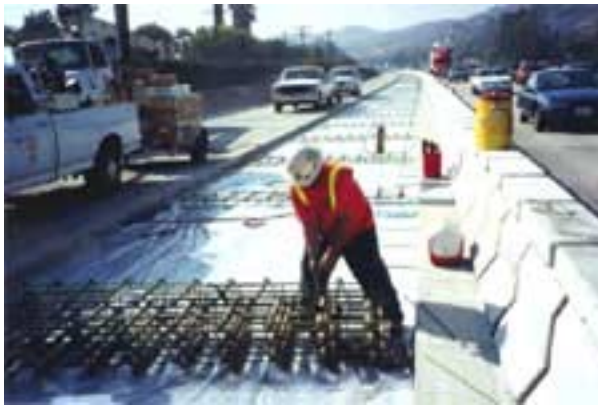
Figure 39. Installation of dowel bar basket.

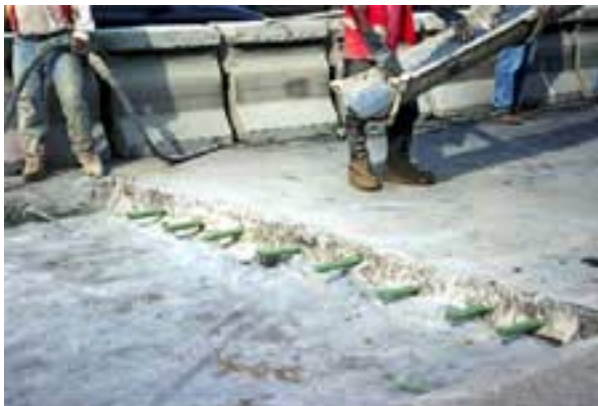
Figure 41. Placement of dowel bars in existing slab.

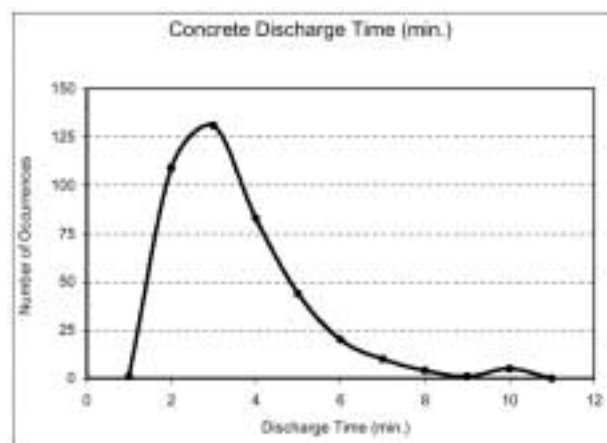
Figure 49. Distribution of cycle time of concrete discharging from mixer trucks.

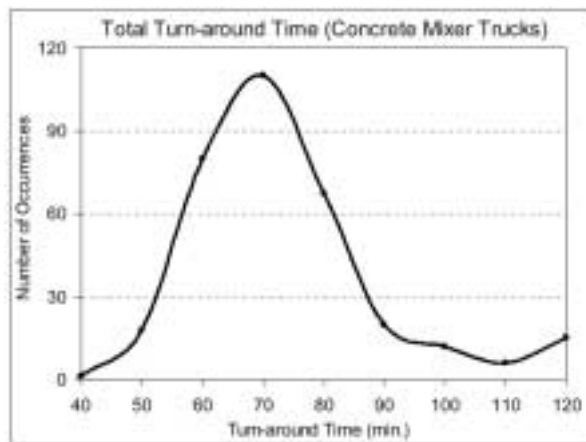
Figure 51. Distribution of turnaround time of mixer trucks.

- The average turnaround time for concrete mixer trucks was 74 minutes with a 4-minute standard deviation, as shown in Figure 51.

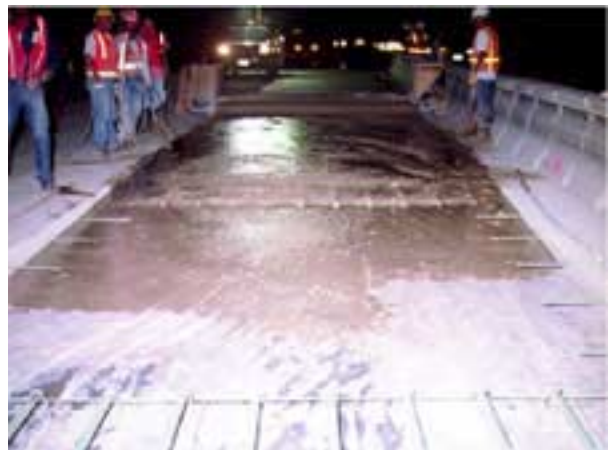
Figure 55. Example of poor quality, watery concrete.

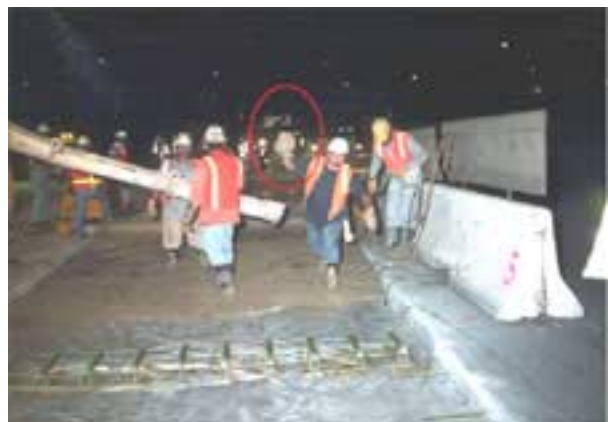
Figure 56. Cement ball from the mixer truck; evidence of buildup.

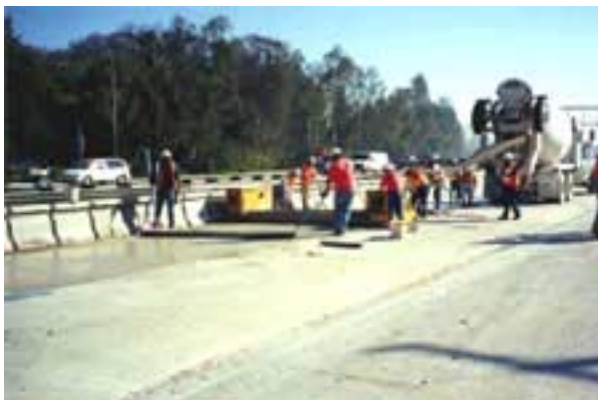
Figure 59. Manual finishing and texturing of the pavement.

Finishing and texturing were completed manually by two laborers who floated, trowelled, and broomed the pavement surface behind the concrete screed, as shown in Figure 59. Curing compound was sprayed on the surface immediately after finishing and texturing, as shown in Figure 60. Approximately two hours after the concrete was finished, a 44-mm deep saw cut was made on each transverse joint with a single saw team, as shown in Figure 61. The condition of the finished surface was rough, but the contractor planned to diamond grind the surface during a nighttime closure as part of the contract with Caltrans. The Caltrans specification allowed for a maximum grinding depth of 6 mm (4).

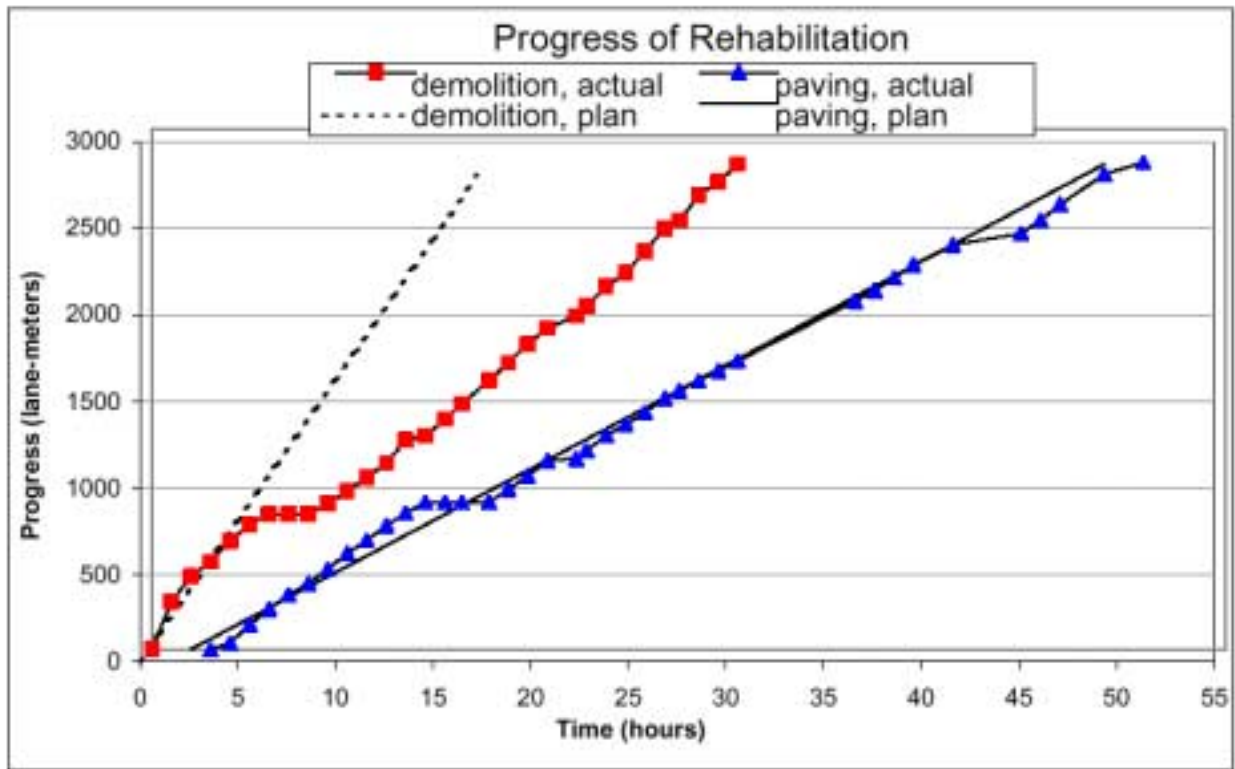
Figure 62. Actual progress of the rehabilitation compared with planned progress.
