Natural fish passage structures in urban streams (part 1: hydrologic and resource issues)

NATURAL FISH PASSAGE STRUCTURES IN URBAN STREAMS (PART 1: HYDROLOGIC AND RESOURCE ISSUES)

Charles H. Hegberg (410-316-7862, chegberg@kci.com), Division Chief, P. Alan Schlindwein, PE, AICP (410-316-7864, achlindwein@kci.com), Wetlands Engineer, and Stephen J. Cohen, PG (410-316-0813, scohen@kci.com), Senior Environmental Scientist, Environmental Planning Division, KCI Technologies, Inc., 10 North Park Drive, Hunt Valley, Maryland 21202.
Fax: 410-316-7895

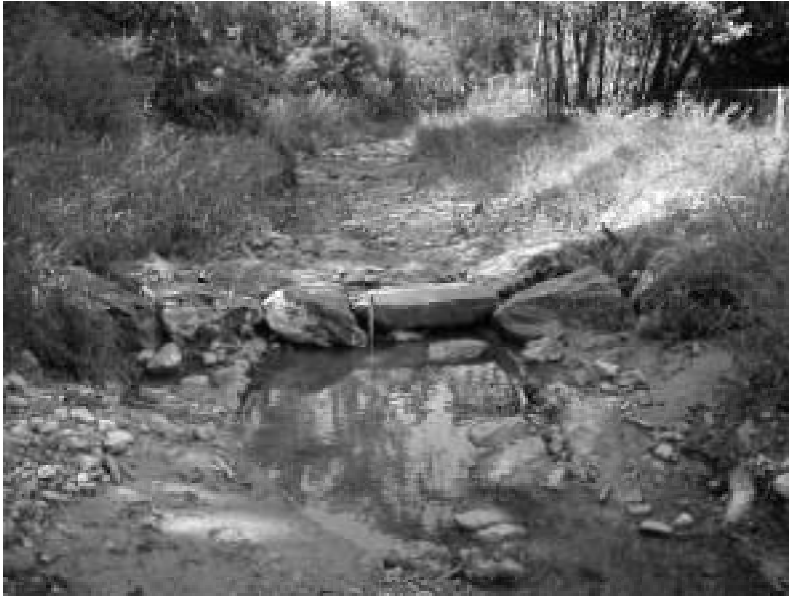
Fig. 1. Example of Natural Structure Becoming a Blockage

Natural design approaches are adequate in rural or wilderness watersheds because the natural baseflow can be relatively close to dominant discharges. In urban settings, baseflows decrease and flood flows become flashy, scouring channels to unnatural widths resulting in shallow homogeneous channel that are unable to struggle to support fish populations (Sovern 1997). Designing for dominant discharge in urban streams does not necessarily translate to fish passage because of the relatively large disparity between baseflow and dominant discharge. Consequently, the common use of stone cross vanes and other "natural" grade control structures in urban streams can create additional fish passage blockages in our wide urban streams (Figure 1). When these "natural" structures are added to the endless list of exposed utilities, dams, culverts and over-widened channels, fish passage is nearly impossible in these urban areas.

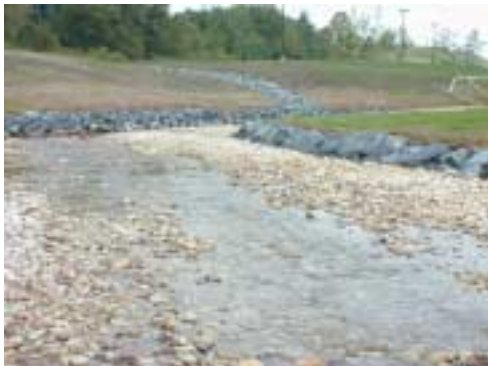
Fig. 2. GF in Sacramento River

Numerous types of natural rock structures are available for stream restoration and habitat enhancement projects, some of which are described below. In California, the USACE --, Sacramento District constructed a Gradient Facility on the Sacramento River as a diversion device for an irrigation canal (Figure 2). As part of the design criteria, three feet of head was required on the RGC to provide fish passage and recreational boating (Hogan 2000).

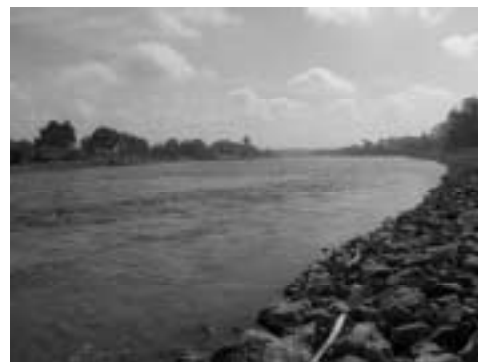
Fig. 3. RGC in White Marsh Run

In Baltimore County, Maryland, six RGCs were constructed to stabilize White Marsh Run, a high bedload stream that has previously rendered traditional stabilization structures ineffective due to high sediment deposition (KCI 1995). Although these structures were not designed specifically for fish passage, spring flow depth and velocity measurements on these RGCs indicate that they would promote fish passage (MDNR 2000). The White Marsh Run RGCs are unique in that they are installed in series, whereas most constructed riffles were installed as point location structures (Figure 3).

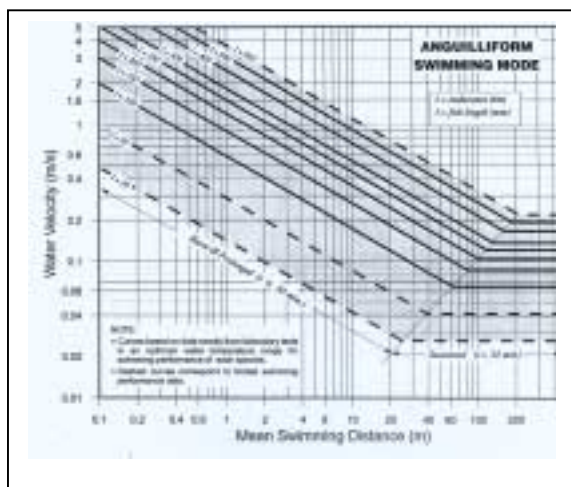
Fig. 4. Anquilliform Swimming Chart

Figures 4 and 5 provide useful information regarding the swimming speeds and swimming durations for some anadromous fish. The U.S. Fish and Wildlife Service or state natural resource agencies can likely provide most or all of the above information. The Freshwater Institute, Manitoba, Canada, produced a fishway design document that contains useful information regarding swimming characteristics of anadromous fish (Katopodis 1992).
