Barriers for steelhead (*Oncorhynchus mykiss*) smolt migration through the lower flood channel of Alameda Creek

Final Draft

LA222

May 2009

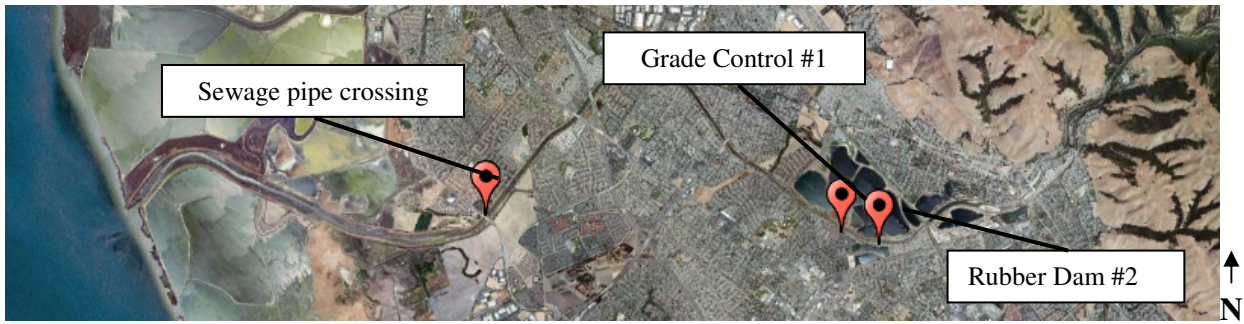
Figure 3. Map of Rubber Dam #2, Check Dam #1, and Union Sewage pipe crossing

To determine potential barriers downstream of the BART weir, I interviewed specialists from various agencies involved in Alameda Creek such as the Alameda County Flood Control District (ACFCD), Alameda Water District, East Bay Regional Parks District and the Alameda Creek Alliance. Additionally, I used a combination of aerial photographs and maps provided by the ACFCD, and I surveyed the entire reach from the BART weir to the salt marsh on foot. In this process I looked for physical barriers that had any of the following characteristics: pooling upstream, long flat cement sections, sharp drop offs, or habitat that would yield warm temperatures and shallow water elevations. From this preliminary step I chose to focus my study on the following structures: the decommissioned Rubber Dam #2, Check Dam #1, and the Union Sanitary District sewage pipe crossing (Figure 3).

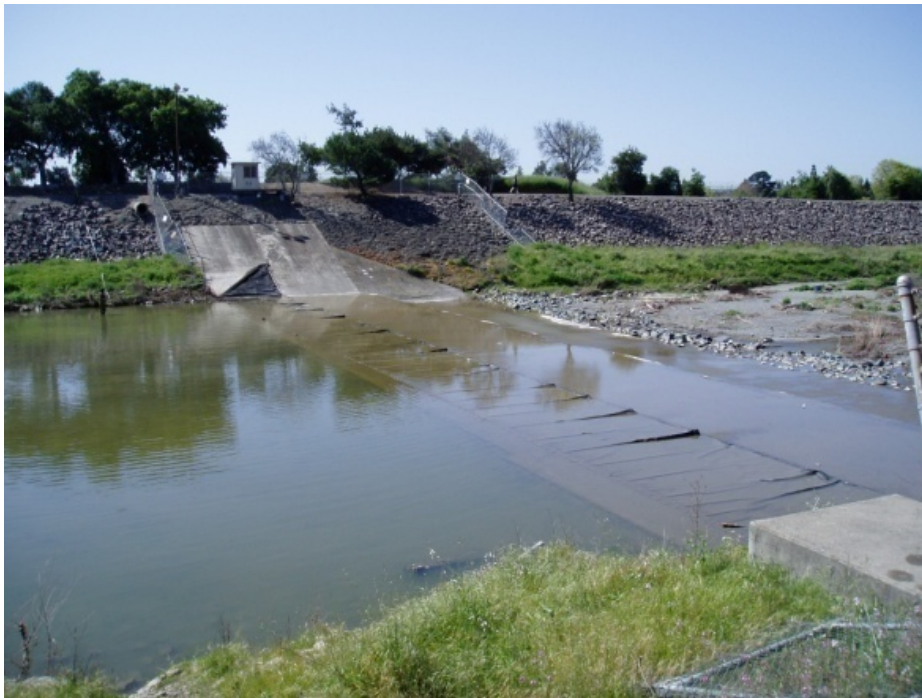
Figure 4. Photo of Rubber Dam #2

Rubber Dam #2 was characterized by a two-tiered cement platform, with the deflated rubber dam atop the first tier (Figure 4). The total area of the top tier was approximately 5920 ft² with a length of 37 ft. The portion of the top tier covered by the deflated rubber dam was 15 ft, had an average temperature of 20°C and

The average depth atop tier two of Rubber Dam #2 was > 0.1 ft, far below the CDFG and NMFS recommended depth requirements for outmigrating smolt. Tier one was deeper than tier two (0.26 ft) but it was also below the minimum depth requirement. The increased depth of tier one was caused by pockets of water formed in the folds of the deflated dam. When the rubber section of the dam is removed later in the year, it is likely that the depth atop of tier one will be similar to the depth of tier 2. Although steelhead are known for their strong and fast swimming ability, it is likely that the 54 ft length of Rubber Dam #2 and its insufficient depths could strand fish atop the structure, discourage fish from attempting to cross, cause high stress and/or cause bodily injury. The other problematic condition of Rubber Dam #2 was the 3.28 ft drop from tier 1 to tier 2. The NMFS recommends a minimum drop of six inches for juveniles into a jump pool of at least two feet in depth; neither of which were met at Rubber Dam #2 (NOAA 2001). The depth atop both Check Dam #1 and the sewage pipe crossing were both under the recommended depth requirements; however the lengths of the structures were significantly shorter and there were pockets of deeper water atop the structures allowing smolts to pass more freely than through Rubber Dam #2. Additionally, the pool beneath the 1.6 ft drop at Check Dam #1 had an average depth of 1.1 ft, thus providing a more secure passage than Rubber Dam #2. The sewage pipe crossing was also less of a concern because it was completely underwater during high tide, allowing for easy passage.

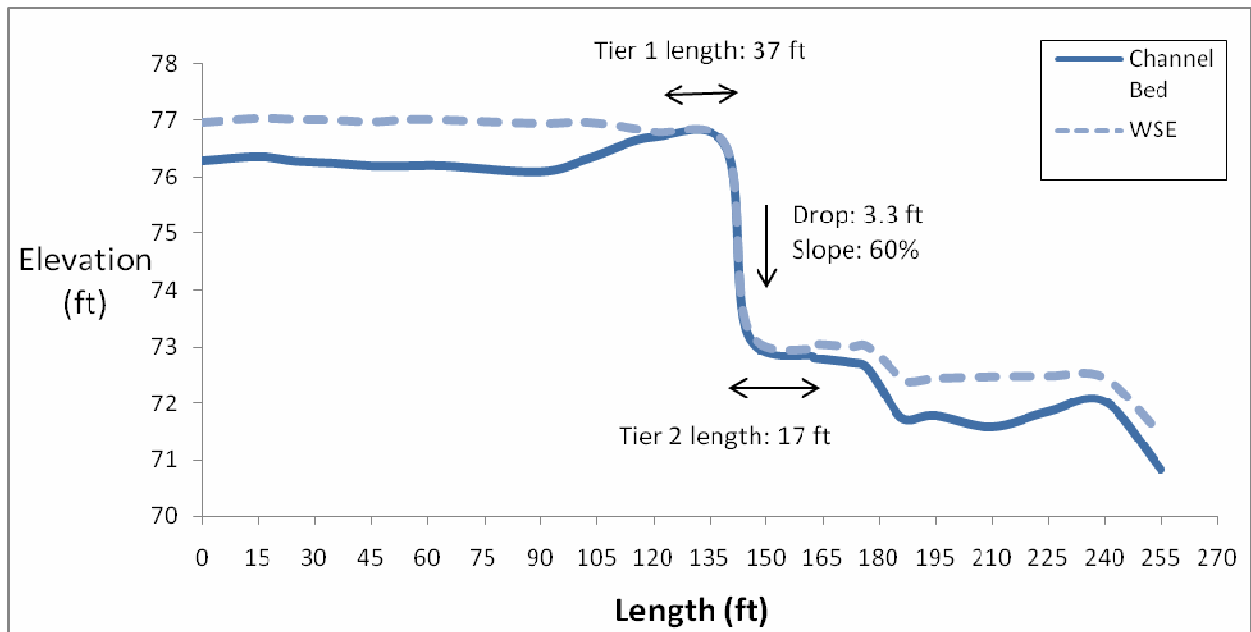
Figure 5. Long Profile of Rubber Dam #2

an average depth of 0.26 ft (Table 1). The drop off between the two tiers was 3.28 ft at a 60% slope (Figure 5). The second tier was characterized by flat paved cement bottom with a total area of 2880 ft² and a length of 17 ft. The bottom tier had an evenly spread thin sheet of water with an average depth of < 0.1 ft and an average temperature of 20°C. Immediately following the second tier was a series of mid-size boulders and gravel bars, followed by a 5 ft length riffle and then a deeper channel with a fine sediment bottom. The daily mean discharge recorded at the downstream gauge (#11180700) on the date we collected the data was 4.0 cubic feet per second (cfs) (Figure 6).

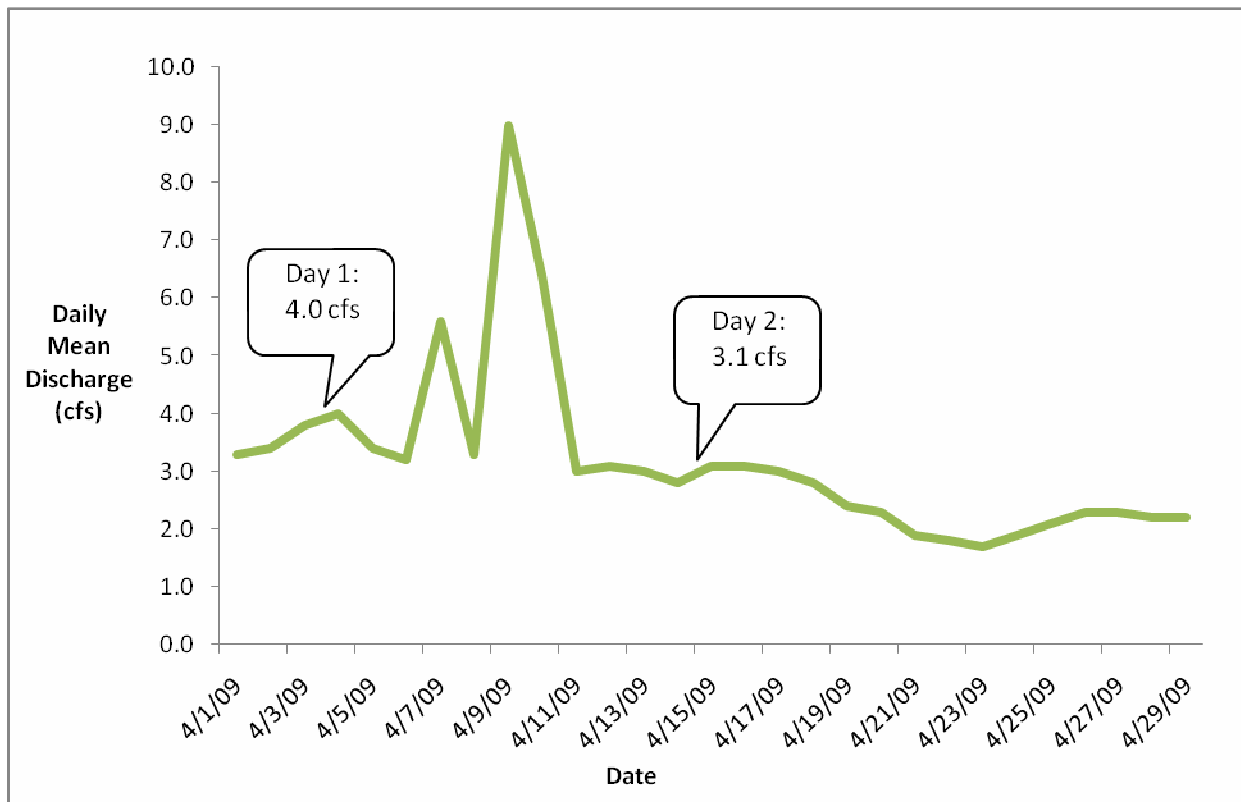
Figure 6. Daily mean discharge from USGS Gauge #11180700 near study sites

Check Dam #1 was constructed of cement and embedded mid-size boulders (Figure 7). Although the dam spanned the entire width of the channel (130 ft), water was only able to breach the top of it through a 22 ft wide shallow notch through the center. The length of Check Dam #1 was 8 ft, with an average depth of 0.13 ft, and an average temperature of 15°C atop the structure (Table 2). The drop off from the top of Check Dam #1 was 1.57 ft at a 78.5% slope (Figure 8). The 60 ft section below Check Dam #1 was characterized by a narrow pool (average depth of 0.79 ft) formed by a large gravel bar a few feet from the foot of the dam. Further downstream the creek reformed into a straight narrow channel (approximately 90 ft wide) until it neared the next check dam above DeCoto Road. The daily mean discharge recorded at the downstream gauge (#11180700) on the date we collected the data was 3.1 cfs (Figure 6).

mean discharge, with the lowest mean flow of 1.7 cfs on 4/23/09 (Figure 6). The average monthly flow for April from 1978-2008 was 134.5 cfs, while the average flow for April 2009 was 3.34 cfs (Figures 6 and 12). Even though 2009 was a relatively low flow year, it is important to note that 27% of the monthly discharges in April from 1978-2008 were below the mean monthly flow of 3.34 cfs seen in April 2009. Overall the hydrograph data indicated that there is a great deal of variability in the flood channel of Alameda Creek and that the impacts of these structures on steelhead smolt should be considered for both high and low flows (Figure 10). Furthermore, it indicated that flow conditions through the flood control channel are often lower than the flows I observed for this study. To better predict the effects of flow, it would be advantageous to quantify the relationship between discharge and environmental conditions at the study sites in future studies.
