SOME GEOMETRICAL ASPECTS OF BREAKDOWN OF SODIUM BETA ALUMINA

Published in Materials Research Bulletin,  
Vol. 14, pp. 589-595, 1979

L. C. De Jonghe, L. Feldman, and P. Millett

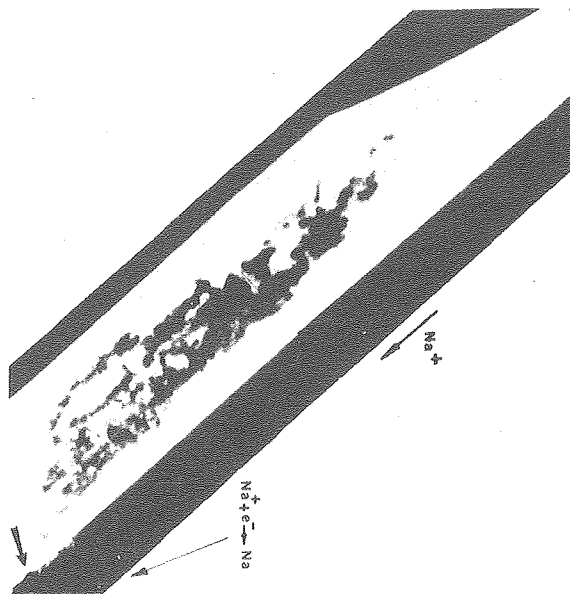
FIG. 3

Geometry of the 300°C, D.C. breakdown after partial propagation. The degradation apparently initiated at the place where the Kovar reservoir welded to the electrolyte (arrow at lower right corner).

Increasing currents were passed through samples as shown in Figure 1, until a blackening was seen to emerge rapidly from the negative electrode. Sectioning of the sample revealed that the blackening had started at a point where the Kovar reservoir was welded directly to the electrolyte, providing a Na<sup>+</sup> blocking site with electron injection. The geometry of the breakdown shown in Figure 3 strongly suggests that the Na metal penetration is not readily described in terms of a single metal filled crack propagating through

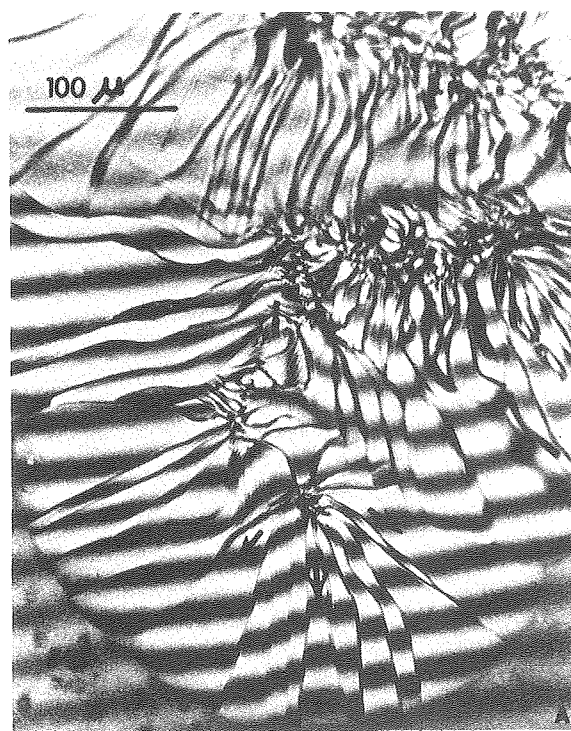
FIG. 6

Geometry of the sodium filled crack. a) Interferometer observation, b) geometry derived from the interferometry.

The geometry of the metal formation is clearly shown in Figure 5. The formed metal is highly reflective, permitting direct interferometric study of the cleavage plane. Also, evaporation of some gold on one of the cleaved faces of the crystal permitted to find the approximate metal filled crack opening, assuming the crack opening was symmetrical with respect to the cleavage plane. The results of these examinations are shown in Figures 6a and 6b for the breakdown produced with blocking electrodes (Figure 2a).

It is clear that depleting of a single conducting plane cannot provide sufficient sodium to fill the crack. Therefore, the crack must be fed from the steps, or rivermarks that intersect many conduction planes. Since the crack propagation mode and morphology is identical in the configuration where the positive electrode is supplying  $\text{Na}^+$ , it is thought that in all cases the crack steps play an important role as sites where Na is fed into the crack. The observations suggest that in modeling beta alumina breakdown progression, one cannot simply assume that the crack is only tip fed. This introduces another difficulty in the modeling of sodium filled crack propagation due to current passage in sodium beta alumina.
