Wind, Thermal, and Earthquake Monitoring of the Watts Towers

A thesis submitted in partial satisfaction
of the requirements for the degree Master of Science
in Civil Engineering

Jackson English

2013

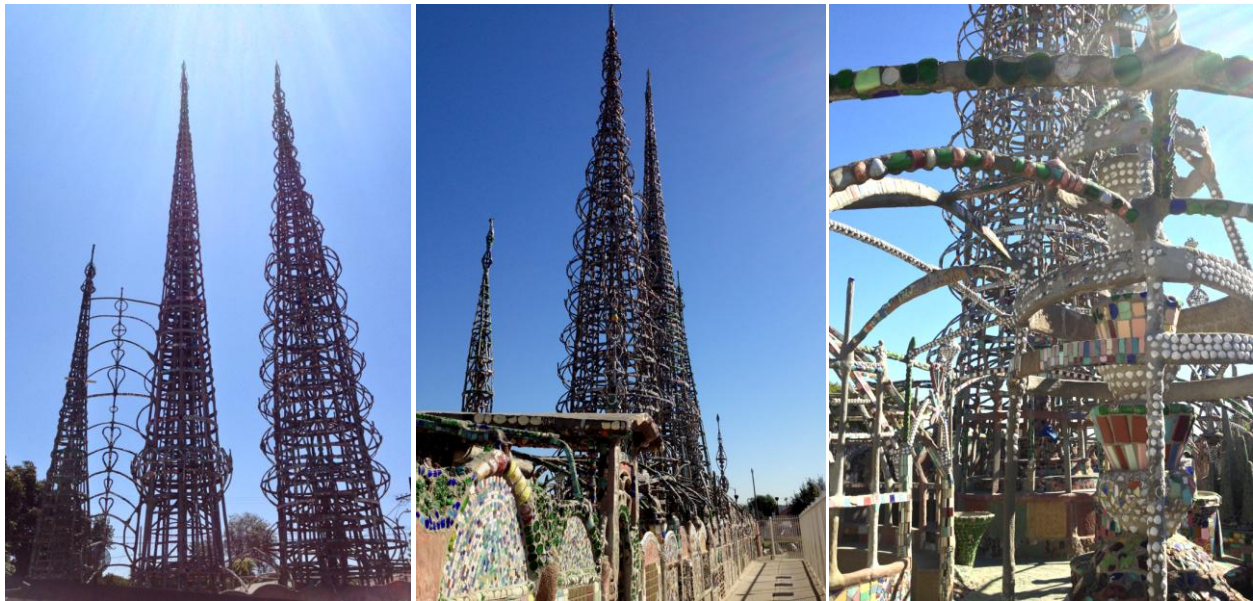
Figure 1.1: Photographs of the Watts Towers: A) view looking south, showing the three towers B) view looking east along the south wall C) view from inside the site, showing parts of the other structures and the overhead arches connecting all around the site

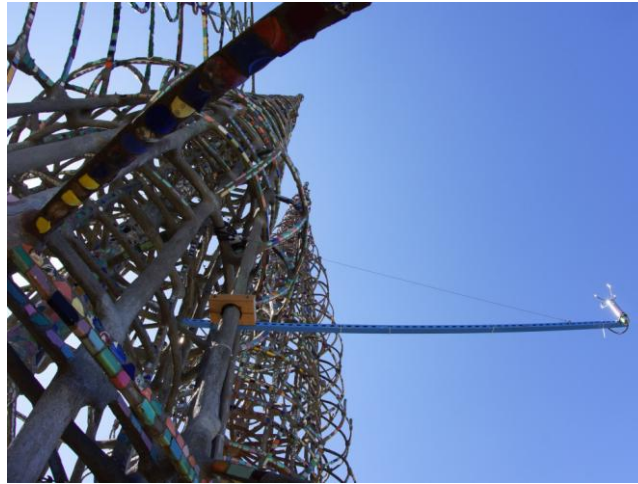
northerly at the site. This sensor can measure dynamic components of wind gusts to about 5 Hz, and so will be a proxy for dynamic wind pressure on the Central Tower.

Figure 3.3: Wind sensor

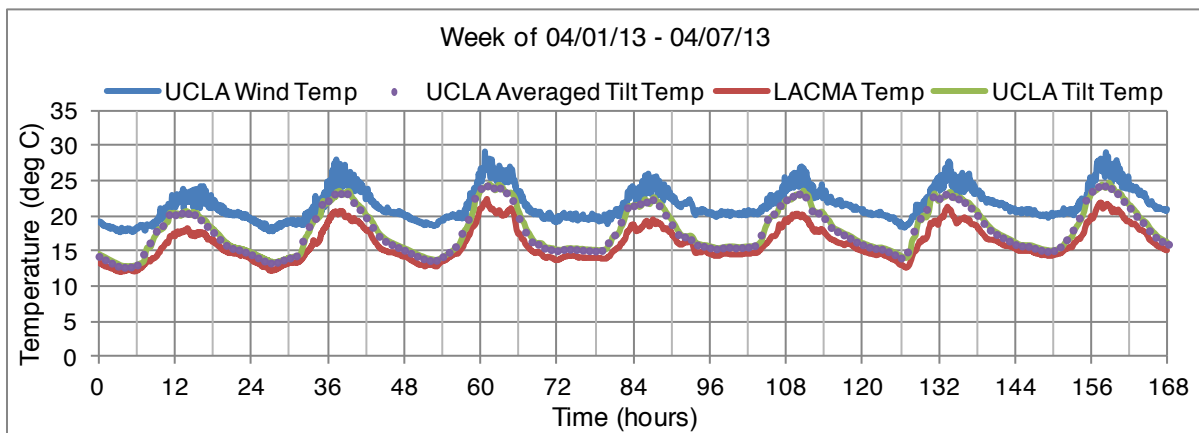
The LACMA and UCLA weather data will both be used to examine various trends, so it is necessary to check how they compare to each other and to verify that the recorded values for temperature and wind speed are consistent. The LACMA station samples the weather data once every five minutes. To facilitate a one to one comparison, the UCLA data were resampled at the five-minute rate.

Figure 4.1: LACMA vs. UCLA temperature comparison

record 1.7°C and 5.4°C higher temperature values than the LACMA station, respectively. Another thing to note is that the one-hour average temperature values follow the same trend as the 5-minute sampling—accurately capturing the peaks and valleys throughout the day. The tiltmeter and LACMA weather station are within a close enough range that the difference can likely be attributed to variations in exposure and location. The temperature difference between the wind sensor and the other two sensors is large enough that it will have to be taken into consideration when using the data.

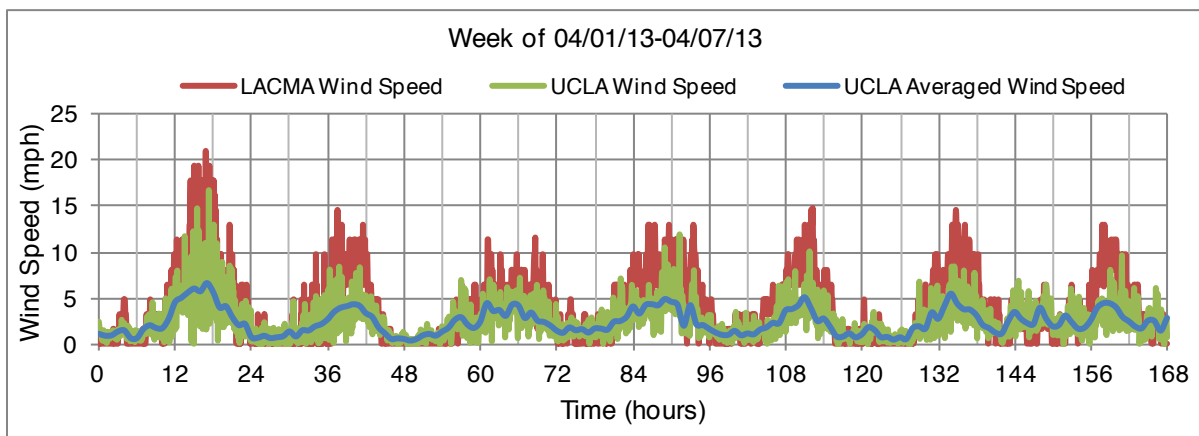
Figure 4.2: LACMA vs. UCLA wind speed comparison

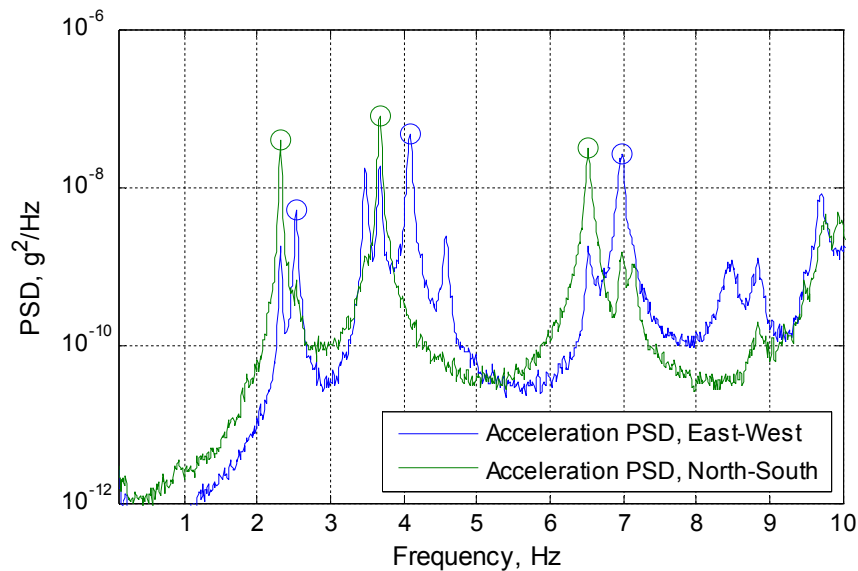
By plotting the resulting power density versus frequency, it is easy to identify the first three modes, as shown in Figure 4.3. The simple method of “peak-picking” was used here to obtain the dominant natural frequencies (cf. circled locations in the figure). In order to pick the peaks, a range of frequencies was selected for each mode after viewing the initial results. For example, the first mode was assumed to fall between 1 and 3 Hz, the second mode between 3 and 5 Hz, and the third mode between 5 and 8 Hz. The maximum value was found within each of those ranges, and the corresponding frequency value was saved. There are other, more advanced, methods that can be used to identify the dominant modes, but the simplicity of peak-picking and the ability to automate the process in Matlab made it the preferable option when dealing with such a large data set.

Figure 4.3: Acceleration power spectral density

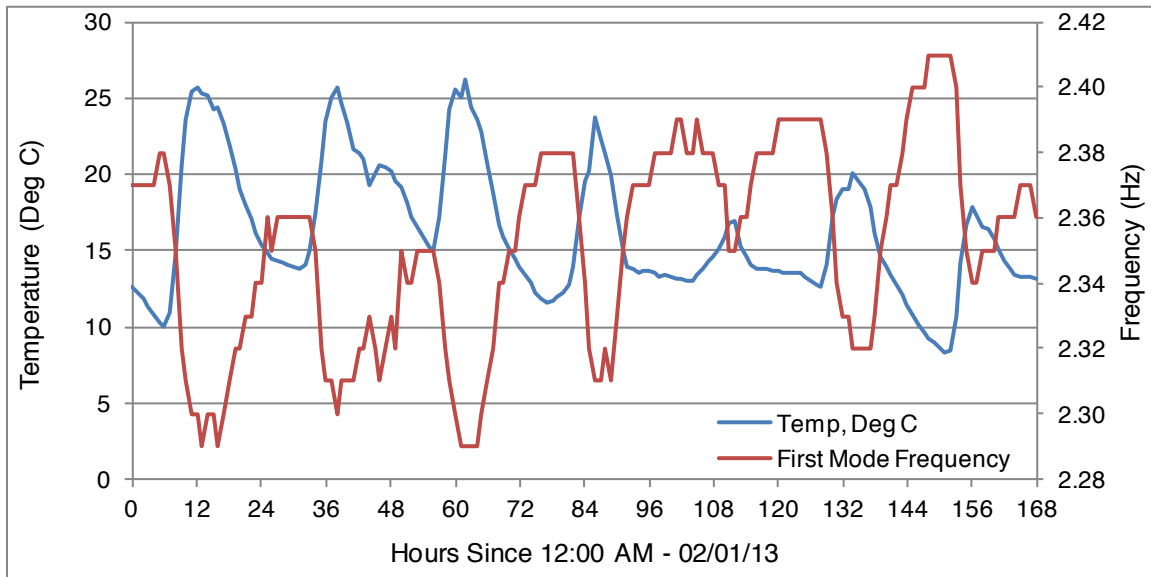
greater depth in §6. The dominant frequencies were identified for each one-hour set of data using the previous methods. Figure 4.4 displays the shift in the north-south first mode frequency relative to the variations in temperature during the first week of February.

Figure 4.4: Frequency vs. temperature over time

A clear trend can be seen in this figure; as the temperature increases, the stiffness of the tower decreases, causing a drop in first mode frequency. The Central Tower acts as an unrestrained cantilever; as the temperature increases, the structure expands and the material becomes more flexible. It was found that throughout the day, the first mode frequency in the north-south direction could vary by as much as 5%; over the course of several days, the variation is as high as 8%. The shift in higher mode frequencies was even larger, with long-term variations of approximately 12% for the second and third modes in the north-south direction. The first mode frequency of a structure is proportional to the square root of its stiffness and inversely proportional to the square root of its mass. The mass of the structure will change slightly over time due to variations in moisture content on wet or dry days, but overall the differences will be negligible. The mass can therefore be considered constant, meaning an 8% shift in frequency corresponds to approximately a 15% shift in stiffness. The change in frequency can be seen over

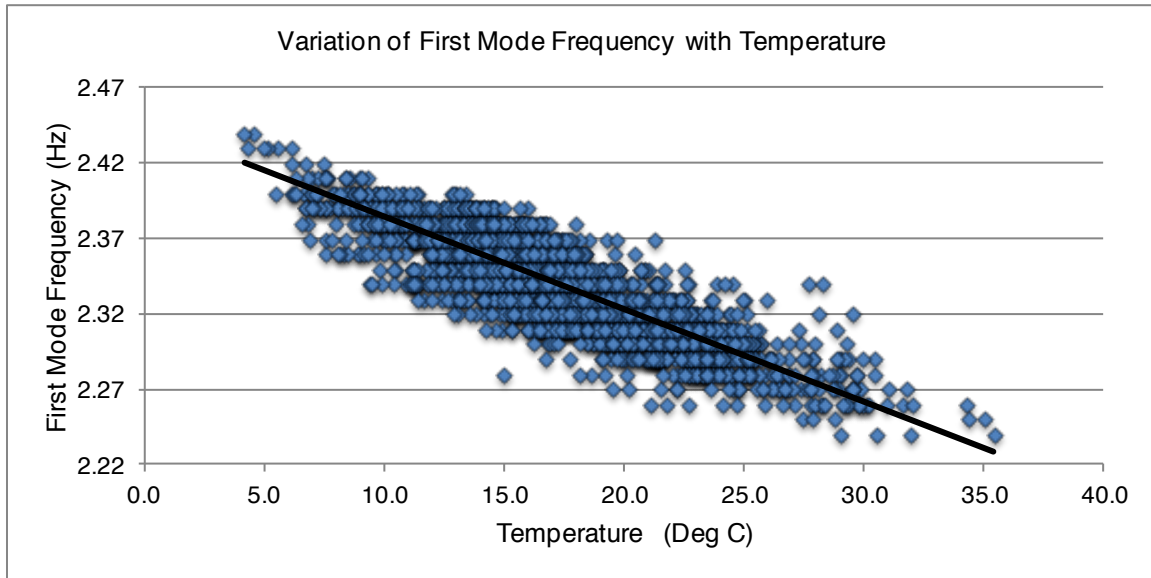
the course of several months through the figures below, which show the hourly variation in frequency between January 30, 2013 and May 12, 2013.

Figure 4.5: January - May frequency vs. temperature

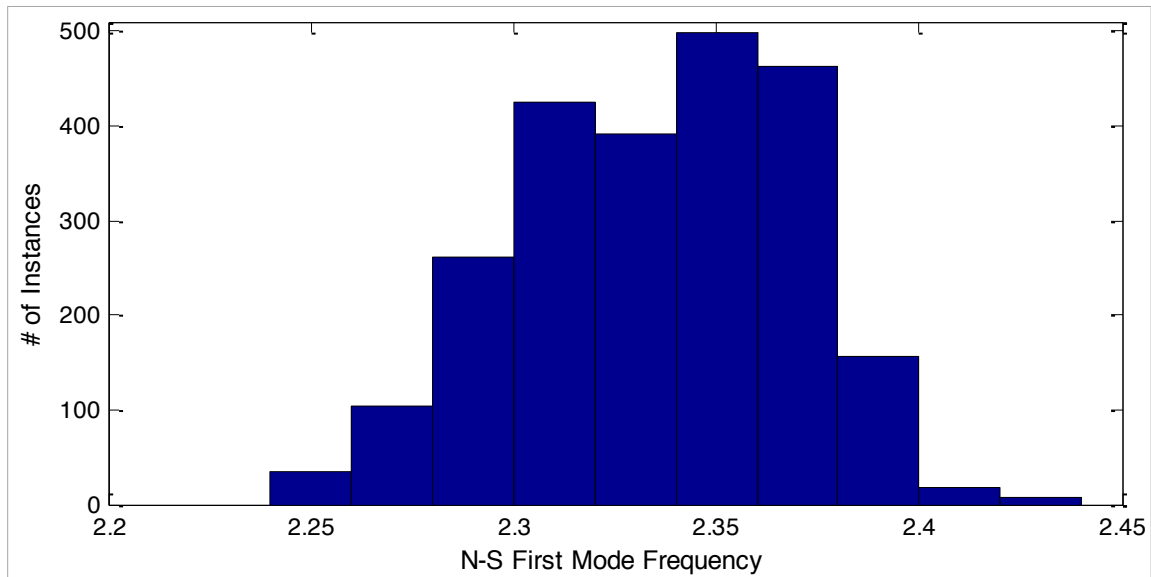
Figure 4.6: Frequency histogram

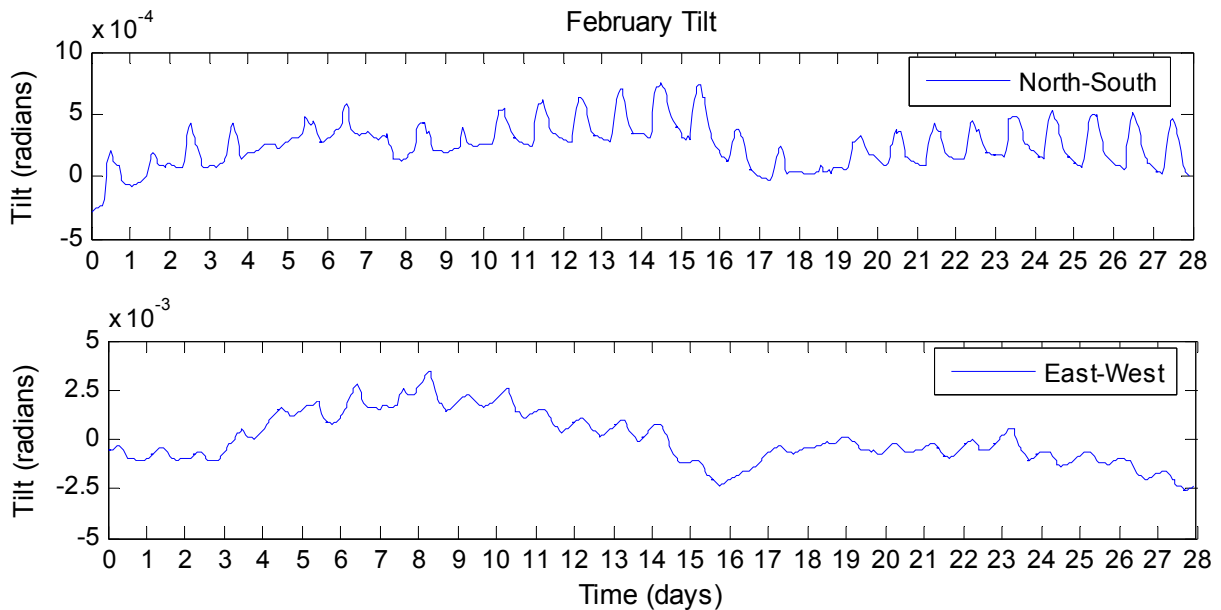
Plants will grow toward a light source in order to maximize the amount of energy available for photosynthesis—a behavior known as phototropism. The Central Tower conversely leans away from the sun over the course of the day due to differential heating of the side exposed to the sun compared to the shaded, cool side. The elements on the sunny side will expand faster and to a larger extent. The figure below displays the daily tilt cycles in the north-south and east-west directions.

Figure 4.7: Thermally induced daily tilt cycles

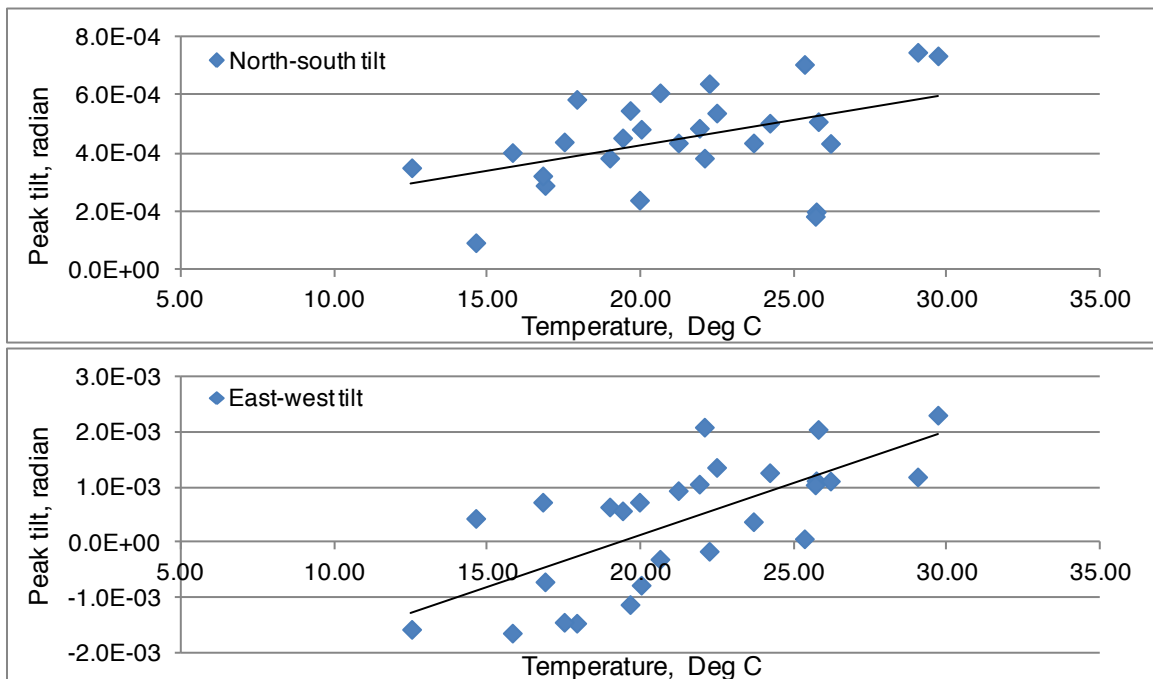
In both directions, there is a noticeable long-period drift to the tilt data. These trends may be a function of electronic drift or might reflect real behavior. The values tend to return to zero, however, which suggests that it is an actual behavior of the tower. One possible explanation is that during abnormally hot days, the tower tilts to a more extreme angle, and during the night it does not fully return to its initial position before the next daily cycle. Figure 4.9 displays the average daily temperature versus the peak daily tilt for the month of February.

Figure 4.9: Average daily temperature versus peak daily tilt

The temperature and tilt tend to follow a similar pattern; an increase in temperature leads to an increase in the peak tilt, which suggests that this hypothesis is credible. The relationship appears to be stronger in the E-W direction than it is in the N-S direction. Other transient factors such as windstorms can influence the tilting behavior of the tower. In order to better visualize the daily motion of the tower, the data were filtered using a fifth-order Butterworth band-pass filter, which is available in Matlab's signal processing toolbox (Matlab, 2013). The low-pass frequency was set at 1/30 [1/hr], and the high-pass frequency was set at 1/18 [1/hr]. This filtering effectively leaves only the 24-hour period data.

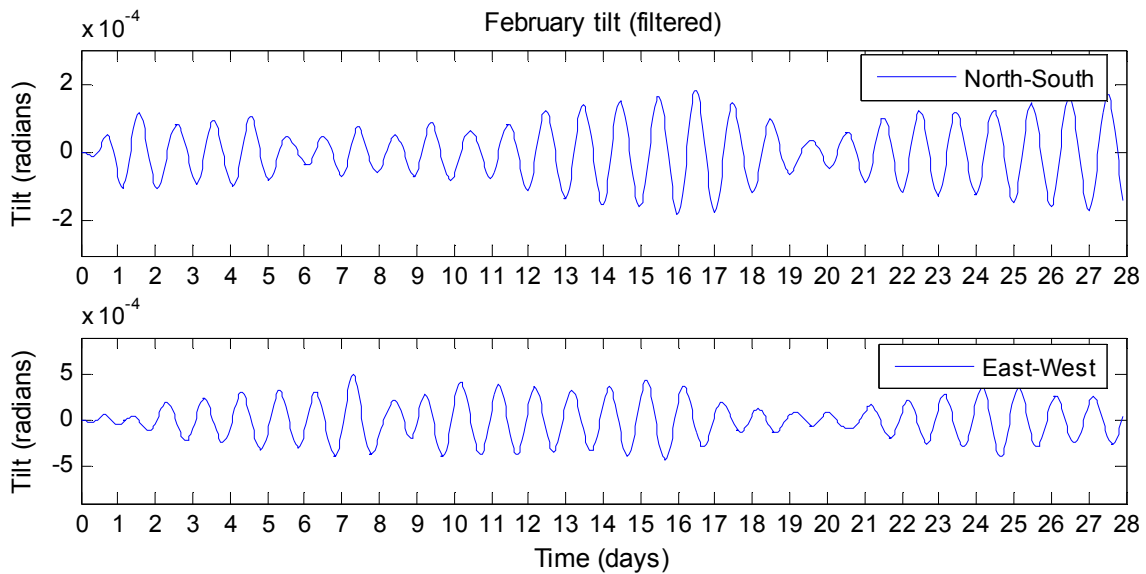
Figure 4.10: Band-pass filtered February tilt

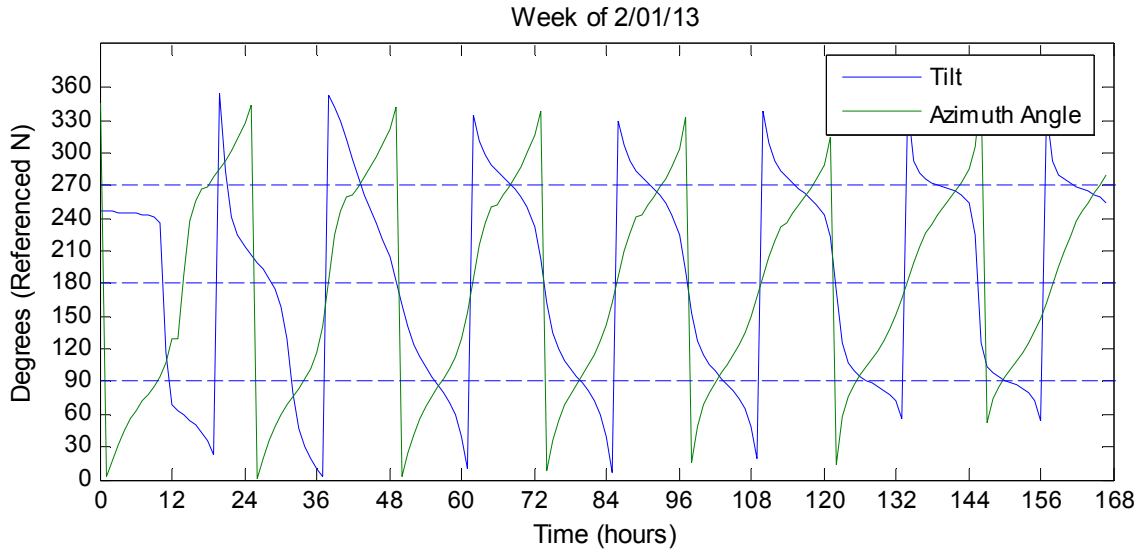
surface). Plotting the azimuth angle versus the resultant tilt of the structure allows the hypothesis to be tested.

Figure 4.11: Week of 2/01/13 tilt versus the azimuth angle

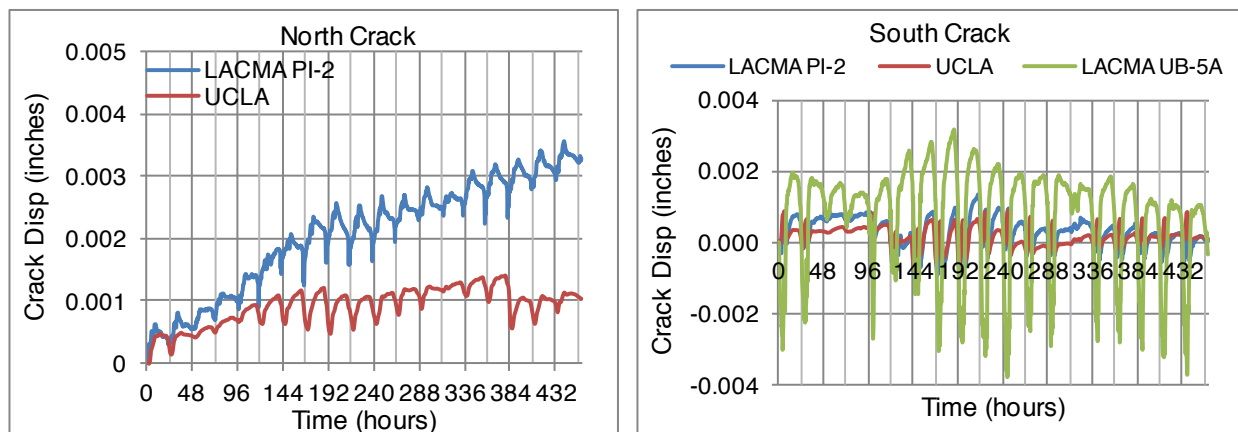
The cracks along the Central Tower's columns were also instrumented by the LACMA team with two different types of sensors. On the north column, LACMA placed a TML PI-2 displacement transducer, which works by attaching a combination of strain gauges across an arch-shaped spring plate. The south column was instrumented with another PI-2 sensor, as well as a UB-5A displacement transducer. Mounting of the UB-5A transducer requires cutting into the column around the crack, whereas the PI-2 is surface mounted with epoxy, making the PI-2 the more desirable option. Figure 4.13 shows the north and south crack displacement as recorded by both the UCLA and LACMA systems.

Figure 4.13: LACMA vs. UCLA crack displacement comparison

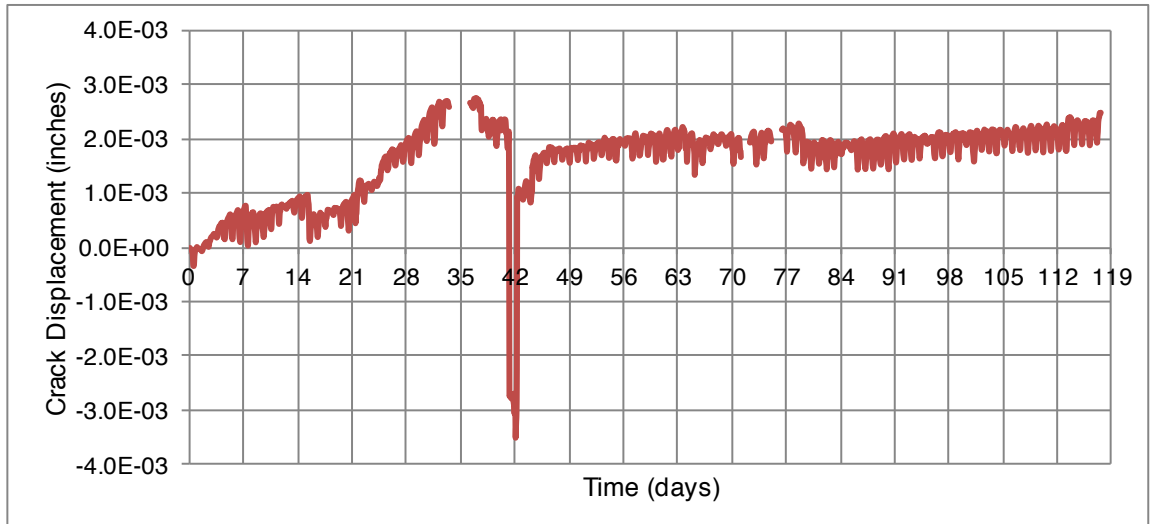
The long-term drift in the north crack continued for a period of time before leveling off. Figure 4.14 shows the north crack's displacement for the first four months of monitoring, between April 13 and August 13, 2013. During the first five weeks, the crack opens approximately 0.003 inches, much larger than the average daily opening and closing. The downward spike at the beginning of the sixth week is likely due to some form of work being done on or around that column. The crack remains fairly close to its baseline for the remainder of the time.

Figure 4.14: North crack displacement time-history

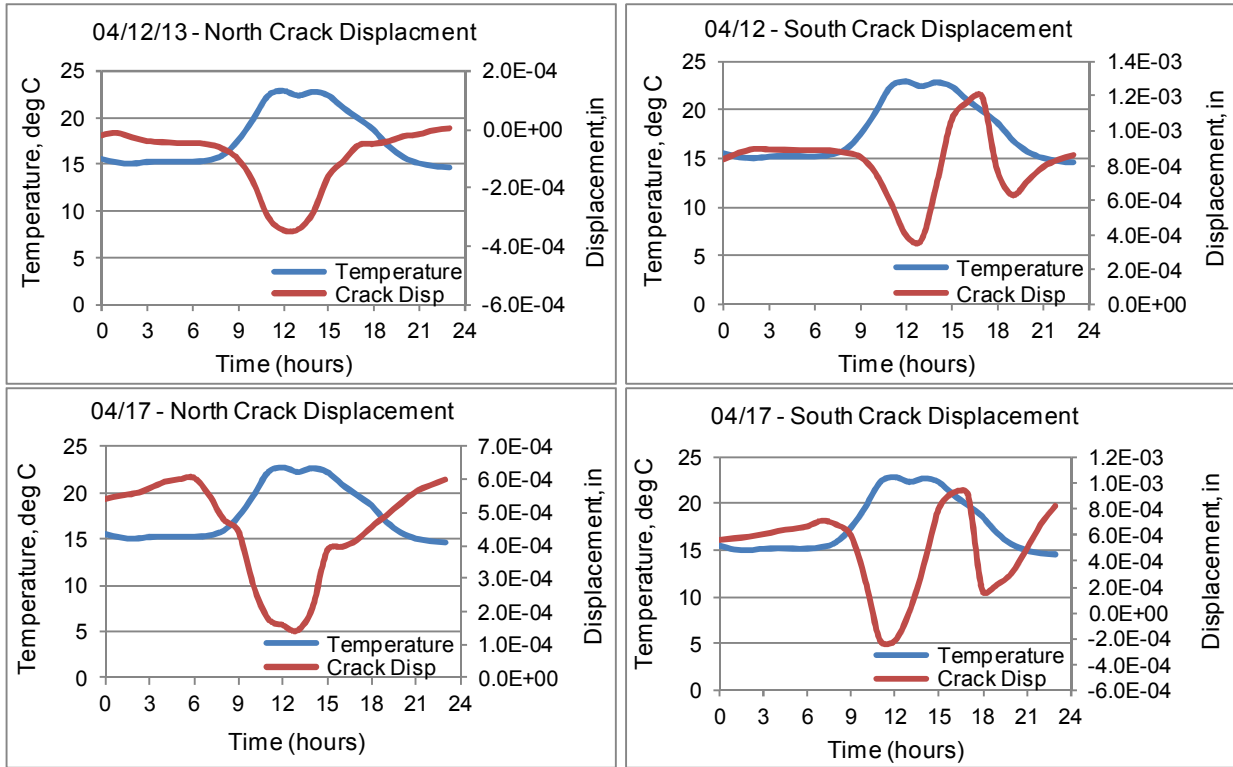
On a daily basis, both cracks display remarkably consistent, albeit distinct, behaviors, as shown in Figure 4.15 on the next page. The north crack follows an inverse relationship with temperature. As the temperature increases, the crack tends to close. This is likely due to the concrete cover expanding. The south crack, on the other hand, has a bimodal shape that bottoms out around noon each day, before opening back up until around 4-6 pm. At sunset, the crack starts to close again. The daily displacement for the north crack is around 0.0004 inches, whereas the south crack is more active with a larger daily displacement of 0.001 inches.

Figure 4.15: North and south crack daily displacement for 4/12 and 4/17

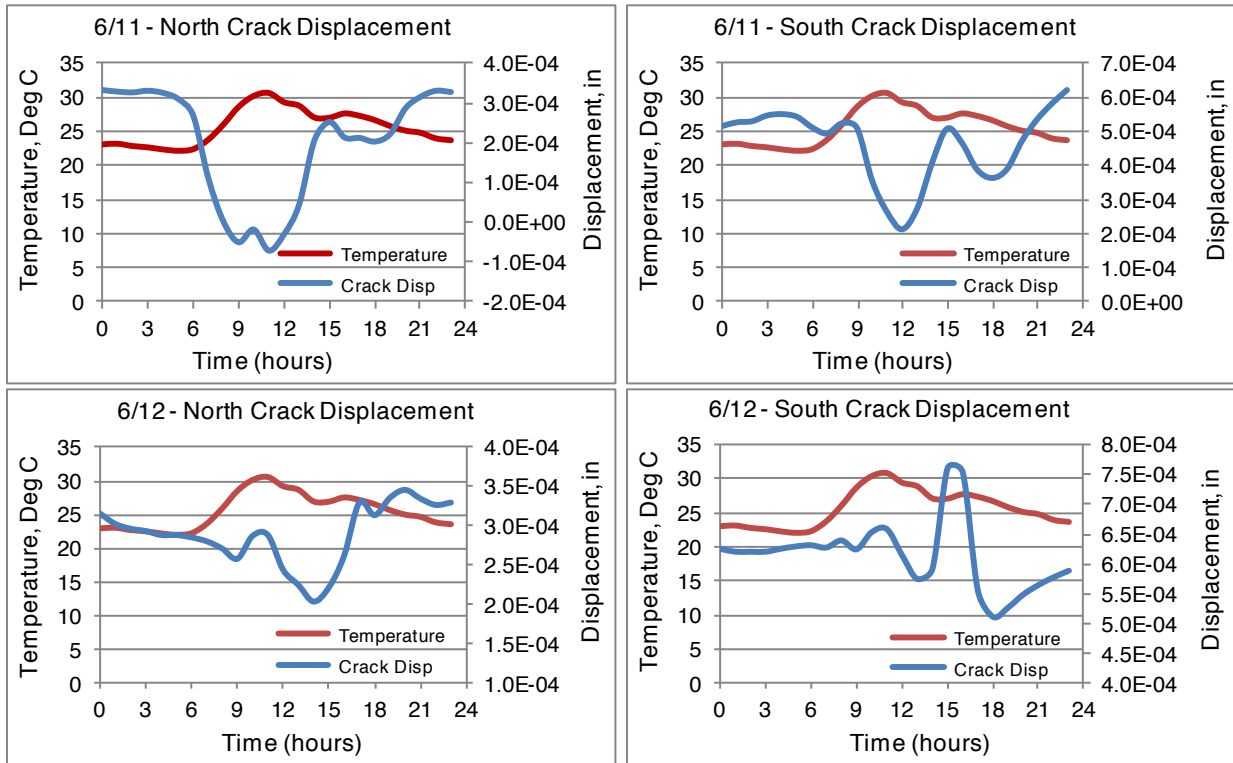
Figure 4.17: Selected daily crack displacement for high and low solar radiation days

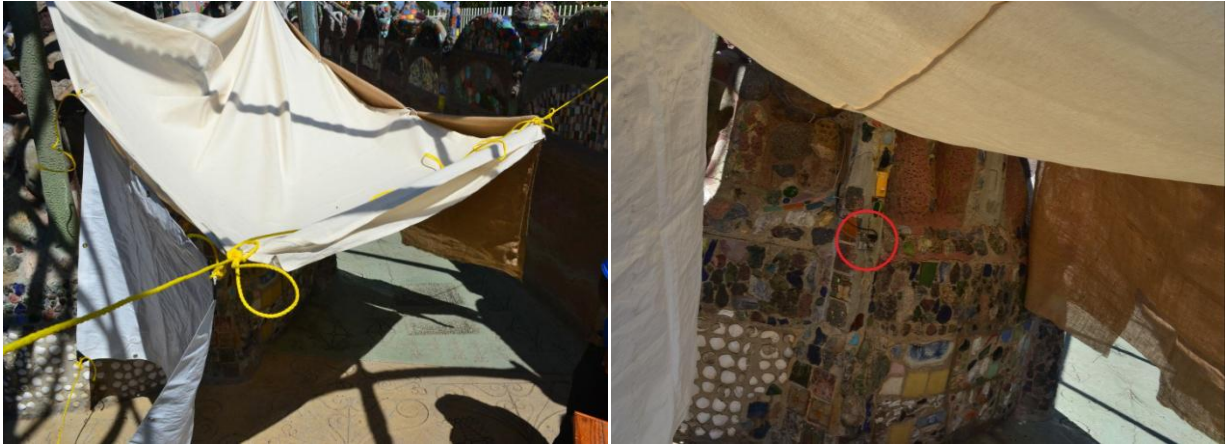
affect its behavior. In order to better test the effects of direct sunlight, a shade experiment was devised that involved covering the south-side crack with an 8'×12' double-layered canvas tarp as shown in the photographs below. The location of the crack sensor is circled in the right picture.

Figure 4.18: Shade experiment setup

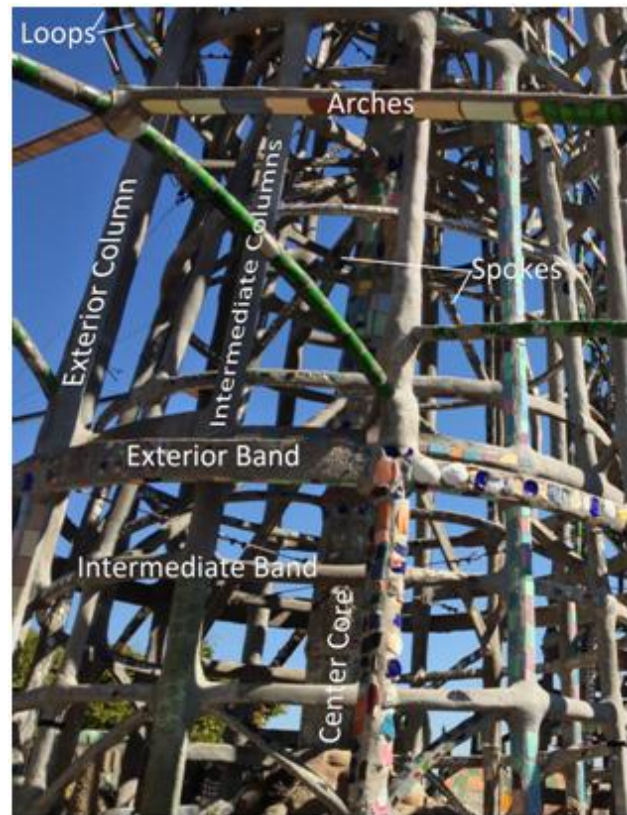
- **Center Core:** large column at the center of the tower that runs vertically over the entire height
- **Columns:** vertical members surrounding the center core that are typically arranged in three layers (interior, intermediate and exterior).
- **Bands:** horizontal members surrounding the columns that help to provide bracing to the columns
- **Sub-Band:** a band that only goes around part of the tower's circumference.
- **Spokes:** any member that connects a column (typically the center core) to a band or column. These act along with the braces to provide additional stability.
- **Braces:** any member connecting two intermediate or exterior columns
- **Loops:** any member, typically connected to an exterior column or band, that arches away from the structure.

Figure 7.2: Tower member labels

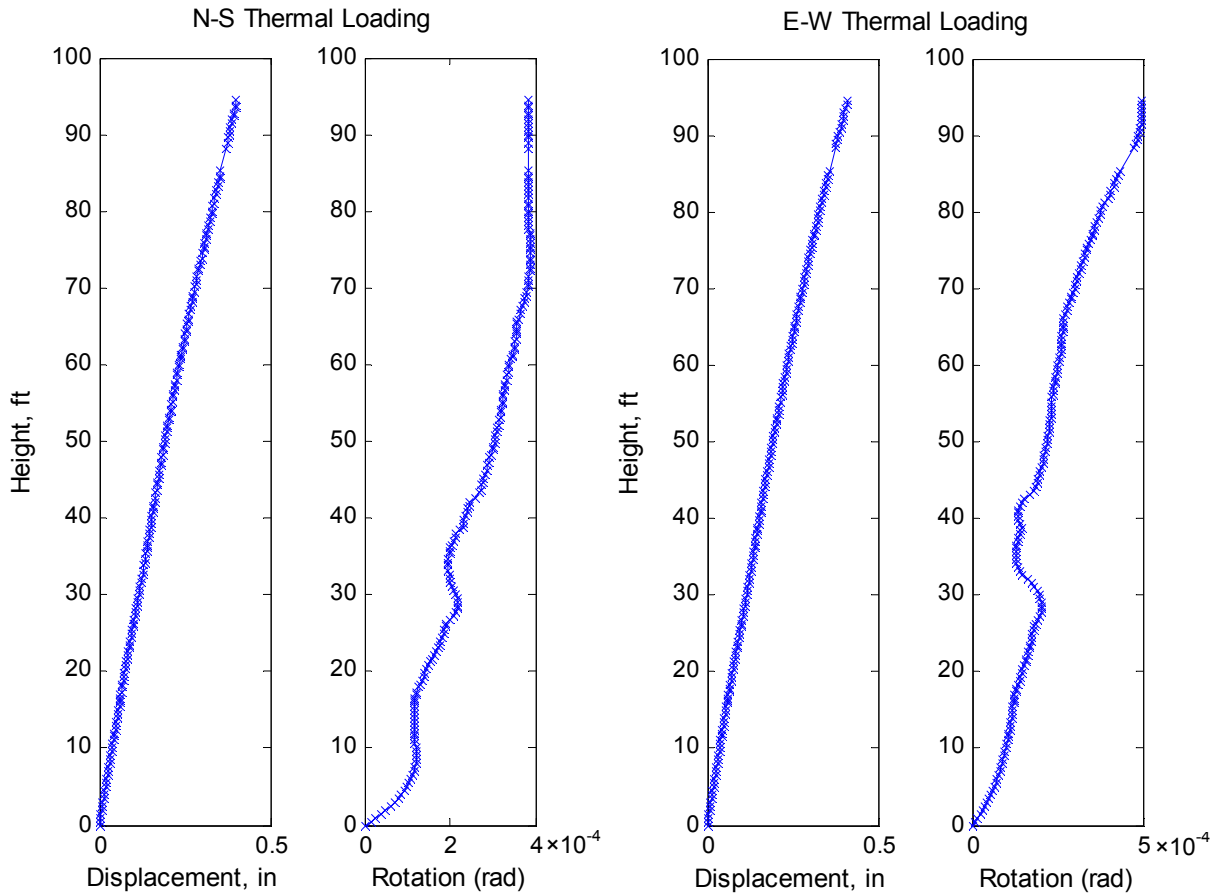
Modeling the daily tilting behaviors may shed some light on the creation and propagation of cracks. An initial steady-state thermo-elastic simulation was completed by specifying the temperature at one side of the tower and decreasing it linearly across the width of the tower. A thermal expansion coefficient of $1 \times 10^{-5}/^{\circ}\text{C}$ was assumed for the composite material. Typical values for the thermal expansion coefficient for lightweight concrete range from $6.5 \times 10^{-6}/^{\circ}\text{C}$ to $1.1 \times 10^{-5}/^{\circ}\text{C}$, while reinforcing steel has a coefficient of $1.8 \times 10^{-5}/^{\circ}\text{C}$ (MacGregor and Wight, 2012). For the initial simulation, the gradient was set with a temperature of 30°C applied to one side of the tower and a temperature of 25°C applied to the opposite side. The reference temperature—i.e., temperature at which the elements are at zero stress—was set to 18°C . The hot side was first set as the north side of the tower, and then the east, with the following results for displacement and rotation. The displacement and rotation values were taken at the nodes along the center column.

Figure 7.8: Steady state thermal displacement

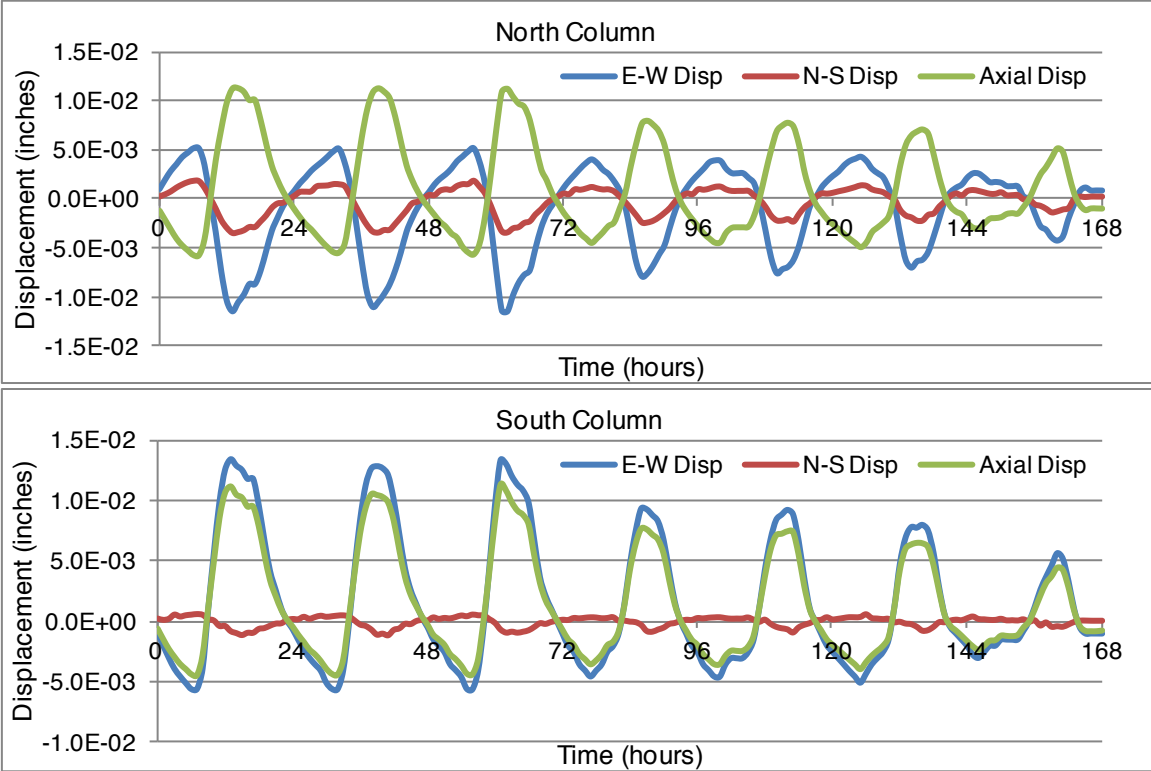
Figure 7.15: North and south column displacements
