Contamination artifact that mimics in-situ carcinoma on contrast-enhanced digital mammography.

Eur J Radiol. 2017 October ; 95: 147–154. doi:10.1016/j.ejrad.2017.08.002.

Purpose: Contrast-enhanced digital mammography (CEDM) is an advanced breast imaging technique using iodinated intravenous contrast to detect breast cancer. This article describes imaging features of skin contamination artifact on CEDM that mimic in situ carcinoma in a case series.

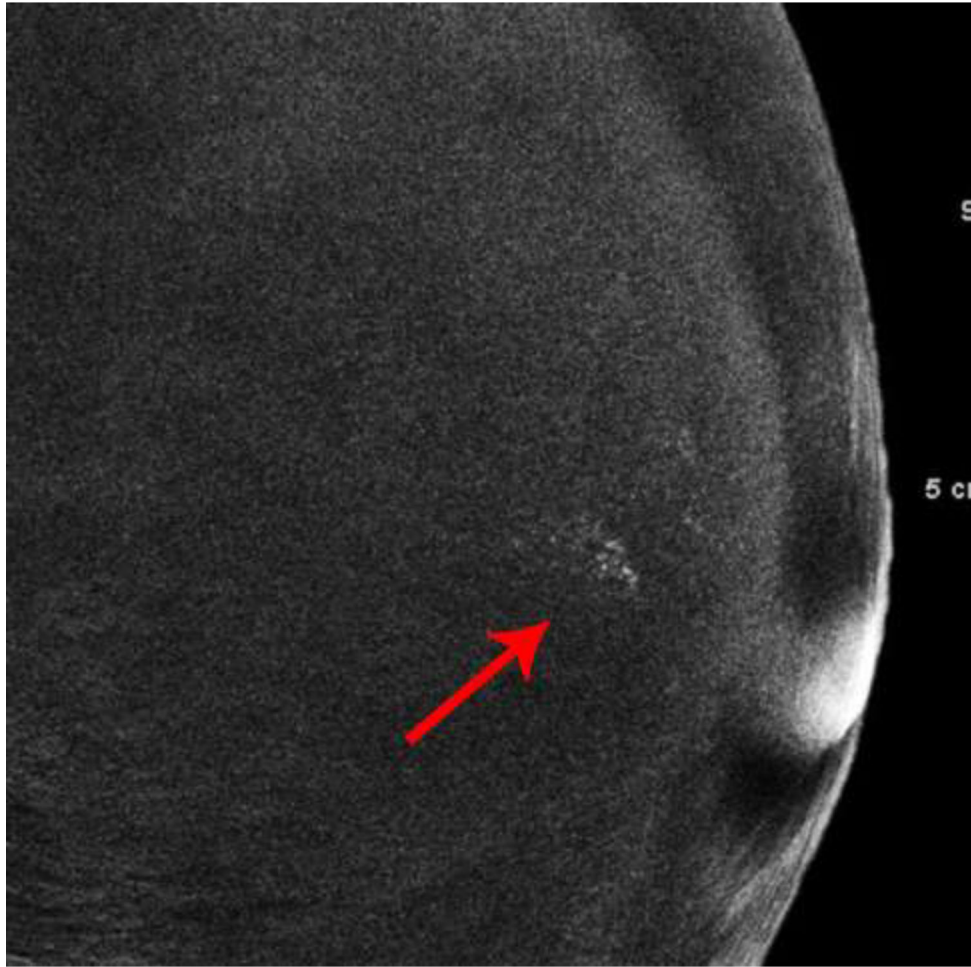
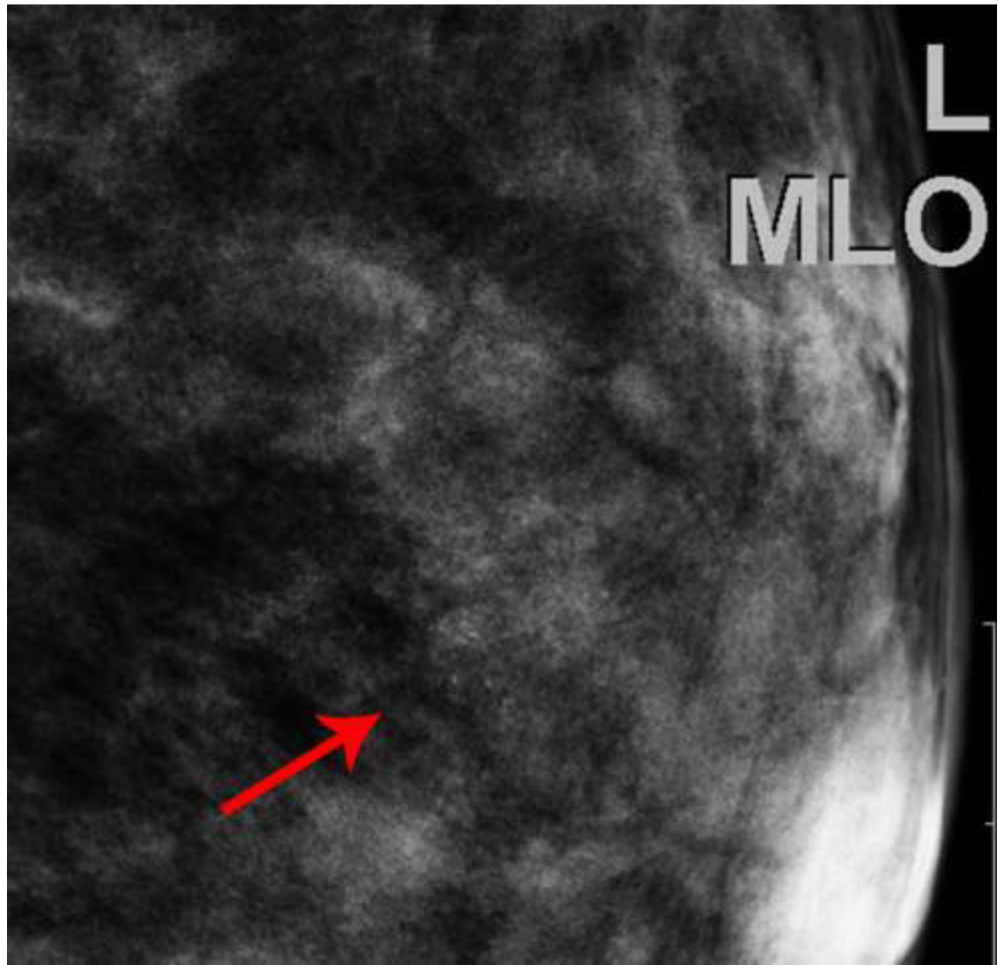
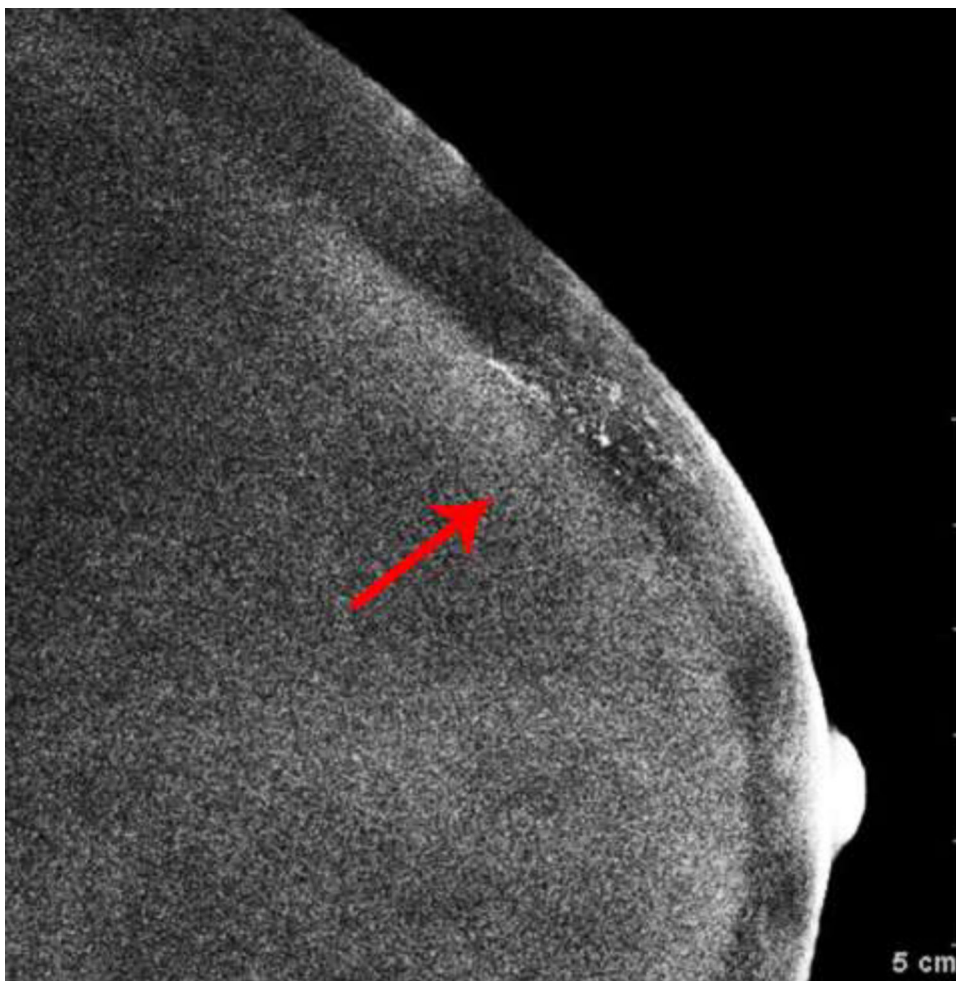
Fig. 1—. Left digital mammogram of Patient A, a 65-year-old female with remote history of right mastectomy for invasive ductal carcinoma and DCIS. Left mediolateral-oblique image (A) demonstrates densities which appear to be fine linear calcifications (arrows). Recombined left mediolateral-oblique (B) and cranial caudal (C) images demonstrate apparent linear non-mass enhancement in the same distribution as apparent calcifications. Spot magnification views did not demonstrate calcifications. No suspicious enhancement on same day MRI. Stereotactic biopsy was performed in area of suspicious non-mass enhancement on CEDM, resulting in benign pathology. No calcifications on specimen radiography or pathologic analysis.

The first patient presented with questioned calcifications and non-mass enhancement in the left breast [Fig 1]. Scheduled same-day breast MRI did not show a corresponding abnormality. Patient returned for spot magnification views which did not demonstrate calcifications. A stereotactic biopsy was performed due to the suspicious non-mass enhancement, with targeting using architectural landmarks, which resulted in benign pathology. No calcifications were identified on specimen radiography or pathologic analysis.

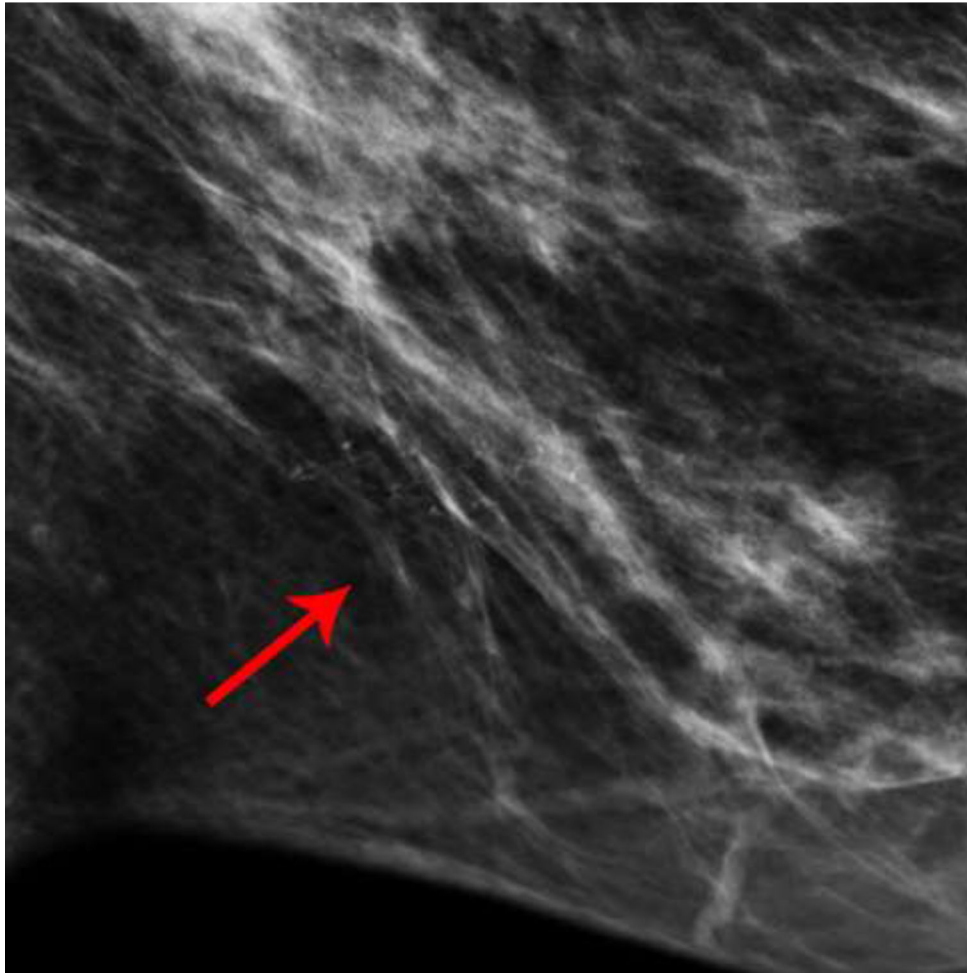
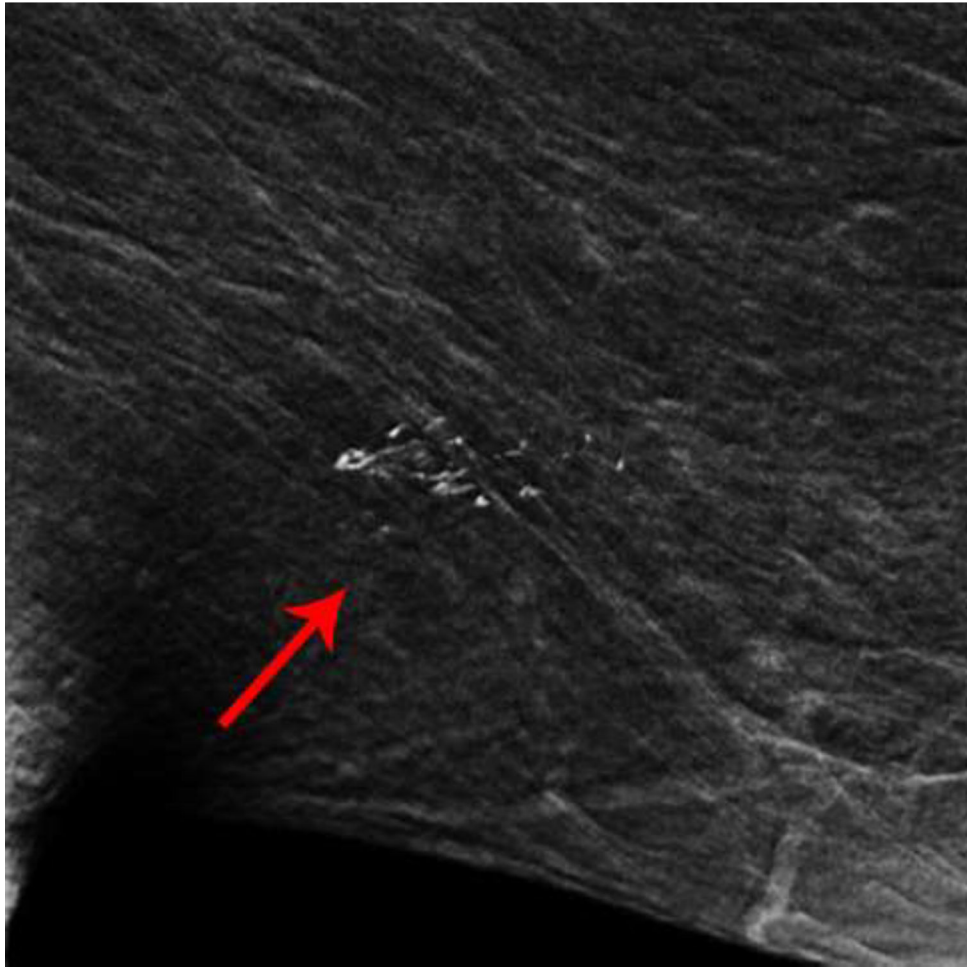
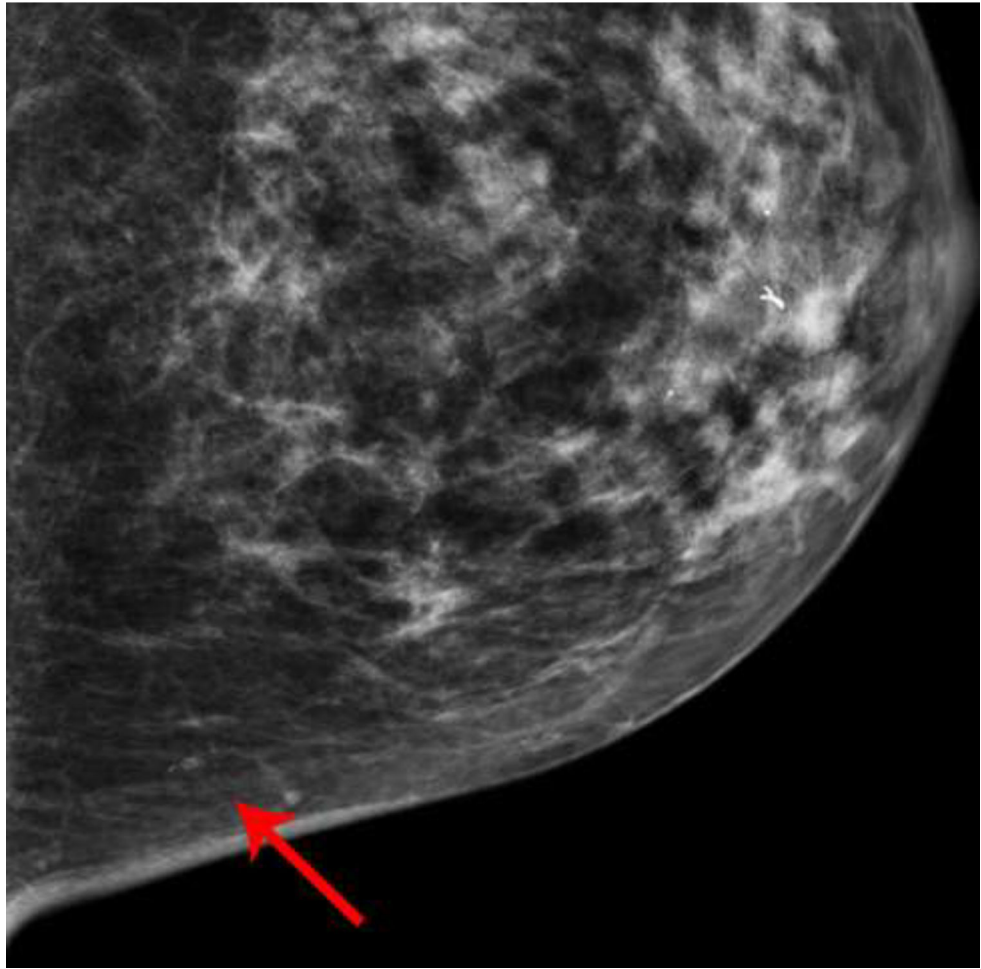
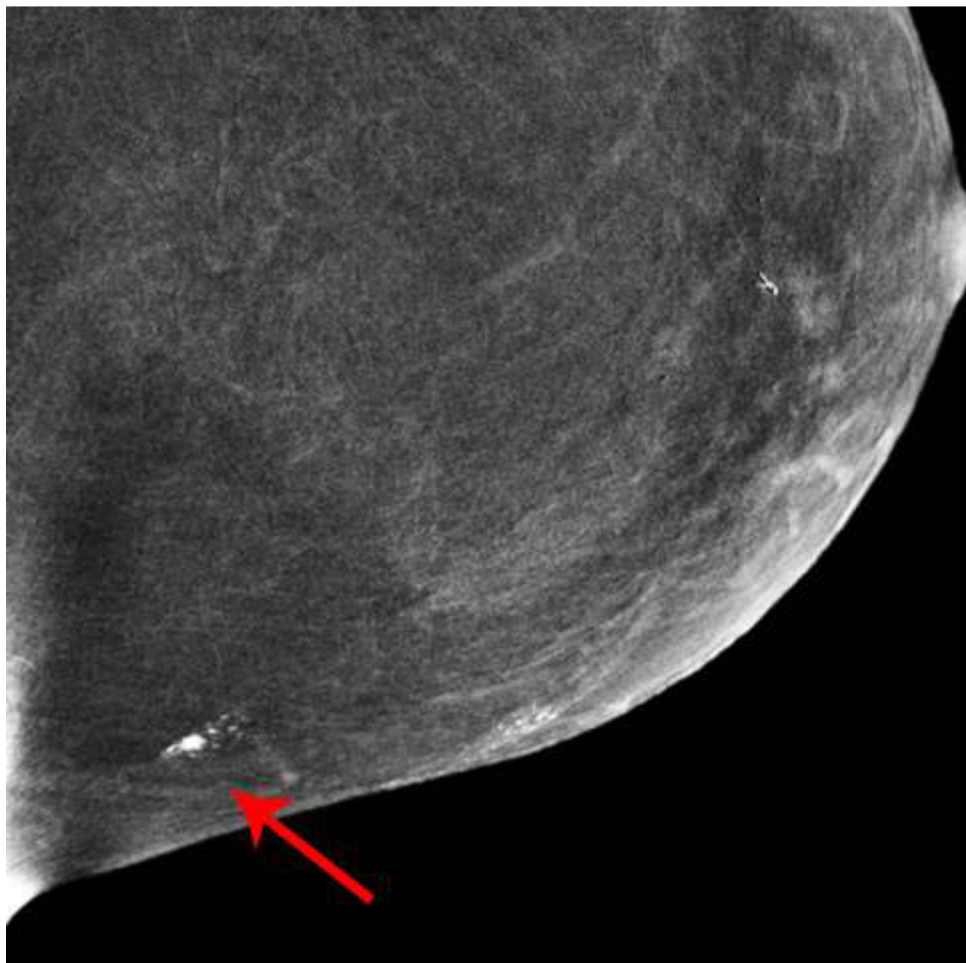
Fig. 2—
 Left digital mammogram of Patient B, a 59-year-old female with history of surgical excision of left breast Atypical Ductal Hyperplasia one year prior. Mediolateral-oblique (A) and craniocaudal (C) projections demonstrate apparent fine linear calcifications in the lower inner left breast. Recombined images in the MLO (B) and CC (D) projections demonstrate apparent linear non-mass enhancement in a similar distribution. These findings were not present on contralateral breast images. Spot magnification views performed after breast cleansing showed no calcifications (not shown). A follow-up breast MRI performed nine days later demonstrated no suspicious findings.

Subsequently, two patients had a similar appearing artifact [Figs 2 and 3]. In both, the apparent contrast artifact on initial imaging was not seen on subsequent imaging of the

contralateral breast, suggesting the abnormality was not on the mammography equipment nor caused by malfunction of the imaging system. For these two patients, the affected breast was cleansed prior to magnification views for questioned calcifications. No calcifications were seen on magnification views. Because of the preceding experience, both patients were referred for an MRI which did not demonstrate correlative non-mass enhancement. Based on our previous experience, we determined that this was an artifact and opted to follow the patients with imaging.

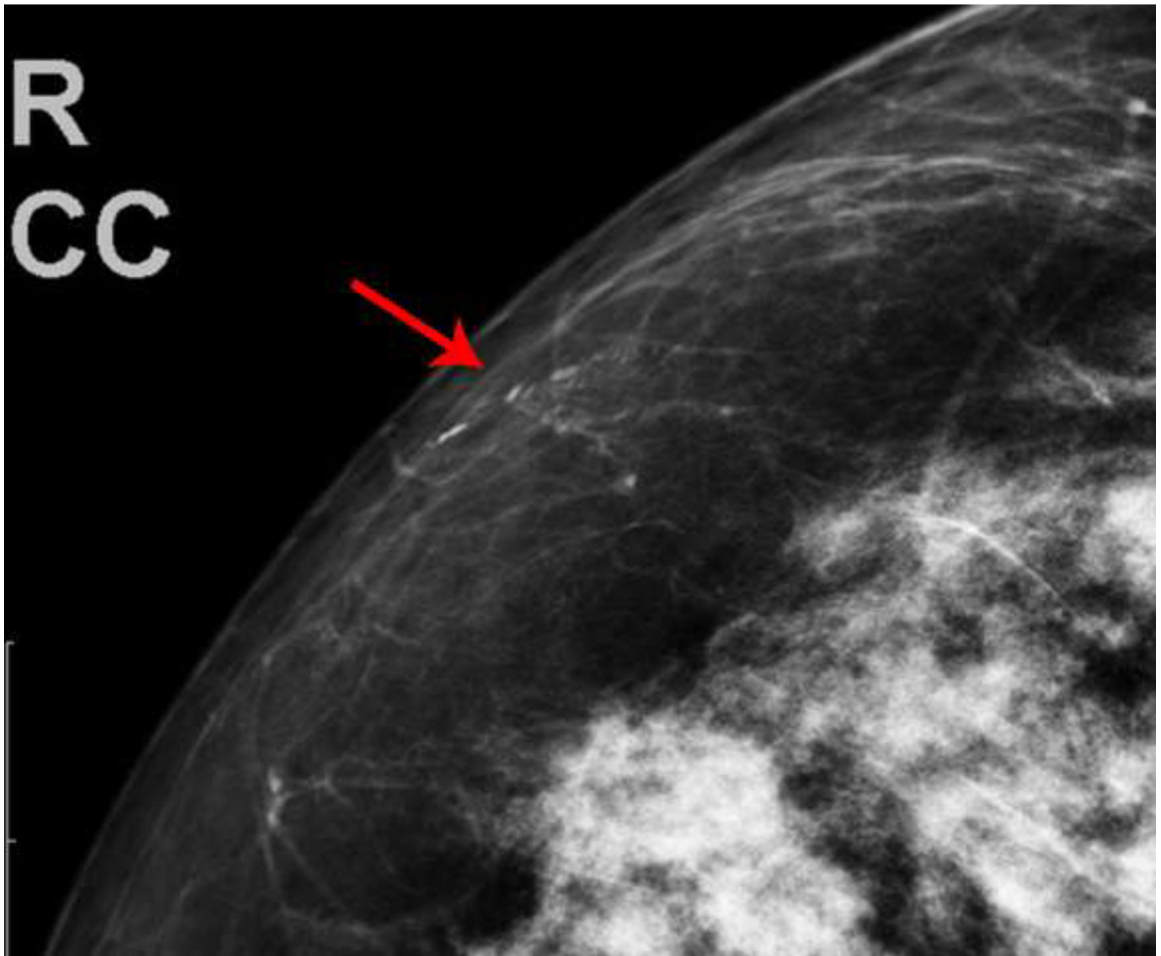
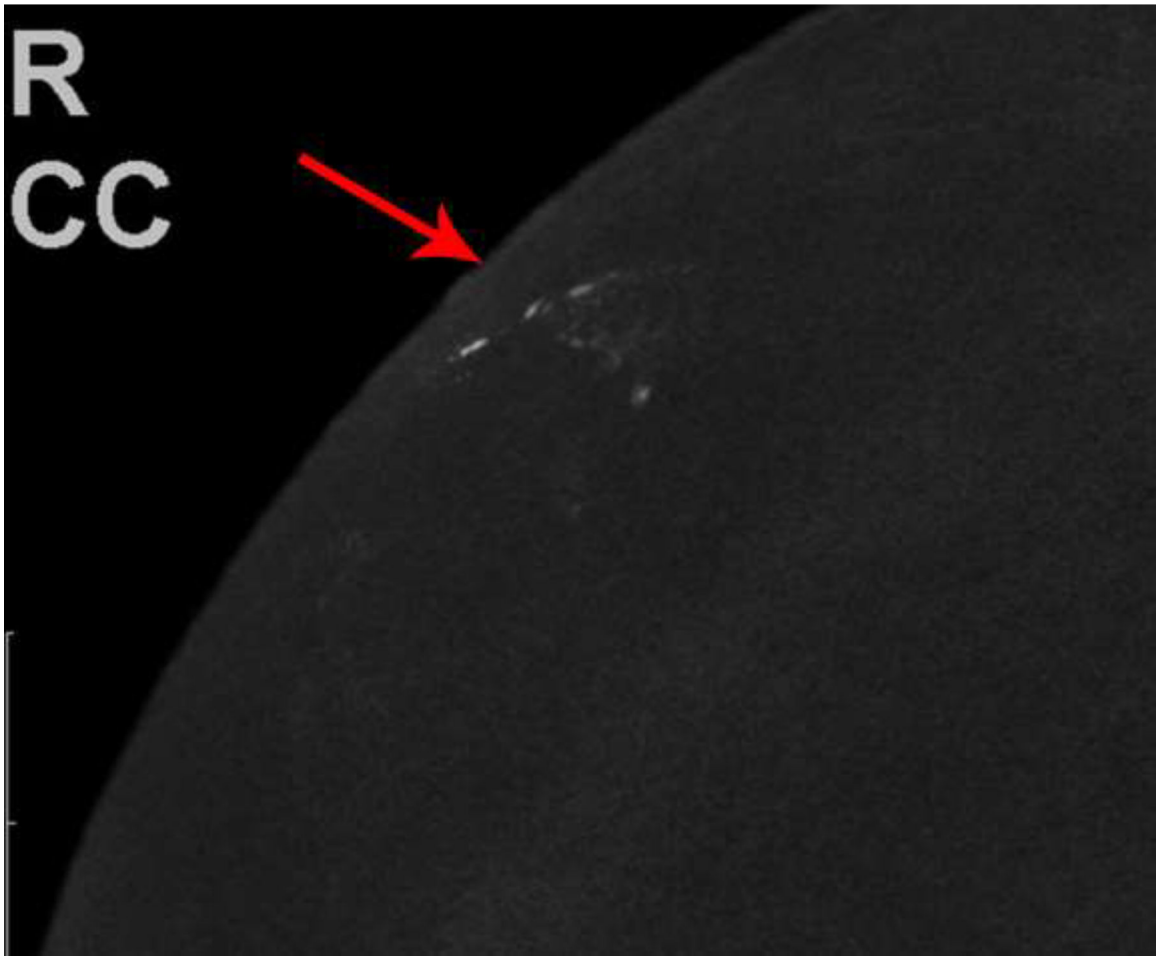
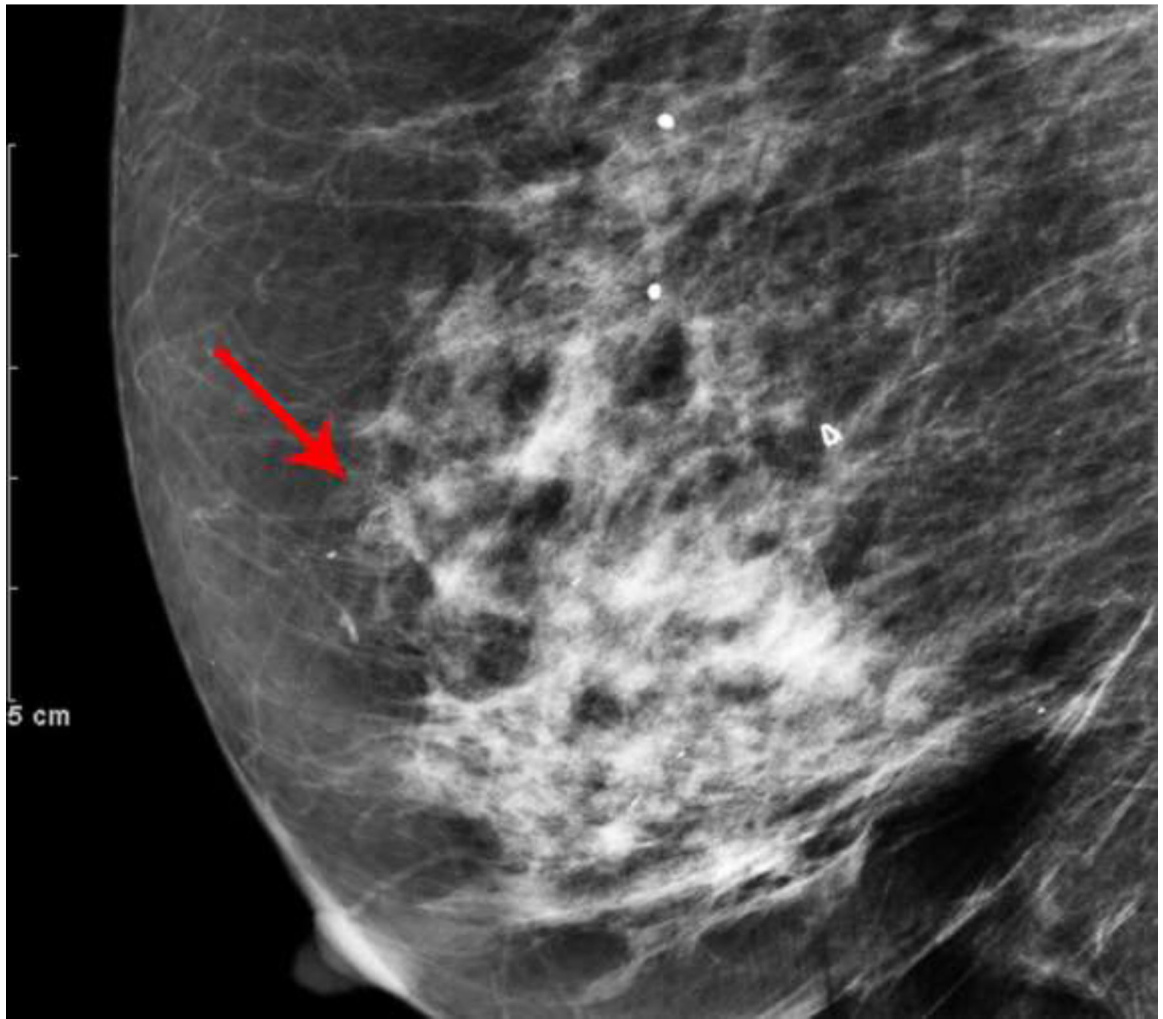
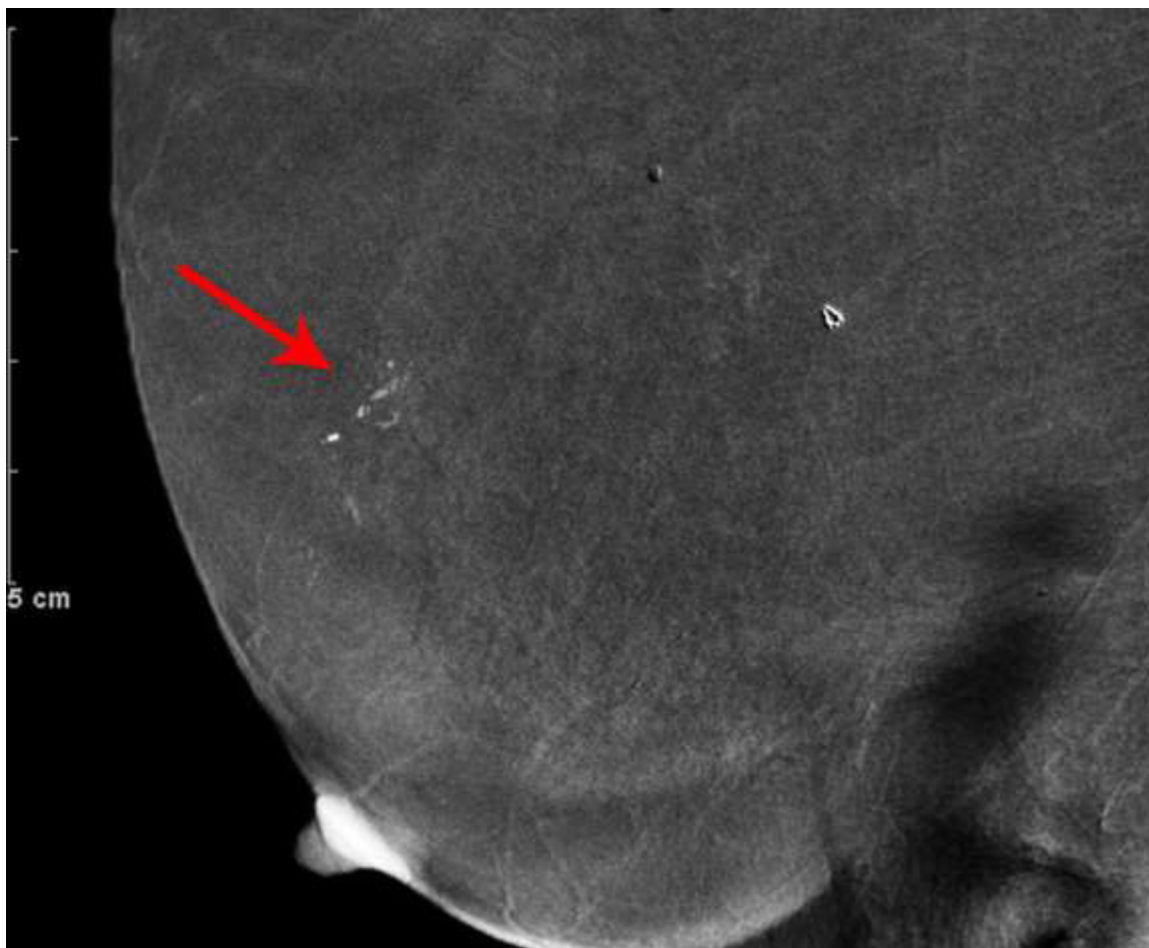
Fig. 3—
 Right digital mammogram of Patient C, a 74-year-old female with remote history of treatment for right breast DCIS. Right cranial caudal (A) and mediolateral-oblique (C) views demonstrate what appear to be grouped fine-linear branching calcifications in the upper outer breast. Recombined images in the right cranial caudal (B) and mediolateral-oblique (D) projections demonstrate apparent linear non-mass enhancement in a similar distribution. These findings were not present on contralateral breast images. Spot magnification views performed after breast cleansing showed no calcifications (not shown). Breast MRI performed 21 days later was negative.

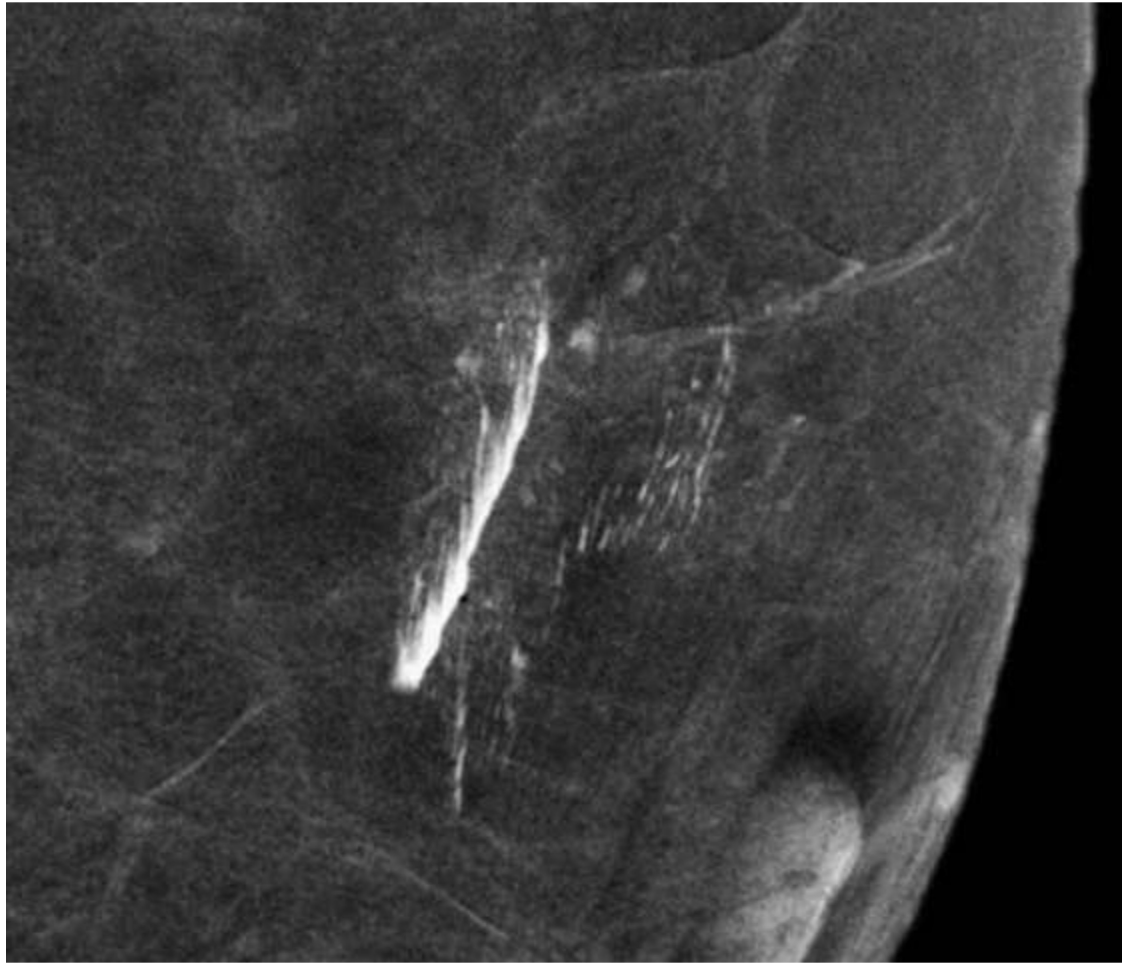
Fig. 4— Left mediolateral-oblique mammogram of Patient D, a 57-year-old female with abnormal screening mammogram, demonstrating a suspicious mass in the far posterior left breast, which was subsequently biopsied with pathology yielding fibroadenoma (not included in cropped image). Recombined image of the left breast in mediolateral-oblique projection demonstrates contrast which appears to be within the skin folds just posterior to the nipple.

Two additional patients had CEDM performed for diagnostic evaluation following abnormal screening mammograms. The apparent non-mass enhancement was superficially located in both patients, and in one patient appeared to be located within skin folds behind the nipple (Fig 4), suggestive of artifact. Both patients had directed ultrasound to the area of non-mass enhancement, yielding no correlative findings, and one patient (Patient E) had followup MRI, which showed no correlative enhancement.

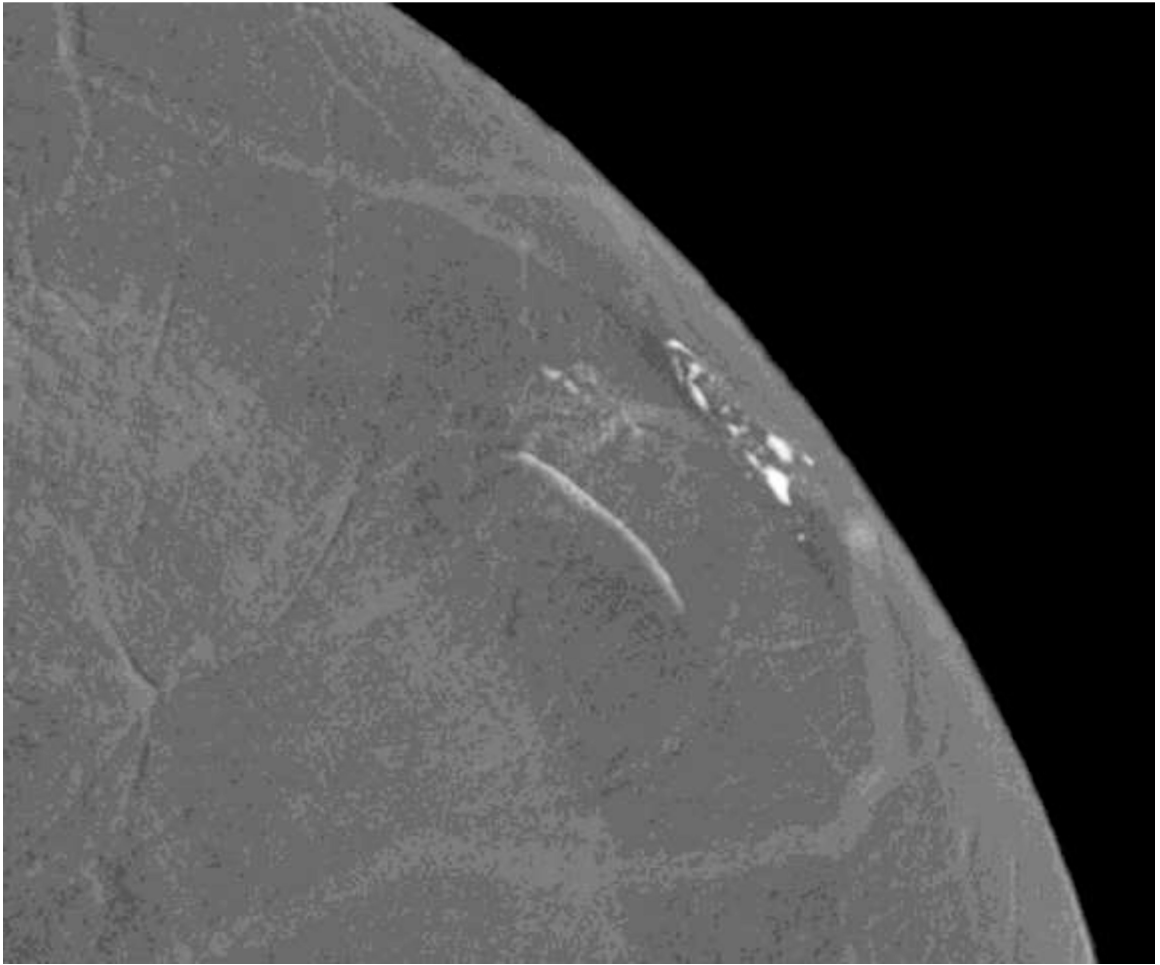
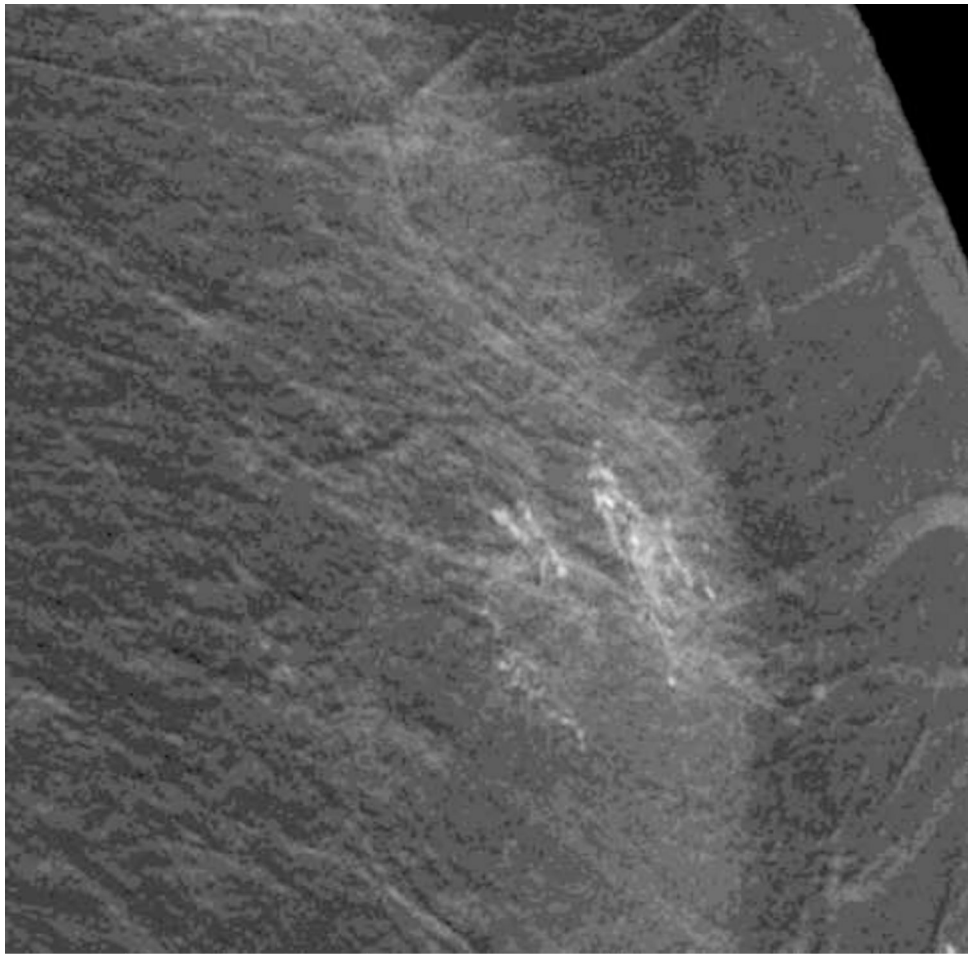
Fig. 5—
Left mammogram of Patient E, a 59-year-old female with right breast abnormality on screening mammogram, which was subsequently biopsied yielding Invasive Ductal Carcinoma and DCIS. Recombined images of the left breast CEDM demonstrate apparent linear non-mass enhancement in a superficial location in the outer (A) upper (B) quadrant.

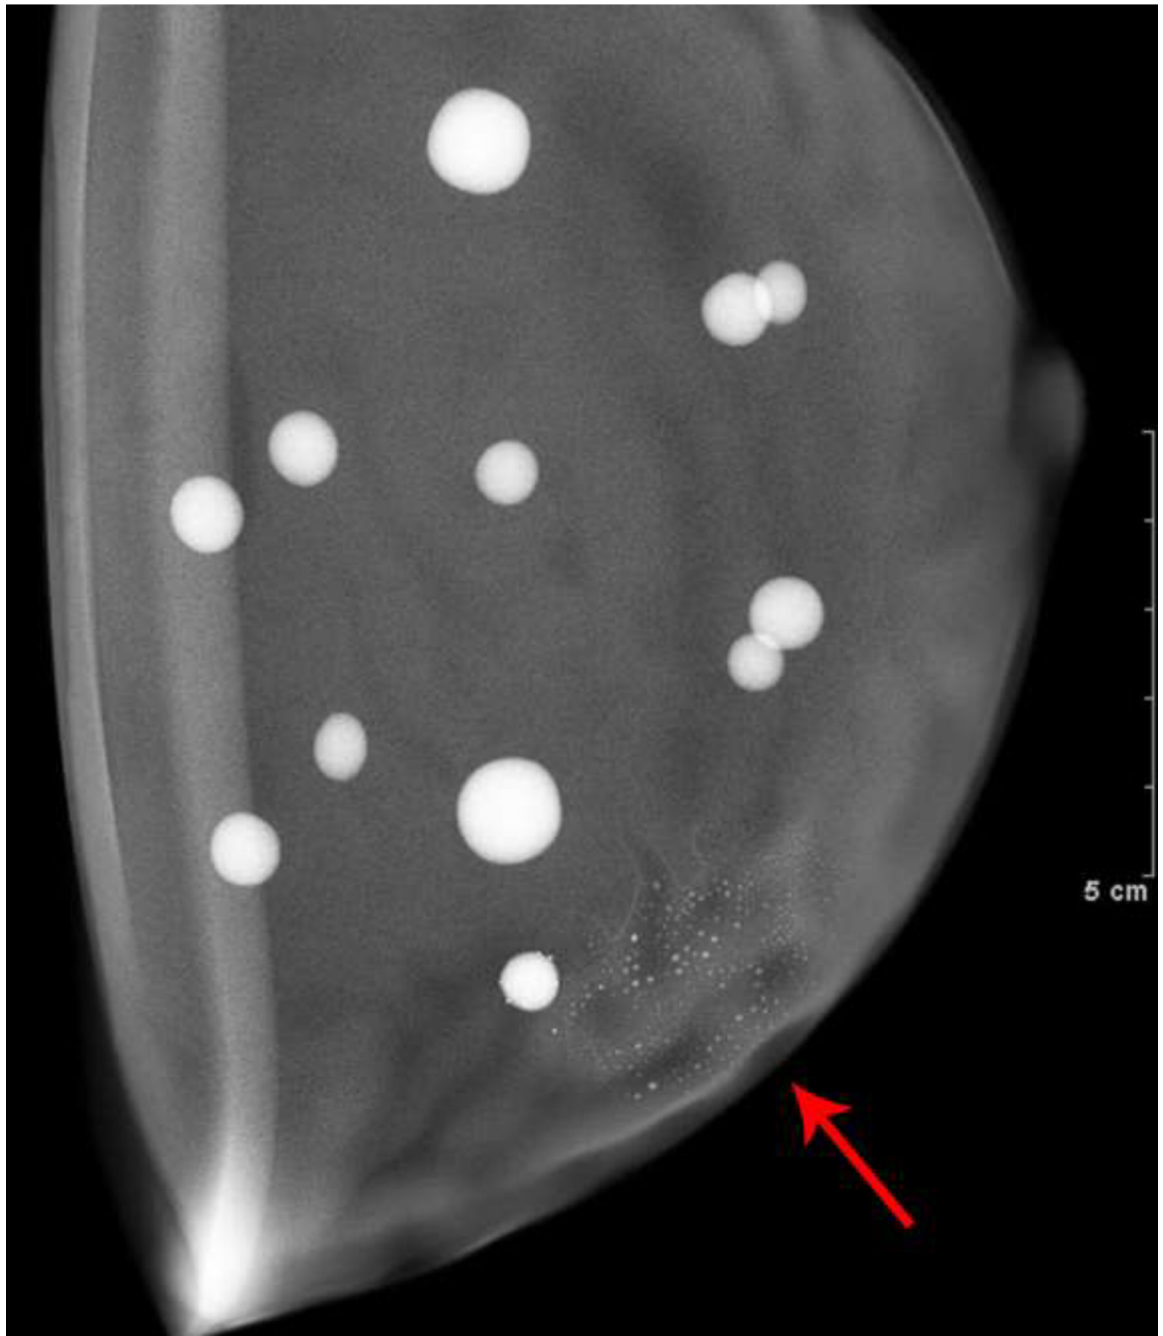
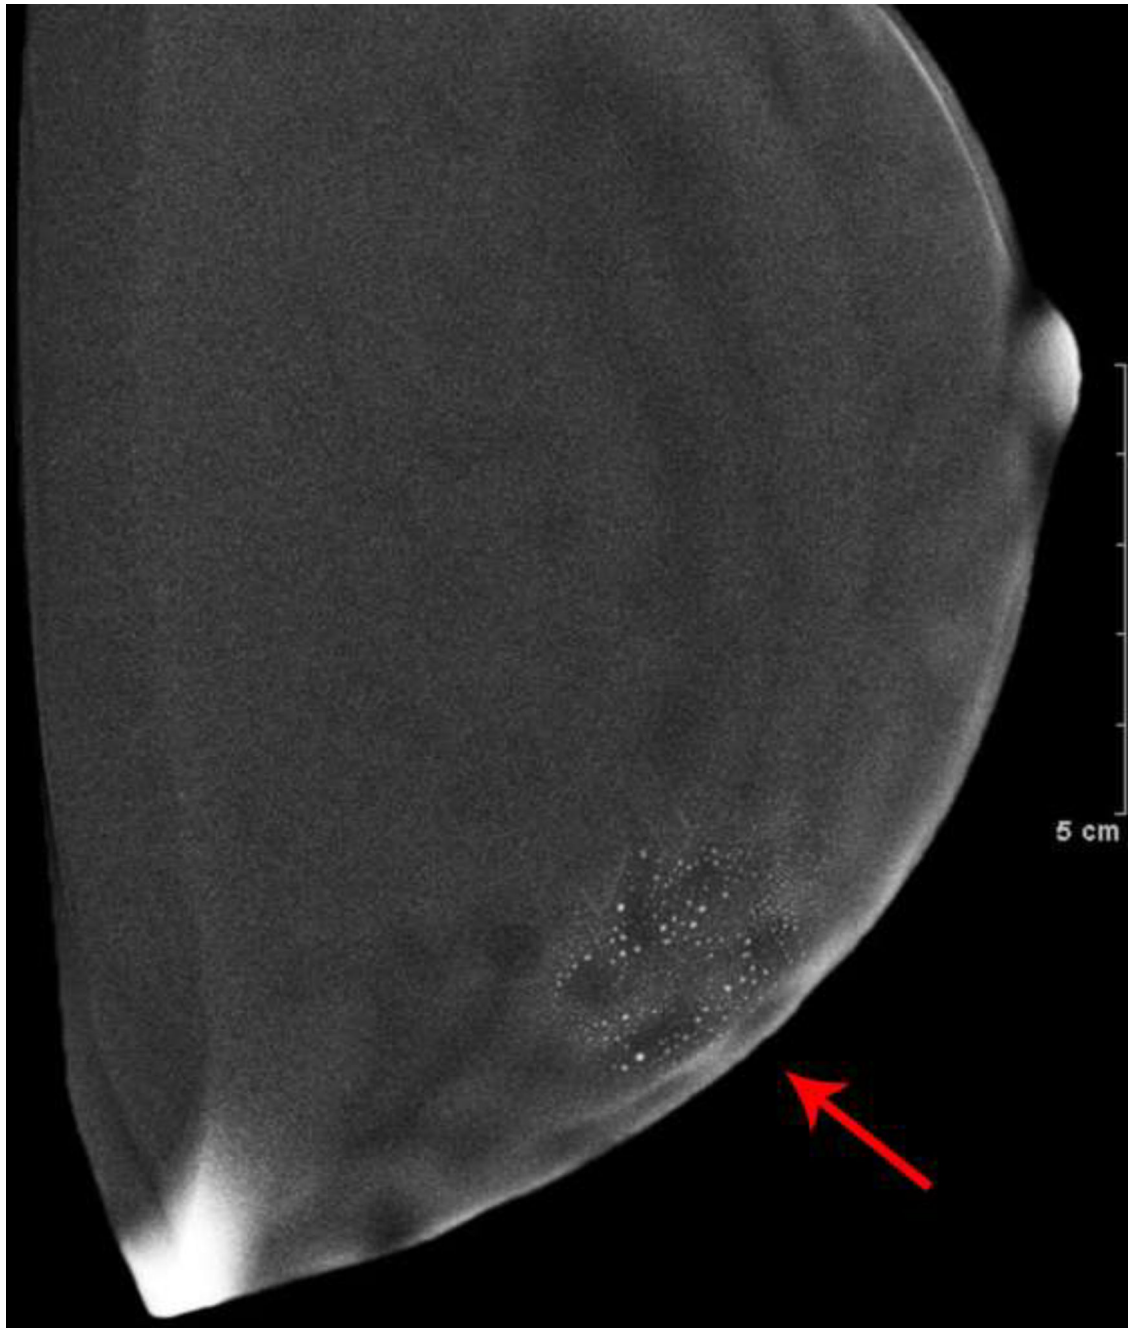
Fig. 6—
Phantom Images: Dual-energy images of a breast phantom after application of trace Omnipaque 350 contrast to the surface of the phantom. The low energy (A) and recombined (B) images demonstrate contamination artifact with iodinated contrast. This confirms that surface contamination with iodinated contrast is visible on LE images.

Two phantoms were used to test the hypothesis of skin contamination. Mammographic images utilizing the dual-energy technique were acquired with a StereoTactic Needle Biopsy Phantom, Model 013 (CIRS Inc, Norfolk, Virginia). The compressed phantom is 4.1 cm thick and composed of a gelatinous material designed to approximate the radiological properties of breast tissue. A small quantity of Omnipaque 350 was spread thinly across the surface of the phantom, which was then imaged with a LE exposure of 28 kVp using the molybdenum target and rhodium filter, and a HE exposure of 45 kVp using the molybdenum target and copper filter.

Small quantities of iodinated contrast spread thinly on the 2 phantoms (breast phantom and forearm) reproduced the appearance of calcifications and non-mass enhancement seen on the patient mammograms (Figs. 6, 7). The commonality of pattern appearance on the phantom mammograms with the artifact on the breast mammograms confirmed the origin of this artifact.
