Contamination artifact that mimics in-situ carcinoma on contrast-enhanced digital mammography.

Eur J Radiol. 2017 October ; 95: 147–154. doi:10.1016/j.ejrad.2017.08.002.

Purpose: Contrast-enhanced digital mammography (CEDM) is an advanced breast imaging technique using iodinated intravenous contrast to detect breast cancer. This article describes imaging features of skin contamination artifact on CEDM that mimic in situ carcinoma in a case series.

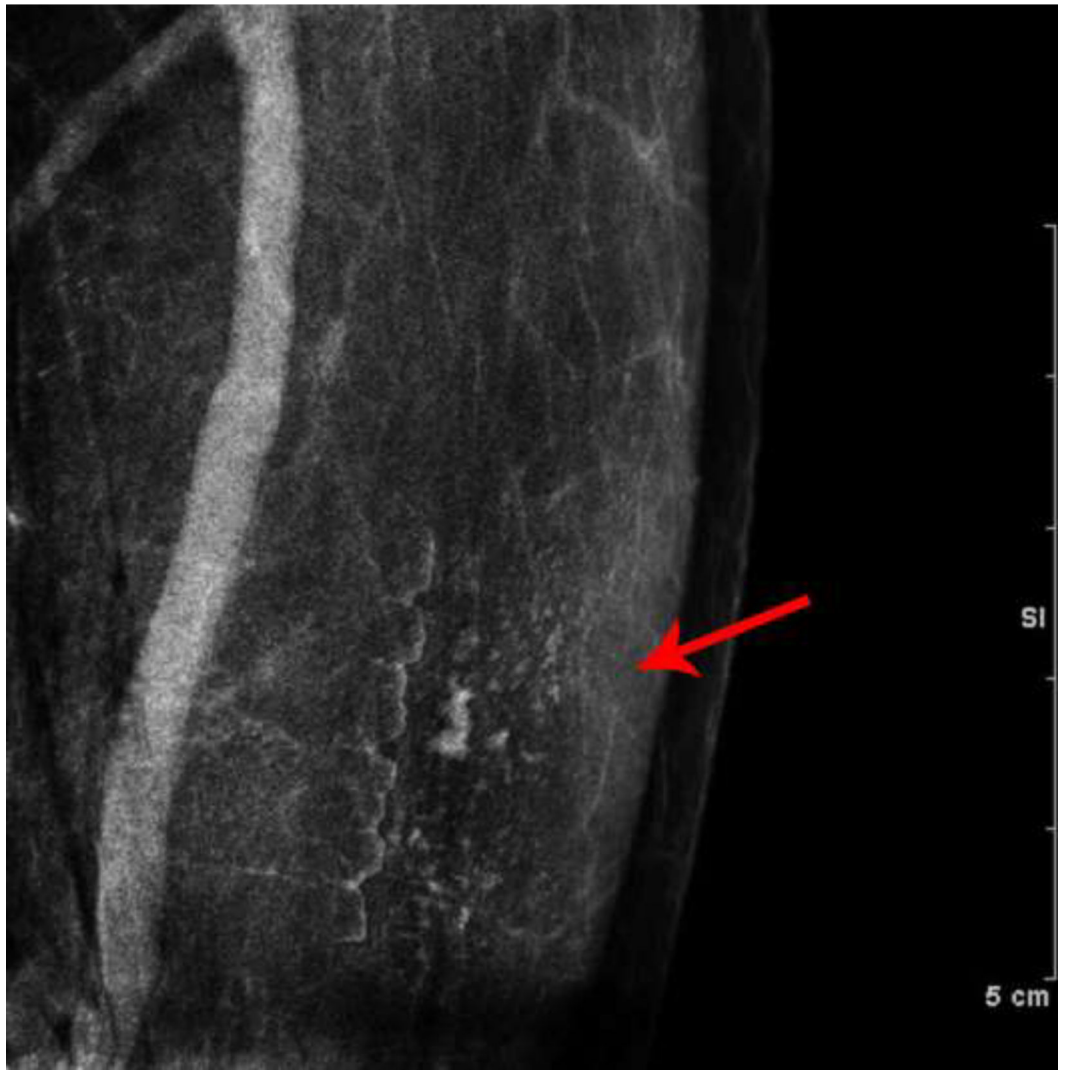
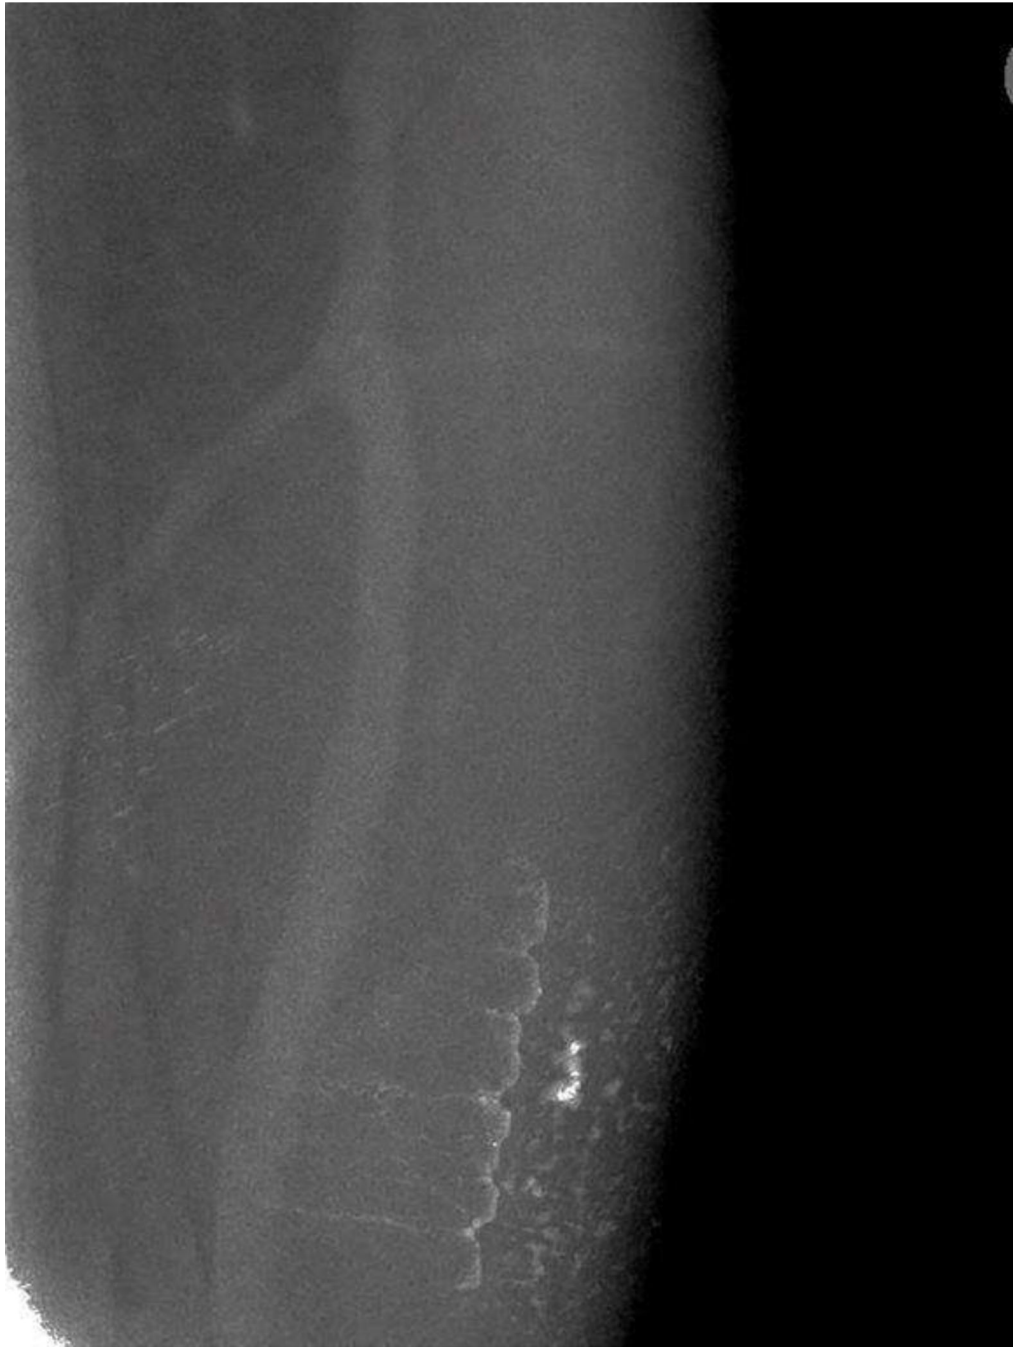
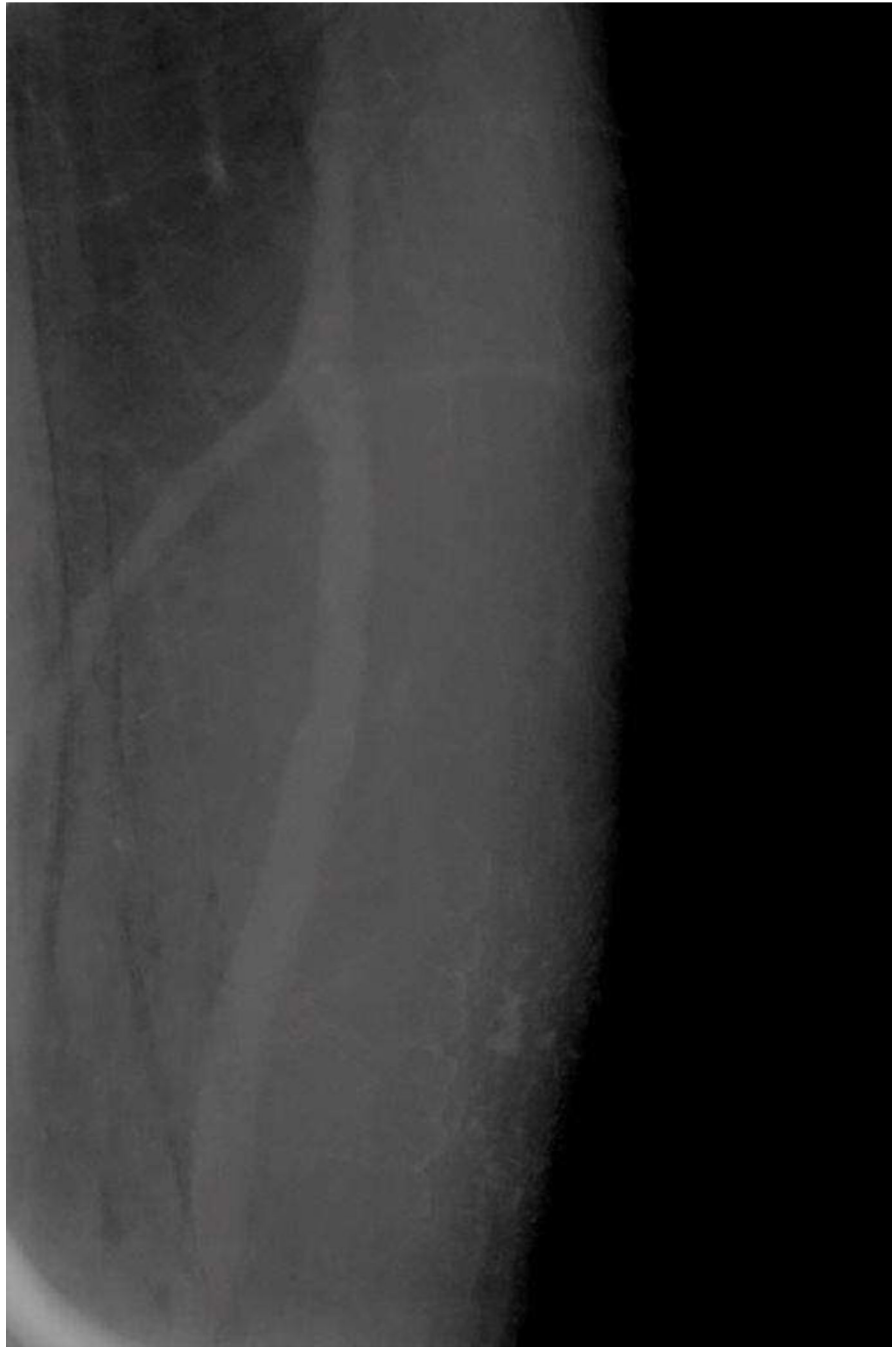
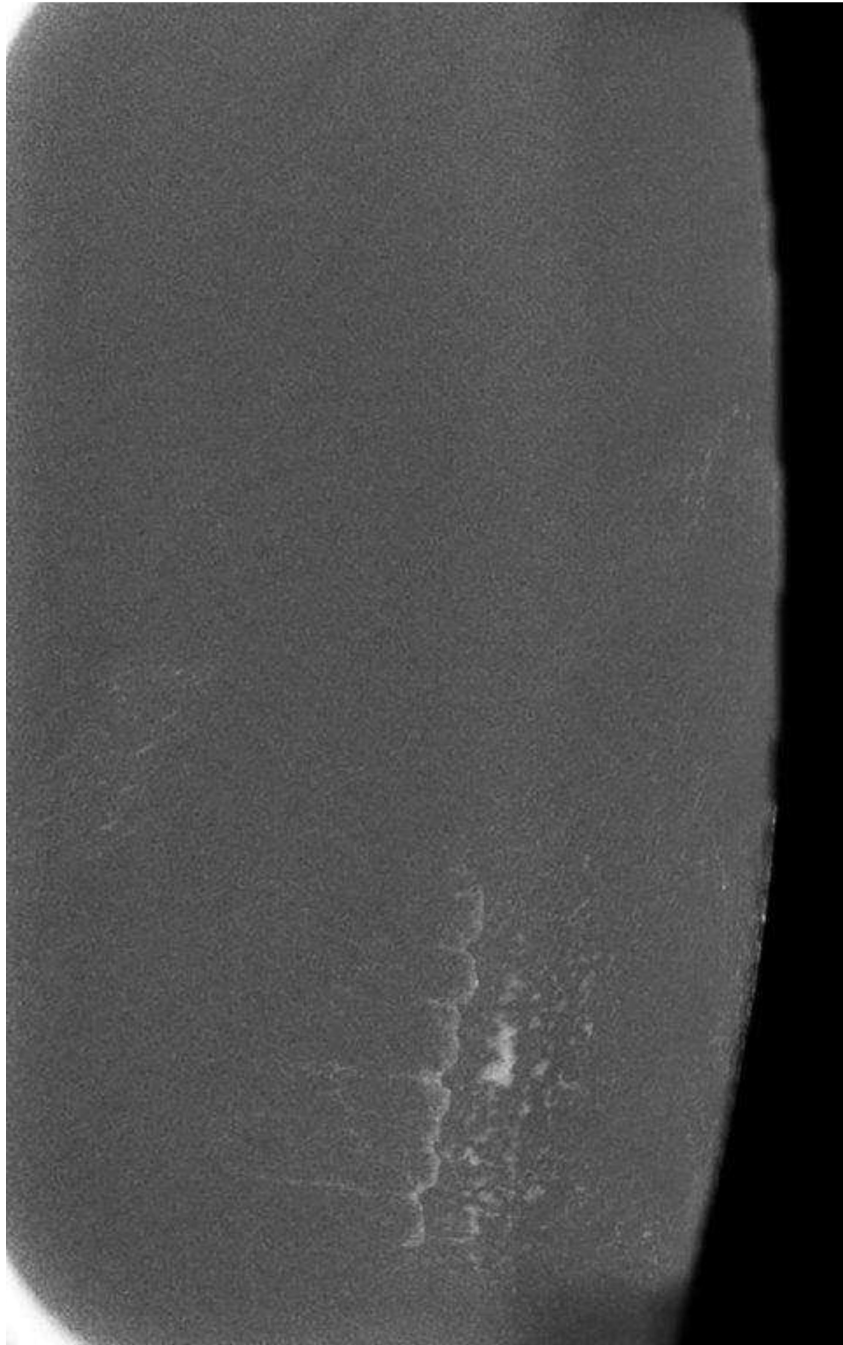
Fig. 7—.
Skin Texture Model Images: Images of the superficial soft tissues of a volunteer's left forearm were obtained with dual-energy mammographic technique, after a small amount of Omnipaque 350 contrast was spread thinly onto the skin. A) Low energy processed image, B) High energy unprocessed image, C) Low energy unprocessed image, and D) Recombined image. All images show the appearance of skin contamination with iodinated intravenous

contrast material. This confirms that skin contamination with iodinated contrast is visible on LE images.

A medical physicist voluntarily imaged the superficial soft tissues of his left forearm with a dual energy technique after spreading a small amount of Omnipaque 350 on his skin, which more closely mimicked breast tissue with porous skin, subcutaneous fat, and blood vessels. The left forearm soft tissues were 4.4 cm thick when compressed. This in vivo specimen was imaged with a LE exposure of 28 kVp using the molybdenum target and rhodium filter, and a HE exposure of 45 kVp using the molybdenum target and copper filter.

Small quantities of iodinated contrast spread thinly on the 2 phantoms (breast phantom and forearm) reproduced the appearance of calcifications and non-mass enhancement seen on the patient mammograms (Figs. 6, 7). The commonality of pattern appearance on the phantom mammograms with the artifact on the breast mammograms confirmed the origin of this artifact.
