Forced Vibration Testing of a Four Story RC Building Utilizing the nees@UCLA Mobile Field Laboratory

FORCED VIBRATION TESTING OF A FOUR STORY RC BUILDING UTILIZING THE NEES@UCLA MOBILE FIELD LABORATORY

Eunjong Yu¹, Derek Skolnik², Daniel H. Whang³ and John W. Wallace⁴

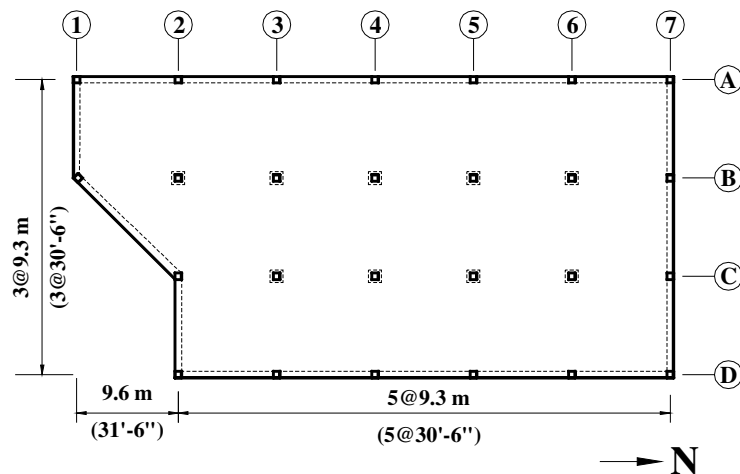
Figure 1. Typical plan of test building

The four story reinforced concrete office building, referred to as the Four Seasons Building is located in Sherman Oaks, California. The building was constructed in 1977 and the structural system consists of a perimeter moment resisting frame and an interior post-tensioned slab-column gravity frame with drop panels. Figure 1 shows a plan view of the building.

Typical interior gravity frames consist of a 216 mm deep post-tensioned flat slab constructed of 21 MPa lightweight concrete and 610 mm square column with 1219 mm square 190 mm deep drop panel of 28 MPa normal weight concrete. Seven wire post-tensioning strands

having a minimum ultimate tensile strength of 1,862 MPa were used for the unbonded post-tensioned slab. Lateral seismic resistance is provided by a Special Moment Frame (SMF) located around the perimeter of the building constructed of 28 MPa normal weight concrete. The perimeter SMF beams are 610 mm wide by 760 mm deep, except for beams on the 2nd floor level which are 610 mm wide by 1097 mm deep. Typical perimeter columns have 610 mm square section reinforced with 8 #9 to 12 #10 bars and #4 hoops at 102 to 152 mm on center. Reinforcement with specified yield strength of 413.7 MPa is used for longitudinal and transverse reinforcement in all structural members. Additional details and detailed drawings of the structural system, connection details and material properties are provided in Yu [2005].

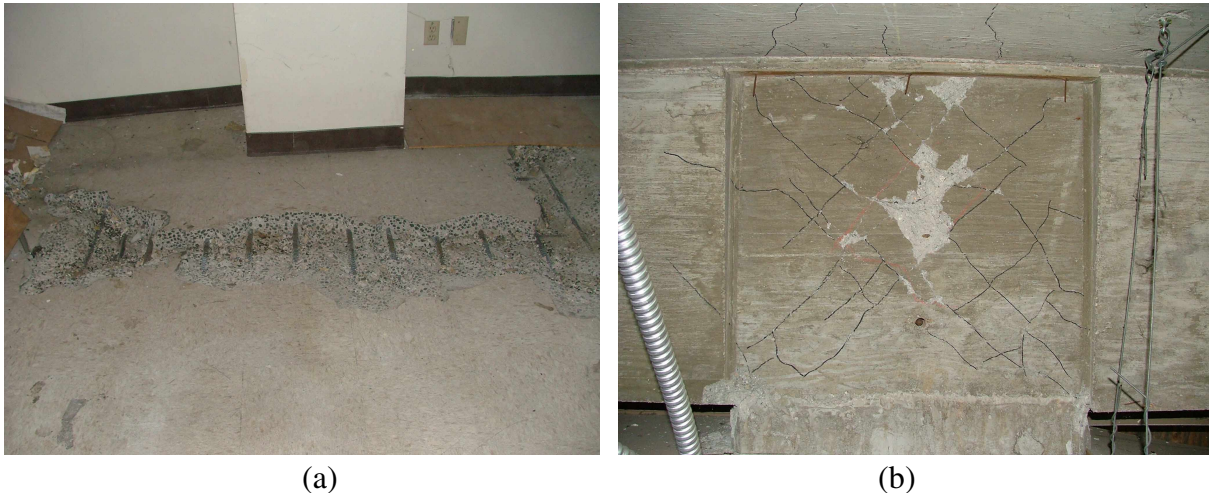
Figure 2. Earthquake damages of the building, (a) Punching shear failure (Column B6 at the 3rd floor level), and (b) Shear crack on beam-column joint (Column A4 at the 3rd floor level)

Detailed visual inspection of the building damage was performed prior to the forced-vibration testing to document the existing structural condition. Damage was particularly severe at slab-column connections due to slab punching shear failure around the perimeter of the drop panels. The most dramatic failures were observed at the south end of the 2nd floor level (column B2) and the north end of the 3rd floor level (column B6, Figure 2(a)). In addition to the slab punching failures, significant joint diagonal cracks, column flexural cracks, and minor concrete spalling at some girders adjacent to the beam-column joint were observed on the perimeter moment frame.

Significant diagonal cracks were observed within the beam-column joint regions (Figure 2(b)) along the east and west perimeter frames, primarily at the 3rd floor level between columns

A4 to A6 and columns D4 to D6. Concrete spalling was observed at the middle of the joint, and the diagonal cracks often extended up to the floor slab. Moderate joint cracks were observed at several locations in the east and west perimeter frame except at the 2nd floor level. No joint cracks were noted in the north and south perimeter frames except for column C7 at the roof level. The damage survey also indicated that the majority of the girders in both directions had minor to moderate concrete crushing at the beam - joint interface, and almost all of columns had flexural cracks distributed over the height on all four sides. Overall, the perimeter frame damage patterns indicate that the building experienced considerably more deformations in the N-S direction than the E-W direction.

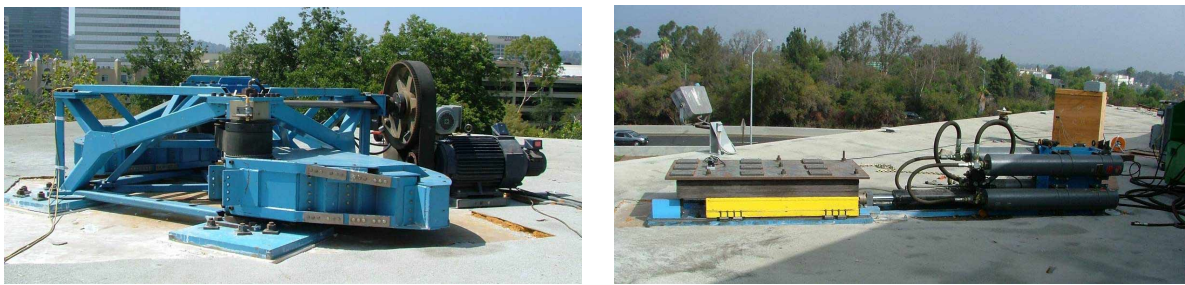
Figure 3. Field shakers, (a) Eccentric mass shaker and (b) linear shaker

Two, large capacity, eccentric mass shakers (ANCO Model MK-15) and a modest-capacity linear shaker were anchored at the roof of the building as vibration sources. A single eccentric mass shaker develops uni-directional harmonic forces with two counter-rotating baskets, with a peak force output of 445 kN. The two baskets contain several compartments that can be filled with steel bricks so as to alter the amplitude of force by increasing the mass-eccentricity. In the present test, two different basket configurations were used as shown in Table 1. The eccentric mass shakers were positioned at the north and south ends of the roof to maximize the torsional excitation that could be produced, while also enabling translational excitation in the N-S and E-W directions.

The linear shaker is driven by a hydraulic actuation system capable of moving a nominal weight of 2.25 ton with a peak force of 66.75 kN through a stroke of ± 38.1 cm. The linear shaker was mounted at a 45° angle from the N-S perimeter frames about 3.3 meters away from the approximate center of the roof (the reference point). This location and orientation were selected to impart approximately equivalent levels of excitation in N-S and E-W translations while also providing torsional excitation.

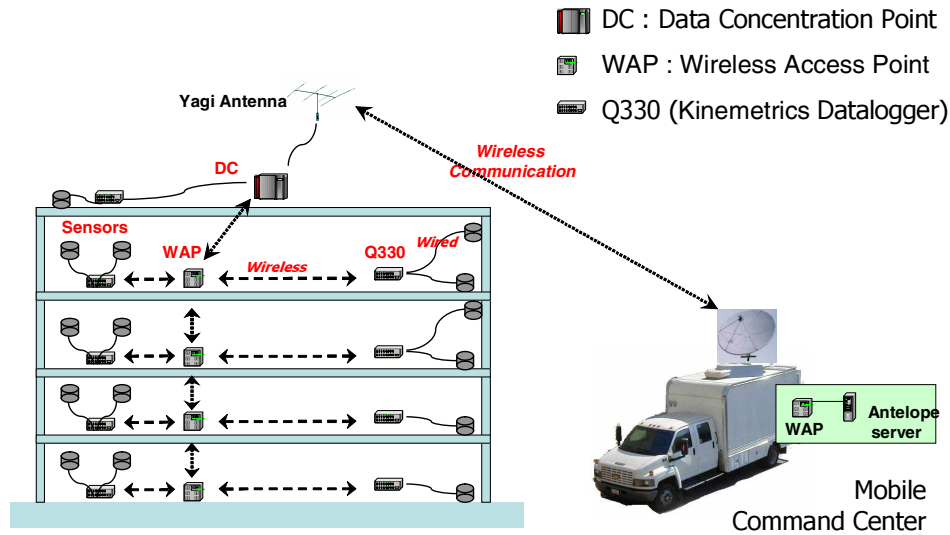
Figure 4. A schematic drawing of the Kinemetrics DAQ system

two separate systems: a Kinemetrics/Antelop system and a National Instrument/Labview system. Data from both systems were GPS time-stamped to ensure data compatibility. Figure 4 shows a schematic of the Kinemetrics data acquisition system and data flow through the system.

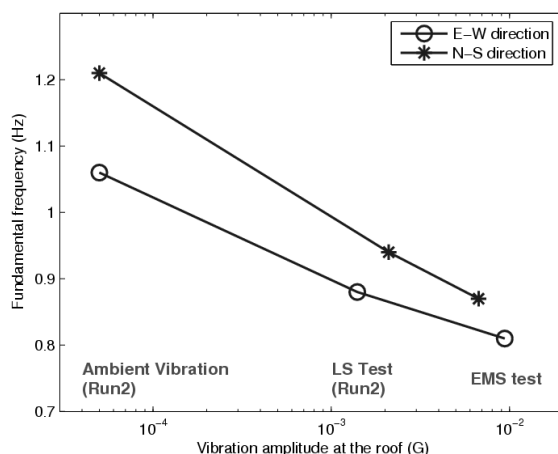
Figure 6. Change of natural frequencies with vibration amplitude

Previous researchers have observed the dependence of the natural frequencies on the amplitude of vibration. Foutch [1978] reported that the fundamental frequencies decreased from 5 to 7 % based on an increase of 15 fold in the excitation force. Trifunac [1972] also found that the natural frequencies obtained by forced vibration tests were about 4% lower than those by the ambient vibration. In the current test, the peak values of the story accelerations around the fundamental frequencies, obtained by filtering them with a very narrow bandpass filter (fifth order Butterworth filter with cutoff frequencies of 95% and 105% of the fundamental frequencies in each test), are $5 \times 10^{-5}g$, 0.002g to 0.0015g, and 0.007g to 0.009g for the ambient, linear shaker tests, and EMS tests, respectively. Figure 6 shows the relationship between the two quantities. The decrease in fundamental frequencies appears to be proportional to the exponential of the (filtered) vibration amplitude increase.

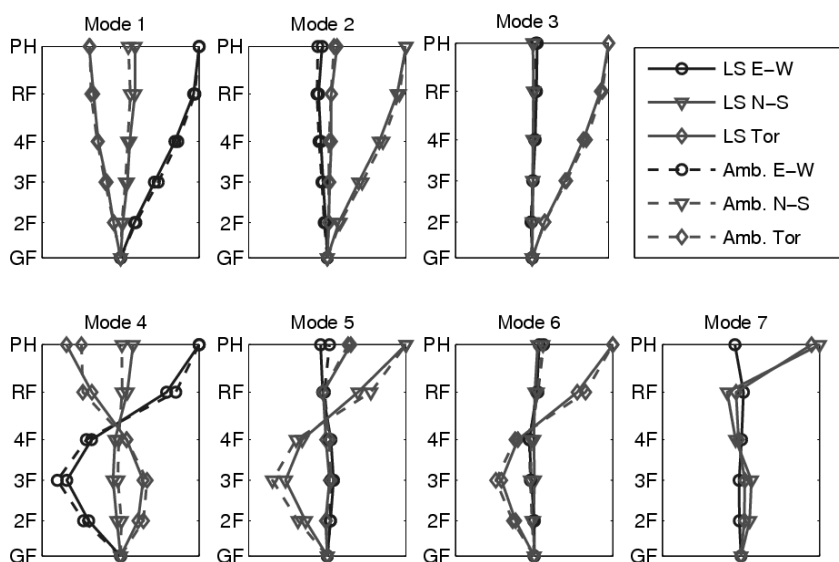
Figure 7. Mode shapes (Linear Shaker test Run2 and Ambient vibration Run2)
