Hybrid Simulation of Corroded Hybrid Fiber Reinforced Concrete Structures Exposed to Seismic Loading

Jacob Fuller Duncan

Doctor of Philosophy

University of California, Berkeley

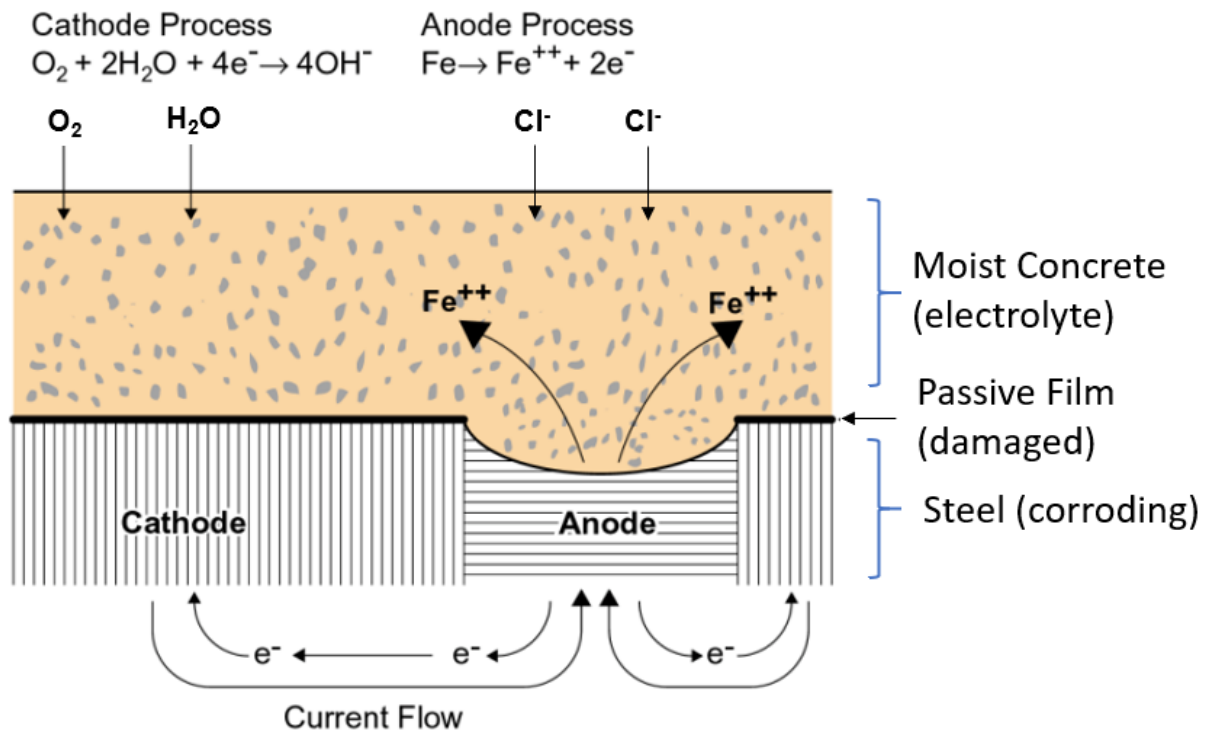
Figure 2 - 1: Diagram of chloride-induced corrosion of reinforcing steel embedded in concrete (After Mehta and Monteiro 2014).

Once the passive film has been compromised, steel corrosion can proceed more rapidly and iron ions are readily released from the steel surface. The moist concrete cover acts as an electrolyte creating a corrosion cell between the anode region where the oxidation reaction occurs and the cathode region where the reduction reaction occurs. The process is diagrammed in Figure 2 - 1 for the case of chloride-induced corrosion.

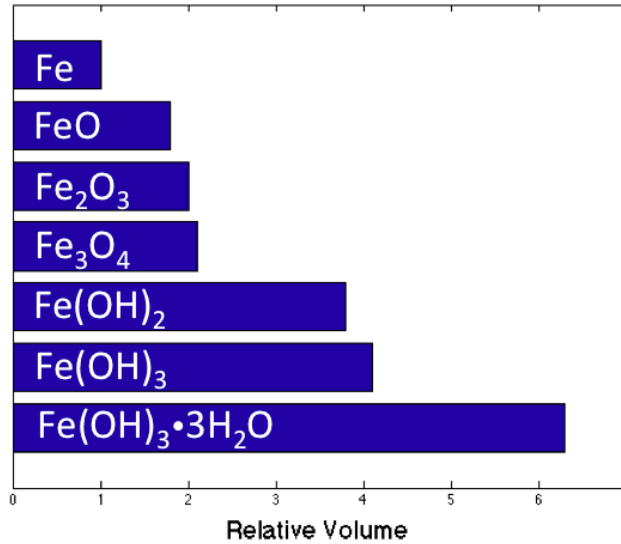
Figure 2 - 2: Various corrosion products and their relative volume compared to atomic iron (After Mehta and Monteiro 2014).

larger volume than their original volume in the bulk metal. Due to the tendency of these iron oxides to imbibe water molecules, they can expand to over 600 percent of the volume of the original iron ion (Mehta and Monteiro, 2014). A chart of various species of iron oxides and their associated volume change can be seen in Figure 2 - 2.

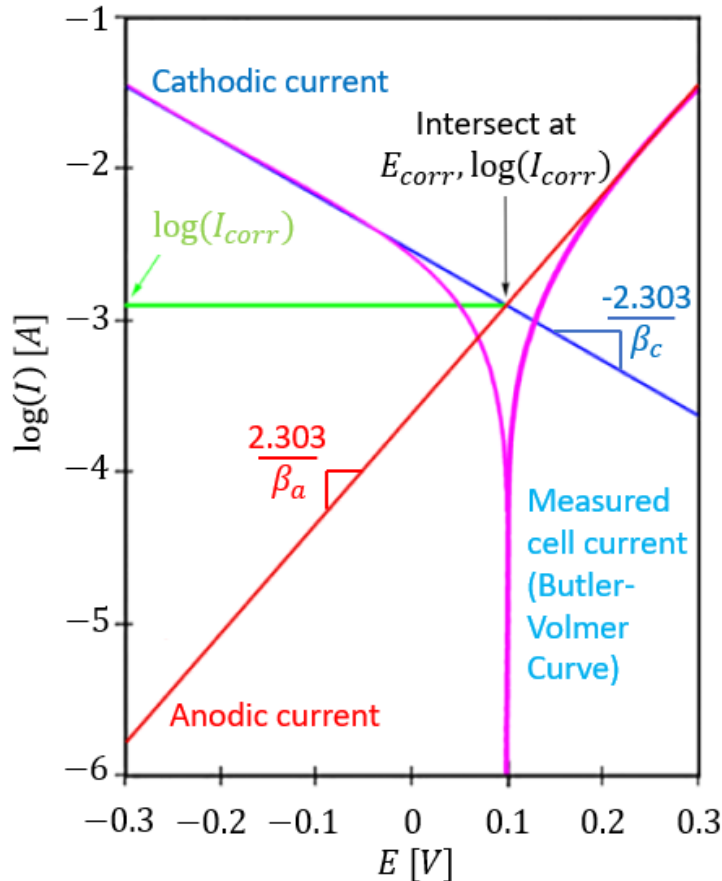
Figure 2 - 7: Components of the Butler-Volmer equation plotted (magenta curve), anodic component (red curve) and cathodic component (blue curve) (Image modified from <https://www.gamry.com/application-notes/corrosion-coatings/basics-of-electrochemical-corrosion-measurements/>. Sourced on 8/10/19).

oxidation of iron (anodic reaction) and one describing the reduction of hydrogen or oxygen (cathodic reaction). Where β_a and β_c determine the slopes of the anodic and cathodic curves, respectively, as shown in Figure 2 - 7.

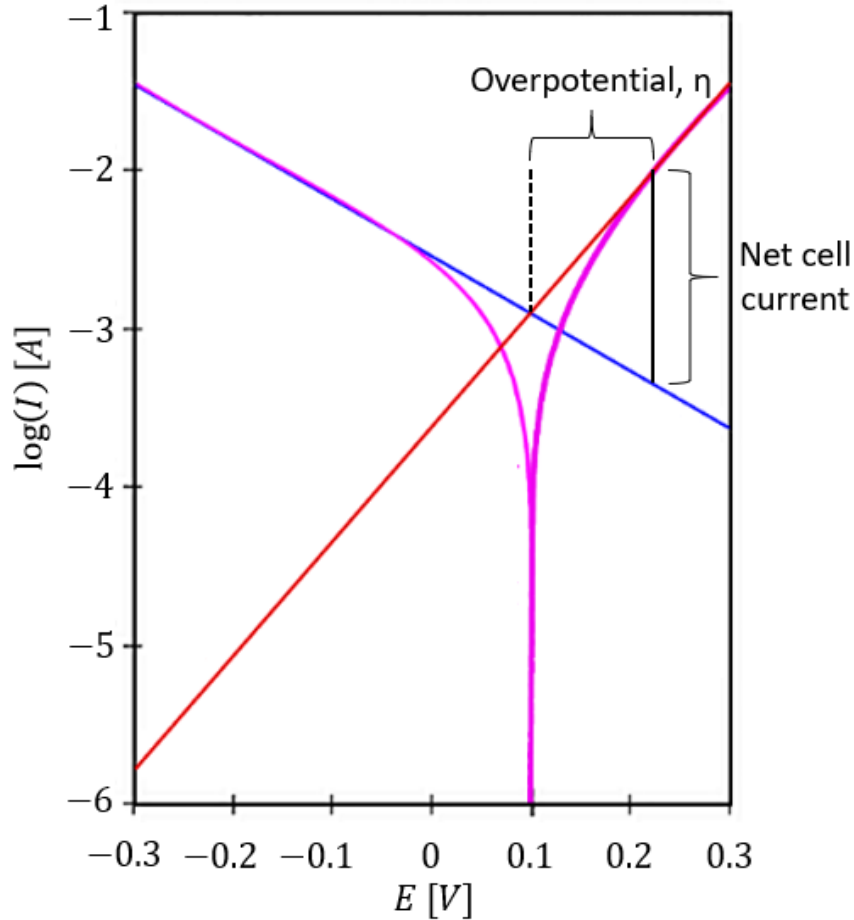
Figure 2 - 8: Polarization curve and principle of accelerated corrosion. (Image modified from <https://www.gamry.com/application-notes/corrosion-coatings/basics-of-electrochemical-corrosion-measurements/>. Sourced on 8/10/19).

Due to the nature of the polarization curve and the oxidation and reduction reactions occurring in the corrosion process, if an overpotential is applied, a net cell current is induced that is equal to an increase in the rate of one reaction and a decrease in the rate of the other, as shown in Figure 2 - 8. If an applied current supplies electrons to the anode (i.e. the rebar) this lowers the oxidation rate and thus slows the corrosion process. This is known as cathodic protection and is a well-established method of corrosion protection for civil engineering structures such as bridge decks, and can be applied to prestressed tendons and bridge columns (Glass and Buenfeld 1997; Ishii et al. 1998; Wilson et al. 2013). If polarization of the reinforcing steel takes electrons away from the anode, the oxidation rate increases, thus accelerating the corrosion process. This is the fundamental process behind accelerated corrosion by applied current, by removing electrons from the reinforcing steel, iron ions are oxidized at a higher rate and released into solution. A potentiostat can be used to either apply a potential and measure the resulting cell current, or it can be used as a galvanostat to apply a current and measure the resulting cell potential.

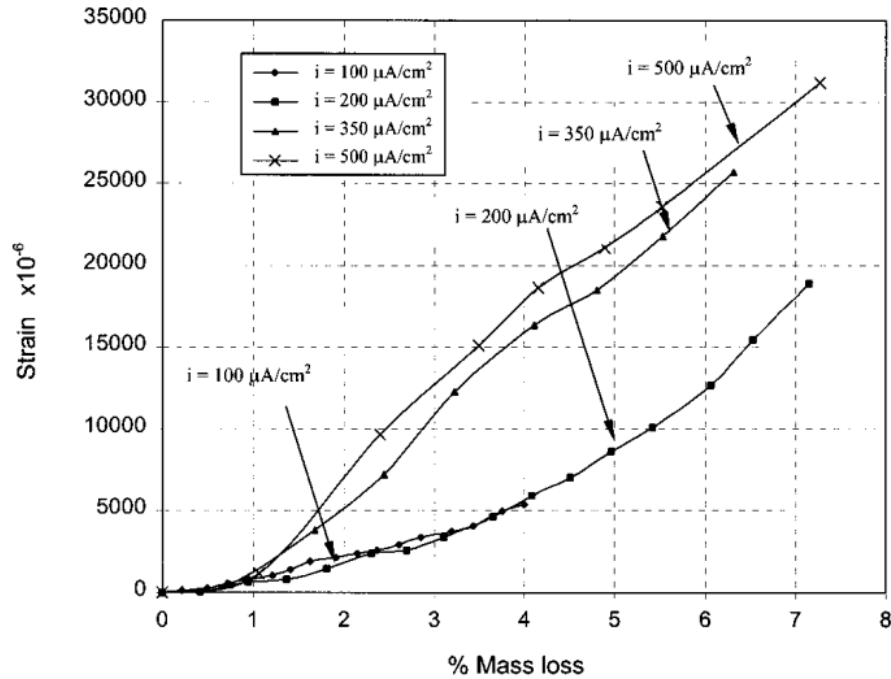
Figure 2 - 9: Strain development vs rebar mass loss for various current densities (El Maaddawy and Soudki 2003).

Practical limits to applied current used in accelerated corrosion have been suggested by El Maaddawy and Soudki (2003). By measuring strain in the concrete cover during experiments, the authors were able to find that above a critical current density, there was a stark increase in strain rate developed in the section, shown in Figure 2 - 9. This indicates that the development of corrosion products at the bar surface was being affected by the intensity of applied current. A cell current density lower than 0.2 mA/cm^2 is recommended, as a current density higher than this will result in strains that are not typical of natural corrosion (Andrade et al. 1993).

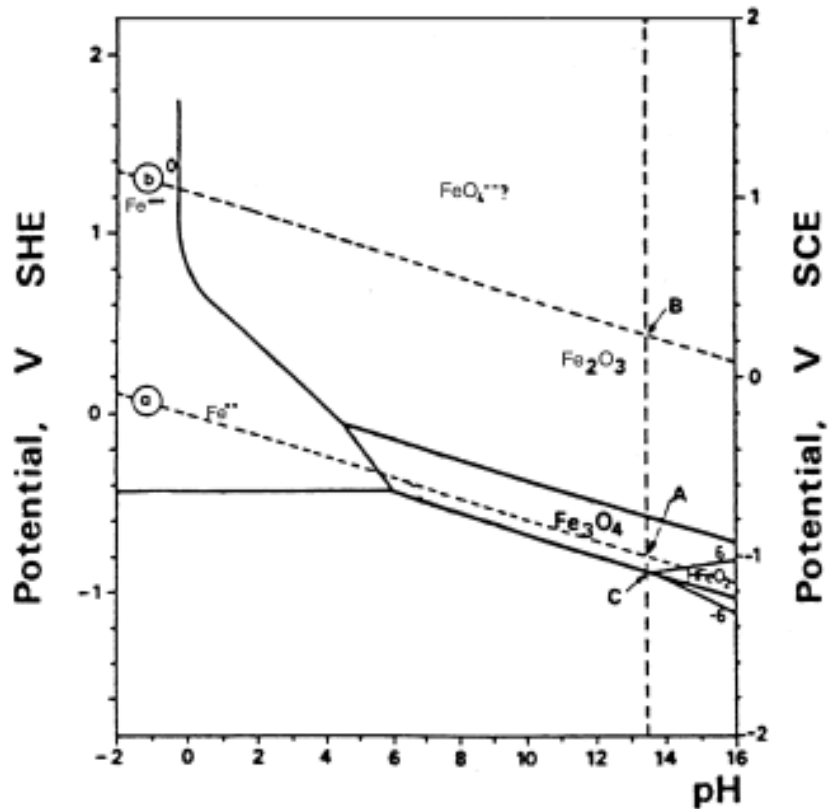
Figure 2 - 10: Pourbaix diagram of iron, vertical dashed line indicating the expected pH in fresh concrete. (After Pourbaix 1974, image sourced from ACI 222-R1 2001).

Internal acidic conditions would change the reaction kinetics by introducing new oxidation reactions to the system. A local change in pH would also influence the corrosion products that form. Figure 2 - 10 shows the Pourbaix diagram of iron, which describes the stable species of a metal in an aqueous solution of varying pH and shows that the formation of solid corrosion products is sensitive to the pH of concrete pore solution (Pourbaix 1974).

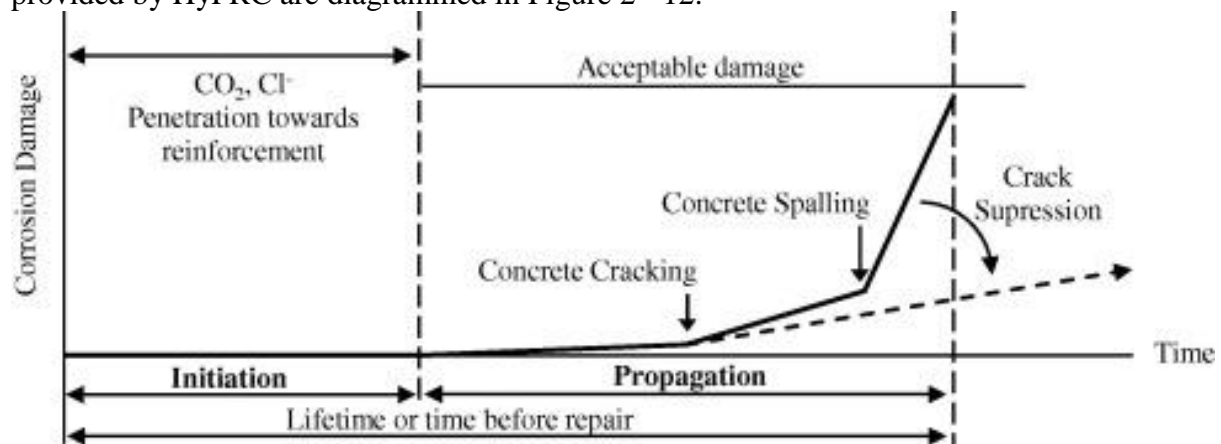
Figure 2 - 12: Corrosion propagation behavior enhancements provided by HyFRC (Jen and Ostertag 2016).

HyFRC promotes ductility through the formation of diffuse microcracking rather than the formation of a few dominant cracks (Blunt and Ostertag 2009). This multiple cracking behavior is the result of a toughened matrix that retains tensile strength even after cracking has initiated. The cracking resistance of HyFRC has been shown to improve the corrosion performance in two ways. First, by preventing cracking during service loading, the initiation period is extended, as high permeability pathways to reinforcement are prevented from forming in the matrix, thus stifling the ingress of aggressive agents. Second, after the corrosion propagation phase has begun, the matrix continues to resist crack formation, further preventing exposure of embedded steel to the environment (Jen and Ostertag 2016). The enhancements to corrosion propagation behavior provided by HyFRC are diagrammed in Figure 2 - 12.

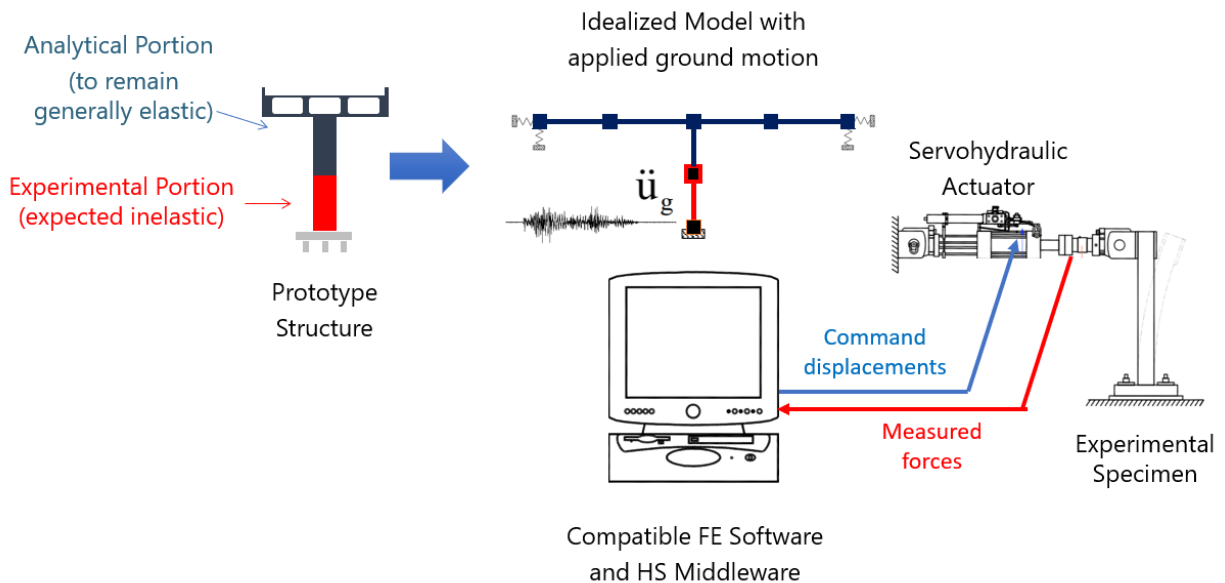
Figure 2 - 13: Schematic diagram of HS procedure.

To perform HS, a structural model must be segmented to isolate a region of interest that will experience large amounts of inelastic behavior, called the experimental substructure. A physical test specimen representing this portion of the model must be constructed and placed into a test setup so that one or more servo hydraulic actuator can control any experimental degrees of freedom (DOFs) of interest. A compatible finite element software can then be used to apply an extreme loading event such as an earthquake ground motion to the computer model, which interfaces with the experimental test setup through a middleware. A simplified diagram explaining the HS procedure is shown in Figure 2 - 13.

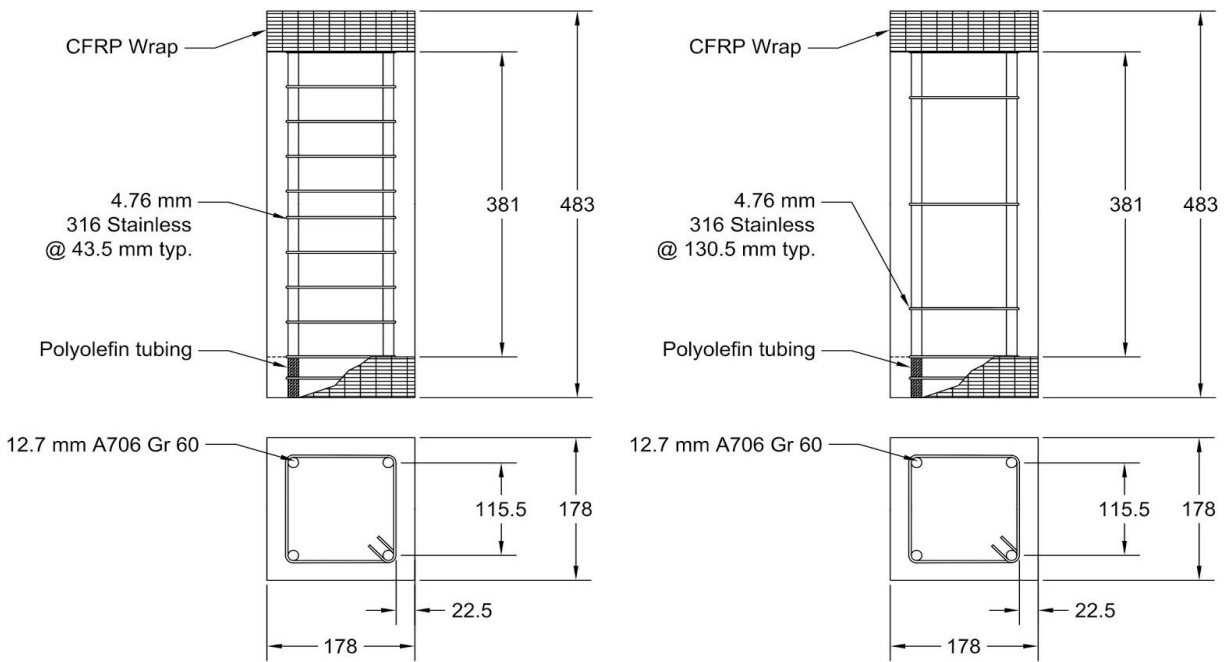
Figure 3 - 1: Details of column specimens [mm]. C and H1 (left), H2 (right).

referred to herein as H1, contained identical reinforcement details to the C specimens, while the second set, referred to as H2, contained a reduced transverse reinforcement ratio (reduced by a factor of 3). The set of low-transverse reinforcement ratio columns serve to demonstrate the ability of HyFRC materials to confine the column core, reducing the required transverse reinforcement to provide lateral stability to longitudinal reinforcement (Panagiotou et al. 2014). A drawing of a typical column can be found in Figure 3 - 1, and reinforcement properties can be found in Table 3 - 2. All specimens used ASTM type A706 grade 60 steel for longitudinal reinforcement and had mill scale removed via abrasion to promote corrosion initiation (ASTM 2016).

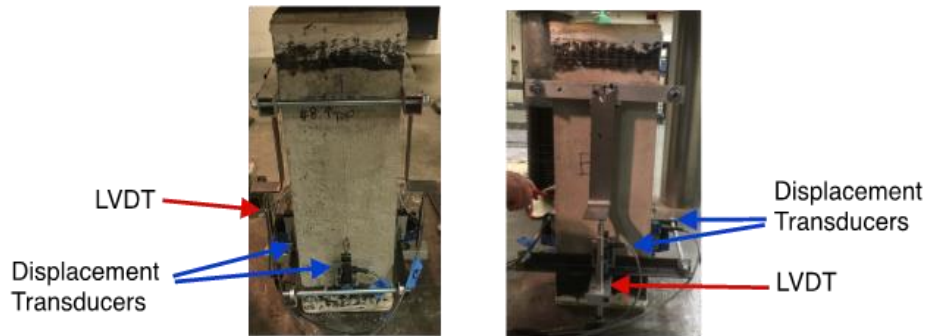
Figure 3 - 3: Typical stiffness test setup for a column.

Stiffness measurements were performed using a 1.8 MN universal testing machine (UTM) by loading the columns elastically to a predetermined load approximately 30% of the ultimate strength in five consecutive cycles. This was performed at four weeks, 24 weeks, and at approximately 140 weeks to track any changes in elastic stiffness. Sacrificial specimens were also cast and tested to failure for each sample set at 28 days in order to validate the elastic range, as well as for comparison purposes for future testing. Displacements at the 28-day mark were measured using displacement transducers epoxied to the concrete surface. Subsequently, at the 24-week measurement, linear variable differential transformers (LVDT) were added via a bracket system in order to achieve an improved signal. Images of the bracket system used during mechanical testing can be seen in Figure 3 - 3. All LVDTs were removed from the bracket prior to the final loading to failure at the conclusion of the experiment. For the final loading for specimens C-a and H1-a, the strength of the columns had exceeded the capacity of the testing machine, so these columns were tested using a 17.8 MN universal testing machine.

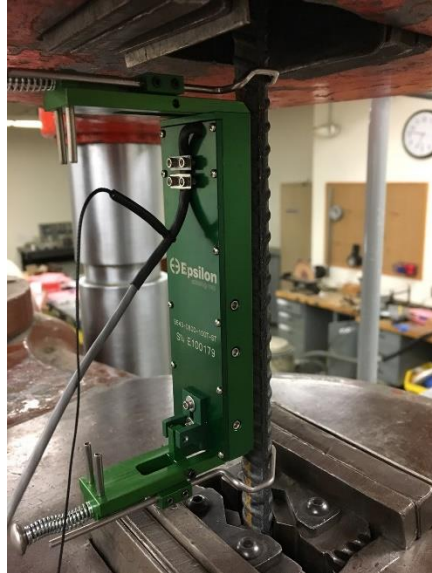
Figure 3 - 4: Tensile testing of reinforcing steel. The digital extensometer (Green) is attached to the rebar via clips. Rebar is loaded into UTM. (Image courtesy of Ian Williams).

Reinforcing steel from columns that did not undergo full compression testing was then tested in tension on a 534 kN UTM. Testing was performed using displacement control with a strain rate of 0.0017 per min (set by using an initial load rate set at 44.5 kN/min during the elastic regime). Pristine bars were also tested in this setup as a control. Data collection was done via a digital extensometer. An image of the tensile testing setup can be seen in Figure 3 - 4.

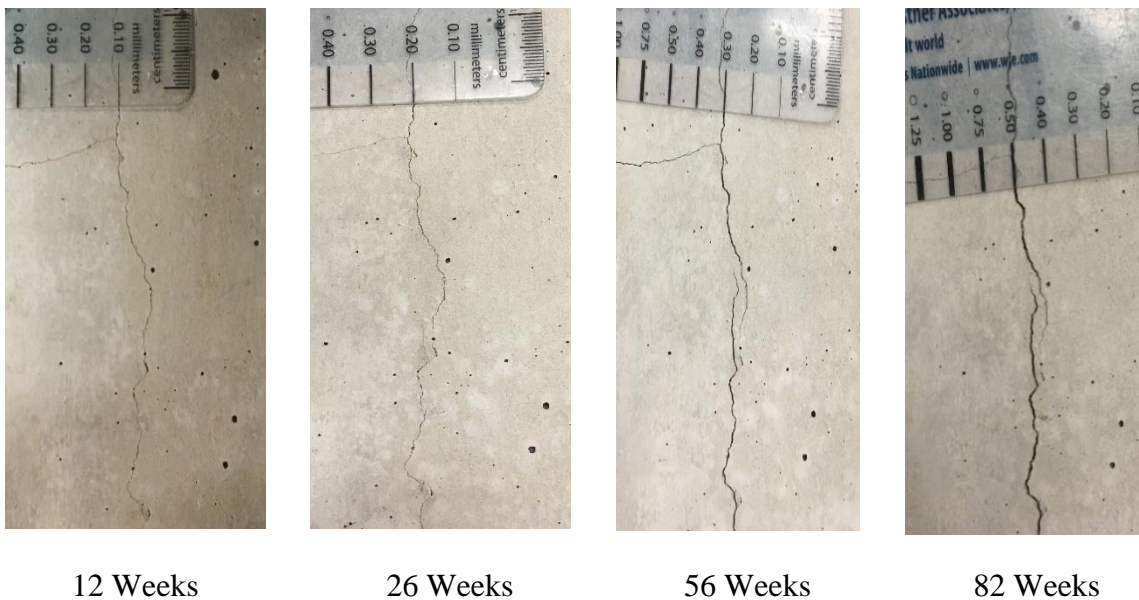
Figure 3 - 5: Crack growth in C column specimen.

Surface cracking was first inspected at 28 days, at which point no cracking was observed in any specimens. First cracking was observed in C column specimens at 12 weeks. Detail images in Figure 3 - 5 of a sample crack progression in a C column specimen show crack growth and how crack widths were determined using a crack comparator. A summary of maximum measured crack width and number of full-length splitting cracks at various times during the corrosion exposure period are shown in Table 3 - 3.

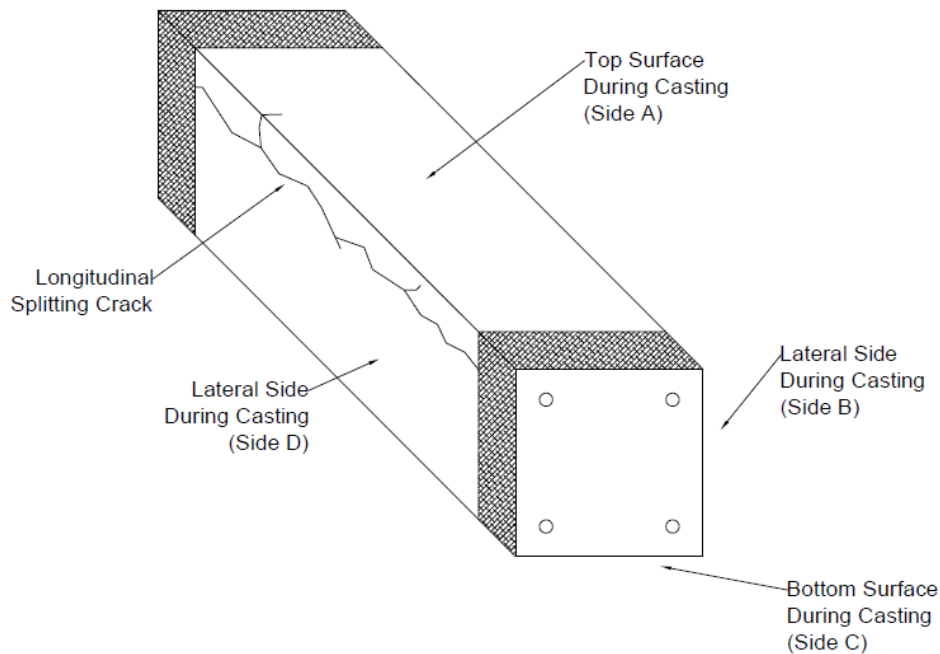
Figure 3 - 6: Diagram showing casting orientation of column specimens.

Since specimens were cast horizontally, cracking patterns were dependent on orientation and are referred to according to the diagram shown in Figure 3 - 6. The first cracking observed in C specimens manifested as full-length splitting cracks along the longitudinal reinforcement oriented closest to the casting surface on the sides adjacent to the top surface during casting (along the ‘top’ bars on sides B and D in Figure 3 - 6). First cracking in both H1 and H2 specimens occurred later, at 56 weeks and manifested as short, discontinuous cracks. These cracks eventually extended and, in some cases, connected to form partial-length splitting cracks by 82 weeks. Corrosion of fibers at the surface was observed in both H1 and H2 specimens. A flatbed scanner was used to collect high resolution images of each surface of column specimens following the corrosion exposure period. Images of representative cracking patterns in different specimen types are shown in Figure 3 - 7.

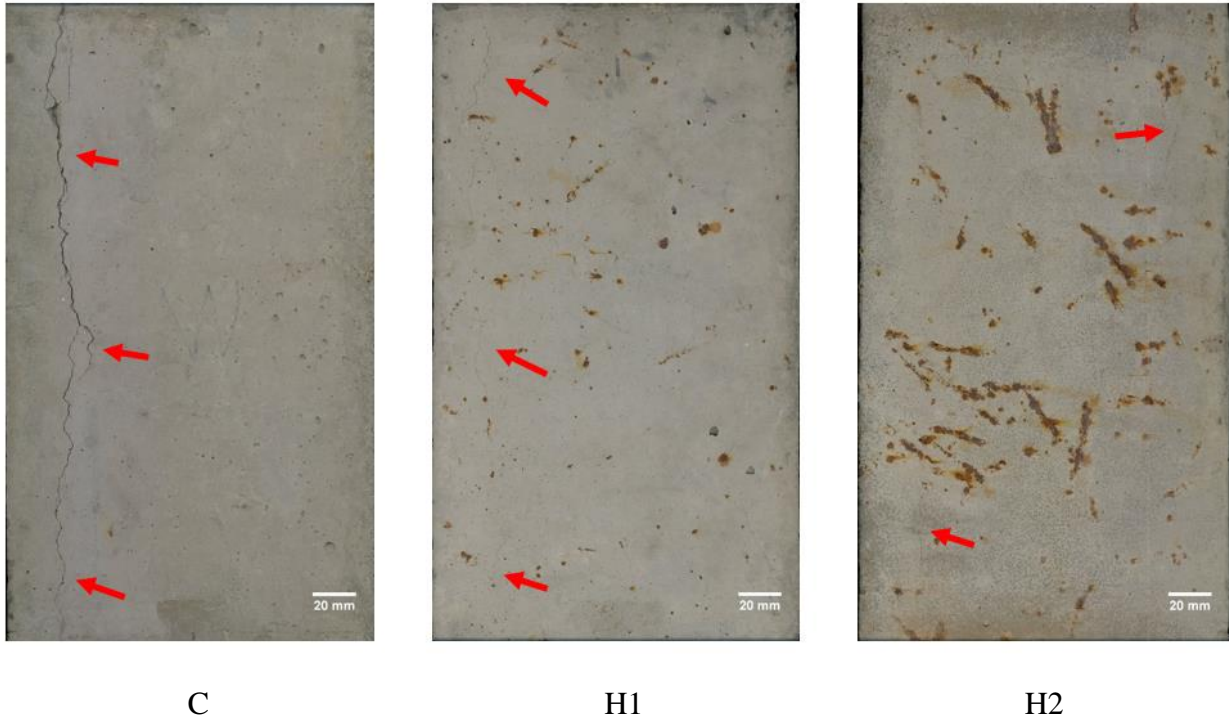
Figure 3 - 7: Images of typical crack morphology on lateral (B or D) sides of column specimens. Red arrows indicate full or partial length splitting cracks.

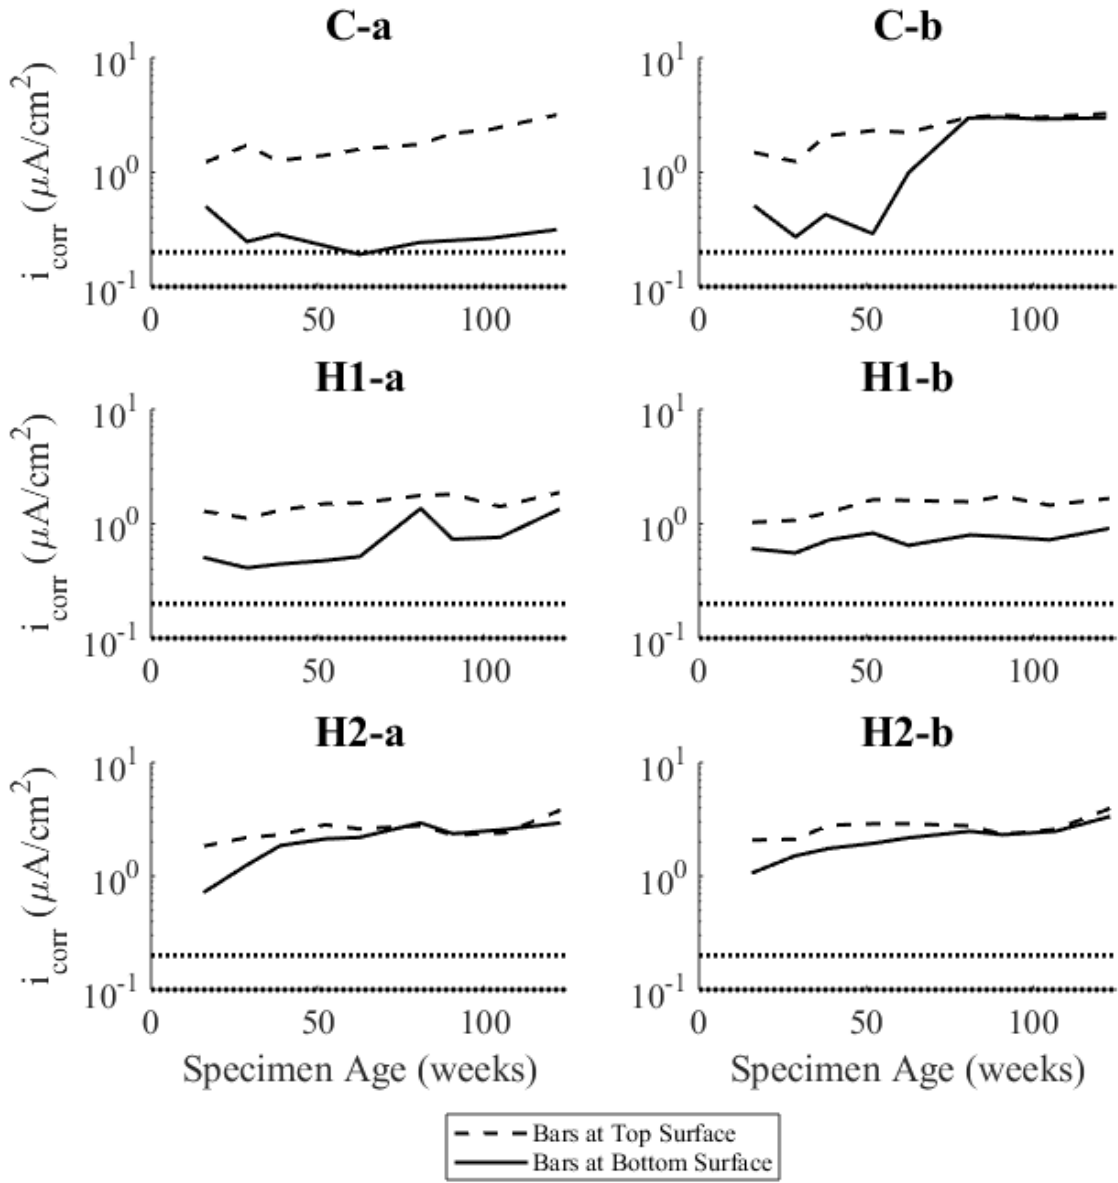
Figure 3 - 10: Corrosion rate of column specimens over time.

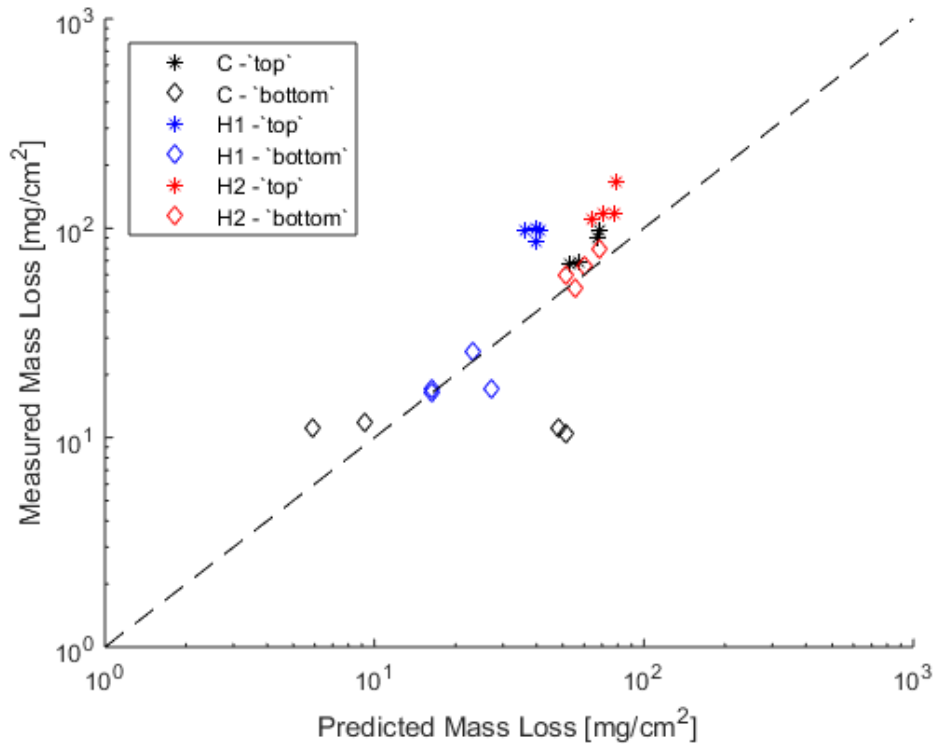
Figure 3 - 12: Predicted versus Measured mass loss for all rebars.

Table 3 - 4 lists the observed average mass loss for 'top' and 'bottom' bars from each column type (C, H1, and H2) along with their corresponding expected values from electrochemical measurements (Figure 3 - 11). Measured versus predicted mass loss for all rebars, presented normalized by rebar surface area, is shown in Figure 3 - 12.

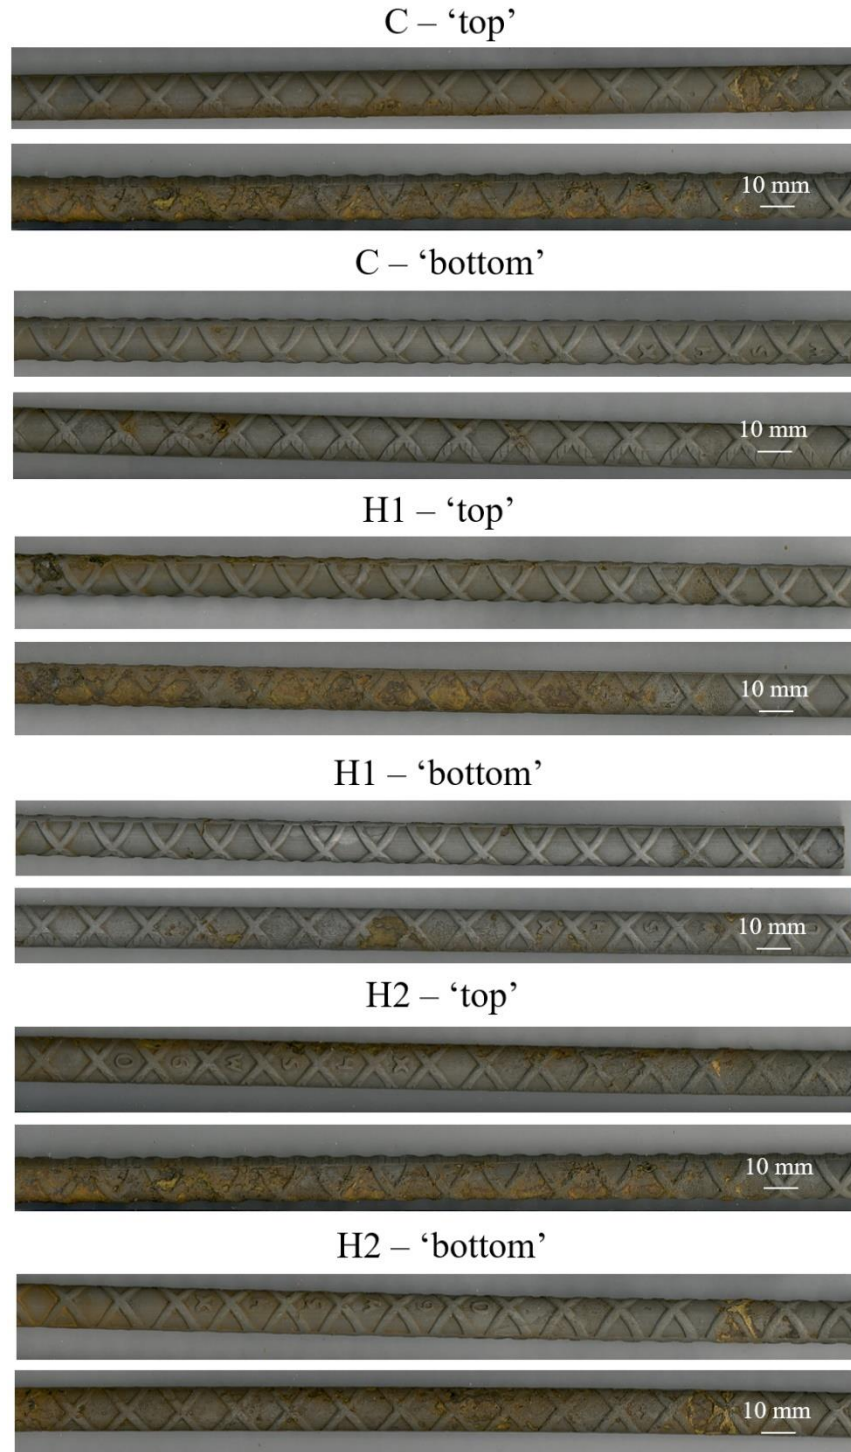
Figure 3 - 13: Representative scans of corrosion damage to reinforcing steel following excavation. The first image in each pair shows the side of the rebar closest to side A, while the second image shows the side closest to side C.

Corrosion damage patterns were also inspected following rebar excavation. Figure 3 - 13 shows corrosion patterns for typical 'top' and 'bottom' bars for specimen types C, H1 and H2. Each pair of images represents two sides of the same rebar. Scans of all reinforcing bars following mass loss measurements can be found in Appendix A-3.

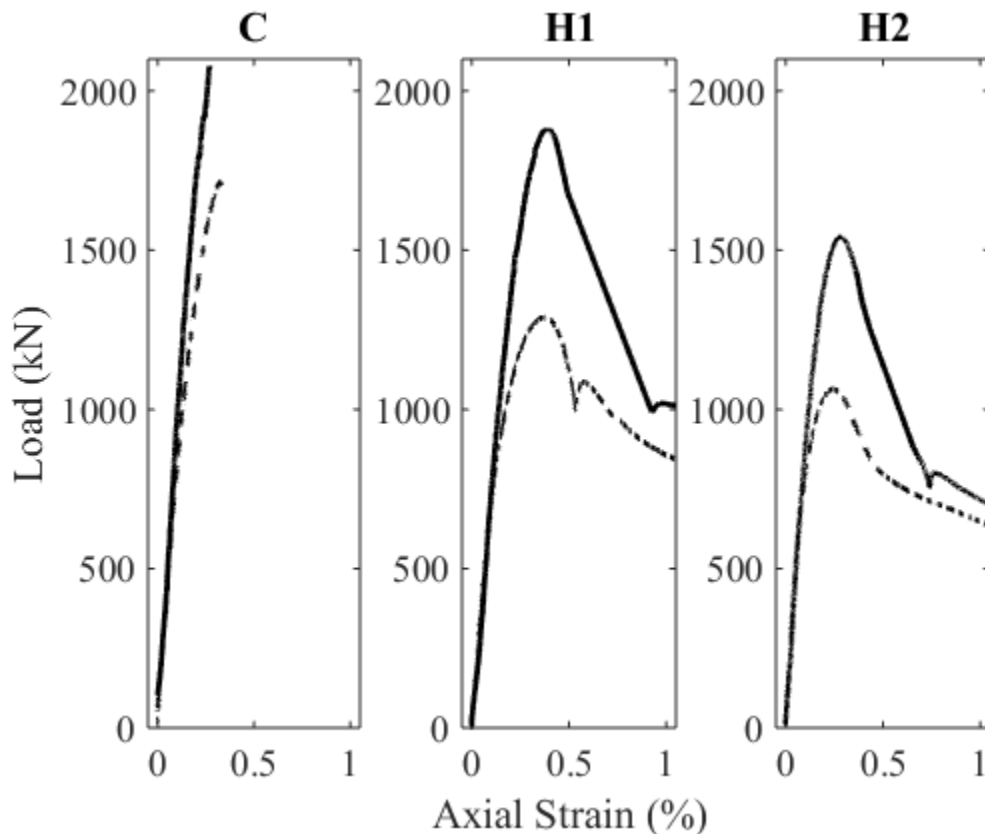
Figure 3 - 14: Load vs Strain behavior of columns, prior to corrosion exposure (dashed line) and at the end of the experiment (solid line).

Following the corrosion exposure period, one subset of columns (those labeled ‘b’ in electrochemical measurements) were subsequently tested in compression monotonically to failure. These tests were compared with uncorroded columns that were tested at one month. The results for each column type are shown in Figure 3 - 14.

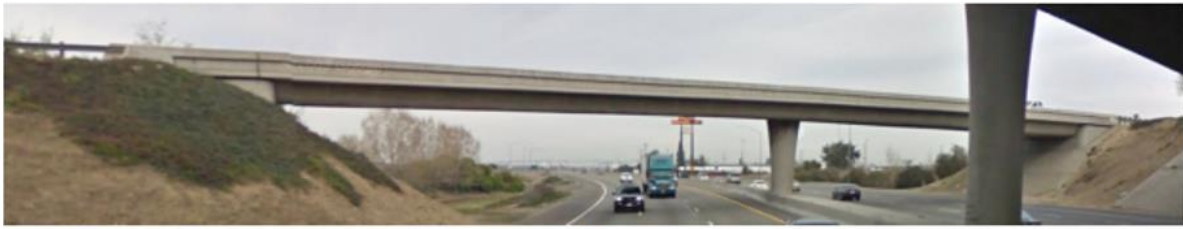
The bridge model utilized in this experiment is based on a single-column bridge structure over Highway 99 in Ripon, CA built in 2001. The model for the bridge was originally developed in OpenSEES by Kaviani (2011) as bridge ‘A’ and was created for research on the behavior of skewed bridge abutments in seismic events. For the purposes of this experiment, the skew of the bridge was set to zero degrees, as was the angle of application of ground motion (in longitudinal direction of bridge). In the research presented here, the abutments, deck, and upper portion of the column serve as the analytical substructure, while the lower portion of the column serves as the experimental substructure. An image of the bridge structure along with an elevation drawing is shown in Figure 4 - 1. A schematic drawing of the bridge model is shown in Figure 4 - 2.

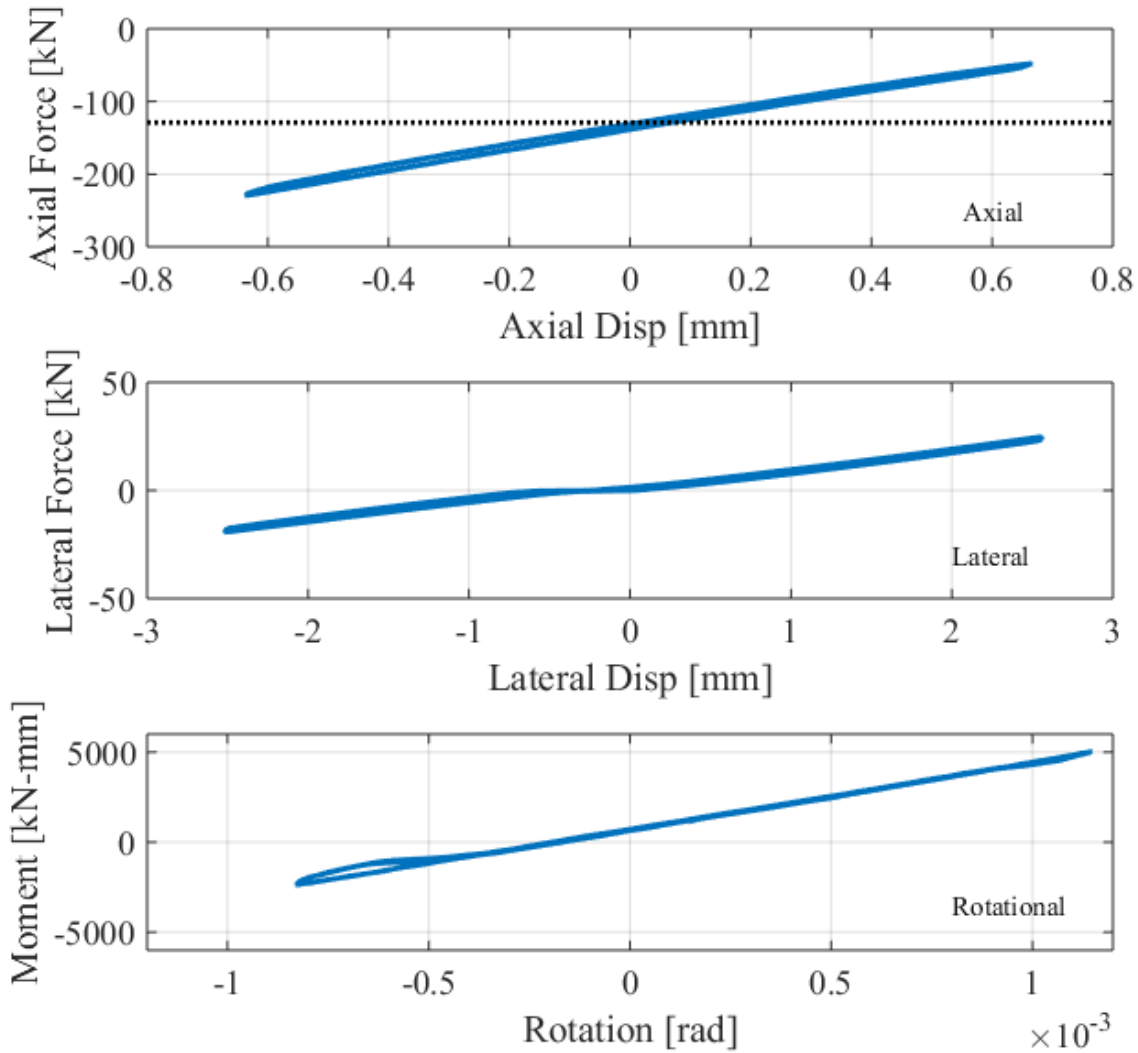
Figure 4 - 10: Plots of cyclic loading for stiffness determination for experimental element. The stiffness was taken to be the average slope for each plot.

Prior to running the HS experiment, the stiffness of the experimental specimen in the testing frame was determined and compared with expected values for the section. The stiffness was determined by commanding a small displacement in the degree of freedom of interest while holding other degrees of freedom fixed. The results of the stiffness determination are shown in Figure 4 - 10 with the slopes of the curves shown in Table 4 - 3 as the 2D stiffness matrix for the element. It should be noted that in the model, the full 3D stiffness matrix was approximated using these values, though all other DOFs were held fixed and are thus not shown here.

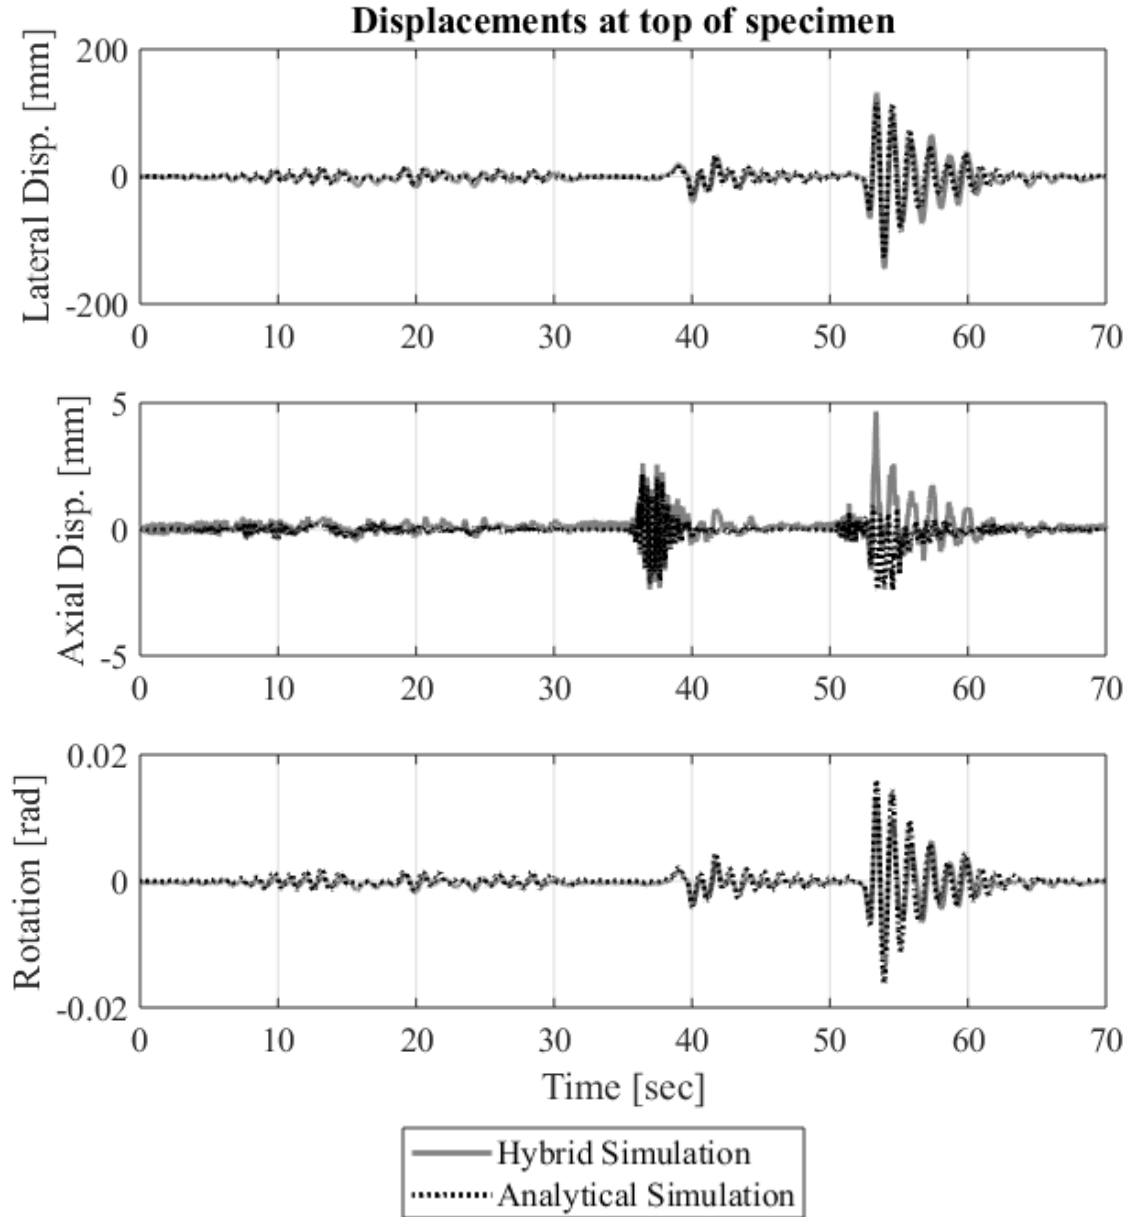
Figure 4 - 11: Displacement versus time at the top of the experimental specimen for ground motion series scaled by 0.375.

Prior to HS, an analytical simulation was run in which the experimental element was replaced with an elasticBeamColumn element with the stiffness properties matching the initial stiffness of the experimental substructure (determined in section 4.4.1). This analytical simulation is compared with the HS utilizing the experimental specimen. Figure 4 - 11 shows the displacements (at model scale) recorded at the control point node at the interface between the analytical substructure and the experimental substructure. The reaction forces at the control point were recorded and are displayed versus time in Figure 4 - 12. The results are compared with the corresponding node in the analytical simulation. Both simulations utilized a series of three consecutive ground motions (described in section 4.2.5), with an applied scale factor of 0.375 and the x-axis shows simulation time.

Lateral displacements in the HS show good agreement with the analytical simulation in the reduced scale series of ground motions where little to no yielding of the column is expected. In GM3, the HS response exceeded the analytical response. As lateral deformations increased, in the second and third ground motions, the lateral deformations appeared to influence the vertical displacements. Lateral deformations in the HS are slightly larger than the analytical simulation, while the opposite is true for the rotational degree of freedom.

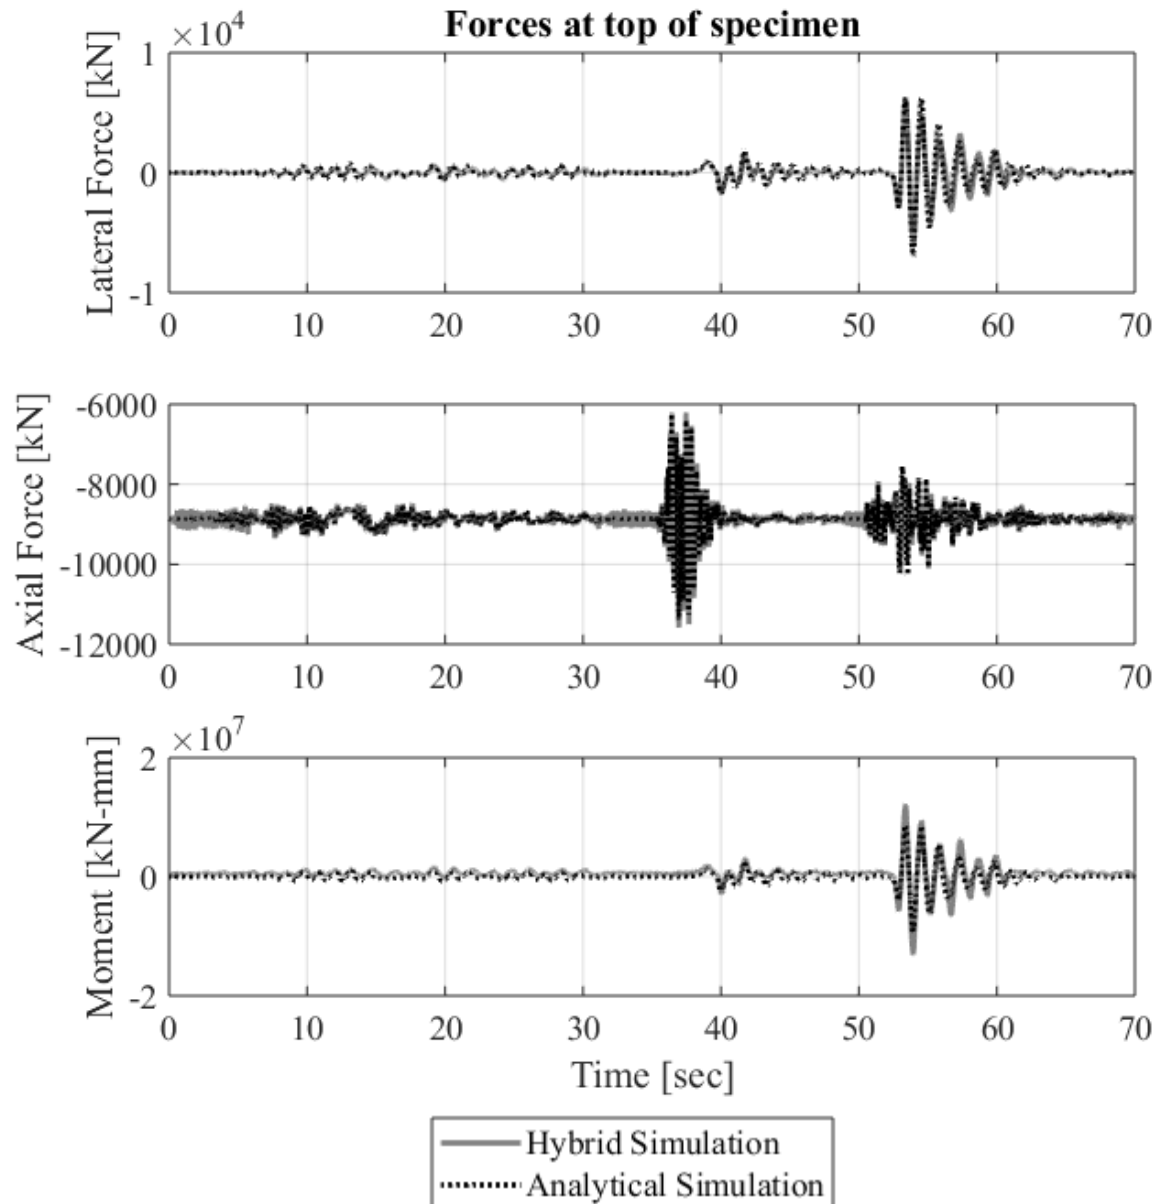
Figure 4 - 12: Forces versus time at the control point for ground motion series scaled by 0.375.

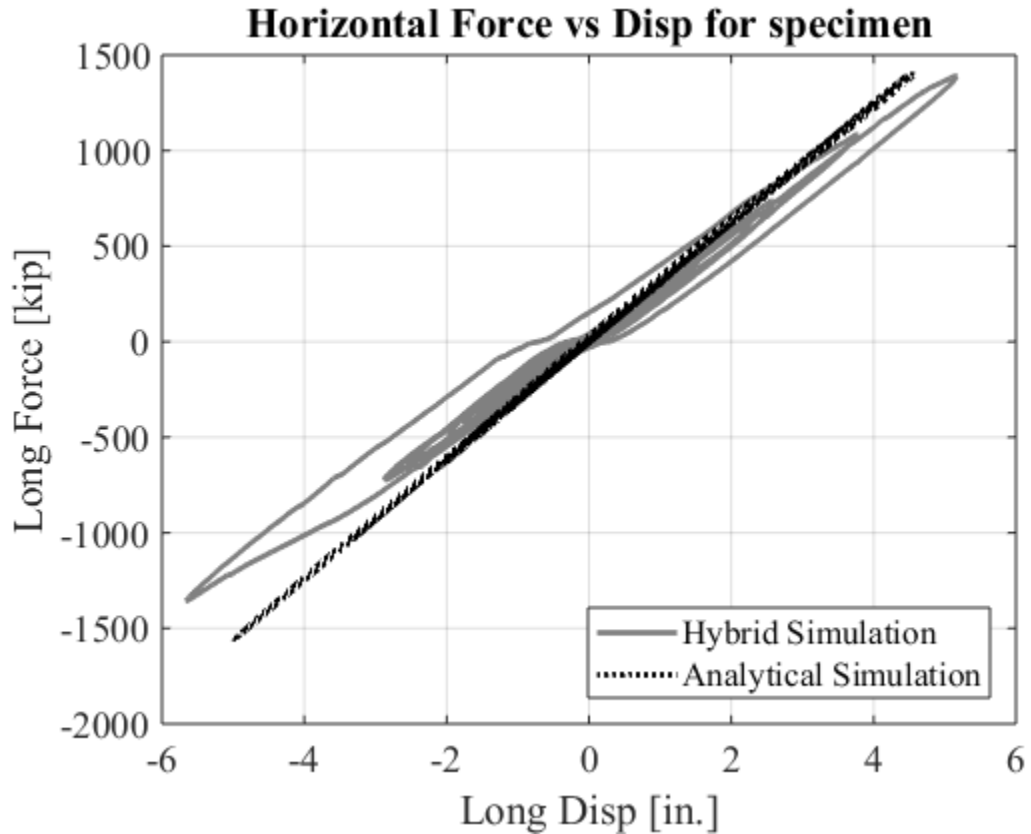
Figure 4 - 14: Force versus displacement relationships for HS and analytical simulation with ground motion scaled by 0.375.

The force versus displacement response for the lateral DOF is plotted in Figure 4 - 14 to compare the stiffness of the simulated experimental element with HS, and to observe the overall response. Backlash in the lateral actuator can be seen in the plateau at the origin in Figure 4 - 14. The stiffness prediction is a good match for the system, though the elastic element used in the analytical simulation cannot capture backlash or the small amount of hysteresis observed during HS.
