Hybrid Simulation of Corroded Hybrid Fiber Reinforced Concrete Structures Exposed to Seismic Loading

Jacob Fuller Duncan

Doctor of Philosophy

University of California, Berkeley

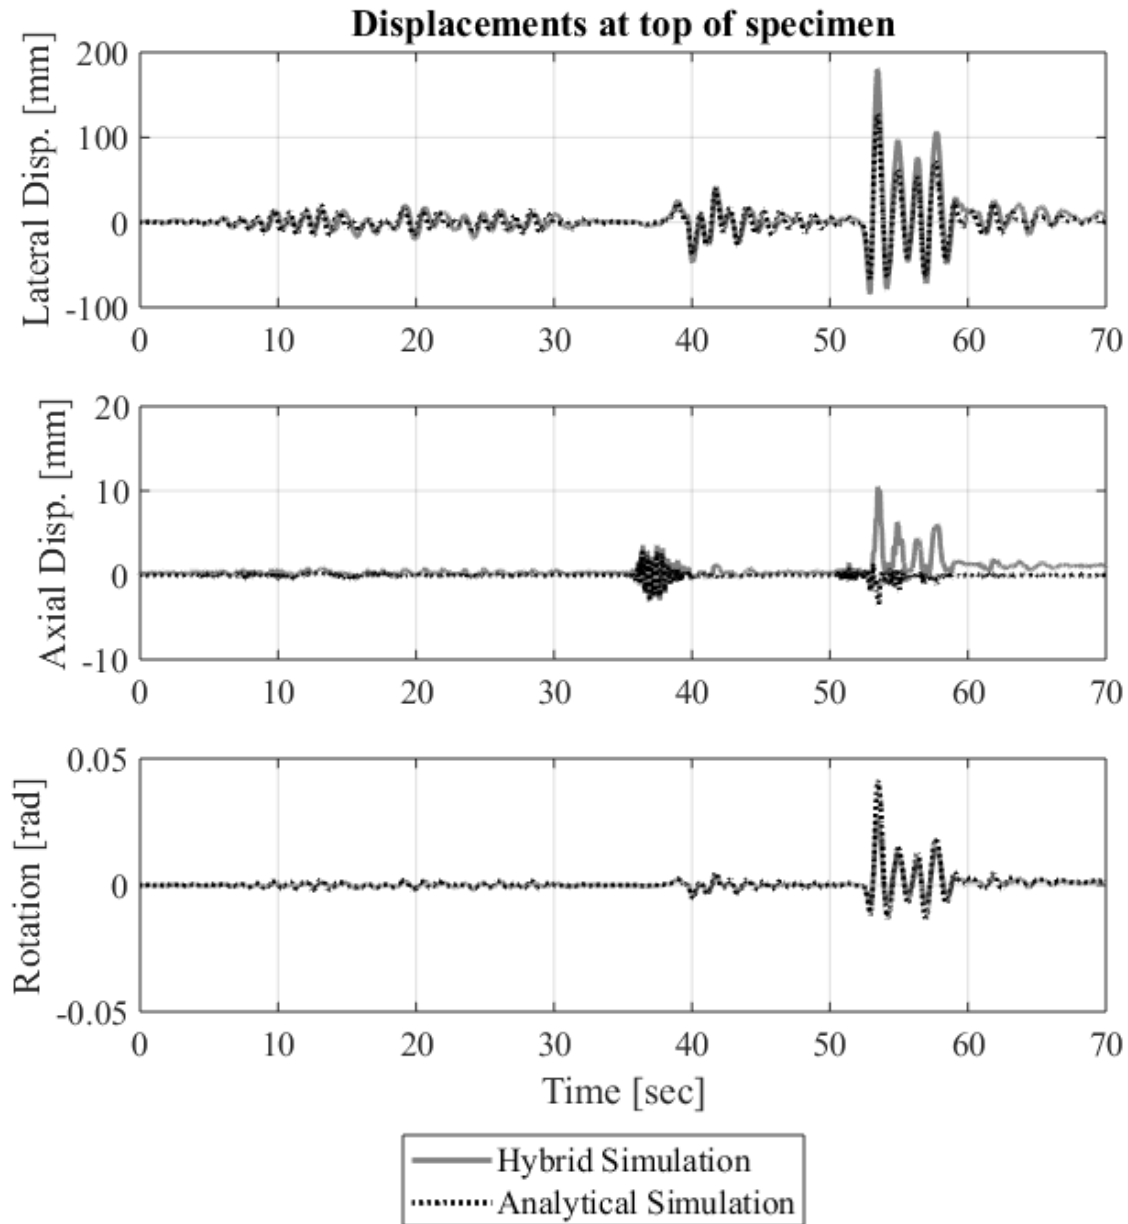
Figure 4 - 15: Displacement versus time at the top of the experimental specimen for ground motion series scaled by 0.5.

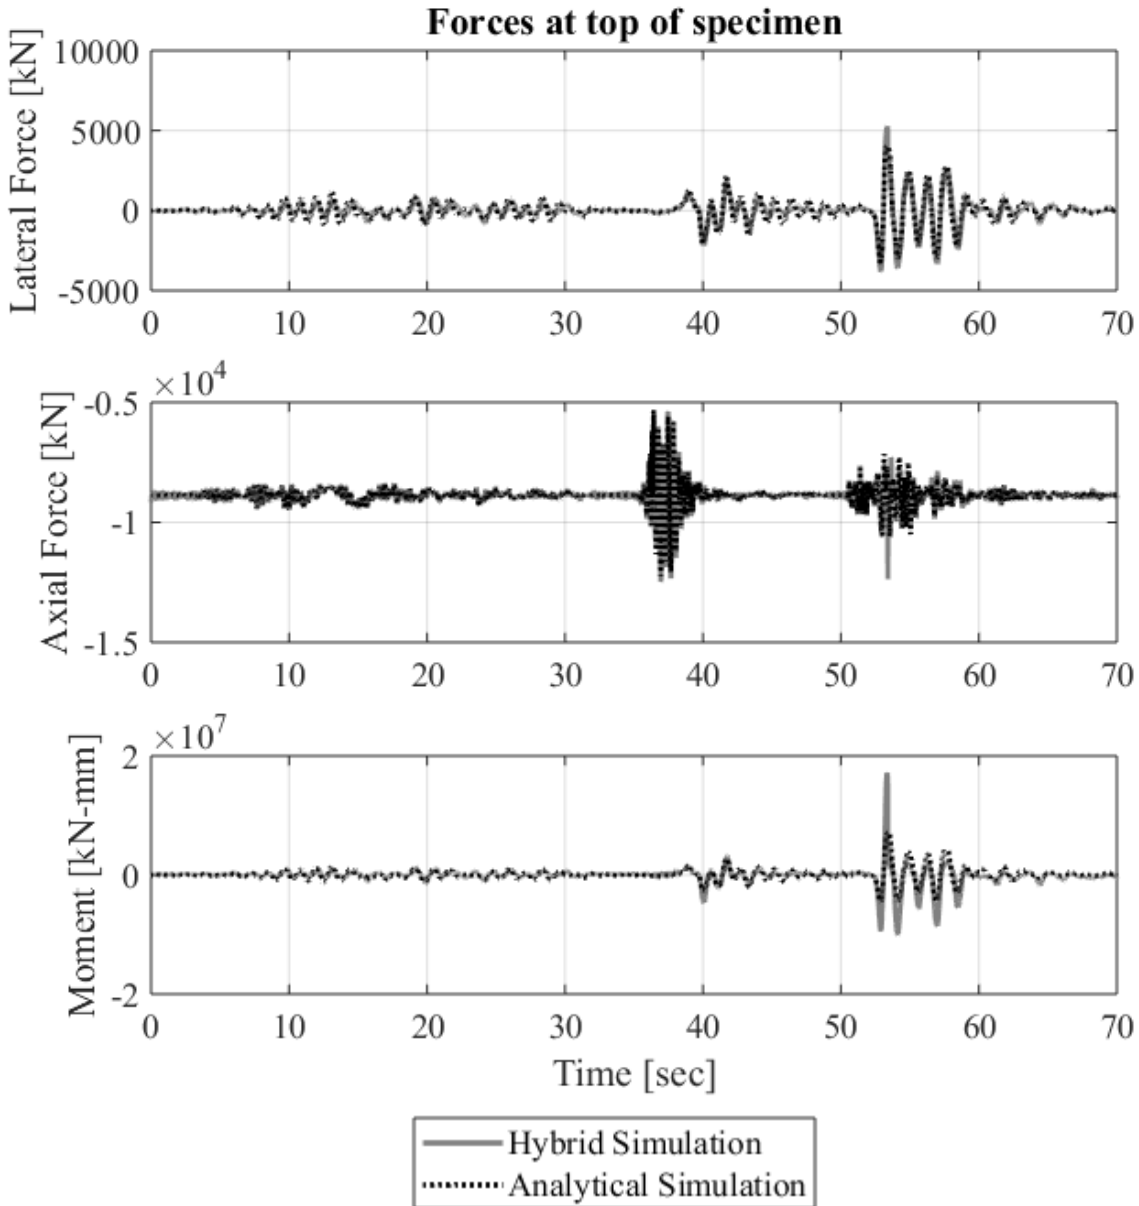
Figure 4 - 16: Force vs time at the top of the experimental specimen for ground motion series scaled by 0.5.

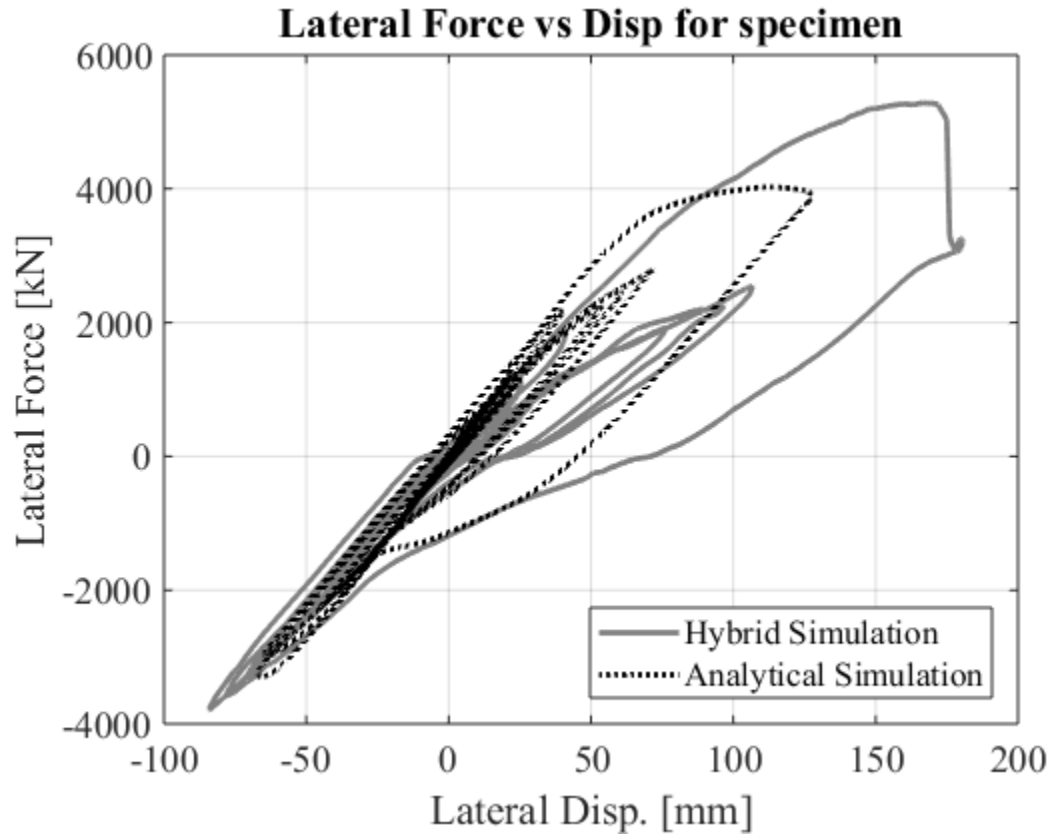
Figure 4 - 17: Force versus displacement relationships for the top of the experimental element.

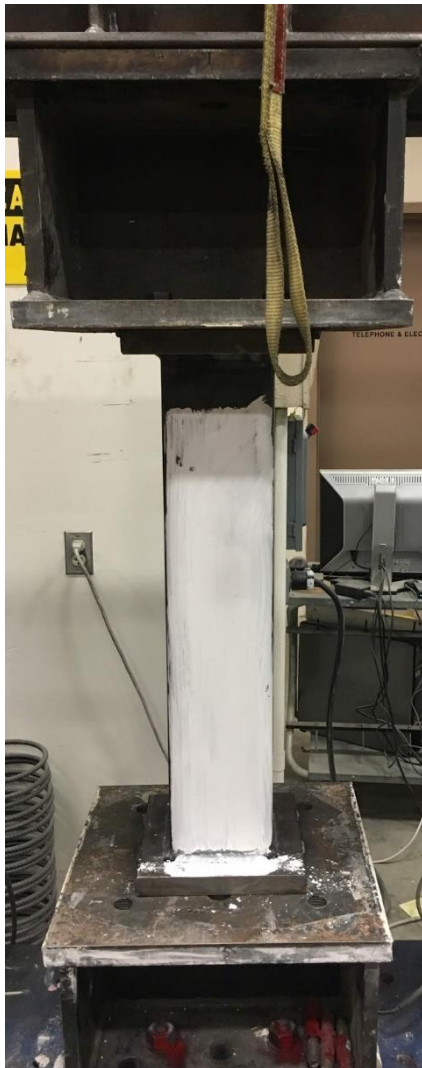
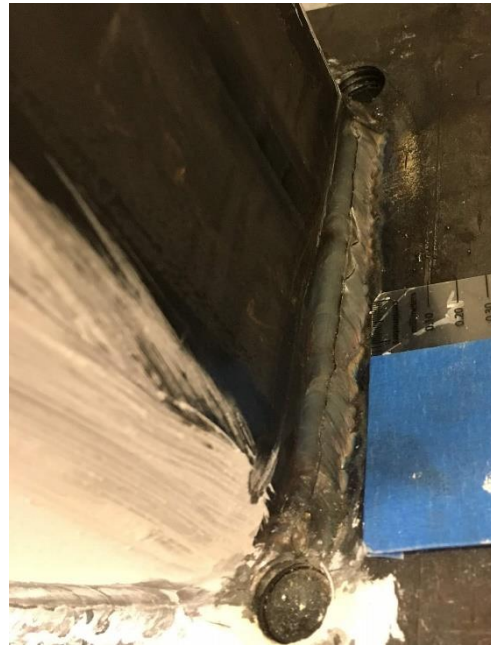
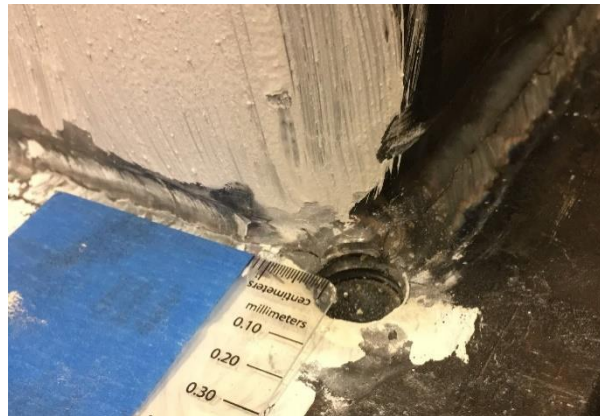
During testing, a loud sound was heard coming from the test specimen at this instance and it was observed after testing that the weld at the base of the experimental substructure fractured. Images of the weld crack are shown in Figure 4 - 18. The weld fracture traverses the bolt hole near at the corners of the experimental specimen. These bolt holes are stress concentrations and likely contributed to the initiation of the cracks under the repeated HS runs.

Figure 4 - 18: Images of the experimental specimen following HS with ground motion series scaled by 0.5. Cracking occurred at the weld at the bottom right of the column in (a). Close up details of fracture shown in (b) and (c).

6. The experimental substructure fractured at the weld following the HS run with the groundmotion series scaled by 0.5. Fatigue loading from repeated HS simulations and stress concentrations due to bolt holes at the weld corners were likely responsible for the early fracture.

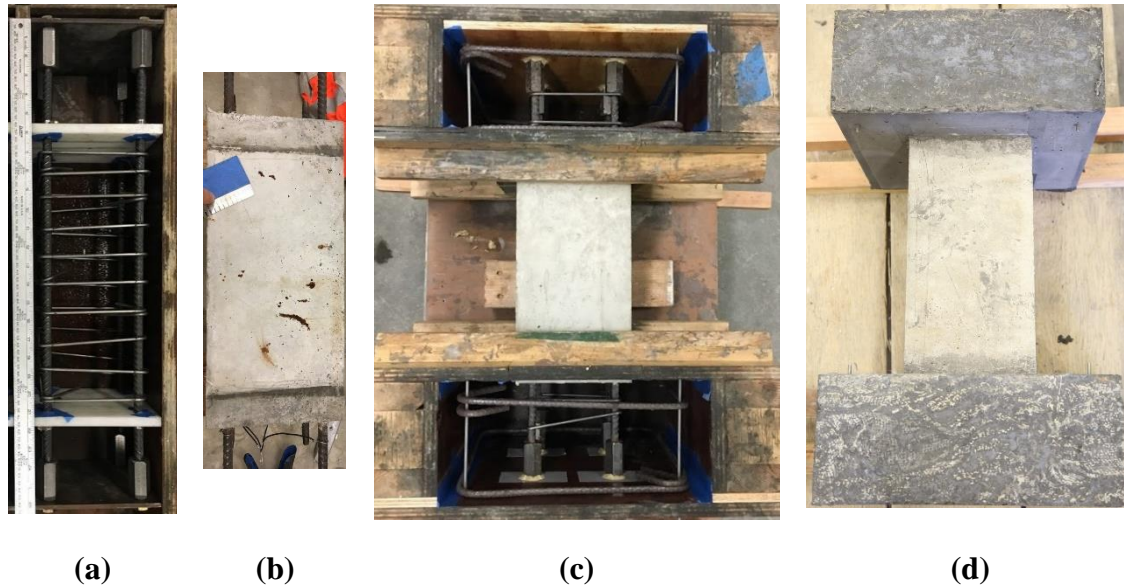
Figure 5 - 2: Construction progression for typical experimental specimen: (a) Column reinforcement prior to casting, (b) column element after casting, (c) column element in endcap formwork, (d) final experimental specimen.

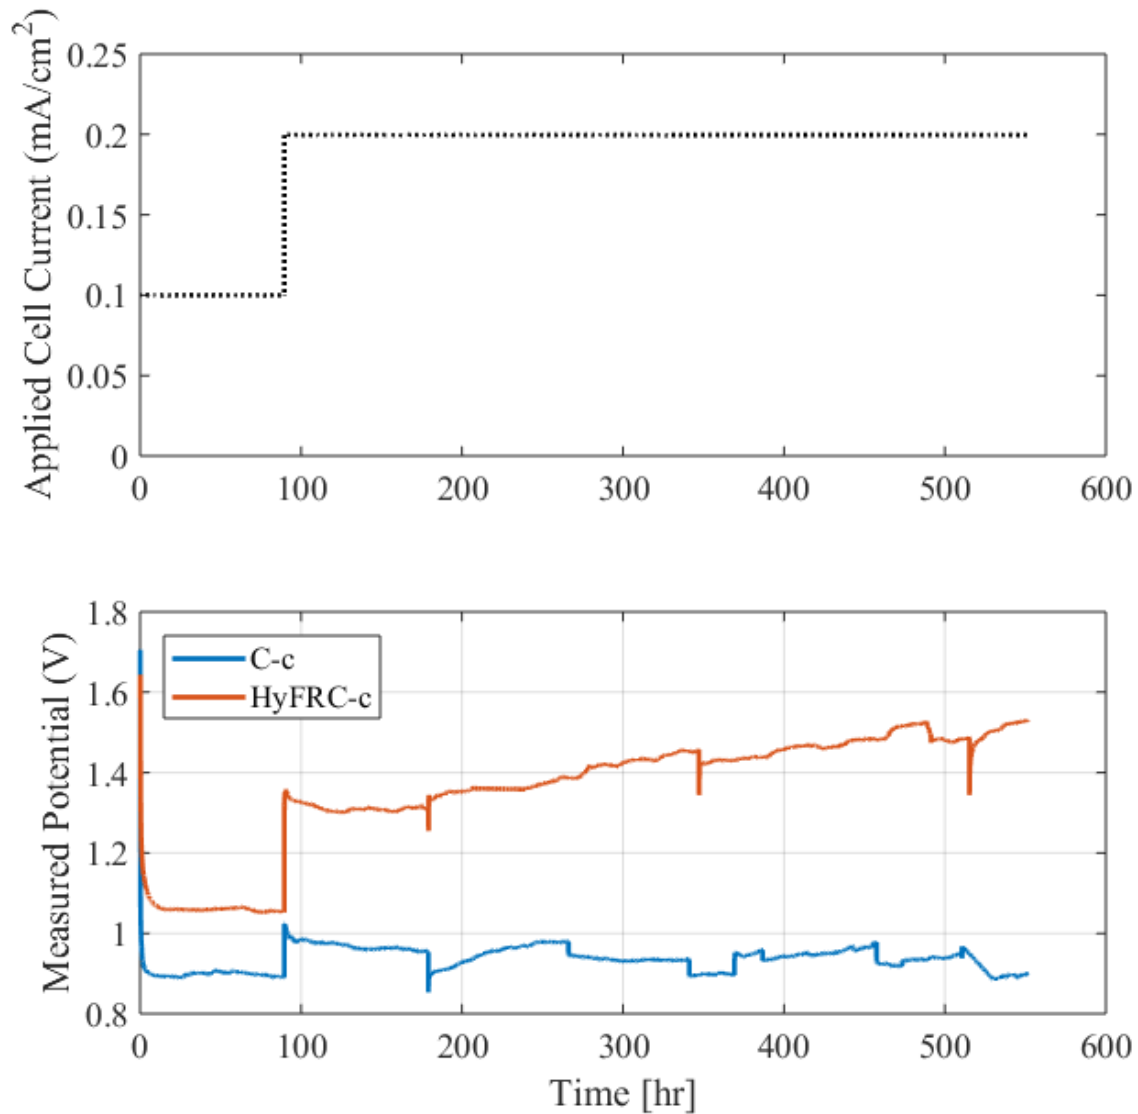
Figure 5 - 5: Applied current vs time (a) and the measured potential vs time (b) for HyFRC-c and C-c columns.

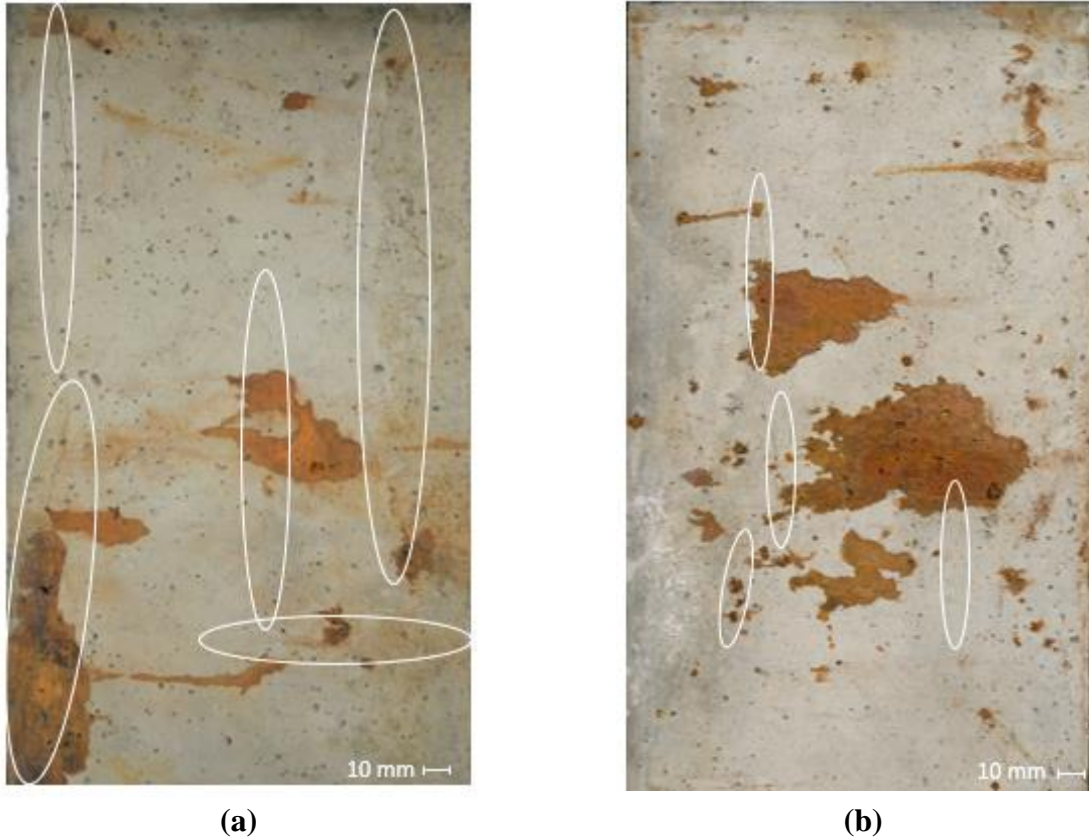
Figure 5 - 6: Surface cracking and corrosion egress following accelerated corrosion for C-c (a) and HyFRC-c (b) at the end of the accelerated corrosion test.

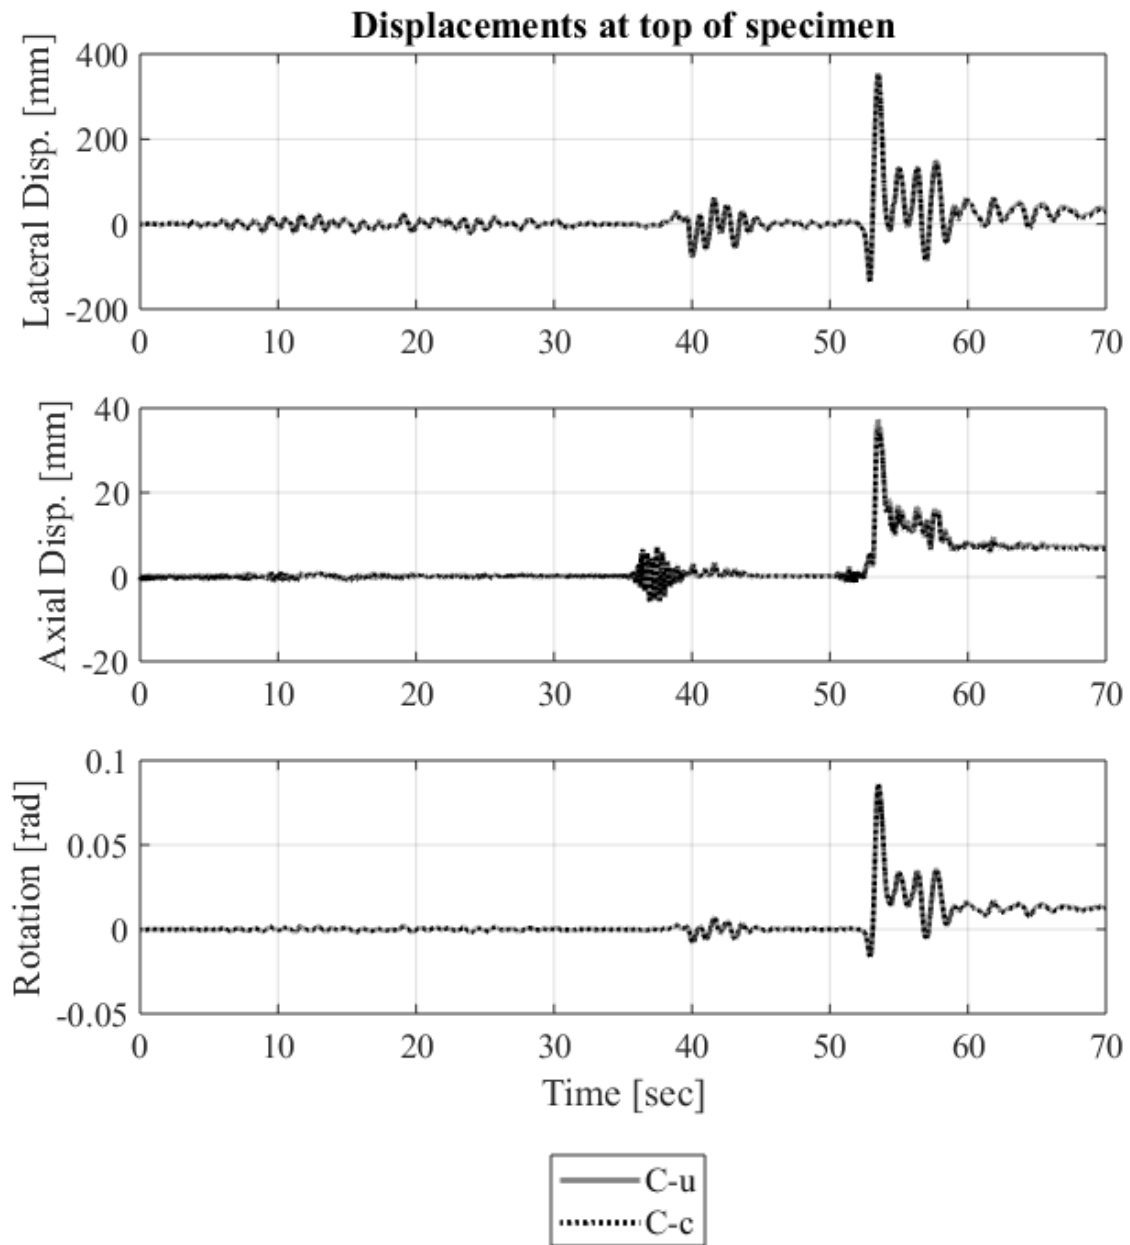
Figure 5 - 8: HS displacement history at control point for C specimens.

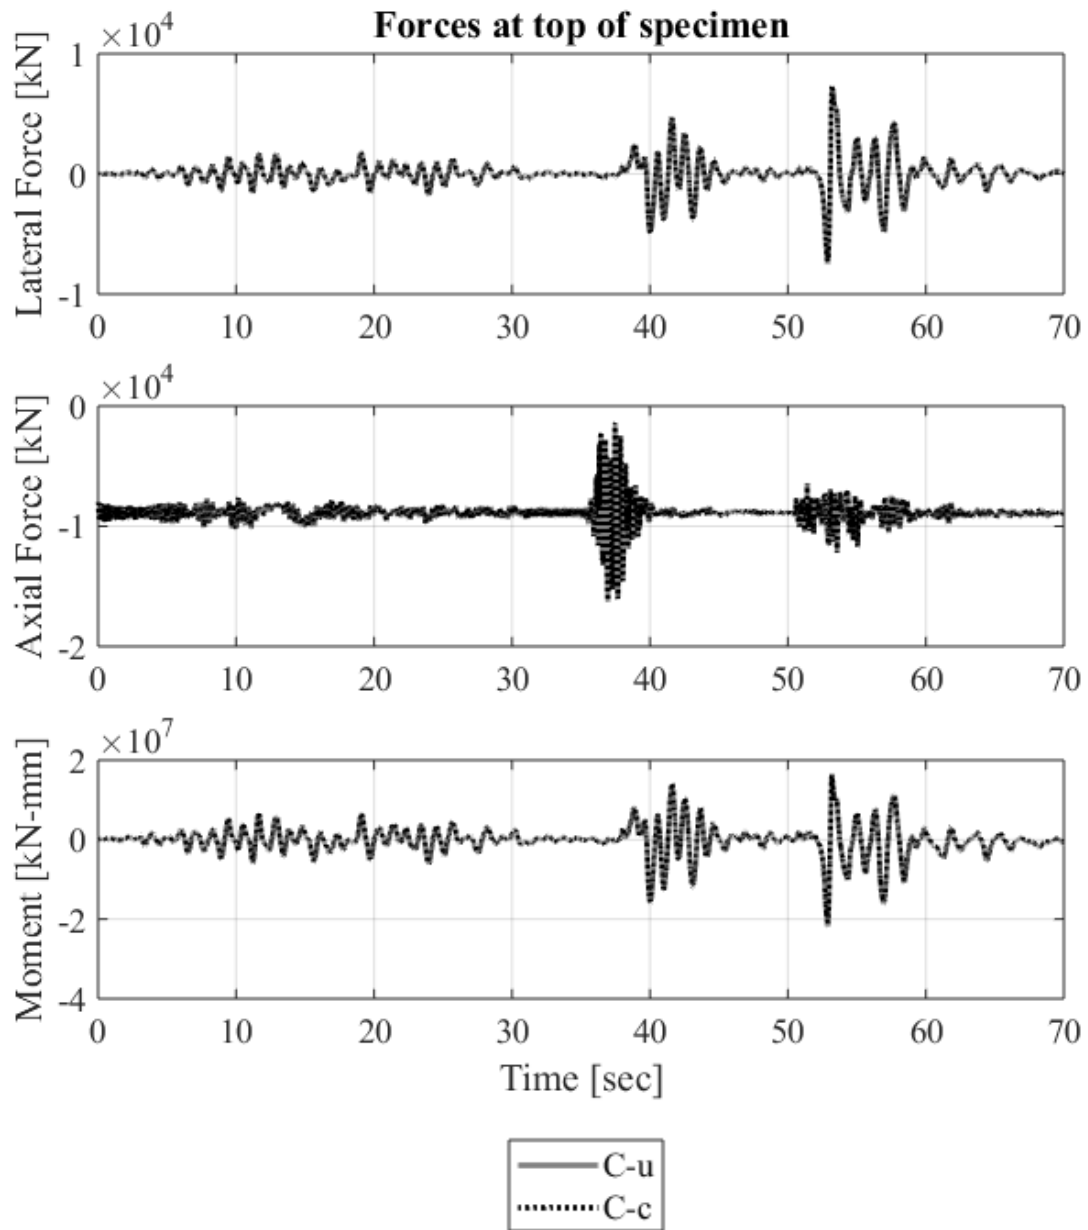
Figure 5 - 9: HS force history at control point for C specimens.

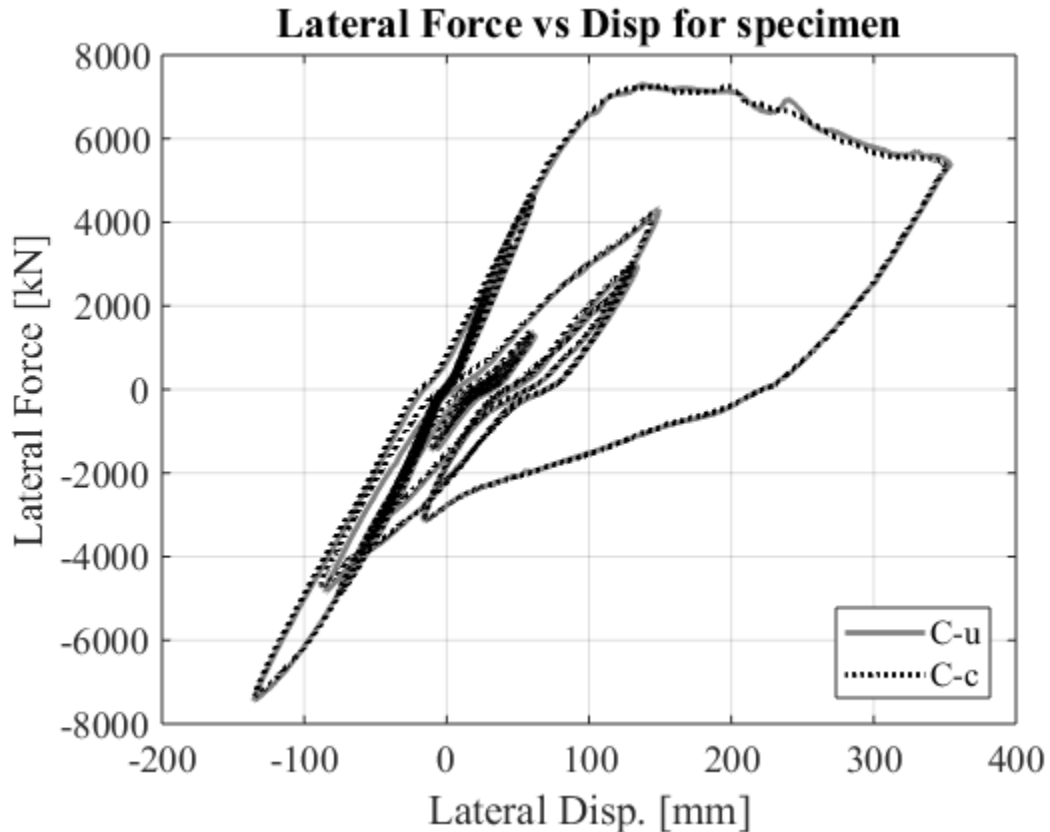
Figure 5 - 10: Force versus displacement at control point for C specimens.

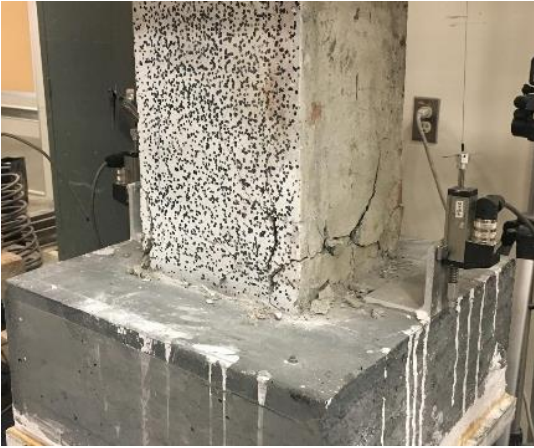
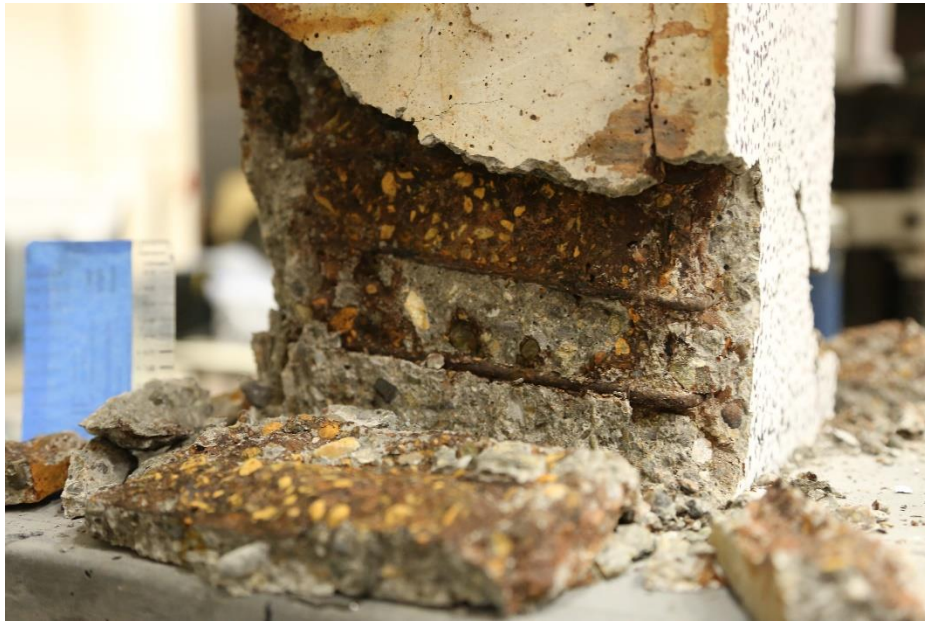
The results of HS show that the corrosion damage induced in this experiment did not have a distinguishable effect on the seismic performance of the columns. While it is possible that the level of corrosion damage was insufficient to create a large difference in performance, it is more likely that the method of attachment of the experimental specimen to the test frame was insufficient and dominated behavior while the column remained elastic. Some slight differences are observed in the inelastic behavior of the major pulse, but the ultimate displacement and softening curve seem to demonstrate that behavior of specimen is not dominated by the specimen itself, but rather governed by the flexibility of the test setup. The columns did observe permanent deformations following the large displacements of GM3 as seen in Figure 5 - 8. Both columns experienced spalling in the plastic hinge region of the column. The cover material was delaminated and was removed by hand following HS. Images of the damaged columns are shown in Figure 5 - 11.

Figure 5 - 11: Damage to C columns following HS: C-u (a), C-c (b), C-c with cover removed (c).

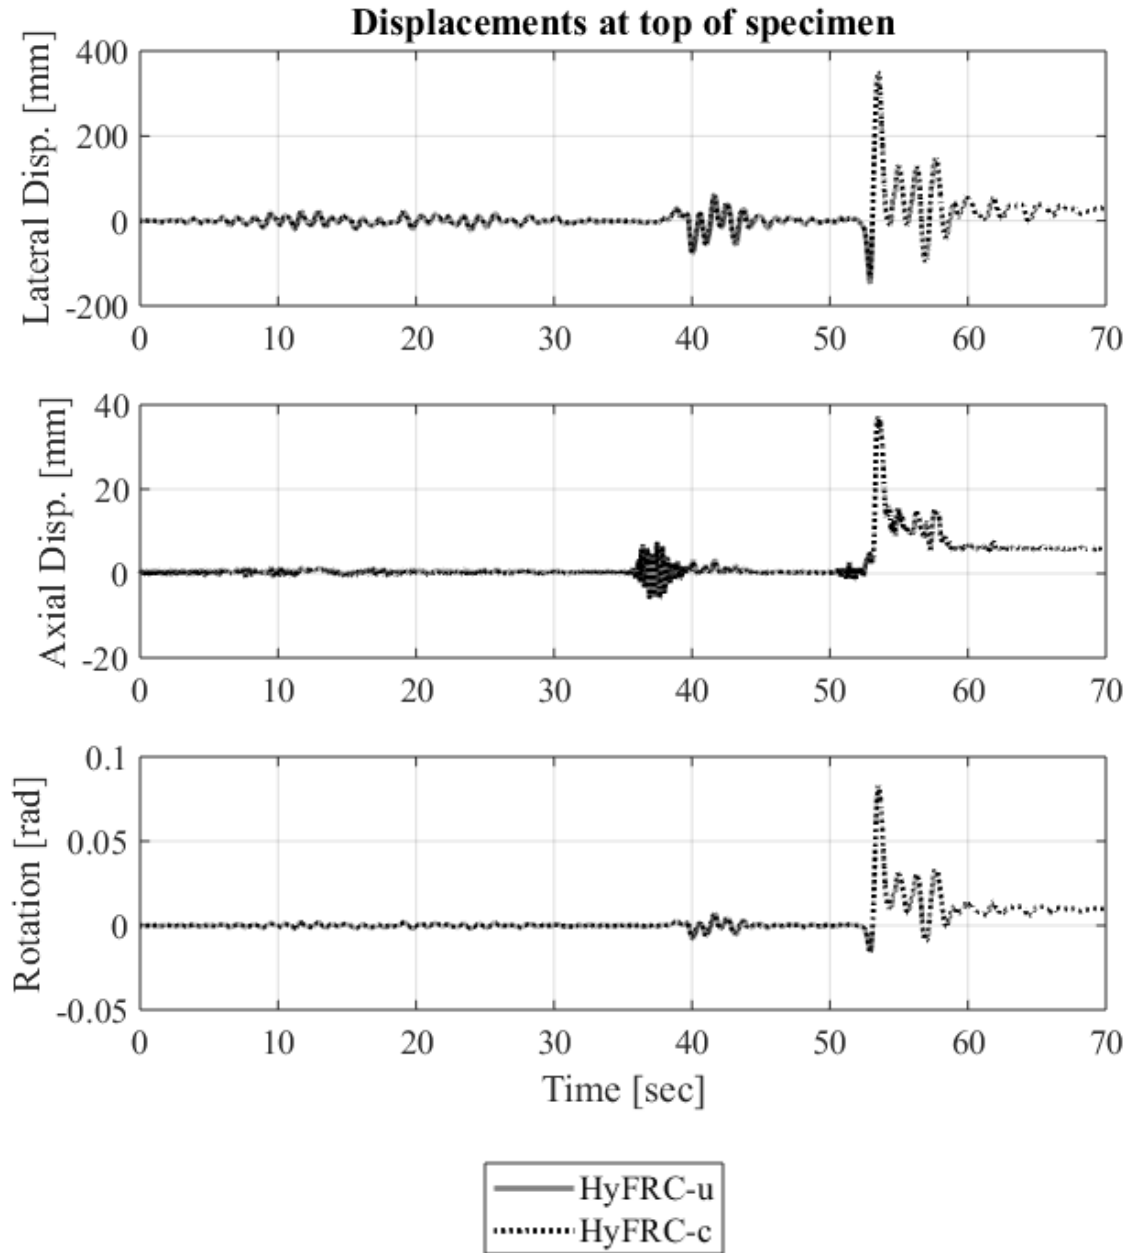
Figure 5 - 12: HS displacement history at control point for HyFRC specimens.

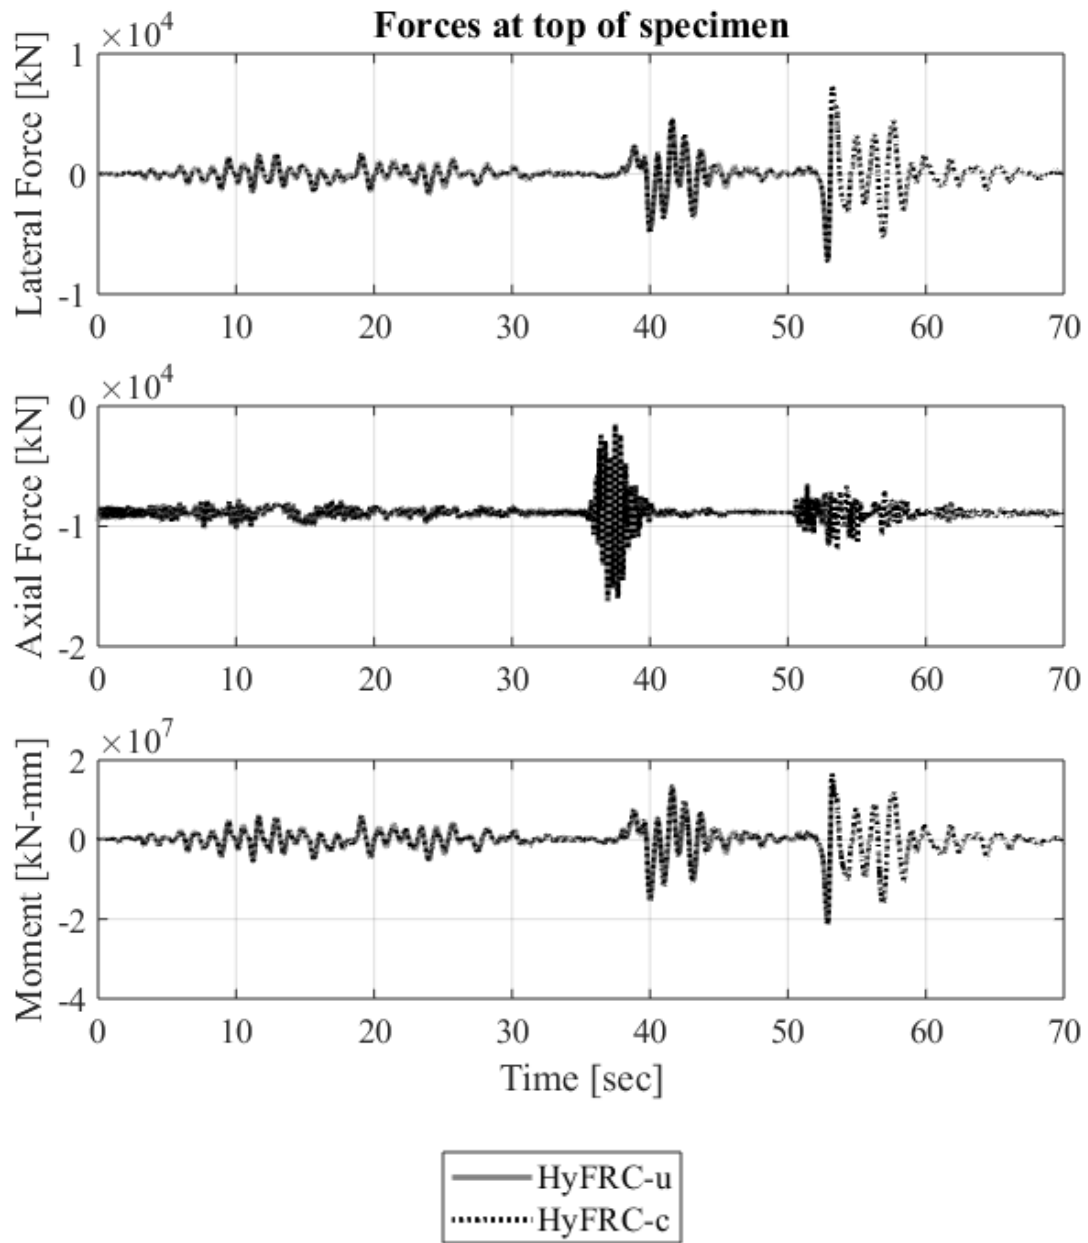
Figure 5 - 13: HS force history at control point for HyFRC specimens.

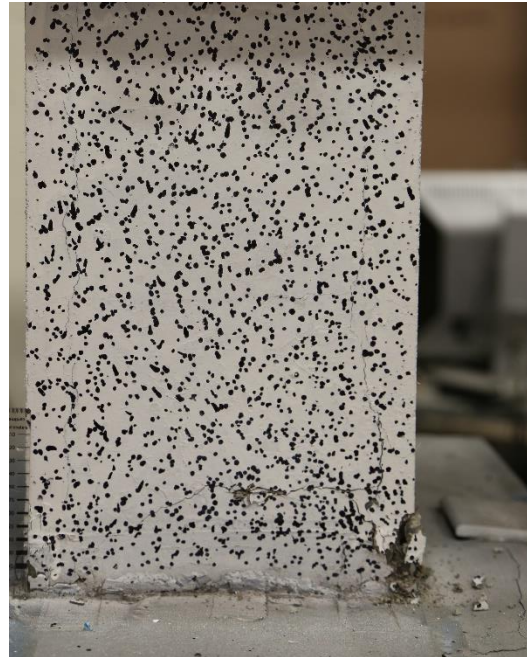
(b)

Figure 5 - 15: Damage to HyFRC columns following HS: HyFRC-u (a) and HyFRC-c (b).

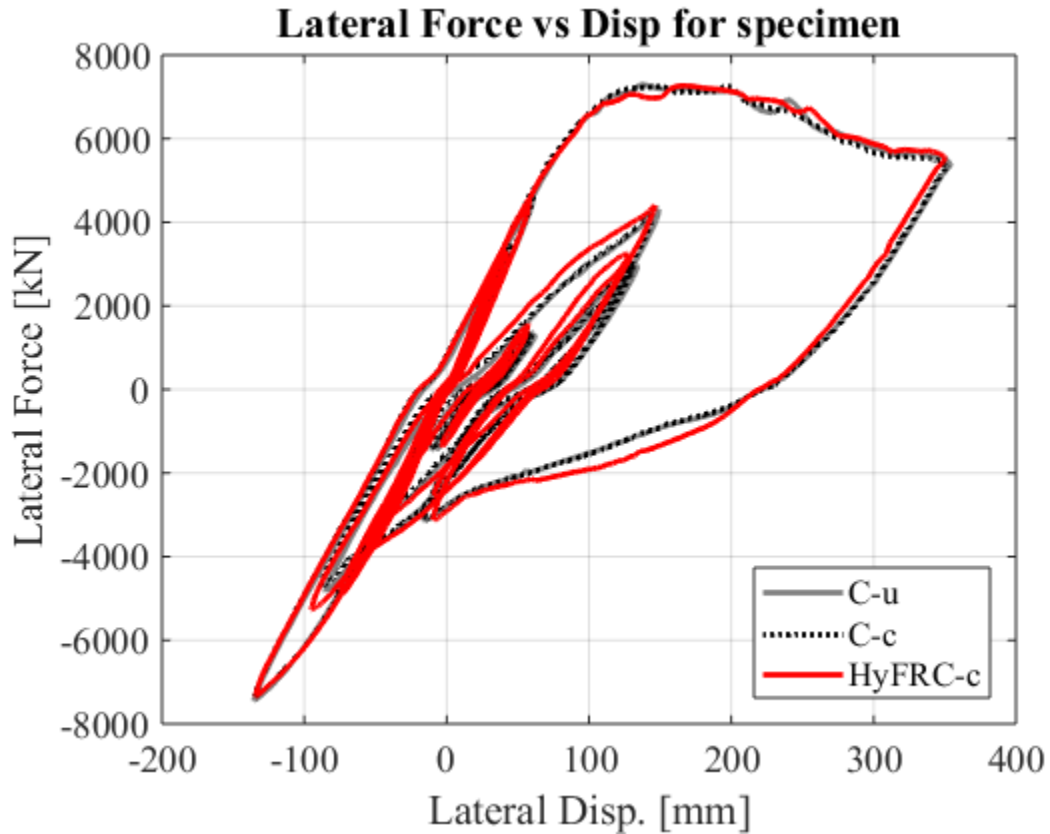
Figure 5 - 16: HS force versus displacement at control point for C-u, C-c and HyFRC-c specimens.

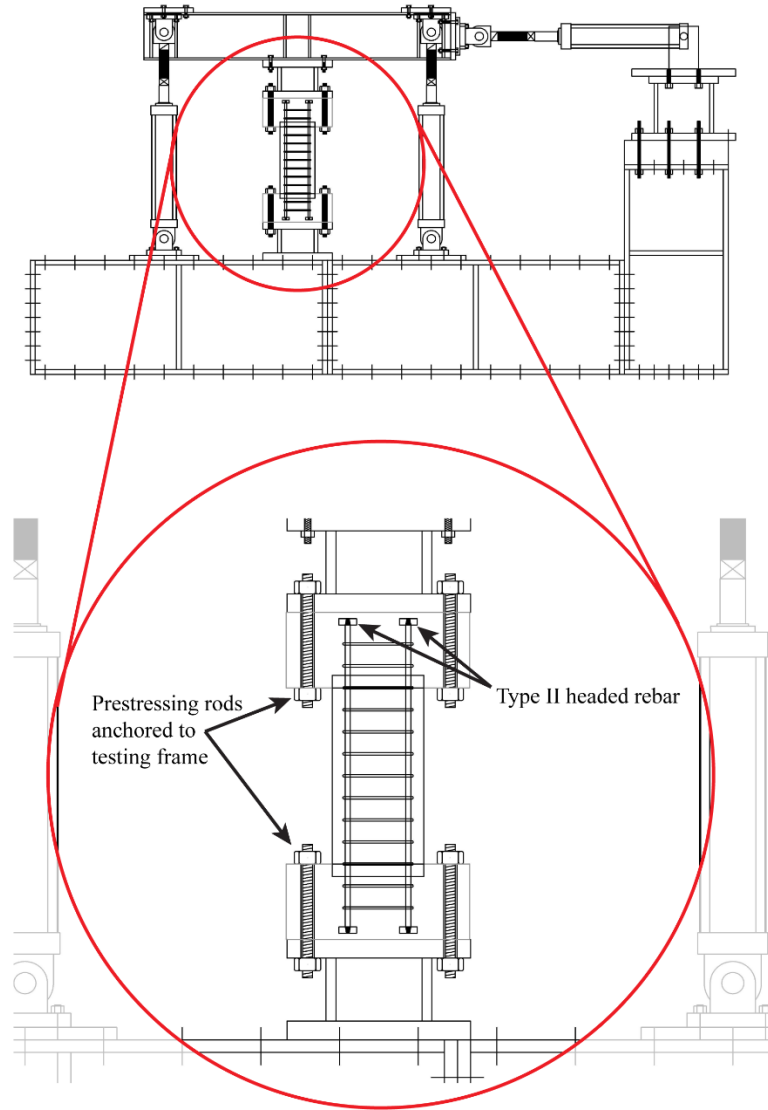
Figure 5 - 17: Updated test specimen would allow for a more rigid connection between the test frame and the experimental specimen (Drawing courtesy of Ian Williams).

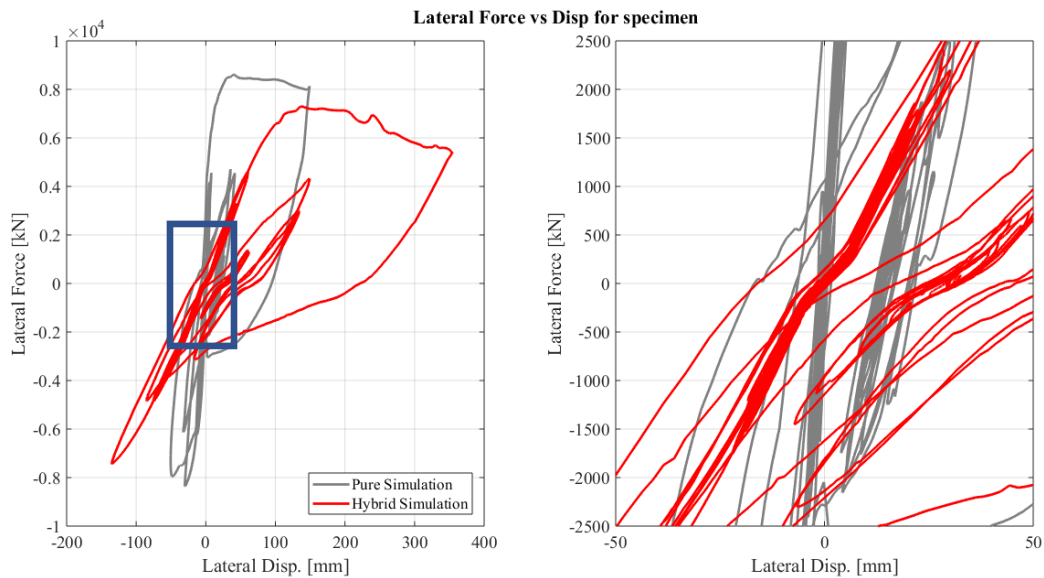
Figure 6 - 1: Lateral force versus displacement for HS and nonlinear analytical simulation.

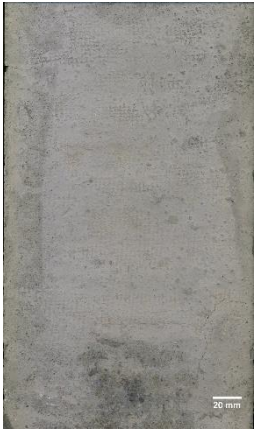
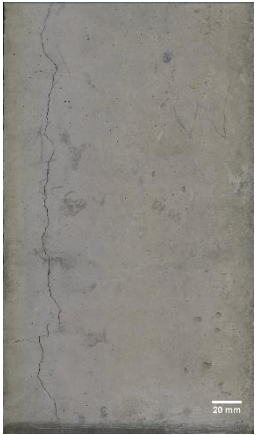
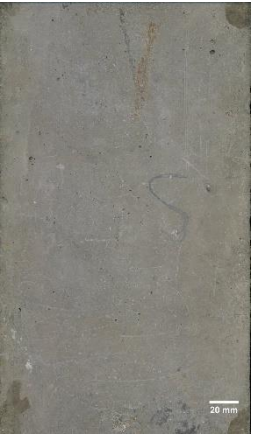
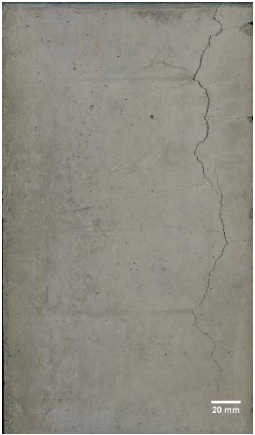
A - Top Surface	B- Lateral Surface	C - Bottom Surface	D- Lateral Surface
C-a

A-1: Individual Column Surfaces at Conclusion of Corrosion Exposure.
