Evaluating the Effects of Vortex Rock Weir Stability on Physical Complexity: Penitencia and Wildcat Creeks

Completed for LA 227 River Restoration
Fall 2007

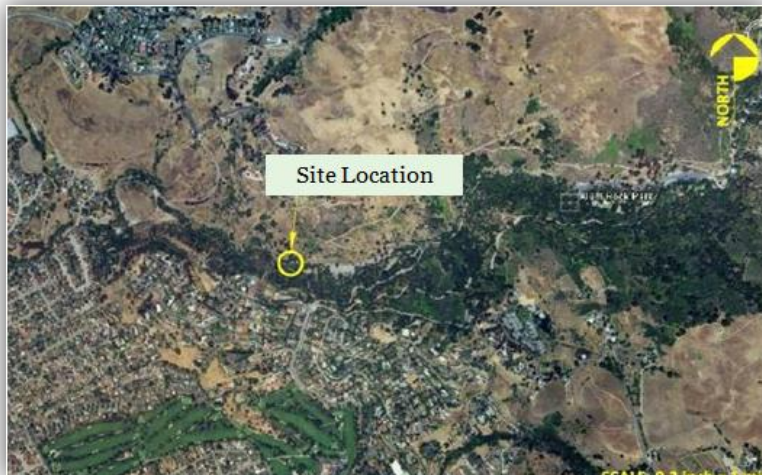
Figure 6. Penitencia Creek site location map.

The Penitencia Creek restoration project is located near the transition of the creek out of the Diablo Mountain Range foothills onto its (prior to development) alluvial fan, as shown in Figure 6. The 2-year event and 100-year event are estimated to be 360 cfs and 4,050 cfs, respectively with lower summer base flows of approximately 0.5 cfs. The approximate slope in this restoration reach is 3.5%.

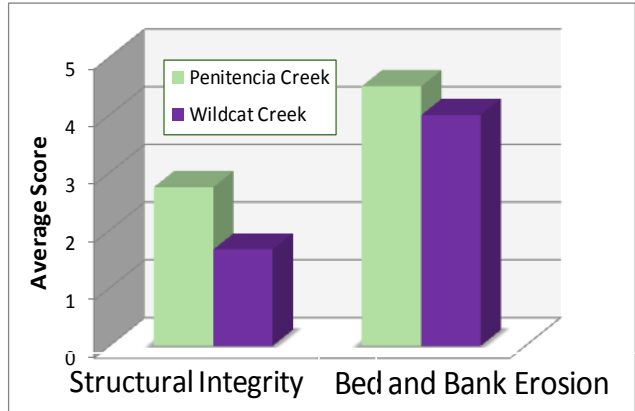
Table 1 presents a summary of the stability criteria scores. The scores for both structural integrity and bed and bank erosion were higher for Penitencia than for Wildcat Creek.

Figure 8. Average structural stability scores for Penitencia Creek and Wildcat Creek.

The reach level stability scores are higher at Penitencia Creek (7.25) than at Wildcat Creek (5.67), which is a possible cause for the higher complexity at Penitencia Creek and the dissimilarity between variance calculations at each weir on Wildcat Creek. This indicates a potential correlation between vortex rock weir stability and physical complexity. Further investigations which would increase the data set used for comparison may increase confidence in this correlation. The dissimilarity between the weirs on Wildcat Creek, in terms of variance "predictability" captures the effect of weir degradation. Complexity differences between each of the weirs is predicted as the rocks in the weir are displaced, erode, or are moved downstream at varying rates depending on specific site factors. The degradation of the weirs unpredictably influences water movement around the structure and decreases development of the downstream pool. The dissimilarity of variance measurements at Wildcat Creek captures this phenomenon.

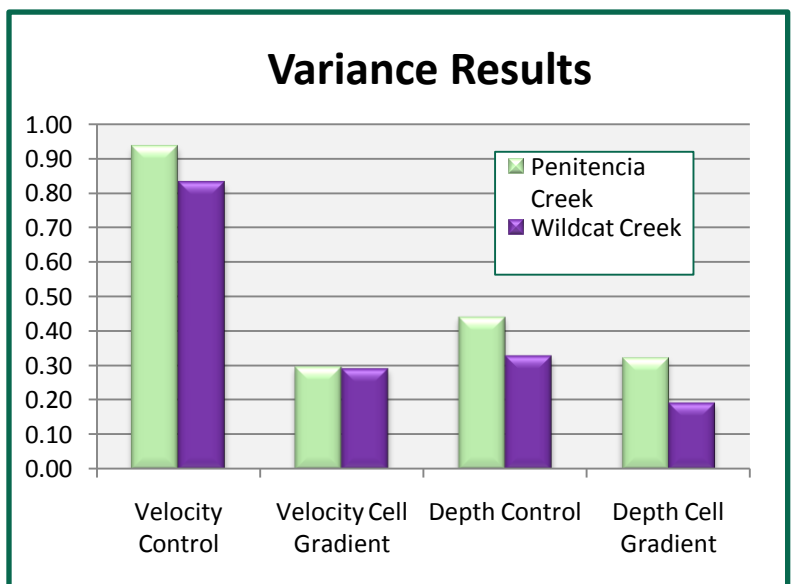
The primary mechanism for determining physical complexity used two methods of variance calculation, one by calculating the variance as a measure of depth and velocity gradients across adjacent cells and the second by calculating variance compared to the control. In other words, the first method compares each cell's values to the values around it and the second method compares the cell to the expected values if the reach contained no complexity at all. Figure 15 presents the results for these calculations on a weir and reach basis. For the entire Penitencia Creek reach, the velocity and depth cell variance

Figure 15. Physical Complexity Variance Results

between cells are $0.3 \text{ ft}^2/\text{s}^2$ and 0.32 ft^2 , respectively. For the entire Wildcat Creek reach the velocity and depth cell variance between cells are $0.46 \text{ ft}^2/\text{s}^2$ and 0.2 ft^2 , respectively. For the entire Penitencia Creek reach the velocity and depth variance, as compared to the control, are $0.89 \text{ ft}^2/\text{s}^2$ and 0.45 ft^2 , respectively, and for the entire Wildcat Creek reach, the velocity and depth cell variance, as compared to the control, are $0.8 \text{ ft}^2/\text{s}^2$ and 0.30 ft^2 , respectively. The variance results in a tabular format are shown below in Table 2.

The variance measurements, used here as a complexity indicator, were higher overall at Penitencia Creek than at Wildcat Creek, indicating the vortex rock weirs at Penitencia Creek create more velocity and depth complexity, as well as a larger amount of vorticity in the flow. Vorticity is proportional to the gradient, or the square root of variance in the flow. The one outlier is the velocity variance, as compared to the cells around it, at weir number three on Wildcat Creek. A single velocity measurement of 3.64 ft/s dramatically influences the variance calculation at this weir. In reflection on our field methods at this location, we have confidence in this measurement, though in future applications we would more carefully standardize our velocity measurements through locations where water quickly accelerates through the weir.

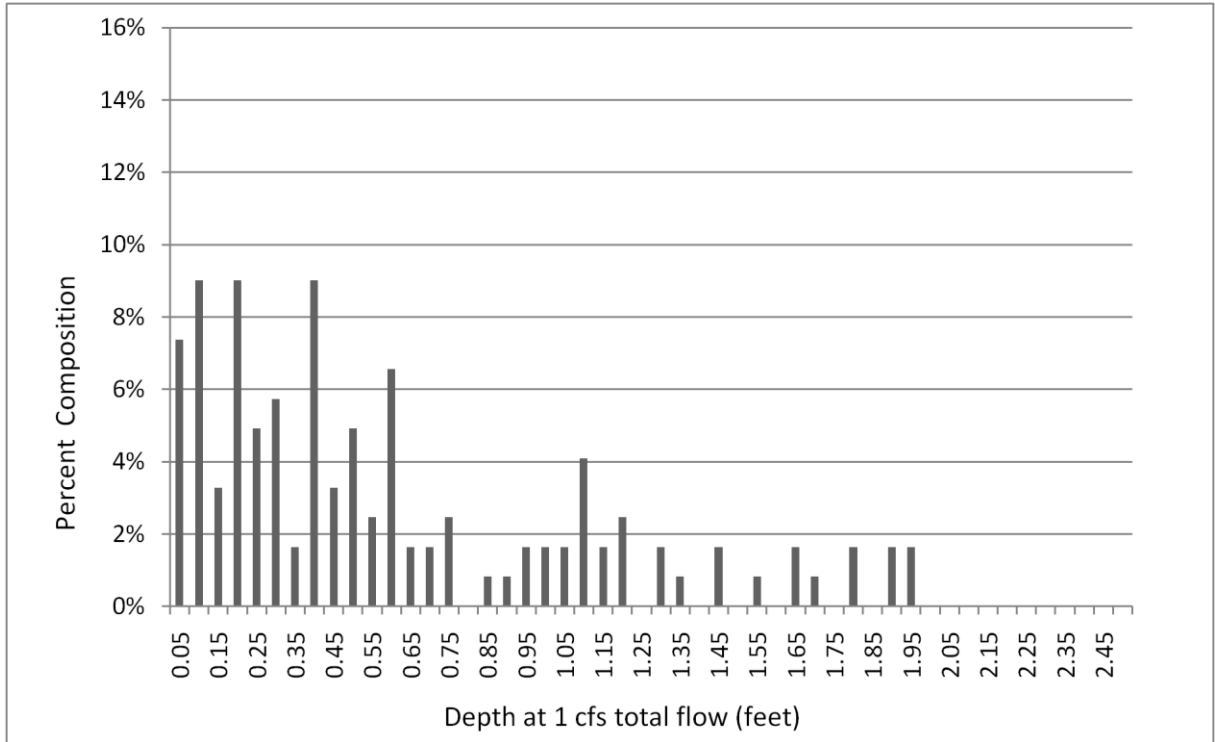
Figure B11: Depth Histogram for Penetencia Creek.

Penitencia Creek has easily observed scour pools directly downstream of each weir, while Wildcat Creek has pools beginning to develop directly upstream of each weir (refer to Figures 13 and 14). The depth histograms show that shallow depths at both sites dominate the creek landscape and that there were very few depths large enough to represent the presence of a substantial pool. The histograms are weighted heavily toward shallow and intermediate depths, and have a well graded, even distribution.

In terms of complexity, and as expected, the results for the two project sites differ from the modeled control channel. The depth histogram for Penitencia Creek shows a high degree of variation, specifically when compared to the control channel.

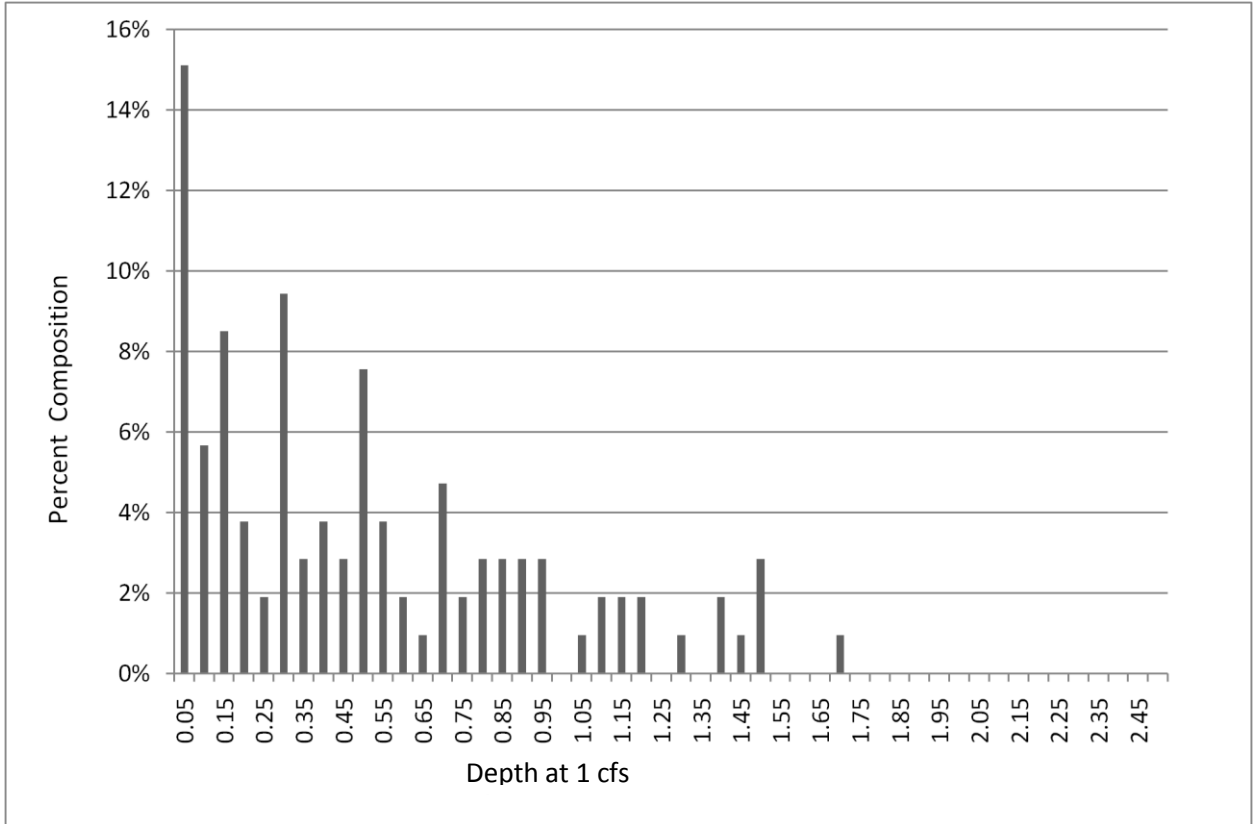
Figure B12: Depth Histogram for Wildcat Creek.

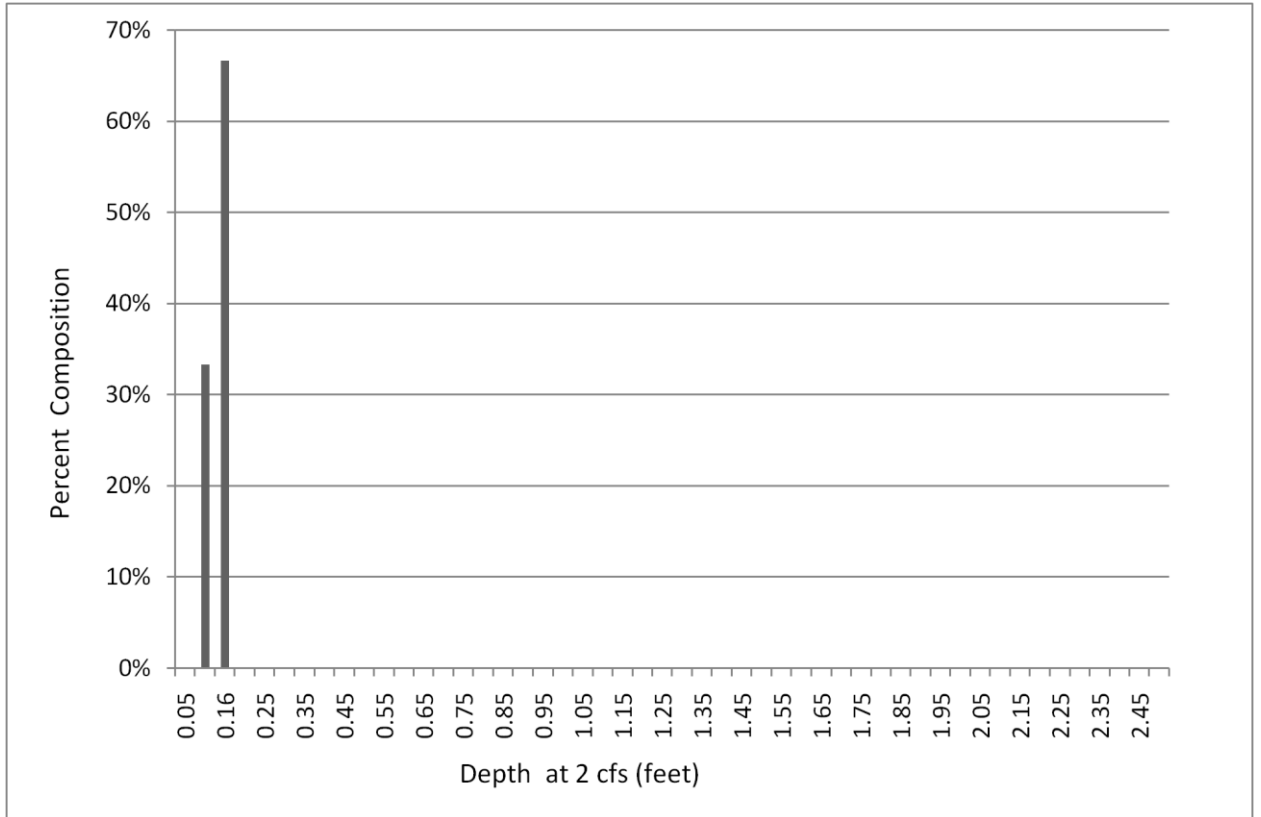
Figure B13: Depth Histogram for the modeled control channel.

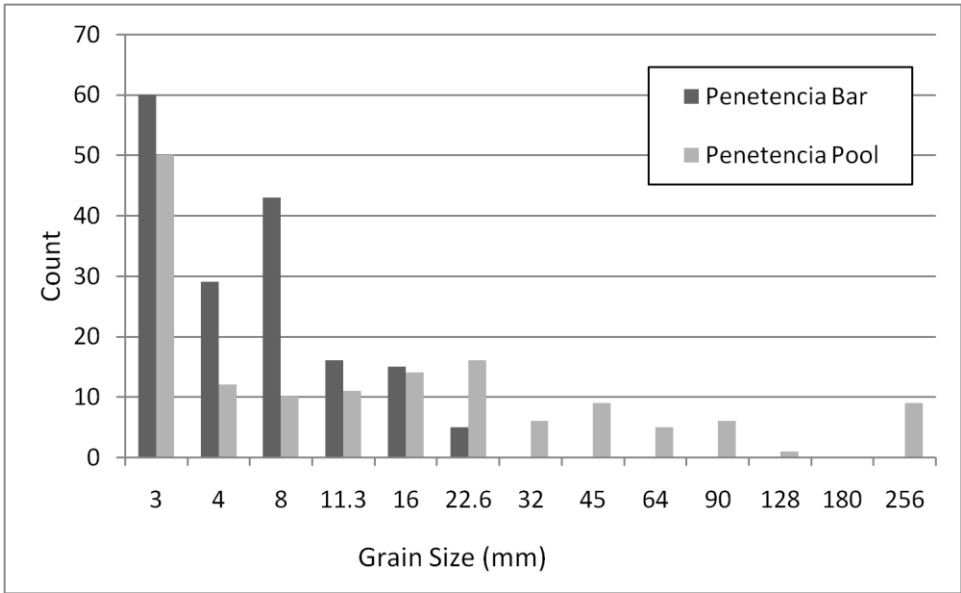
The pebble count results for Penitencia Creek's pools and riffles gave D_{50} values of 1.00 inches and 0.35 inches, respectively, with 34-39 percent of the sample and 45-50 percent of the deposition bar sample smaller than 6.35 mm. Wildcat Creek's pool and riffles had D_{50} values of 0.50 inches and 0.40 inches, respectively, with 39-46 percent of the pool sample and 50-60 percent of the deposition bar sample size below the threshold of 6.35 mm. Grain size distributions for Penitencia and Wildcat Creek, are also included in Appendix B.

Figure B14: Surface grain size distribution for Penetencia Creek.
