ENGINEERING RECONNAISSANCE FOLLOWING THE AUGUST 24, 2016M6.0 CENTRAL ITALY EARTHQUAKE

GEER Association

2017

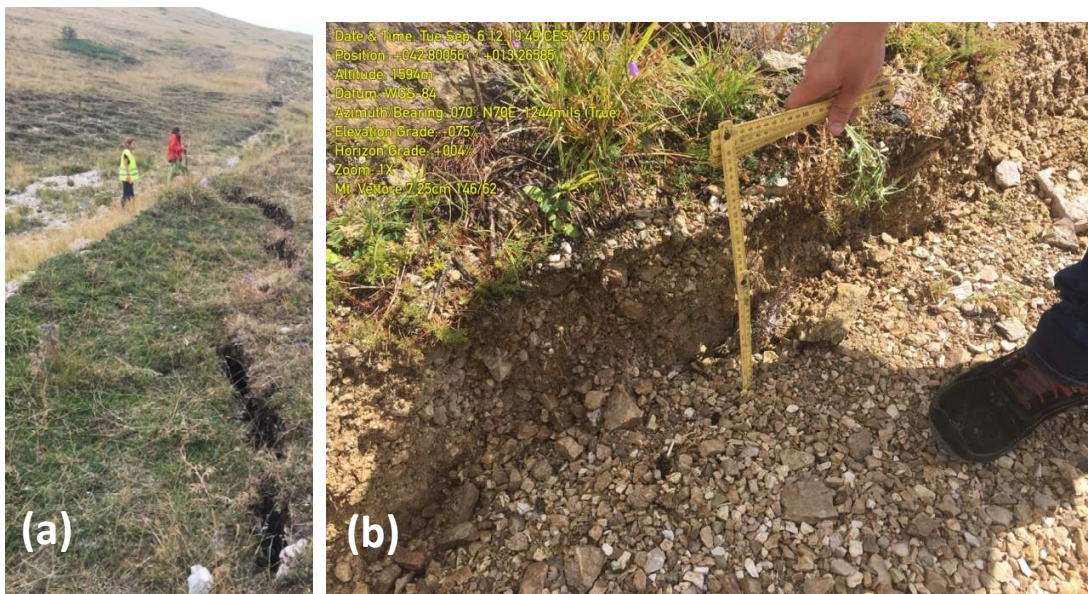
**Fig 3** – (a) photographs of surface rupture on trace of Mt. Vettore fault (N42.79953, E13.26634, 5 September 2016) and (b) typical measurement (N42.8056, E13.26585, 6 September 2016).
