Under the Boardwalk - Case History - St. John's Sideroad at the McKenzie Wetland, Aurora, Ontario, Canada

## **UNDER THE BOARDWALK – CASE HISTORY – ST. JOHN’S SIDEROAD AT THE MCKENZIE WETLAND, AURORA, ONTARIO, CANADA**

**Ian D. Buchanan** (905-830-4444, ian.buchanan@york.ca), Manager, Natural Heritage and Forestry Services, and **Dino Basso, P.E.**, Regional Municipality of York, 17250 Yonge Street, Newmarket, Ontario L3Y 7E2, Fax: 905-895-7735 Canada

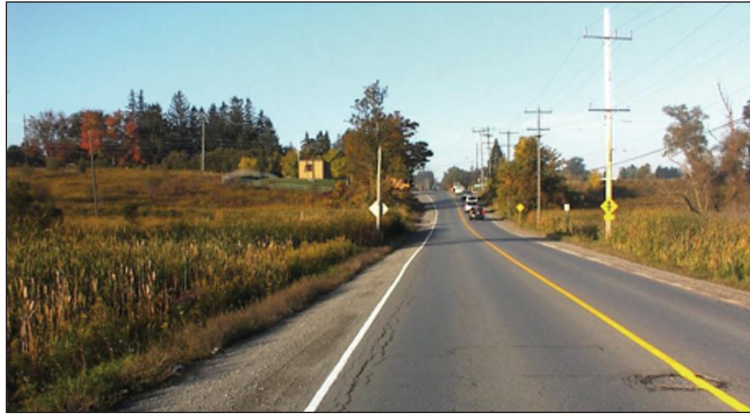
As a result of increased traffic volumes due to highly active residential development in the area, the existing two-lane rural road section could not meet the needs of the growing population (figure 1). In response to the proposed development growth in the Town, the Class Environmental Assessment study undertaken for the project identified that additional roadway capacity was needed, and recommended that this section of roadway be widened to a four-lane urban cross-section.

Figure 1. St. John’s Sideroad prior to construction looking west across the McKenzie Wetland.

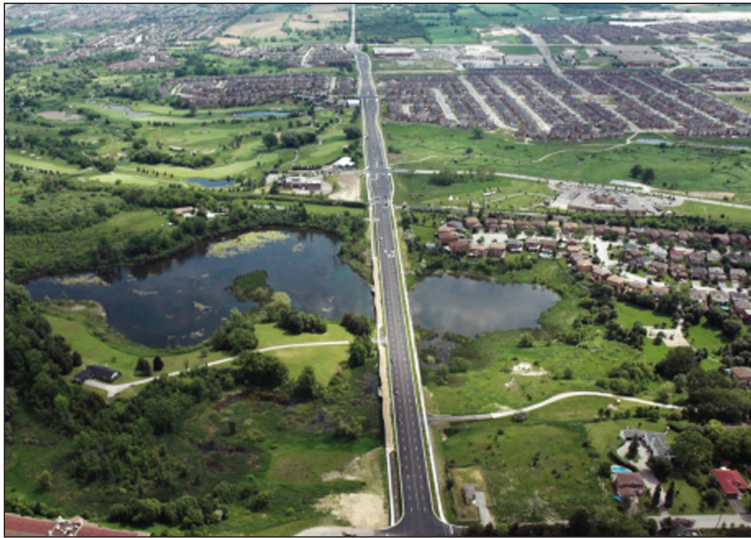
This \$20 million project presented several challenges that in turn provided opportunities to develop unique design approaches. This project complimented the surroundings by being sensitive to both the natural environment, while enhancing the communities enjoyment of the area (figure 2).

Figure 2. Aerial view of the St. John's Sideroad project post construction, looking eastward.

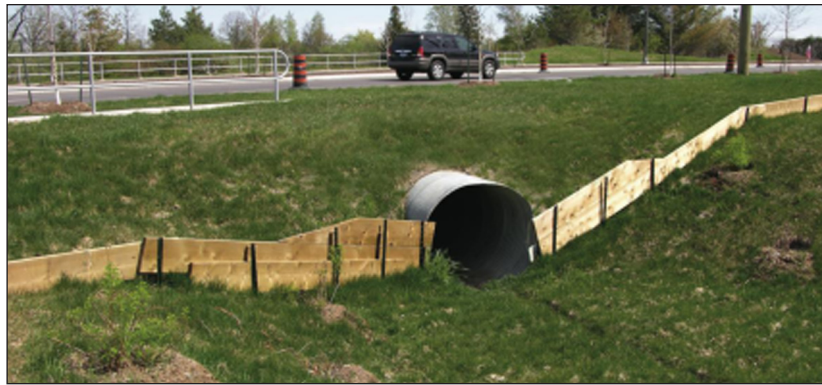
This project provided for the protection of both wetland and upland habitats, while increasing the opportunity for the unobstructed movement of fish and wildlife through the variety of culverts placed under the road bed. These culverts provide an alternative means for animals to gain safe passage from one side of the road to the other while reducing the incidence of wildlife loss from roadkill. Three culverts (two wet and one dry) were incorporated into the design of the road through the marsh. The dry culvert, having a diameter of 1.2 m was installed with drift fencing at both ends and strategically situated on higher ground just east of the wetland (figure 4).

Figure 4. Dry culvert at McKenzie Wetland with drift fencing to direct wildlife movement.

The project included the installation of a 1.2 m CSP culvert in a terrestrial location. The culvert was installed with permanent drift fencing at both ends. It was noted that the drift fencing was not functioning at 100% efficiency due to a gap in the fencing at the culvert interface. This situation was corrected following the 2006 survey. A Digital Game Camera (Model IR-3BU) was obtained from Leaf River Outdoor Products. The camera works with an infra-red sensor and motion detector, and set up to take pictures day or night and store them on a Compact Flash Card (512MB). At night an infra-red flash, invisible to animals, is used to illuminate the image while not disturbing the animals. The camera was in place from August 11th until October 10th, 2006 (60 days).

Certainly the dry culvert is working for wildlife passage as indicated by a well worn trail leading to and from the culvert.. In 2007 it is hoped to deploy the camera earlier in the Spring to hopefully capture reptile and amphibian migration. In addition, it is suggested that vegetation be planted and or woody debris be placed along the drift fence at the culvert to provide cover for moving wildlife and deter predation.

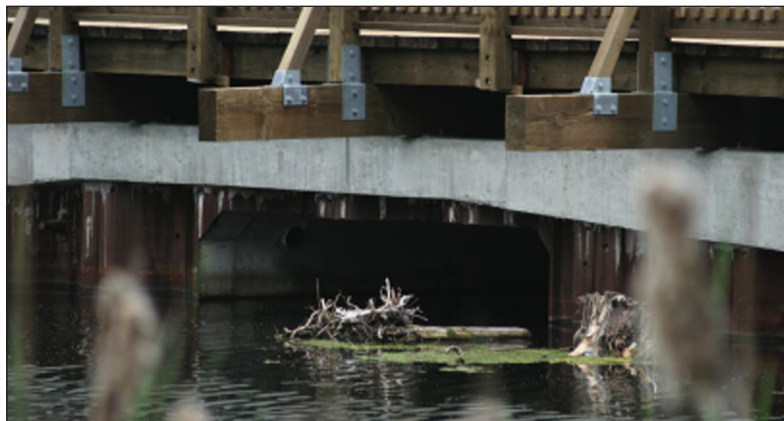
The largest wet culvert is a 4 m-wide concrete box culvert, which replaced a 0.6 m diameter culvert that was too small and often plugged with sediment and debris. The larger culvert allowed fish and other wildlife to move back and forth from one side of the marsh to the other (figure 5). The new structure was deliberately oversized (i.e. it is considerably larger than required for hydrological purposes) so that it would facilitate improved fish and aquatic wildlife passage under the road. The design also included the installation of fish habitat friendly structures called ‘root wads’ which were placed in the open marsh to provide important cover for resident fish. Water quality improvements associated with the project also provided benefits to the fisheries resource.

Figure 5. Wet culvert at McKenzie Wetland for fish, waterfowl, reptile and amphibian passage.

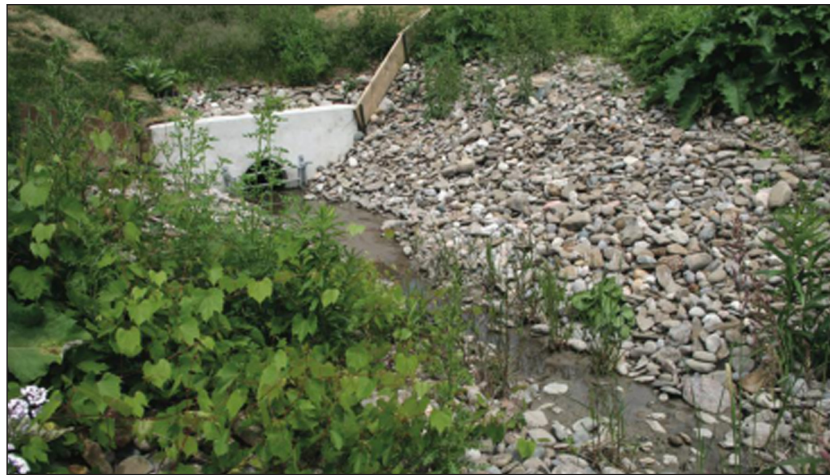
Improvements to water quality and quantity were achieved through the installation of storm water management structures which included an integrated system of curbs and gutters, an oil grit separator and the use of infiltration swales (figure 6). Each of these storm water management components improves the quality of water before it enters the wetland. The system of culverts underneath the road not only improve wildlife and fish passage, but serve to re-connect the water flow from the north and south sides of the wetland and balance water levels. These improvements in water quality and connectivity are vital to sustaining a thriving wetland and its inhabitants.

Figure 6. Storm water outfall retrofit to promote infiltration.

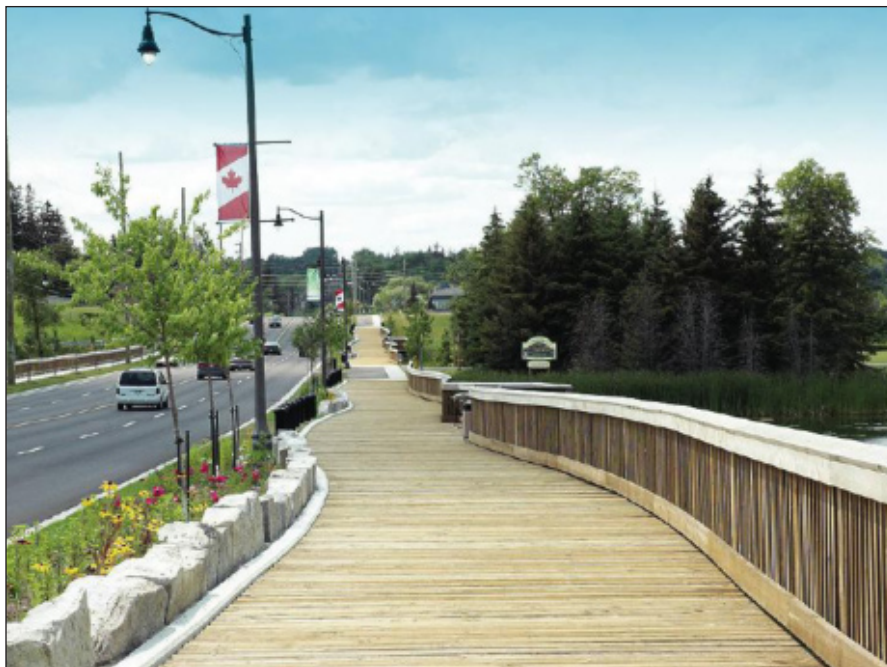
To accommodate these highly valued and traditional human uses of the area, while avoiding direct intrusion into the sensitive wetland ecosystem, a 3.6 m wide timber boardwalk has been constructed along the north side of the road through the wetland (figure 7). The boardwalk is used by both pedestrians and cyclists and has viewing outlooks that provide excellent vistas of the wetland. Interpretive signage mounted on pedestals has been placed in strategic locations along the length of the boardwalk to provide visitors with information about the features and functions of the wetland, its ecological significance, and how protection and enhancement of the McKenzie Marsh ecosystem has been incorporated into the design of the road. This boardwalk prevents human access to the wetland itself, provides a safe environment for walking and cycling away from vehicular traffic and has established a key east-west link in the Nokiida Trail System, linking it to the regional Holland River Trail System.

Decorative lighting has been installed to provide safe lighting levels along the boardwalk and incorporates special distribution to prevent light spillage into the wetland which could impact nocturnal wildlife.

Figure 7. Boardwalk, lighting and viewing platform at the McKenzie Wetland looking west.

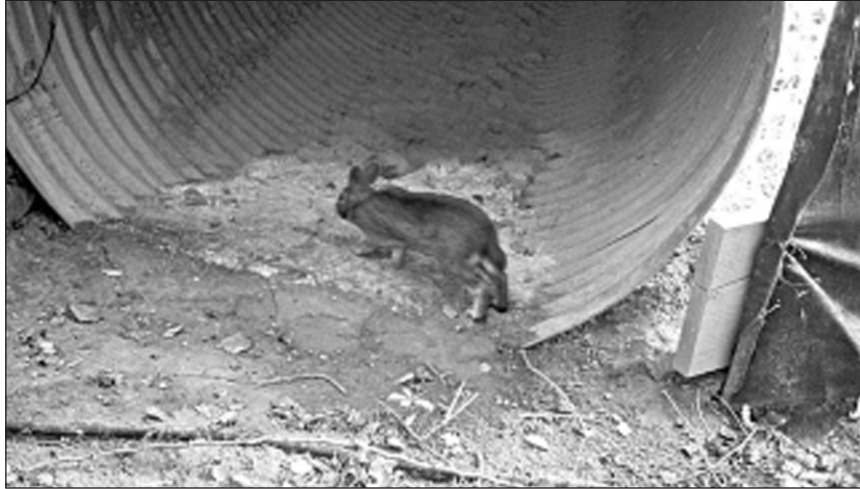
Figure 8. Rabbit at north entrance to dry culvert.

Images captured of animals using the culvert included primarily racoons (10 records), Eastern Cottontail rabbits (3 records), and a singled record of a Red fox. Animals recorded at the entrance to the culvert included groundhogs, Eastern Gray squirrels, domestic cats, American Robin and one inquisitive young boy who appeared to be inspecting the culvert.

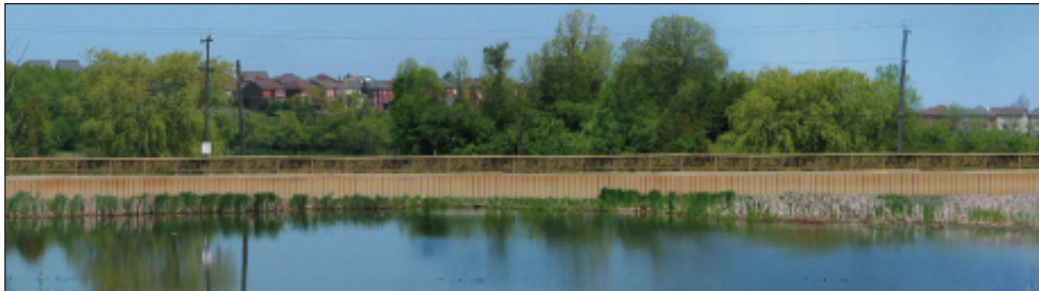
Sometimes it is difficult for members of the community to visualize how the end result of the project might appear and this can lead to unintentional misconceptions by the public. Therefore photo imagery using computer generated renderings was useful in presenting how the proposed work would appear before construction occurred. Figure 9 presents a rendering that was created for the public consultation centres to present the project. The renderings were very useful in easing the concerns of the public towards this project. Also, design input by the community resulted in the project team modifying the cladding/facing of the sheet pile wall with wood planks instead of steel. This was done on the south side of the road that faces the adjacent residential development. Figure 10 is a post construction photograph, demonstrating the accuracy of the computer rendering.

Figure 9. Computer rendering of the proposed road improvements through the McKenzie Wetland.

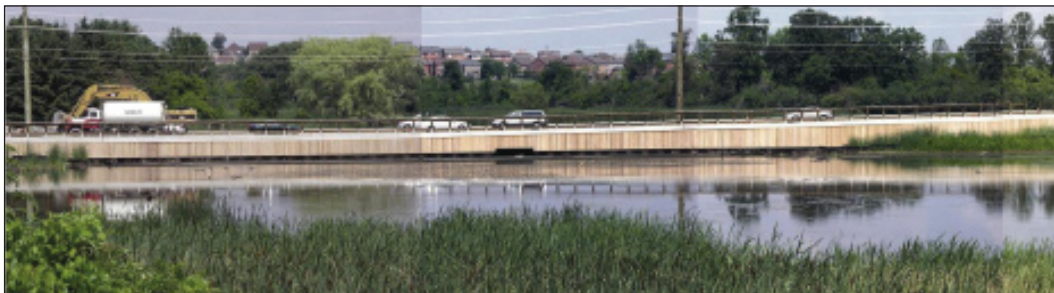
Figure 10. Photograph looking northwards across the McKenzie Wetland to St. John's Sideroad.

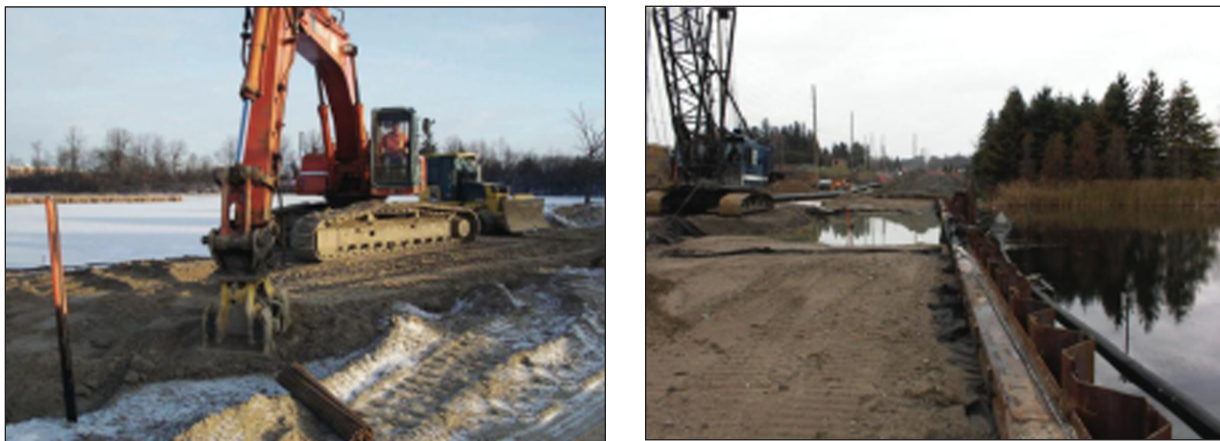
Within the wetland area itself, a surficial zone of peat material was sub-excavated after the pile-driving operation and replaced with clear stone backfill material wrapped in geotextile filter material. This excavation ‘in the wet’ avoided pumping large volumes of water out from behind the retaining wall, and eventually back into the wetland.

Figure 11. Road platform and the sheet-pile retaining wall under construction.

Sheet-pile retaining walls were selected over other retaining wall systems such as gravity or cantilever retaining walls for several reasons. First, due to the consolidation of the sensitive material underlying the road platform, it was necessary to select the lightest structure possible. Second, sheet-pile walls could be driven by equipment positioned on the existing road platform, and therefore disturbance to the wetland by equipment or by workers was avoided. Third, once the sheet-pile walls were driven, they immediately formed a barrier between the construction work zone and the wetland environment for the remainder of the project.

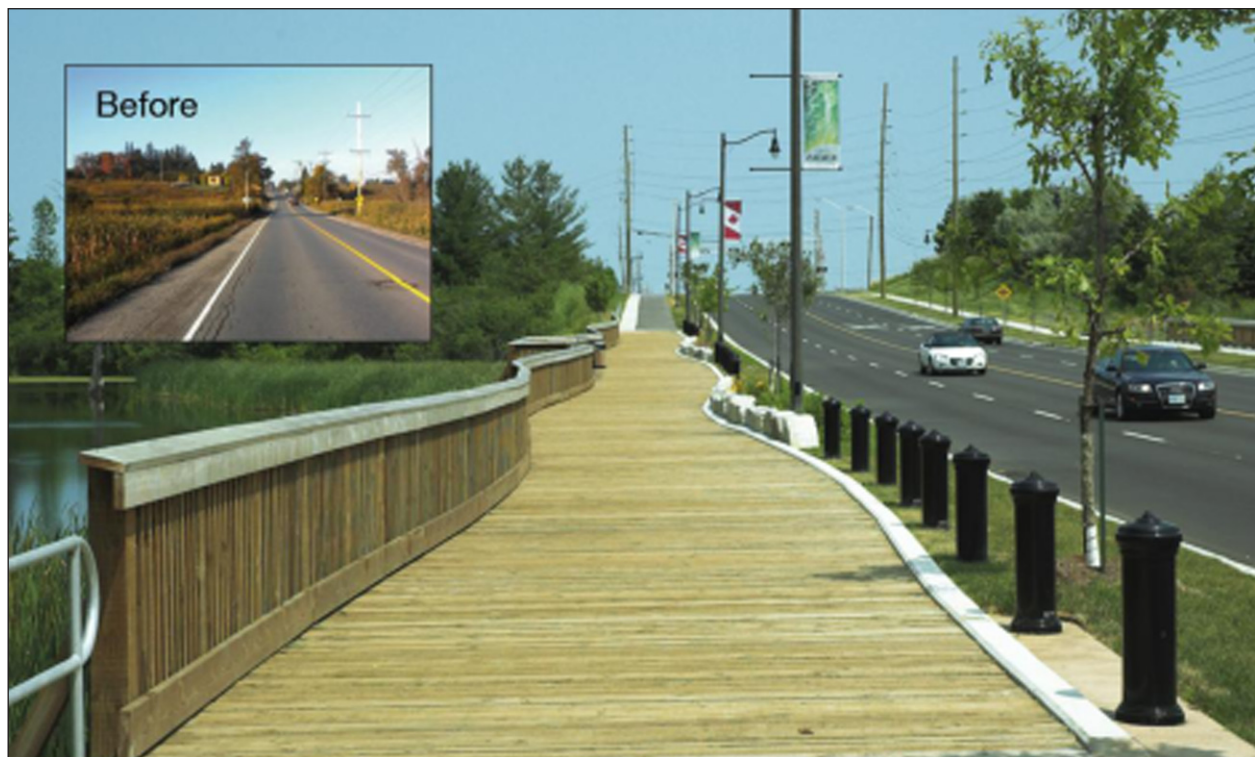
York Region was able to overcome initial resistance to the project from a concerned community through a context sensitive solutions approach and constructive engagement. This project was an opportunity for the design team, in consultation with stakeholders, to include environmental enhancements which recognized the unique setting of the McKenzie Wetland, and to make this project much more than a typical road widening project. As a result of this project, York Region was able to not only protect the sensitive natural environment but enhance it by designing and constructing the infrastructure to address natural environment and social concerns. Overall the road widening and habitat enhancement have served to create an area where local residents and wildlife can safely co-exist side by side (figure 13).

Figure 13. Before and after pictures of the St. John's McKenzie Wetland project.
