Using vegetated strips to manage runoff from Zone 7 Water Agency access roads

Miki Kuroda and Jeff Williams

Final draft

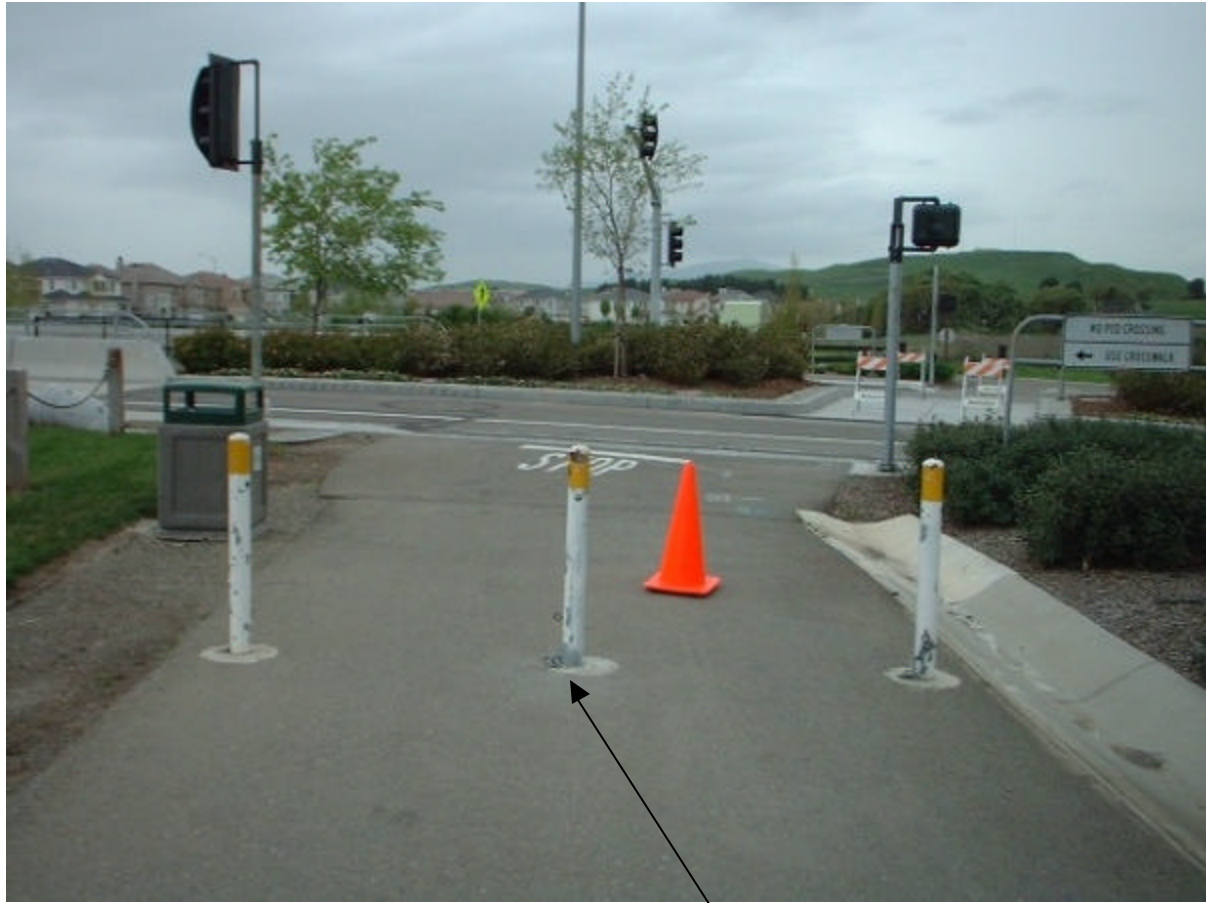
Figure 2: Benchmark site, Tassajara Creek, 3/25/2004

Benchmark site

On March 25, 2004, we surveyed a cross-section of the access road and V-ditch on the east side of Tassajara Creek between Central Parkway and Dublin Boulevard (Figure 1). Using a level and a measuring rod, we measured the elevations at seven stations on the access road and the V-ditch. As a benchmark, we used the bottom of a pylon in the middle of the access road, just south of Central Parkway (Figure 2); we gave this benchmark an arbitrary elevation of 100 feet. We photographed several sections of the access road and its V-ditch for illustrative purposes and to provide a record of their condition.

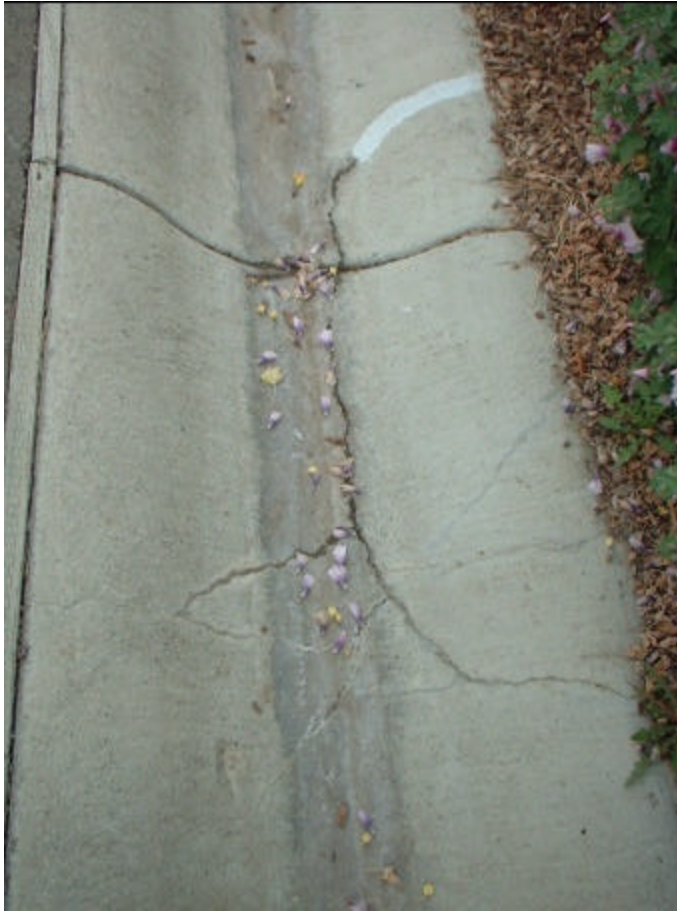
Figure 3: Cracks in V-ditch at Tassajara Creek, 3/25/2004

also found unrepaired cracks in several parts of the ditch, although none of them appeared to pose an immediate threat to the ditch's structural integrity (Figure 5).

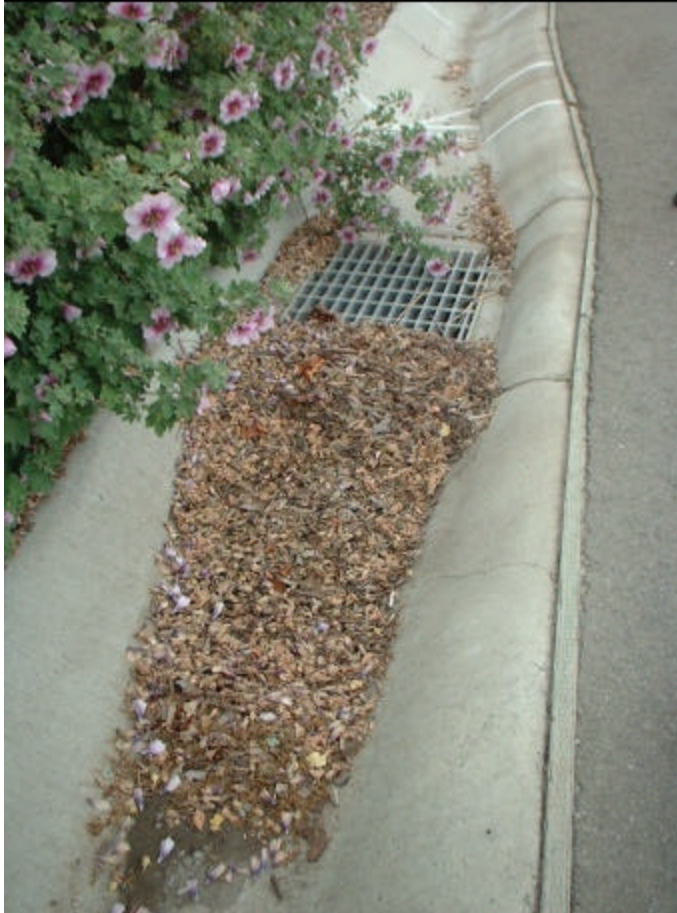
Figure 4: Debris clogging a drainage grate at Tassajara Creek, 3/25/2004

All of the drainage grates in the V-ditch were covered by debris, including leaves, silt, and bark chips from the adjacent landscaping strip. Blankets of leaves covered as much as half of each drainage grate (Figure 4). Also, at several locations along the access road, the V-ditch enters one or two pipes, each with a diameter of 0.5 ft, so that cars can drive from adjacent streets onto the access road. The entrance to each pipe was at least partially blocked by debris (Figure 5). We conducted our observations during the rainy season, so the deposits may have been recent. However, it was not possible to determine how long they had been there or whether they had impeded the flow of runoff during earlier storms.

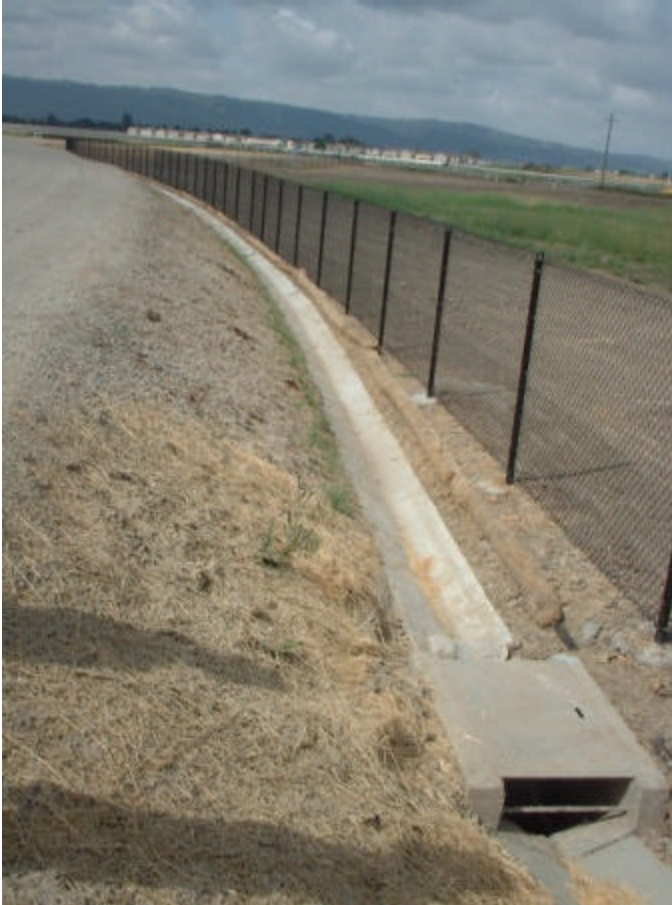
Figure 6: V-ditch partially covered with straw at Arroyo Las Positas, 4/14/2004

At the newly modified reach of Arroyo Las Positas, the access road is approximately 12 feet wide, and its concrete V-ditch is approximately 2 feet wide. We did not observe any cracks or other damage to the V-ditch. During construction of the project, workers had covered a hill adjacent to the ditch with straw to prevent erosion; some of this straw had fallen or been washed into the ditch (Figure 6).

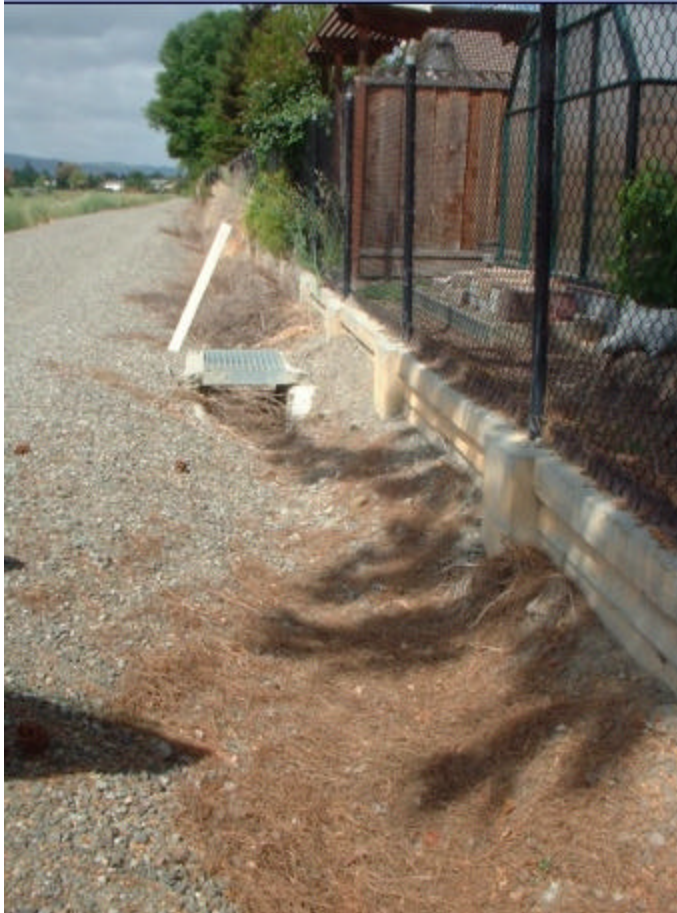
Figure 7: Earthen V-ditch at Arroyo Las Positas, looking downstream, 4/14/2004

The reach that Zone 7 modified in the early 1990s uses an earthen V-ditch, lined with gravel, to convey runoff from the unpaved access road. This V-ditch did not appear to have any vegetation or other material that would hold its banks in place. In many places, the ditch appears to have collapsed, becoming a slight depression in the ground rather than a distinct channel. Figure 6 shows an example of the earthen V-ditch's appearance.

Zone 7's concerns about the maintenance of earthen vegetated strips are understandable, especially considering the degraded state of the unvegetated earthen ditch at Arroyo Las Positas. However, our observations indicate that concrete V-ditches have their own maintenance needs as well; at Tassajara Creek, we saw several cracks that had been repaired in the past and others that would require repairs in the future. Also, the most serious maintenance issue appeared to be debris such as mulch and dead leaves that clogged pipes and drainage grates. Regardless of the material used to build the V-ditch, someone must remove this debris often enough that it does not impede runoff during a storm.
