Shaking Table Evaluation of Reinforced Concrete Bridge Columns Repaired using Fiber Reinforced Polymer Jackets

Pardeep Kumar

Doctor of Philosophy

University of California, Berkeley

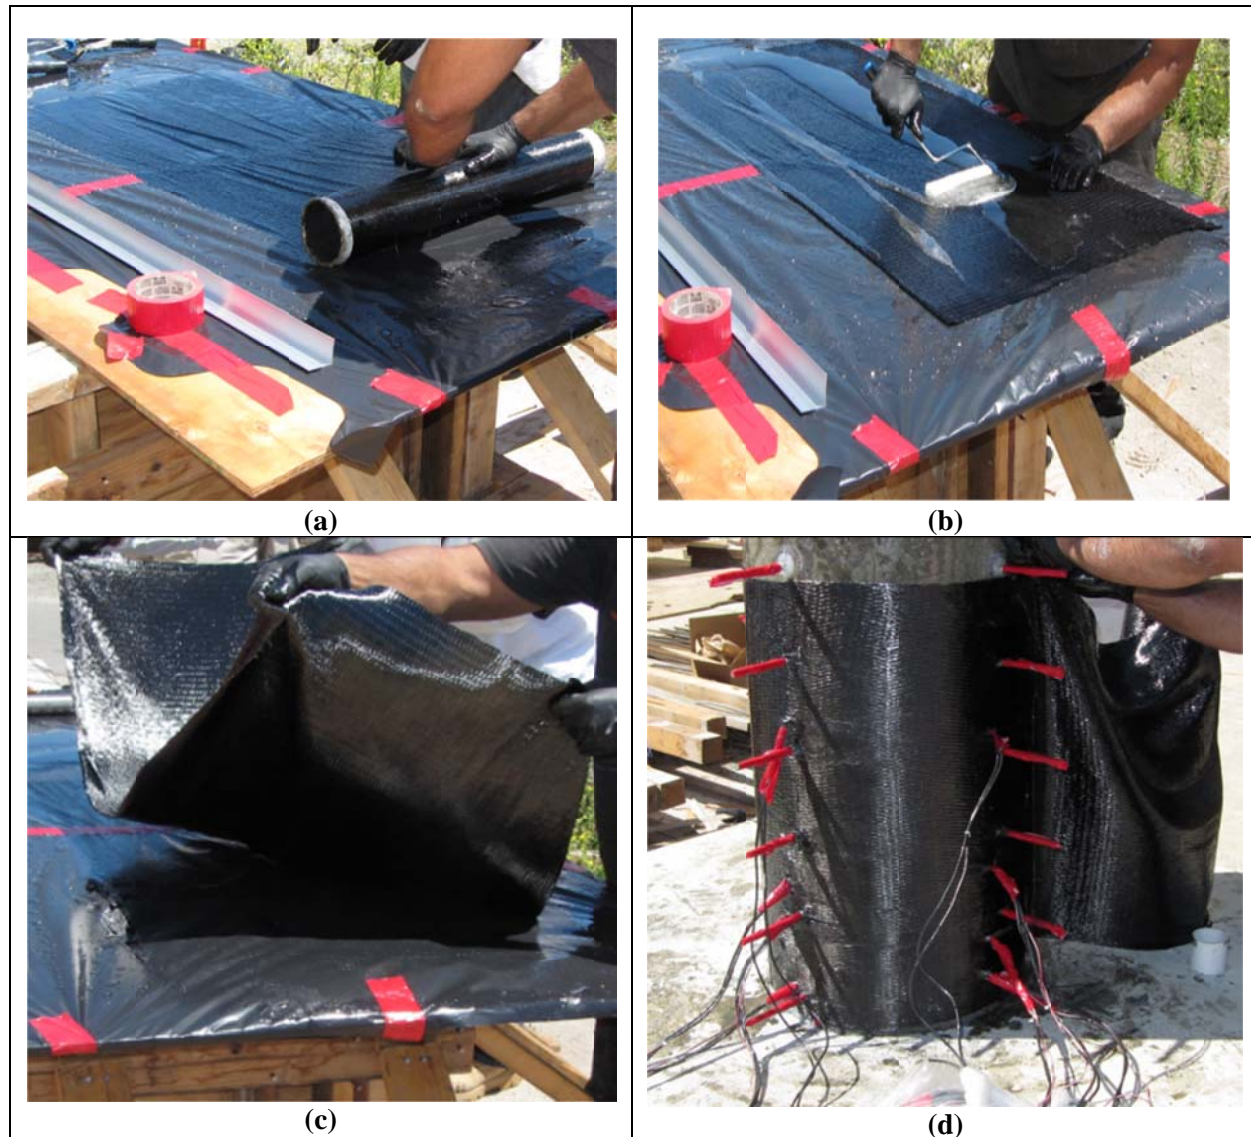
**Figure 1.1 Wet layup process: (a) CFRP roll; (b) application of epoxy; (c) CFRP soaked in epoxy resin; (d) wrapping of the column specimens.**

The wet layup process is the most common in-situ method of installing the FRP jackets on the structural system and was also used in this study for repairing the test specimens (Figure 1.1). Fabric generally comes in rolls and is laid on the surface with a layer of polymer resin (Figure 1.1a). Another layer of resin is applied on top of the fiber roll using paint roller until the FRP surface is completely drenched and dripping (Figure 1.1b and Figure 1.1c). The FRP sheets are then applied over the surface to be repaired (the bridge column curved surface in this case) and smoothed using the paint roller to release any trapped air (Figure 1.1d). The system is then allowed to cure (depending on the curing time of the polymer resin).

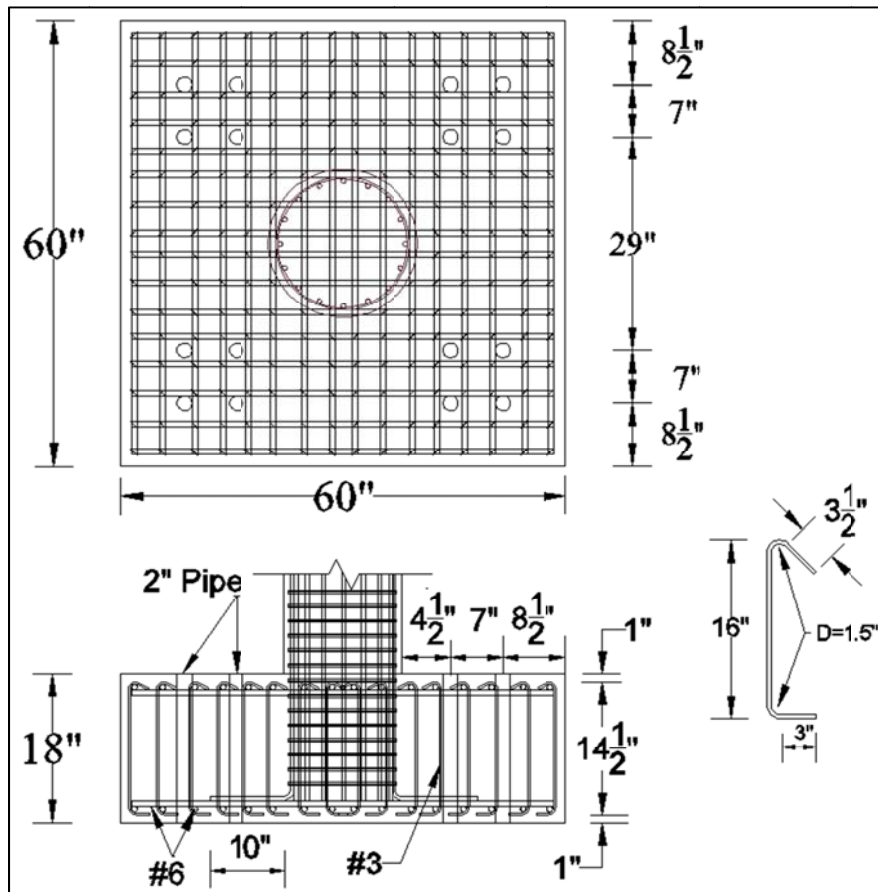
Figure 2.3 Top and elevation view of the concrete footing.

Cantilever column was supported by a 60 in × 60 in × 18 in (1524 mm × 1524 mm × 457.2 mm), rigid footing at its base. Figure 2.3 shows the geometric details of the concrete footing. Footing was designed symmetrically, to avoid any direct or punching shear failure during the testing. Depth of footing was based on the required development length of the longitudinal steel bars to avoid bar pullout/anchorage failure. Longitudinal and transverse reinforcements were extended into the footing and the top mass with the same configuration. Longitudinal bars were bent at 90° at the end inside the footing to provide sufficient anchorage. During the test set-up four load cells were installed at the four corners under the footing to measure the base reaction forces. Post-tensioning rods were used to firmly attach footing and load cells with the shake table to avoid any tension (or decompression) under maximum expected overturning moment and to prevent sliding at maximum shear transfer relative to the shaking table. Self-weight of footing was about 5.7 kips (25.35 KN).

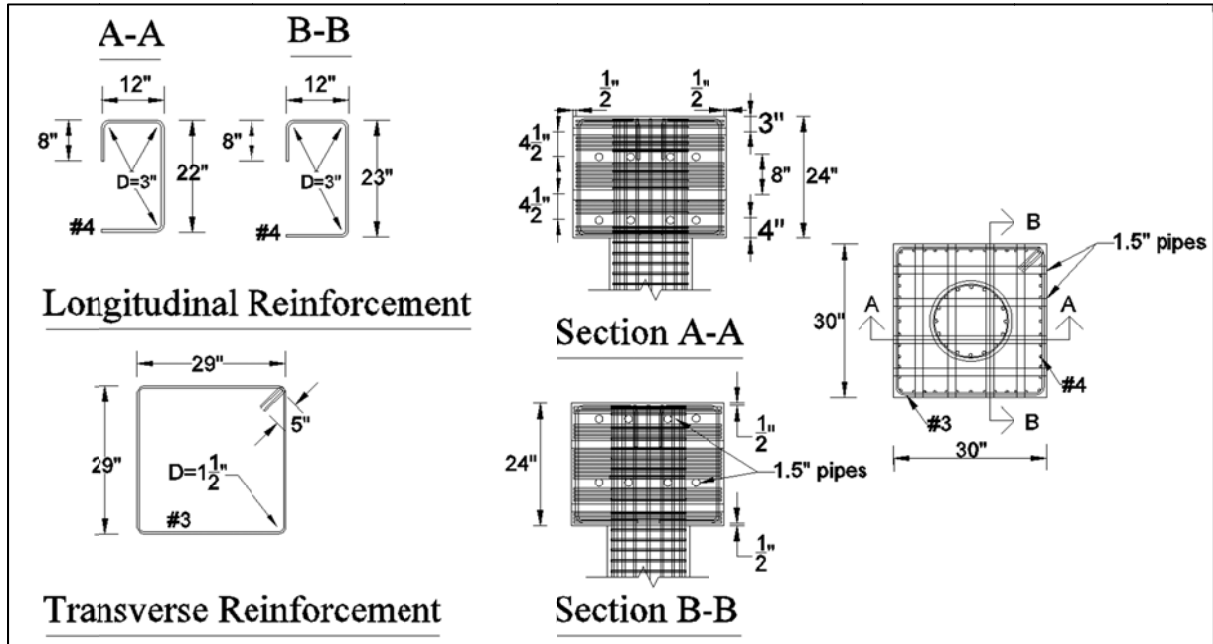
Figure 2.4 Section, elevation and top view of the mass blocks.

Top mass block was designed using minimum design criterion to avoid any form of flexural or shear failures during the shaking table testing (Figure 2.4). #4 steel reinforcing bars were used as the longitudinal reinforcement and #3 deformed steel reinforcing bars were used as hoop reinforcement. This block was formed mainly to attach additional superstructure mass at column top. Similar to the assembly for the repaired column tests, 8 PVC pipe holes running in each of the two perpendicular directions were made during the construction and to attach steel tubular beams with lead blocks (additional mass needed for scale-compensation).

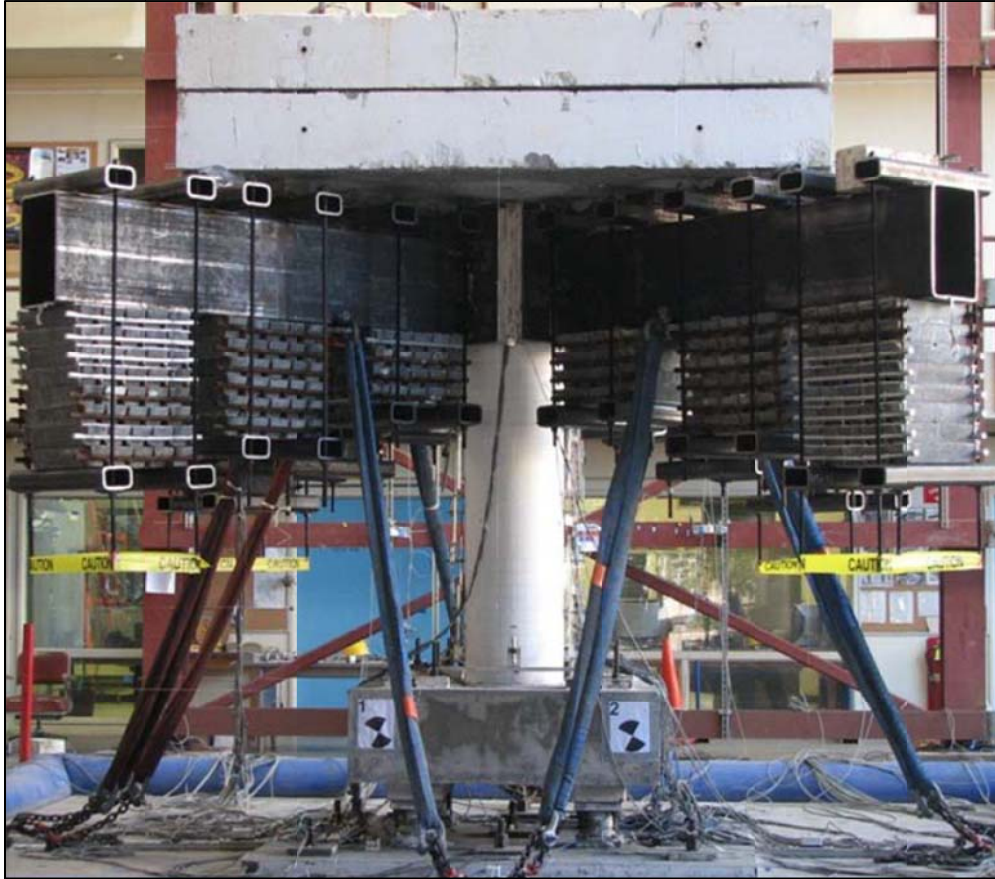
**Figure 2.6 Test setup of as-built SP1.**

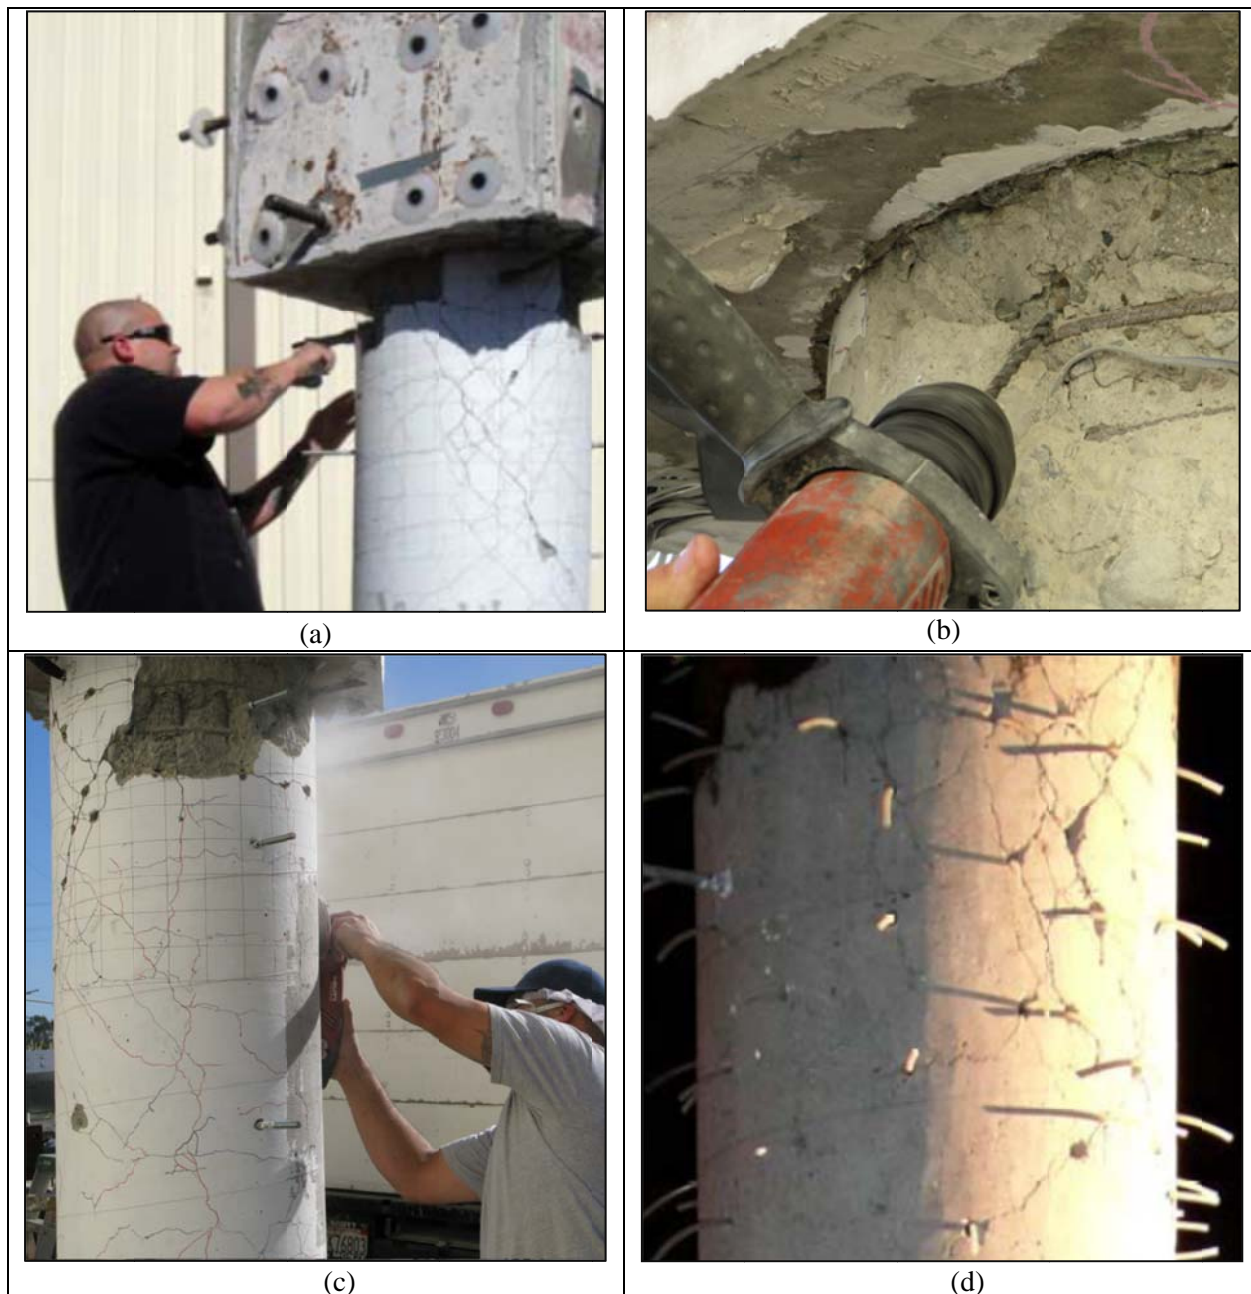
**Figure 2.8 Repair of as-built test specimen (preparation stage): (a) hammer test to remove loose material; (b) hole-drilling in the cracked regions; (c) grinding of the surface paint; (d) Injection ports in damaged regions.**

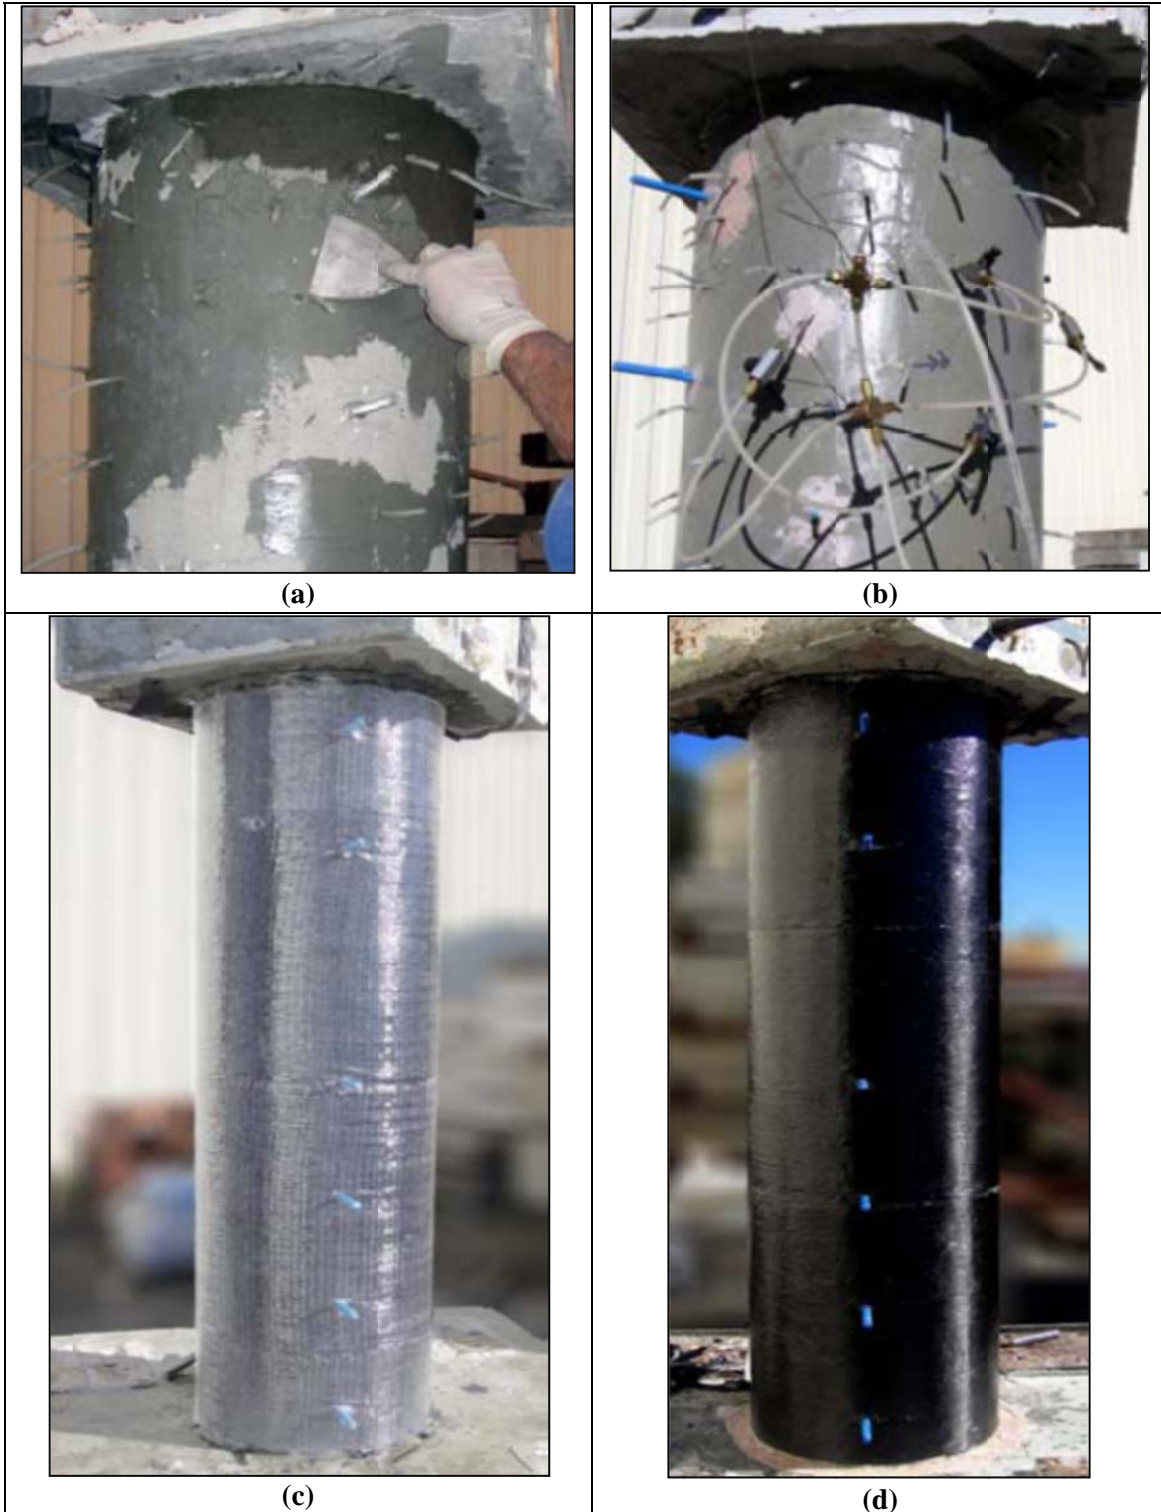
**Figure 2.9 Repair of as-built test specimen (application stage): (a) cap sealing and surface repair; (b) multi-port injection system; (c) GFRP repaired SP1; (d) CFRP repaired SP2.**

Surface was then cleaned of any dust and debris and one coat of RN075 prime was applied on it as a primer. Four layers of E-Clad FRP composite system were installed on damaged specimen SP1 (Figure 2.9c). E-Clad is an FRP composite system comprised of FE261 unidirectional Advantex glass fiber fabric impregnated with RN075 structural epoxy system. Two layers of C-Clad FRP composite system were installed on damaged specimen SP2 (Figure 2.9d). C-Clad is an FRP composite system comprised of FC061 unidirectional carbon fiber fabric impregnated with RN075 structural epoxy system. PT006 temporary polyvinyl compression/curing tapes were wrapped on the installed composite sheets and were discarded after 2 weeks.

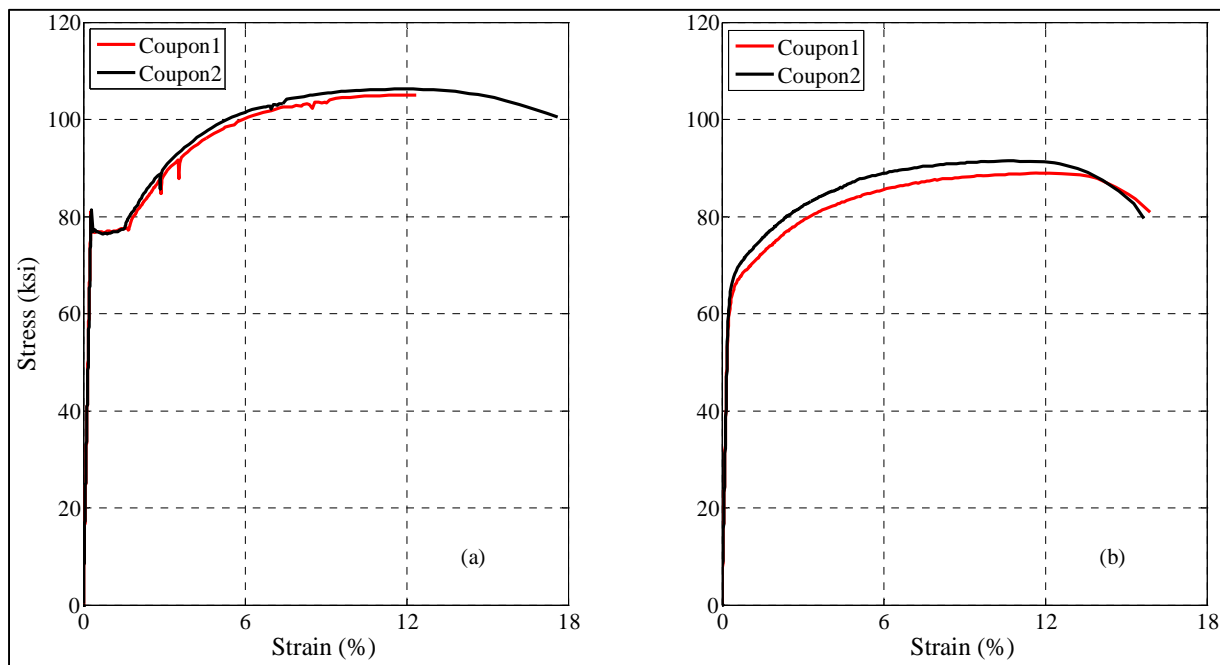
**Figure 2.11 Stress-strain plots of steel coupons: (a) #5 bars for longitudinal reinforcement; (b) #2 bars for circular hoops.**

16, #5 Grade 60 longitudinal steel bars, conforming to ASTM A706, were used as the longitudinal reinforcement in both test specimens SP1 and SP2. Two steel bar coupons were tested under monolithic tensile loading. The yield strength of the reinforcement was 77.4 ksi (533.7 MPa) and the ultimate stress at bar fracture was 105.06 ksi (724.4 MPa). Corresponding value of yield strain was 0.25% and strain measured at ultimate stress was 12.04%. #2 deformed bars hoops were used for providing the confinement. The hoops were lap welded at the ends. The yield and ultimate strength of the #2 deformed bars was 63.13 ksi (435.3 MPa) and 90.25 ksi (622.3 MPa) respectively, with yield strain of 0.22% and strain of 11.64% corresponding to ultimate tensile strength. #2 hoops coupons were straightened before the tensile testing. Figure 2.11 shows the stress-strain plots of the #5 and #2 reinforcing bars, respectively.

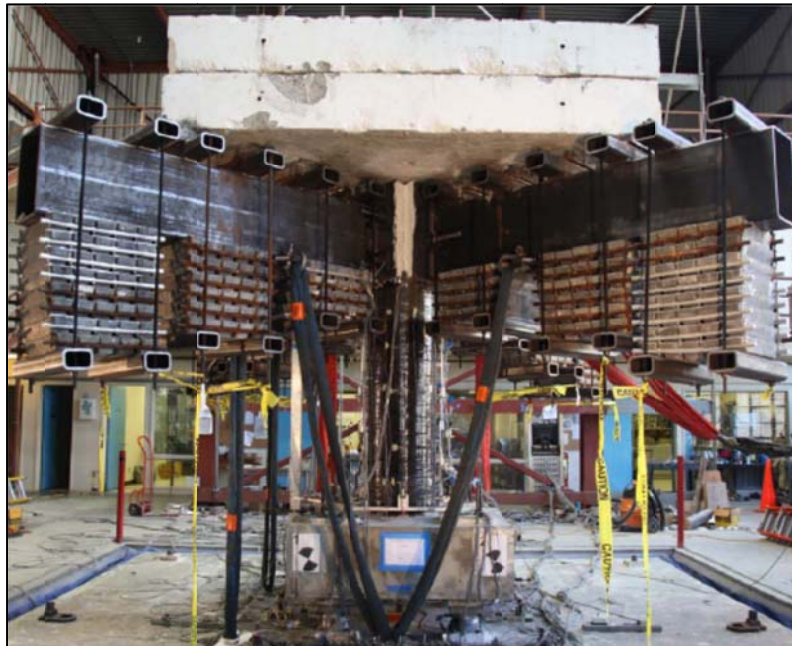
**Figure 3.2 North-side view of the repaired SP2.**

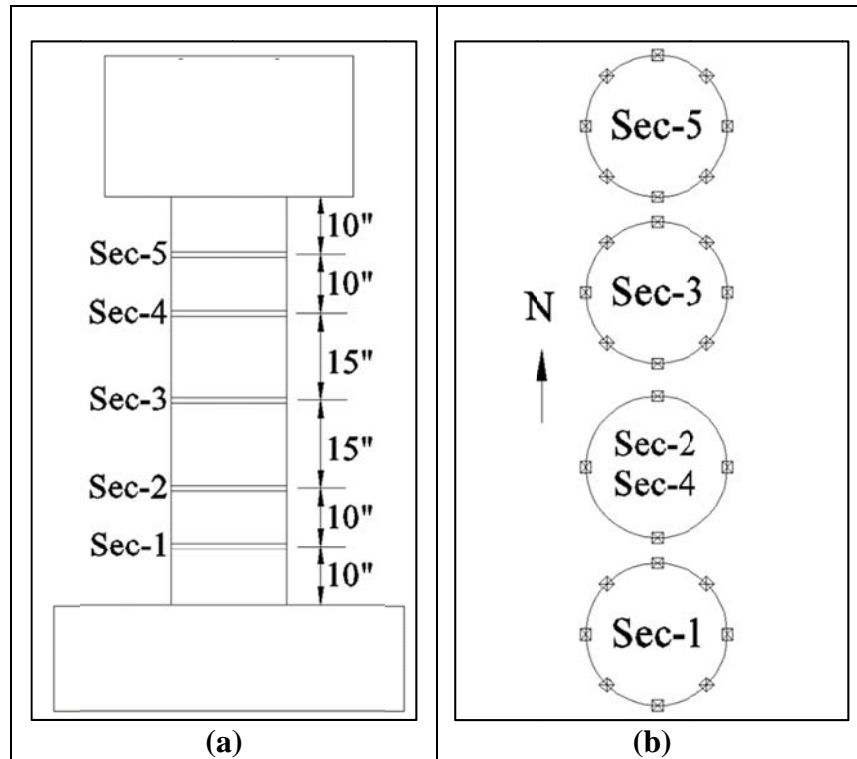
Figure 3.7 Strain gauges installed on the FRP jackets: (a) elevation view; (b) section details.

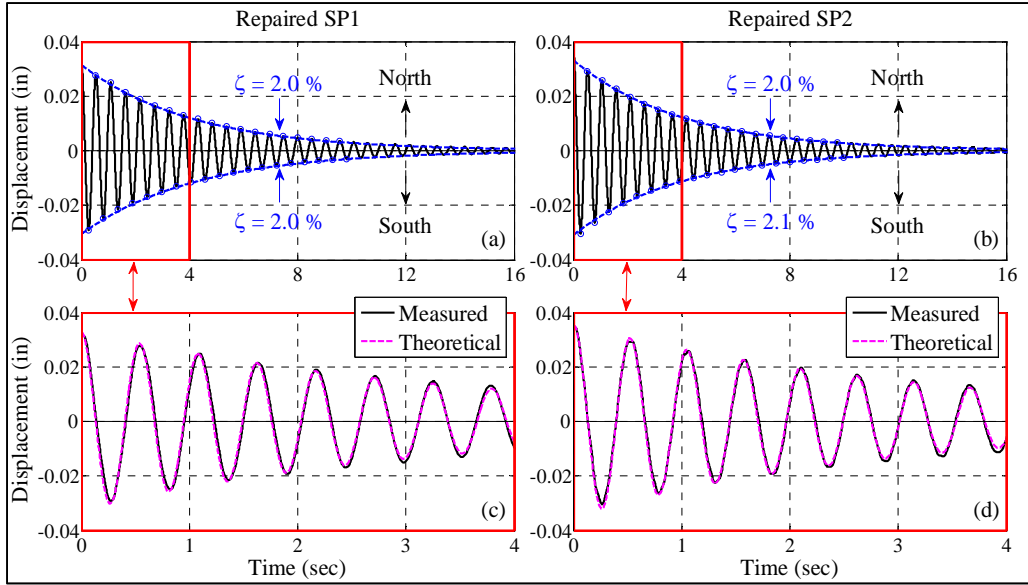
Figure 4.1 Displacement histories measured at the column's top during the first free vibration test.

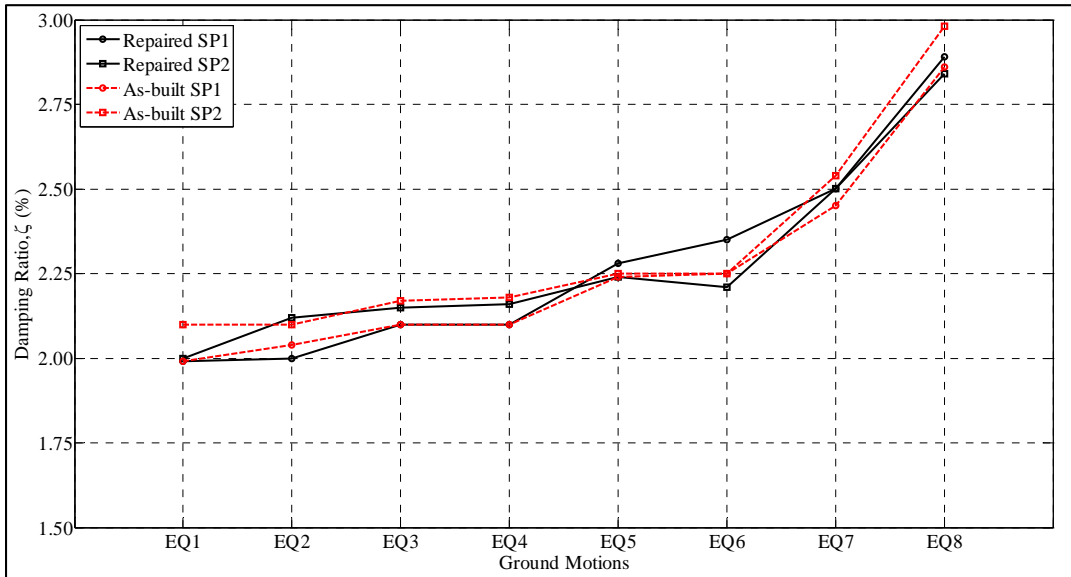
**Figure 4.19 Damping ratio of the repaired and as-built test specimens.**

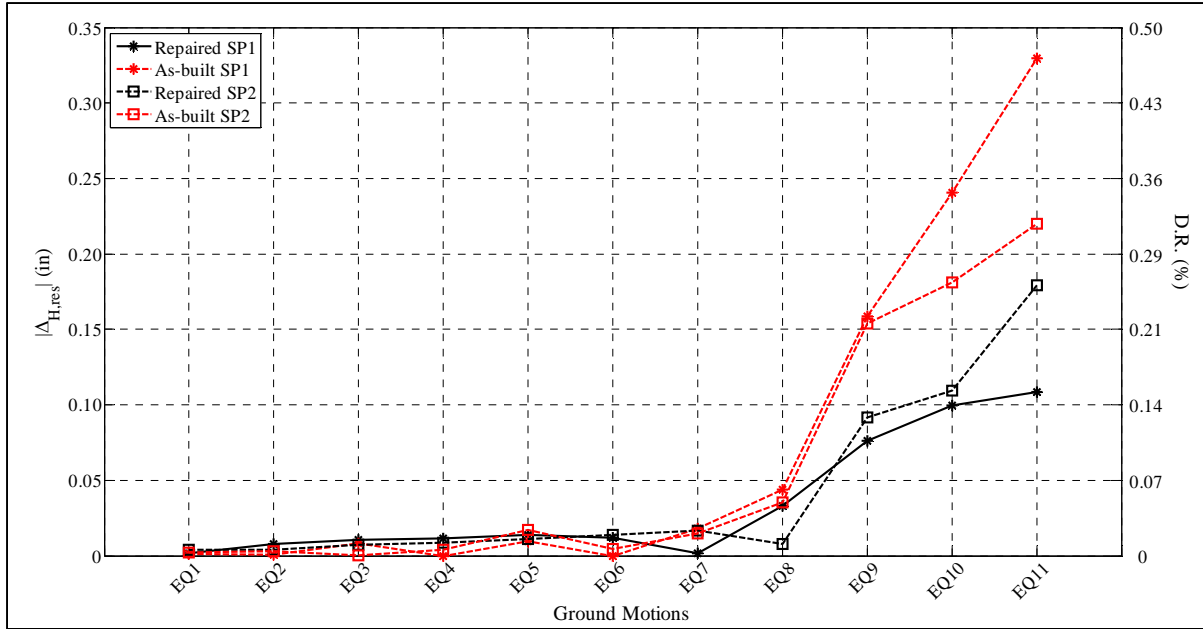
Figure 4.26 Absolute horizontal residual displacement ( $\Delta_{H, res}$ ) of the repaired and as-built test specimens.

The residual top displacement ( $\Delta_{H,res}$ ) was defined as the relative lateral displacement of the column top at the end of each ground motion run with respect to the specimen footing. Moreover, the residual drift ratio (D.R.) was defined as the ratio of the residual displacement ( $\Delta_{H,res}$ ) to the cantilever column height (70 in, (1778 mm)). Figure 4.26 shows the comparison of the residual displacements ( $\Delta_{H,res}$ ) of the test specimens measured during the loading protocol. Despite the lesser damage along the column height, the residual D.R. of the as-built SP1 was higher than that of the as-built SP2. This is attributed to the fact that the residual displacement of the as-built SP1 was shifted towards the North during the entire loading protocol, while the residual displacement of the as-built SP2 was shifted towards the South from EQ1 to EQ6 then shifted towards the North from EQ7 to EQ11. Both repaired specimens followed a similar residual D.R. pattern to that of the as-built SP2. The residual displacement ( $\Delta_{H,res}$ ) of the repaired SP1 and SP2 was 67% and 20% less than their as-built counterparts, respectively, after the completion of the entire loading protocol. Figure 4.27 shows the bar plot of the residual displacements ( $\Delta_{H,res}$ ) of the test specimens (as-built and repaired) at the end of each ground motion, but normalized with respect to the absolute maximum lateral displacement ( $\Delta_{H,max}$ ) during that ground motion run. The as-built specimens had much higher normalized residual displacements compared to the repaired ones after EQ5. Both repaired specimens had normalized residual displacement 10% or less in most of the runs. The increase of the earthquake intensity above EQ7 led to a steady increase of the normalized residual displacement for all the test specimens. However, the increase of the normalized residual displacement was slower for the repaired specimens than for the as-built counterparts. This indicates that the effectiveness of the investigated FRP repair technique to increase the resiliency of bridge columns when subjected to severe earthquake loading. Finally, at the end of EQ11, the residual displacement of the repaired SP1 and repaired SP2 was 0.109 in (2.759 mm) and 0.179 in (4.553 mm), respectively.

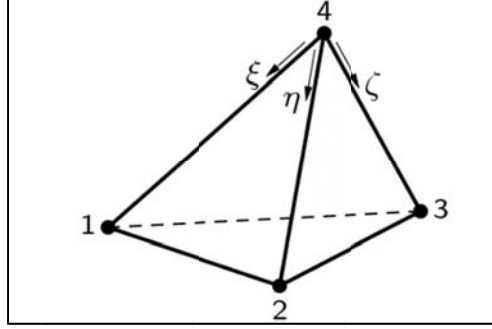
Figure 6.1 Solid tetrahedron element TE12L.

where  $\xi$ ,  $\eta$  and  $\zeta$  are the parametric coordinates of the TE12L element. The linear polynomial yield a linear stress and strain distribution over the element.

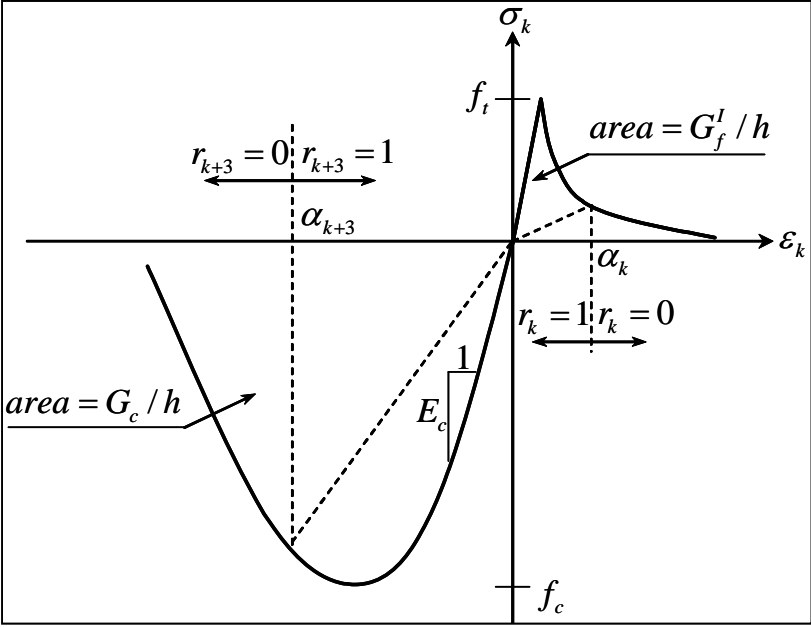
Figure 6.2 Unidirectional concrete material model in the principal directions.

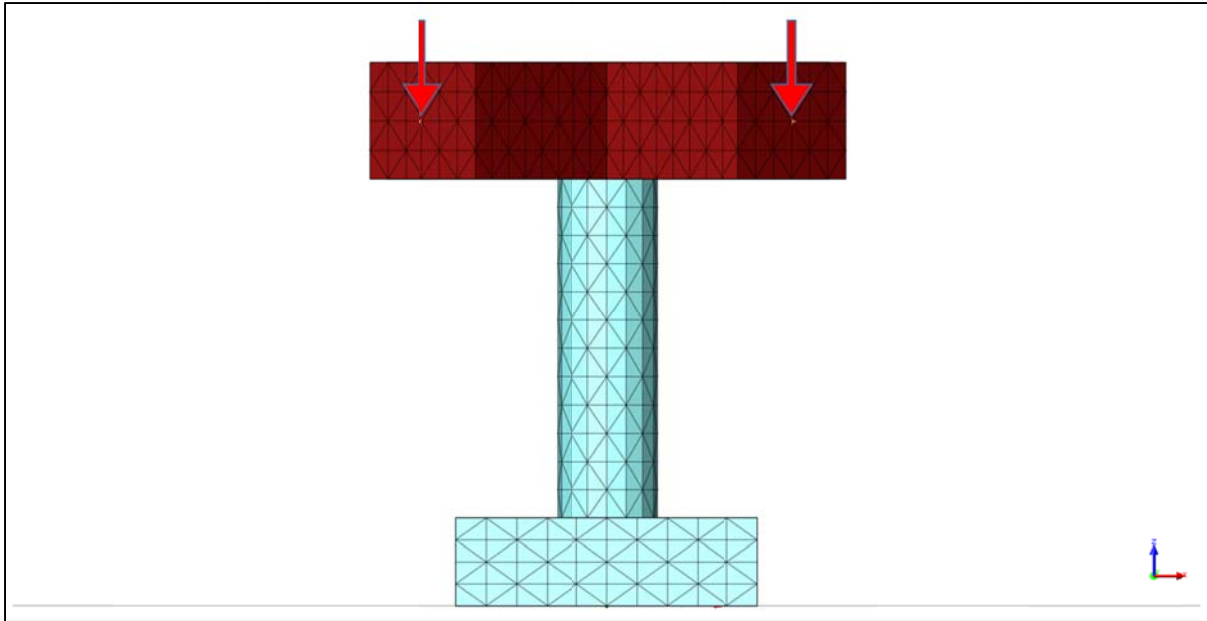
Figure 6.6 Elevation view of the analytical model.

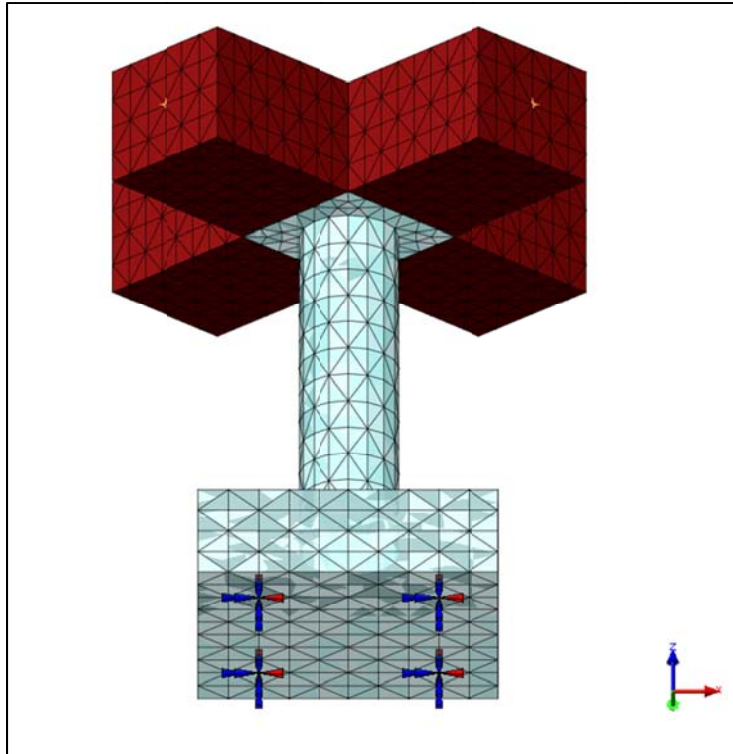
**Figure 6.8 Zero-length spring supports, BC-I.**

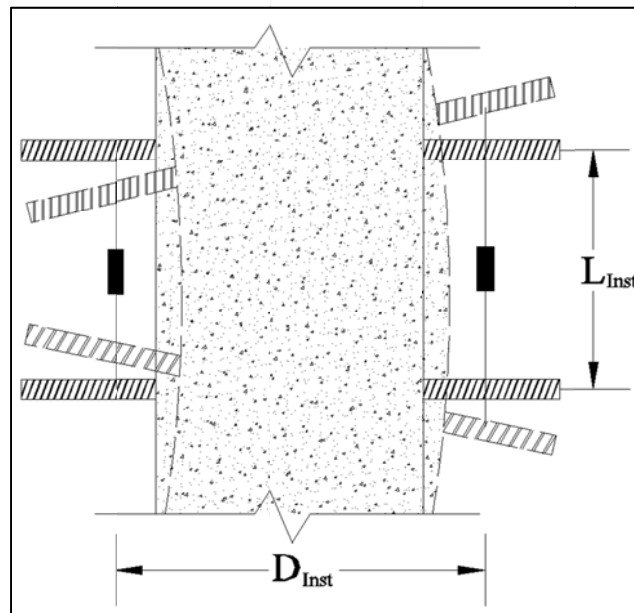
Figure C.1 Curvature calculations using LVDTs.
