Window opening effects on structural behavior of historical masonry Fatih Mosque

International Journal of Architectural Heritage, 13(4)

## Window Opening Effects on Structural Behavior of Historical Masonry Fatih Mosque

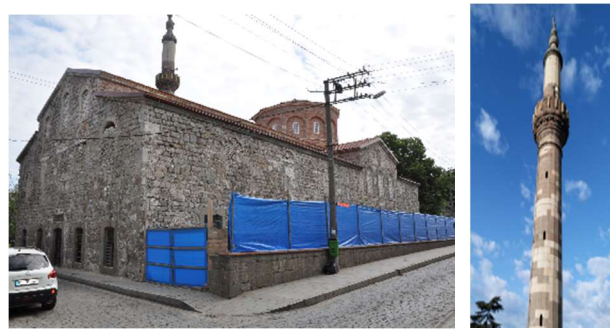
Fig. 1. Views of Fatih Mosque and its minaret

Fatih Mosque was built as stone masonry in 914 in the city of Trabzon, Turkey. Although the construction date of the structure is unknown, it is estimated that it was built as a church in 914. The church was built as a rectangular plan with a base area of approximately 795 m<sup>2</sup>. The church was converted to a mosque in 1461, and its minaret was built adjacent to the corner of the mosque. Views of the mosque and its minaret are shown in Fig. 1.

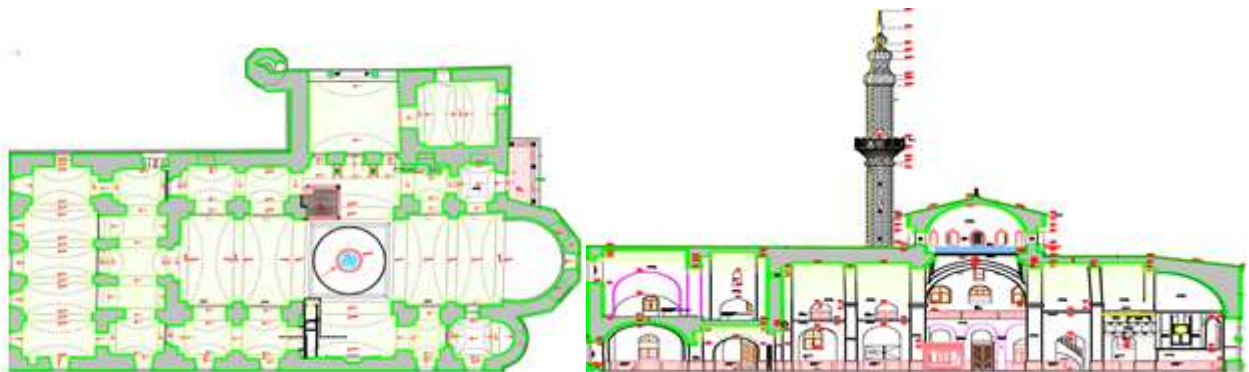
Fig. 2. Drawings of the mosque and its minaret (Restoration Project, 2014)

Some views of the drawings prepared according to the data taken from laser scanning are given in Fig. 2. The cylindrical minaret was built with a circular cross section. The mosque with rectangular plan consists of stone-bearing walls of approximately 1000 mm in thickness.

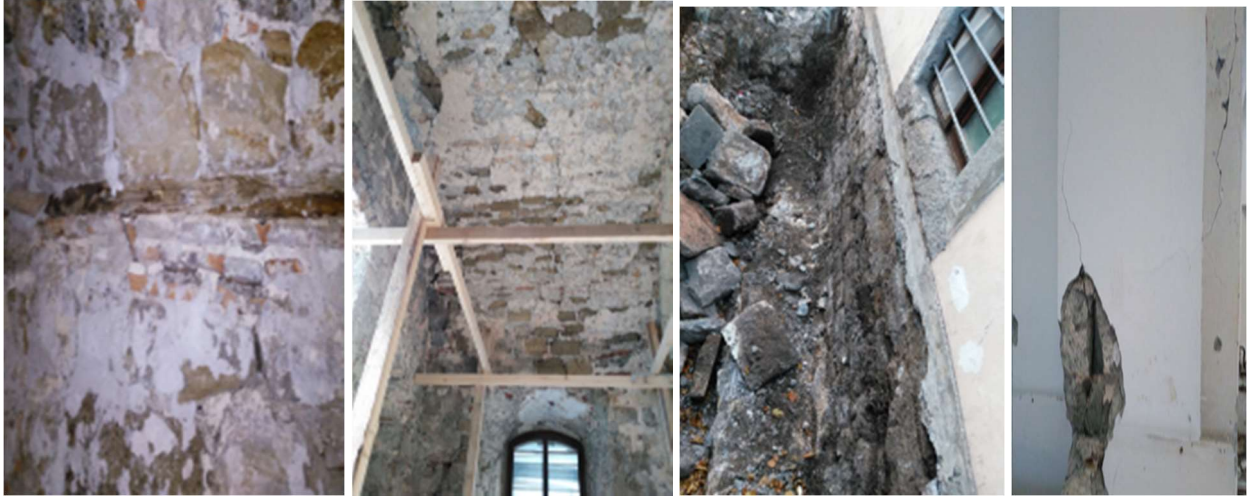
Fig. 4. Views from damages in the mosque

It is understood from the art history report (Art History Report (2014)) that Fatih Mosque has undergone many repairs in the past and such restoration works are currently continuing. Within the scope of the restoration works, the plaster was removed, and the deterioration of the binder mortar, joint openings, deterioration in the wooden elements, cracks and moisture in the structural elements were observed (Fig. 4). In addition, as can be seen from Fig. 5, 12 previously window openings on the exterior structural walls were closed apparently to enhance the wall load bearing capacity.

loads are obtained as 0.51MPa and 1.23MPa, respectively, near the bottom of columns. It can be seen from Fig. 4 that real damages occurred at the bottom of the columns. When the window openings exist, the maximum and minimum static principal stresses are determined as 0.53MPa and 1.24MPa, respectively. The maximum and minimum static principal stress values obtained in cases of with and without window openings are close to each other. However, as can be seen from Figs. 12-13, these values of maximum and minimum static principal stresses occur only in a small local region. The increment in stresses is mainly due to stress concentration at corners and finite element mesh refinement of this region. The maximum and minimum principal stresses occurring throughout the mosque are smaller. It is observed that the maximum principal static stress distributions increase in case of windows are open. However, the minimum principal static stresses are close to each other in the case where the window openings are blind and open.

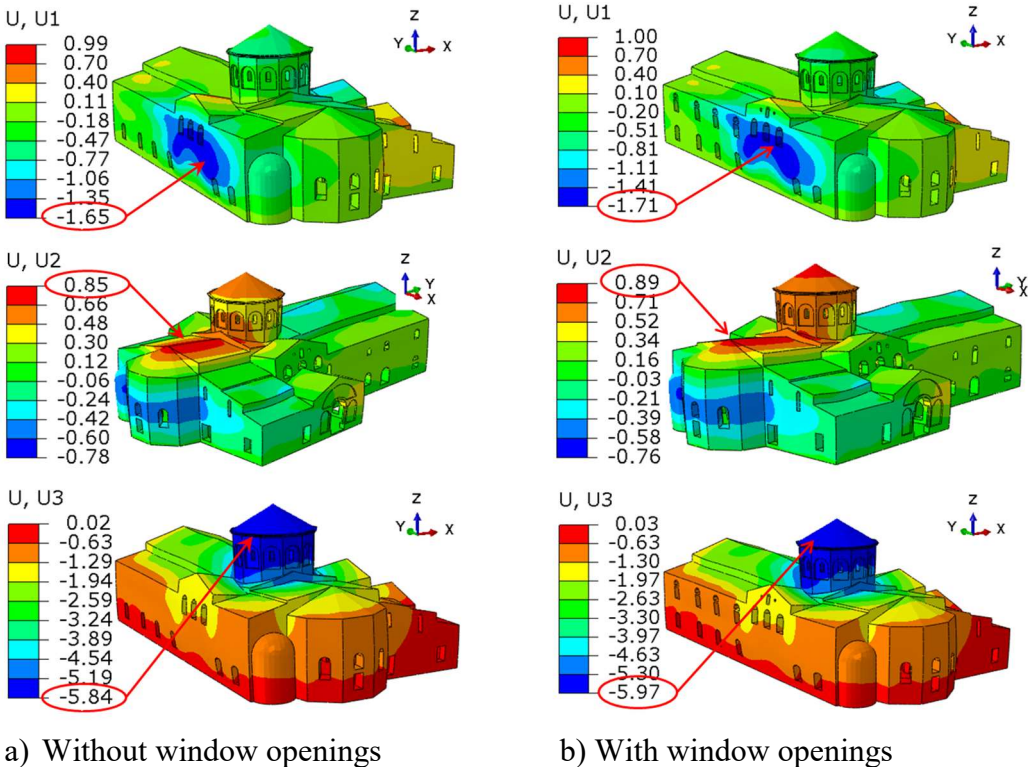
Fig. 11. Static displacement propagations in transverse (U1), longitudinal (U2) and vertical (U3) directions

of  $5 \text{ kN/m}^2$  is considered in the analysis as recommended for design of mosques in Turkish load standard TS498 (1997). Fig. 11 shows the maximum static displacements and distributions of U1, U2 and U3 obtained in the transverse (X-axis), longitudinal (Y-axis) and vertical (Z-axis) directions from the finite element models with and without window opening. The maximum static vertical, transverse and longitudinal displacements are calculated as 5.84 mm, 1.65 mm and 0.85 mm, respectively, in the case of blind window opening, whereas the corresponding values in the case of with window opening are 5.97mm, 1.71mm and 0.89 mm, respectively. The above results indicate that the existence of the 12 windows has slightly increased the maximum static displacements. When the displacement propagations given in Fig. 11 are examined, the static displacements occurring in both cases of window opening generally shows similar behavior. It can be stated that opening of the blind windows slightly affects static behavior of the mosque.

- Opening of the blind windows in the walls of the Fatih mosque slightly increases the static displacement by an average of 3.5% in three directions considered.

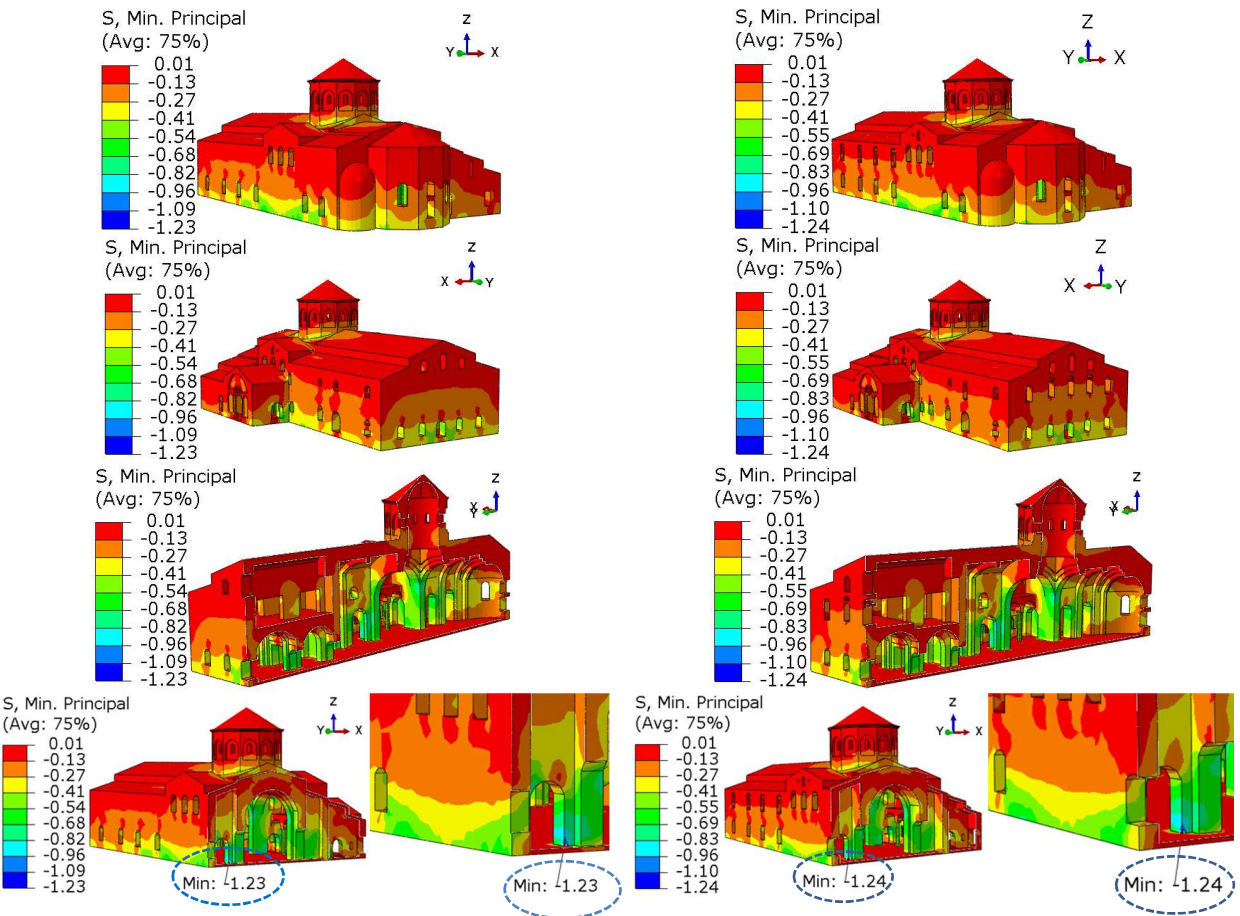
The minimum (compressive) and maximum (tensile) static principal stresses obtained when the window openings are blind and open are given in Figs. 12-13. When the window openings are blind, the maximum and minimum static principal stresses under the mosque’s self weight and live

a) Without window openings  
 b) With window openings  
 Fig. 12. Propagations of minimum static principal stresses

- The minimum (compressive) and maximum (tensile) static principal stress values obtained in cases of with and without window openings increase by 3.9% and 0.8%, respectively but do not exceed strength of the walls. It is also observed that the maximum principal static stress distributions of the mosque walls increase in the case of opened windows. However, the minimum principal static stress distributions are close to each other in both window cases.

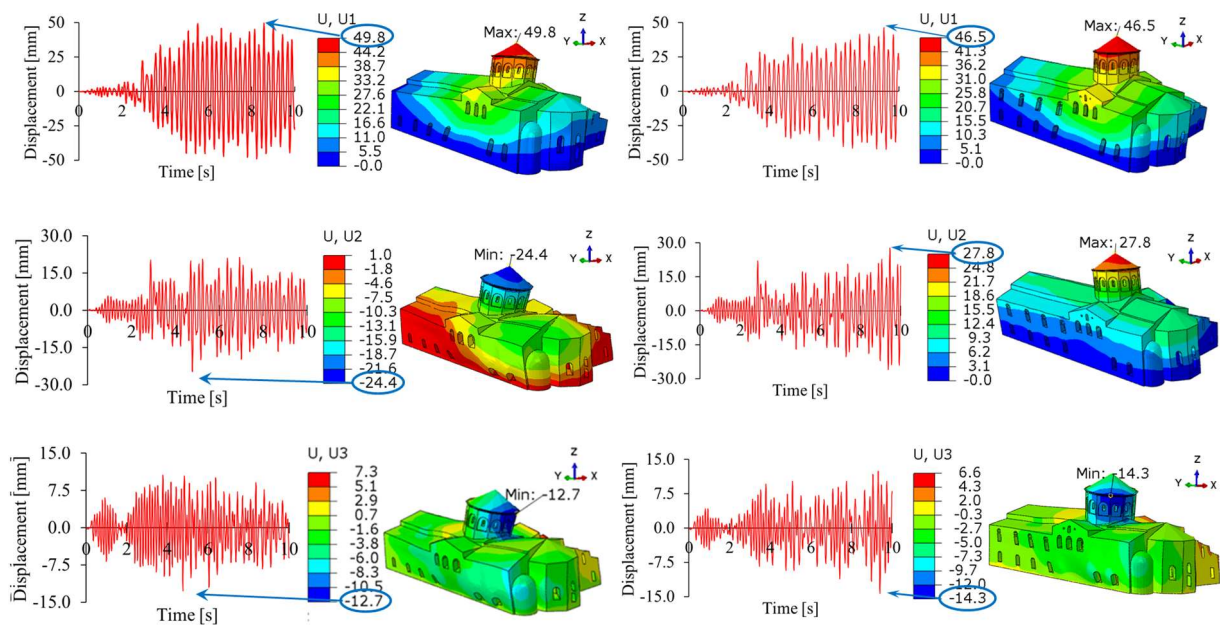
The maximum dynamic displacements and distributions of U1, U2, and U3 obtained in the transverse (X-axis), longitudinal (Y-axis) and vertical (Z-axis) directions from the finite element models with and without window opening are given in Fig. 15. The maximum dynamic transverse, longitudinal and vertical displacements were obtained as 49.8 mm, -24.4 mm and -12.7 mm in the case of blind windows; and 46.5 mm, 27.8 mm and -14.3 mm in the case of opened windows, respectively. The maximum dynamic displacements occur on the dome. In the case of opening of the blind windows, a decrease in transverse displacement, an increase and direction change in longitudinal displacement, an increase in vertical displacement are observed. In addition, as can be seen from Fig.15 that there is a change in the frequency contents of dynamic displacements and significant differences occur in the dynamic displacement distributions. The displacement time histories and occurrence times of peak values change with considering window openings during the earthquake. It can be also seen from the displacement colour contours in the mosque that displacement distributions change with opening windows.

The allowable roof drift limit for historical masonry structures recommended by TYDRYK (2017) is 0.3% of structure height. The maximum dynamic horizontal displacements in the transverse direction in the case of with and without window openings are 0.0465m and 0.0498m, respectively. The height of the mosque is 16.84m. The roof drifts of the mosque with and without window openings are calculated as 0.00276 and 0.00295, respectively. The roof drift of the mosque with

window openings is smaller than that of the mosque without window openings. Both calculated roof drift ratios very close to the allowable roof drift limit ratio of 0.3%.

a) Without window openings                      b) With window openings  
 Fig. 15. Time histories and propagations of dynamic displacement in transverse (U1), longitudinal (U2) and vertical (U3) directions

- In the case of opening of the blind windows, the maximum dynamic transverse displacement decreases by 6.6% whereas the dynamic displacements in the longitudinal and vertical directions increase by 13.9% and 12.3%, respectively compared with the case of blind windows. The displacement time histories and occurrence times of peak values change when considering window openings during the earthquake.

- The roof drifts of the mosque with and without window openings are obtained as 0.276% and 0.295% of the mosque height, respectively. Both roof drift ratios are very close to the allowable roof drift limit ratio of 0.3% recommended by TYDRYK (2017).
