Assessment of FRP composite strengthened reinforced concrete bridge structures at the component and systems level through progressive damage and Non-Destructive Evaluation (NDE)

**ASSESSMENT OF FRP COMPOSITE STRENGTHENED REINFORCED
CONCRETE BRIDGE STRUCTURES AT THE COMPONENT AND SYSTEMS
LEVEL THROUGH PROGRESSIVE DAMAGE AND NON-DESTRUCTIVE
EVALUATION (NDE)**

Doctor of Philosophy

Structural Engineering

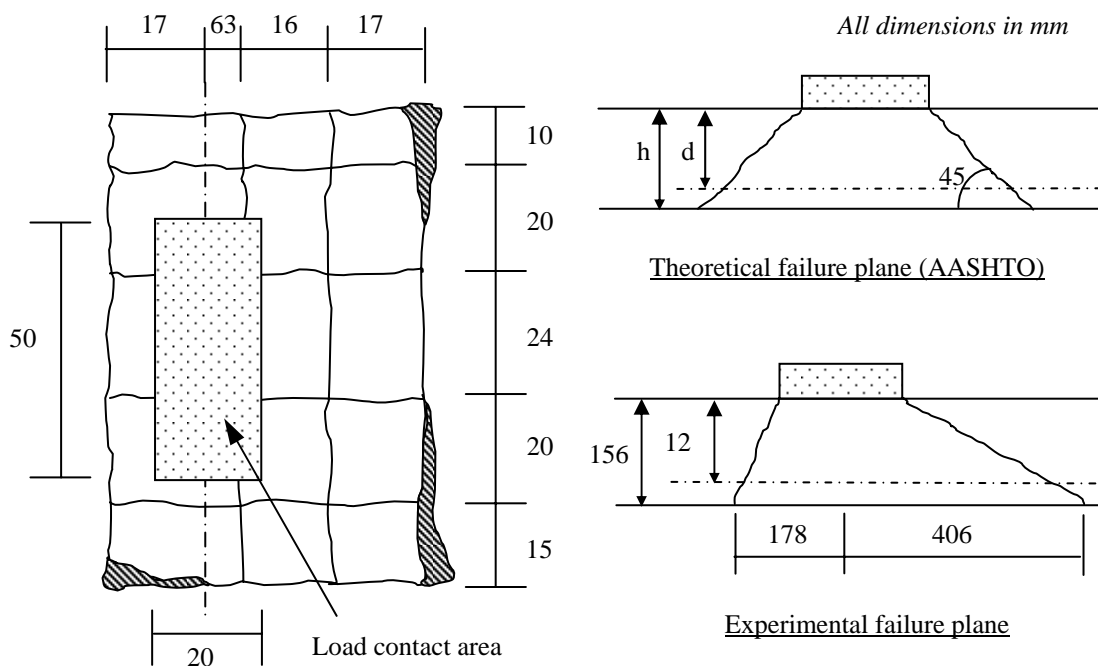
Figure 3.12 Crack pattern in Specimen 1

formed at about 457 mm (18") on either side of the slab centerline. Fatigue deterioration due to in-service loading of the slabs, prior to their removal from the bridge, had resulted in preexisting cracks spaced at about 17 mm (7") in the longitudinal direction and at about 203 mm (8") in the transverse direction. During the test the cracks opened up more and small pieces of concrete would drop near the peak load at every cycle. However, the most noticeable opening of cracks was observed at the locations of the main cracks where the shear failure plane originating from the top of the slab around the loading contact area intersected the bottom of the slab. The crack patterns noted at the bottom and over the cross-section in specimen, S1 are schematically presented in Figure 3.12.

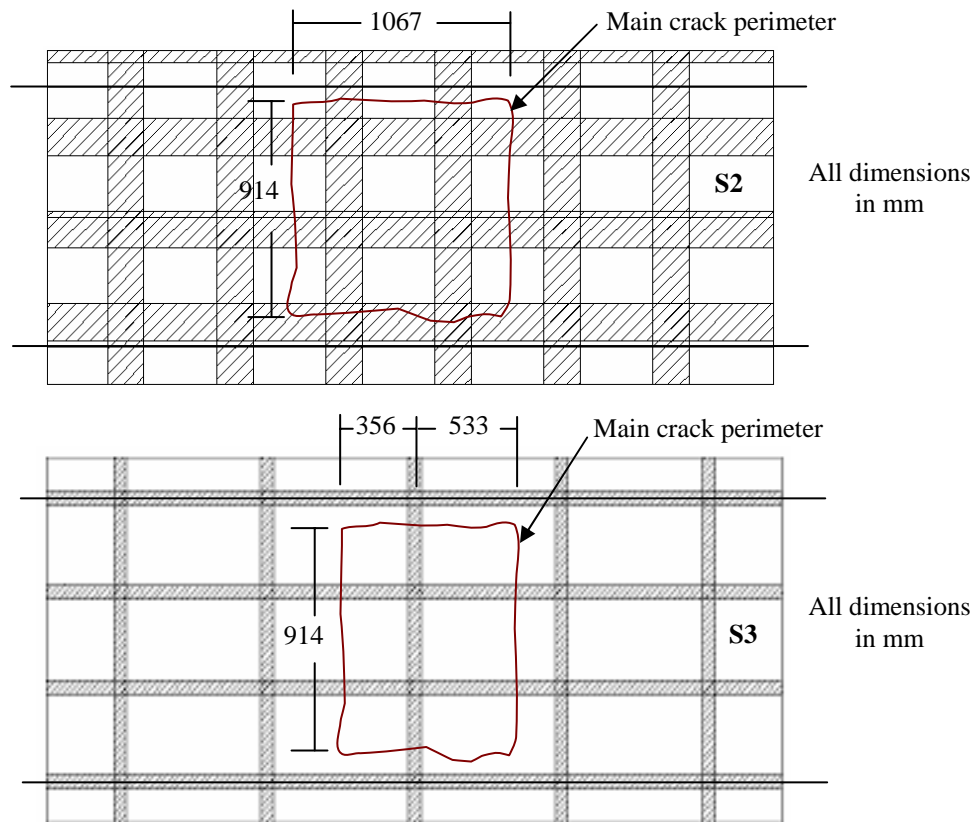
Figure 3.13 Crack patterns in strengthened specimens 2 and 3

The opening of the cracks was significantly less in the FRP strengthened specimens before the delamination of the composite strips since the strips were able to effectively hold together the cracks. In S2, strengthened with the carbon composite fabric laminates, the failure zone was spread over a larger area with the main transverse cracks forming at around 533 mm (21") from the centerline of the slab. For S3, strengthened with prefabricated pultruded carbon composite strips, the main transverse cracks formed at around 533 mm (21") on the right and at 356 mm (14") on the left from the centerline of the slab. Although cracking was primarily restricted to pre-existing cracks, for specimen S3, a number of new minor cracks started to appear between the major pre-existing transverse and longitudinal cracks at a load level of 623 kN (140 kips). For both the specimens the main longitudinal cracks were formed at about 457 mm (18") from the centerline of the specimens. The failure zones defined by the primary crack patterns at the bottom of the specimens, S2 and S3, are presented in Figure 3.13.

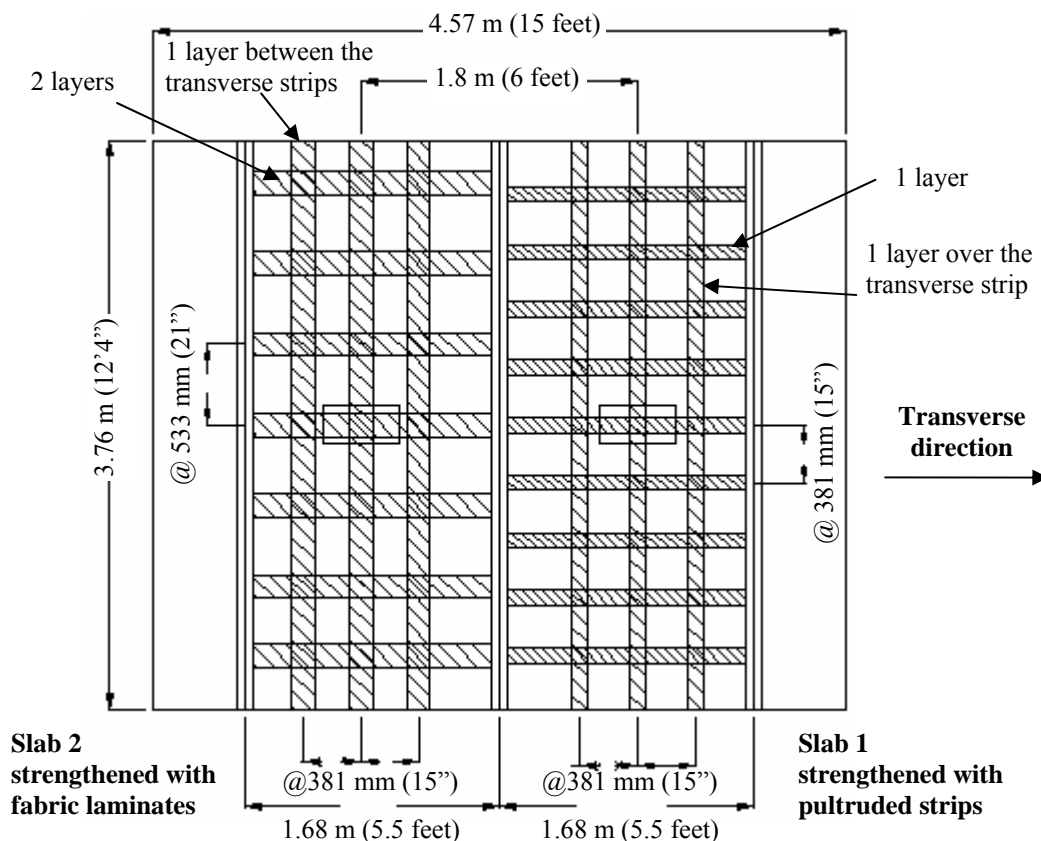
Figure 4.14 Schematic of the strengthening of deck slabs

Both the slabs were designed to reach the same ultimate capacity and this was also observed in the test, as will be presented in Chapter 5, when both the slabs reached ultimate load of 935 kN (210 kips). Thus for equivalent capacity of the slabs, the weight of the carbon fibers in the pultruded strip system was approximately 10% higher as compared to the weight of the carbon fibers in the fabric laminate system.

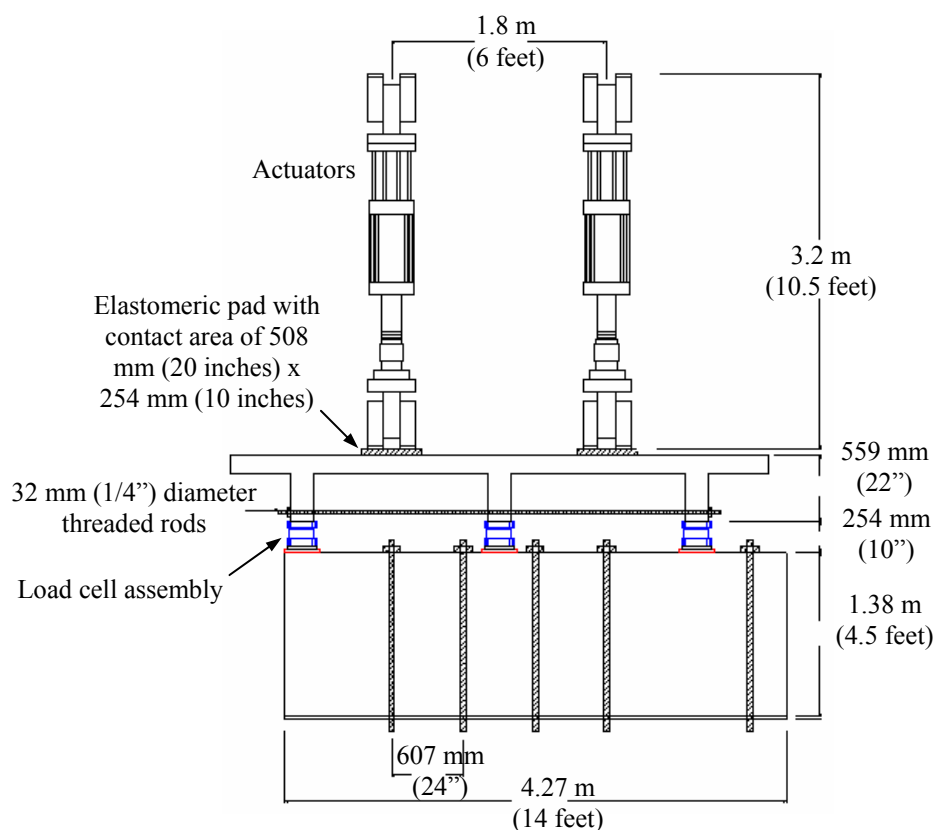
Figure 4.20 Cross-sectional schematic of test setup

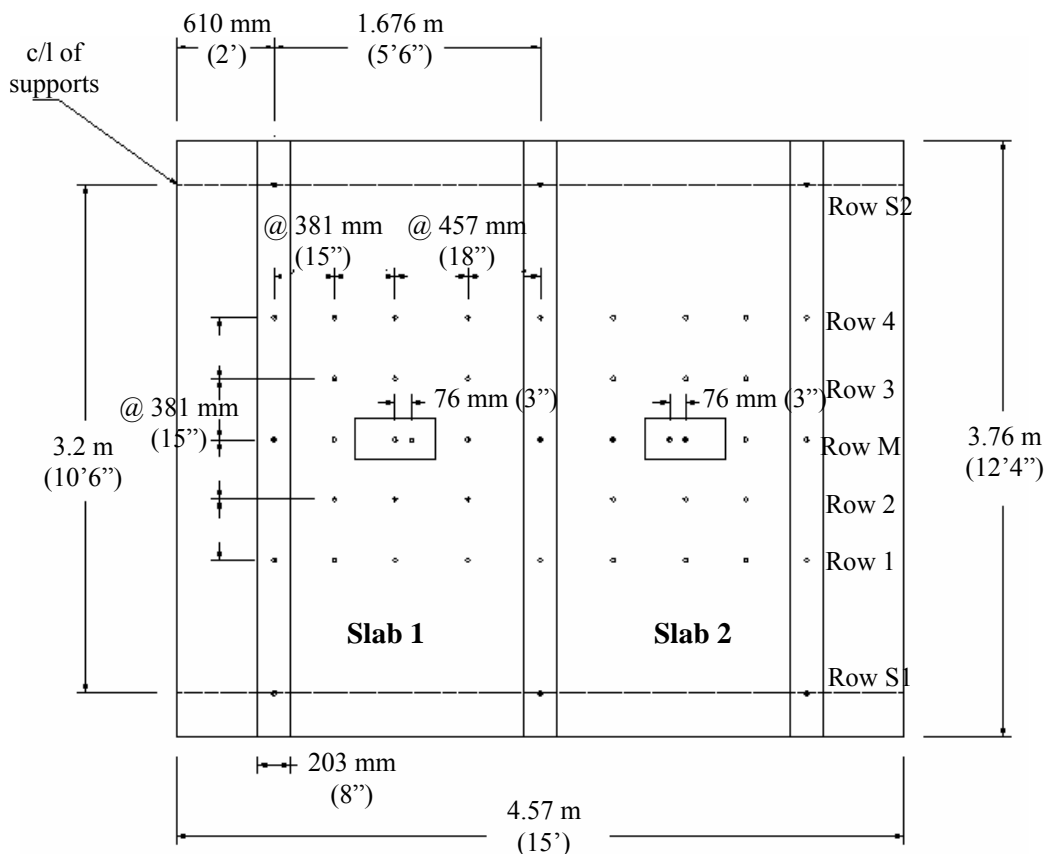
Figure 4.30 Locations of vertical linear potentiometers

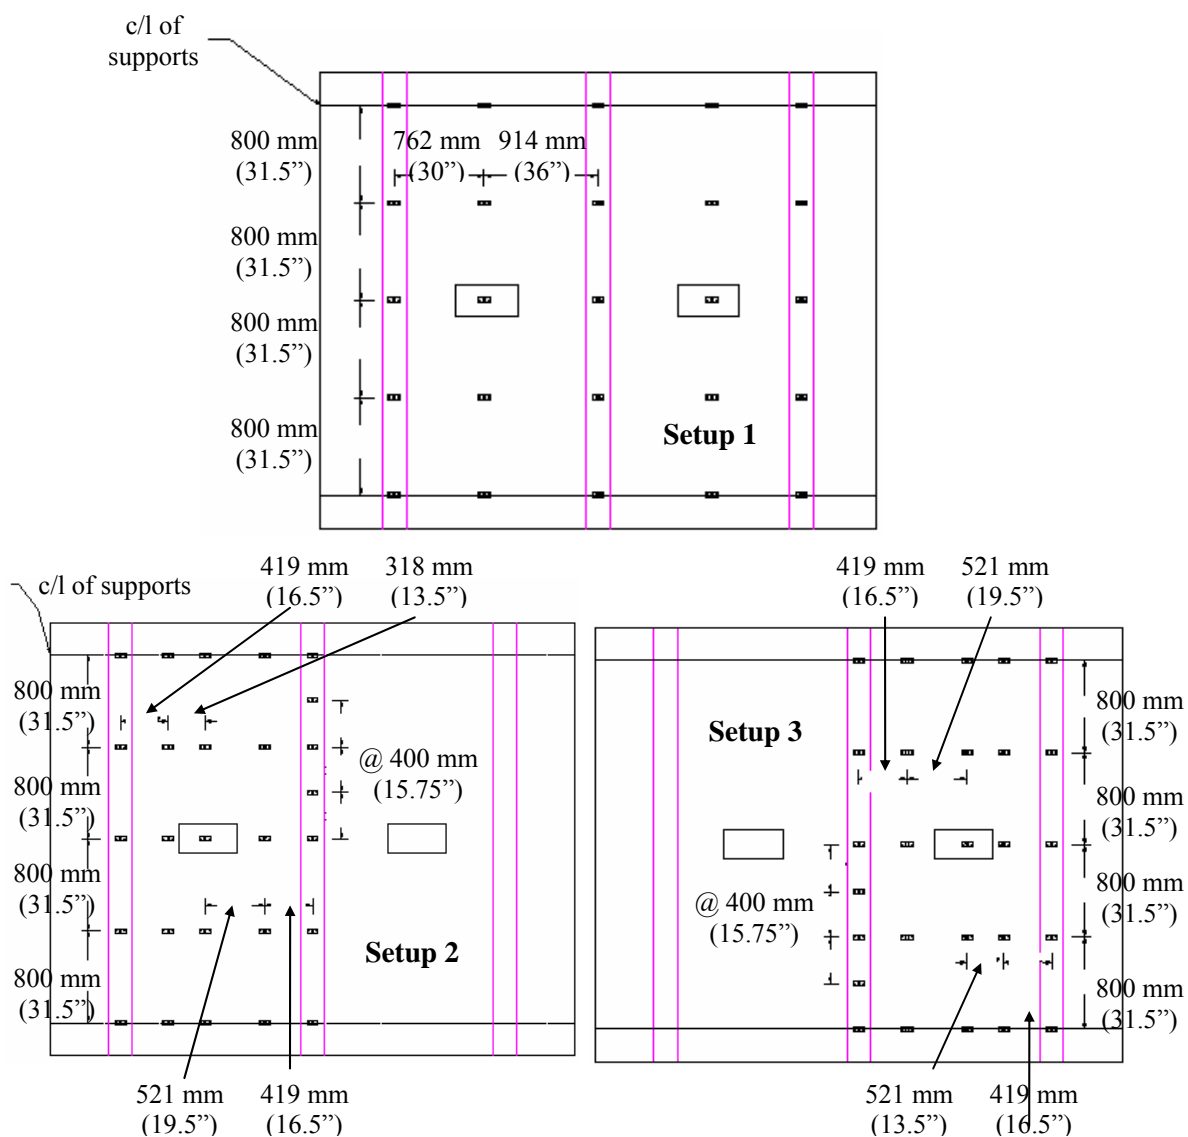
Figure 4.36 Locations of accelerometers for the three setups

Three setups of accelerometers were used for the vibration tests. The first setup included 25 accelerometers evenly distributed over the test specimen in 5 rows of 5 each and was used to get the global modal characteristics of the test specimen. The second setup included 27 accelerometers distributed over slab 1 and the third setup of accelerometers included 27 accelerometers distributed over slab 2. These two setups were used to get local modal characteristics in the slab components indicating relative damage in the two slabs. Combination of setups 2 and 3 would also be used to obtain a better spatial resolution in obtaining the mode shapes of the test specimen. The setup locations are presented in Figure 4.36.

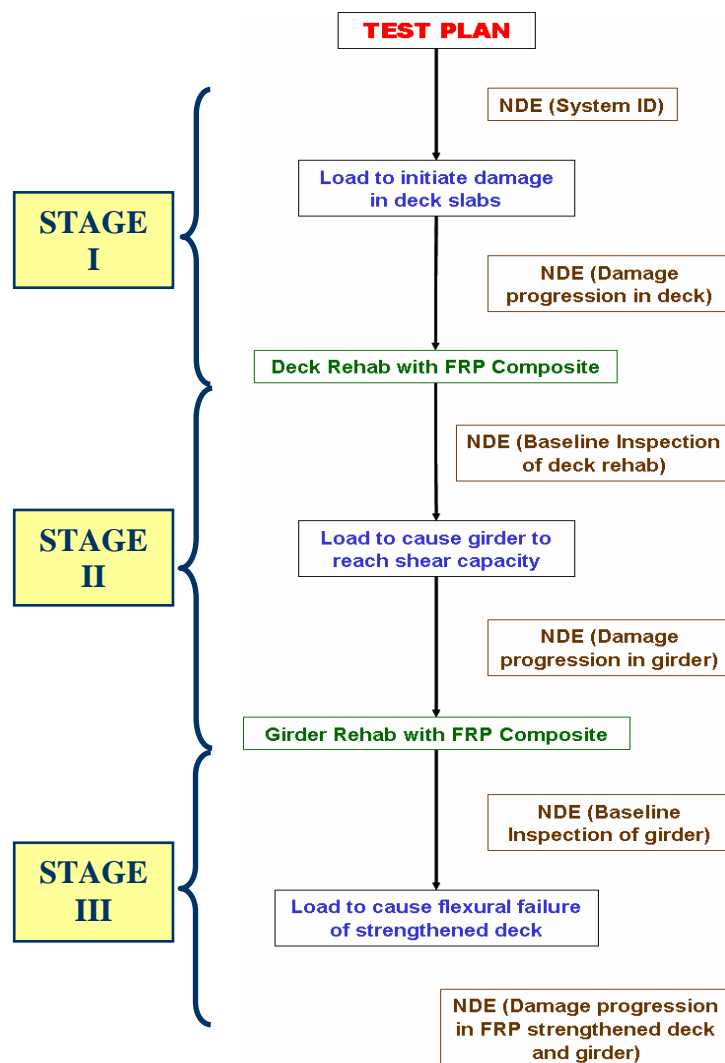
Figure 5.1 Schematic of test plan

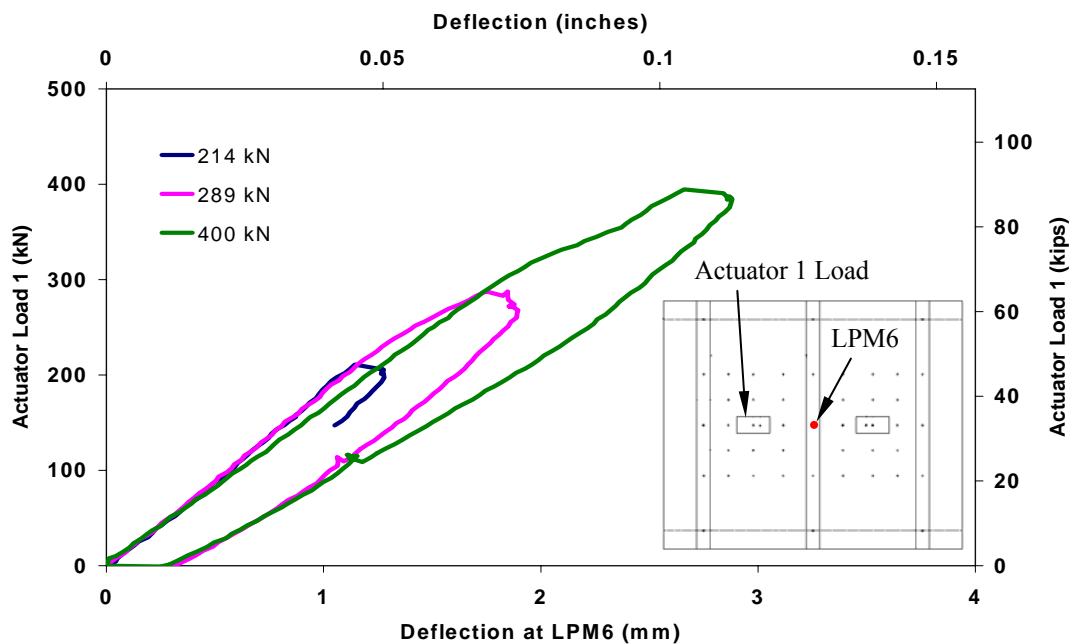
Figure 5.4a Actuator load 1 vs. mid-span deflection plots for middle girder

The deflections at the center of the middle and edge girders as measured by the linear potentiometers, LPM6, LPM1 and LPM11 respectively, were plotted against actuator load in Figures 5.4a and 5.4b. For the center girder some degradation in stiffness was seen between the 289 kN (65 kips) and 400 kN (90 kips) load cycles. However for the edge girders there was very little change in the slope of the load-deflection plots over the load cycles indicating that there was insignificant degradation. This was substantiated by visual observations of crack patterns, from which it could be seen that most of the damage for phase 1 was concentrated in the deck slabs. The only damage observed in the center girder was in the form of flexural cracks in the middle region of the girder and some cracks in the support region propagating from the slabs onto the center girder. The crack pattern observed in the girder with loading will be presented later in section 5.1.2. No significant cracks were observed in the edge girders. The deflections at the center of the edge girders, E1 and E2 (as shown in Figure 5.4c) were compared and the girder E1 was found to have comparatively larger deflection than that of E2 [1.41 mm at center of E1 as compared to 1.25 mm at center of E2 at peak load of 400 kN load cycle].

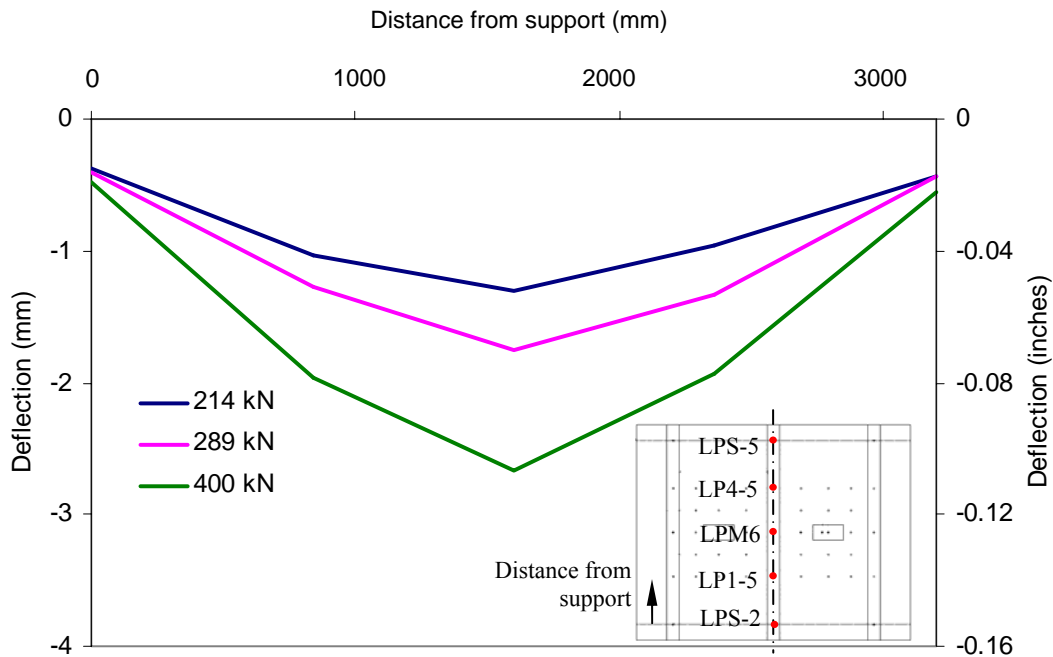
Figure 5.6a Deflection along length of middle girder

The deflection profiles over the test specimen were obtained from the linear potentiometers. The deflection profiles along the lengths of the middle and edge girders at the peak loads in each of the load cycles of phase 1 are presented in Figure 5.6. The deflections were measured at mid and quarter span and at supports of the girders. As expected, since the load on the middle girder was contributed by the influence areas of both the slabs, the center deflection of the middle girder (Figure 5.6a) was about 1.9 times the center deflection of the edge girders. The deflections of the two edge girders are shown in Figures 5.5b and 5.5c. The maximum deflection in edge girder 1 was slightly higher than that in edge girder 2 [1.41 mm in edge girder 1 as compared to 1.25 mm in edge girder 2] at peak load of 400 kN load cycle.

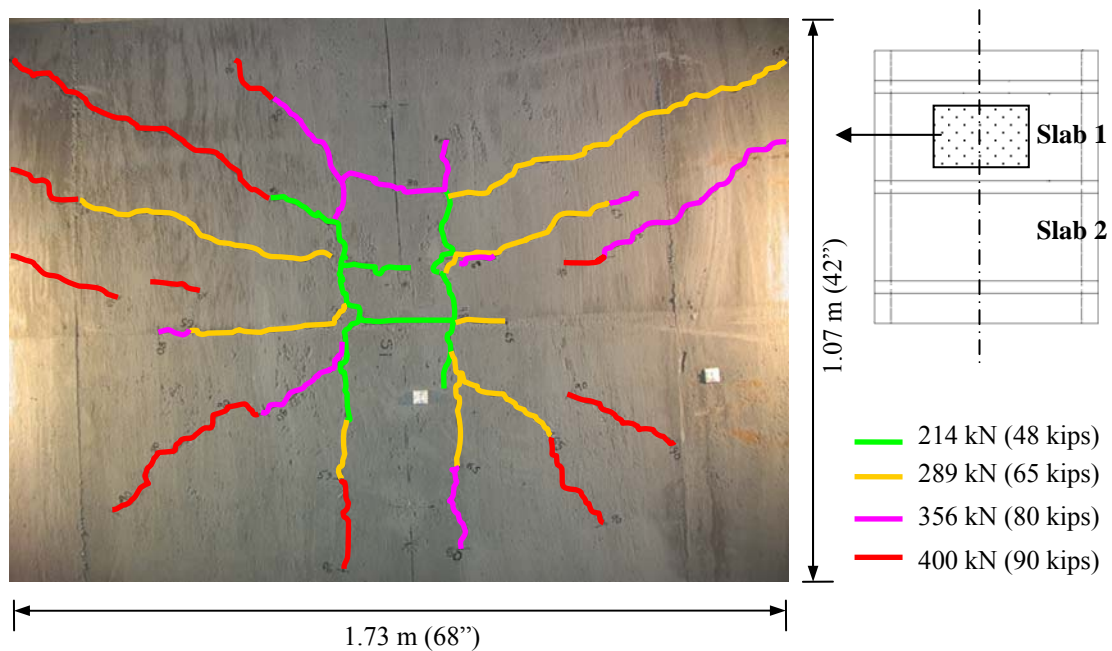
(a) Crack pattern in Slab 1 during Phase 1 loading

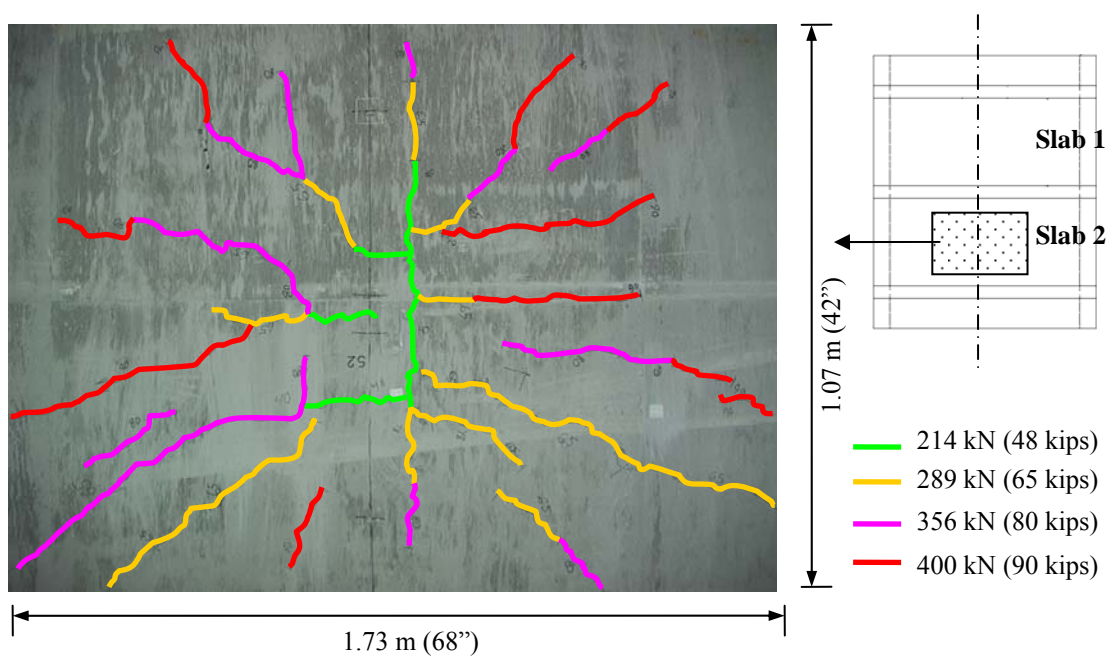
(b) Crack pattern in Slab 2 during Phase 1 loading

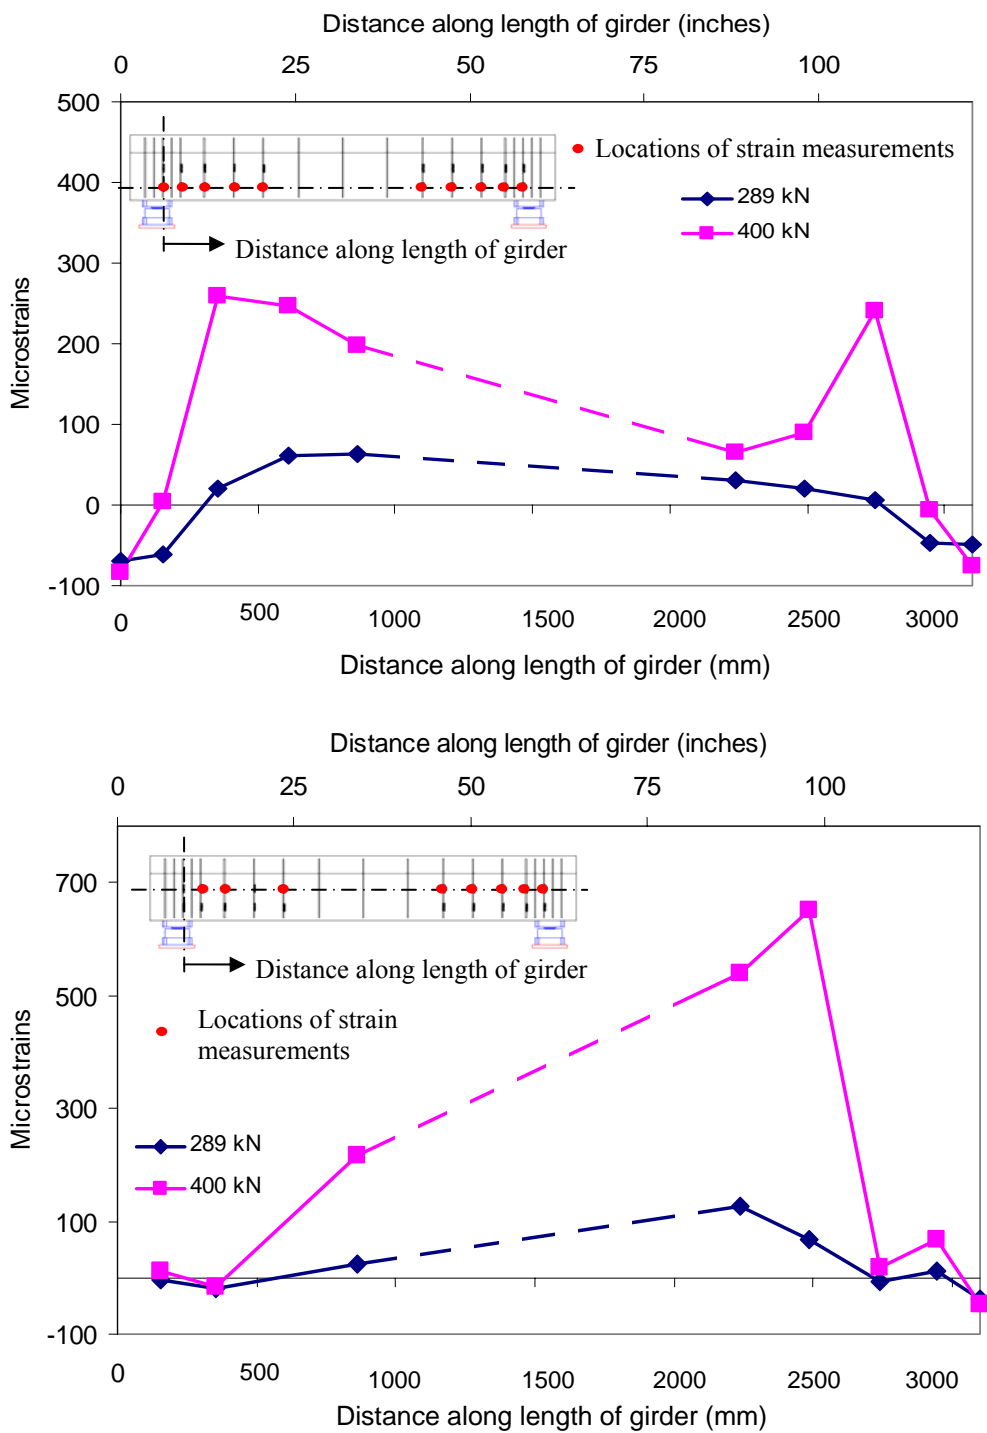
Figure 5.16 Strain profile in center girder stirrups

this load level was 652 micro-strains, which was about 27% of predicted yield strain in the steel stirrups of 2414 micro-strains. This corroborated the visual observations that showed very little damage in the girders. The highest strain recorded in each instrumented stirrup along the length of the center girder is presented in Figure 5.17. The stirrups with higher strains towards the girder supports corresponded well with the areas at which the shear cracks were observed. The crack pattern in the center girder was shown earlier in Figure 5.13.

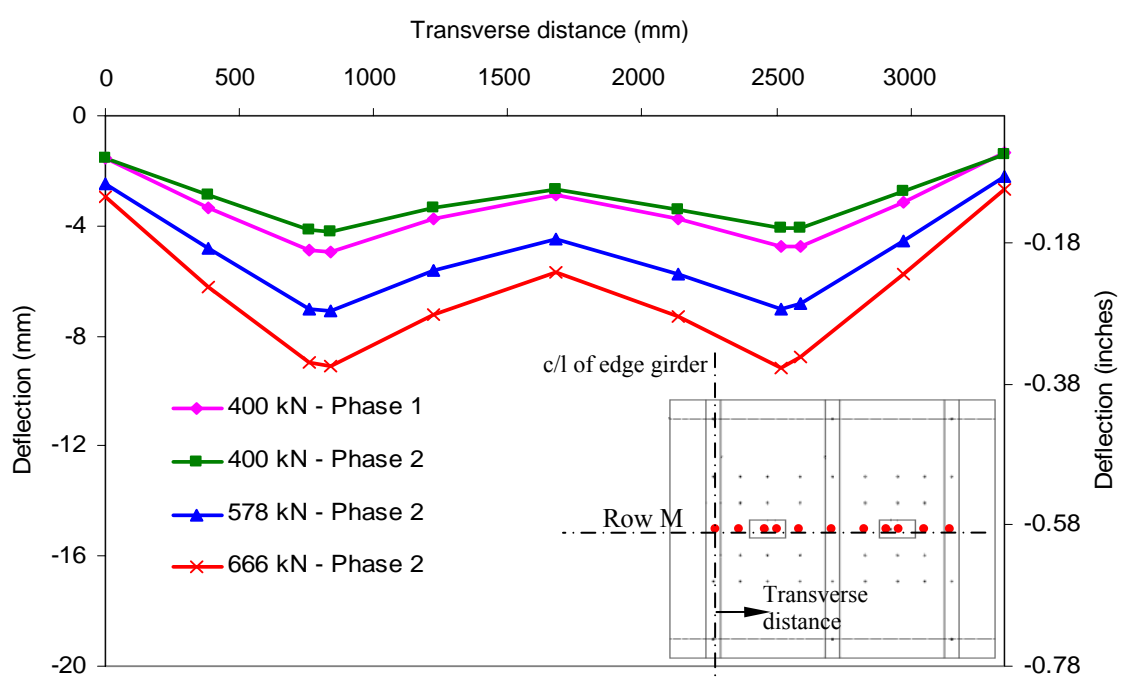
Figure 5.29 Deflection profile along Row M of linear potentiometers

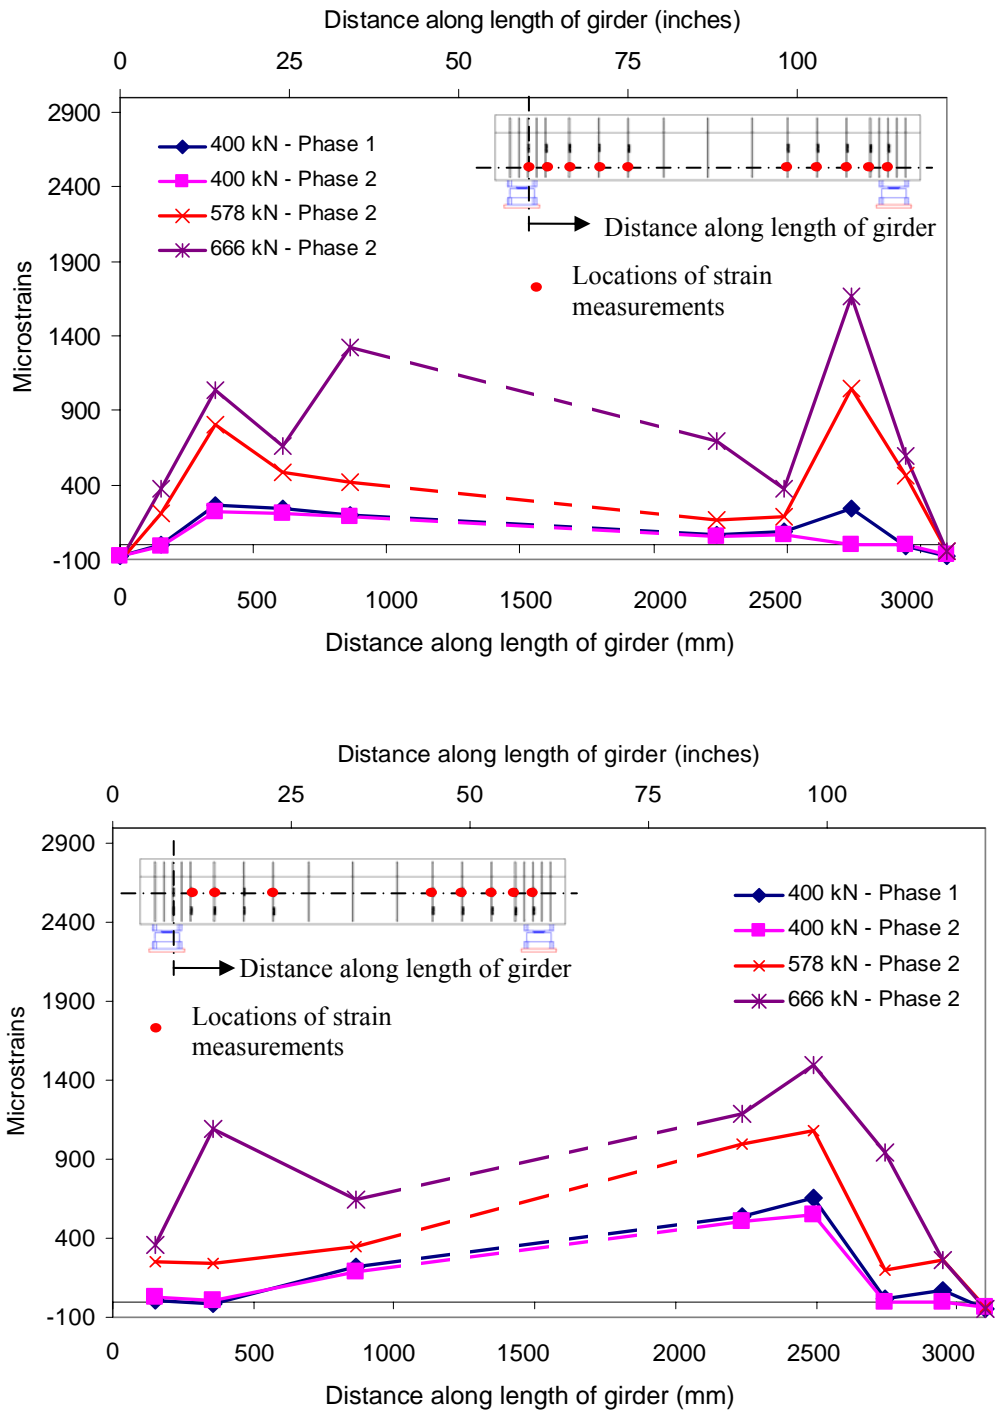
Figure 5.35 Strain profile in center girder steel stirrups

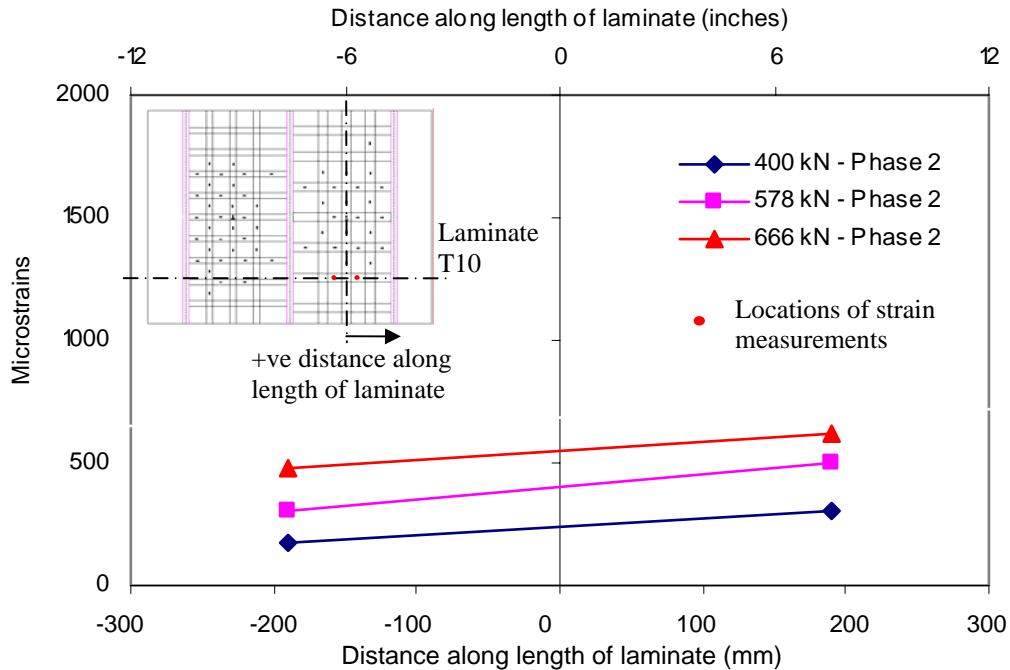
Figure 5.38b Strain profile in transverse composite laminate T10 of strengthened Slab 2 for phase 2 loading

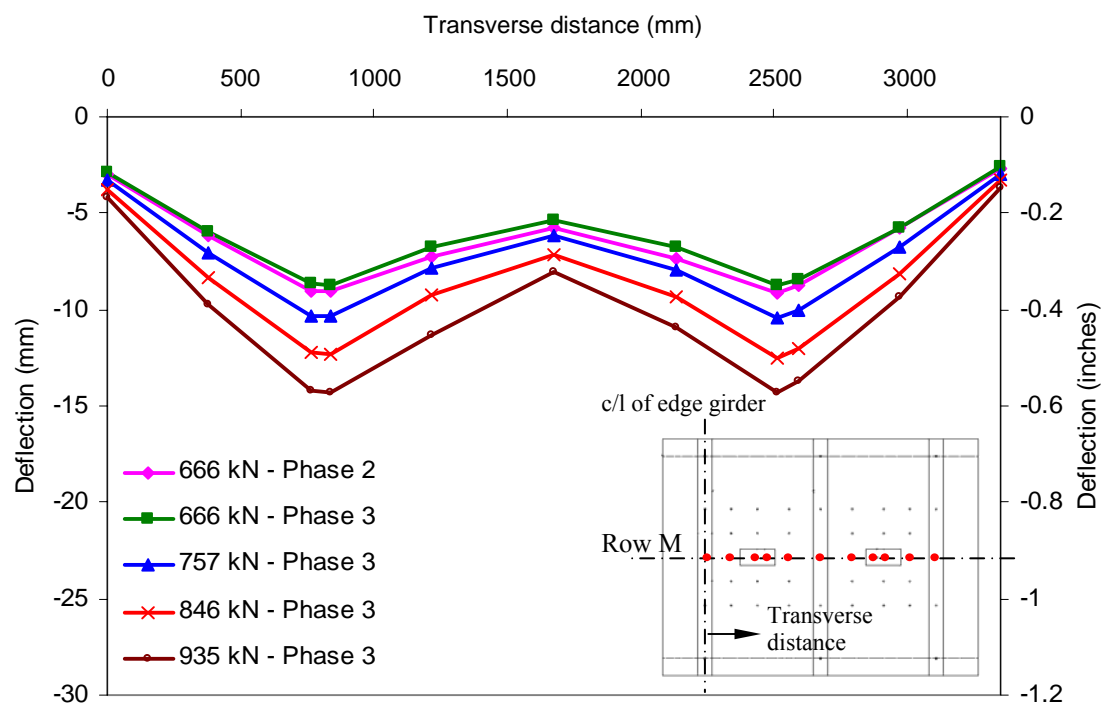
Figure 5.47 Deflection profile along Row M of linear potentiometers

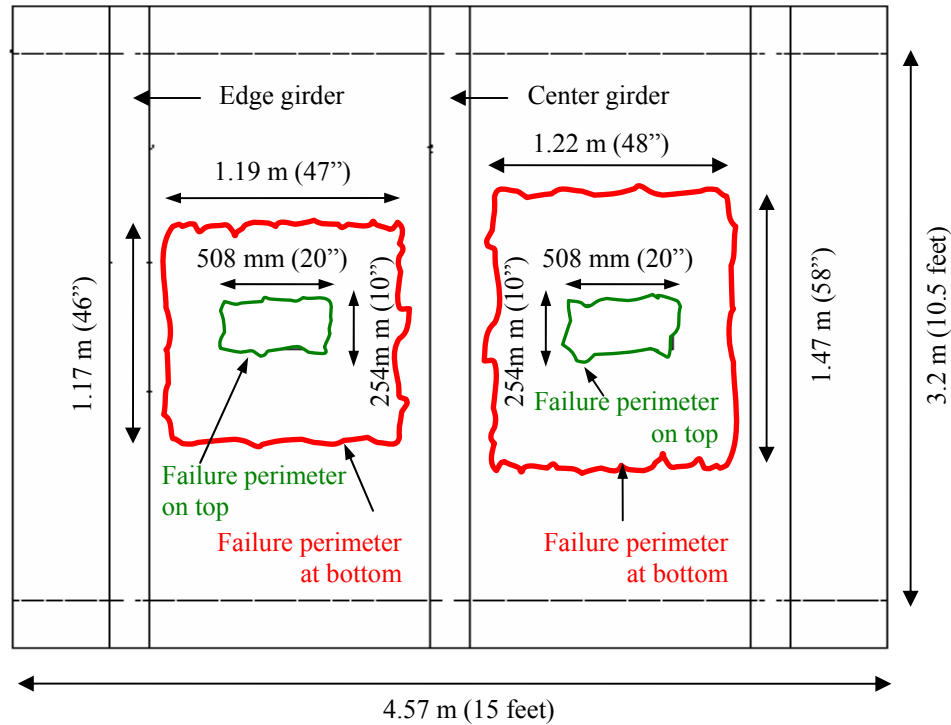
Figure 5.51 Schematic of punching shear failure perimeters in slabs

calculations shown in Chapter 4), as soon as debonding of the composite occurred at a load of 935 kN, which was 1.75 times higher than the unstrengthened punching shear capacity, the debonding was followed by simultaneous punch through of the load pad, representing the wheel load, through the concrete. The punching shear failure perimeter is presented schematically in Figure 5.51.

Comparison of the punching shear failure perimeters of the two slabs indicated that slab 1 strengthened with the pultruded strips, had a smaller damage area of 1.39 sq.m (15 sq.ft) as compared to damage area of 1.79 sq.m (19.3 sq.ft) in slab 2 which was strengthened with the fabric laminates. This indicated that the fabric laminates in slab 2 were able to distribute the load over a larger area as compared to the pultruded strips in slab 1. Thus even though till failure both the slabs had identical behavior, the extent and types of damage at ultimate failure of the two slabs were different. The locations of the punching shear failure perimeters at the bottom of the slabs with respect to the composite strips/laminates are presented in Figure 5.52.

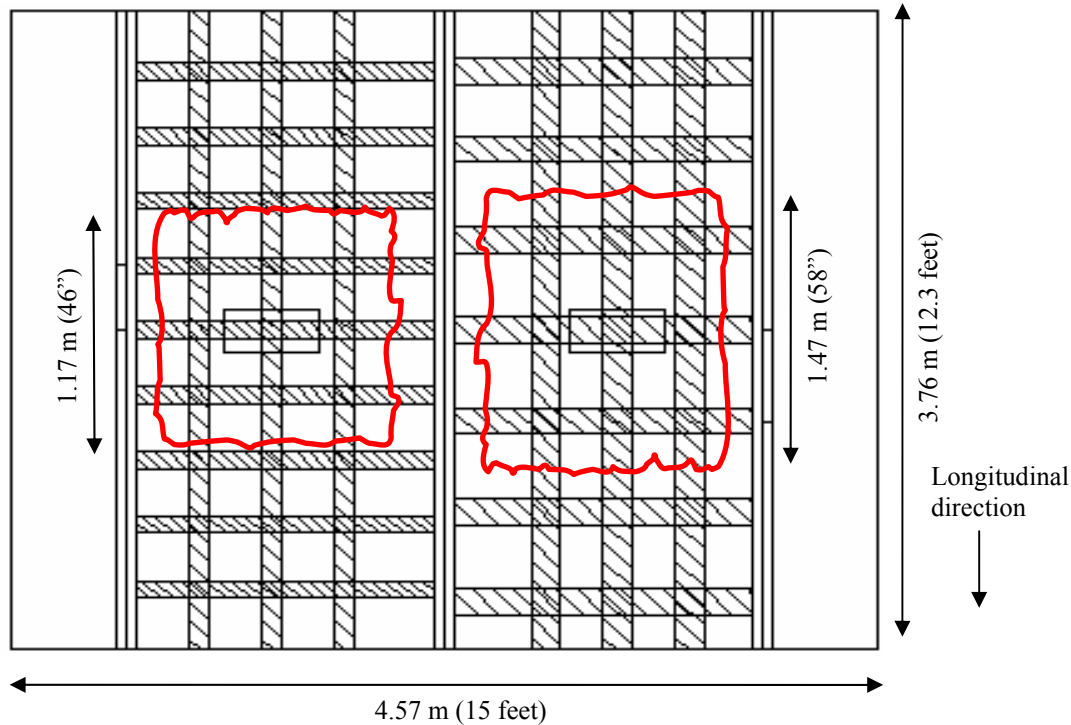
Figure 5.52 Schematic of intersection of the punching shear cracks with composite

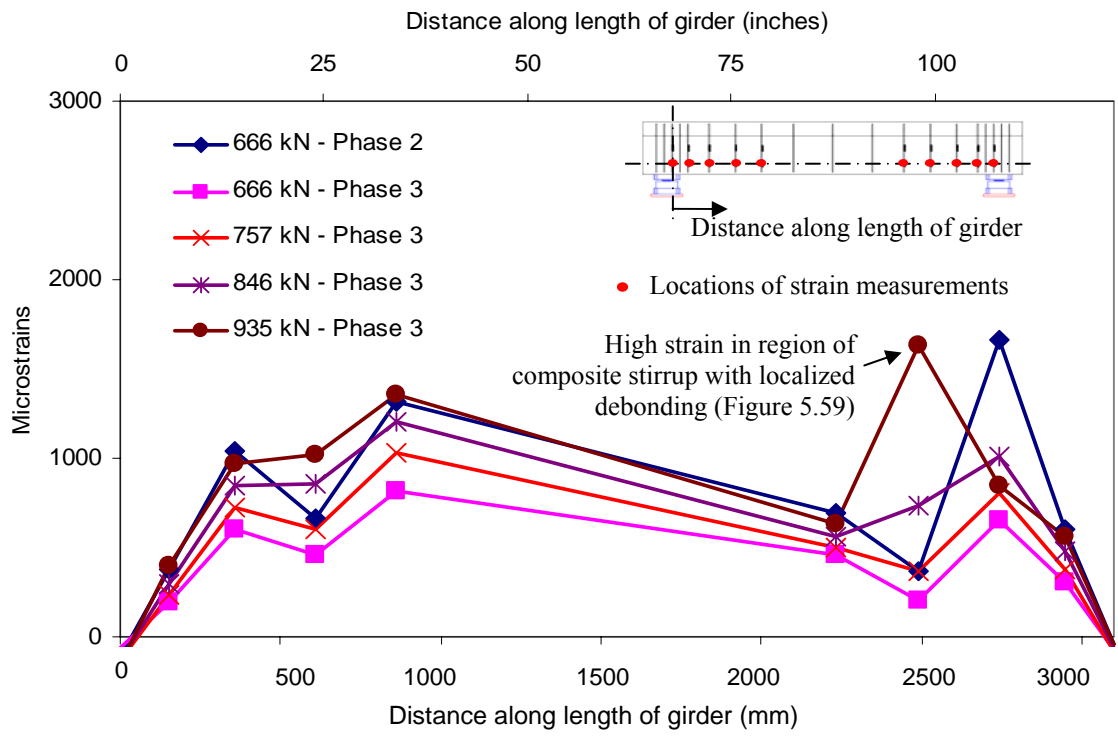
Figure 5.62a Strain profile in center girder steel stirrups along bottom line of gages

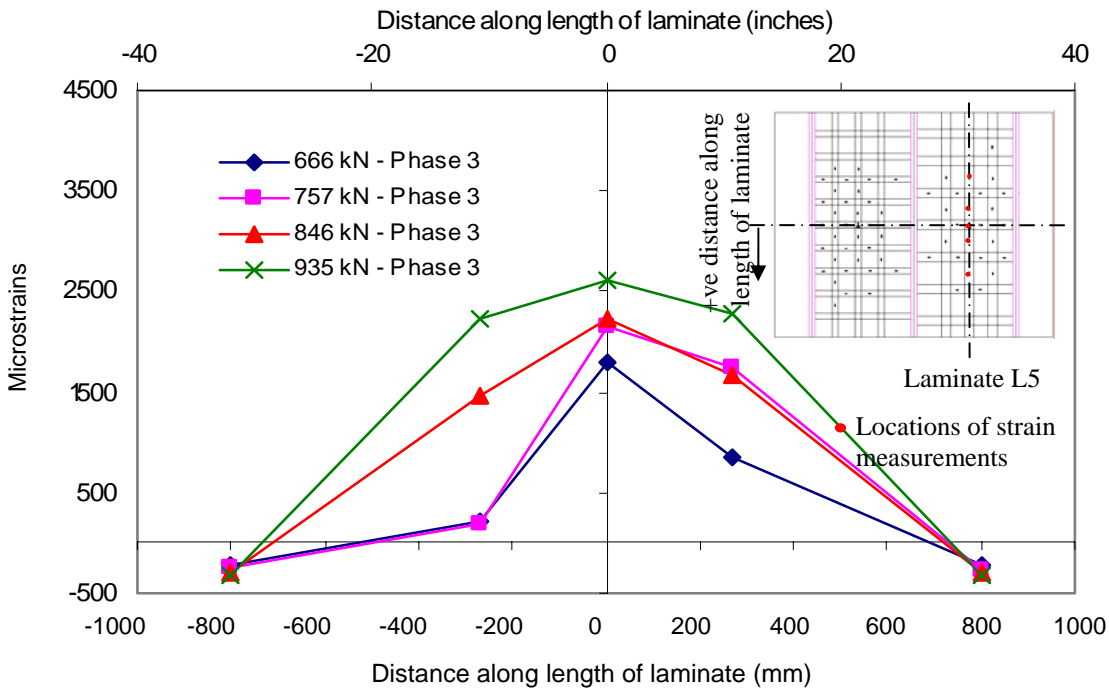
Figure 5.65b Strain profile in longitudinal composite laminates of strengthened slab 2

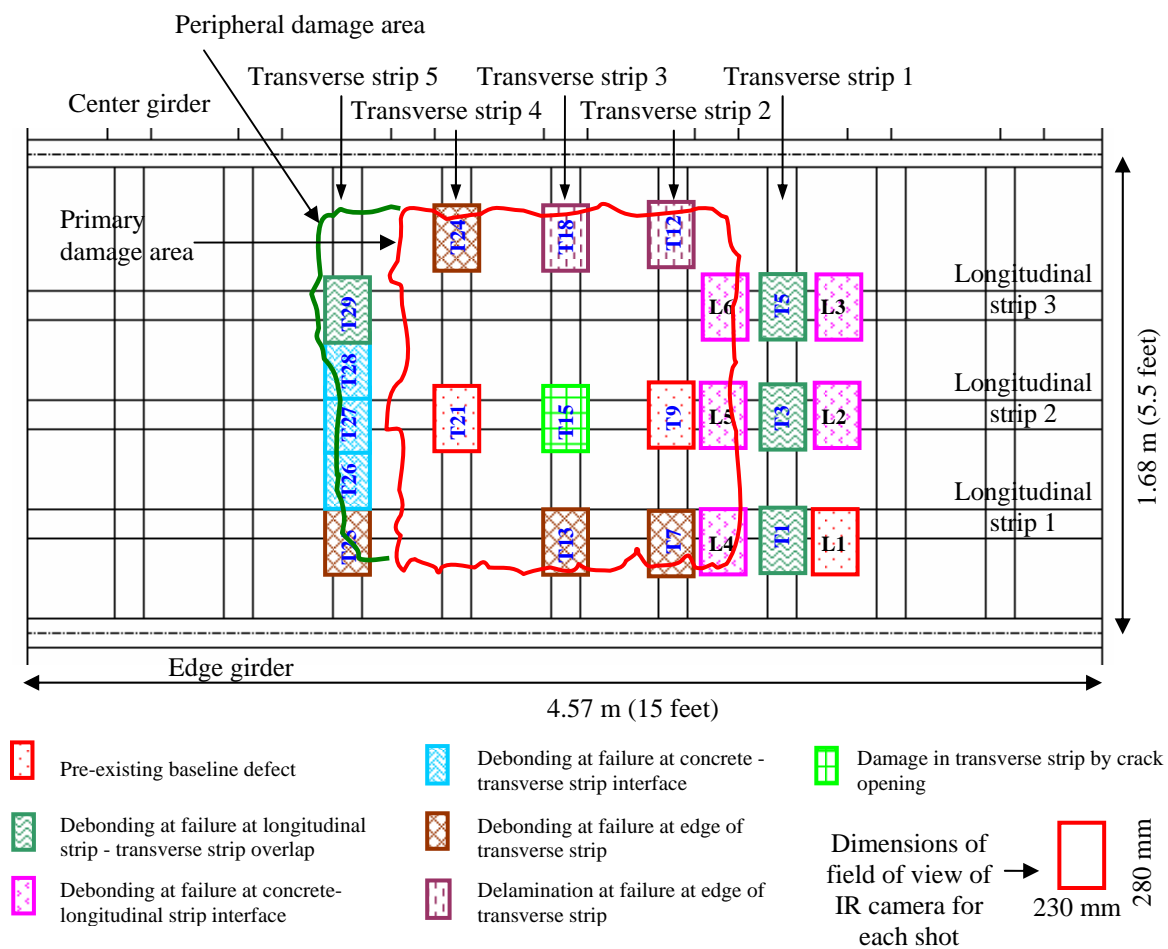
Figure 6.19 Damage areas identified through thermography inspections

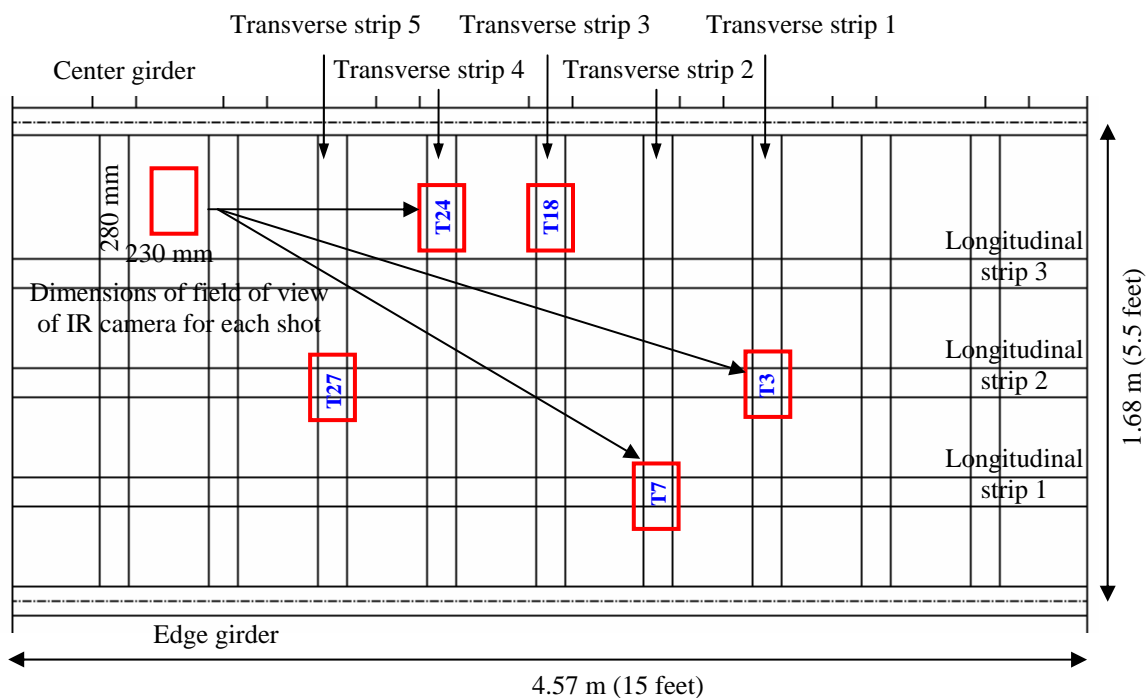
Figure 6.22a Locations of thermography inspections in Slab 1 used in Figure 6.22 (b) to show correspondence between thermography and visual observations

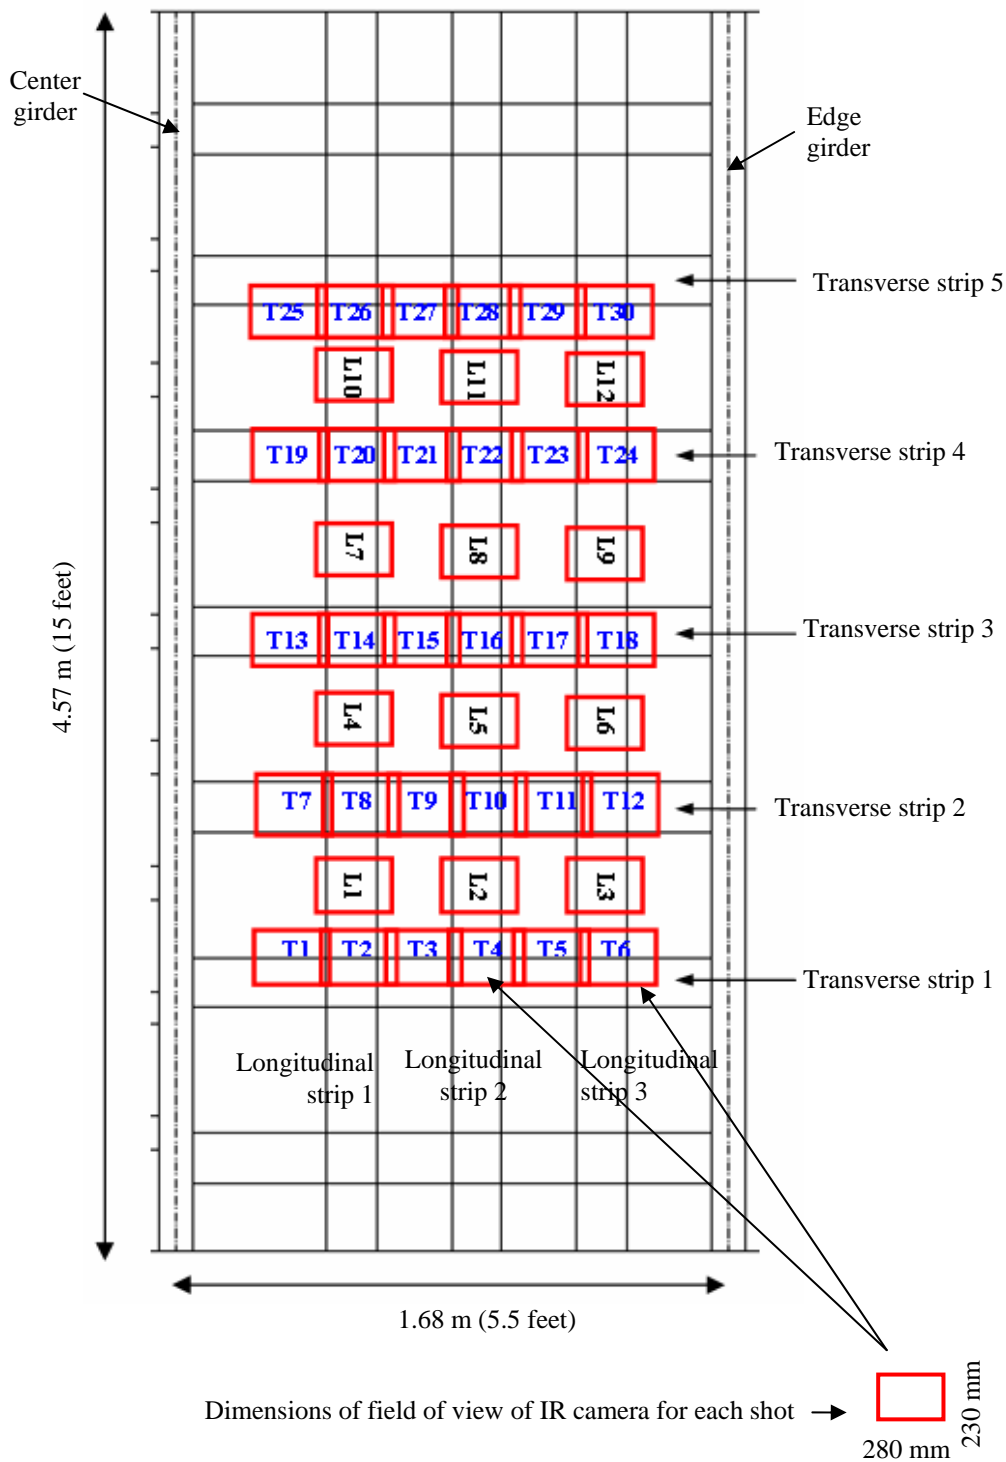
Figure 6.26 Locations of thermography inspections in Slab 2
