Assessment of FRP composite strengthened reinforced concrete bridge structures at the component and systems level through progressive damage and Non-Destructive Evaluation (NDE)

**ASSESSMENT OF FRP COMPOSITE STRENGTHENED REINFORCED
CONCRETE BRIDGE STRUCTURES AT THE COMPONENT AND SYSTEMS
LEVEL THROUGH PROGRESSIVE DAMAGE AND NON-DESTRUCTIVE
EVALUATION (NDE)**

Doctor of Philosophy

Structural Engineering

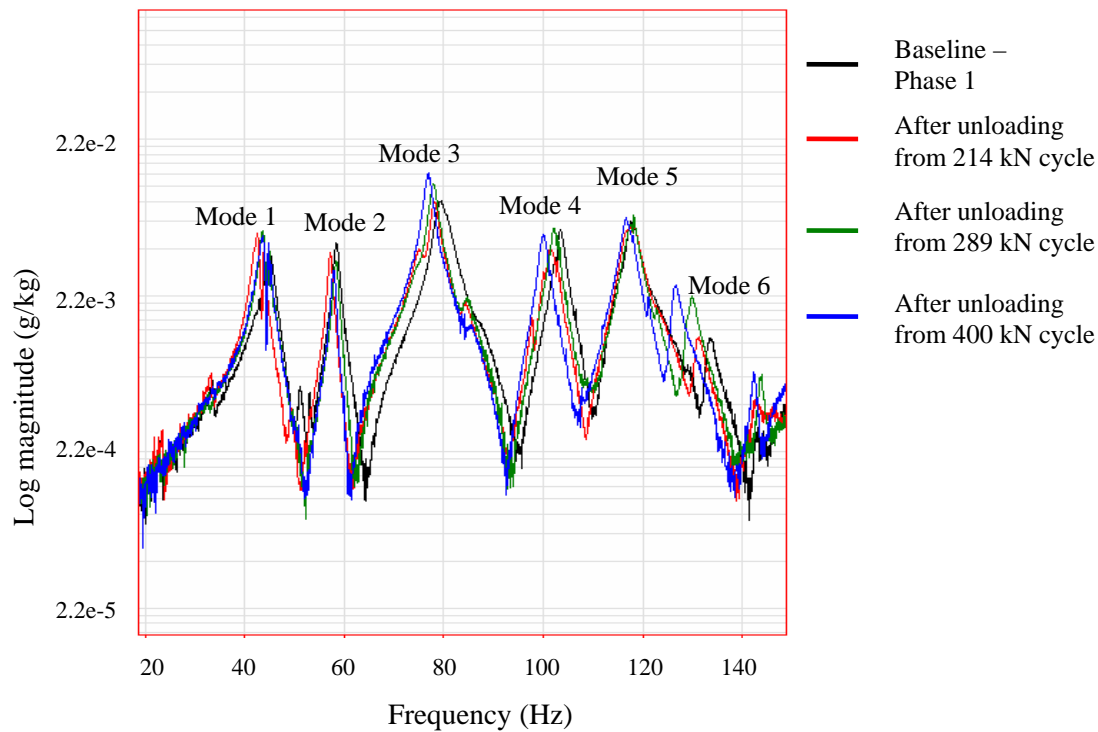
Figure 7.4 FRF magnitude plots for Phase 1 of testing

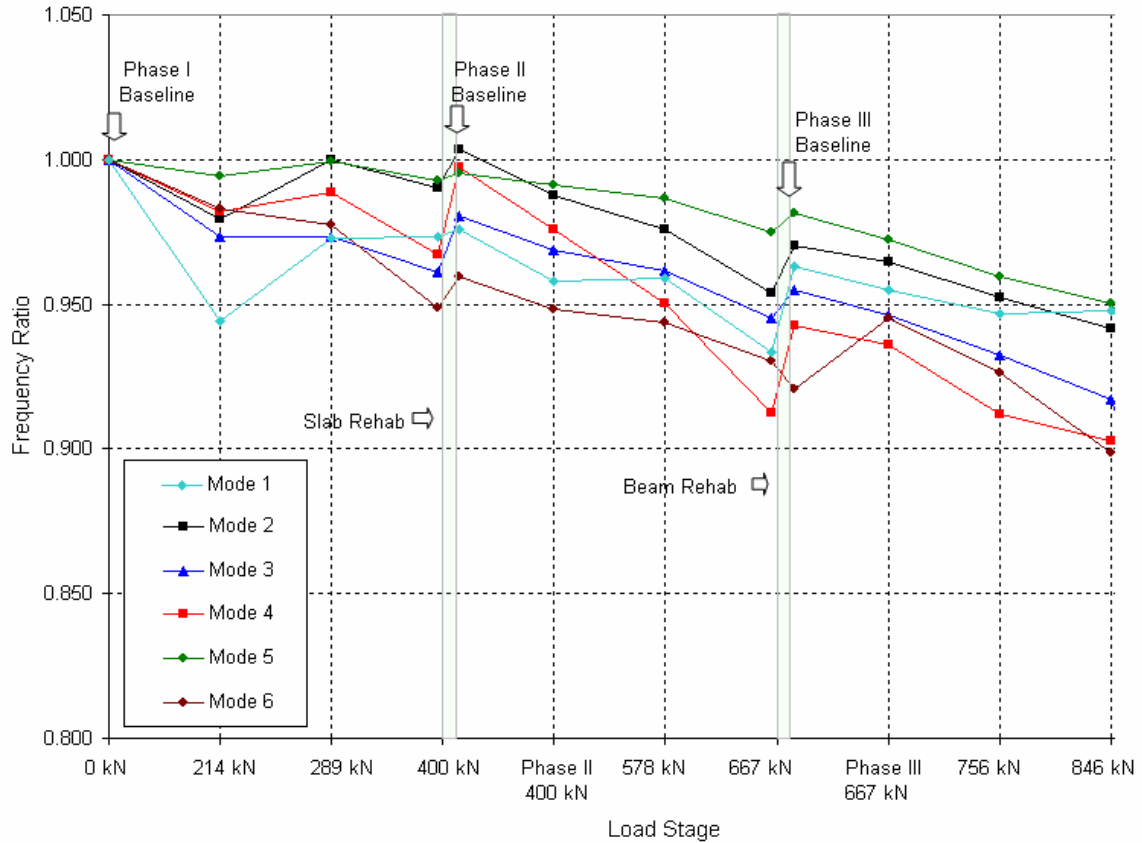
Figure 7.7 Trend of frequency ratio over the load stages

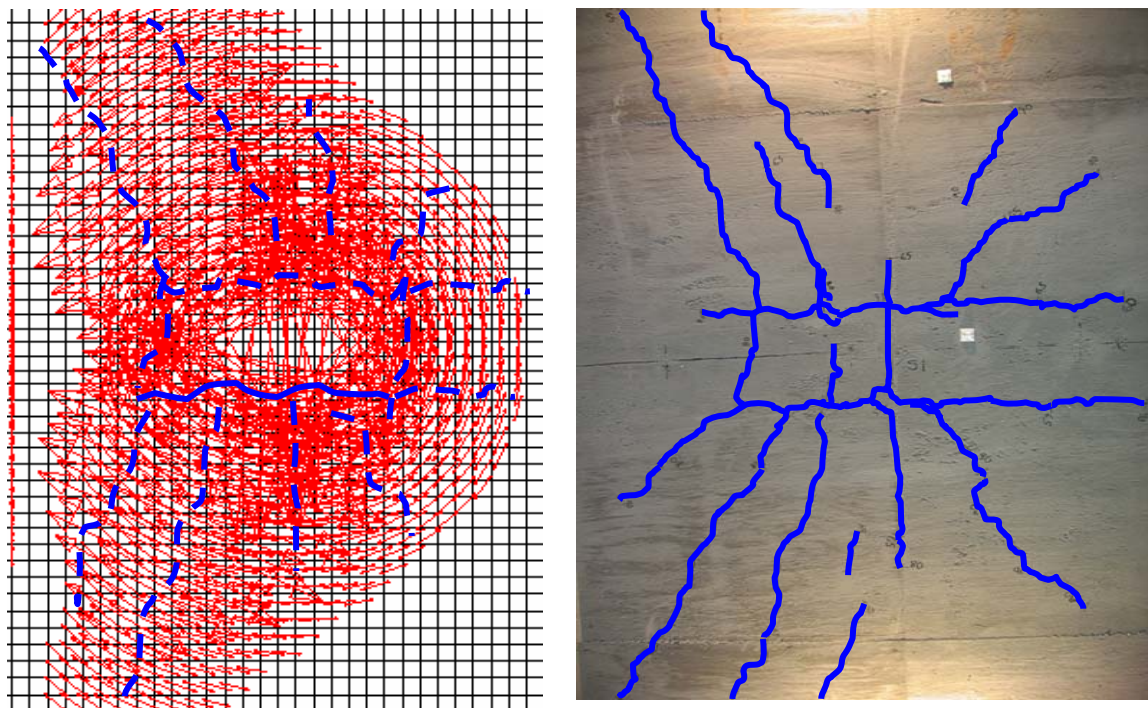
Figure 8.18a Comparison of crack patterns in slab 1 below load area from numerical model and test observations at 400 kN (90 kips) - End of Phase 1

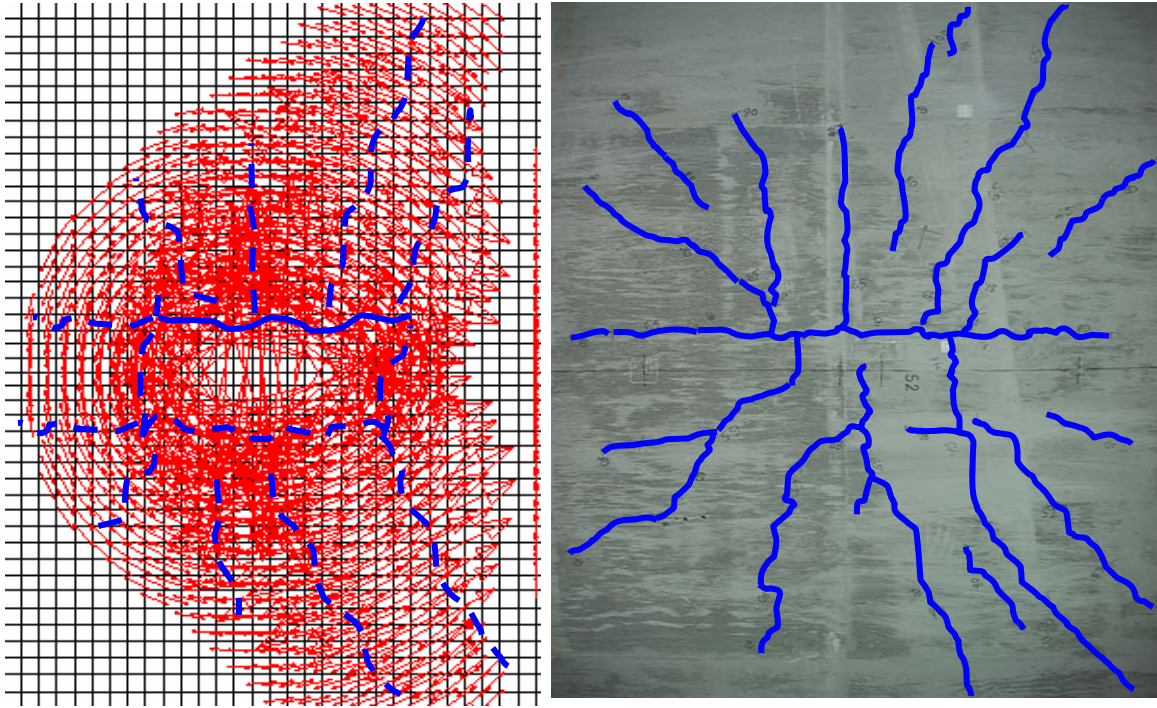
Figure 8.18b Comparison of crack patterns in slab 2 below load area from numerical model and test observations at 400 kN (90 kips) - End of Phase 1

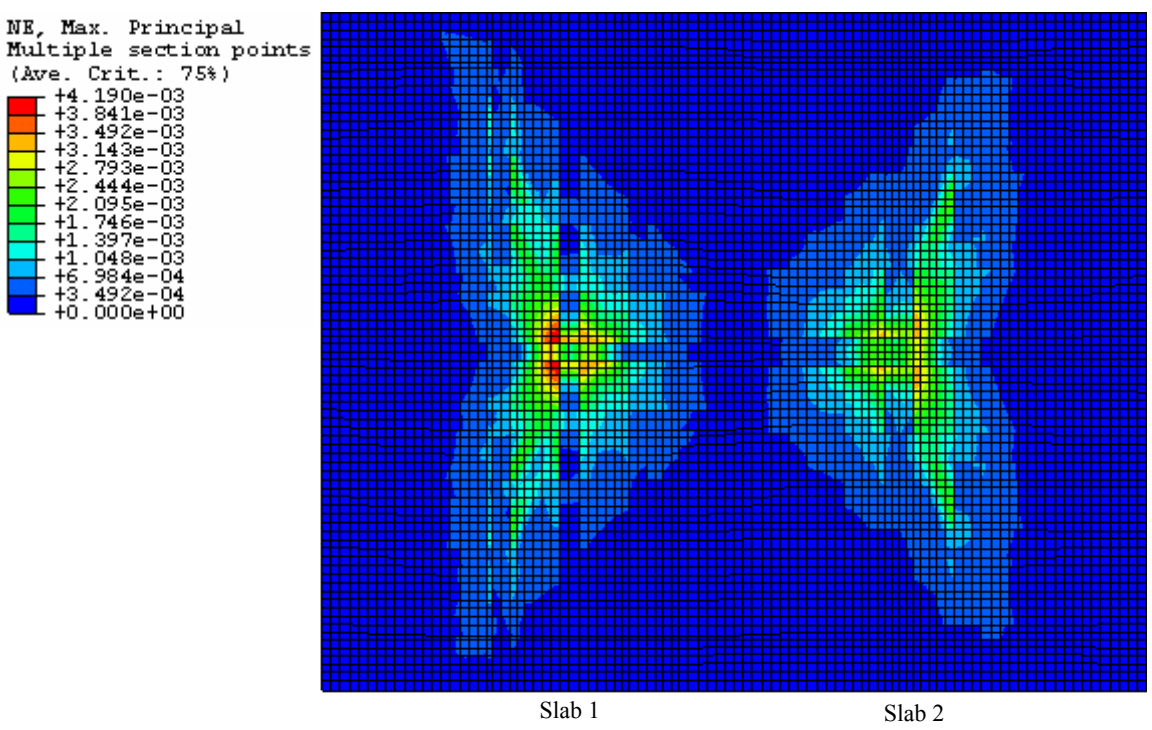
Figure 8.40 Maximum principal strain contours at slab bottom at 930 kN – Phase 3

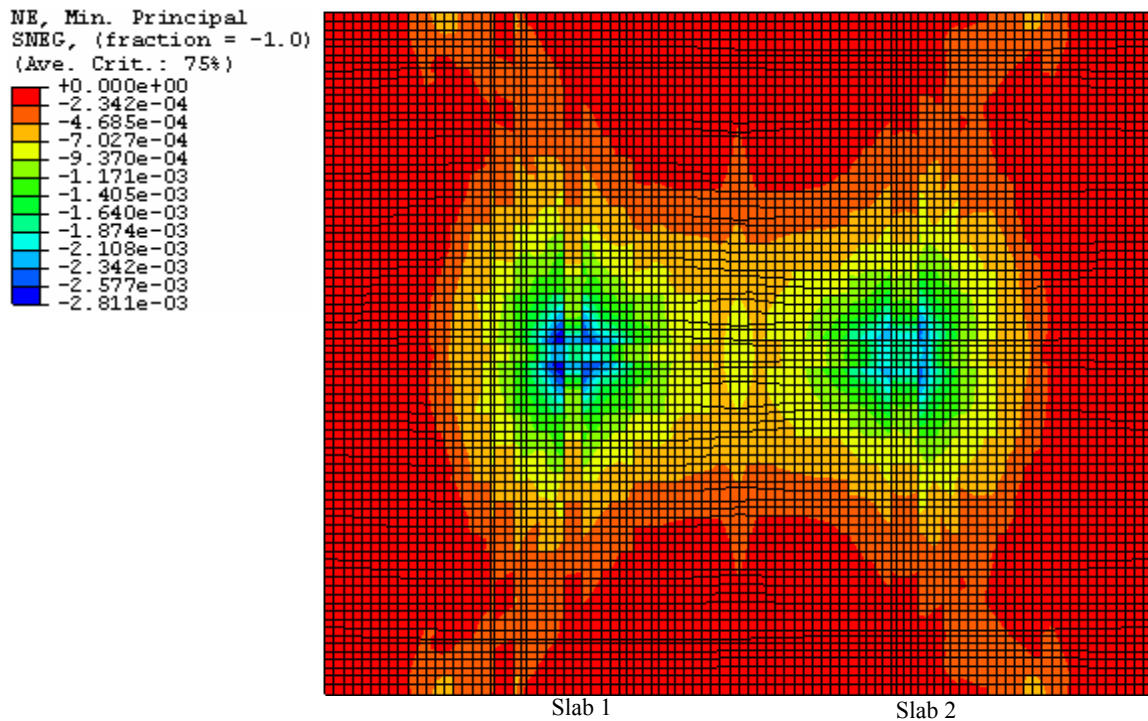
Figure 8.42 Minimum principal strain contours on slab top at 930 kN – Phase 3
