Re-cementation of Crushed Material in Pavement Bases

# Re-Cementation of Crushed Material in Pavement Bases

<b>DOCUMENT RETRIEVAL PAGE</b>		<b>Technical Memorandum No.:</b> UCPRC-TM-2009-04			
<b>Title:</b> Re-cementation of Crushed Material in Pavement Bases					
<b>Authors:</b> L. Chai, C. L. Monismith, and J. Harvey					
<b>Caltrans Technical Lead and Reviewer:</b> D. Maskey					
<b>Prepared for:</b> California Department of Transportation Division of Research and Innovation Office of Roadway Research		<b>FHWA No.:</b> CA131890A	<b>Date Work Submitted:</b> March 30, 2010	<b>Memorandum Date:</b> October 2009	
<b>Strategic Plan Element No:</b> 3.1.4		<b>Status:</b> Stage 6, final version		<b>Version No:</b> 1	
<p><b>Abstract:</b> When recycled crushed concrete and crushed cement-treated materials have been used in pavement bases and subbases, increases in stiffness have been observed. This stiffness increase has been attributed to re-cementation of these materials. To evaluate this phenomenon, four projects that used these recycled materials and for which data are available have been studied. Two of the projects are pavements that had been subjected to Heavy Vehicle Simulator (H

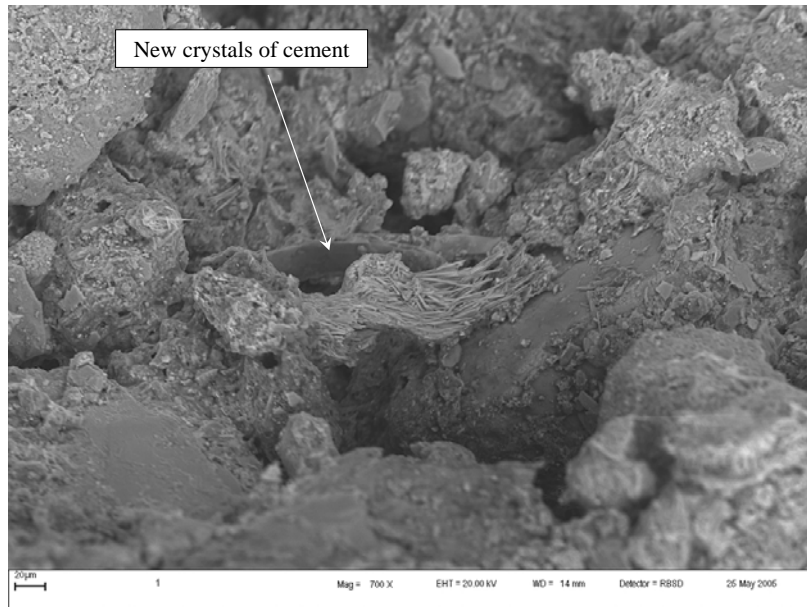
**Figure 2.1: New crystals of cement reaction products (10).**

Re-cementation is a process that occurs when materials such as crushed concrete and cement-treated soils are mixed with water and other granular materials to improve compactability, and compacted as base and subbase layers in pavement structures. Previously unhydrated cement particles will be exposed to water allowing additional hydration to continue in the compacted material over a long period of time. Figure 2.1 shows an example of new crystals of cement reaction products formed from the re-cementation process. That material shown is from an asphalt emulsion-stabilized base made with in-place recycled cement-treated base with 4 percent cement that was originally built in the late 1960s and later recycled with the emulsion in 1974 because it had failed by block cracking from shrinkage of the cemented base. The sample shown was freshly taken from the pavement 30 years later in 2005, but it shows evidence of ongoing formation of new cementitious material, in addition to evidence of older cementitious material apparently dating back to the original construction. Evidence was also found in the base of unhydrated cement even 35-plus years after the original mixing of the cement and 30 years after its being recycled with emulsion. The evidence that this is a new re-cementation product is its shape and the presence of unhydrated cement in the face of the base layer when the pit was opened in 2005.

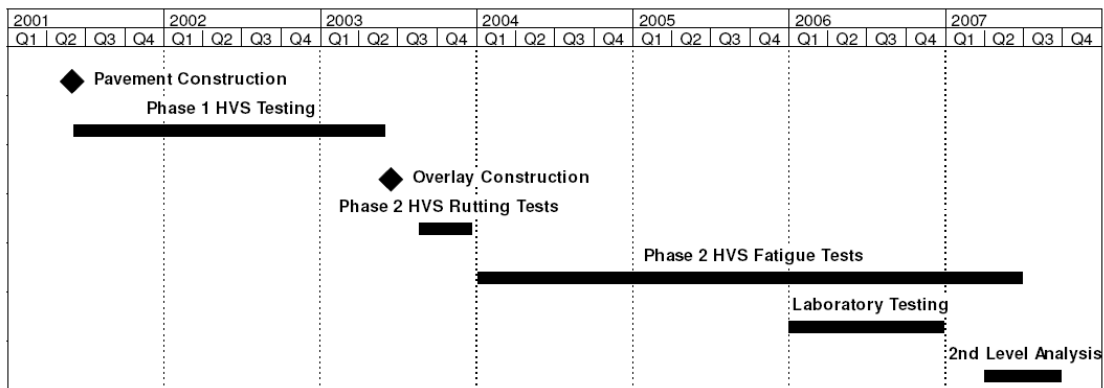
Figure 3.1: Reflective Cracking Study schedule. (5)

The test track was constructed in September 2001 according to Caltrans practice. Figure 3.1 illustrates the schedule for the test plan followed in the project. Figure 3.1 shows that the program involved (1) construction of a new pavement section, (2) cracking the HMA layer of this pavement using an HVS to produce cracked sections for overlays (Phase One), (3) overlay construction, and, (4) HVS testing of the various overlay sections (Phase Two).

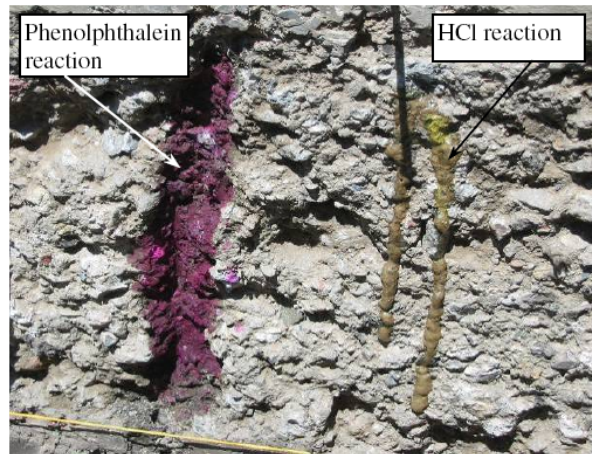
**Figure 3.2: 580RF phenolphthalein and hydrochloric acid reaction on base material.**

Re-cementation of the base material was visible. A cement odor was present and strong effervescence was noted when dilute hydrochloric acid was sprayed onto the base material, indicating the presence of old cement (Figure 3.2). When phenolphthalein was sprayed onto the base material, the sprayed area turned red, signifying a pH greater than 10, which is indicative of uncarbonated cemented material (Figure 3.2).

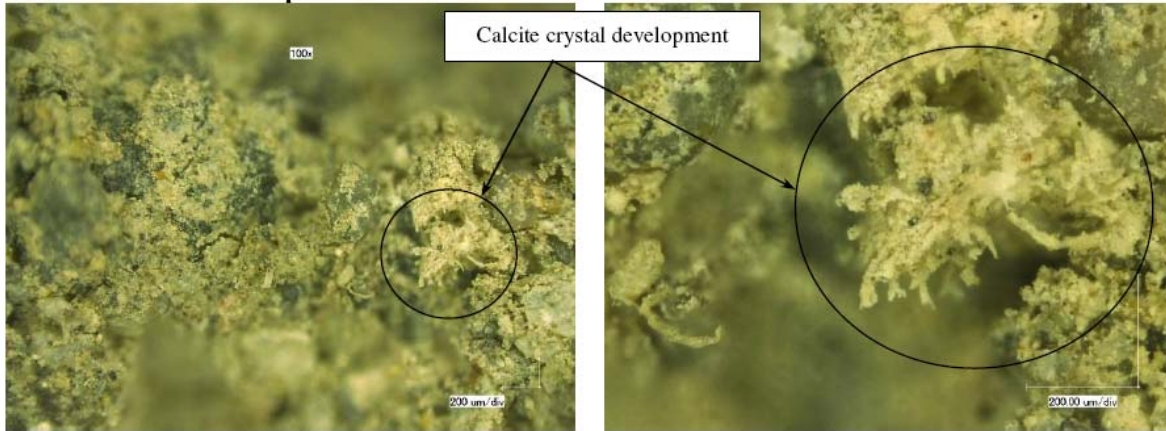
**Figure 3.3: Optical microscope view ( $\pm 100\times$ ) of calcite crystal development associated with cracks.**

**Figure 3.4: Optical microscope view ( $\pm 200\times$ ) of calcite crystal development associated with cracks.**

Figure 3.3 (optical microscope at  $\pm 100x$  magnification) and Figure 3.4 (optical microscope at  $\pm 200x$  magnification) show the presence of calcite crystals associated with the cracking in the carbonated sample, none of which were evident in the uncarbonated material. The well-crystallized nature of the material is indicative of recent formation (during the week before examination). There was also a conspicuous absence of calcium hydroxide, indicating severe carbonation.

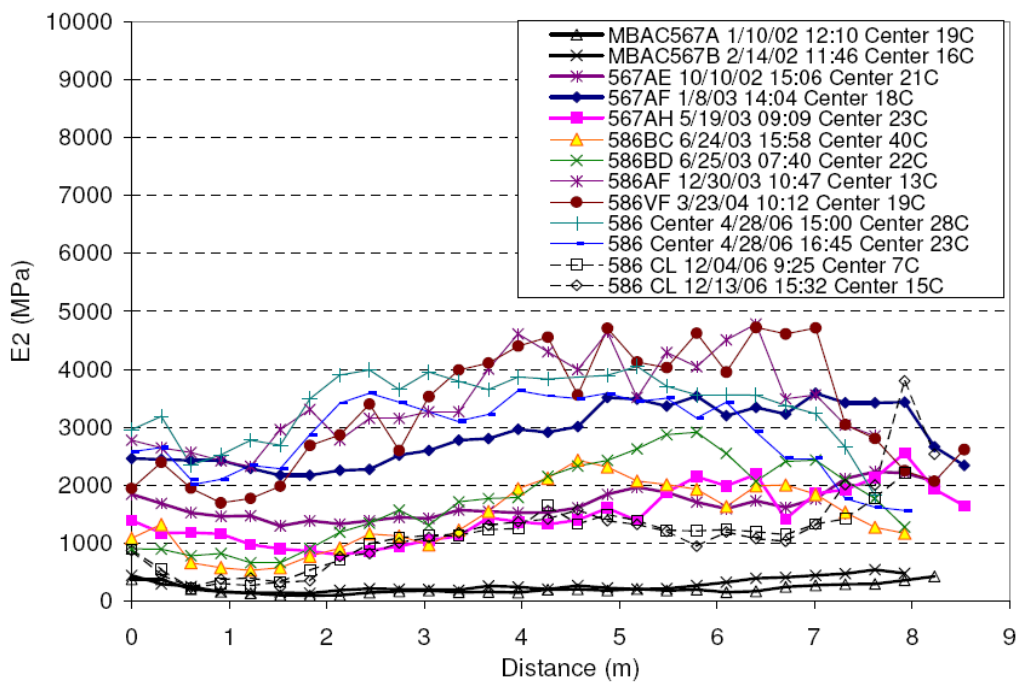
**Figure 3.5: Moduli of aggregate base from FWD measurements over a period of about five years; Sections 567RF/586RF (center of wheelpath).**

Very little time passed between the initial construction and the initial HVS testing on Section 567/586RF, and during that period no FWD tests were conducted. Backcalculations show that the moduli of the base changed between 1,000 and 4,000 MPa (145,000 and 580,000 psi) during the approximately five years that passed between the initial and the second HVS trafficking; Figure 3.5 and Figure 3.6 show that changes especially occurred during the first two years. During this time there was almost no truck traffic and only light car traffic. This would indicate that while some of the stiffness increase is likely due to curing (drying out causing suction) of the base, much of the stiffness gain should be attributed to re-cementation of the recycled concrete aggregate particles used in the base material (12). Most virgin Class 2 bases have stiffnesses that generally do not exceed 500 MPa (73,000 psi), while this base material had stiffnesses that were 2 to 8 times higher than most virgin Class 2 AB materials.

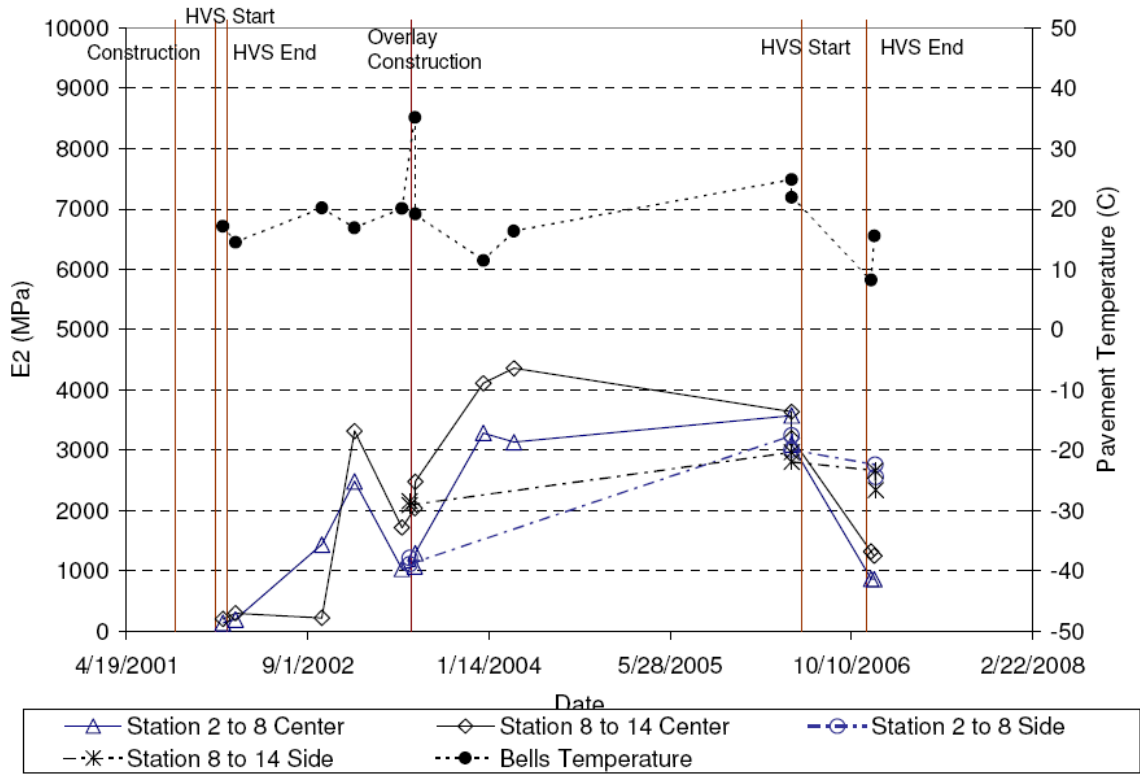
Figure 3.6: Moduli of aggregate base from FWD measurements versus time for Sections 567RF/586RF.

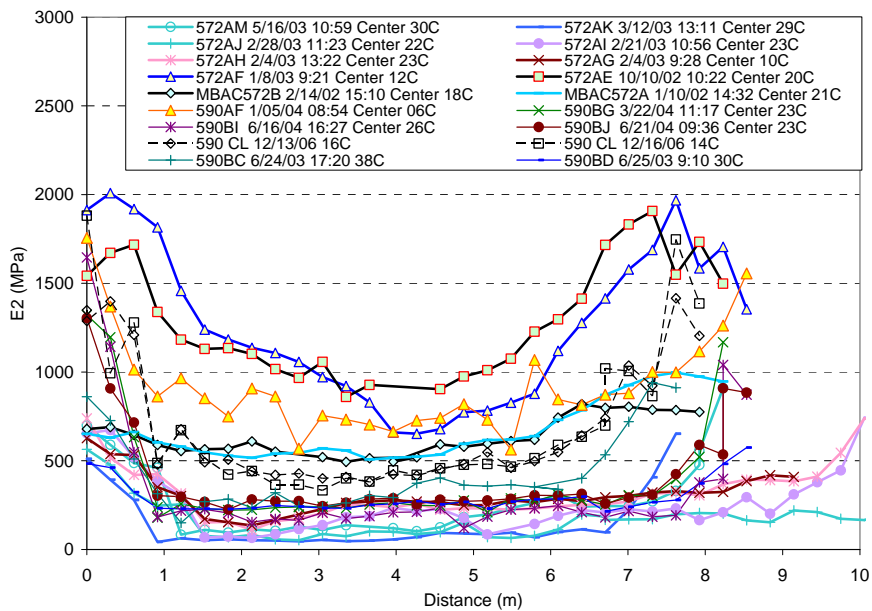
Figure 3.7: Modulus of aggregate base from FWD on Sections 572RF/590RF (center of wheelpath).

A similar trend can be seen for Section 572/590RF which was constructed at the same time with materials from the same source (Figure 3.7 and Figure 3.8). Section 572/590RF had approximately 18 months of light traffic between initial construction and initial HVS trafficking, another year between the two HVS tests, and another two years between measurements after the second HVS trafficking. It can be seen in Figure 3.8 that in the 18 months after initial construction the stiffness increased to approximately 1,000 MPa (145,000 psi). The very heavy loading of HVS trafficking then reduced the stiffness to approximately 150 MPa (22,000 psi), after which it increased over the next year to approximately 750 MPa (108,000 psi). The second round of heavy loading from the HVS brought the stiffness down to about 250 MPa (36,000 psi), which then increased over the next two years to about 500 MPa (73,000 psi).

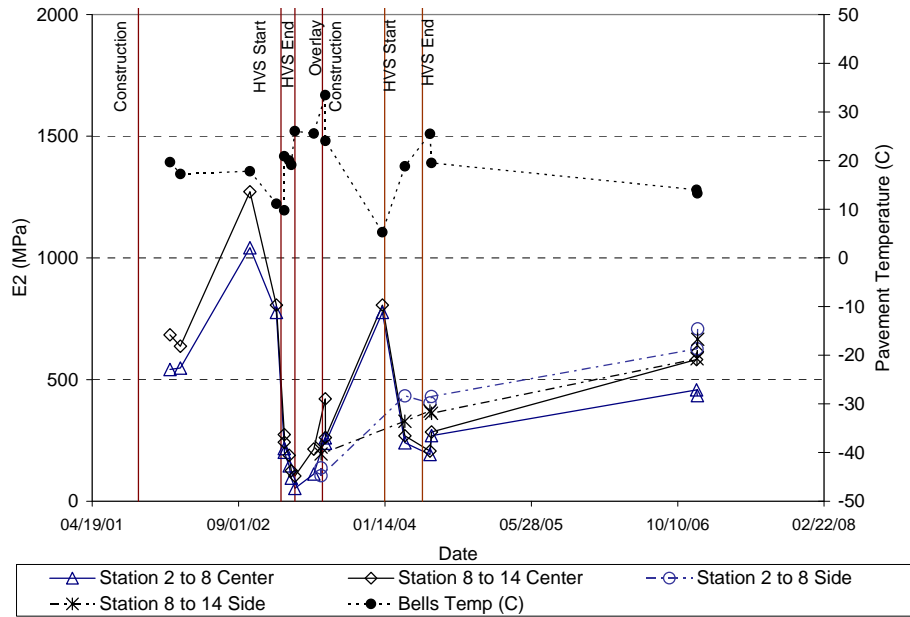
**Figure 3.8: Modulus of aggregate base from FWD versus time on Section 572RF/590RF.**

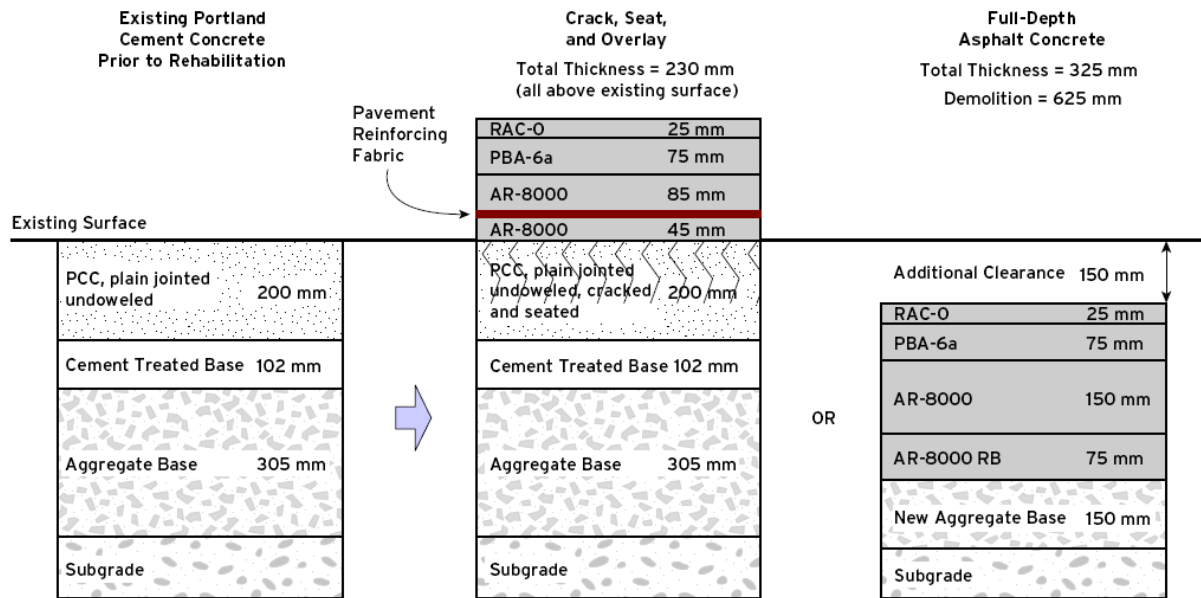
**Figure 3.9: Illustration of I-710 rehabilitation strategies.**

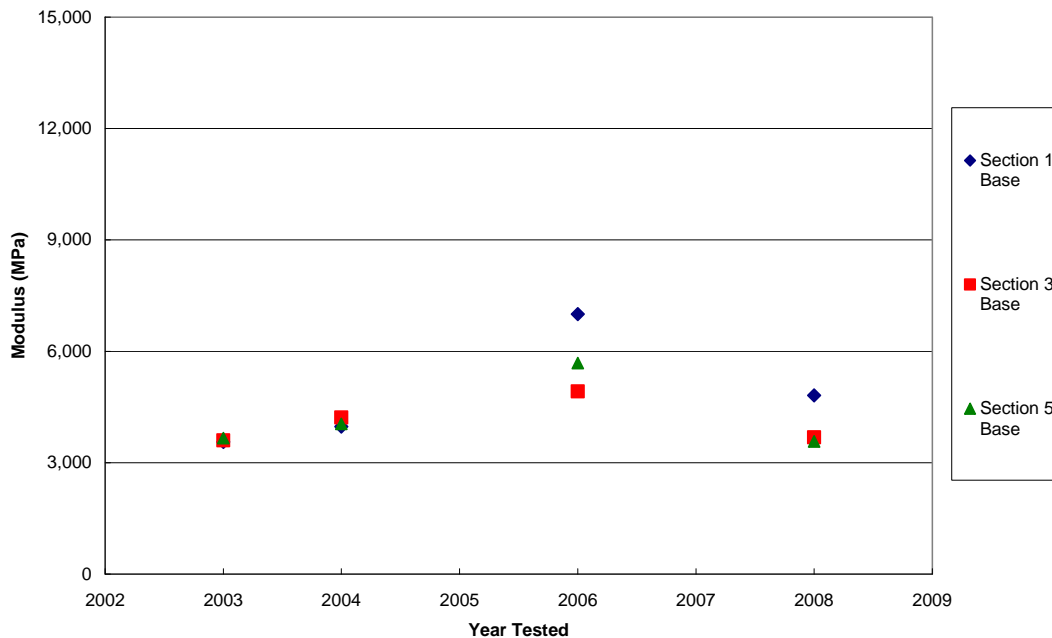
**Figure 3.10: I-710 Northbound Lane 1 full-depth sections—layer moduli with time.**

Figure 3.10 through Figure 3.12 show the backcalculated base moduli for the three full-depth sections. Average moduli values for the crushed concrete base section in the full-depth sections were of the order of 4,000 MPa (580,000 psi) with a range of about 1,200 MPa to 7,000 MPa (174,000 to 1,016,000 psi). These values are higher than observed values for conventional crushed aggregate base material. It is suspected that significant cementing must have taken place in the base layer to account for the high levels determined through backcalculation even though no cores were obtained that could be used for strength measurement or to provide evidence of cementation in a laboratory study. Nevertheless, although the computed values might not precisely represent the in-situ characteristics of the material, increased stiffness was evident.

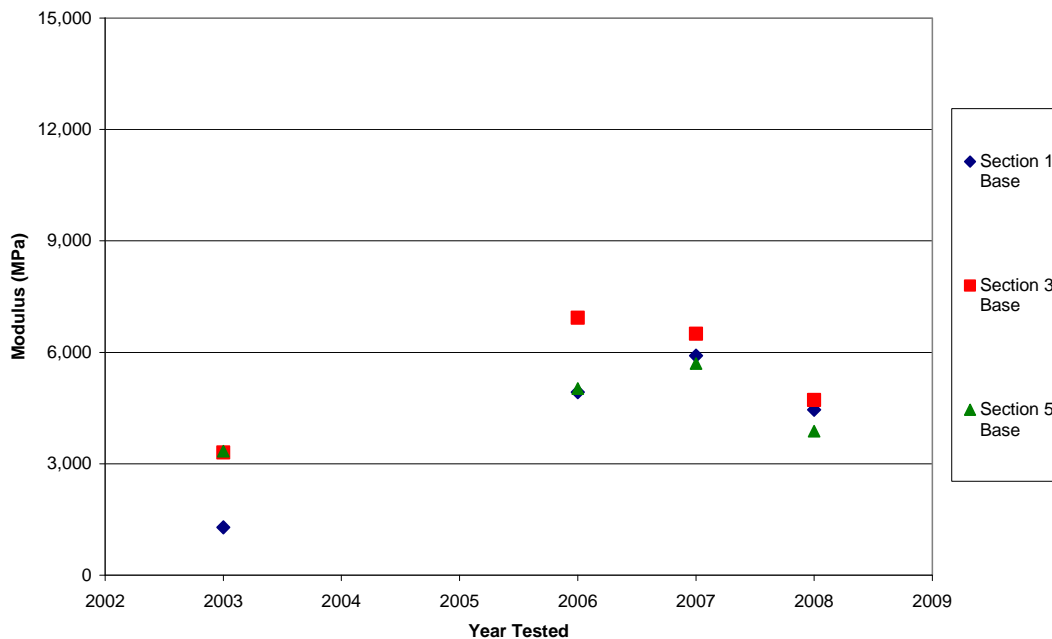
**Figure 3.11: I-710 Northbound Lane 2 full-depth sections—layer moduli with time.**

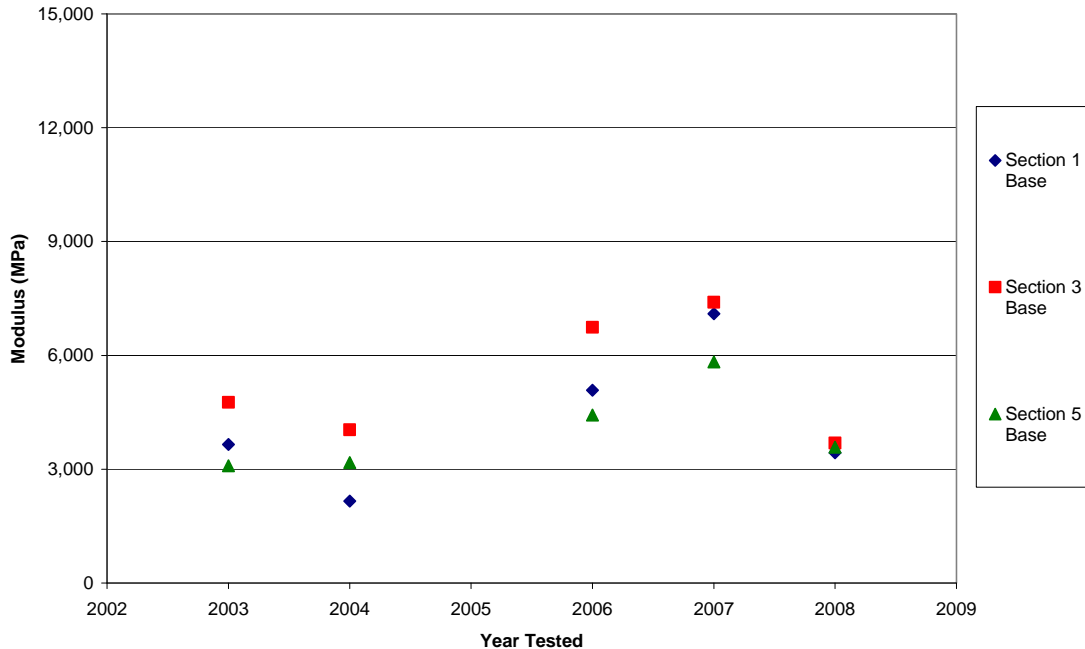
**Figure 3.12: I-710 Northbound Lane 3 full-depth sections—layer moduli with time.**

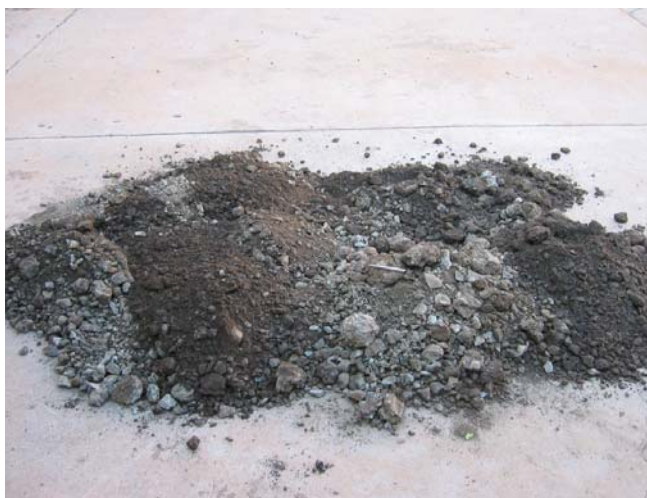
**Figure 3.13: Base course material from test pit.  
(Note large cemented lumps.)**

In Figure 3.13, lumps of cemented base from the original road were noted. Freshly exposed faces reacted to phenolphthalein turning a dark red color, indicating the presence of cement (Figure 3.14). A reaction was also obtained when hydrochloric acid was sprayed onto the material, indicating the presence of carbonate.

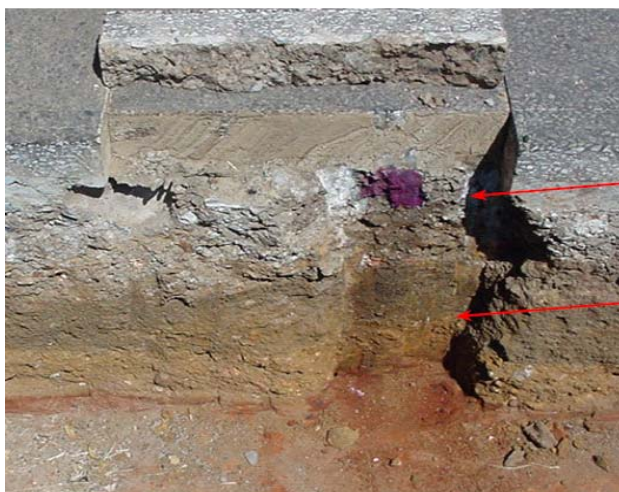
**Figure 3.14: Phenolphthalein reaction on base.**

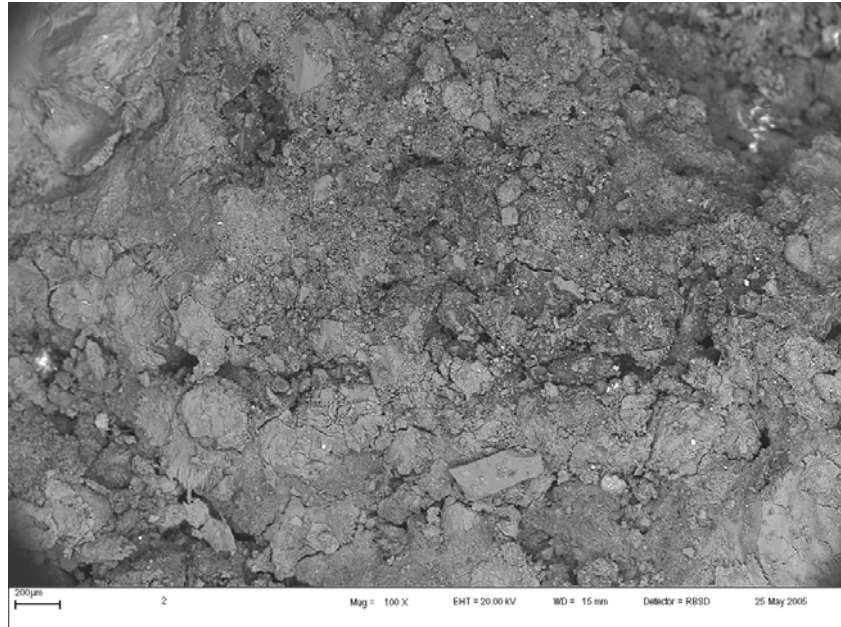
**Figure 3.15: Example of carbonated specimen cracking (shown in the lower part of the photograph).**

Figure 3.15 and Figure 3.16 show a typical result of carbonation where the development of calcite (calcium carbonate,  $\text{CaCO}_3$ ) from lime (calcium hydroxide,  $\text{Ca}(\text{OH})_2$ ) in the material results in expansion and cracking. This cracking was seen previously in a range of different carbonated materials. The highly crystallized nature of the material is indicative of recent formation. There is also a conspicuous absence of calcium hydroxide, indicating severe carbonation.

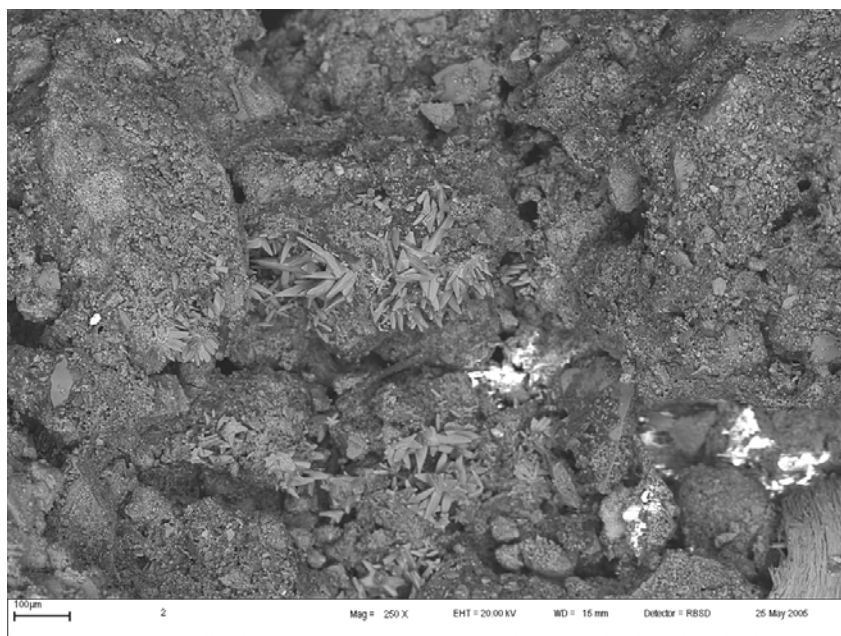
**Figure 3.16: Development of young calcite crystals associated with cracks.  
(Note ettringite crystals in the bottom right corner).**

Well-formed fibrous ettringite is also clearly visible in Figure 3.16 (strawlike [wispy] crystals in the bottom right corner), which indicates that cement was present in the matrix after construction, the former apparently generated during breakdown of the highly cemented pre-existing base.

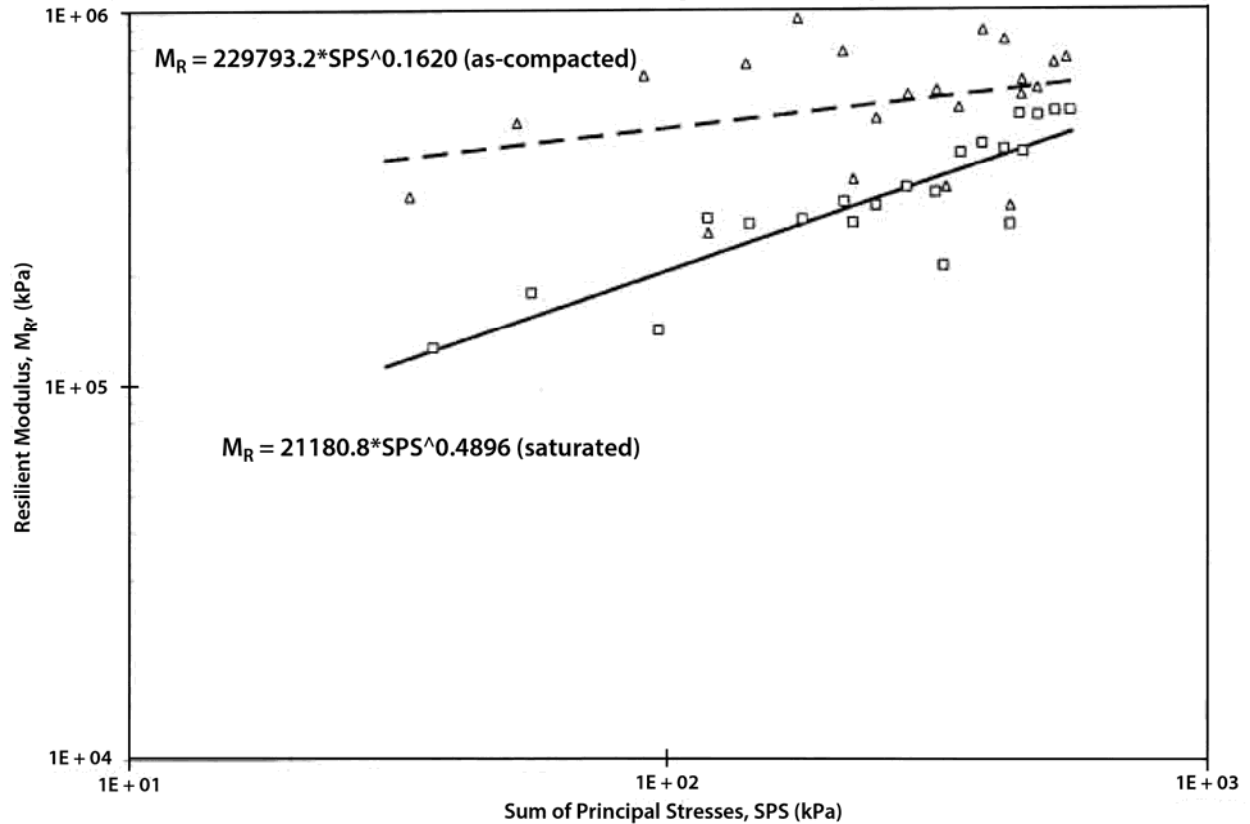
Figure 3.17: Laboratory resilient modulus test results for aggregate base.

Results of the initial laboratory resilient modulus testing on the aggregate base are shown in Figure 3.17. It can be seen that the stiffness is between about 300 and 500 MPa (44,000 and 73,000 psi) depending on the confining stress in the as-compacted moisture condition, which is the expected range for high quality uncemented aggregate base. FWD testing performed across the 1,000 ft-long test pavement just after construction in 1995 showed stiffnesses that averaged 285 MPa (41,000 psi) with a standard deviation 73 MPa (11,000 psi), again well within the range of expected values for uncemented aggregate base.

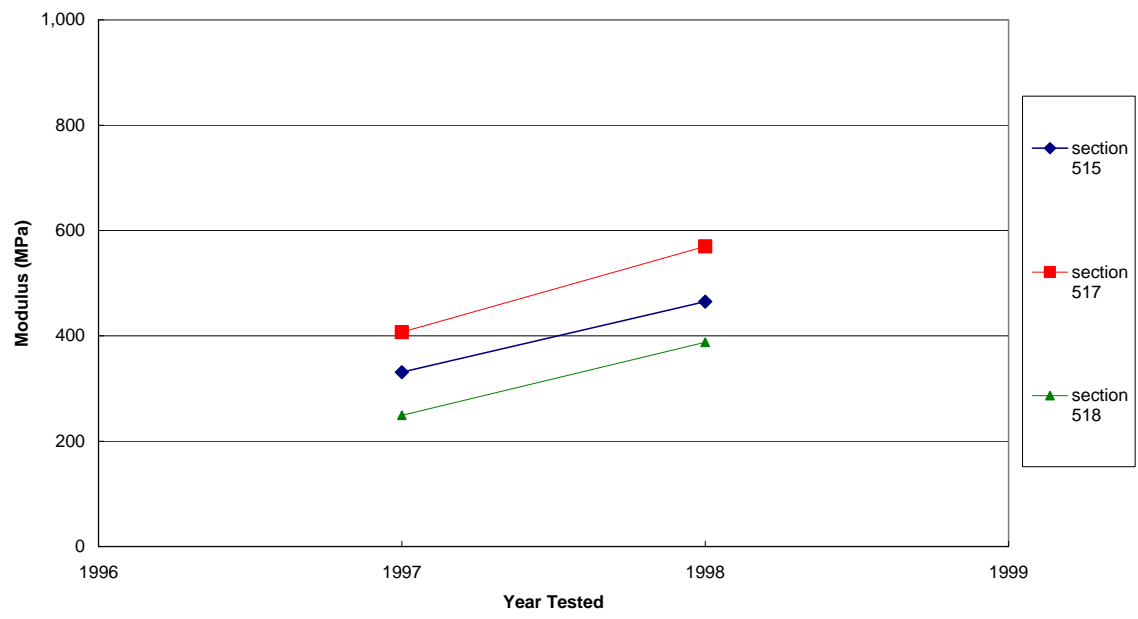
**Figure 3.18: Backcalculated moduli from FWD deflections.**

FWD testing and backcalculations performed in 1997 and 1998 showed some increase after 1995 on areas that were not subjected to any trafficking from the HVS, as shown in Figure 3.18, with stiffness ranging between 250 and 400 MPa (36,000 and 58,000 psi). For each of three sections examined (RF 515, 517, and 518), the computed stiffness moduli of the granular base layers increased again with time between 1997 and 1998 as seen in Figure 3.18. This increase was about 45 percent for each section over the year.
