Evaluation of Type I Hot Corrosion Resistance of Marinized Materials Through Low Velocity Burner Rig Testing

DISSERTATION

in Materials Science and Engineering

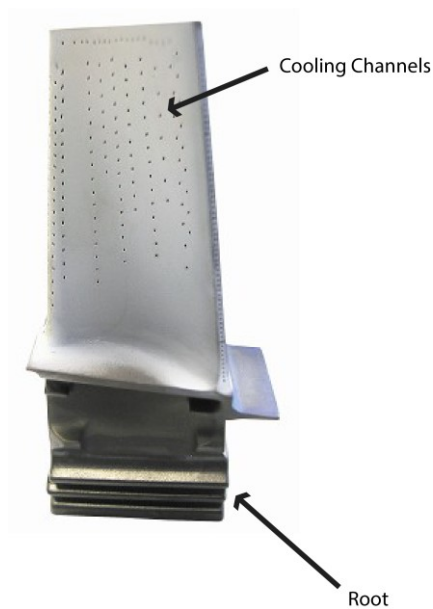
*FIGURE 18. Image of a turbine blade where the root and cooling channels, both uncoated areas susceptible to hot corrosion attack, are highlighted [77].*

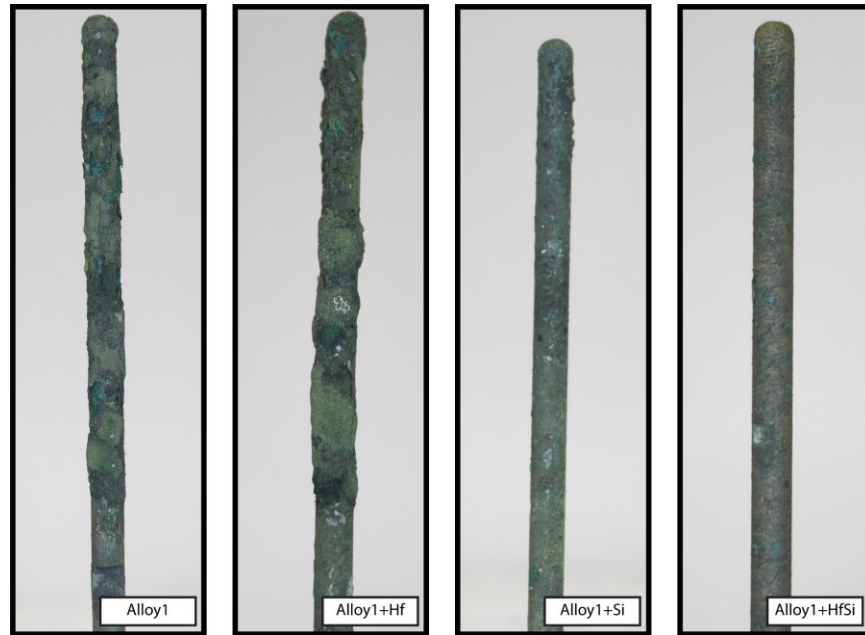
*FIGURE 22. Image of Alloy1 and its doped variations post-exposure.*

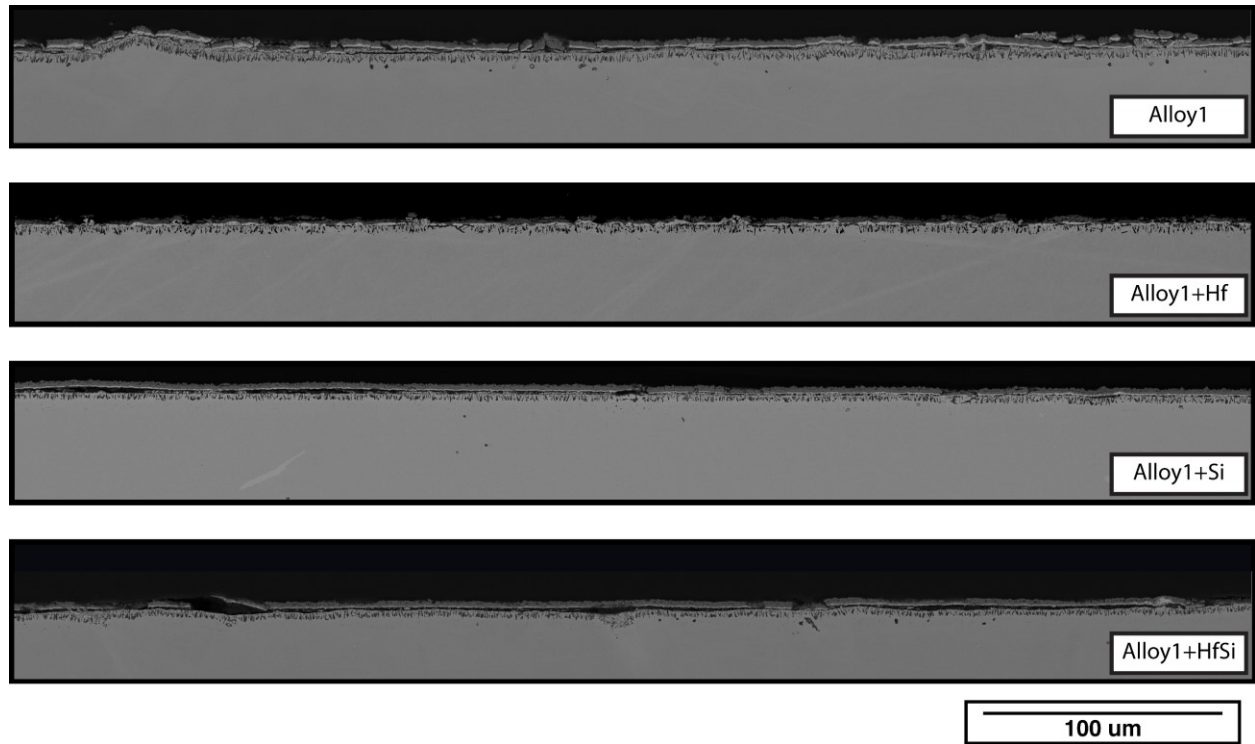
FIGURE 30. Backscattered SEM images of cross-sections of Alloy1 and its doped variations after a 10-hour LVBR exposure.

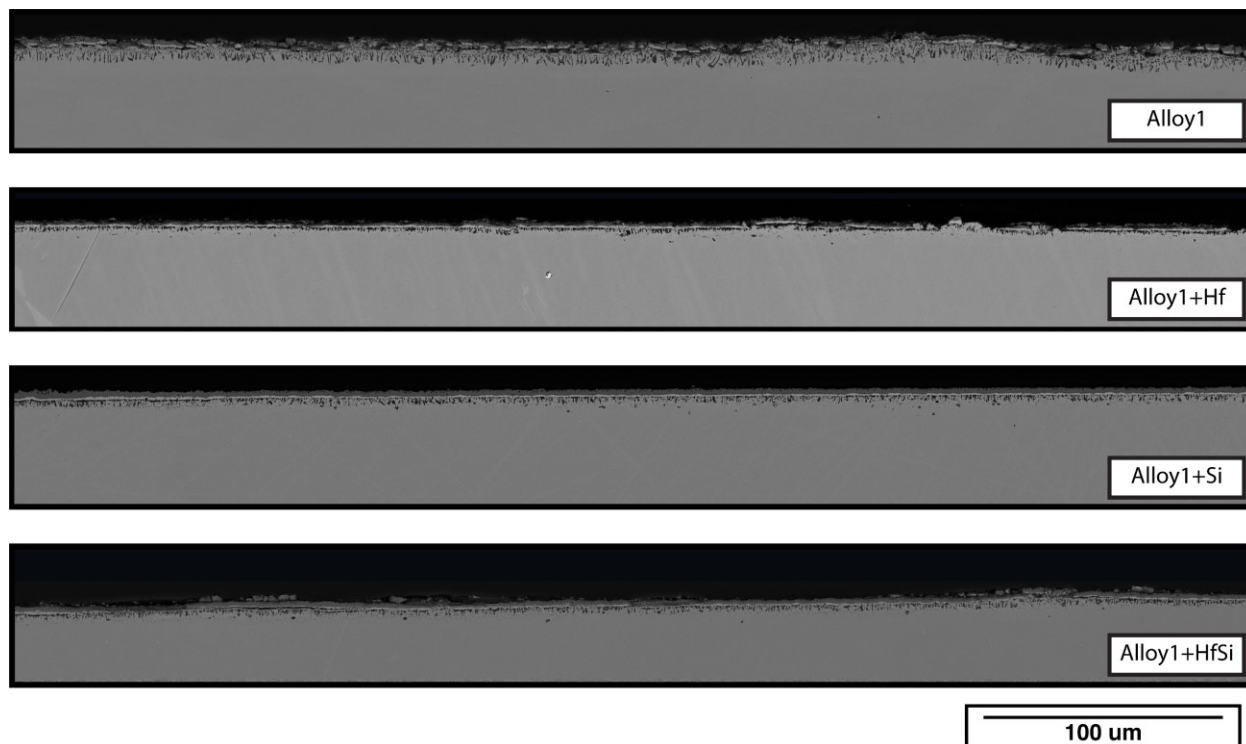
FIGURE 36. Backscattered SEM images of cross-sections of Alloy1 and its doped variations after pre-oxidation treatment PreOx1 followed by a 10-hour LVBR exposure.

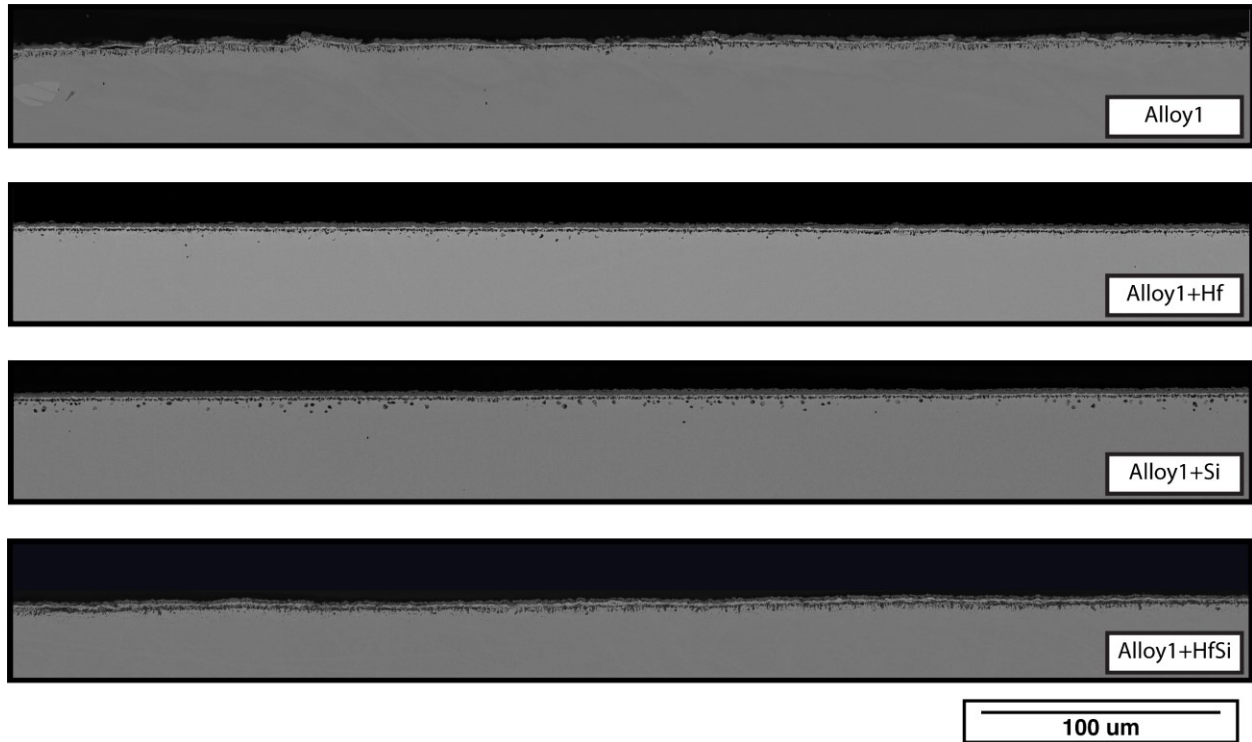
FIGURE 37. Backscattered SEM images of cross-sections of Alloy1 and its doped variations after pre-oxidation treatment PreOx2 followed by a 10-hour LVBR exposure.
