STRUCTURE AND MECHANICAL PROPERTIES OF Fe-Ni-Co ALLOYS WITH AND WITHOUT CARBON

LBL-477

Mathur Ramachandran Veera Raghavan
(D. Eng. Thesis)

March 1972

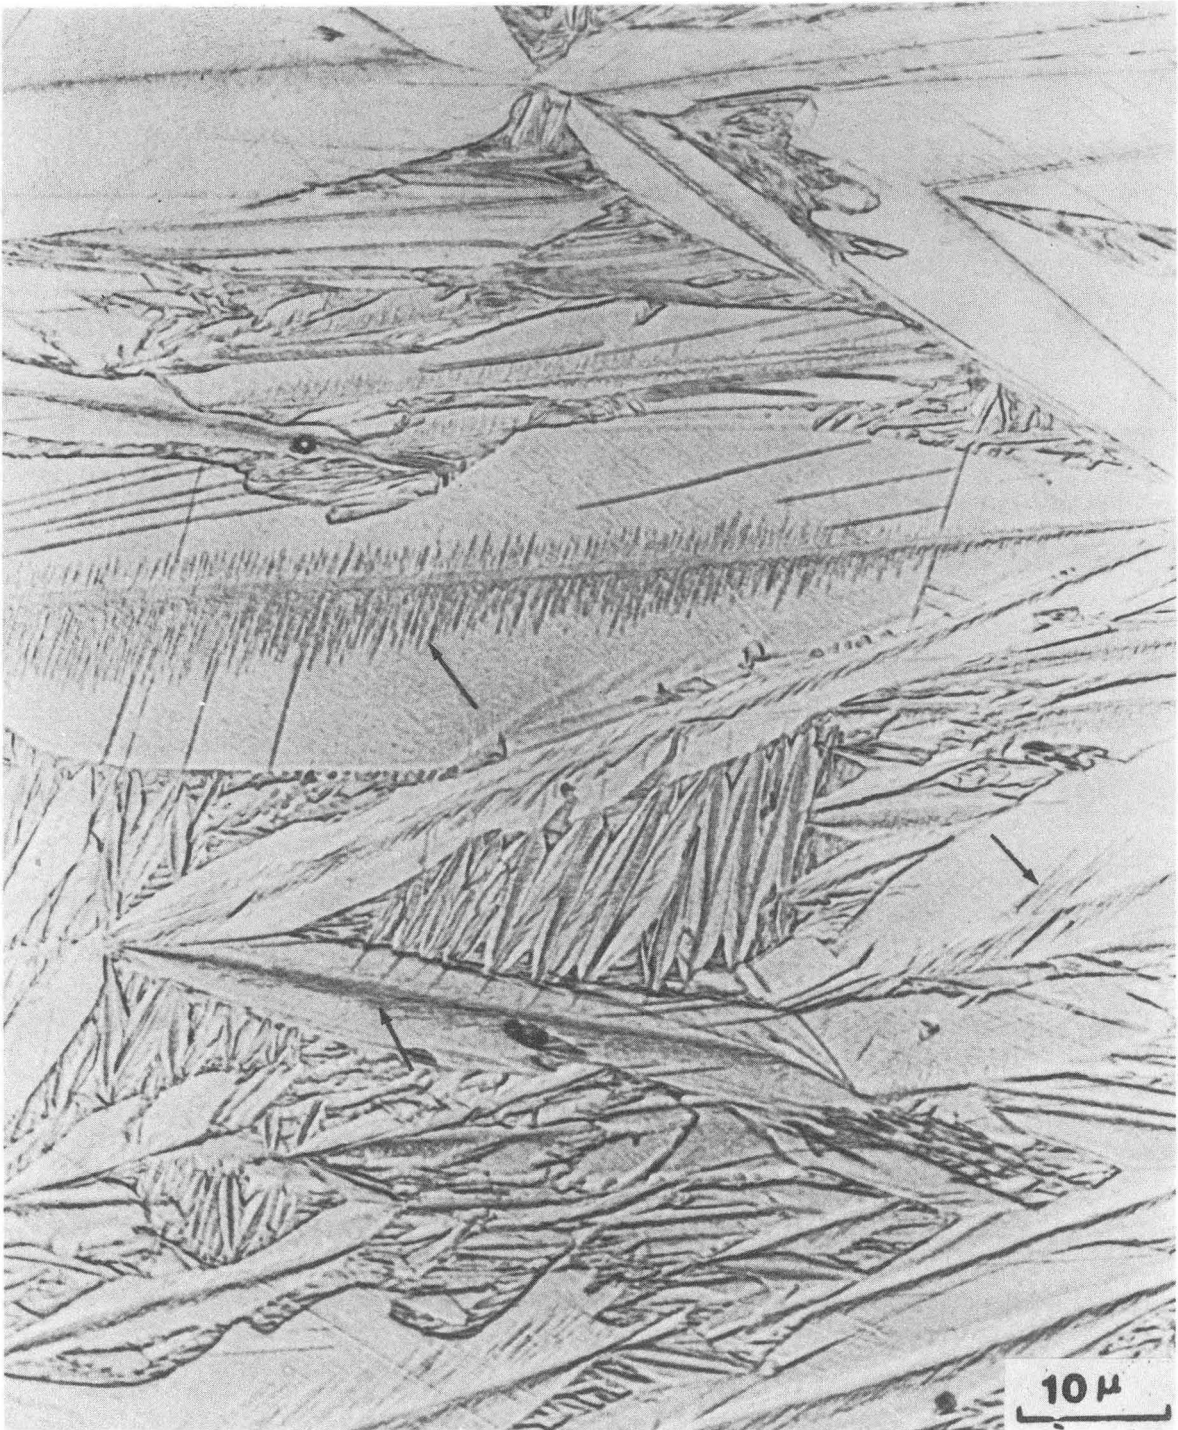
Fig. 7 Optical micrographs of the as-quenched structures of alloys T in (A) and U in (B).

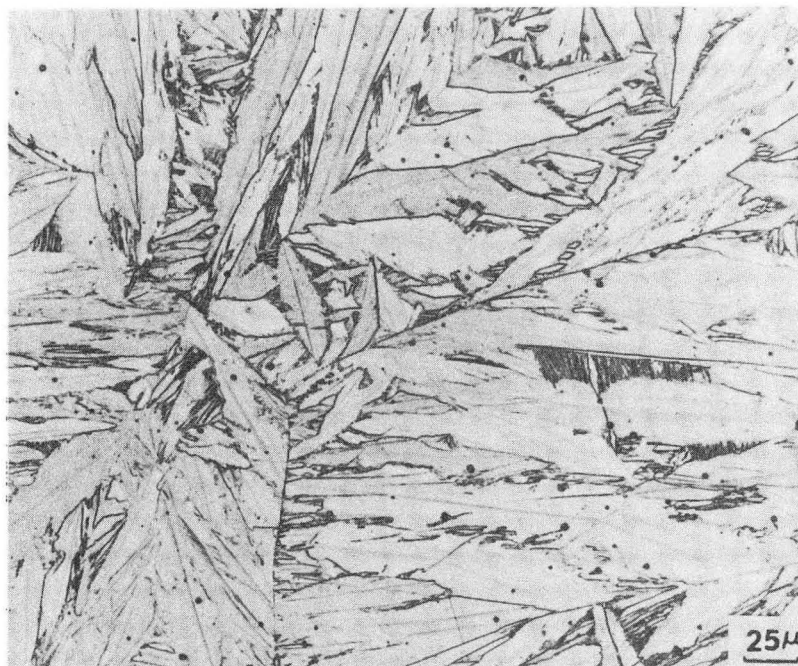
Fig. 9 (A) Optical micrograph of steel UC, as-quenched, showing fine plates and laths and (B) shows lenticular martensitic plates of steel TC in as-quenched condition.

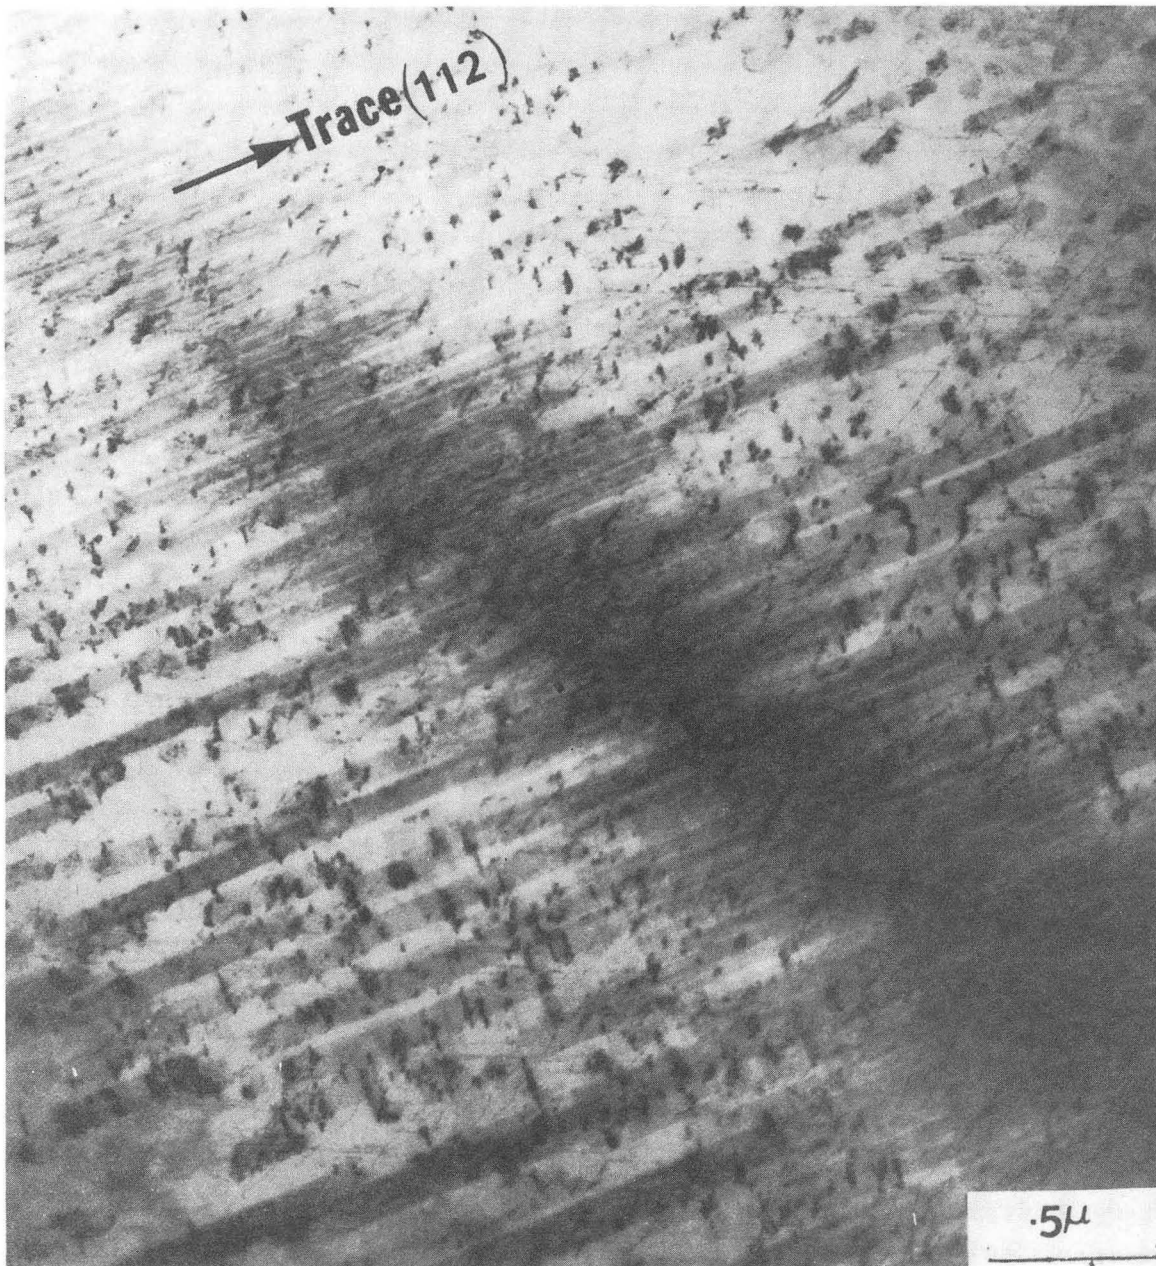
Fig. 17 Steel TC quenched and tempered at 200°C, showing nucleation of carbide (cementite) at the twins. The twin traces are faintly visible and are identified as (112) Traces.

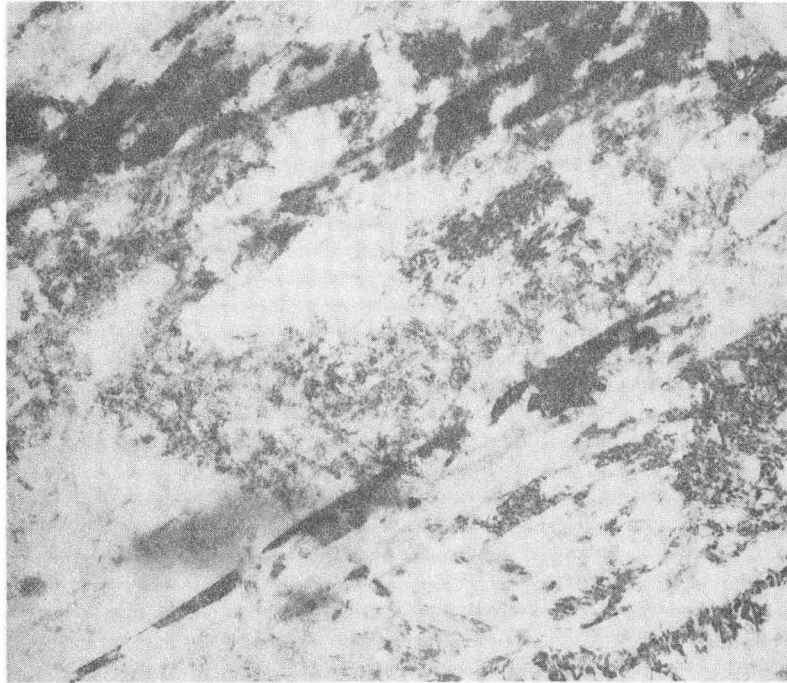
Fig. 26 Steel UC quenched and tempered at 400°C, (A) bright field image indicating no preferential precipitation of carbides along the lath boundaries whereas the dark field image of a carbide reflection (B) shows adequate precipitation of carbides preferentially formed along the lath boundaries.

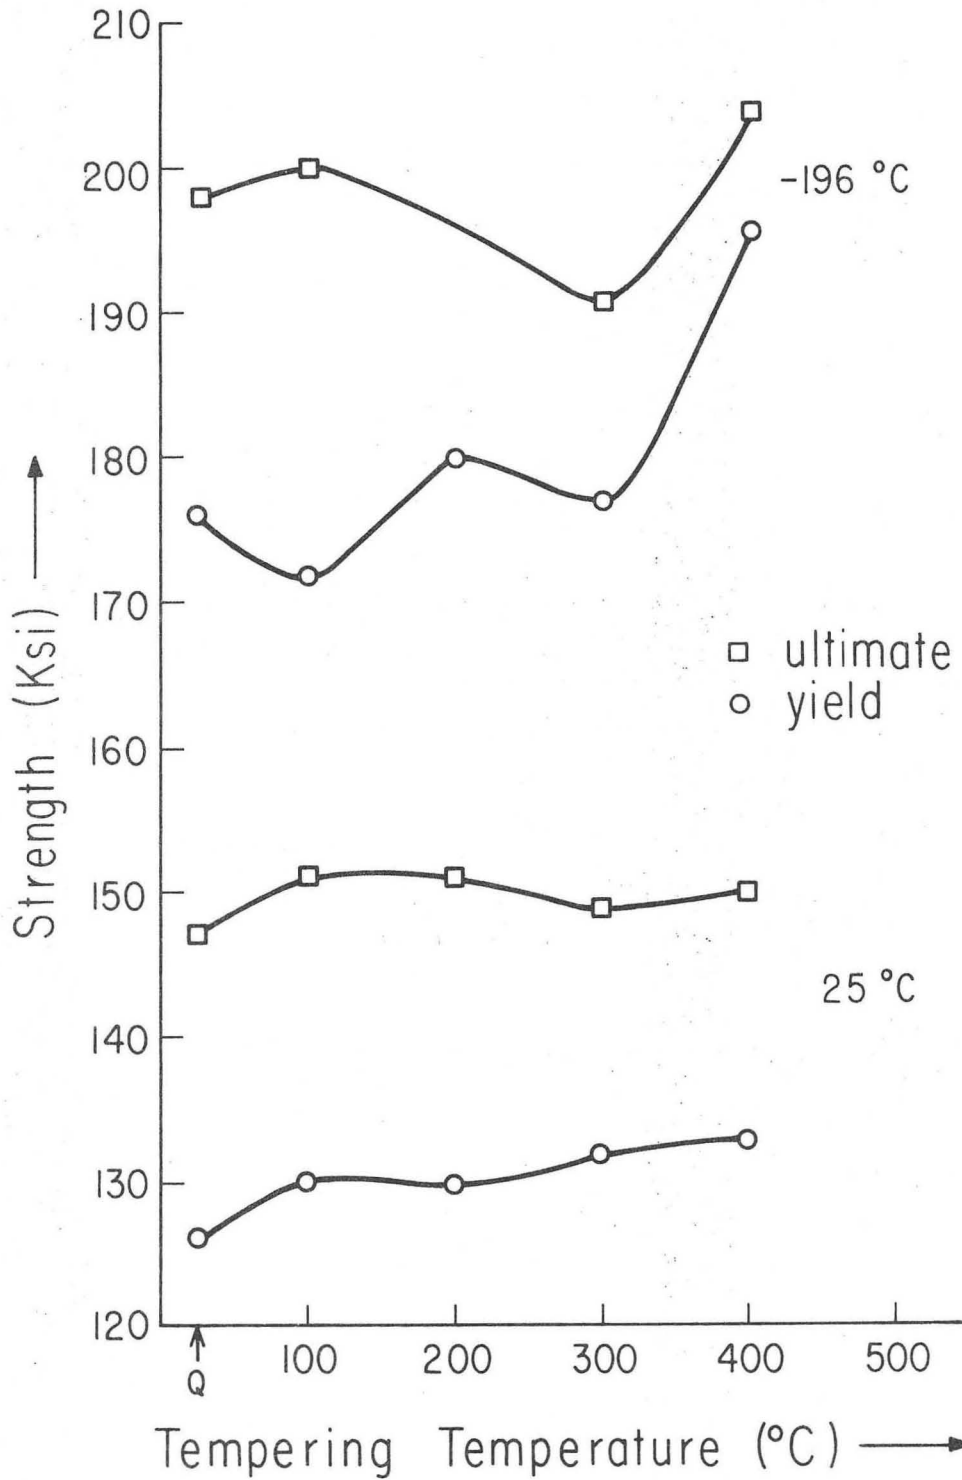
Fig. 29 Effect of tempering on the strength of steel UC at -196°C and 25°C.

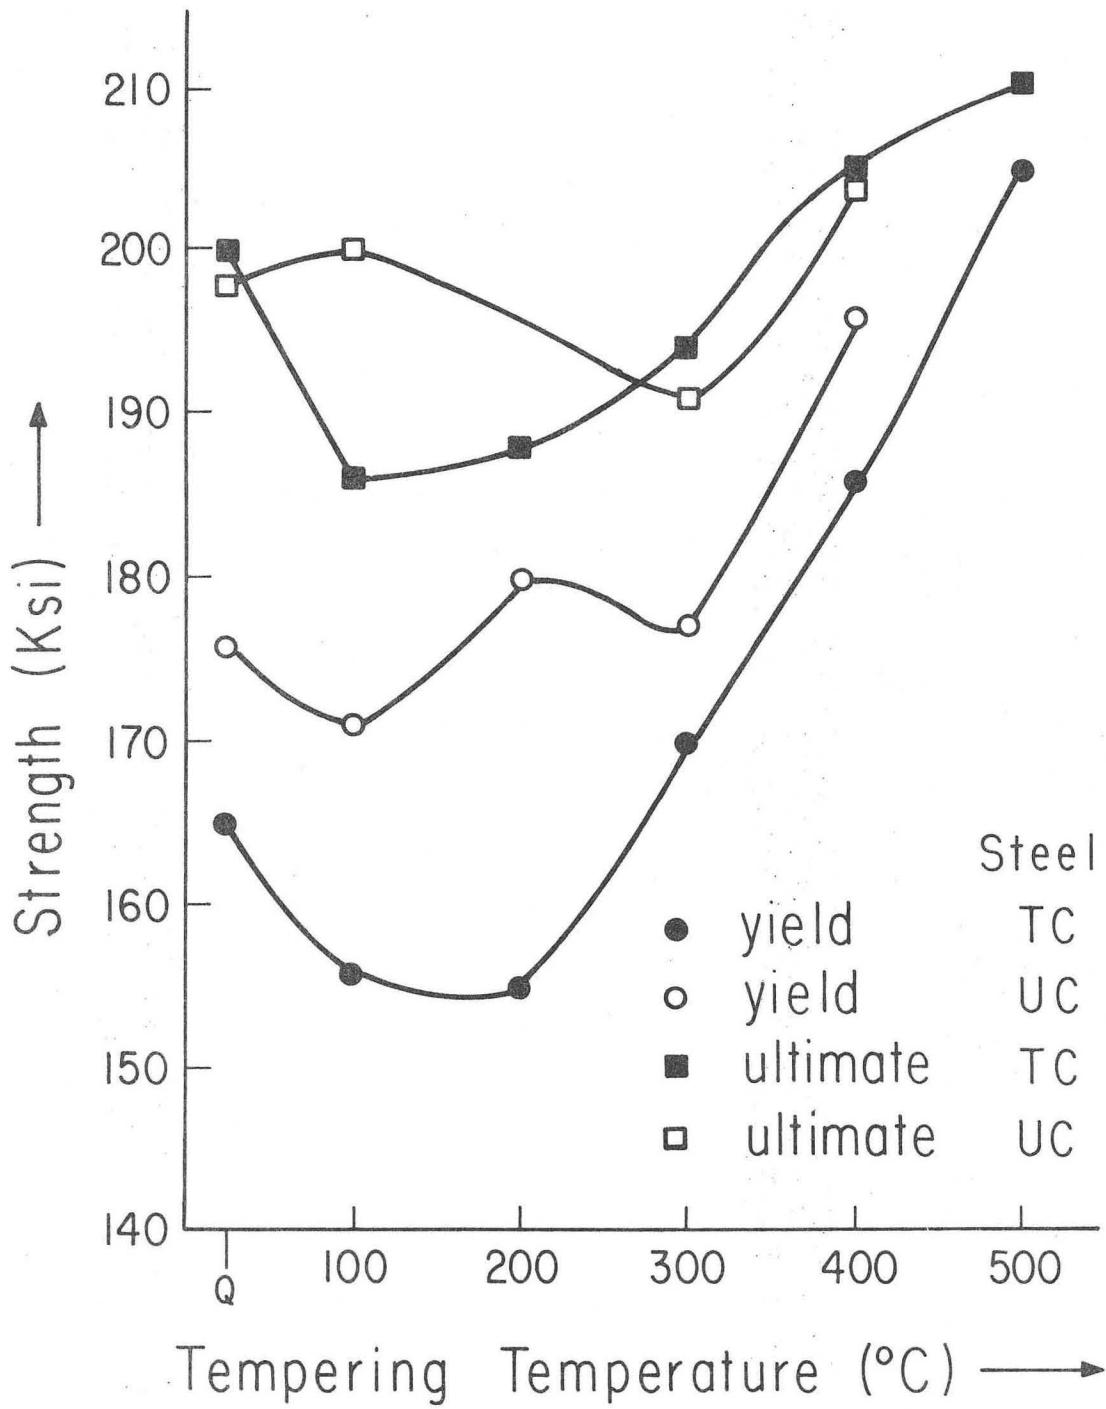
Fig. 31 Effect of tempering on the strength of steels TC and UC at -196°C

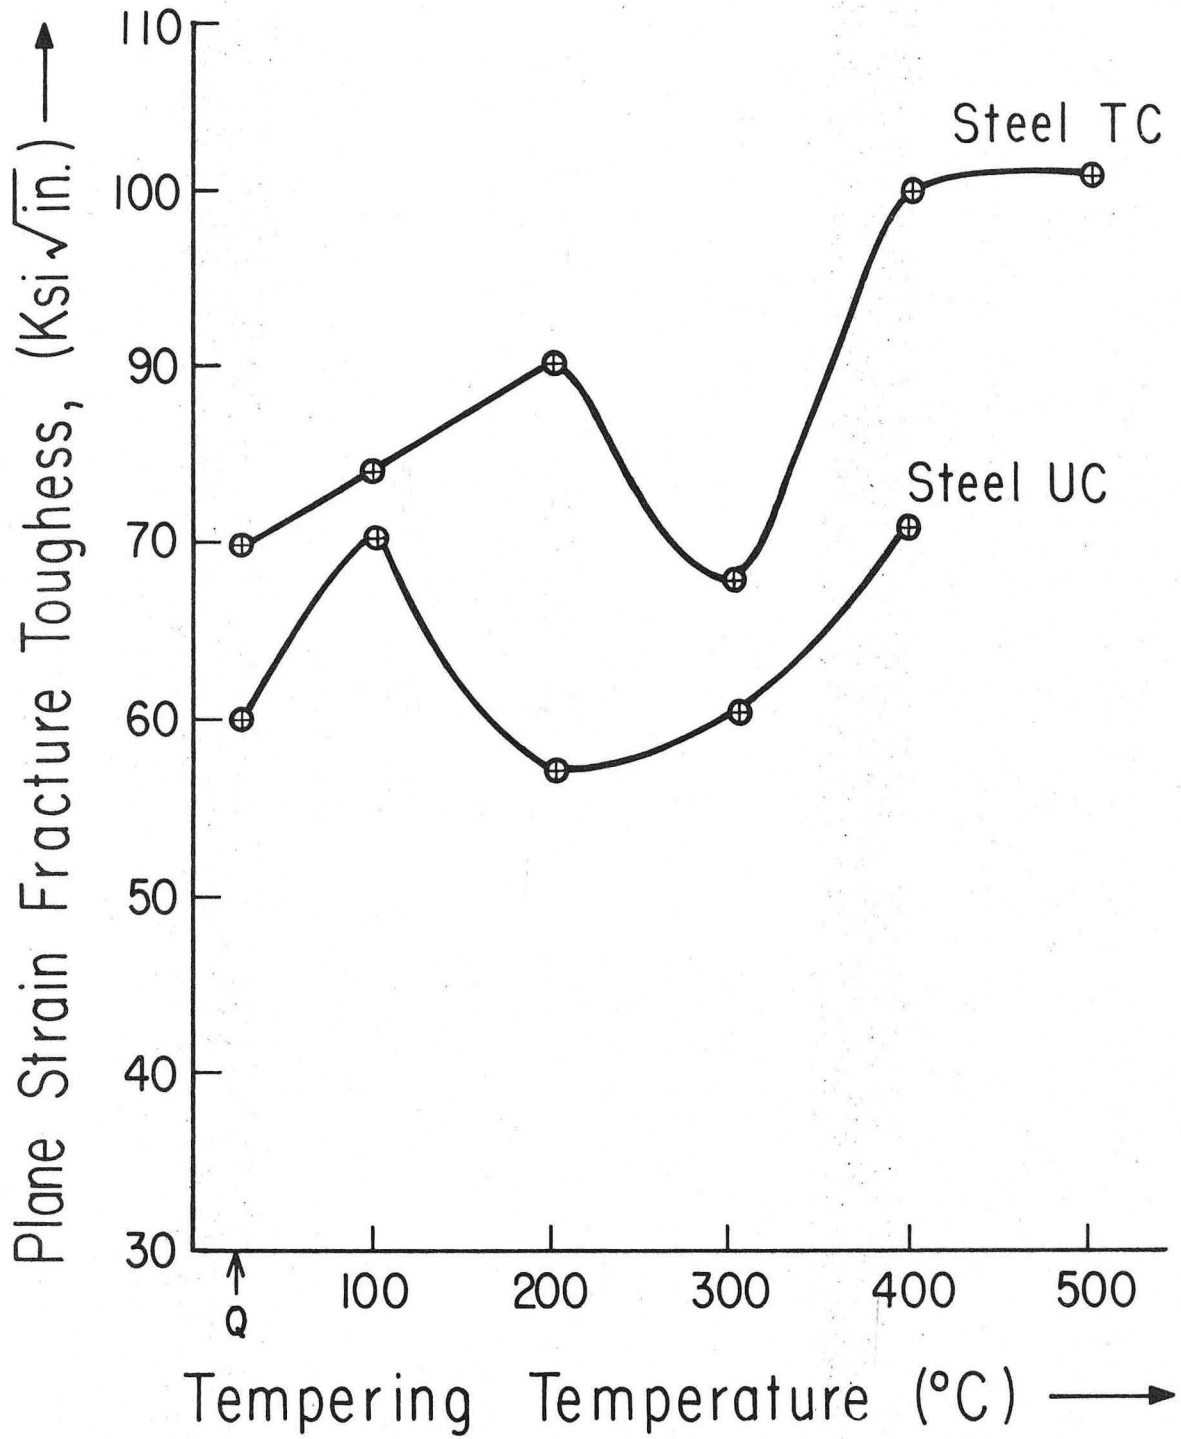
Fig. 33 Effect of tempering on the plane strain fracture toughness value of steels TC and UC.
