Land disposal of San Luis drain sediments: Progress Report October 1998 through November 2000

LAND DISPOSAL OF SAN LUIS DRAIN SEDIMENTS

Progress Report

Peter T. Zawislanski, Sally M. Benson, Robert TerBerg, and Sharon E. Borglin

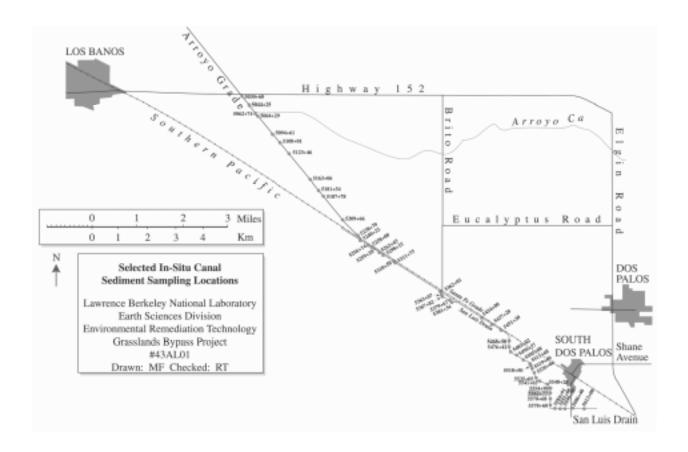
Figure 2.1. Location of LBNL sediment sampling points along the San Luis Drain.

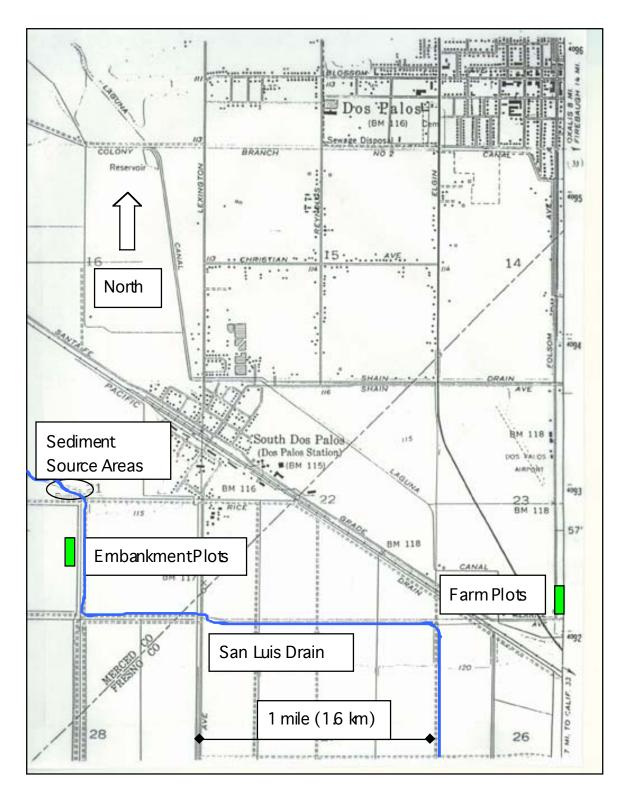
Figure 2.2. Locations of sediment source areas, embankment plots, and farm plots, relative to the San Luis Drain.

Two sites were selected for the pilot-scale application. Both are south of Dos Palos (Fig. 2.2). Sediment from Source Areas 1-3 was laid down on the adjacent or nearby embankment, west of the SLD, in embankment plots 1, 2, and 3 (EP-1, EP-2, and EP-3), respectively. The embankment was chosen because it is a likely candidate for large-scale sediment disposal, due to its proximity to the source area, easy access, and well-compacted, engineered soils, which limit infiltration. Sediment from Source Areas 4 and 5 was laid down on a cultivated field, or farm plot, FP-1 and FP-2, respectively. This type of application is another candidate for large-scale disposal. It offers the advantage of incorporating the organic-rich sediment with top-soil. Furthermore, the available farmed area is far greater than that of drain embankments.

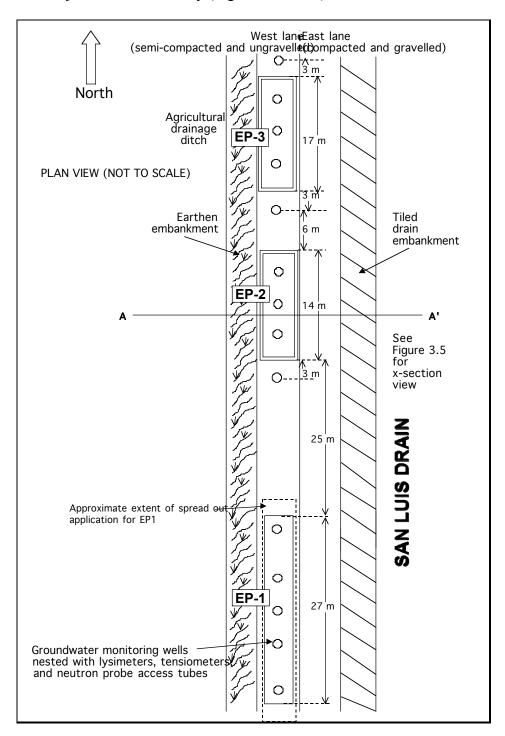
Figure 3.1. Layout of embankment plots and monitoring equipment.

1.3 m intervals. Shortly after 1/14/99, the sediment stockpile was moved over and graded onto the embankment adjacent to the roadway (Figs. 3.1 and 3.2).

EP-2 and EP-3 (Fig. 3.3 and Tables 3.2 and 3.3). Of the nine clusters described, there were three inside each of the two test plots, and three clusters used as control points (Fig. 3.1). Cores were collected from the 0-1.65 m depth of the neutron probe access boreholes and from the 1.65-2.85 m intervals of the groundwater well boreholes. Subsequent neutron probe measurements were calibrated to the initial moisture contents assessed on the cores from 0-1.65 m depth. Geological conditions were uniform across the plots with minor variations in color: olive gray sandy clay from 0-0.15 m, dark olive gray clay from 0.15-0.45 m, dark olive brown clay from 0.45-0.75, light olive brown clay from 0.75-1.5 m, and wet olive brown clay with minor silt from 1.5-2.85 m. The instrumentation was monitored on a weekly basis for 6 weeks before the 9/3/99 application.

Wells distributed throughout the embankment plots (Fig. 3.1) are used to measure the groundwater level. The depth of the water table in EP-1, EP-2, and EP-3 is shown in Figs. 4.5, 4.6, and 4.7, respectively. With the exception of slow post-installation response of some of the wells, the water table fluctuated between 1 and 2 m below ground surface. Groundwater levels fall during the summer and fall, and start rising following the first major rainfall. This behavior does not comply with trends in drainage ditch water levels, suggesting that the ditch affects the hydrology of embankment sediments less than anticipated.

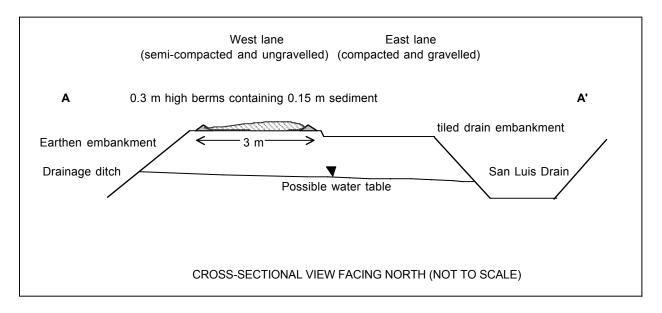
Figure 3.2. Cross-sectional view of embankment plots along section A-A'.

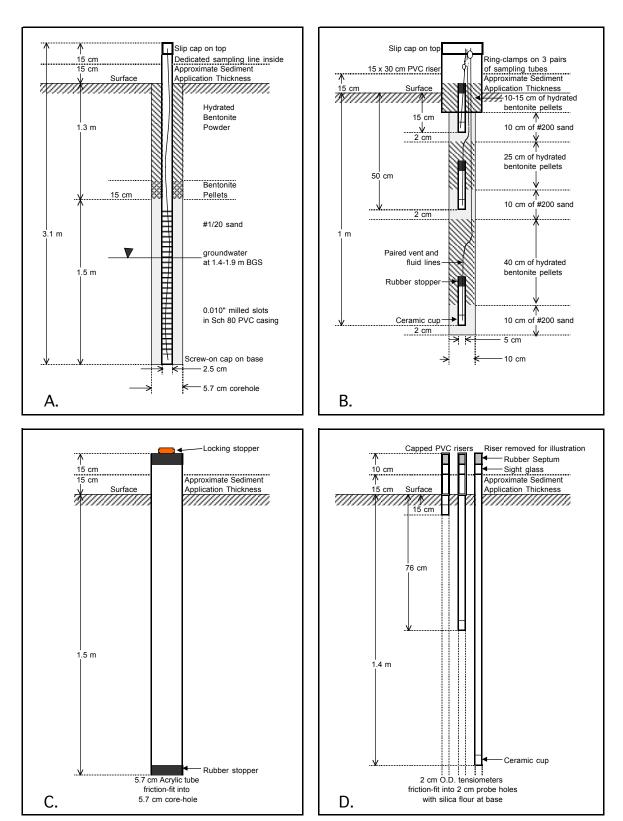
Figure 3.3. Construction detail of embankment plot instrumentation: a.) Groundwater monitoring well, b.) Suction lysimeter, c.) Neutron probe access hole, and d.) Tensiometer cluster.

From 6/22/99 to 7/6/99, five clusters of lysimeters, tensiometers, groundwater wells, and neutron probe access tubes were installed in EP-1. Installation design for each type of instrument is shown in Fig. 3.3 and described in Table 3.1. Lysimeter were installed above the water table, complimentary to groundwater monitoring wells. Tensiometers were installed in the unsaturated zone down to the water table. Neutron probe access boreholes were installed to depths just below the water table. Sediment cores were collected from the 0-1.65 m depth of the neutron probe access boreholes and from the 1.65-2.85 m intervals of the groundwater well boreholes. Subsequent neutron probe measurements were calibrated to the initial moisture contents obtained from cores at 0-1.65 m depth (calibration presented in Section 4.2). After installation, the instrumentation was monitored on a monthly basis.

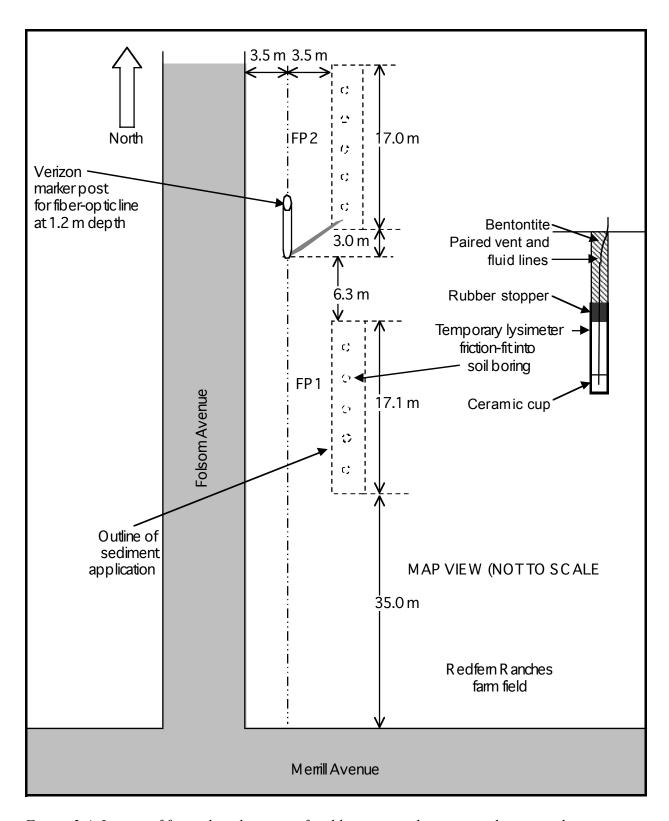
Figure 3.4. Layout of farm plots, location of soil borings, and temporary lysimeter design.

Prior to sediment application, two 3 m \times 17 m plots were measured and set up end to end in a north-south alignment, with 9.3 m of space separating them (Fig. 3.4).

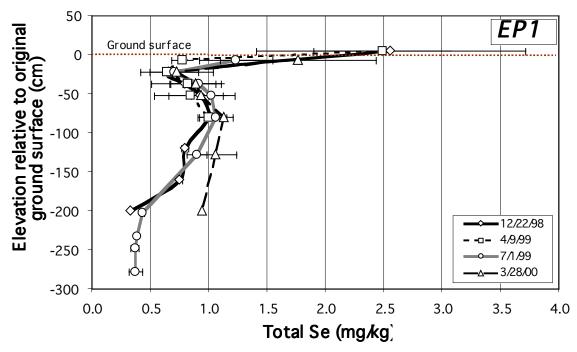
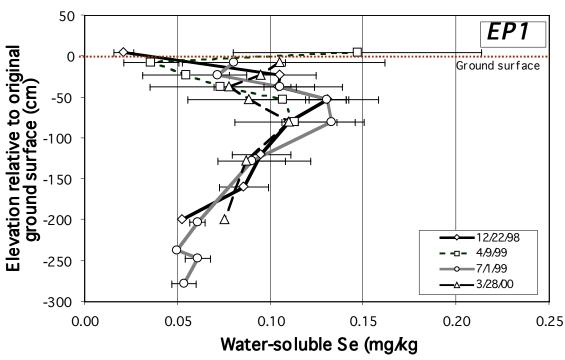
Figure 4.1. Total (a) and water-soluble (b) selenium concentrations normalized to soil mass in plot EP-1. Error bars represent one standard deviation on either side of the mean.

The soil profile under the future EP-1 plot was cored on 12/22/98 and after SLD sediment application on 4/9/99, 7/1/99, and 3/28/00. The results of this sampling and the subsequent Se analysis are shown in Fig. 4.1a and 4.1b, for total and soluble Se, respectively. The initial application of sediments containing on average 2.5 µg g⁻¹ Se, is apparent in data from 12/22/98 and 4/9/99. Since the plot was disked in May of 1999, the applied sediment was not distinguishable during later sampling, and the near surface concentrations were somewhat lower $(1.25 \mu g g^{-1} \text{ on } 7/1/99 \text{ and } 1.75 \mu g g^{-1} \text{ on } 3/28/00)$. Nonetheless, there is overlap in this data, as shown by the standard deviations, signifying a lack of profile-wide changes in Se concentrations. It is also clear that Se did not move deeper into the profile, as evidenced by the static concentration profiles, in both total and water-soluble Se, below a depth of 0.25 m. The increase in water-soluble Se between 12/22/98 and 4/9/99 at +5 cm is due to the oxidation of Se in the applied sediments. The difference of approximately 0.13 µg g⁻¹ corresponds to a net oxidation of 5% of the total Se inventory in the applied sediments. After the applied sediments were disked in, the increase in soluble Se is observed just below the new ground surface (7/1/99, at -5 cm). Although future increases in soluble Se concentrations near the soil surface can be anticipated. they will surely be small (Zawislanski and Zavarin, 1996). Under present conditions, downward displacement of Se is not expected to be significant due to the flat concentration gradient and low permeability of underlying sediments.

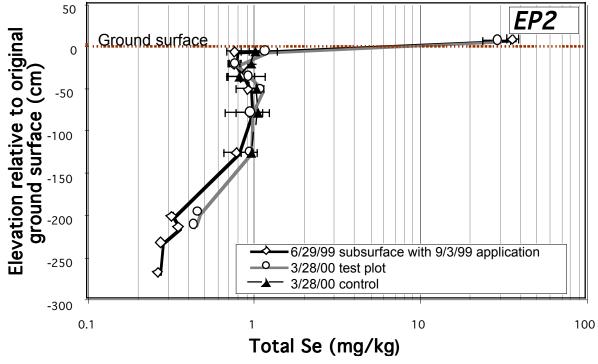
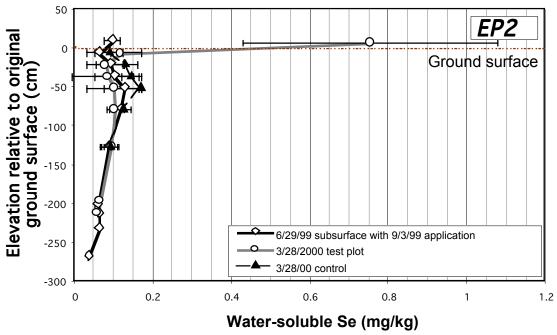
Figure 4.2. Total (a) and water-soluble (b) selenium concentrations normalized to soil mass in plot EP-2. Error bars represent one standard deviation on either side of the mean.

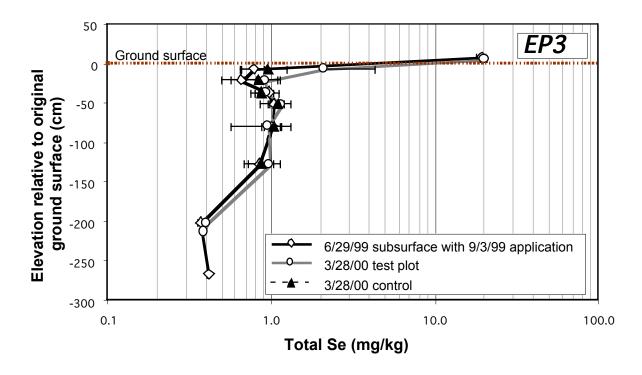
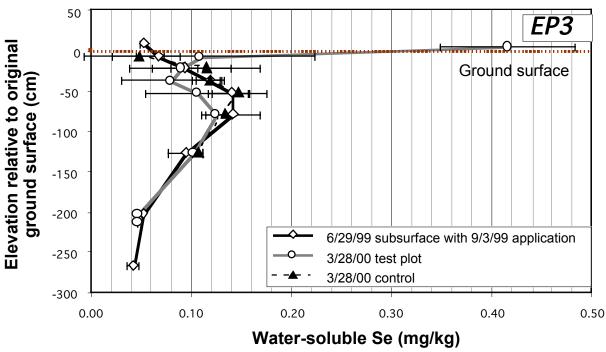
Figure 4.3. Total (a) and water-soluble (b) selenium concentrations normalized to soil mass in plot EP-3. Error bars represent one standard deviation on either side of the mean.

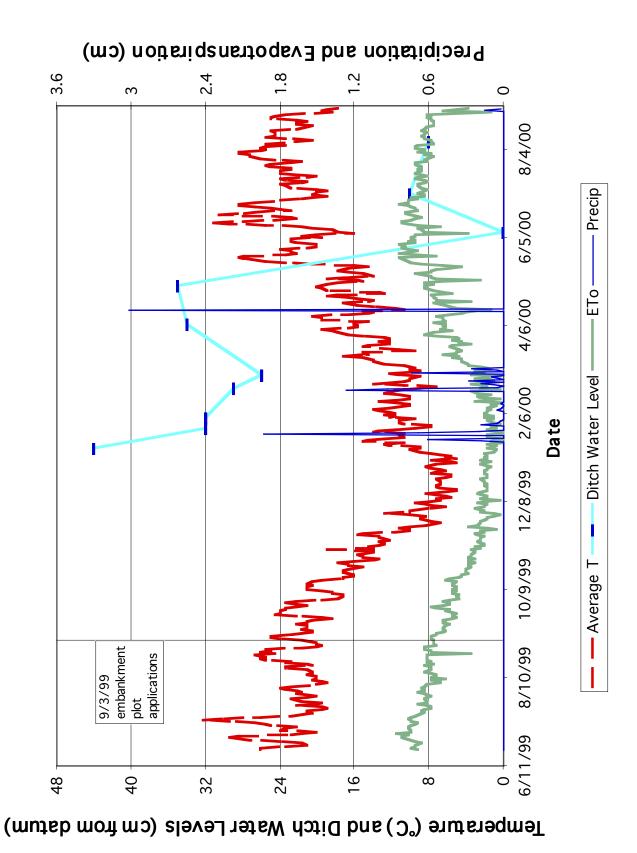
Figure 4.4. Daily weather records and ditch water levels at the embankment plots.

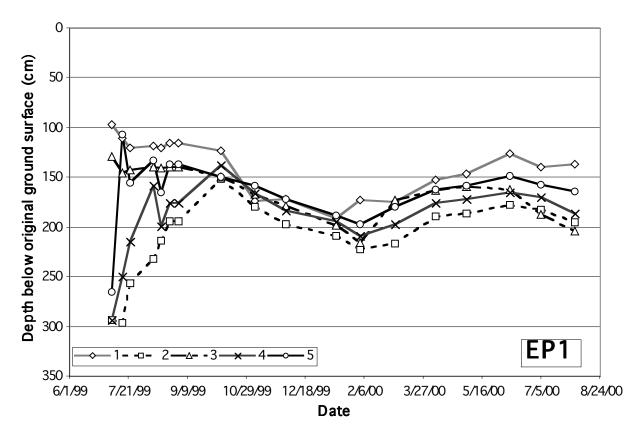
Figure 4.5. Depth to groundwater at EP-1.

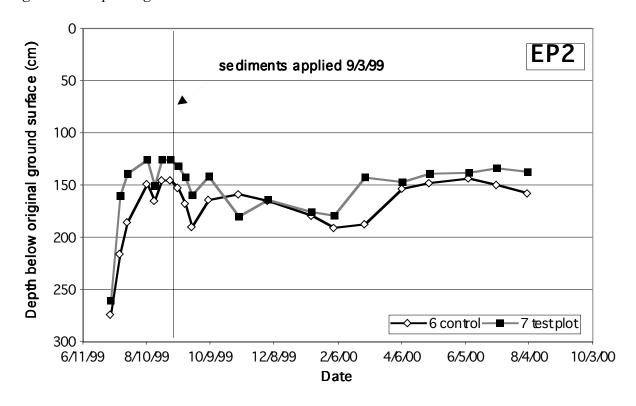
Figure 4.6. Depth to groundwater at EP-2.

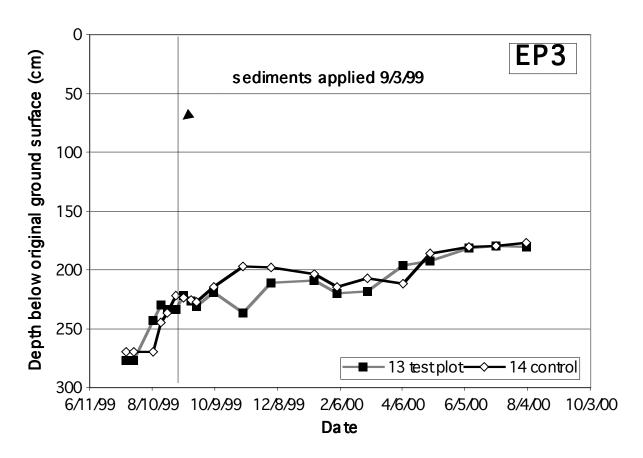
Figure 4.7. Depth to groundwater at EP-3.

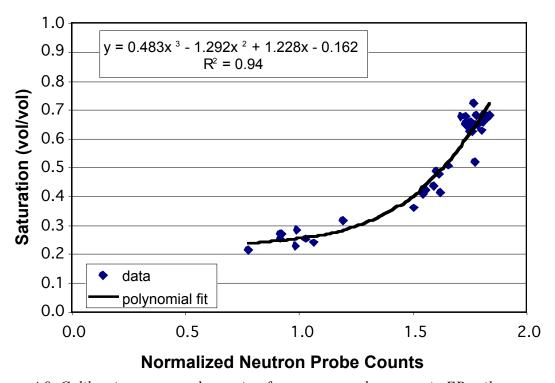
Figure 4.8. Calibration curve and equation for neutron probe counts in EP soil.

The effects of the application of SLD sediments on EP-2 and EP-3 are apparent in Figs. 4.10 and 4.11, respectively. Since the calibration curve shown in Fig. 4.8 was derived from embankment sediments and not SLD sediments, the saturation data for SLD sediments (above-ground values) is qualitative. Nevertheless, the original high moisture content of the applied sediments is clearly shown on 9/3/00 (thick line), the day of the application. The data shown here, and other data collected subsequently, indicate that the wet SLD sediment did not affect the hydrology of the underlying embankment sediments. This can be explained by high moisture-retentive properties of the SLD sediments and the very high evaporation rate observed in the field immediately after application.

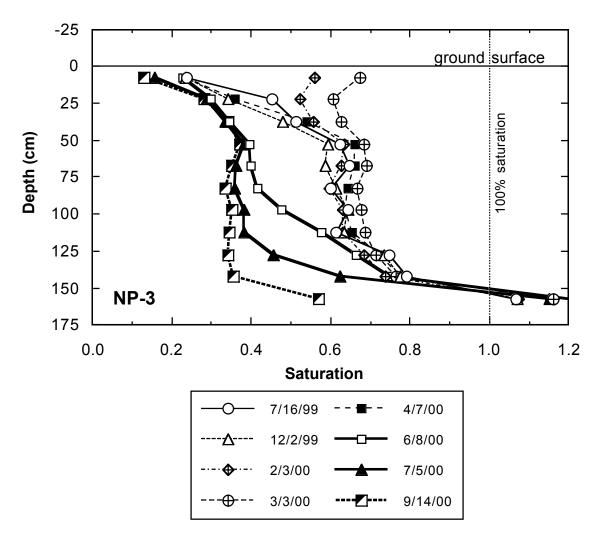
Figure 4.9. Sediment profile saturation at EP-1 (access hole NP-3) based on neutron probe measurements.

Neutron probe measurements and tensiometer readings were used in the embankment plots to measure moisture content and water potential, respectively. Moisture content (expressed as saturation) was derived from a calibration based on moisture measured in sediment cores vs. neutron probe readings in those boreholes shortly after sampling. This calibration curve is shown in Fig. 4.8. Representative results of moisture content (expressed as saturation) measurements from each of the embankment plots are shown in Figs. 4.9-4.11. Although there are some differences amongst the plots, the general trends are similar. Saturation increases in the winter, in particular at the sediment surface. Increases observed on 2/3/00 and 3/3/00 follow the bulk of the year's rainfall events. Within one month of the latter measurement, near-surface moisture content decreases to background levels. The extent of rainfall infiltration is marked by increases in moisture at depths of 0.40 m in EP-1, 20 cm in EP-2, and 10 cm in EP-3, relative to the original ground surface. Later decreases in saturation at greater depths (7-9/00, between 0.50 m and 1.00 cm) are likely a result of evapotranspiration.

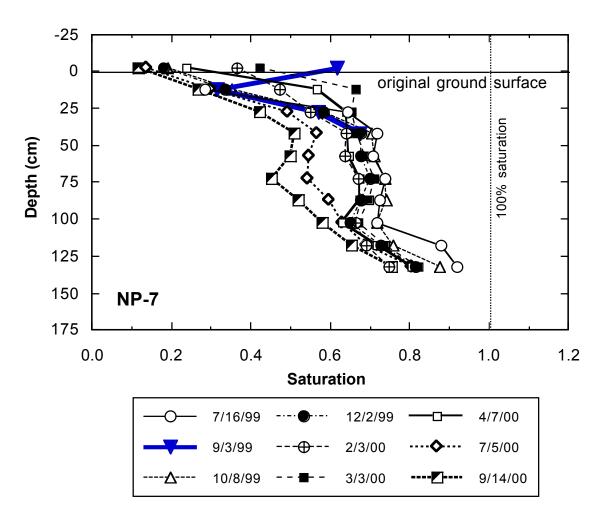
Figure 4.10. Sediment profile saturation at EP-2 (access hole NP-7) based on neutron probe measurements.

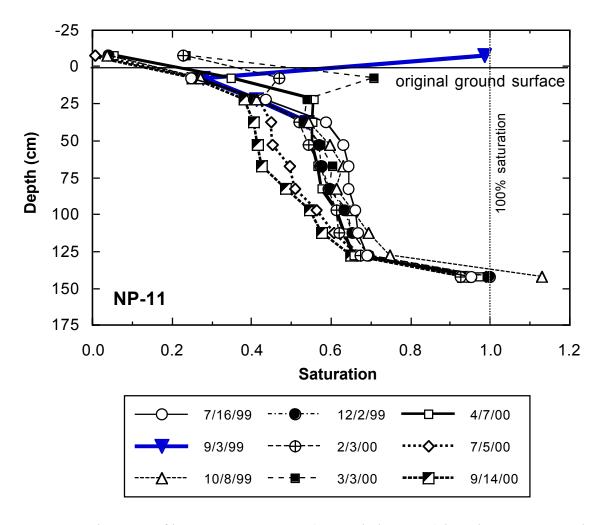
Figure 4.11. Sediment profile saturation at EP-3 (access hole NP-11) based on neutron probe measurements.

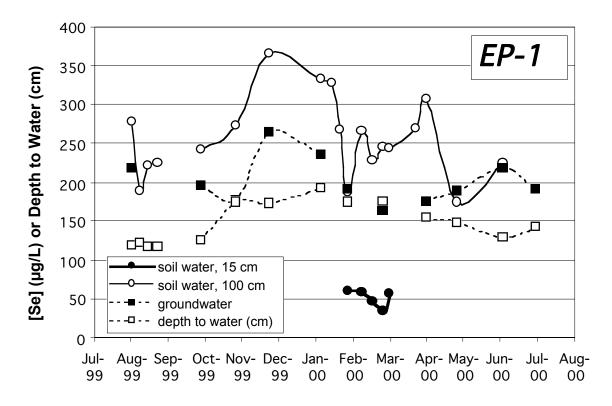
Figure 4.12. Soil water and groundwater Se and depth to water in EP-1.

Soil water sampling in the embankment plots yielded nearly continuous data from the 1.00-m-deep samplers, intermittent data from the 0.15-m-deep samplers, and very rare data from the intermediate depth samplers at 0.50 m. This is due to limited rainfall infiltration, resulting in a matric potential close to or beyond the effective working range of vacuum lysimeters. The 1.00-m samplers were close enough to the water table, that they readily produced samples. The 0.15-m lysimeters produced samples following some of the larger rainfall events, specifically in February and March 2000. Samples from the 0.50-m lysimeters were available on only a few days and in only 3 out of 14 monitoring clusters. Groundwater was collected regularly and without any difficulty. Selenium data from representative instrument clusters in EP-1, 2, and 3 are presented in Figs. 4.12-14. Also shown is the depth to the water table at each of these locations. Corresponding results from a control site are shown in Fig. 4.15.

Selenium concentrations in the 1.00-m lysimeters fluctuate in a range from 150 to 400 µg L⁻¹, depending on the site. The fluctuations generally reflected those in the groundwater data, suggesting the dominance of groundwater conditions on deep soil water. Groundwater Se concentrations are inversely correlated with the depth to the water table, which means that as the water table rises, it likely enters into more seleniferous soil, resulting in higher Se concentrations. During a period between January and March 2000, Se concentrations at 1.00 m in EP-1, EP-2, and the control site drop suddenly and then rebound. This is not related to rainfall infiltration because the drop occurs before any major rainfall events and before any moisture breakthrough is observed in the 0.15-m and 0.50-m lysimeters. It is possible that these fluctuations, which coincide with the lowest groundwater levels, are influenced by water in the adjacent drainage ditch, which contains much lower Se levels (5-10 µg L⁻¹) and is at its highest point at this time. As mentioned above, soil water from the 0.15-m sampler was available during a short period following the larger rainfall events of the season. The record of four to five data points is too small to ascribe any trends to it. Selenium concentrations at this depth ranged from 50 to 200 µg L⁻¹, generally less than Se in deeper soil water and groundwater. Selenium levels observed at 0.15 m corresponded to the concentrations of Se in applied sediments. Shallow soil water Se was highest in EP-2, where sediments with 37 μ g g⁻¹ Se were applied, somewhat lower in EP-3 (applied Se = 16 μ g g⁻¹), significantly lower in EP-1 (applied Se = 2.5 μ g g⁻¹), and similarly low in the control, where native Se levels are around 1 µg g⁻¹. No such correlation of concentrations was found in the 1.00-m data, with EP-3 containing the highest deep soil water Se and EP-2 the lowest. The limited intermediate soil water data is represented in EP-3 (Fig. 4.14). Selenium levels there are similar to those found at the 0.15-m level.

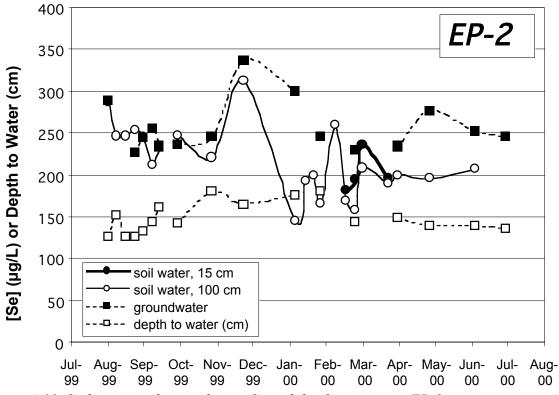
Figure 4.13. Soil water and groundwater Se and depth to water in EP-2.

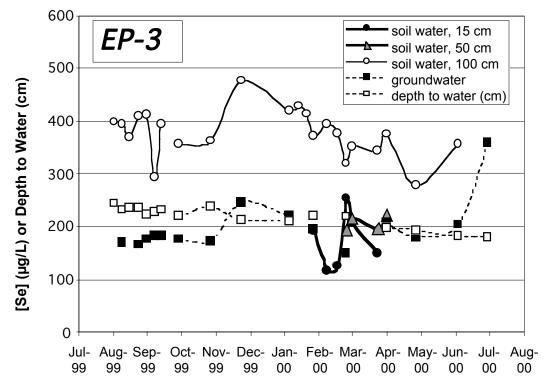
Figure 4.14. Soil water and groundwater Se and depth to water in EP-3.

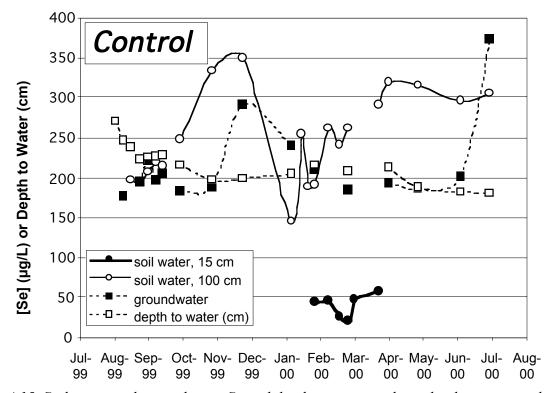
Figure 4.15. Soil water and groundwater Se and depth to water in the embankment control.

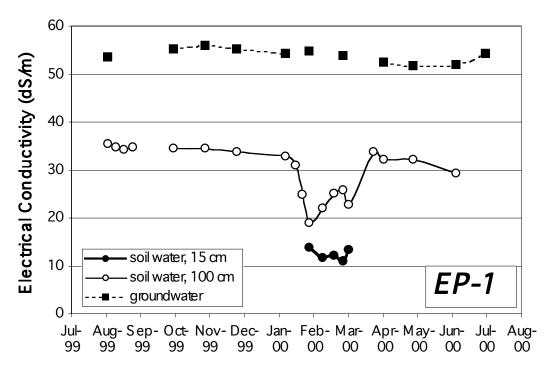
Figure 4.16. Soil water and groundwater EC in EP-1.

Dissolved salts are represented by measurements of electrical conductivity (EC). Data for EP-1, 2, 3 and a control site are shown in Figs. 4.16-19, respectively. Unlike Se, EC is consistently and substantially higher in groundwater than in overlying soil water, and ranges from 50 to 55 dS m⁻¹. Electrical conductivity trends in soil water at 1.00 m are very similar to Se trends, although observed changes have a smaller amplitude. The EC gradient with depth is representative of an un-vegetated site. Since the site has become vegetated during the Spring and Summer 2000, future redistribution of salts and Se can be anticipated. However, most of those changes will occur in the top 0.50 m of soil, where solute monitoring is impeded by low soil moisture content.

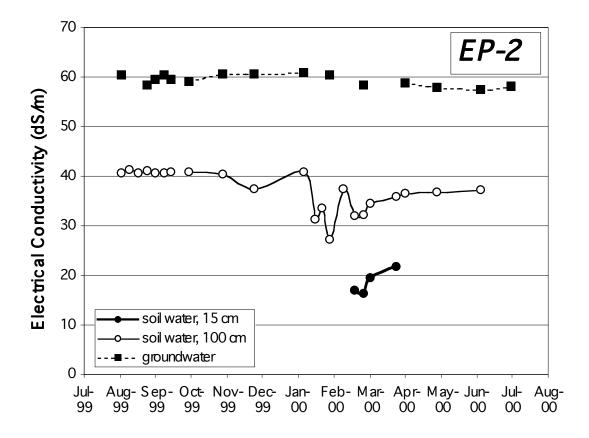
Figure 4.17. Soil water and groundwater EC in EP-2.

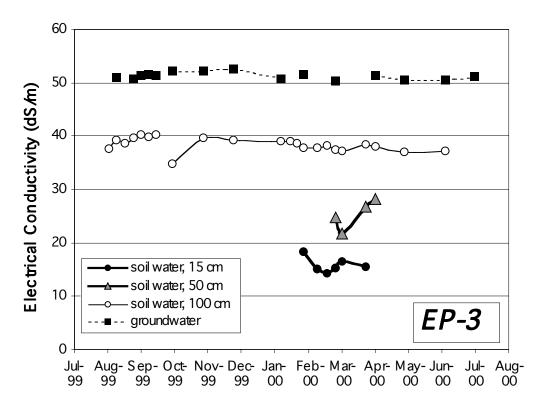
Figure 4.18. Soil water and groundwater EC in EP-3.

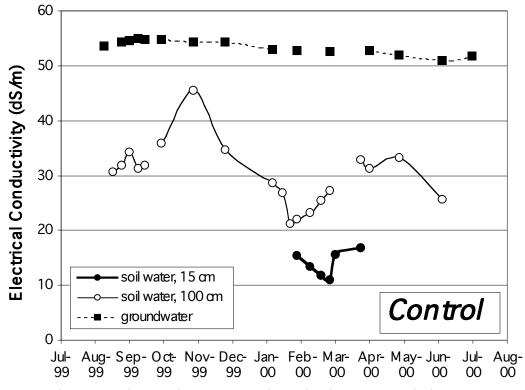
Figure 4.19. Soil water and groundwater EC in the embankment control plot.

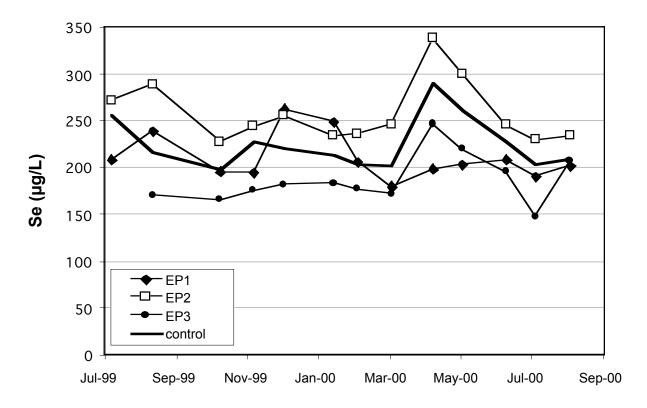
Figure 4.20. Groundwater Se in embankment test plot wells and in control wells.

All of the results presented above indicate that for the test duration thus far, Se applied to the test plots does not influence Se concentrations in groundwater, or deeper soil water. Dissolved Se is being mobilized to a depth of 0.15 m, but not much deeper. This is in agreement with findings in Section 4.2.2, where the absence of significant deep infiltration was shown. Low permeability soils on the embankment, combined with sparse rainfall, greatly reduce the likelihood of significant deep percolation of Se-enriched soil water.

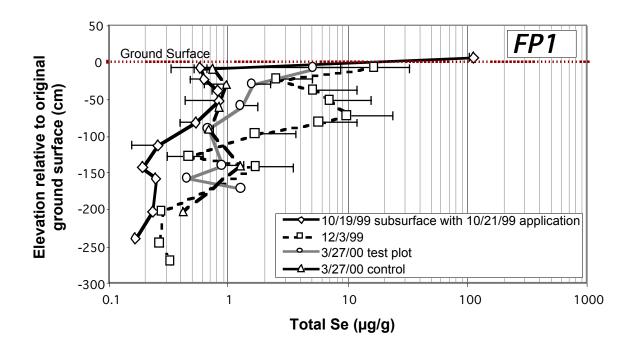
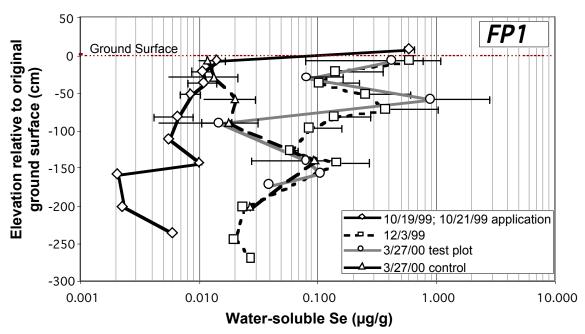
Figure 4.21. Total (a) and water-soluble (b) selenium concentrations normalized to soil mass in plot FP-1. Error bars represent one standard deviation on either side of the mean.

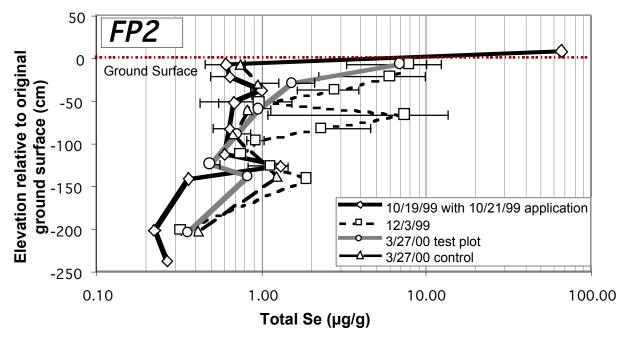
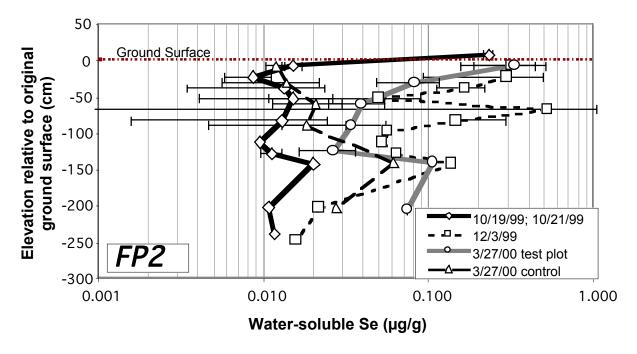
Figure 4.22. Total (a) and water-soluble (b) selenium concentrations normalized to soil mass in plot FP-2. Error bars represent one standard deviation on either side of the mean.

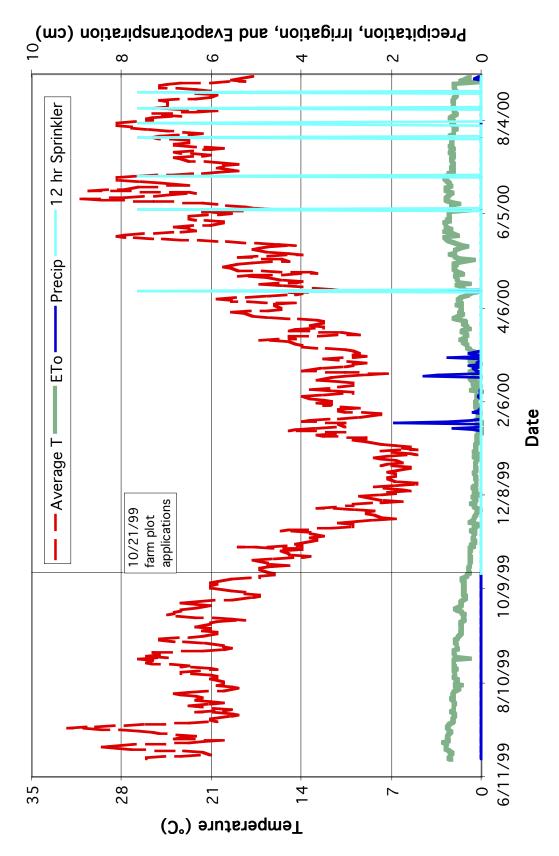
Figure 4.23. Daily weather records and irrigation events for farm plots.

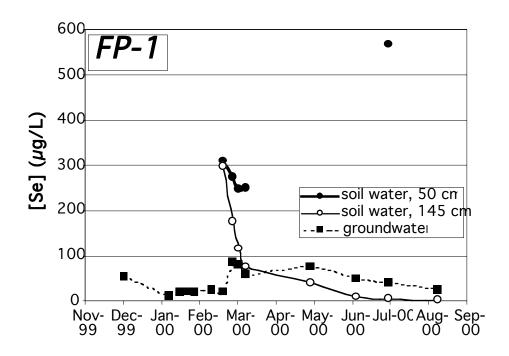
Figure 4.24. Soil water and groundwater Se in FP-1.

Groundwater Se concentrations in FP-1 and FP-2 remained in the range of 10 to 100 µg L⁻¹. Although there appears to be an increase in groundwater Se at times corresponding to the heavy rainfall periods in February and March 2000, the absence of groundwater level measurements makes it difficult to establish whether this change is due to Se leaching or simply differences in soil water Se at different depths in the soil profile. It is interesting to note that groundwater Se levels prior to any possible leaching of applied sediments were already in the 20 to 50 µg L⁻¹ range. In samples from intermediate lysimeters, Se levels are initially high, especially in FP-1 (Fig. 4.24), but quickly dissipate to less than 100 µg L⁻¹ and by June 2000 are less than 10 µg L⁻¹. Perhaps the initial higher concentrations are indicative of a high-Se pulse followed by rainfall and irrigation infiltration after the more soluble Se fraction was leached. Shallow FP-1 data is too sparse to confirm this supposition, but soil water at 0.50 m in FP-2 shows a similar pattern in soluble Se concentrations. Initial values in February 2000 were around 250 µg L⁻¹, but dropped by March to 175 µg L⁻¹ and by June to less than 100 µg L⁻¹. Patterns in EC (Figs. 4.26 and 4.27) roughly correspond to Se trends. It is reasonable to assume that the disking and mixing of applied sediments with farm soil resulted in aeration and some Se oxidation and solubilization. This more readily soluble fraction could potentially be leached by rainfall and irrigation. Given the low total rainfall between January and March 2000 (8 cm), it is difficult to explain leaching down to 1.45 or 1.75 m. Therefore, the effect of rising groundwater also needs to be considered. The next crop in the rotation, winter wheat, does not require post-planting soil manipulation and both lysimeters and tensiometers will be installed. The latter will permit the measurement of the groundwater level.

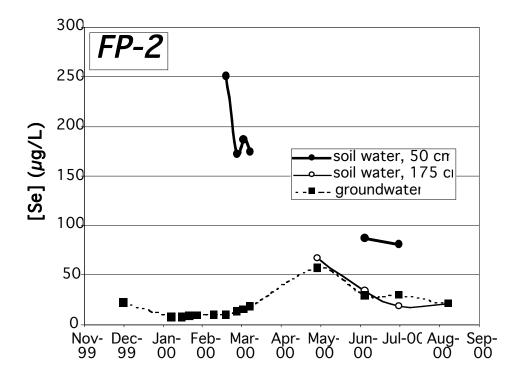
Figure 4.25. Soil water and groundwater Se in FP-2.

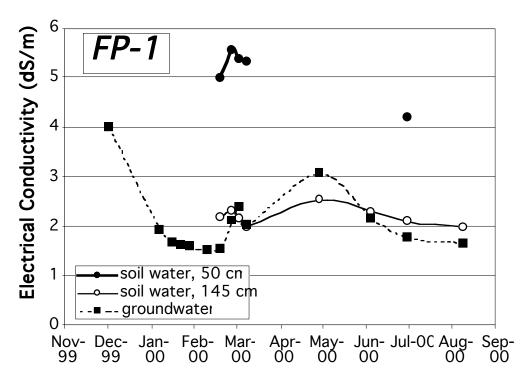
Figure 4.26. Soil water and groundwater electrical conductivity in FP-1.

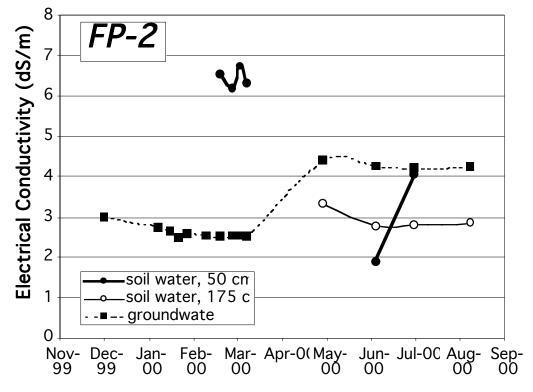
Figure 4.27. Soil water and groundwater electrical conductivity in FP-2.

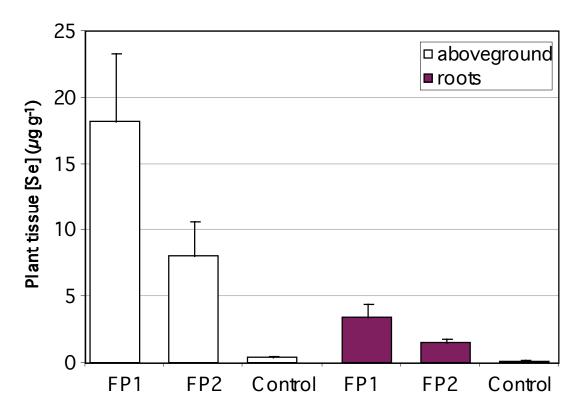
Figure 4.28. Average Se concentrations (± 1 s.d.) in cotton tissue from FP-1, FP-2, and a control area, 7/14/00.

Three complete cotton plants were collected on 7/14/00 from each experimental farm plot and from a control area. Roots and aboveground parts were processed separately. Results of Se analyses of these samples are shown in Fig. 4.28. The data suggest that the cotton plants accumulated Se in the amended plots relative to those in the control plot. Furthermore, the degree of Se enrichment was proportional to soil Se concentrations. The highest Se concentration was observed in FP-1 at 22.7 μ g g⁻¹.

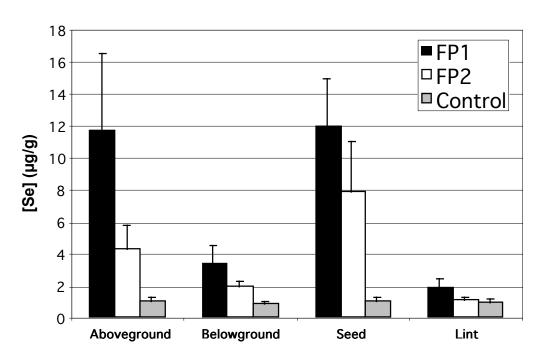
Figure 4.29. Average Se concentration (± 1 s.d.) in aboveground parts (stems and leaves), belowground parts (roots), seeds, and lint of cotton plants in plots FP-1, FP-2, and a control area, 11/4/00.

A more comprehensive sampling of cotton took place at full maturity (11/4/00), shortly after the application of exfoliant. Five complete plants were pulled from each test plot and a control area. In addition, plant density was measured (as number of plants per m^2), permitting the calculation of biomass and cotton yield. Results of Se analysis of various plant parts (aboveground, i.e., roots and stems; belowground, i.e. roots; seeds; and lint) are shown in Fig. 4.29. Selenium concentrations in the aboveground parts were lower than those measured on 7/14/00. Selenium in roots remained the same, between 0.5 and 3.5 μg g⁻¹. Seeds contained the highest Se concentrations, the highest being 16.6 μg g⁻¹ in FP-1. Selenium concentrations in lint were lowest, at or below 2 μg g⁻¹. In all plant parts Se levels were proportional to soil Se in the given plot, i.e., FP-1 > FP-2 > FP-C.

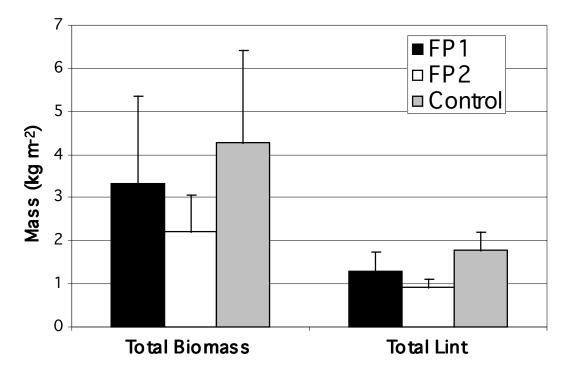
Figure 4.30. Average biomass and cotton lint yield (± 1 s.d.) in plots FP-1, FP-2, and a control area, 11/4/00.

Total biomass and cotton (lint) mass are shown in Fig. 4.30. There are only small differences in both measures amongst the three plots. Due to large spatial variability, these small differences are not statistically significant. Given that soil Se is highest in FP-1 and yet the FP-1 biomass and lint yield are higher than in FP-2, the applied Se-enriched sediment does not negatively affect cotton growth. The removal of cotton lint and seeds during harvest has a negligible effect on the Se mass balance, as it accounts for less than 0.1% of the amended Se. Since the stems, leaves, and roots are eventually incorporated back into the soil, all but 0.1% of the Se is retained. If the entire cotton plant were removed from the plot, a net loss of as much as 0.5% of the total added Se would result. This number is small because, despite significant Se accumulation relative to dissolved Se in soil, the cotton biomass is low.

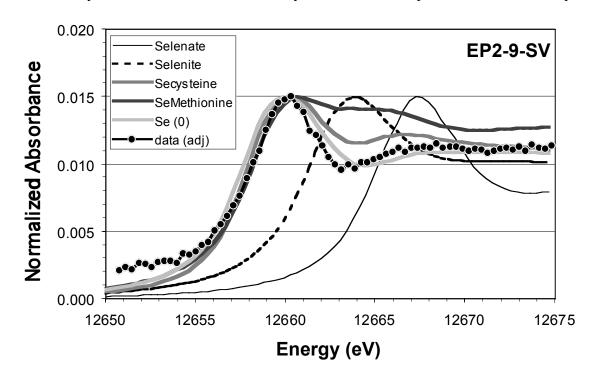
Figure 5.5. Selenium K-edge absorption spectra of Se standards and SLD sediment sample EP2-9-SV, collected on 9/3/99 immediately after application.

A number of samples were run in March and June 2000, but several of the results were compromised by beam instability and other experimental problems. Here we present two successful runs. The findings confirm the dominance of reduced Se species. In sample EP2-9-SV, (Fig. 5.5), which represents the initial sediment application to plot EP-2, and contained 37.7 μg g⁻¹ Se, the spectrum can best be fit with 100% elemental Se, although fits with 53% Se⁰ and 47% Se-cysteine are also satisfactory. Spectra of standard Se compounds are shown for qualitative comparison. The shape of the curve over the range of 12650 to 12680 eV was taken into account when running a fit for one, two, or three Se species. The initial SLD sediment sample applied to farm plot 1 is represented by sample FP1-7 and is shown in Fig. 5.6. The shape of the data is more complex and suggests the presence of Se⁺⁴. Both a 100% Se-cysteine fit and an 87% Se⁰ plus 13% Se⁺⁴ fit adequately matched the data. The similarity of the elemental Se and organo-Se (especially Se-cysteine) standard spectra, and particularly their peaks, is a reminder that the distinction of these species in complex field samples is challenging. Nonetheless, the data confirm the predominance of reduced Se species in SLD sediment, with no detectable Se⁺⁶. These findings agree qualitatively with results of sequential extractions. Additional x-ray runs were conducted in January 2001 and will be presented in a future report.

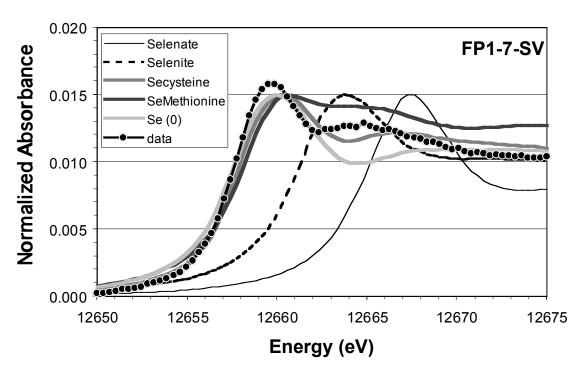
Figure 5.6. Selenium K-edge absorption spectra of Se standards and SLD sediment sample FP1-7-SV, collected on 10/21/99 immediately after application.

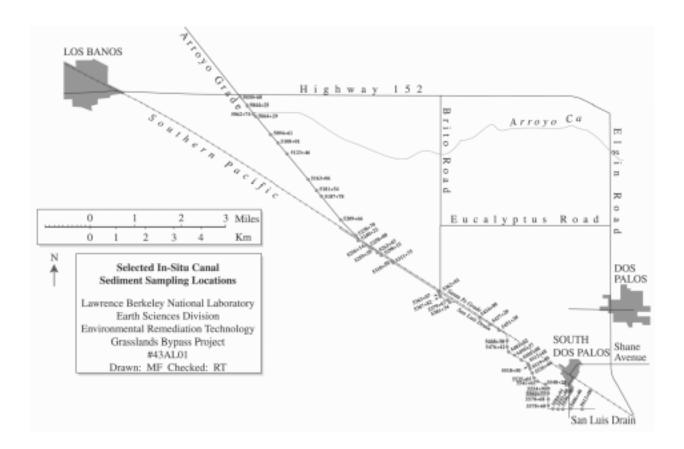
Figure A-1. Location of LBNL sediment sampling points along the San Luis Drain.

The locations of the samples collected for this analysis are shown in Figure A-1. Sampling began just downstream of the Grasslands Bypass Channel and continued northward toward the terminus of the SLD to Check 10. In each case, the sample was collected within 1 m of the access ladders located at 200-m (1/8-mile) intervals along the SLD, and subsequently at higher frequencies close to check structures. Two hundred and twenty samples were collected over 7 sampling events between 12/4/98 to 5/18/99.

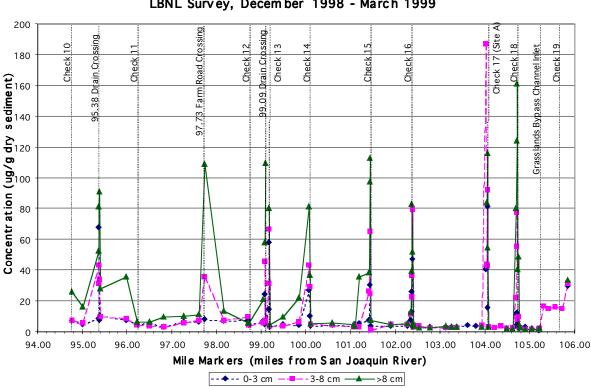
Chart 1: Total Se in San Luis Drain Sediment
LBNL Survey, December 1998 - March 1999

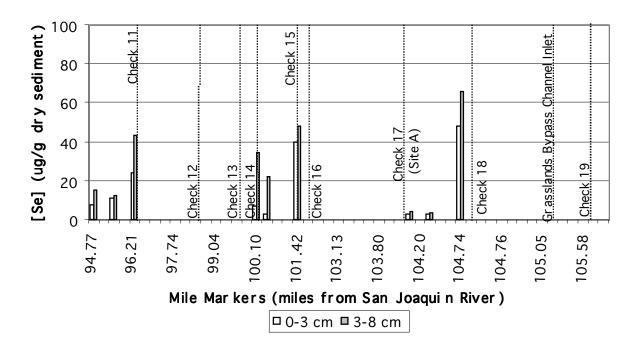
9b: USBR June 1998 Survey

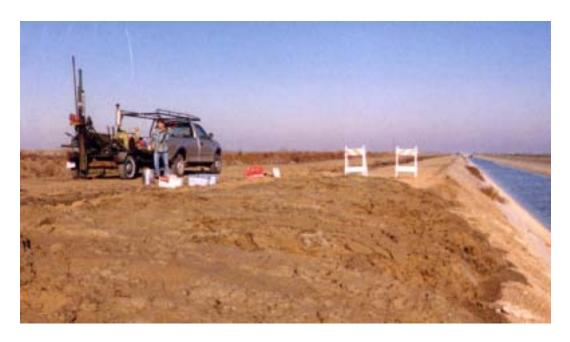
Figure C.1. Dredged SLD sediment (EP-1) drying on berm. Soil core sampling and instrument installation in progress (December 1998). View to the north.

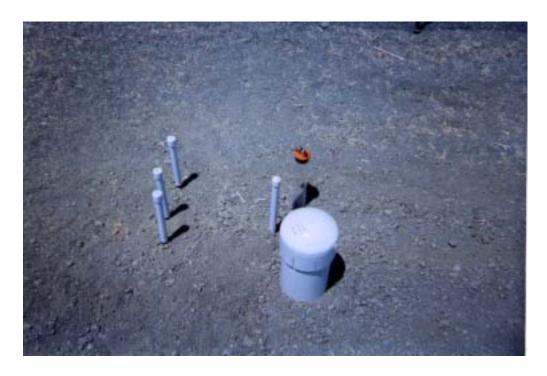
Figure C.3. Instrument cluster 7 in EP-2. From left to right: tensiometers (covered with PVC pipe), neutron probe access pipe (clear acrylic), and soil water suction lysimeters (under large PVC cap).

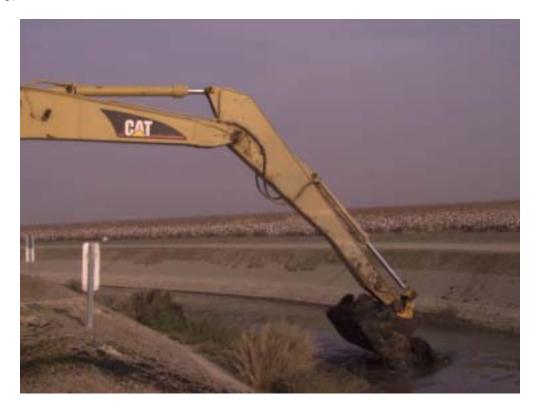
Figure C.4. Dredging of SLD sediment.

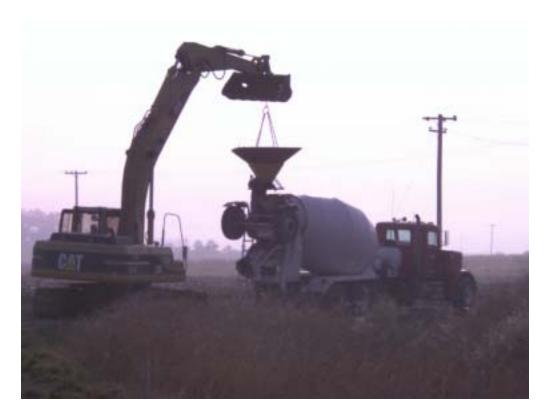
Figure C.5. SLD sediment being placed in cement truck via hopper.

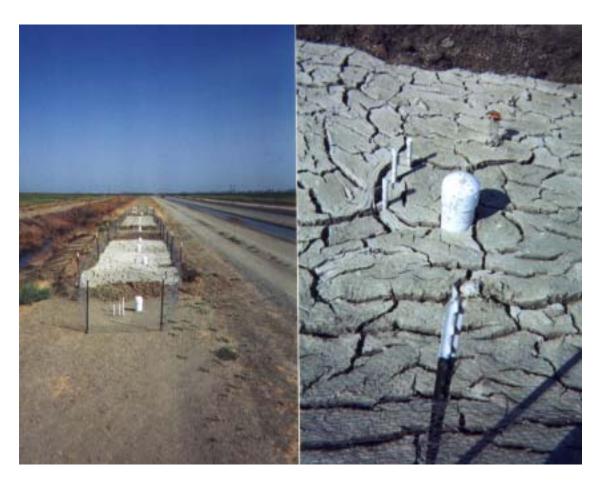
Figure C.7. Left: Sites EP-2 and EP3 after a few days of drying (9/9/99). Close-up view of drying cracks around one of the monitoring clusters (right).

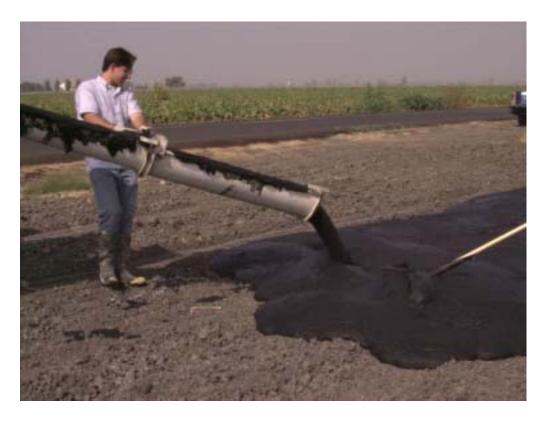
Figure C.8. Application of SLD sediments to FP-1 using cement-truck chute (10/21/99).

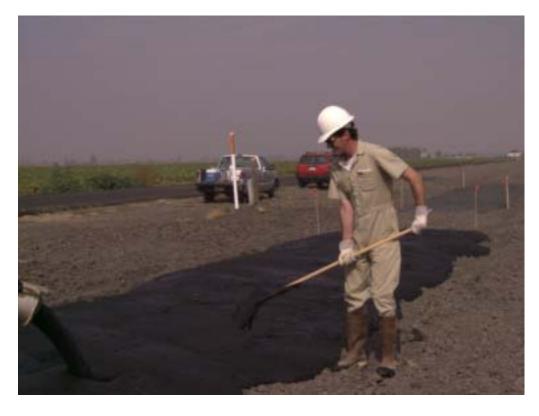
Figure C.9. Spreading of SLD sediments in FP-1 using cement rake (10/21/99)

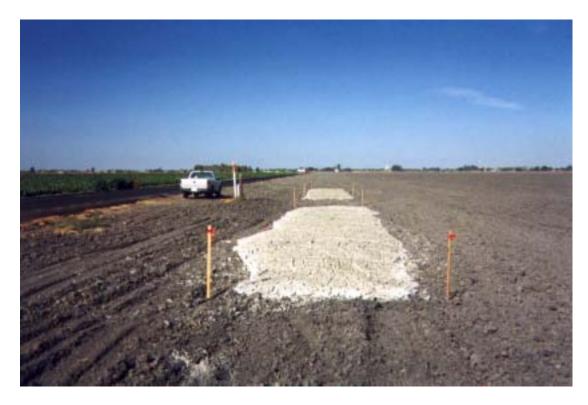
Figure C.10. Sites FP-1 (foreground) and FP-2 after a few days of drying (10/28/99). View to the north.

The application was subsequently incorporated into the soil by the following sequence of events. By 10/28/99, the farm plot applications had become gray and fissured with drying cracks. There had been no record of rain at the test site up to 11/5/99. On 11/15/99 the farm plots were plowed by shanks that cut to 0.45-0.50 m depth, with 0.45 m lateral separation. On 11/19/99, the plots
