Restoration of Rivers and Streams (LA 227)

Effects of a livestock exclosure on channel morphology and vegetation along Long Creek in Lake County, Oregon

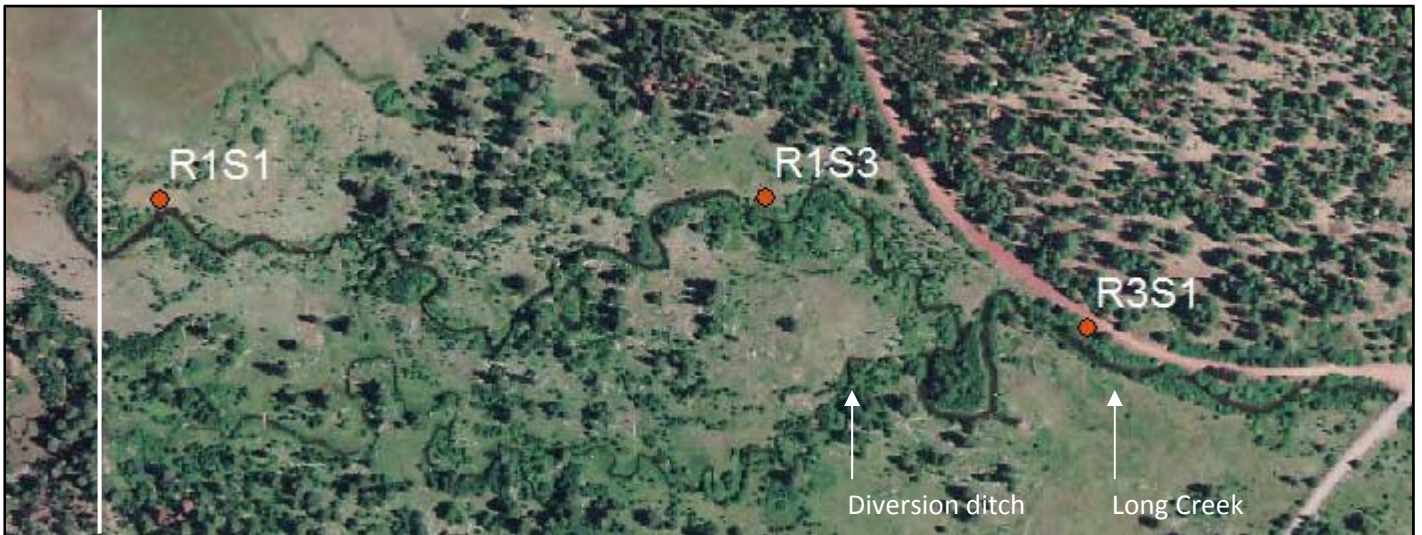
Figure 3. Location of cross-section surveys and photomonitoring along Long Creek.

● Photomonitoring and cross-section locations

Long Creek historically diverged into three channels before entering Sycan Marsh between cross-sections R1S4 and R3S1 (Figure 3). To manage irrigation deliveries, Long Creek water was diverted into the North Fork for irrigation, and the South Fork of Long Creek no longer received flow. In 2008, a change in water rights allowed The Nature Conservancy to rewater the South Fork, which now carries approximately 60% of the Long Creek discharge to Sycan Marsh and substantially reduces the discharge through Reach 4.

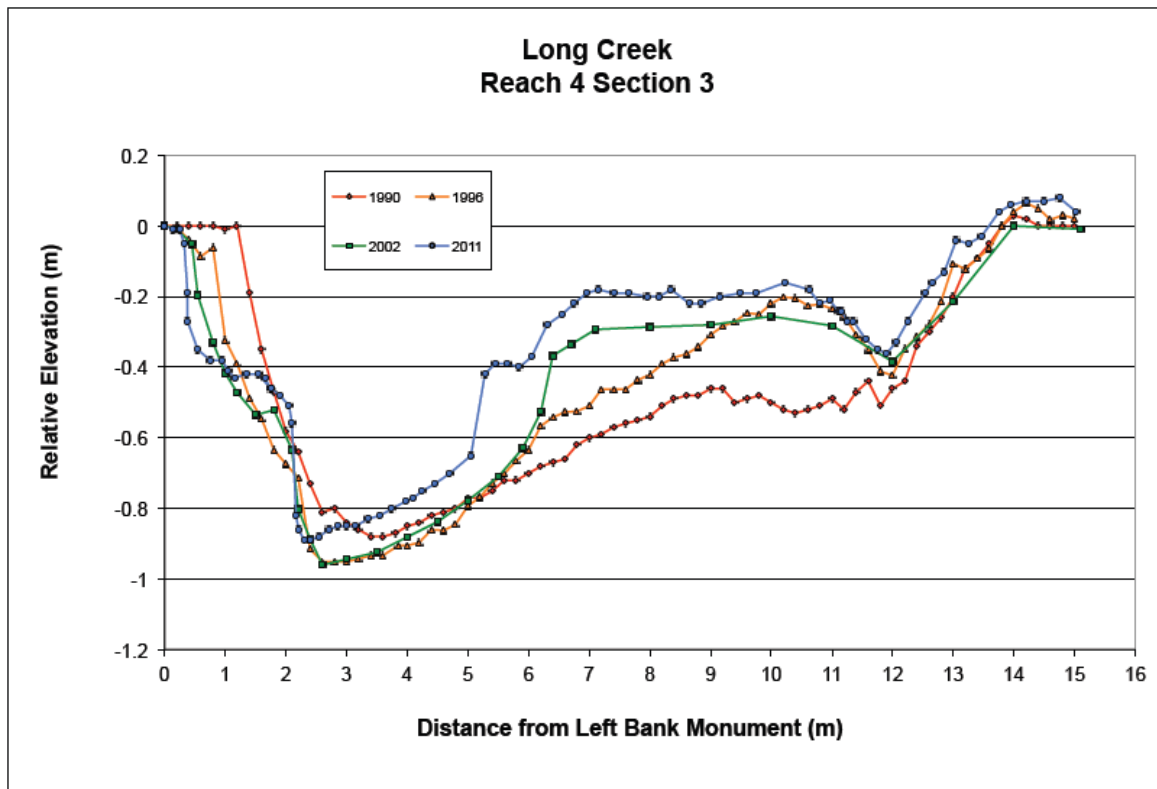
Figure 6. Reach 4 Section 3 exhibited the most substantial change. By 2011 the channel had deepened to ~0.7m (75% change) and narrowed to ~6.5m (10% change). A beaver dam, now present just downstream of the cross section, is the likely cause of the channel change.

By contrast, the channel at Reach 3 Section 1 and Reach 4 Section 3 narrowed over the monitoring period. At Reach 3 Section 1 the channel narrowed from 7.6m to 7.1m (10% change) from 1996 to 2011 (Figure 7), but bed elevation and channel depth remained the same. The channel of Reach 4 Section 3 progressively narrowed, aggraded, and deepened as a result of sediment deposition in the channel and on the floodplain from 1990 to 2011 (Figure 6). In 1990 the Reach 4 Section 3 channel was 7.2m wide and 0.4m deep. By 2011 the channel had deepened to 0.7m (75% change) and narrowed to 6.5m (10% change). A beaver dam is now present just downstream of cross section Reach 4 Section 3. The pond extends up to the cross section.

Geomorphically effective flows and adequate sediment load are both necessary for the channel to narrow. If suspended sediment concentrations are small, narrowing may be a very slow process. Substantial narrowing was observed at Reach 4 Section 3, however. This cross section was located just upstream of a beaver dam (Figure 17). The beaver dam decreases the flow velocity which provides the opportunity for sediment deposition along the banks (Butler and Malanson, 1995). The fact that we observed a significant build up of sediment on the right bank of this cross section could be evidence that there is an adequate supply of sediment for channel narrowing to occur.

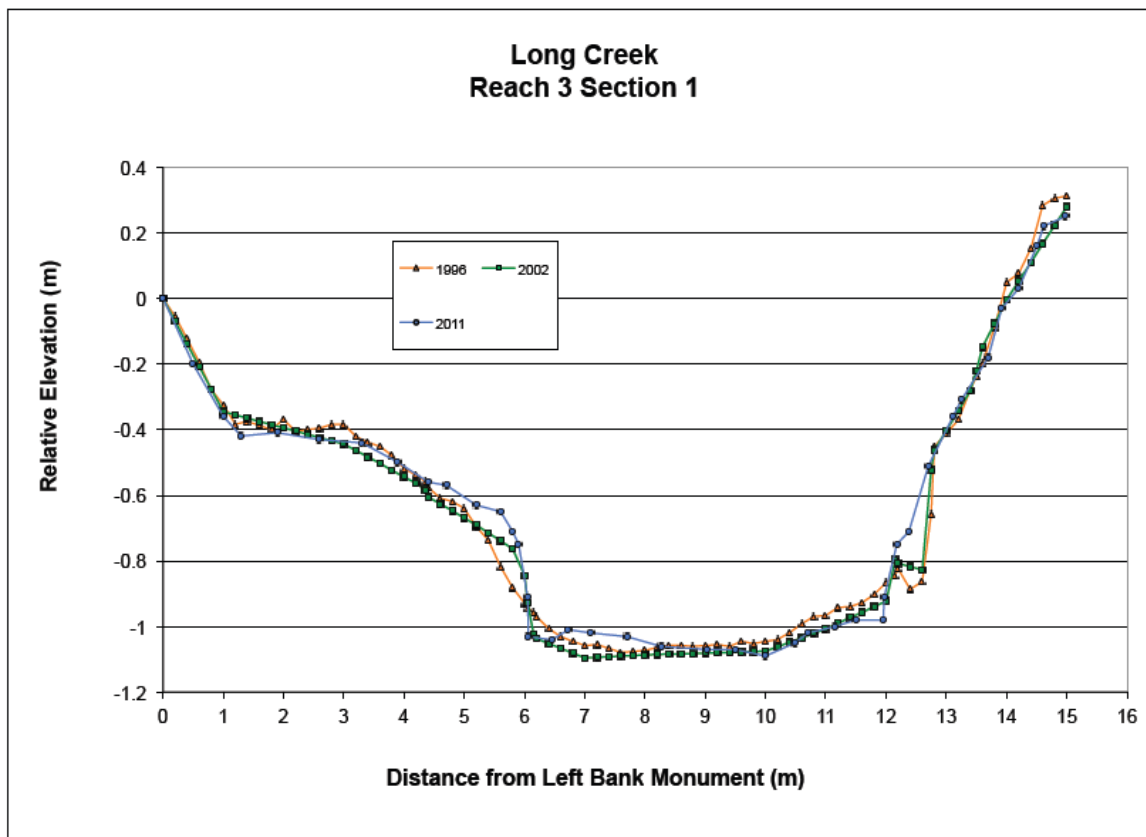
Figure 7. The low-flow channel of Reach 3 Section 1 narrowed slightly from 7.6m to 7.1m (10% change) from 1996 to 2011. There was no change in bed elevation or channel depth during the monitoring period.

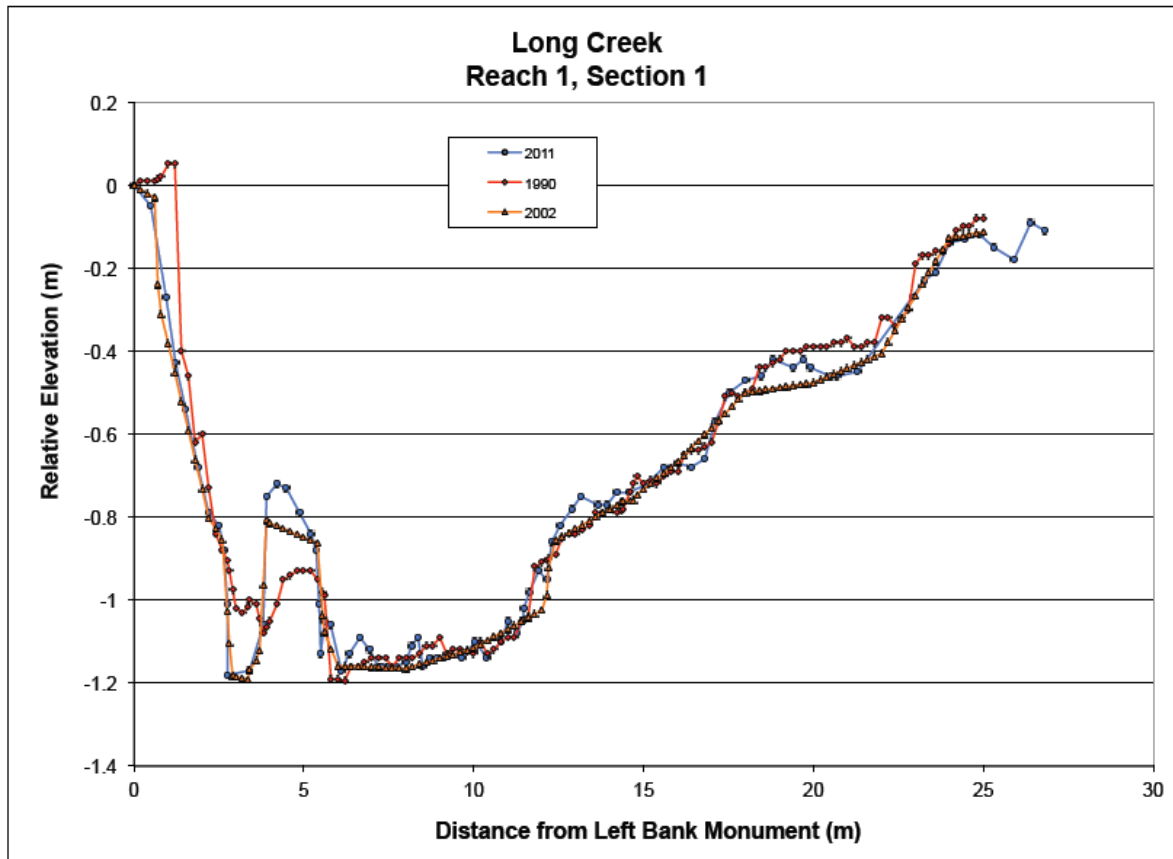
Figure 8. Reach 1 Section1 had no channel change between surveys in 1990 and 2011.

The other two sections included in this analysis did not have any measurable change. Reach 1 Section 1 had no channel change between surveys in 1990 and 2011 (Figure 8). Reach 1 Section 3 had no channel change between surveys in 2003 and 2011 (Figure 9).

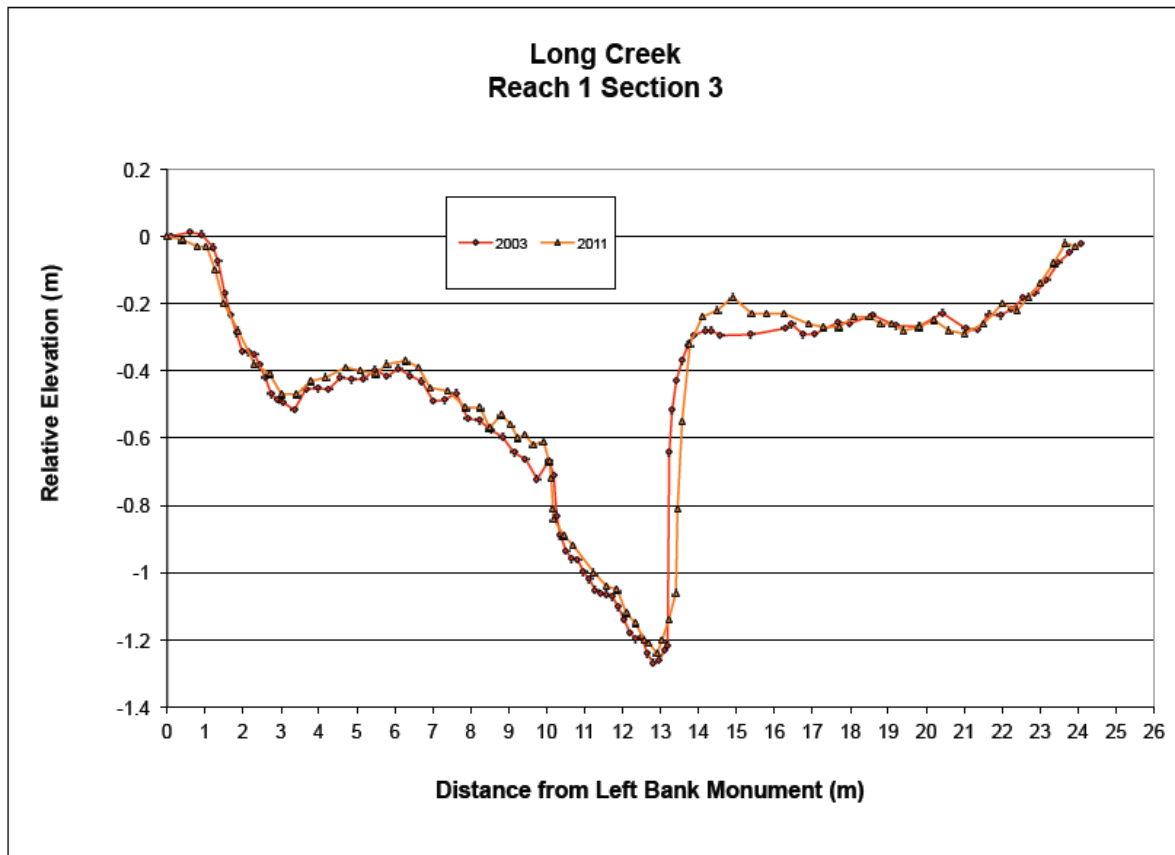
Figure 9. Reach 1 Section 3 had no channel change between surveys in 2003 and 2011.

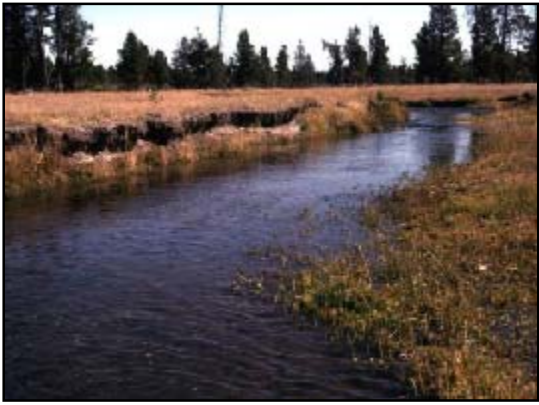
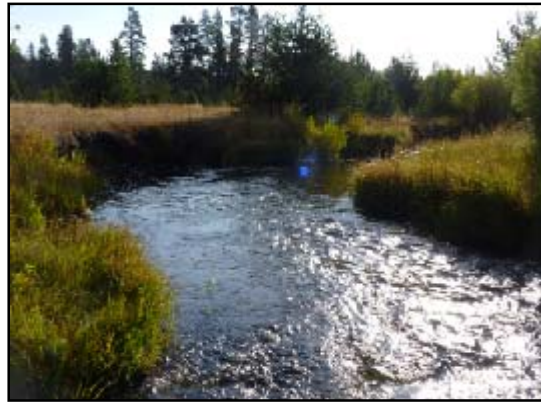
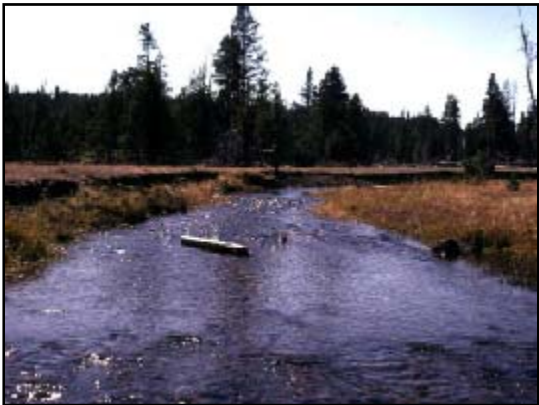
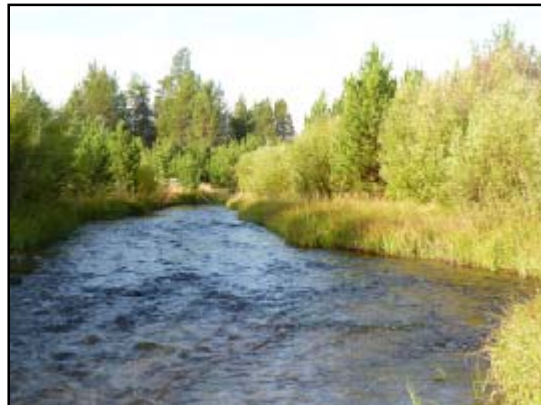
a) Facing West, Downstream

b) Facing East, Upstream

Figure 11. Photopoints at cross-section R1S1 in 1990 and 2011, respectively.

The extent of riparian vegetation from 1990 (nine years before livestock enclosure) to 2011 (eleven years after livestock exclusion) increased substantially within all sampled reaches. Photomonitoring shows a significant increase in riparian vegetation from 1990 to 1996, a period when there were changes in the timing and intensity of cattle grazing. During this period, riparian vegetation became established along the streambank. Then from 1996 to 2003 willow density increased. At cross-section Reach 1 Section 1, the channel banks in 1990 were heavily grazed with evidence of cattle chiseling along the outer banks. Vegetation was consumed down to stubble grasses (Figure 10). In contrast, the 2011 photos show a marked increase in native riparian willows and upland conifers along the channel banks. Photopoints taken at cross-sections Reach 1 Section 2, Reach 1 Section 3, Reach 3 Section 1, and Reach 4 Section 3 illustrate a similar trend of dense riparian and upland species establishing along both stream banks (Figure 11-15). At many cross-section locations, the floodplain is visible from across the channel for approximately 120 feet in 1990 before willows, alders, and lodgepole pines (*Pinus contorta*) line the channel banks in 2011. The rapid encroachment of lodgepole pines is most notably shown at cross-section R1S3 from 1991 to 2003 (Figure 16).

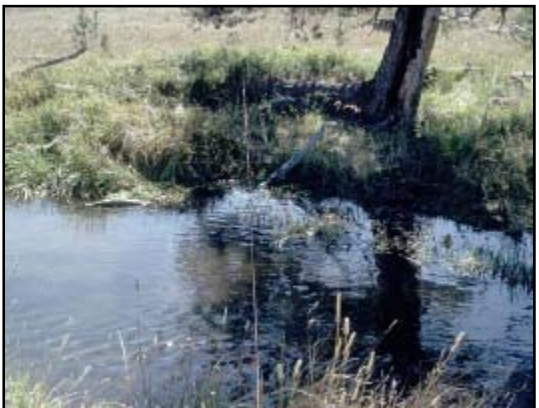
a) Facing South, Right Bank

Figure 12. Photopoints at cross-section R1S2 in 1990 and 2011, respectively.

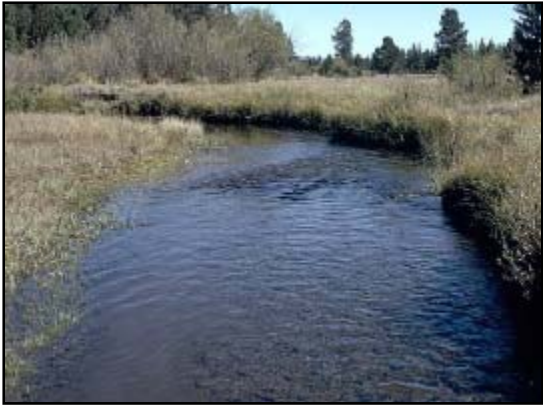
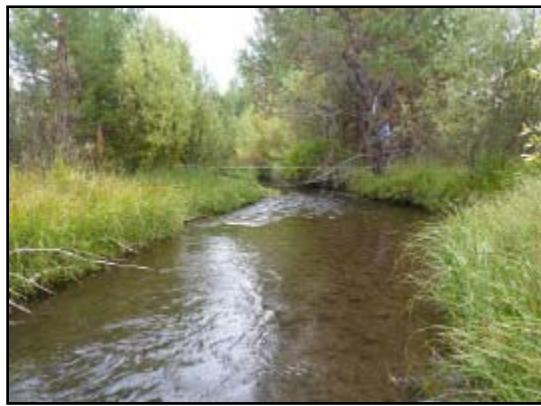
a) Facing West, Downstream

Figure 13. Photopoints at cross-section R1S3 in 1990 and 2011, respectively.

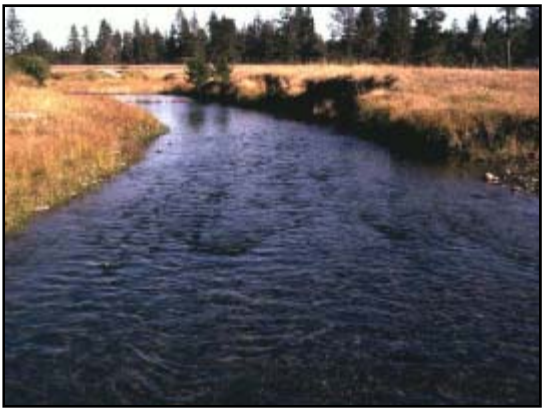
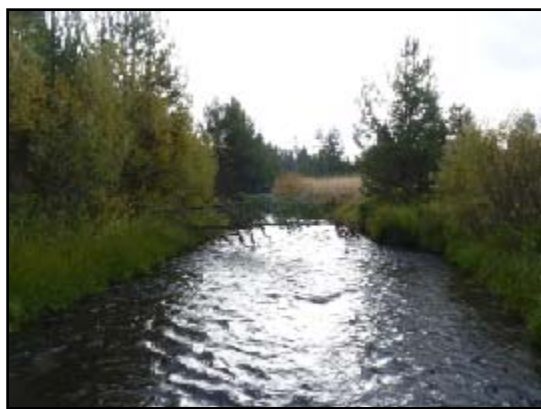
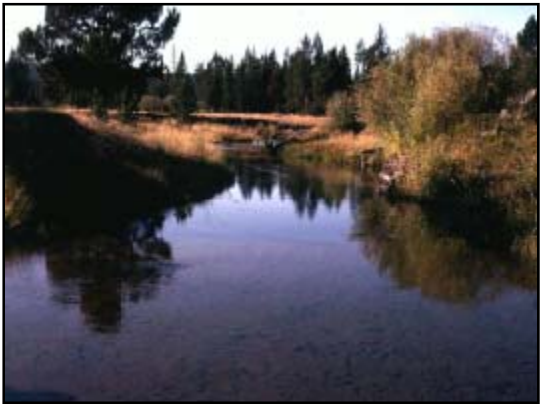
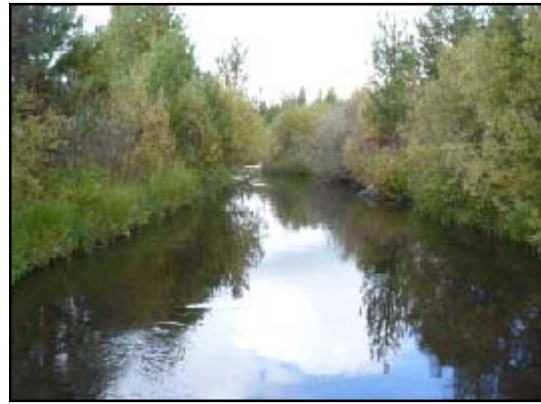
a) Facing West, Downstream

b) Facing East, Upstream

Figure 14. Photopoints at cross-section R3S1 in 1990 and 2011, respectively.

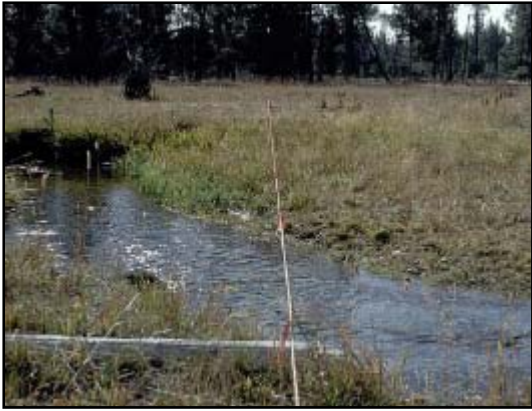
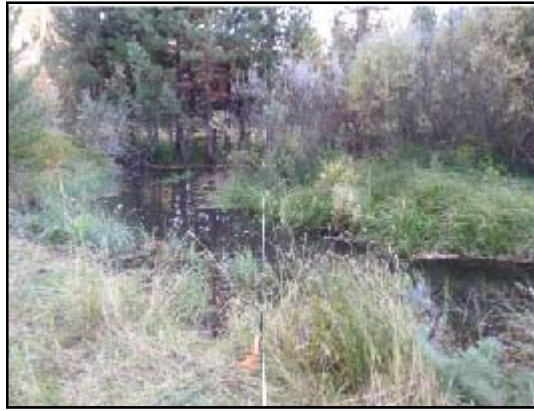
a) Facing South, Right Bank

Figure 15. Photopoints at cross-section R4S3 in 1900 and 2011, respectively.

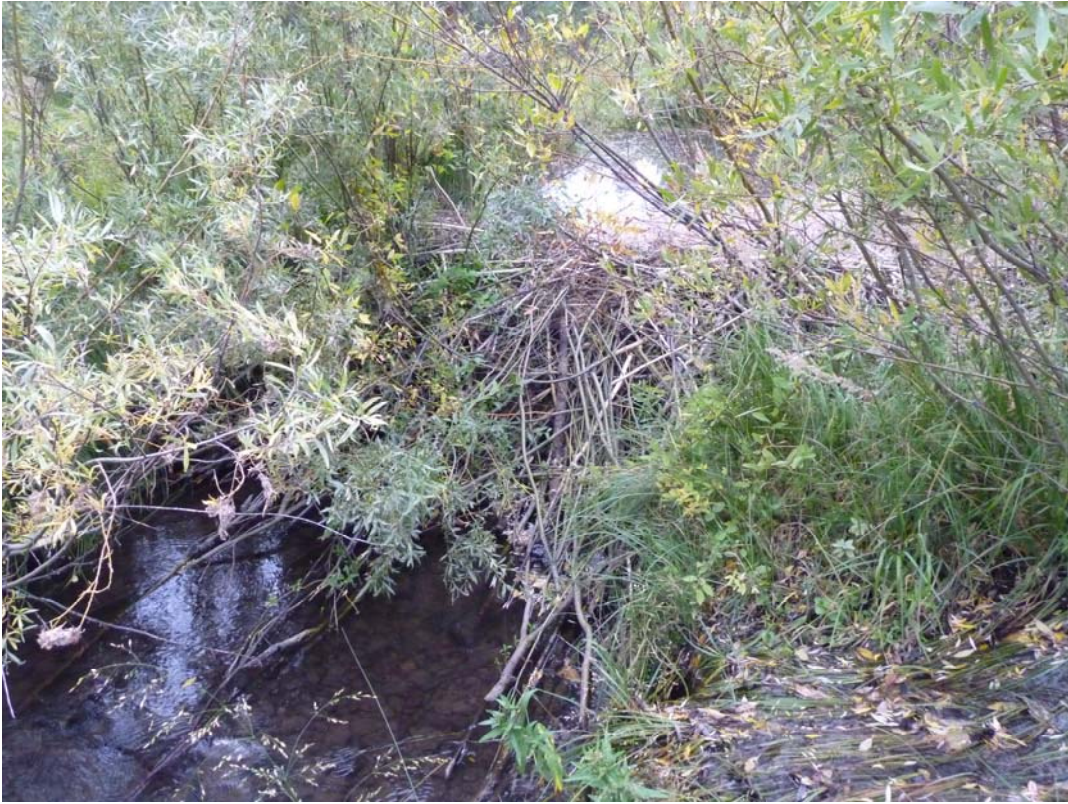
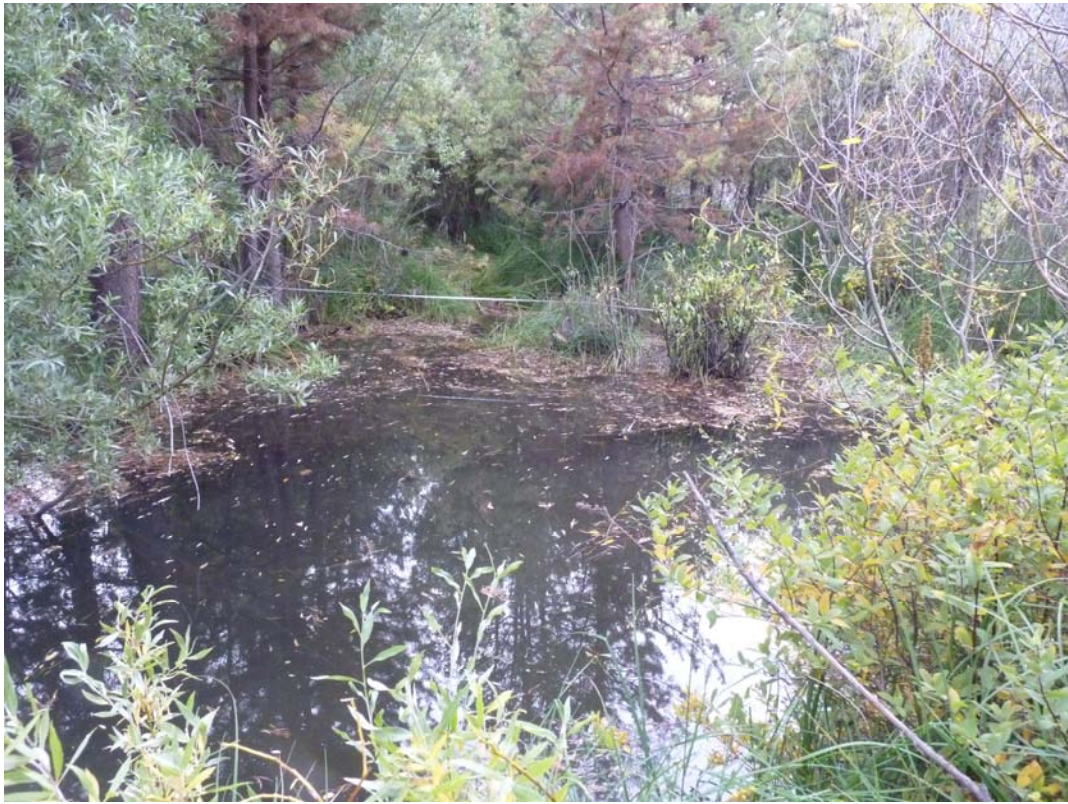
Figure 17. a) Beaver dam just downstream of R4S3. b) The resulting pond that extends upstream of cross section R4S3.
