Restoration Potential of a Mining-Impacted Urban Stream: Horseshoe Branch of Lion Creek, Oakland, CA

Final Draft

LA 227 - Restoration of Rivers and Streams  
UC Berkeley  
15 December 2010

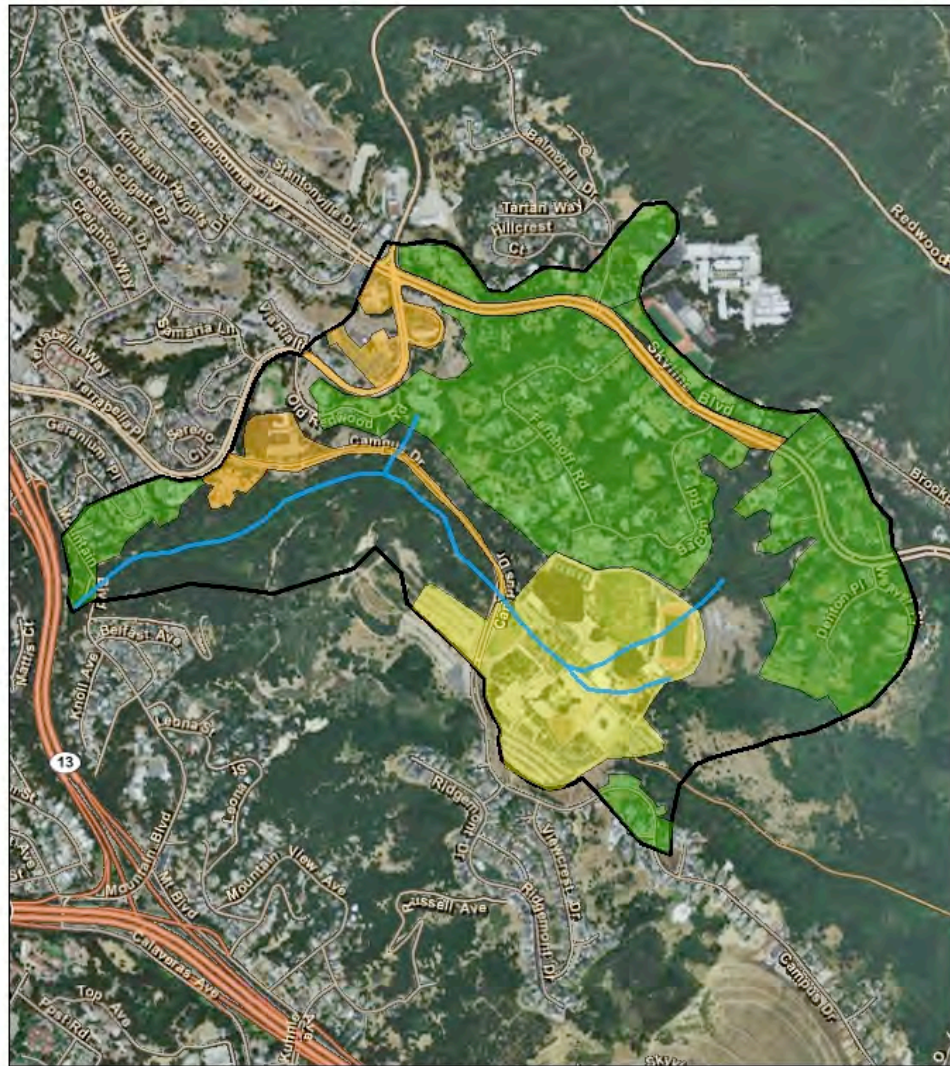
**Figure 3: Developed areas in the watershed. These areas were weighted to assign the runoff coefficient for rational method calculations.**

Table 1 presents the GIS polygon acreage, runoff coefficient values by category, and the calculated weighted-average runoff coefficients for this site. Since the coefficients provide a range of possible values: low, average, and high weighted averages were determined. Table 2 presents the average predicted percent increase in peak flow rate from the baseline, undeveloped condition. The results suggest, on average, a 109-percent increase in peak flow rate to the stream, with a 37-percent increase in the value of the runoff coefficients from Merritt College alone. Assuming no significant change to the channel size, the increased flow rates result in higher in-stream velocities. When water velocity increases, the shear stress on the channel increases. Greater shear stress results in increased erosion of the channel bed and banks -- evidence of which is clearly evident today.

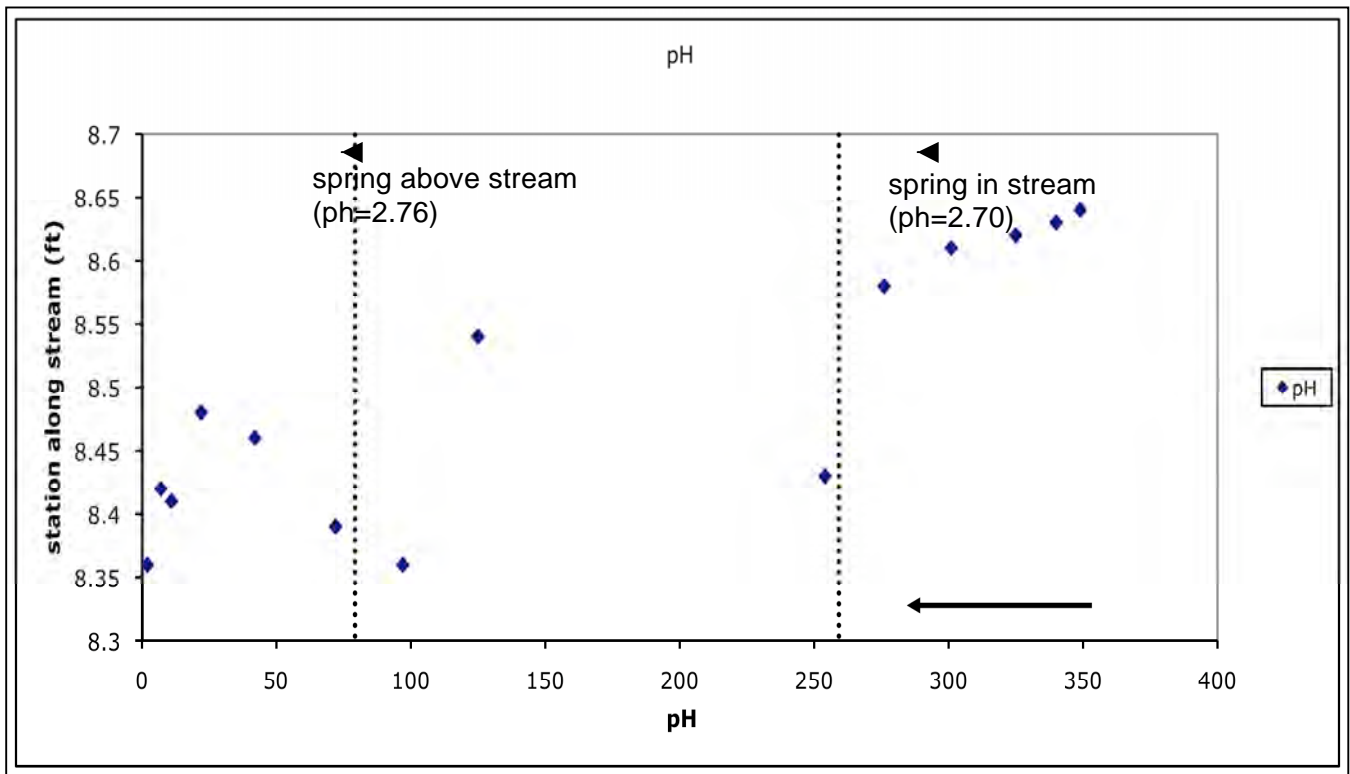
Figure 4: pH along both study reaches of Horseshoe Branch, 10/26/10

2008).<sup>3</sup> We confirmed earlier researchers' findings that pH in in-channel and near-channel springs ranges from two to four. We found that pH in the study reach ranges from 8.36 to 8.64. We found that the bedrock step at the downstream limit of Study Reach 1 marked a slight but distinct change in water quality. Downstream of this step, we noticed several acidic, orange-colored springs in the area where previous research documented elevated levels of lead, zinc, and copper (upstream of this step, pH averaged 8.65 (n=12, range=8.58-8.69) (Figure 4). Downstream of this step, pH averaged 8.43 (n=9, range=8.36-8.54). Neither reach exhibited pH depression to an extent that would impact benthic macroinvertebrate populations.

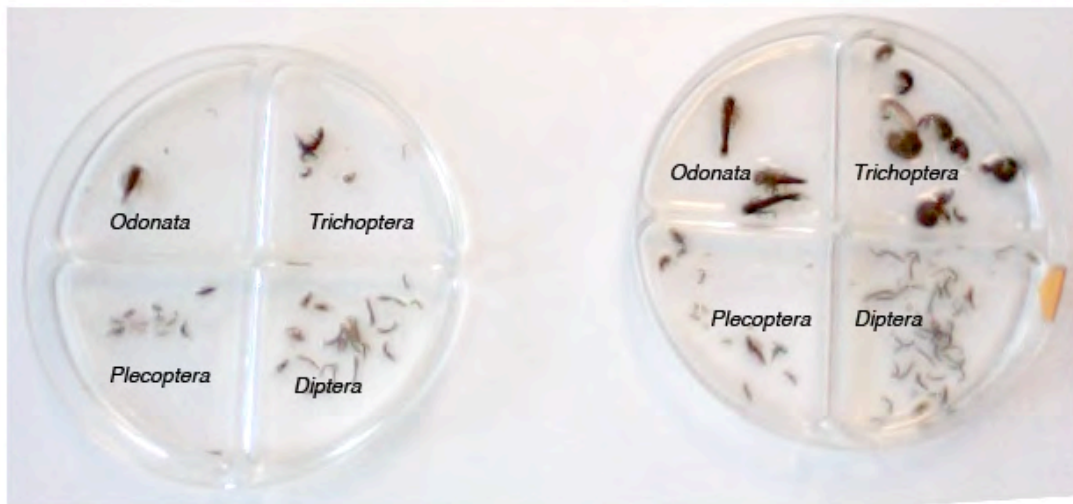
Figure 5: Benthic macroinvertebrates samples, 10/26/10. Note increase in sensitive taxa. Note: Ephemeroptera not shown.

Benthic macroinvertebrate communities differed markedly upstream and downstream of the bedrock step (Table 3, Figure 5,19). Total abundance, number of taxa, and number of sensitive taxa were significantly higher upstream of the bedrock step than in the downstream acidic-spring-influenced reach. This preliminary survey suggests that heavy metals impacts in Horseshoe Branch extend beyond the zone of pH depression.<sup>4</sup>

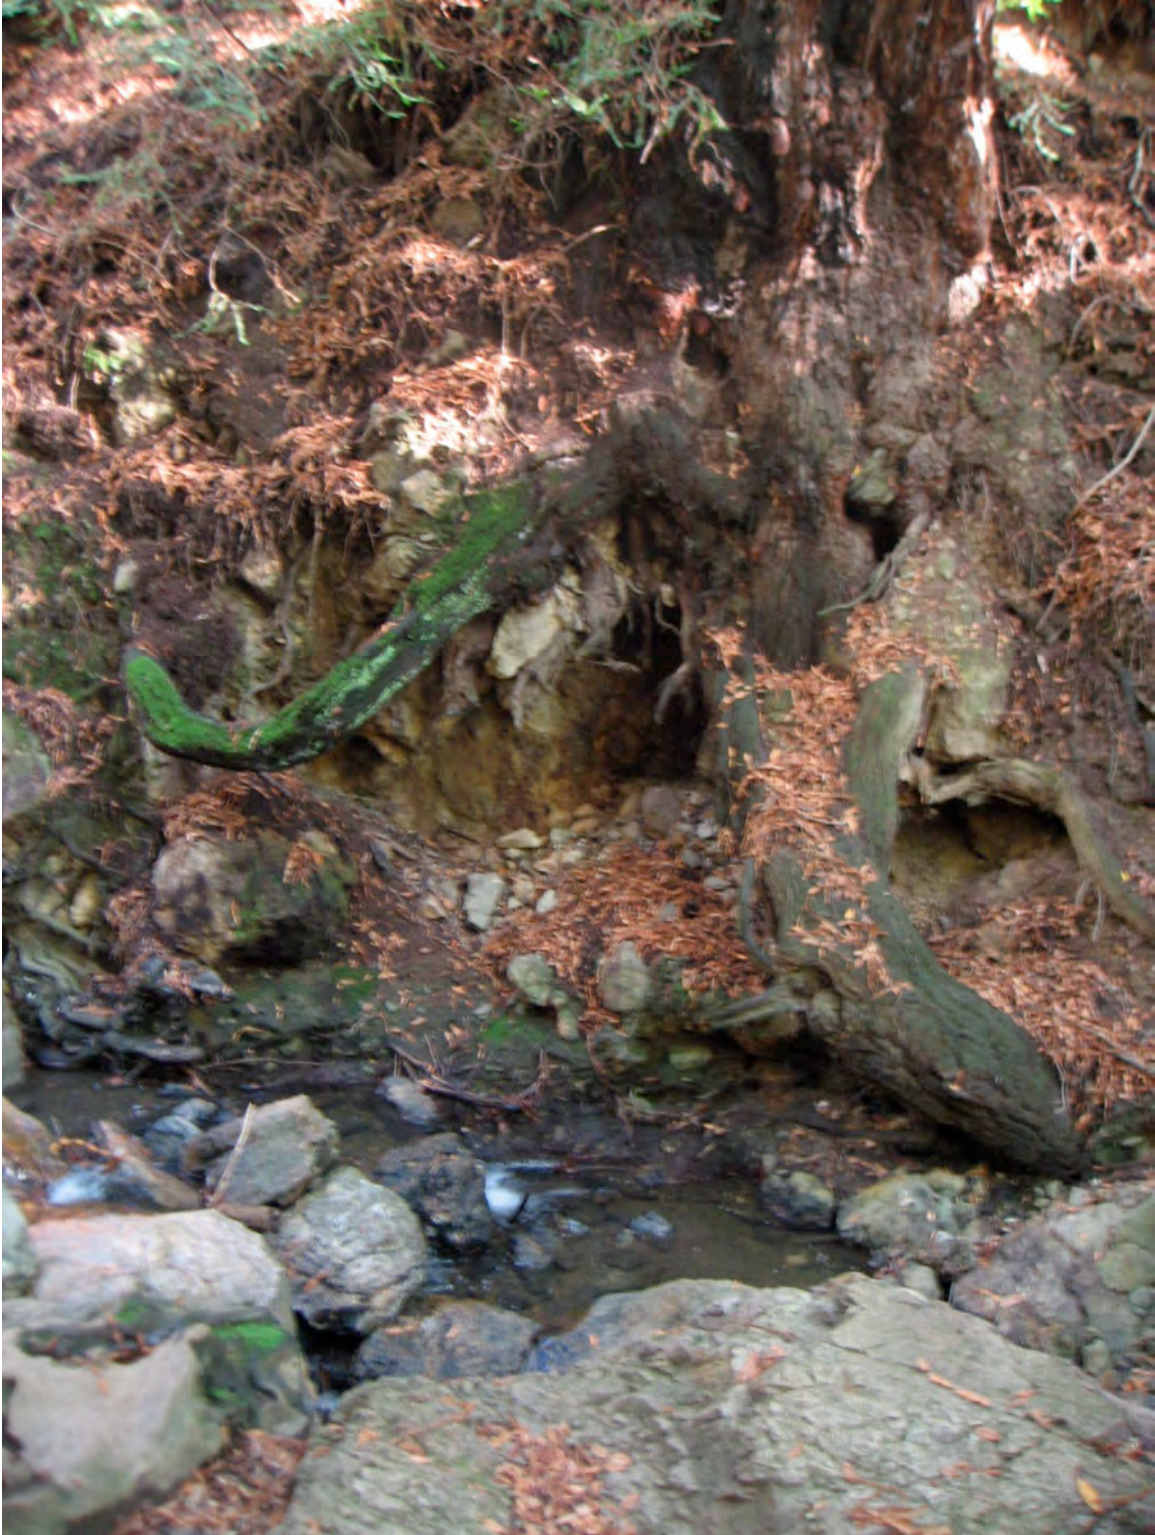
**Figure 14: Tree Roots Exposed and bank failure**

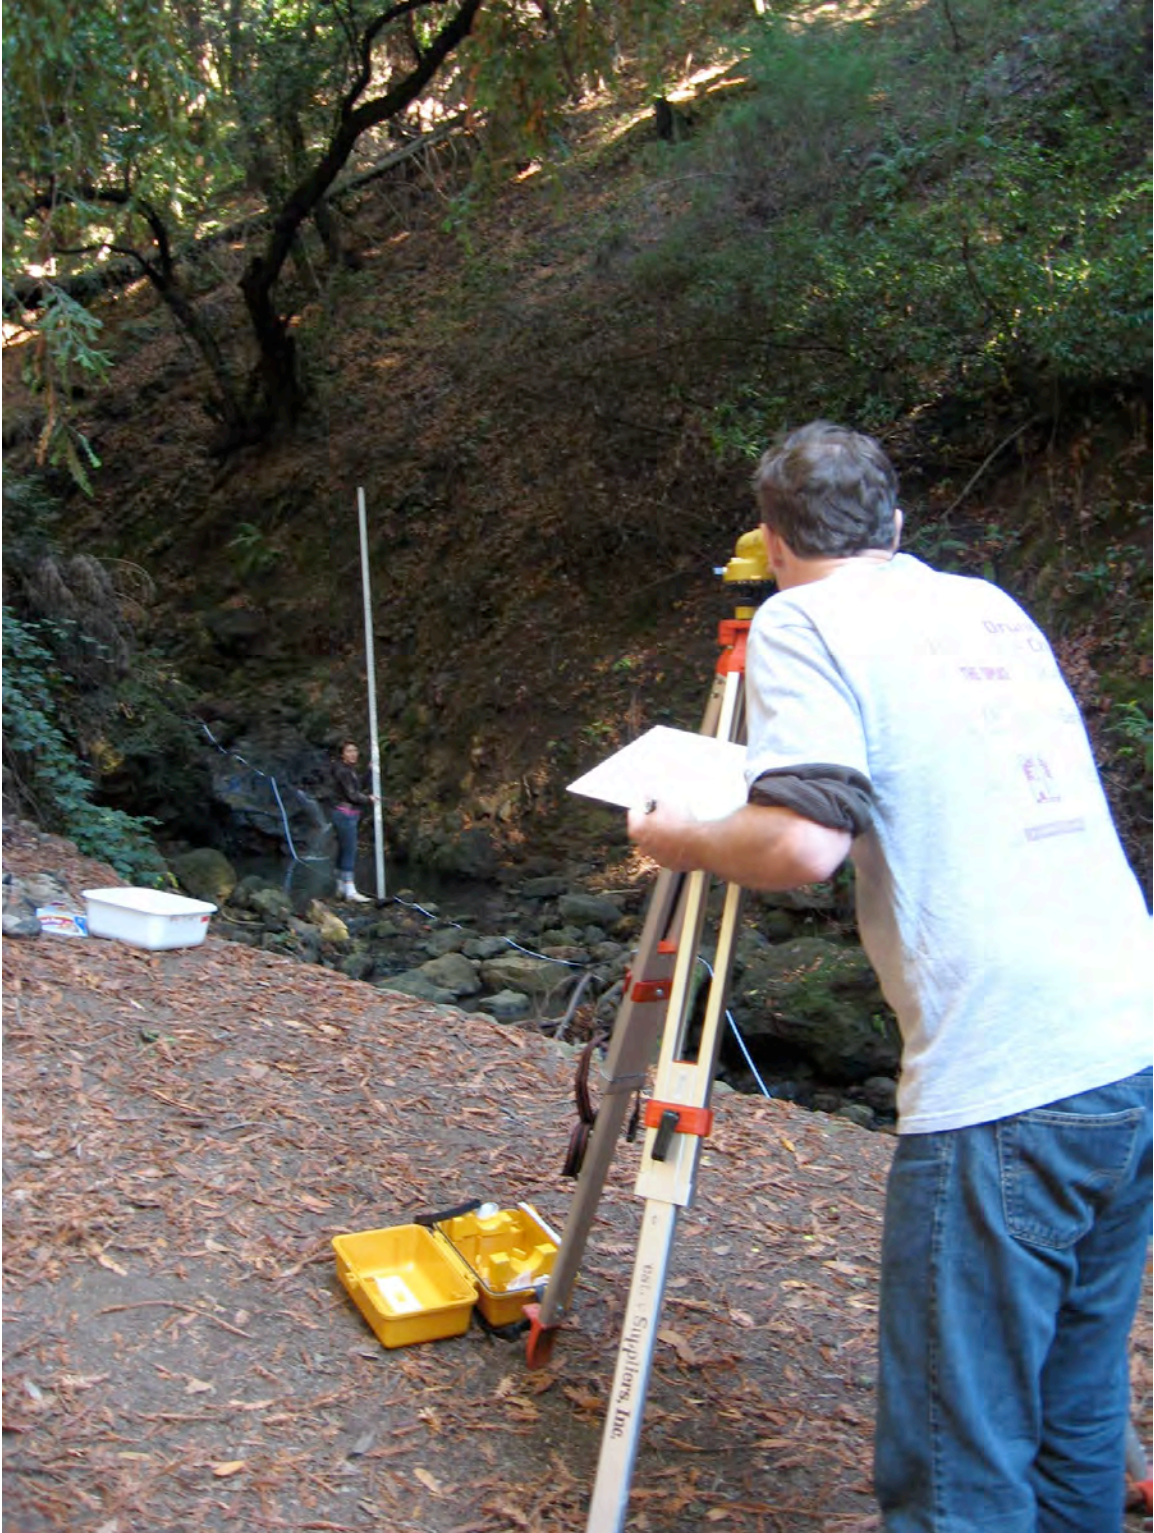
**Figure 15: Survey at Cross Section 2**

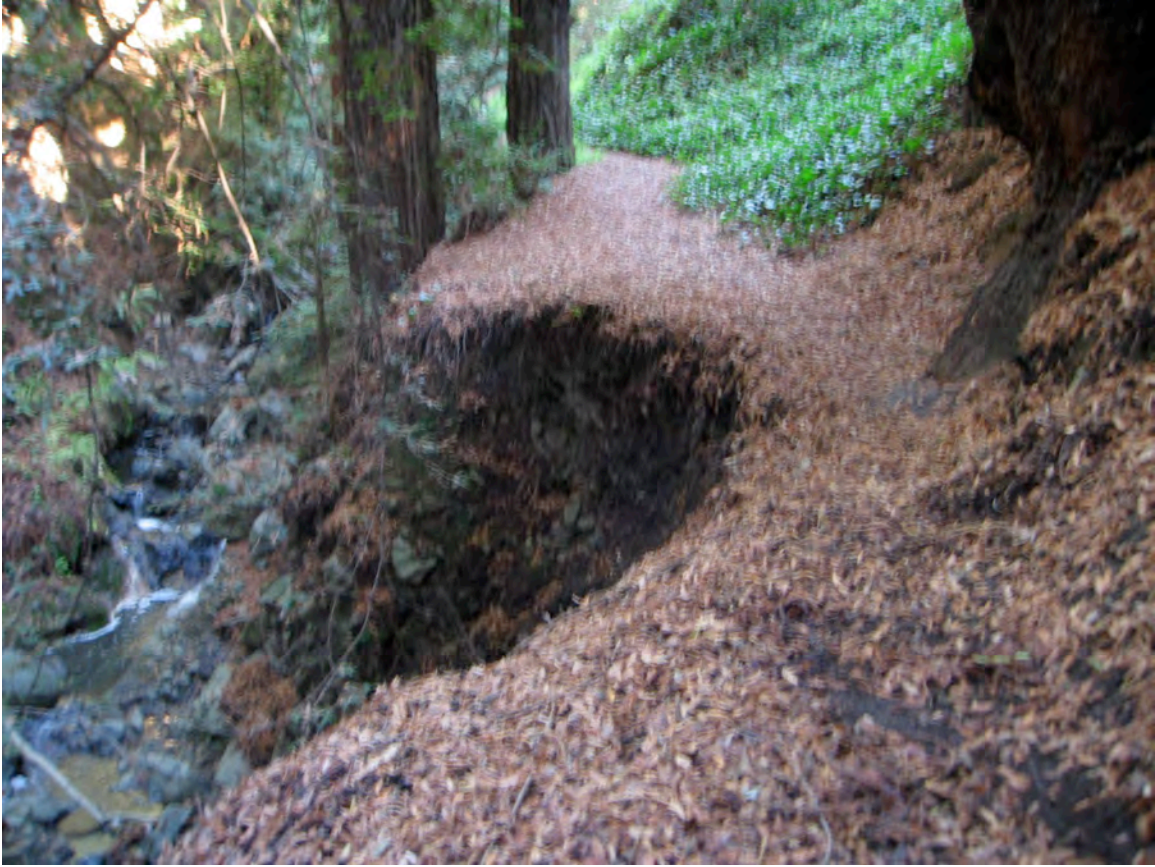
**Figure 16: Bank Erosion and Trail Failure**

3. Public Access: The near-vertical slopes of Horseshoe Creek are not stable in the long term. Most trails are located on the tops of actively eroding terraces (Figure 16), which creates a considerable public safety risk. Relocation of the impacted trails seems like the most viable option. In some locations along the creek, trails could be moved to a lower terrace on the opposite bank. Trail users we encountered during fieldwork identified trail maintenance as a top priority, and some expressed willingness to participate in maintenance activities.

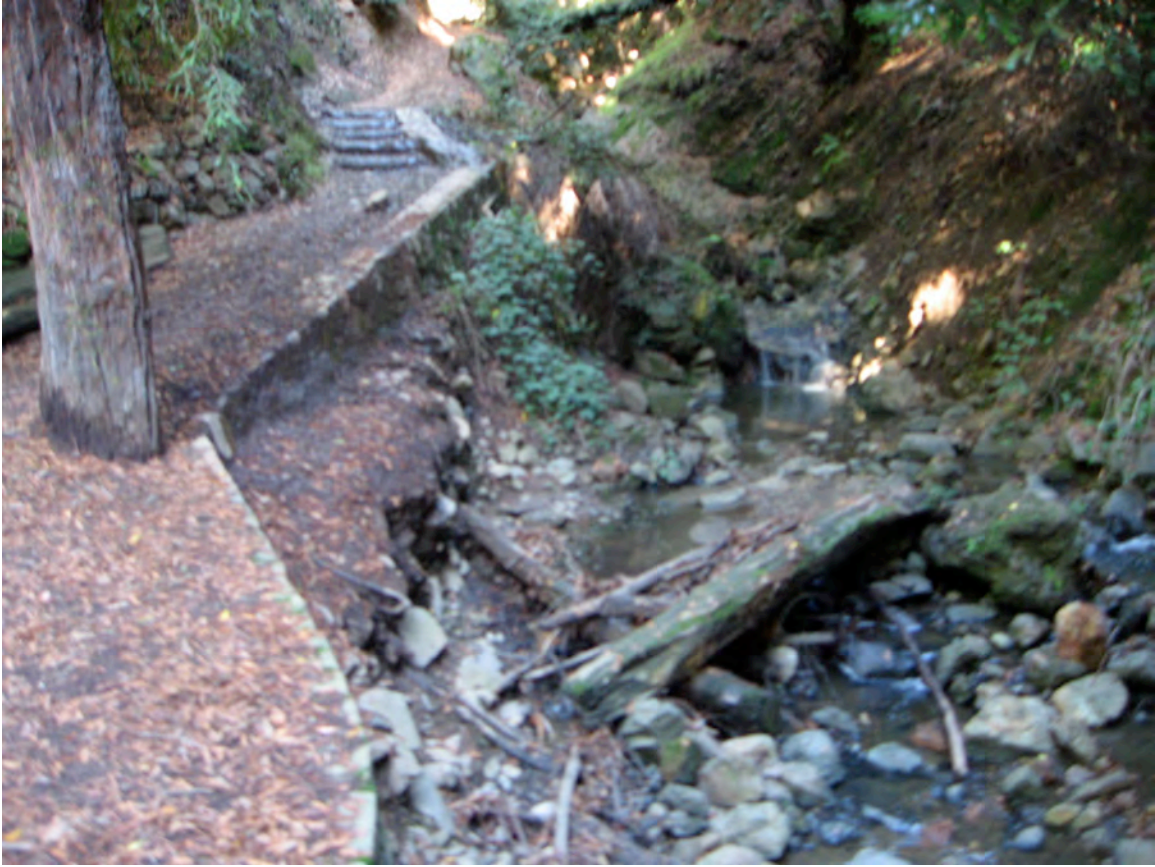
**Figure 17: Upstream View at Lower Profile (Profile 1)**

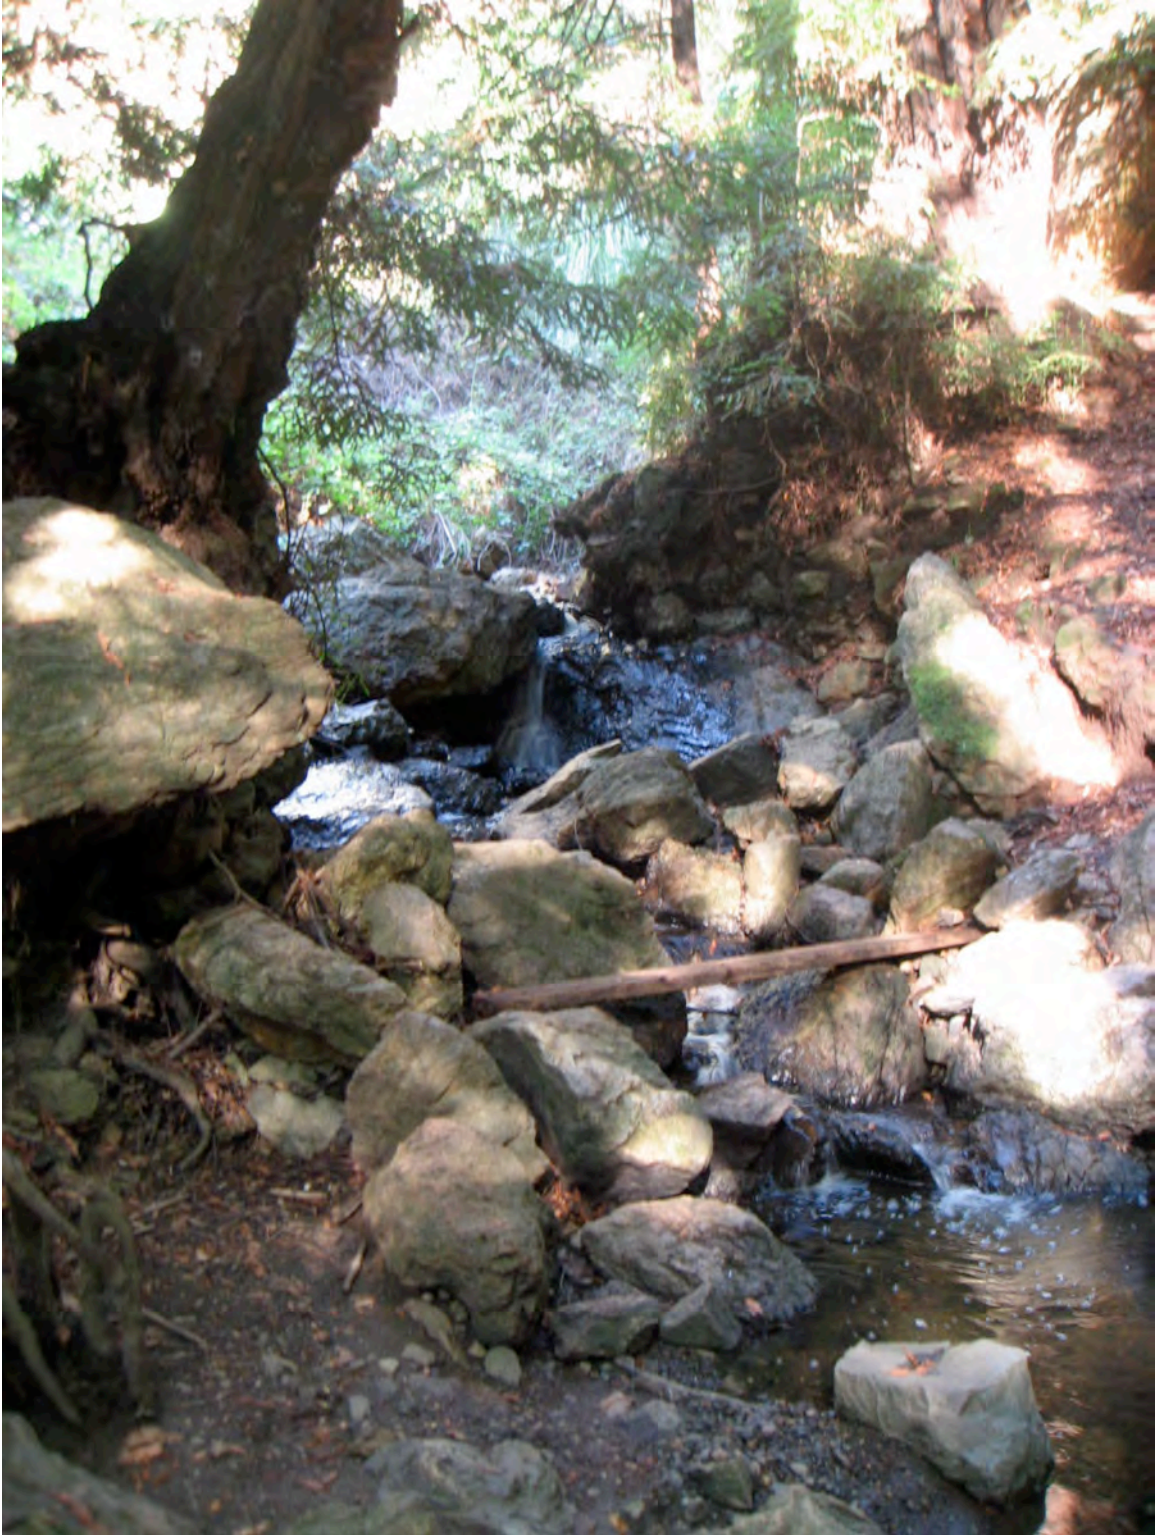
**Figure 18: Upstream View at Upper Profile (Profile 2)**

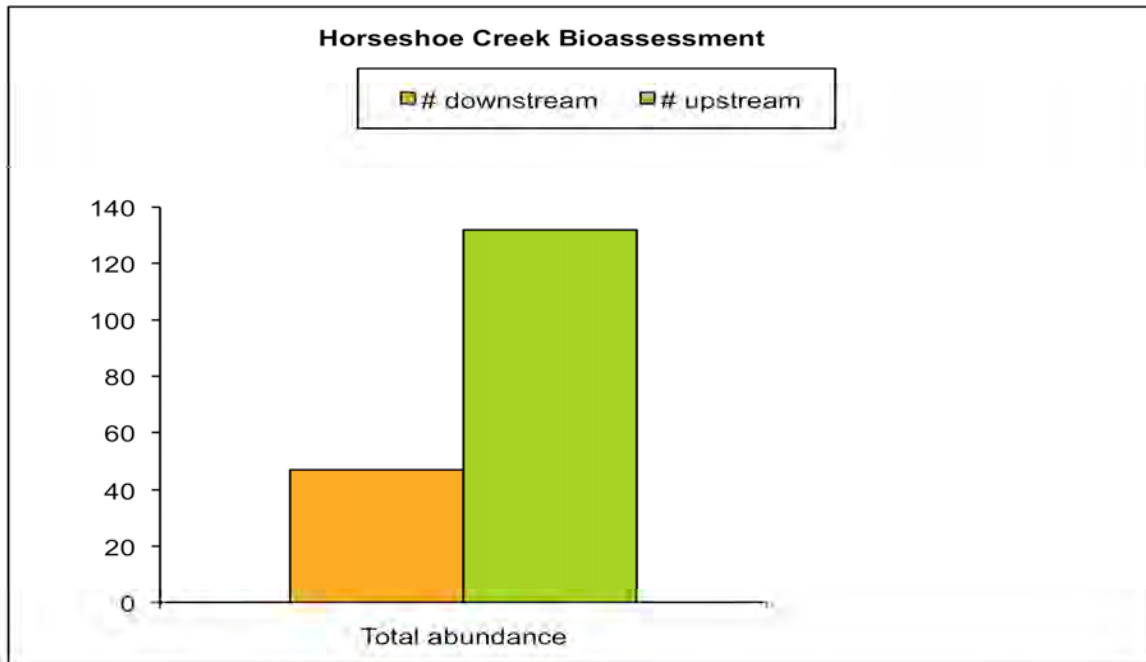
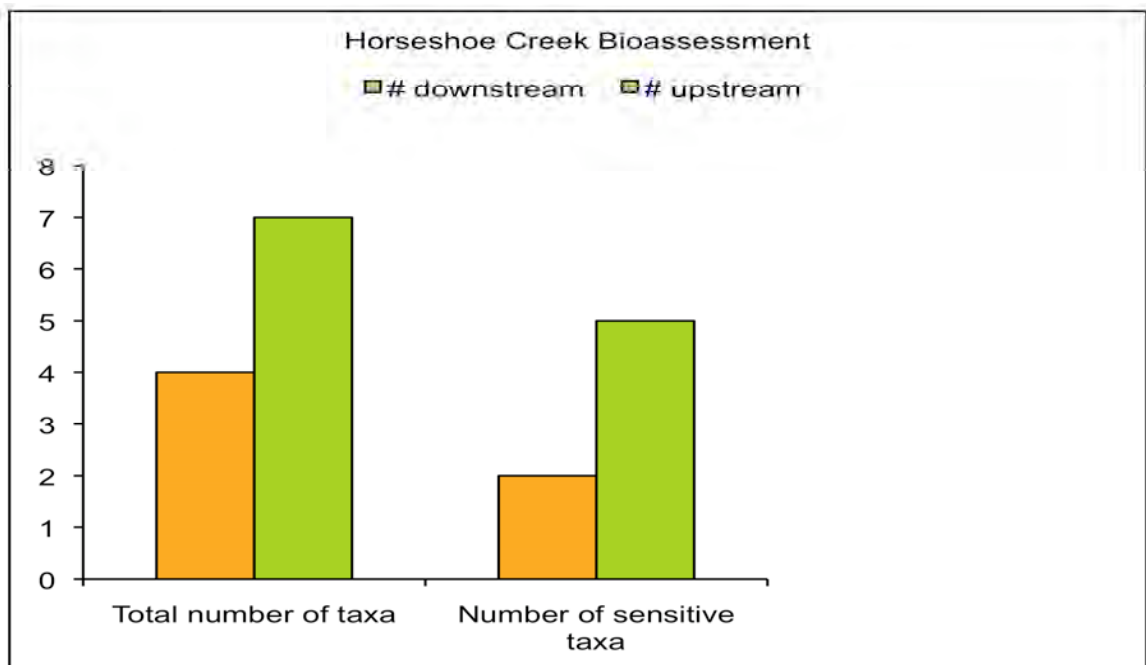
**Figure 19: Bioassessment survey results showing decreased abundance and taxonomic richness below the reach impacted by acid mine drainage.**

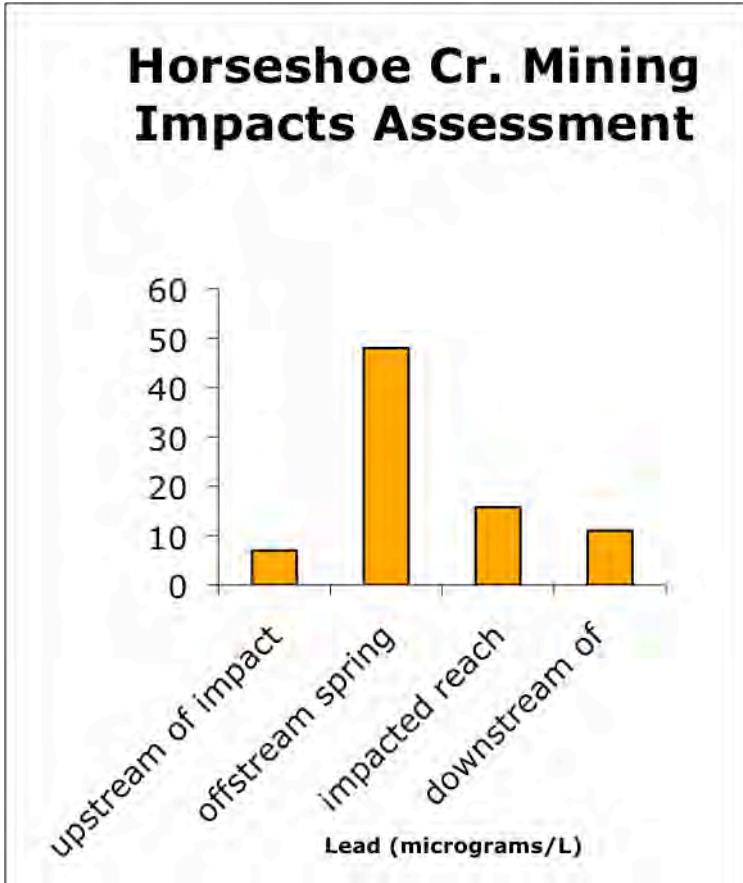
Figure 20: EBAYS lead study results (February and May 2009)

Previous researchers have identified high levels of heavy metals (~50 micrograms/ Liter of lead) in nearby springs, and elevated levels (~10-15 micrograms/L of lead) in our lower study reach (Figure 20), suggesting that contaminants are diluted in the stream, but are present in levels high enough to affect aquatic life (Schmidt et al.,
