Development, Durability Studies and Application of High Performance Green Hybrid Fiber-Reinforced Concrete (HP-G-HyFRC) for Sustainable Infrastructure and Energy Efficient Buildings

Hay, Rotana

Doctor of Philosophy

Spring 2015

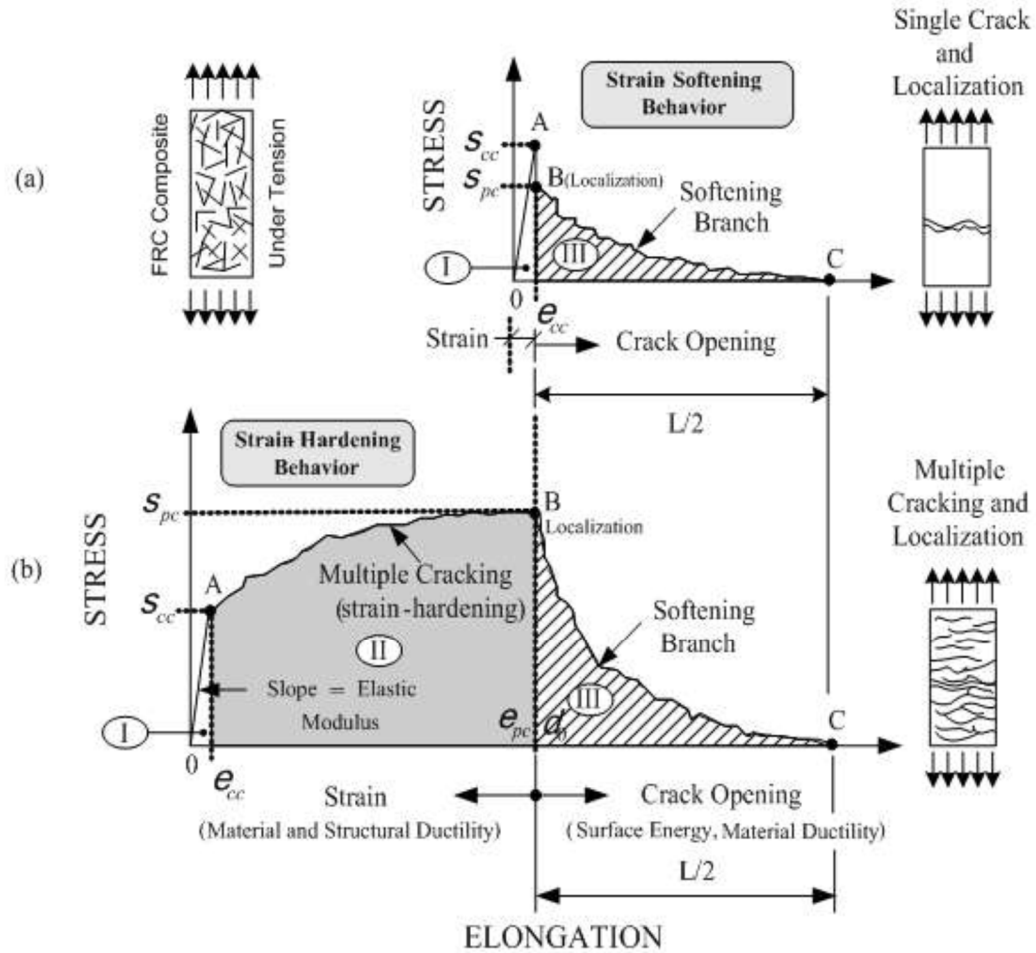
**Figure 1.2: Typical stress-strain response of FRC in tension: (a) strain-softening behavior, (b) strain-hardening behavior (Naaman, 2007)**

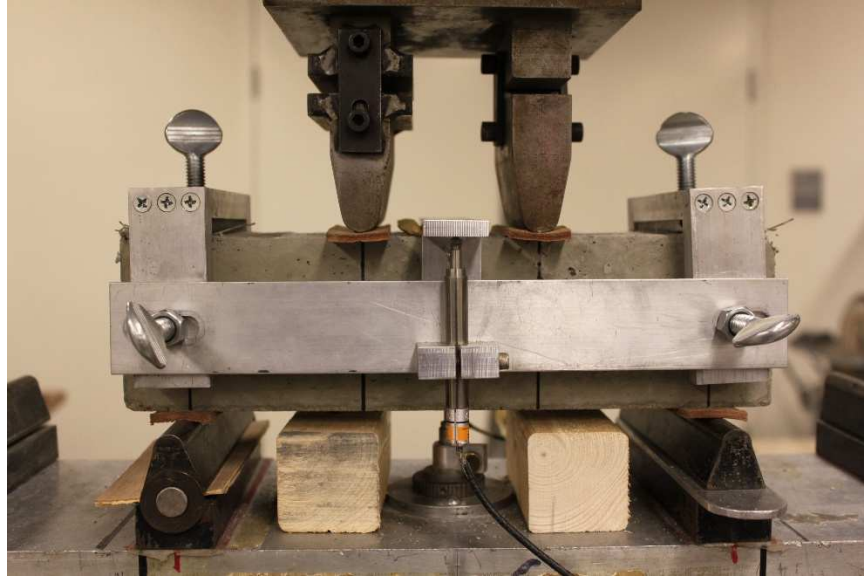
**Figure 2.2: Flexural test setup**

ASTM C469 (American Society for Testing and Materials (ASTM), 2010a) was followed to find the elastic modulus of the cylindrical samples. The samples were capped with capping compound to ensure levelness of the top and bottom surfaces before testing. They were then loaded and unloaded twice up to 40% of their expected ultimate strength before loaded to failure during the third loading. The modulus of elasticity is the average of the slope values of the linear portions from the last two load-deformation curves. Four point loading method of simple beams following ASTM C1609 (American Society for Testing and Materials (ASTM), 2010b) was used to find flexural characteristics of the beam specimens. The flexural test apparatus consisted of a four-point bending jig with pin and roller-type supports at 225 mm spacing. The test setup is depicted in **Fig. 2.2**. The maximum stress experienced by the beam was calculated based on the following relationship

$$\sigma = PL / bd^2 \quad (2.1)$$

where  $\sigma$  is stress,  $P$  is applied load,  $L$  is span length,  $b$  is average specimen width, and  $d$  is average specimen height.

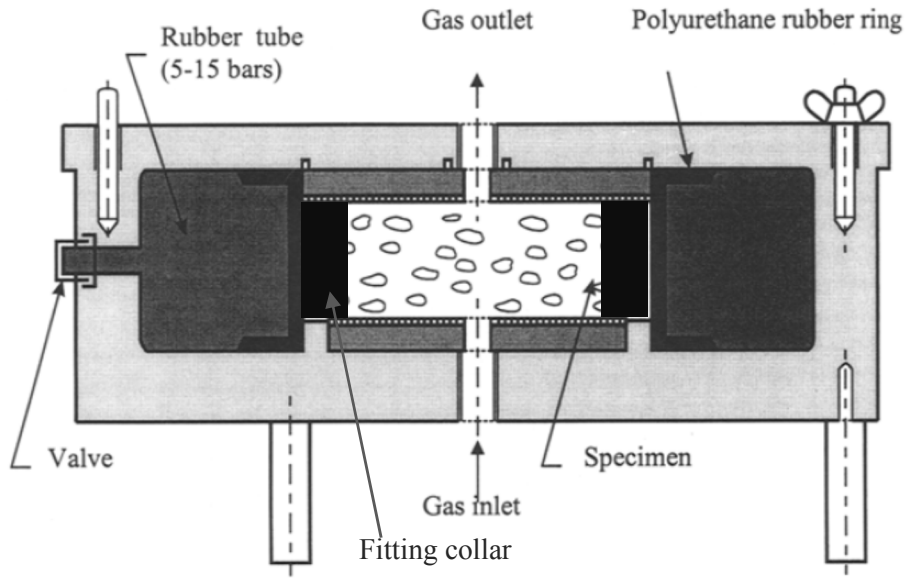
**Figure 2.3: Permeator cell (Rilem, 1999)**

Gas permeability test was conducted based on recommendations by Kollek (1989). Nitrogen gas with dynamic viscosity of  $1.75 \times 10^{-5}$  N-s/m<sup>2</sup> was used as the permeating medium. As the permeator cell was built for 200 mm diameter samples, polyurethane rubber collar was used as a fitting between the sample and a rubber tube which was pressured to 0.82 MPa. The diagram of the permeator cell with the fitting collar is shown in **Fig. 2.3** and the setup of the gas permeability test is elaborated in **Fig. 2.4**. Three absolute pressure stages of 0.15 MPa, 0.2 MPa and 0.3 MPa were applied. The gas flow volumes were adjusted such that the flow times were greater than 20 seconds. The flow times at each pressure level were recorded and were assumed to be at steady state when two successive readings at least 3 minutes apart were different by less than 3%. The coefficient of gas permeability  $K$  (m<sup>2</sup>) at each pressure level was calculated based on **Eq. 2.2** (Kollek, 1989; Rilem, 1999). The overall coefficient was taken as the mean of the values at the three pressure levels.

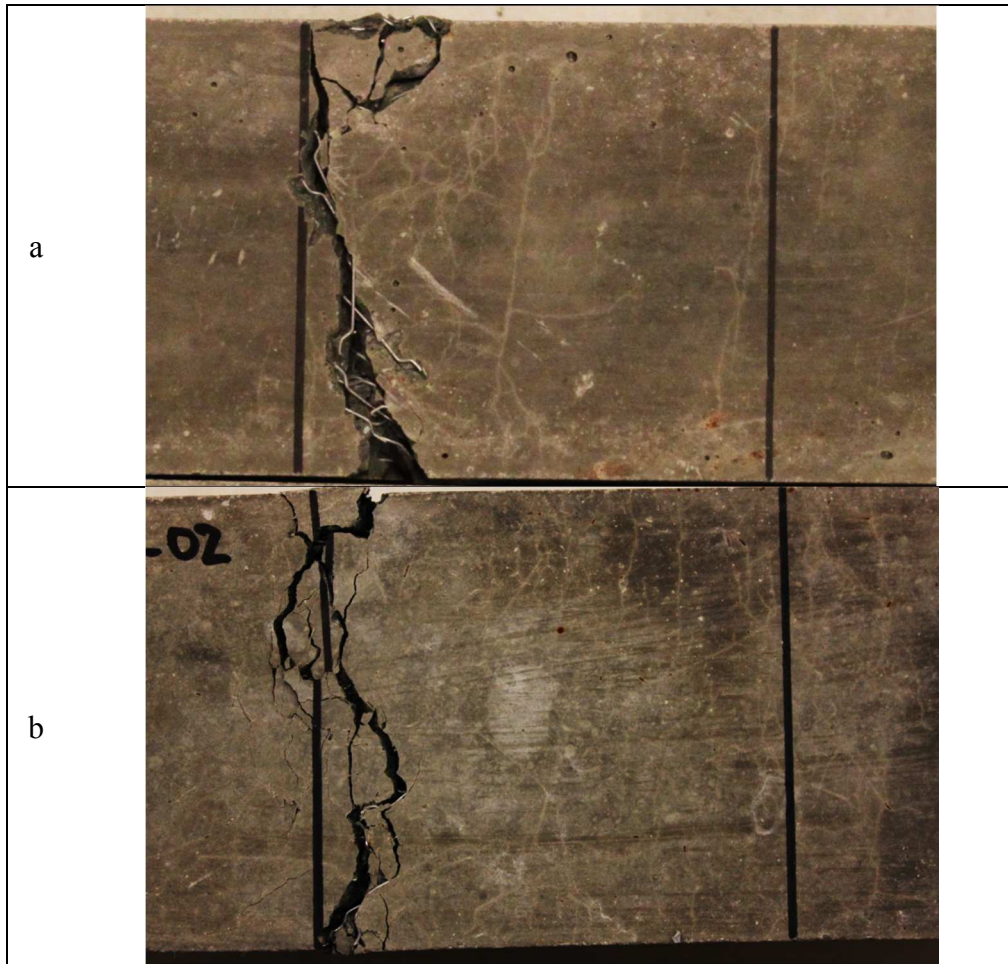
**Figure 2.19: Crack distribution developed on the tensile face of flexure specimen for: (a) PF-0b, and (b) HP-G-HyFRC**

deflection hardening observed in the final mix for HP-G-HyFRC coincides with the formation of multiple microcracks as argued. The beneficial effect of PVA fibers in crack distribution is also observed in **Fig. 2.19**. PF-0b with 1.5% steel fibers but without PVA fibers showed only a few bands of microcracks on its tensile face. This confirms the benefits of PVA fibers in controlling crack propagation and inducing distributed microcracks.

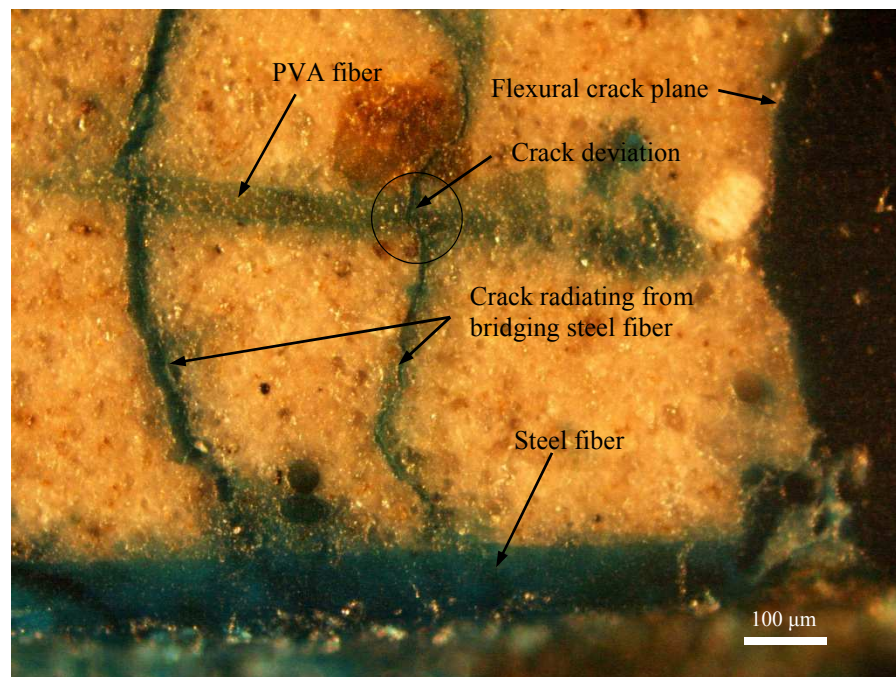
**Figure 2.20: Interaction of macro and microfibers close to crack plane**

visualization of cracks. It is apparent that the cracks radiating from the steel fiber were bridged by PVA microfibers. This is inferred from the deviation of the crack propagation direction. The occurrence of this kind of crack is expected to be more prevalent in flexural samples as compared to compact tension specimens where only a single fiber is subjected to pull-out. This is because as there are more fibers bridging cracks in the flexural specimens, more prominent tensile stress field and cracking would be formed.

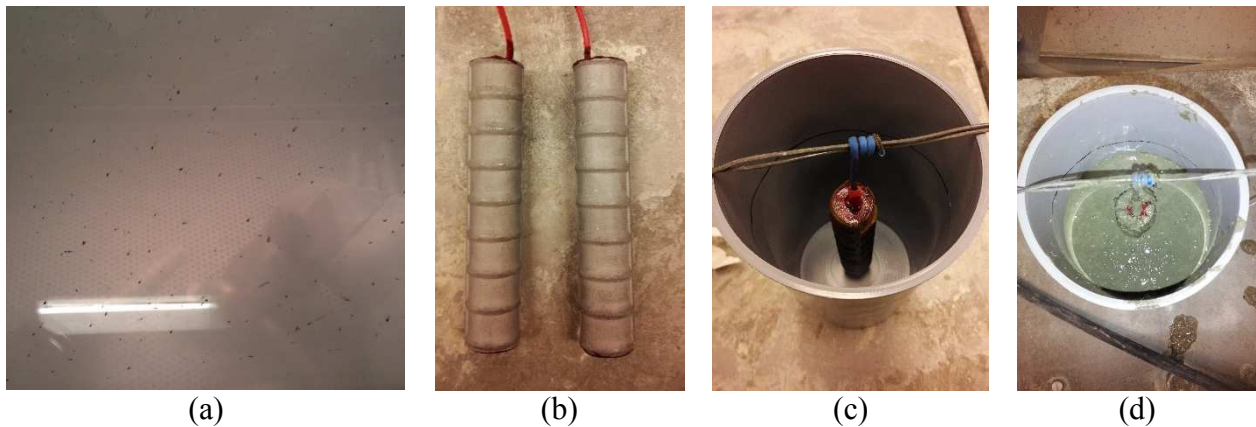
**Figure 3.3: Bar preparation for accelerated corrosion test: (a) sandblasting, (b) bars ready for casting, (c) bar hung by cross rod, and (d) first lift of concrete**

Cylinders of size 100 x 200 mm embedded with 137.5 mm long #8 or 25 mm-diameter bars in the center were procured for the accelerated corrosion test. The bars were cut to the desired length and their surfaces were sandblasted to remove the mill scale. The top end of the bar was tapped to accommodate a 6-32 x 3/8 screw for wiring. To confine the corrosion area to the cylindrical surface of the bar, their end surfaces were coated by electrical protective coating in two layers which were allowed to cure for 24 hours before the casting. The protective coating effectively prevented these portions of the bar from corroding and was confirmed after the accelerated corrosion test. During casting, the wired rebars were hung at 31.25 mm from a temporary cross steel rod which were placed on top of plastic cylindrical molds. Concrete placement was made in two equal lifts. For each lift, the sides of the cylindrical molds were lightly agitated by rubberized hammer to consolidate the fresh concrete. The steps for bar preparation and casting are depicted in **Fig. 3.3**. The specimens were cast and moist cured for at least 28 days. Accelerated corrosion tests were implemented when the samples were at least 28 days old. Six additional cylinders cured under the same regime were also produced to find compressive strengths of each mix design at 28 and 56 days.

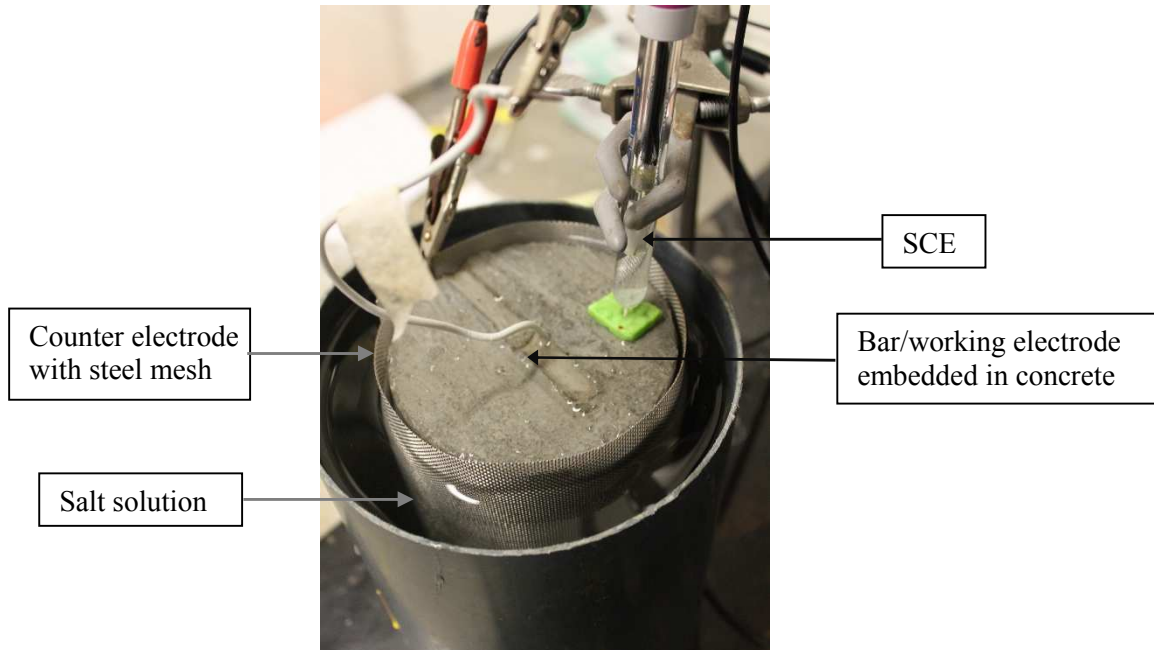
**Figure 3.4: Accelerated corrosion test setup**

immersion solution were equivalent to the concentration used in the mixing water. After immersing the samples in the NaCl solution for 24 hours, the accelerated corrosion tests were initiated. A continuous current of 111.5 mA ( $1 \text{ mA/cm}^2$ ) was applied for either 24 or 48 hours on the accelerated corrosion samples at room temperature. Afterward, the samples were allowed to come to a steady state in their respective NaCl solutions. Following the applied current regimes, the electrochemical tests including linear polarization resistance and Tafel tests were then performed at 1, 3, 7 and 14 days. For non-accelerated samples, electrochemical measurements were made up to 98 days after immersion into NaCl. Linear polarization resistance measurements were conducted by sweeping potential  $\pm 10 \text{ mV}$  from the corrosion potential at a rate of  $0.1 \text{ mV/s}$ . For Tafel scan measurements, a potential sweep of  $\pm 75 \text{ mV}$  was conducted on samples undergoing the same exposure condition. A corresponding set of samples without any applied current was also procured and electrochemical behavior was monitored up to 98 days. It is noted that during the application of current, the counter electrode was used as reference. That is the reference electrode sensor was connected to the counter electrode and no SCE reference electrode was used.

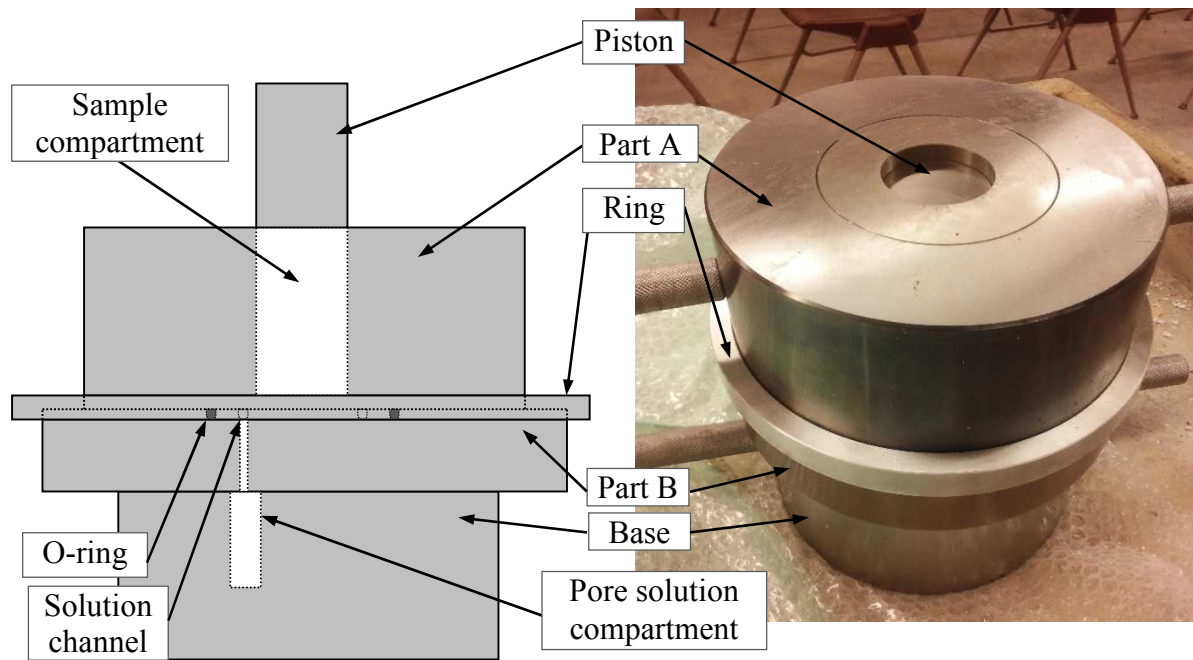
**Figure 3.5: Pore press configuration**

Barneyback & Diamond (Barneyback Jr & Diamond, 1981). The pore press consists of 5 main parts: Piston, Part A, Positioning Ring, Part B and Base as shown in **Fig. 3.5**. Part A contains a 57 mm-diameter sample compartment. In test setup, Part A is placed onto Part B with the aluminum positioning ring to hold them in place. Part B consists of two channels, one to direct the extracted pore solution through a hole into the pore solution collection compartment of the base, the other is to accommodate a greased O-ring so that the extracted solution will be contained. A vial is to be placed in the collection compartment of the base so that the dripping pore solution can be captured. In extraction preparation, the surface of Part B where the sample would be resting, the wall of the sample compartment of Part A and the wall of the piston were lubricated with dry Teflon-based lubricant spray. Cement paste was crushed with a hammer in a heavy duty plastic bag to particles less than 10 mm in size. About 250 g of the crushed sample was placed into the sample cavity in three layers, each layer compacted lightly with a pestle. A Teflon disc 57 mm in diameter and 5 mm in thickness was leveled on top of the compacted sample before the piston was placed on top of it. Pressure was then applied in two steps. A load of about 25 kN was first applied and released to level the plunger and the bearing plate. After ensuring that the piston turned freely inside the cavity, the load was reapplied at a rate of 150 kN/min until it reached 1200 kN and was held at that level for 2 minutes. The load was then slowly released and the pore solution vial was removed. Part A, now with the pressed sample and the piston, was placed on two equal-sized wooden blocks and a small load was applied to remove the pressed sample. After the internal surfaces and channels of the pore press were cleaned with sand paper and ethyl/isopropyl alcohol, the process was repeated for other samples.

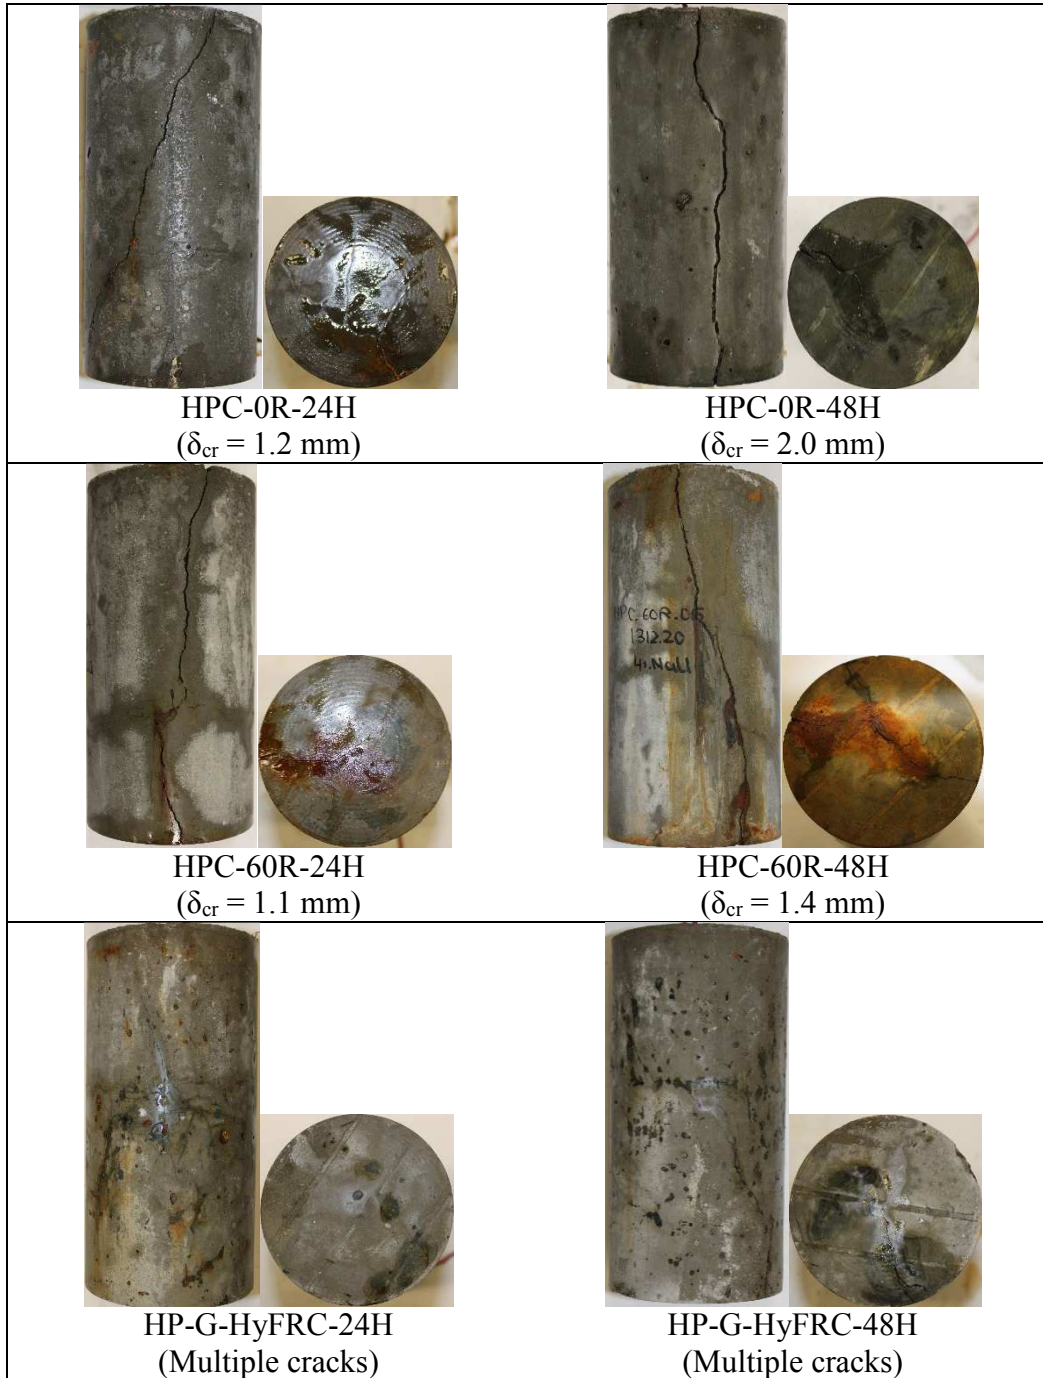
**Figure 3.12: Cracking on surfaces of samples with different regimes of applied current, with  $\delta_{cr}$  representing maximum observed crack width**

behavior of the composite led to the observed crack distribution under expansive pressure caused by corrosion products accumulated at steel concrete interface.

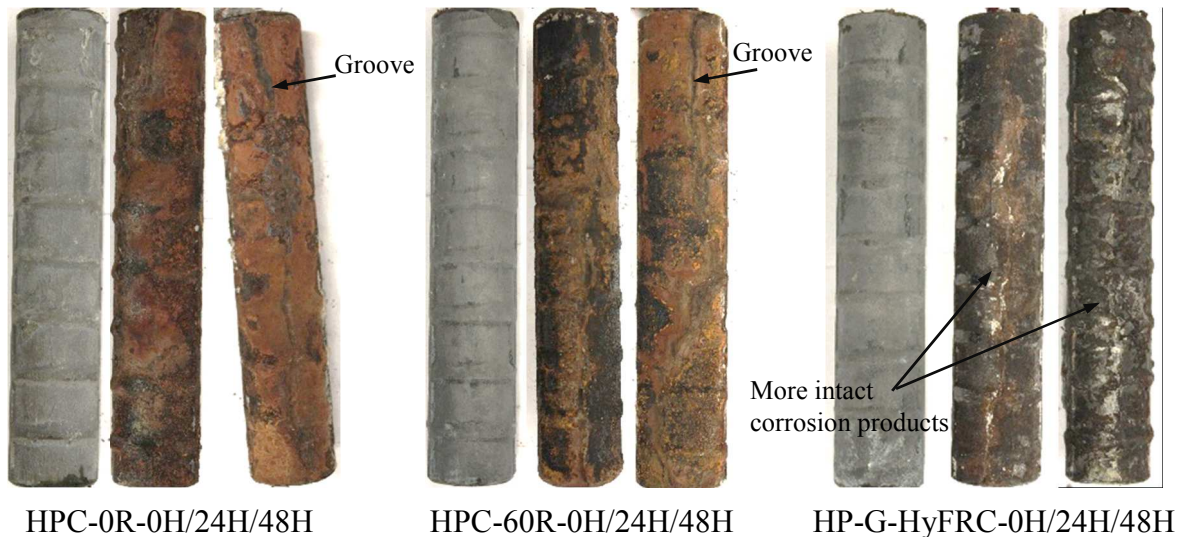
**Figure 3.15: Bar surfaces showing no corrosion for samples with no applied current and uniform corrosion for samples with 24 and 48 hours of applied current**

that for concrete with corrosion-induced crack, post-cracking corrosion may be concentrated to areas under the crack mouths and that may be detrimental to structures due to localized rebar diameter loss as compared to a case with more distributed corrosion. Also, due to a lack of confinement and densification, it is observed that the corrosion products on HPC-0R/60R were less intact as compared to those found in HP-G-HyFRC samples. Slightly longer immersion time in the cleaning solution and more brushing were required to clean corrosion products off rebars retrieved from HP-G-HyFRC samples.

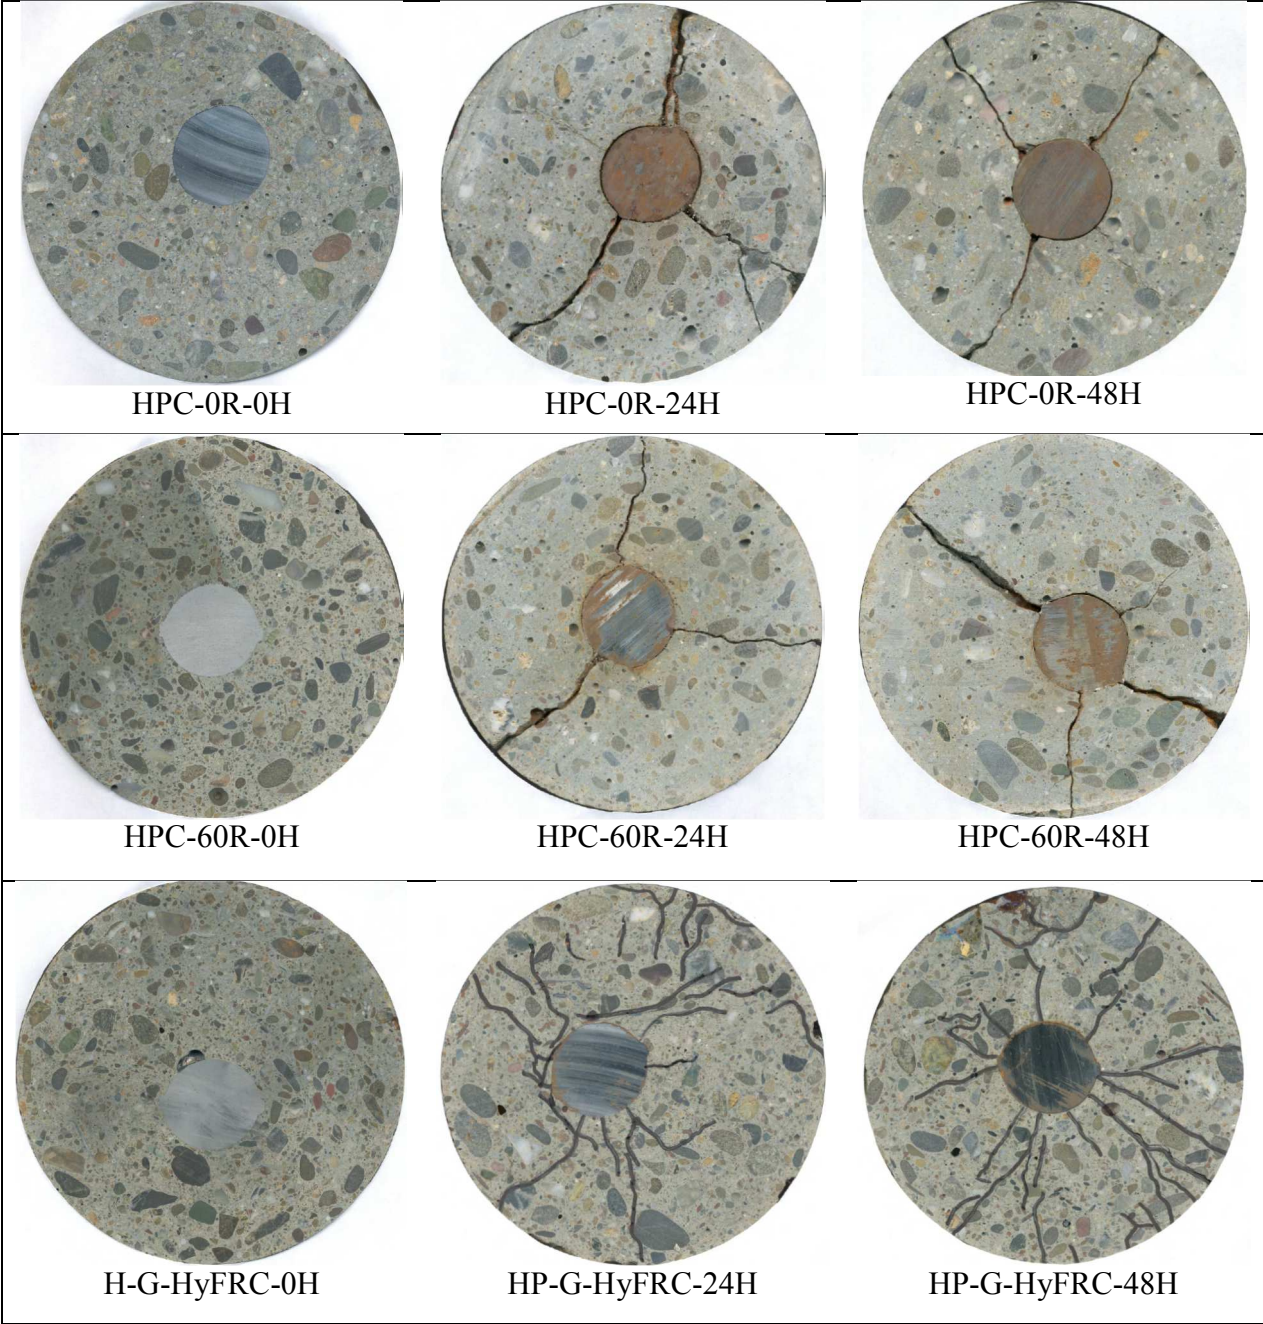
**Figure 3.16: Scanned images of sections for corrosion samples**

The flatbed scanned images of corrosion sample sections are shown in **Fig. 3.16**. Marks for visible cracks were also drawn on the surfaces. With 24 and 48 hours of applied current, as compared to HP-G-HyFRC more extensive cracks occurred for HPC-0R/60R. Single major crack with a few secondary cracks were observed in these set of samples. As the samples disintegrated during the cutting process, the cracks observed in the graphs were not indicative of the real crack widths. On the other hand, cracks in HP-G-HyFRC samples were distributed throughout the surface. As cracks formed, the bridging fibers got stressed. When the crack width grew, the pullout resistance of the bridging fibers also increased as a result of the deflection hardening behavior of the composite. The enhanced resistance to pullout led to new crack formation. The distribution of cracks and subsequent reduced crack opening prevented the egress of corrosion products. The corrosion products would fill up the microcracks and lead to crack plugging and interfacial densification. The limited access of oxygen, moisture and movement of ions in and out of the anodic area led to lower corrosion activity as observed in the corrosion rate results.

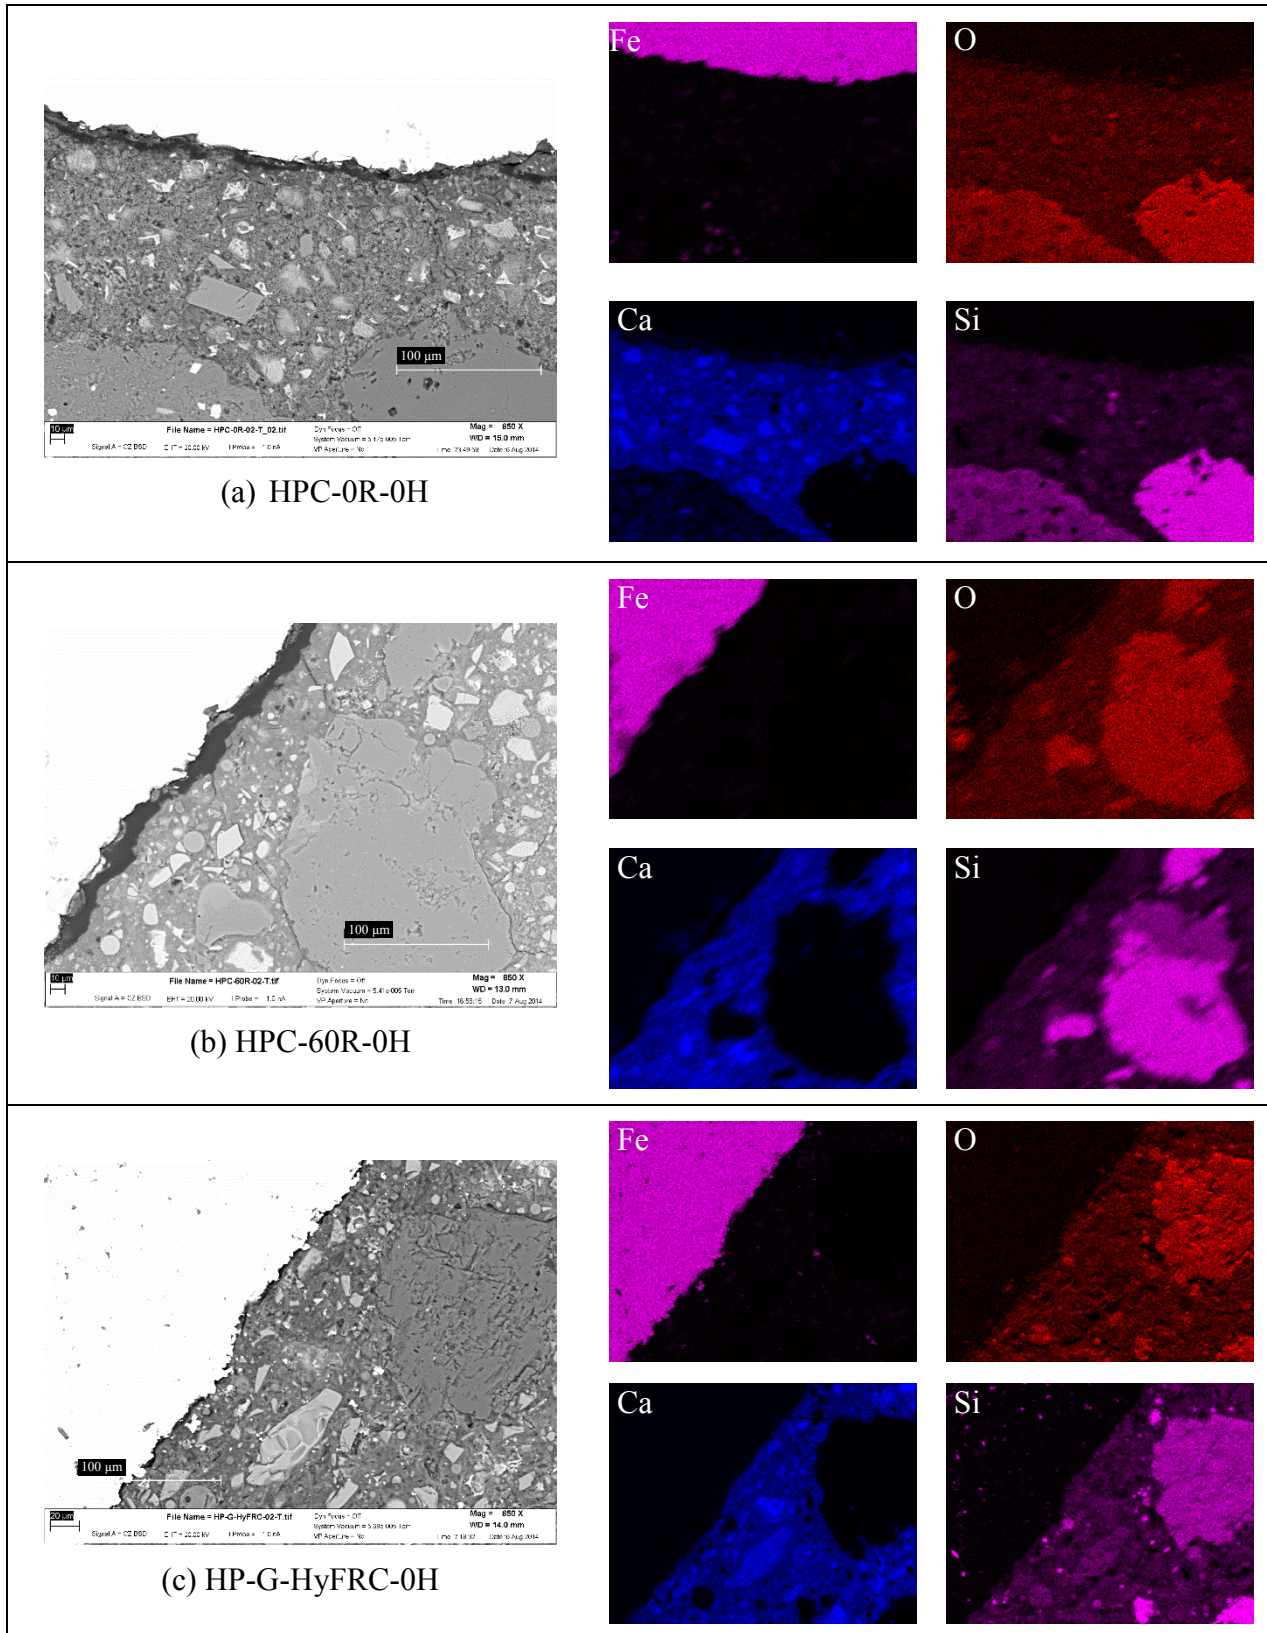
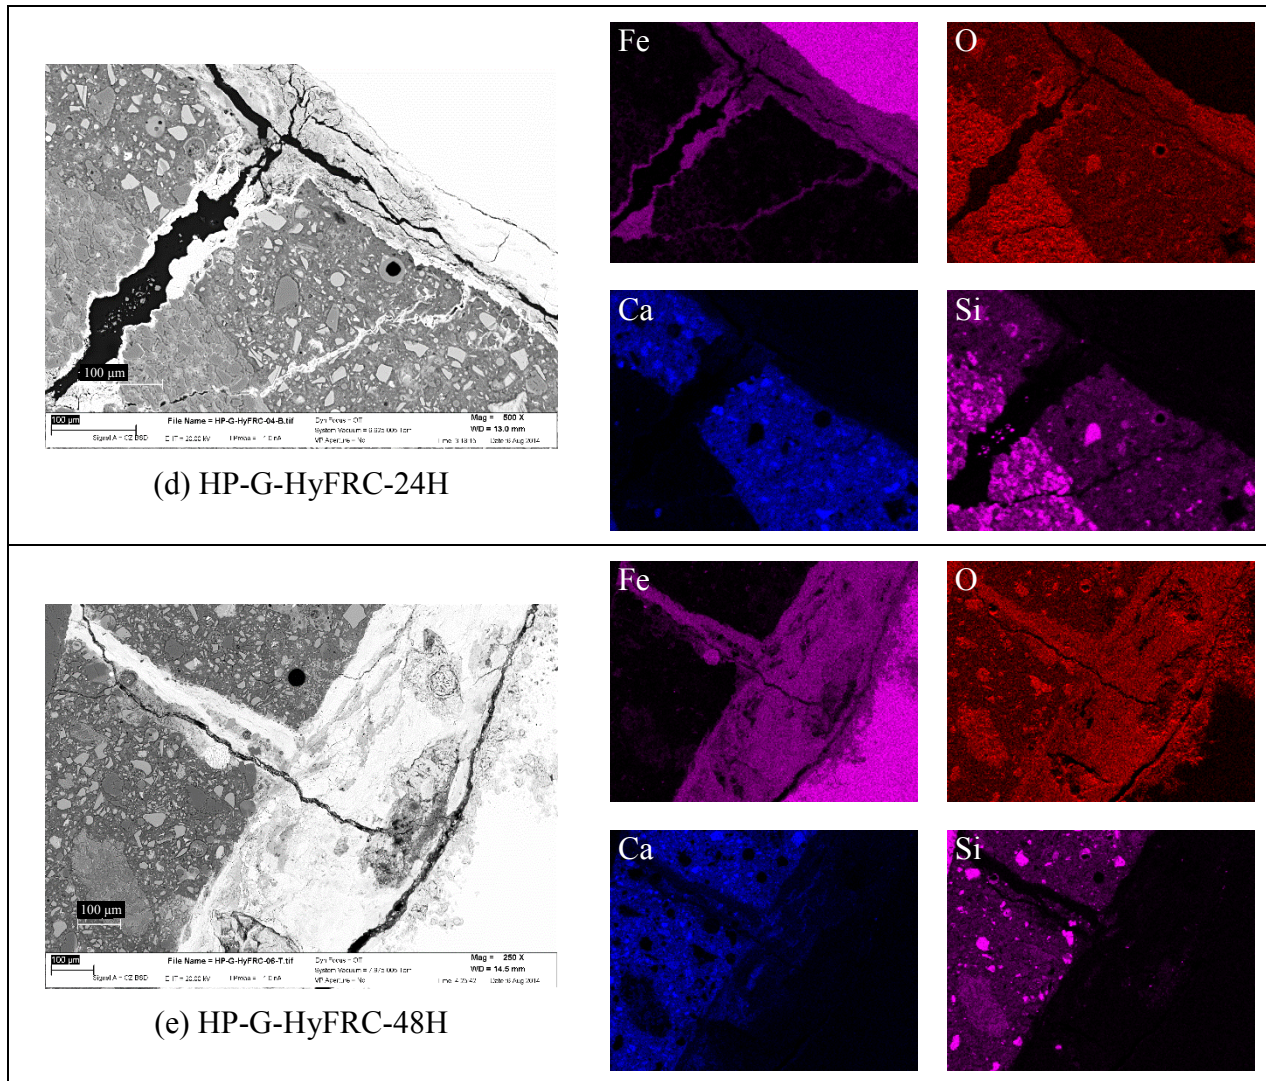
**Figure 3.18: BSE images and corresponding EDX element mapping for: (a) HPC-0R-0H, (b) HPC-60R-0H, (c) HP-G-HyFRC-0H, (d) HP-G-HyFRC-24H and , (e) HP-G-HyFRC-48H**

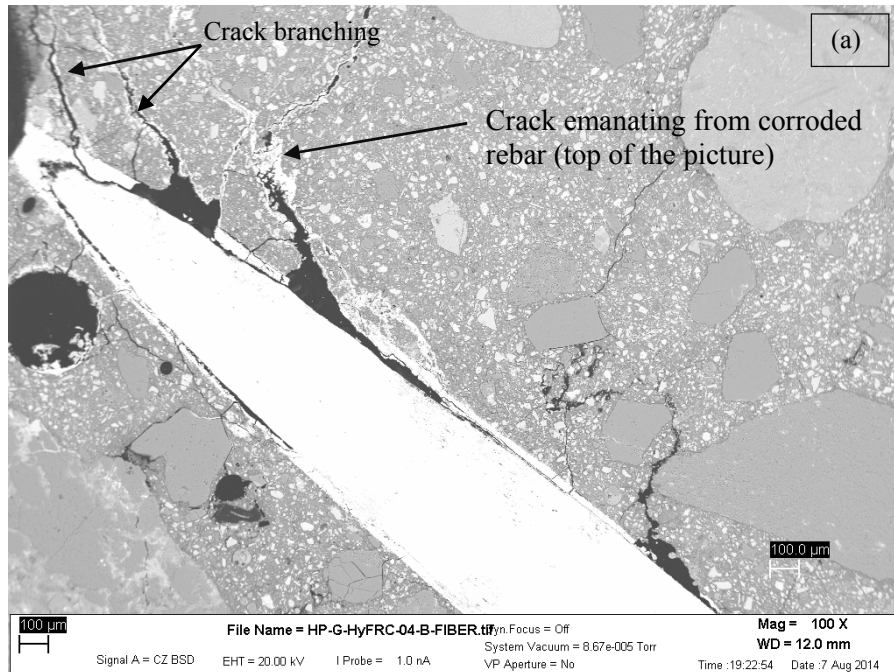
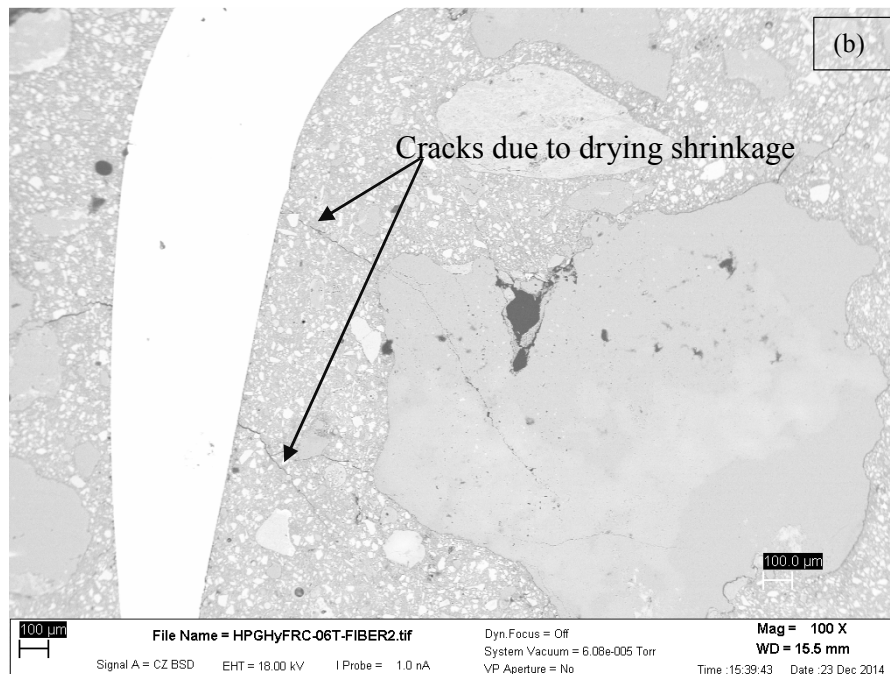
Steel fiber bridging a corrosion-induced crack is shown in **Fig. 3.24 (a)**. For comparison, **Fig. 3.24 (b)** showed a steel fiber which did not bridge any corrosion-induced crack and which did not show any sign of corrosion. Microcracks with no trace of corrosion products emanating from the steel fiber are believed to be caused by drying shrinkage. The arrow in **Fig. 3.24 (a)** points to a crack emanated from the corroded steel rebar. When the crack path met the steel fiber, the crack was deviated and energy was absorbed. The dissipated strain energy was translated into branching of cracks near the tip of the fiber. The stress on the fibers caused debonding of the fibers from concrete and a loose steel fiber-concrete interface was created, leading to a reduced physical protection to the fibers from the concrete against corrosion. As a result, fibers would corrode during both the remaining applied current regime and the NaCl immersion period. The phenomenon is similar to a fiber corrosion under applied current (to be elaborated in **Chapter 5**) and natural corrosion of steel fibers near concrete surface due to fiber exposure to the electrolyte. The latter corrosion is common although the corrosion imposes no adverse effect on the overall durability of structures. Only steel fibers up to a depth of 0.2 mm contributed to spot corrosion observed on concrete surface (Balouch et al., 2010). From the crack branching observation, the beneficial effects of PVA microfibers would be twofold. The pullout process creates microcracks along the steel fiber-concrete interface. Under the presence of PVA fibers and their microcrack arresting capability, the pullout would require more energy and this would enhance the pullout resistance of the steel fibers. This was elaborated in **Chapter 2** of the report. Also, during the corrosion of the disturbed fibers, PVA fibers also help to limit crack-induced corrosion along the steel fibers. This reduced corrosion activity of the steel fibers and maintained the integrity of concrete surrounding the fibers. Hence, the synergistic actions of steel macrofibers and PVA microfibers helped to prolong the structure's life under corrosion.

**Figure 3.24: (a) Steel fiber bridging corrosion-induced crack, and (b) steel fiber not bridging corrosion-induced crack**

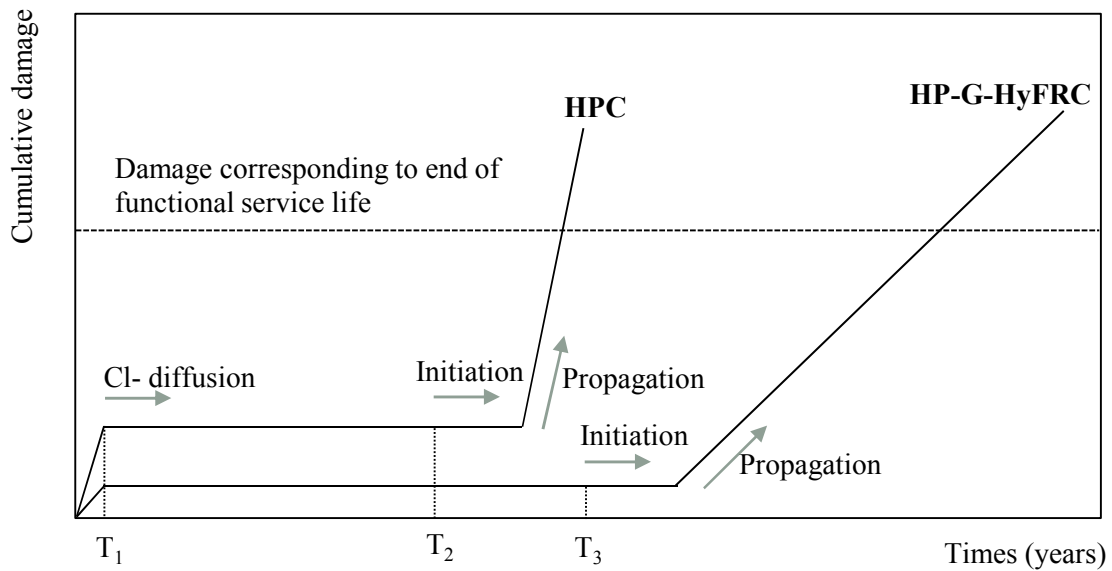
**Figure 3.26: Proposed structural service life models for HPC and HP-G-HyFRC**

into concrete. Times  $T_2$  and  $T_3$  correspond to corrosion initiation in HPC and HP-G-HyFRC, respectively. Due to more initial damage or cracking, it is proposed that corrosion is initiated earlier in HPC. As corrosion products will have to fill up the porous zone at steel concrete interface before exerting pressure and cracking to the surrounding matrix as proposed by Weyers (1998), further damage was delayed for a period of time after corrosion initiation. When corrosion-induced cracking occurs, the hybrid fibers in HP-G-HyFRC bridge and distribute cracks and as a result the level of damage in the composite increases gradually as compared to a more abrupt increase in damage level in HPC. As a result, it is observed that the service life of HP-G-HyFRC structures is much longer than that of HPC with no fiber reinforcement.

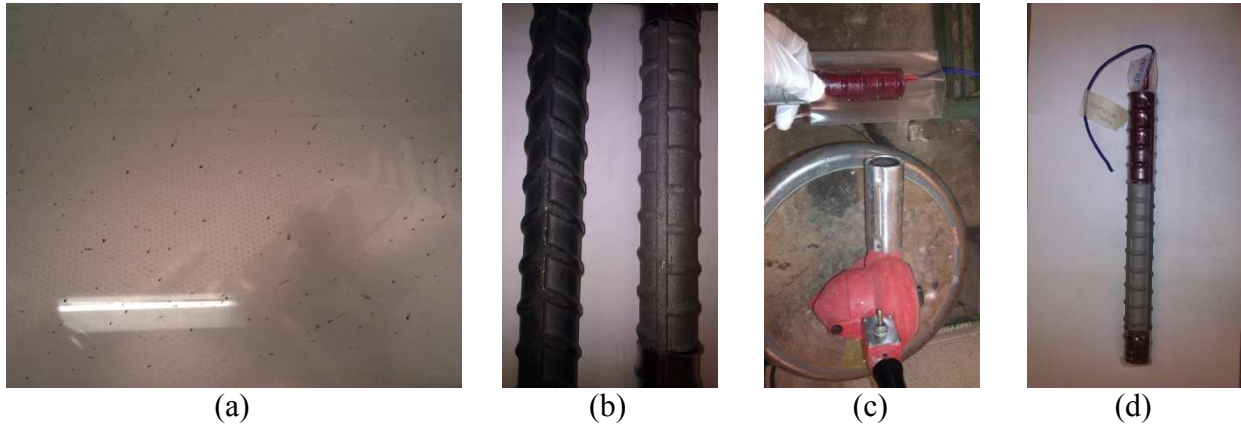
**Figure 4.3: Bar preparation for accelerated corrosion test: (a) sandblasting, (b) bars before and after sand blasting with epoxy coating, (c) heat shrink tubing, and (d) bar with heat shrink tube and wiring ready for casting**

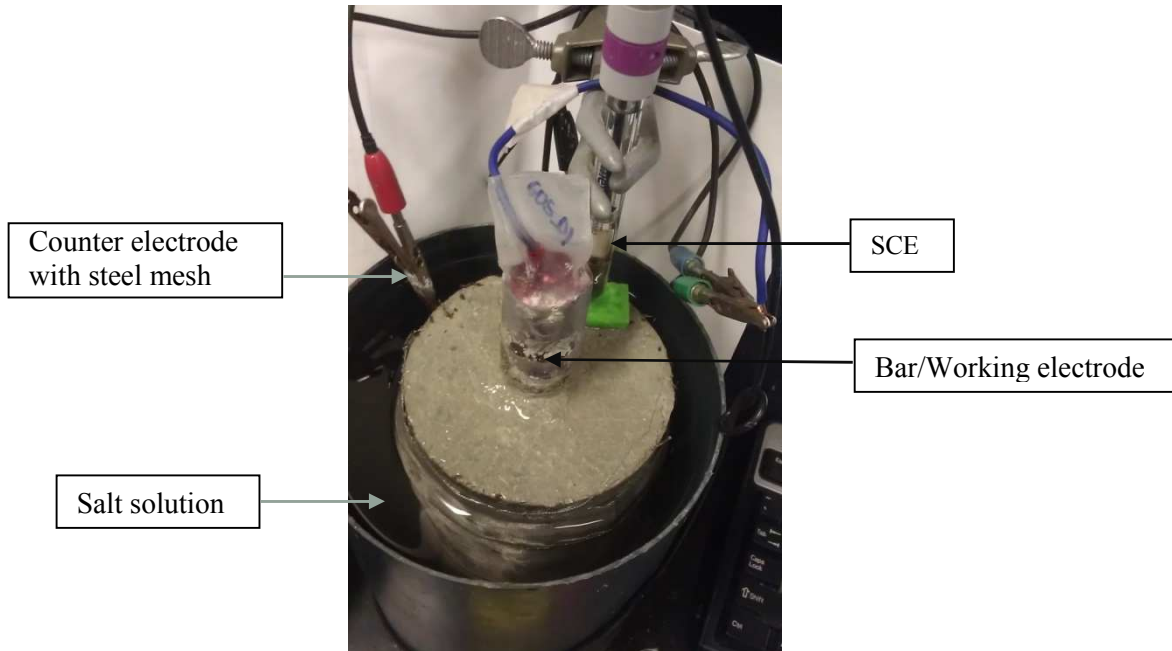
The setup of accelerated corrosion test is shown in **Fig. 4.4**. The test setup is similar to that outlined in **Chapter 3**. However, a number of differences exist. The samples were immersed in a solution with 3.5% NaCl by mass up to a height roughly 12.5 mm from the top surface of the concrete cylinder. After immersing the samples in the NaCl solution for 24 hours, a continuous current of 111.5 mA ( $1 \text{ mA/cm}^2$ ) was applied for either 24 or 48 hours to the accelerated-corrosion samples, after which they were allowed to stabilize in 3.5% NaCl solution. The 48 hours of  $1 \text{ mA/cm}^2$  applied current regime is equivalent to about 55 years of corrosion in real structures with a low corrosion rates of  $0.1 \mu\text{A/cm}^2$  (Andrade & Alonso, 1996). The electrochemical tests consisting of linear polarization and Tafel tests were performed at 1, 3, 7, 14, 28, 56 and 98 days after NaCl soaking for both non-accelerated and accelerated corrosion samples. Linear polarization resistance measurements were conducted by sweeping a potential  $\pm 10 \text{ mV}$  from the corrosion potential at a rate of  $0.1 \text{ mV/s}$ . For Tafel scan measurements, a potential sweep of  $\pm 75 \text{ mV}$  was implemented on the samples. It is noted that during the application of current, the counter electrode was used as reference. That is the reference electrode sensor was connected to the counter electrode and no SCE reference electrode was used.

**Figure 4.4: Accelerated corrosion test setup**

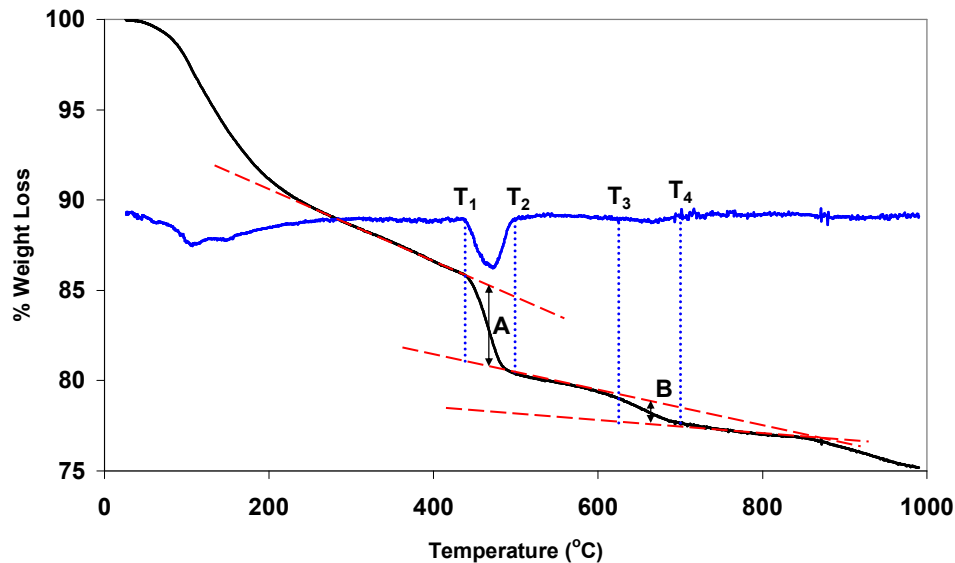
**Figure 4.5: Example illustrating the calculation of A and B in the TG curve (Girao, 2007)**

The thermal analysis was conducted with thermo-gravimetry/differential thermal analyzer EXSTAR6000 TG/DTA series with temperature ranging from 20 to 1000  $^{\circ}\text{C}$  at a scanning rate of 10  $^{\circ}\text{C}/\text{min}$ . Nitrogen gas at a flow rate of 100 ml/min was passed through the system. These conditions produced thermogravimetric (TG) curves of percentage weight loss over time. It was assumed that the total CH was proportional to the weight losses induced by dehydration of water from CH and decarbonation of  $\text{CaCO}_3$  during the heat application. Hence, from the TG curves, the weight of CH was derived from decomposition of both CH and  $\text{CaCO}_3$  using a methodology as outlined by Girao (2007). The mass changes are defined by three governing equations as given below.

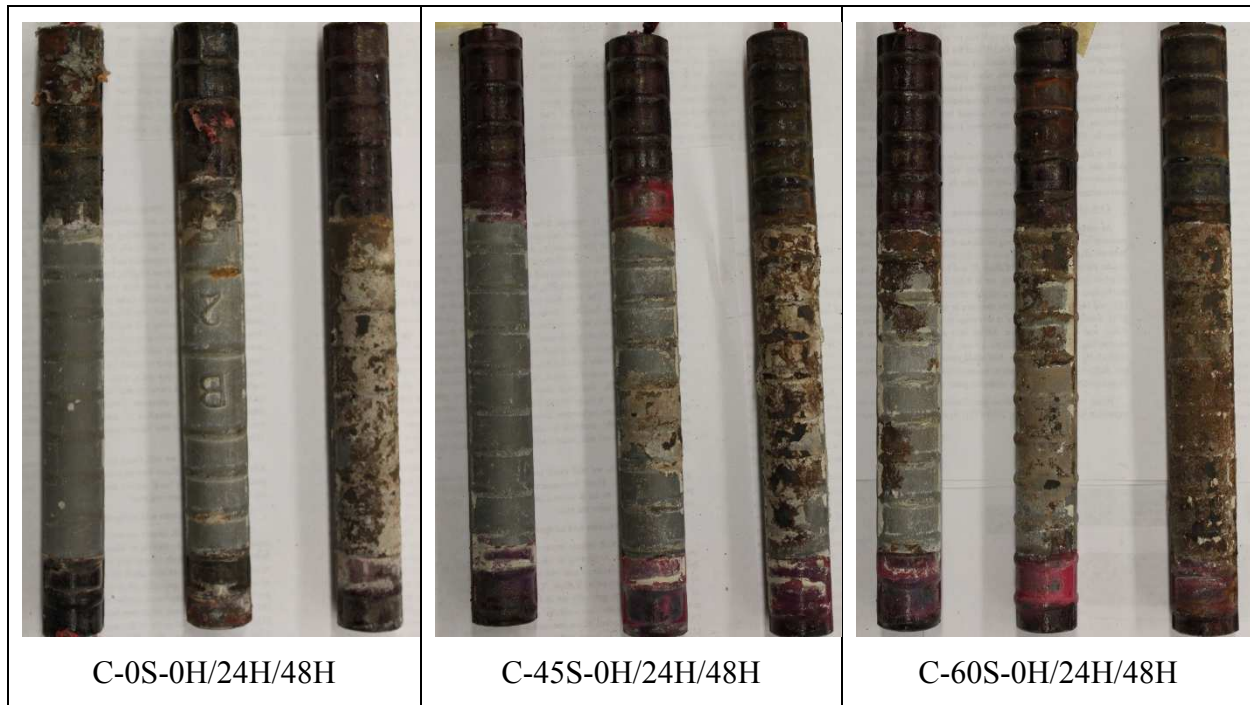
**Figure 4.13: Non-uniformity of corrosion on steel surfaces**

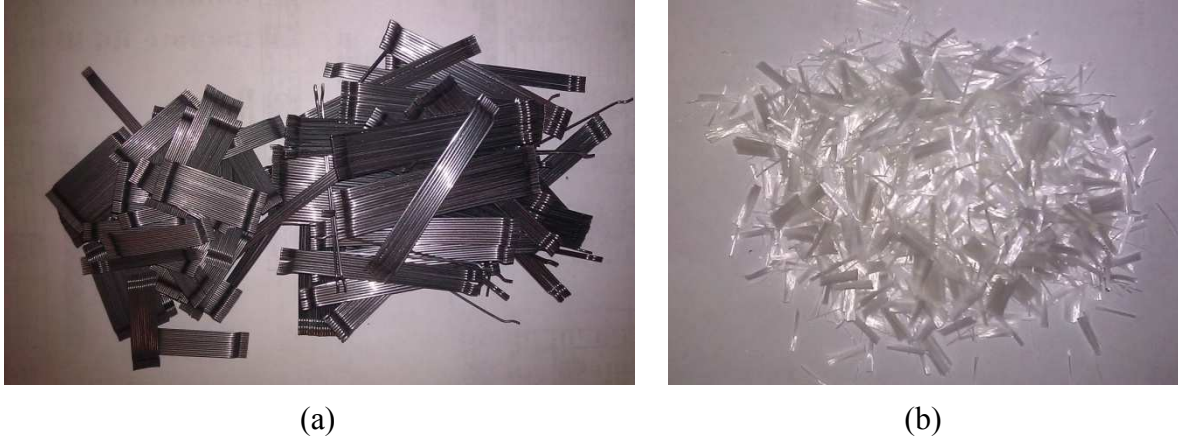
**Figure 5.1: Fibers used in the study: (a) 30 mm and 60 mm hooked-end steel fibers, and (b) PVA microfibers**

3. The hybrid fiber mixture contained a combination of 30 mm and 60 mm steel macrofibers, and 8 mm PVA microfibers (**Fig. 5.1**). The properties of the fibers including those for the 30 mm steel fiber and PVA fibers which were given in **Chapter 2** are summarized again in **Table 5.1**.
