Development, Durability Studies and Application of High Performance Green Hybrid Fiber-Reinforced Concrete (HP-G-HyFRC) for Sustainable Infrastructure and Energy Efficient Buildings

Hay, Rotana

Doctor of Philosophy

Spring 2015

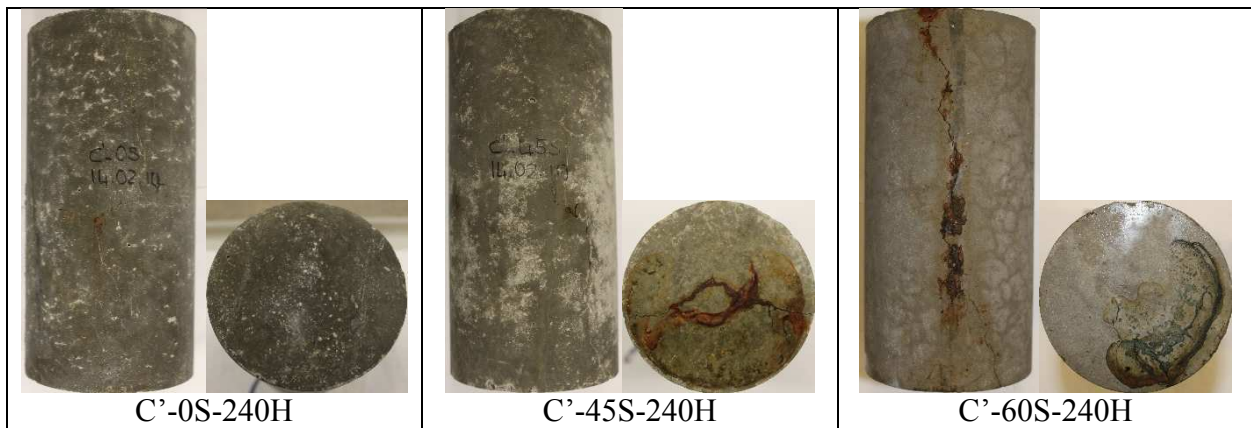
**Figure 5.10: Corrosion-induced cracks for plain concrete with slow applied current**

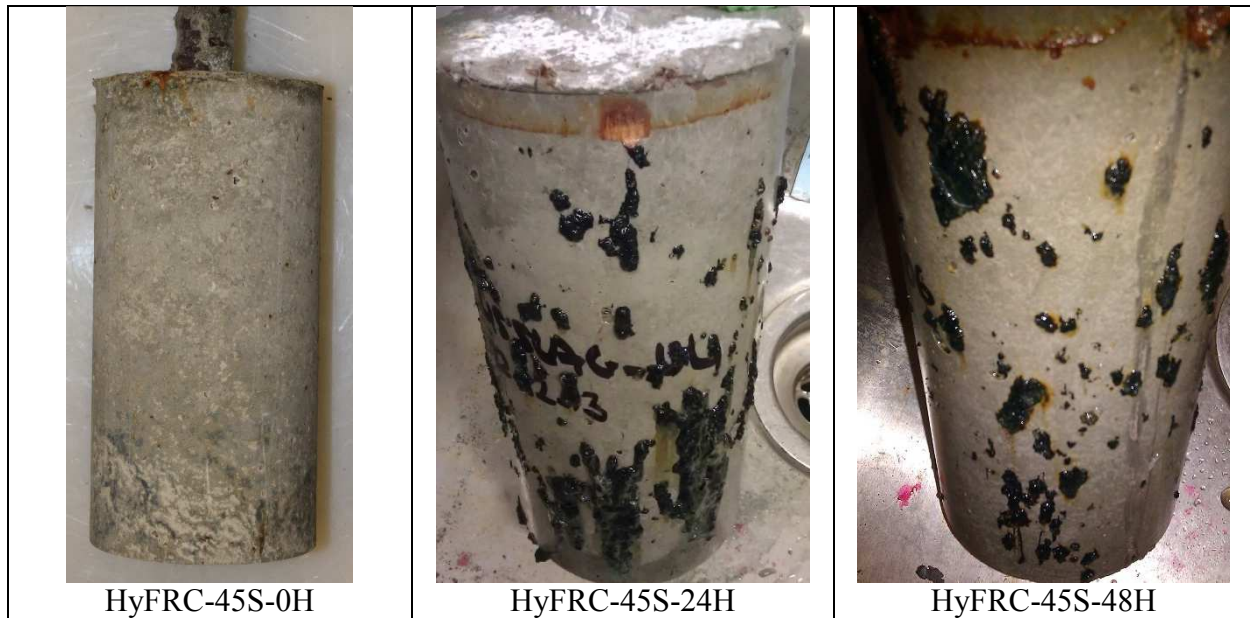
**Figure 5.13: Fiber corrosion on surfaces of HyFRC-45S**

The higher cell voltage across the concrete would also oxidize steel fibers located near the sample surface. The fibers at this location are susceptible to corrosion due to a lack of protection from the matrix. The corrosion of fibers is evident in **Fig. 5.13** where surfaces of the HyFRC-45S samples after 98 days in NaCl and immediately after 24 and 48 hours of applied current were shown. It is observed that after 98 days in NaCl, steel fibers showed little sign of corrosion on HyFRC-45S-0H surface. However, after 24 or 48 hours of applied current, black corrosion products from steel fibers were formed at various locations on the sample surfaces. Similar observations applied for HyFRC-0S and HyFRC-60S although they were not shown here. The mechanism of steel fiber corrosion under accelerated corrosion test will be explained in the next part of this chapter. It is also noted that the white deposit seen on the top surface of HyFRC-45S-24H in **Fig. 5.13** is crystallized salt which accumulated on the surface with time after NaCl solution was poured on top of it in preparation for electrochemical measurements.

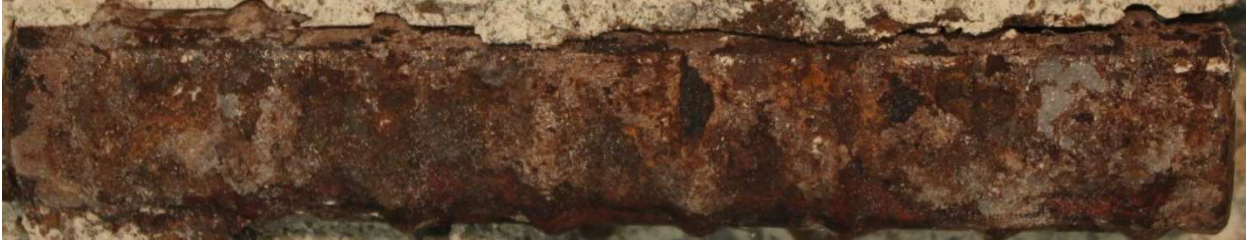
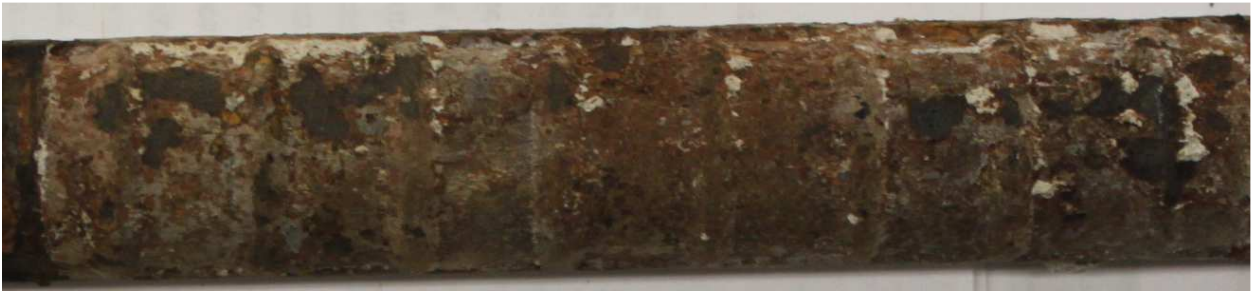
C'-60S-240H

C-60S-48H

**Figure 5.14: Corrosion product natures for C'-60S-240H and C'-60S-48H**

Corrosion products formed with slow and high current intensities seem to be different in nature. Observation of corroded bar surfaces for samples with 60% slag replacement level confirmed that less powdery and more rigid corrosion products appeared in C'-60S-240H as shown in **Fig. 5.14**. It is believed that with smaller current, iron ions would have more time to react with available  $\text{OH}^-$  from the cathode and moisture to form corrosion products of a more stable phase. The smaller required cell voltages to generate the  $0.2 \text{ mA/cm}^2$  would also induce less acidification at the interface and that would further enhance the formation of more stable corrosion products.

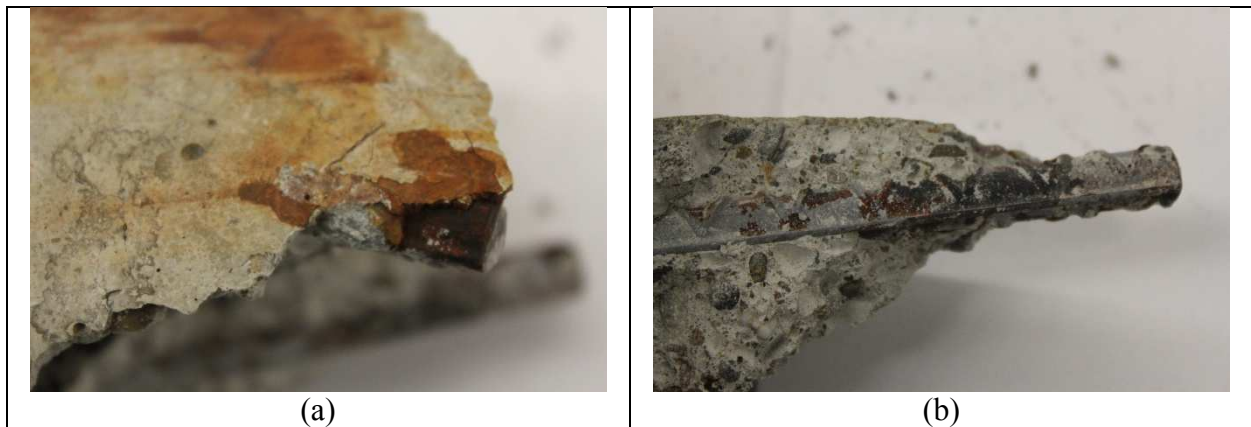
**Figure 5.22: Corrosion of #2 rebar embedded near the surface of the sample: (a) stain on the surface, and (b) extent of corrosion**

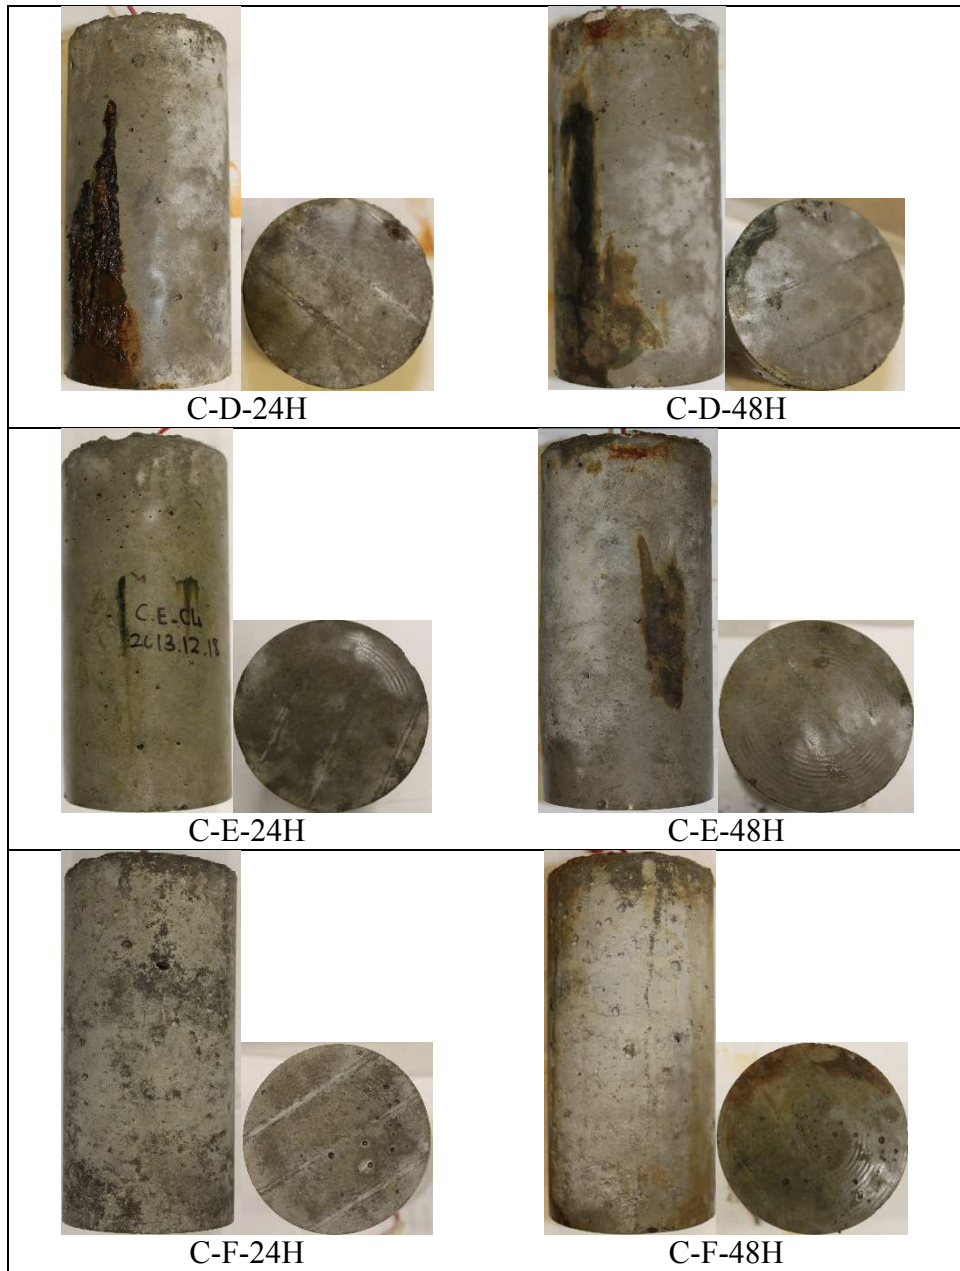
**Figure 6.9: Cracking on surfaces of samples with different regimes of applied current**

The exteriors of the samples were examined after an applied current of 24 and 48 hours. The side and bottom faces of each sample with different applied currents are given in **Fig. 6.9**. It was observed that more extensive cracking occurred for plain concrete samples with rebar in direct contact with the matrix (C-D). This caused more corrosion products to ooze out and caused more stains on the side surfaces. It is also observed that with the configuration of the corrosion samples in which the whole length of rebars was embedded in concrete, cracking did not extend through the entire height of the sample. This is attributed to a reduced stress and more confinement provided by concrete at both ends of the samples. Also, in C-F-24H/48H, part of the corrosion products were squeezed out from the tops of the samples along the electrical wiring. As corrosion products were formed and collected within the filter paper, they imbibed water, resulting in an increase in hydrostatic pressure within the interface. The pressure was built up and released by leaching of liquid with dissolved iron ions through a path formed along the weak interface of the wiring and concrete. This explained the minimal cracking along the cylindrical surfaces and the oozing out of corrosion products from the top faces of C-F-24H/48H samples. Corrosion stain on the top surface of C-F-48H is shown in **Fig. 6.10**. The phenomenon is crucial as it allowed for extraction of the pore solution to prove the acidification that occurs at the steel-concrete interface during accelerated corrosion test. The detail study will not, however, be presented in this report.

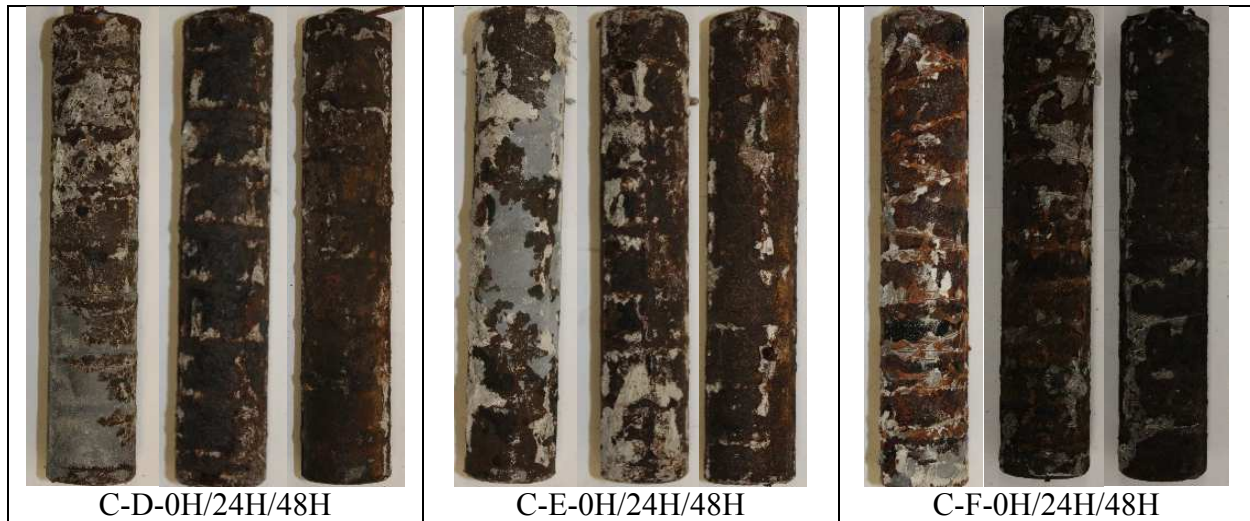
**Figure 6.12: Corrosion on bar surfaces showing patches of corrosion on C-D-0H/C-E-0H and uniform corrosion for all other samples**

Bars retrieved from split cylinders before cleaning off corrosion products are shown in **Fig.6.12**. Patches of corrosion products were observed on the surfaces of C-D-0H and C-E-0H while an almost uniform corrosion was found in C-F-0H. This is consistent with the electrochemical results where corrosion rates for C-F-0H were the highest as compared to corrosion rates in C-D-0H and C-E-0H. Also, corrosion products on C-E-0H seemed to be more powdery as compared to that in C-D-0H, possibly attributed to the different compositions of the matrix at steel-concrete interface. Removal of corrosion products on C-E-0H was easier. Uniform corrosion was observed in all other samples with 24 and 48 hours of applied current. This is different from samples with no added NaCl in the mixing water where limited corrosion was observed with 24 hours of applied current. The presence of salt in the mixing water destabilized the passive film on steel. As a result, the applied current was effective in causing corrosion throughout the rebar surface.

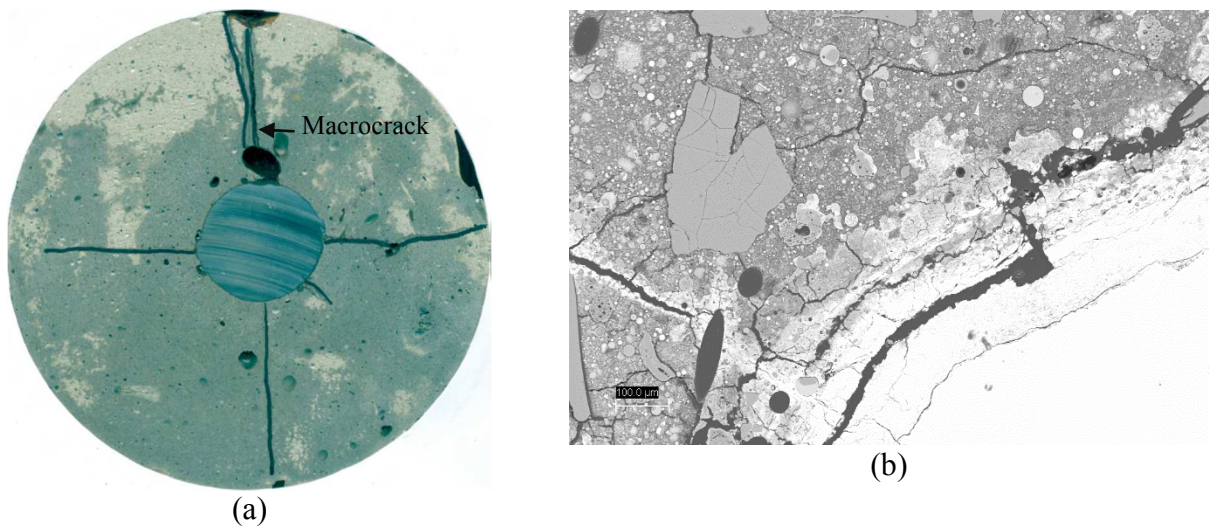
**Figure 6.17: (a) Crack pattern on a cut section of FRM sample, and (b) BSE micrograph showing crack and penetration of corrosion products into the matrix**

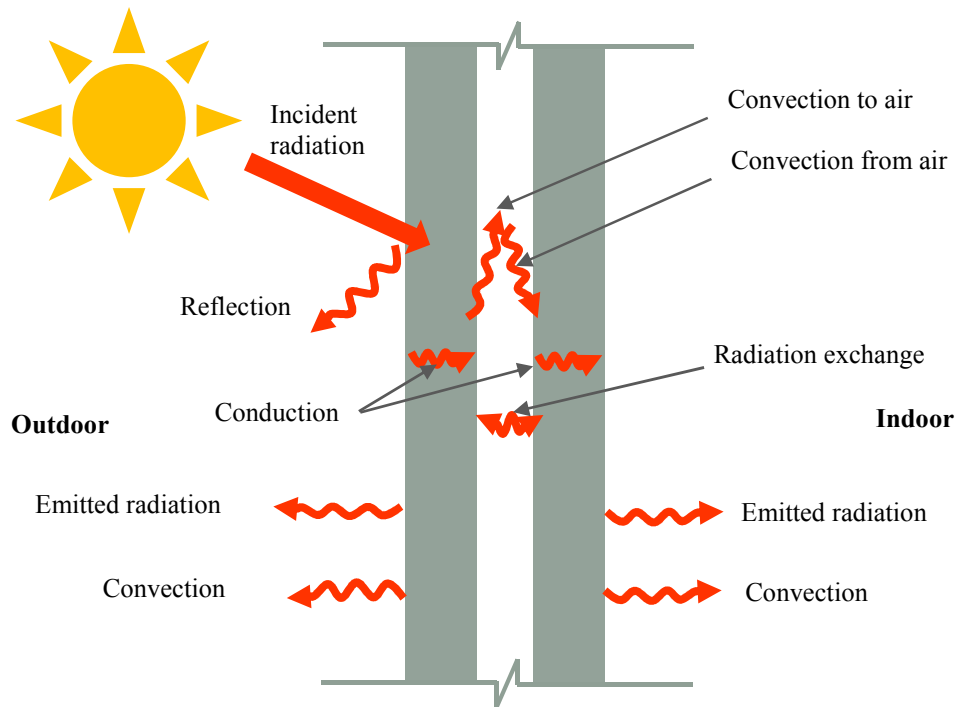
**Figure 7.2: Radiation heat transfer in concrete DSF**

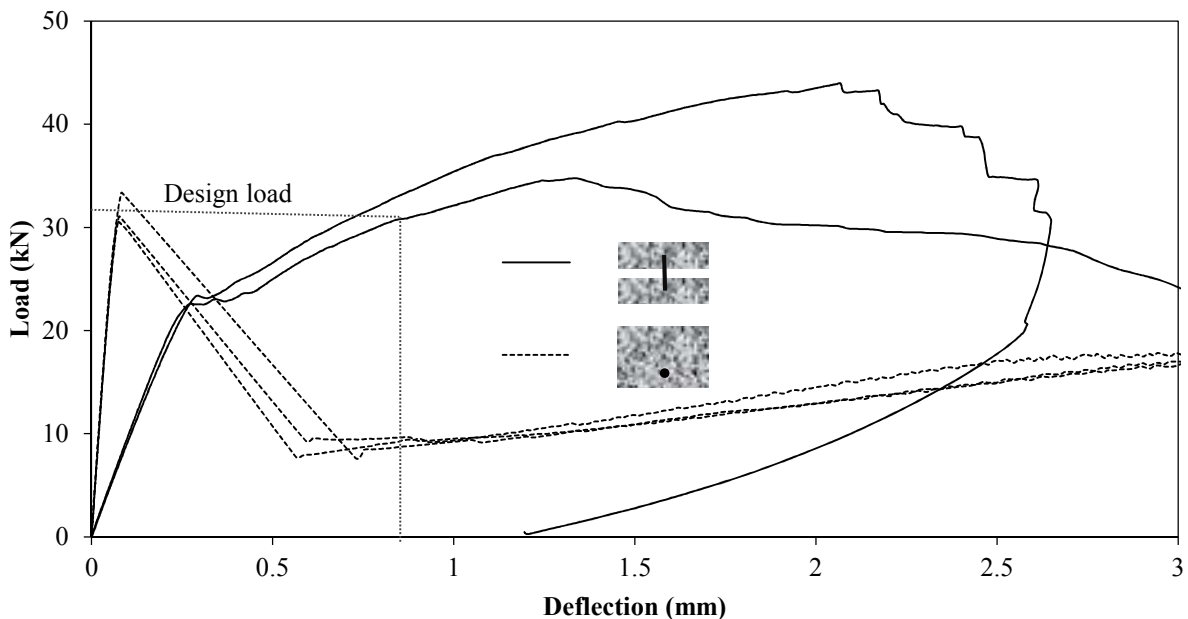
**Figure 7.8: Flexural test results for solid façade, and HP-G-HyFRC DSF**

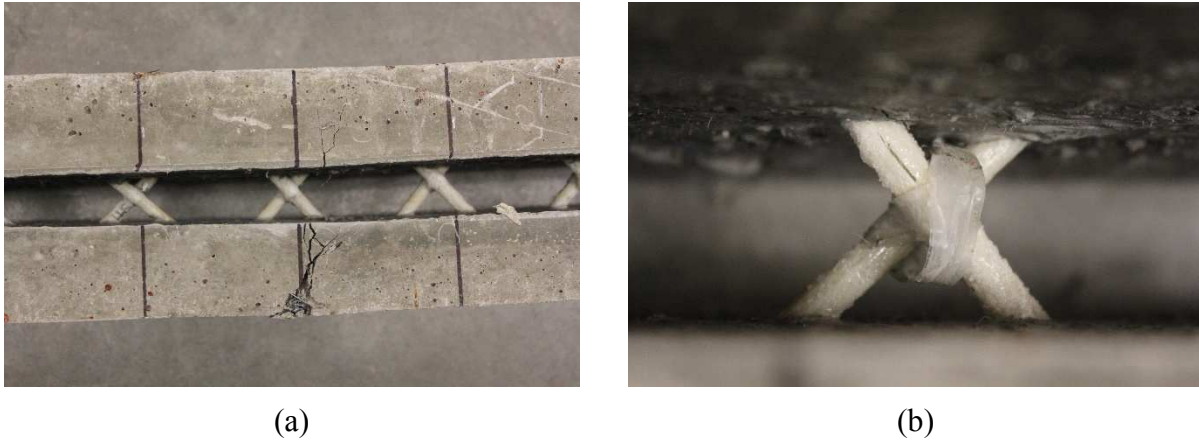
**Figure 7.9: Failure modes of DSF: (a) GHP-G-HyFRC tensile failure, and (b) crushing of GFRP bar**
