Fatigue fracture of a cemented Omnifit CoCr femoral stem: implant and failure analysis

## Case report

## Fatigue fracture of a cemented Omnifit CoCr femoral stem: implant and failure analysis

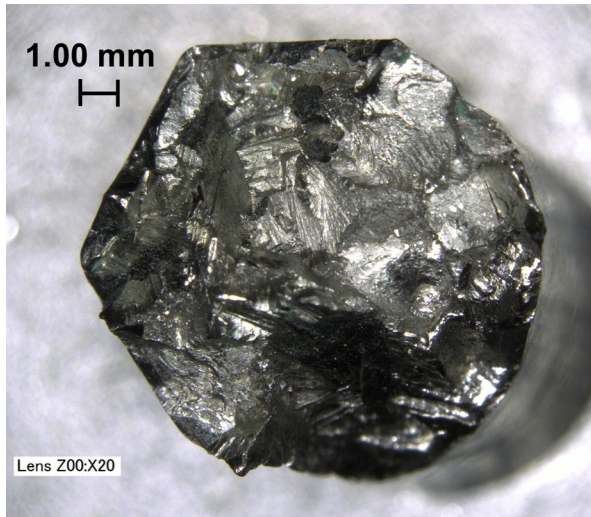
**Figure 3.** Low-magnification photographs reveal a large apparent grain structure at the location of fracture.

Optical inspection of the implant revealed failure at the mid-portion of the stem, at approximately 38% of the stem length, measured from the collar (Fig. 2). Low-magnification photographs (Fig. 3) show a large apparent grain structure at the location of fracture.
