Insights on the Study of Nafion Nanoscale Morphology by Transmission Electron Microscopy

Membranes, 3(4)

Yakovlev, Sergey
Balsara, Nitash P
Downing, Kenneth H

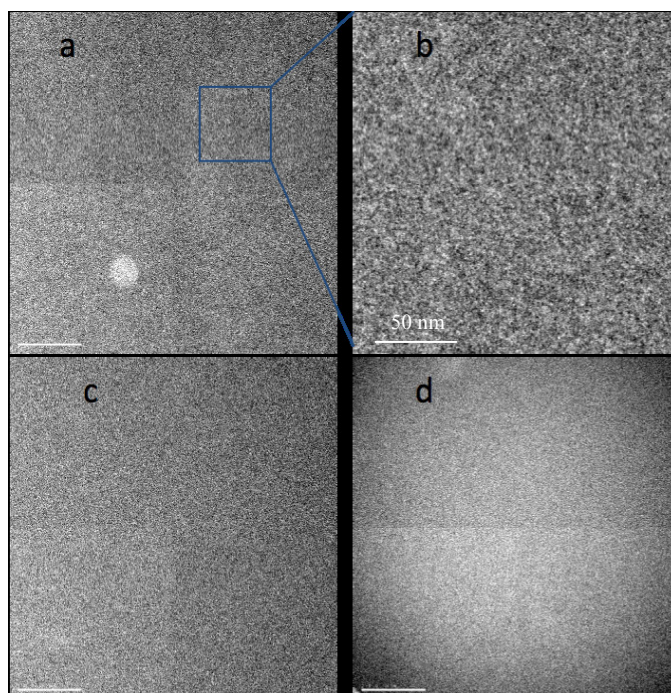
Figure 1. Bright field TEM images of acidic Nafion films initially about 50 nm thick, suspended over a hole in the support film, recorded at room temperature with 200 kV beam, 500 e/nm² at rate 500 e/nm² s. (a) from initially undamaged sample; (b) section magnified 4×; (c) same area after exposure to 10,000 e/nm²; (d) image of specimen at –180 °C recorded with 300 e/nm² at rate 300 e/nm² s, after pre-exposure to 5000 e/nm². Differences in image quadrants arise from variations in gain correction for the camera used in recording these images. Scale bars in a, c and d are 200 nm; in b 50 nm. A more complete set of images is in Supplementary Figure S1.

Figure 1a,b shows an image of a Nafion film around 35 nm thick obtained in bright field TEM mode with 500 e/nm² exposure at a dose rate 500 e/nm² s. We have found that recording images in focus with a small objective aperture (corresponding to a cutoff at about 0.5 nm) maximizes the contrast of heavy atom clusters by reducing the phase contrast granularity usually associated with high resolution TEM imaging. The image shows a relatively low level of contrast and high level of noise due to the low dose and in-focus conditions. It is still possible to conclude that the morphology of the sample is not uniform but appears as densely packed, disconnected clusters (dark spots) with irregular

shape and highly variable sizes, in the 1–3 nm range. Changes in the appearance of these features with defocus confirm that they are real rather than simply shot noise. However, the noise level in images recorded with exposures low enough to avoid serious damage makes it difficult to derive a satisfying characterization of the morphology. Continued irradiation of the sample brings some rearrangement to the structure. In subsequent images some of the clusters lose contrast while others appear and become darker. An image of the same area collected after an accumulated exposure of 10,000 e/nm² is shown in Figure 1c. After such a dose the sample thickness has already stabilized at a value about 80% of the initial thickness. Now we can see a slightly higher level of contrast and larger clusters than before irradiation. However, the images are still dominated by shot noise so that assessing changes in the sample morphology is difficult.

Investigation of the morphology of pristine Nafion in 2D TEM Bright Field images (Figure 1) shows clusters with a characteristic size of a few nanometers and inter-cluster spacings close to 5 nm—the value also inferred from SAXS and SANS experiments. However, observing these spacings in 2D images is surprising as such images represent the projection of the structure and would thus be expected to have overlapping images of clusters distributed through the thickness of the sample. The thickness of our thinnest samples is about 35 nm, which should have caused multiple overlap of the cluster images and apparent decrease of inter-cluster distance in the 2D images. While this kind of problem is typically solved by electron tomography, for Nafion this is extremely challenging due to movement of the features under the beam.

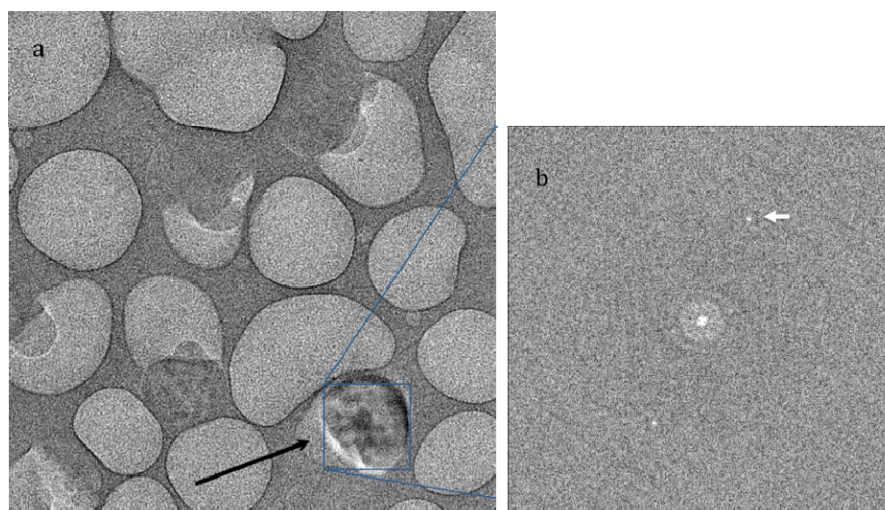
Figure 2. (a) Image of a thick film exposed to 1000 e/nm^2 at 300 kV, showing gas evolution under the beam irradiation. Black arrow shows a single crystal of polytetrafluoroethylene that formed inside a bubble during exposure. (b) Fourier transform of boxed area indicating peaks (white arrow) corresponding to the PTFE spacing of 5.7 \AA , which are only visible if the transform is taken from area including crystal.

As we see from our experiments, some mass loss is always observed in Nafion and needs to be recognized when images are interpreted. To obtain better insight on the mass loss, we have examined thicker parts of the Nafion samples. In experiments with thicker films, on the order of 500 nm thick, we used a higher accelerating voltage of 300 keV to take advantage of the longer electron mean free path. We found that mass loss in Nafion is associated with formation of gas that sometimes creates bubbles. In thinner regions bubbles are never observed, even when much higher dose rate are used, presumably because the gas diffuses to the surface and escapes to the vacuum. In thick parts of the sample even low dose rates of $300 \text{ e/nm}^2 \text{ s}$ at an accelerating voltage of 300 keV are sufficient for bubble formation. Bubbles appear and grow in size and number with irradiation. Figure 2a shows an image of a sample with gas bubbles after irradiation with an exposure of about 1000 e/nm^2 . One notable feature in Figure 2a is a single crystal, marked with an arrow, which grew during the period of bubble growth. The crystalline nature is clear from diffraction peaks visible in the Fourier transform of the image. Such crystalline diffraction is never observed with undamaged material. Presumably, high pressure inside the gas bubble creates conditions for nucleation and growth of single crystals of polytetrafluoroethylene. With continued irradiation, the crystals eventually disappear, as well as the bubbles.

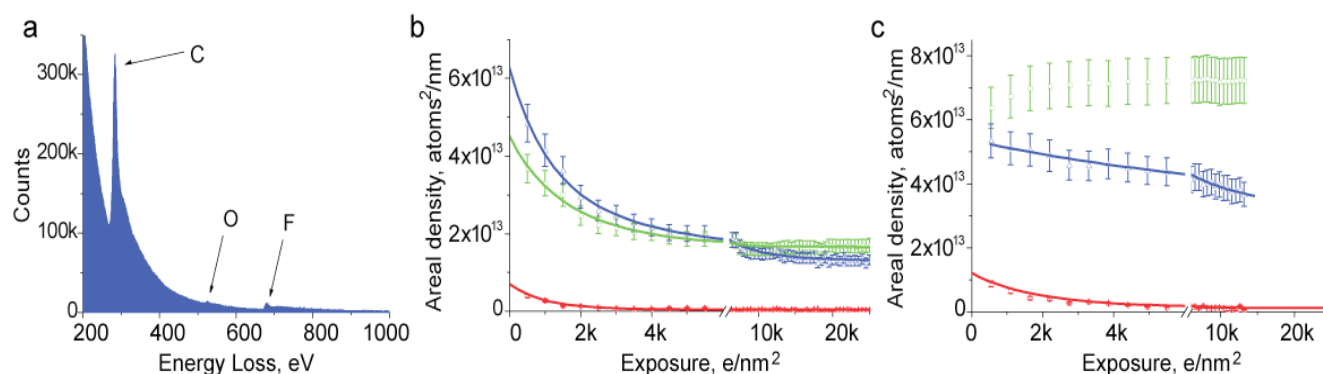
Figure 3. (a) Electron energy loss spectroscopy (EELS) spectrum collected from an acidic film of Nafion; (b,c) Changes in elemental composition of Nafion film with irradiation: (b) film suspended over holey support film; (c) film on continuous carbon support. Arrows indicate peaks and curves corresponding to elements: C—carbon (green), O—oxygen (red), F—fluorine (blue).

We have studied mass loss from Nafion by EELS to gain further insight on the effects of beam damage. We set the electron beam to irradiate a relatively large area of the sample and record a series of EELS spectra with accumulating total exposure. A spectrum collected from initially undamaged material is shown in Figure 3a. This spectrum was collected with parallel irradiation using a 500 e/nm^2 exposure, collection time 2 s and detector collection semi angle 2.5 mrad. Energy dispersion on the spectrometer was set to 0.5 eV. Edges corresponding to carbon, oxygen and fluorine are visible at energies of 284, 532 and 685 eV. We used those edges to find the composition of the sample. Quantification was done using standard routines in Gatan Digital Micrograph software using a power law for background subtraction and the Hartree-Slater method for cross-section calculation.

Figure 3b shows elemental loss from acidic Nafion at room temperature at a dose rate of $100 \text{ e/nm}^2 \text{ s}$. The very first experimental point shows that the fluorine content is about 1.3 times the carbon content. This indicates that some composition change has already happened since this ratio should be close to 2 for Nafion [2]. While in other experiments we were able to obtain a better match in composition by broadening the beam and reducing the dose, in this work conditions were chosen to mimic electron microscopy imaging of Nafion. We fit the experimental points with a single exponential curve. With this specimen, the best fit for carbon and fluorine is obtained with decay constants of 1711 ± 276 and $1676 \pm 165 \text{ e/nm}^2$, respectively. Loss of oxygen is faster and is well described by a decay constant of $811 \pm 109 \text{ e/nm}^2$. It is also evident that the final oxygen content in the sample is essentially zero while both carbon and fluorine come to some equilibrium value. Rapid removal of the oxygen is not surprising since the degradation of Nafion molecule was shown to start from the sulfuric acid group and ether side chain where all the oxygen is localized [10].

The removal of fluorine and oxygen from samples on a continuous support film occurs with lower rates than with unsupported films, with time constants of 3400 and 1600 e/nm^2 , respectively, for the film in Figure 3c. It is also noteworthy that total loss of fluorine at the point where the sample reaches an equilibrium concentration is significantly lower for a sample on a continuous support compared to a film suspended in vacuum. This observation provides additional evidence that charging of Nafion may be a major process causing damage. Using a conductive support films is well known to be one of the best solutions to the problem of charging.

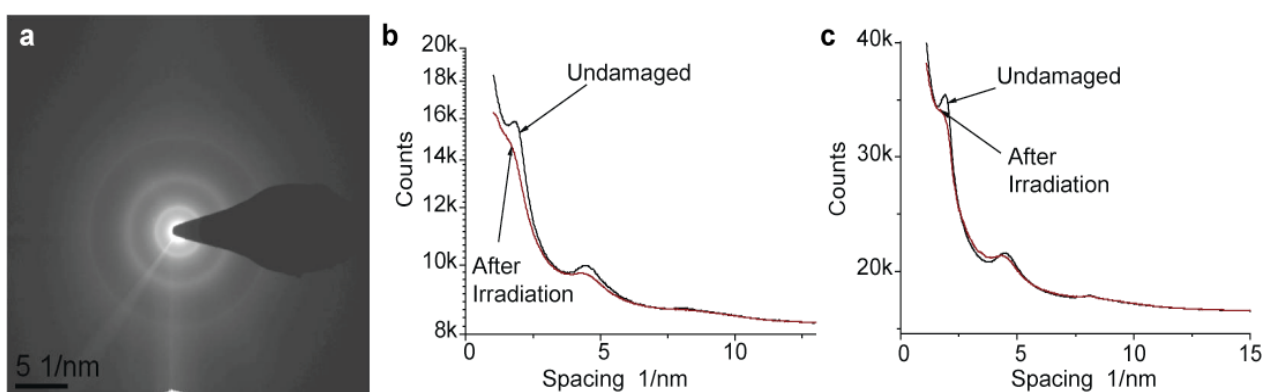
Figure 4. Electron diffraction from Nafion. (a) Diffraction pattern collected from a nearly undamaged Nafion film (200 kV electrons; dose used for data collection was 30 e/nm^2 , dose rate $15 \text{ e/nm}^2 \text{ s}$); (b,c) profiles of diffraction pattern collected from initially undamaged film (black lines) and films pre-irradiated with 1000 e/nm^2 (red lines): (b) room temperature and (c) $-180 \text{ }^\circ\text{C}$.

In determining an exposure limit for imaging sensitive samples, the mass loss is not necessarily the best criterion, as some damage to the structure may occur without mass loss. A common way to determine an exposure limit for crystalline specimens is the observation of changes in an electron diffraction pattern. Because Nafion is a semi-crystalline polymer with some segments of the polytetrafluoroethylene backbones forming crystals, observation of changes in diffraction patterns may be informative. We have studied changes in diffraction patterns at both room and cryo temperature and found that temperature has only a subtle effect on the diffraction pattern decay. Figure 4a shows a diffraction pattern collected from an initially undamaged Nafion film using a very low exposure of 30 e/nm^2 and dose rate of $15 \text{ e/nm}^2 \text{ s}$. The outer ring that corresponds to a spacing of 1.2 \AA (002) appears relatively sharp, the second ring at a spacing of about 2 \AA (101) is more diffuse, and the inner ring at 5.6 \AA (101) is relatively sharp.

In order to illustrate the pattern decay quantitatively, Figure 4b,c shows profiles of diffraction patterns collected at room and cryo temperatures at a low exposure of 30 e/nm^2 , *i.e.*, from nearly undamaged material, and after irradiation with 1000 e/nm^2 . Rings clearly visible at the beginning of the exposure decay with irradiation of 1000 e/nm^2 . After an exposure of 3000 e/nm^2 the rings at 1.2 \AA and 5.6 \AA completely disappear. In some cryo samples, however, mass loss is so strong that we observed the formation of holes in the sample even before complete decay of the diffraction pattern. A slight increase in the dose rate seems to increase the pattern decay rate linearly while application of a dose rate over $1000 \text{ e/nm}^2 \text{ s}$ causes changes so rapid that no quantitative information could be obtained.

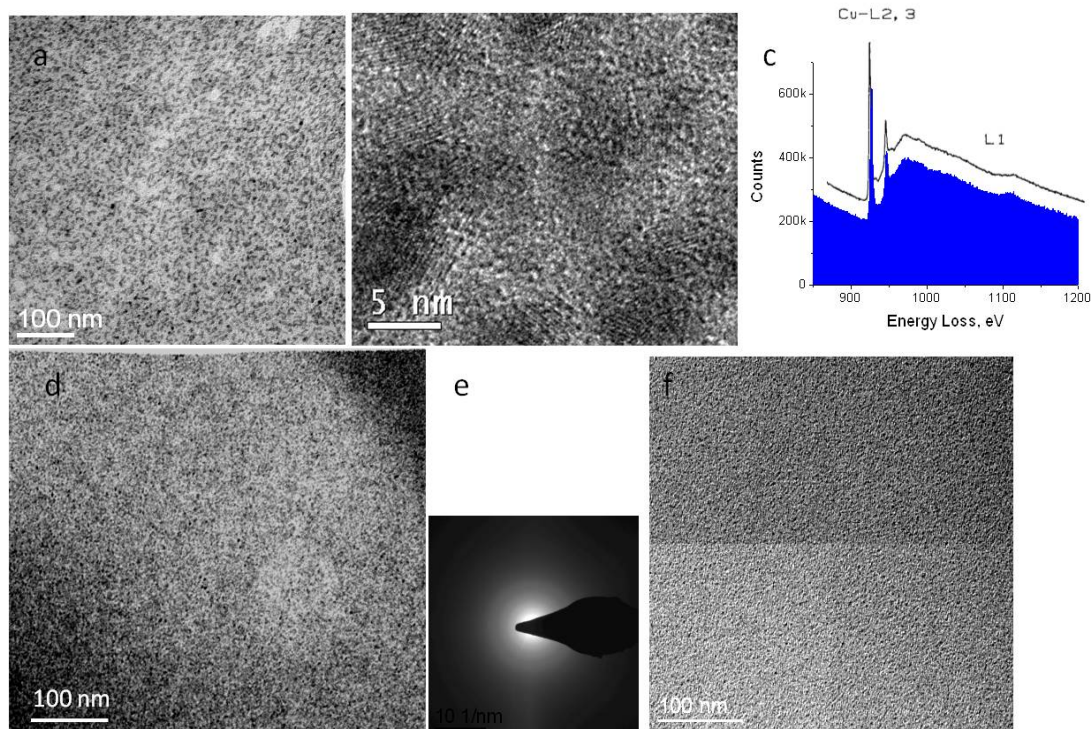
Figure 5. Precipitates in doped Nafion membrane. (a,b) Cu-treated membrane irradiated at room temperature; (c) EELS spectrum (blue) showing edge corresponding to L edge of copper oxide (superimposed curve); (d,e) cryo-image of Cu-treated Nafion and corresponding electron diffraction pattern; (f) Pb-treated Nafion.

Precipitation of the heavy elements following exposure may be observed in electron micrographs. In the case of copper, precipitates created with dose rates over 1000 e/nm² s are extremely well defined (Figure 5a). In fact, high resolution images reveal that precipitates are nano-sized crystals (Figure 5b). Because the film is no longer sensitive to irradiation, very high doses may be applied to analyze the crystal composition. EELS analysis reveals a spectrum near the copper L edge that is identical to that observed from copper oxide (Figure 5c) [15]. By electron tomography, we have seen that the precipitates are distributed throughout the thickness of the sample, confirming that their development is not a surface-related phenomenon.

At cryo-temperatures, growth of precipitates may be observed somewhat similar to room temperature (Figure 5d). However, electron diffraction reveals that precipitates of copper formed at cryo-temperature are amorphous, rather than crystalline (Figure 5e). Whether precipitates crystallize or not, heavy counterions have a protective effect against irradiation by reducing the mass loss. Formation of a hole in the film under irradiation is generally not observed with doped samples. In contrast to copper, ion exchange with lead did not produce crystalline precipitates. At room as well as at cryo-temperature, such films showed only amorphous precipitates (Figure 5f).

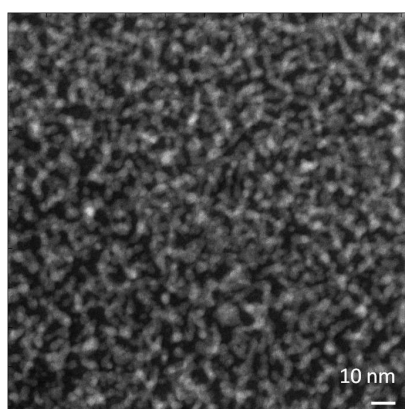
Figure 6. HAADF image of acidic Nafion membrane. Exposure used for the imaging was $10,000 \text{ e/nm}^2$ with a 300 kV beam.

Observations of Nafion in the HAADF STEM mode produce high-contrast artifacts. Figure 6 shows an example of such an image. This kind of image is typical of even the very first scan, which generally requires an exposure of about $10,000 \text{ e/nm}^2$. Reducing the dose to 1000 e/nm^2 produces similar images but with higher noise and much lower levels of contrast. It is important to note that the contrast development is associated with thickness loss in the film. We believe that the contrast in the image presented in Figure 6 is in large part a consequence of preferential etching of the tetrafluoroethylene phase [16].

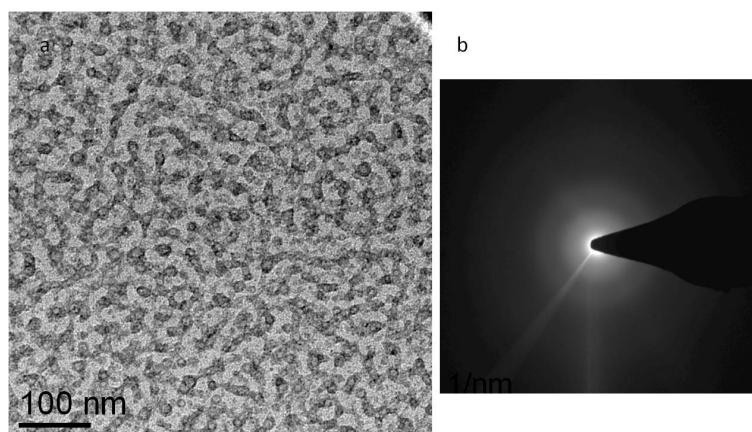
Figure 7. Imaging of highly damaged, hydrated film. (a) TEM Bright Field image of hydrated Nafion and (b) corresponding electron diffraction pattern. Sample was exposed at a dose rate of 10,000 e/nm² s to a total exposure about 50,000 e/nm².

A final observation concerns damage to cryo-preserved Nafion saturated with water. Samples were saturated with water at room temperature and at 80 °C, corresponding to nominal water uptake of 20 and 35 percent, respectively [17]. Images of the undamaged material are very similar to the images collected from the dry samples, with a very low level of contrast and disordered features. We observed that saturation of Nafion with water substantially reduces the electron beam sensitivity and that this reduction seems to increase with increased water uptake. However, damage is still noticeable at any water uptake, and irradiation with dose rates higher than 1000 e/nm² s for prolonged time generates apparent phase separation in the material (Figure 7). Low dose images appear very similar to the images of dry Nafion and only show noisy, disordered clusters with an average size of a few nm. Increasing the water content in Nafion does not visibly affect the observed morphology.
