SPARK DAMAGE AND HIGH VOLTAGE BREAKDOWN OF METALS IN VACUUM AT 14 MEGACYCLES (PRELIMINARY REPORT)

Chupp, Warren W.  
Heard, Harry G.

1952-09-24

ABSTRACT

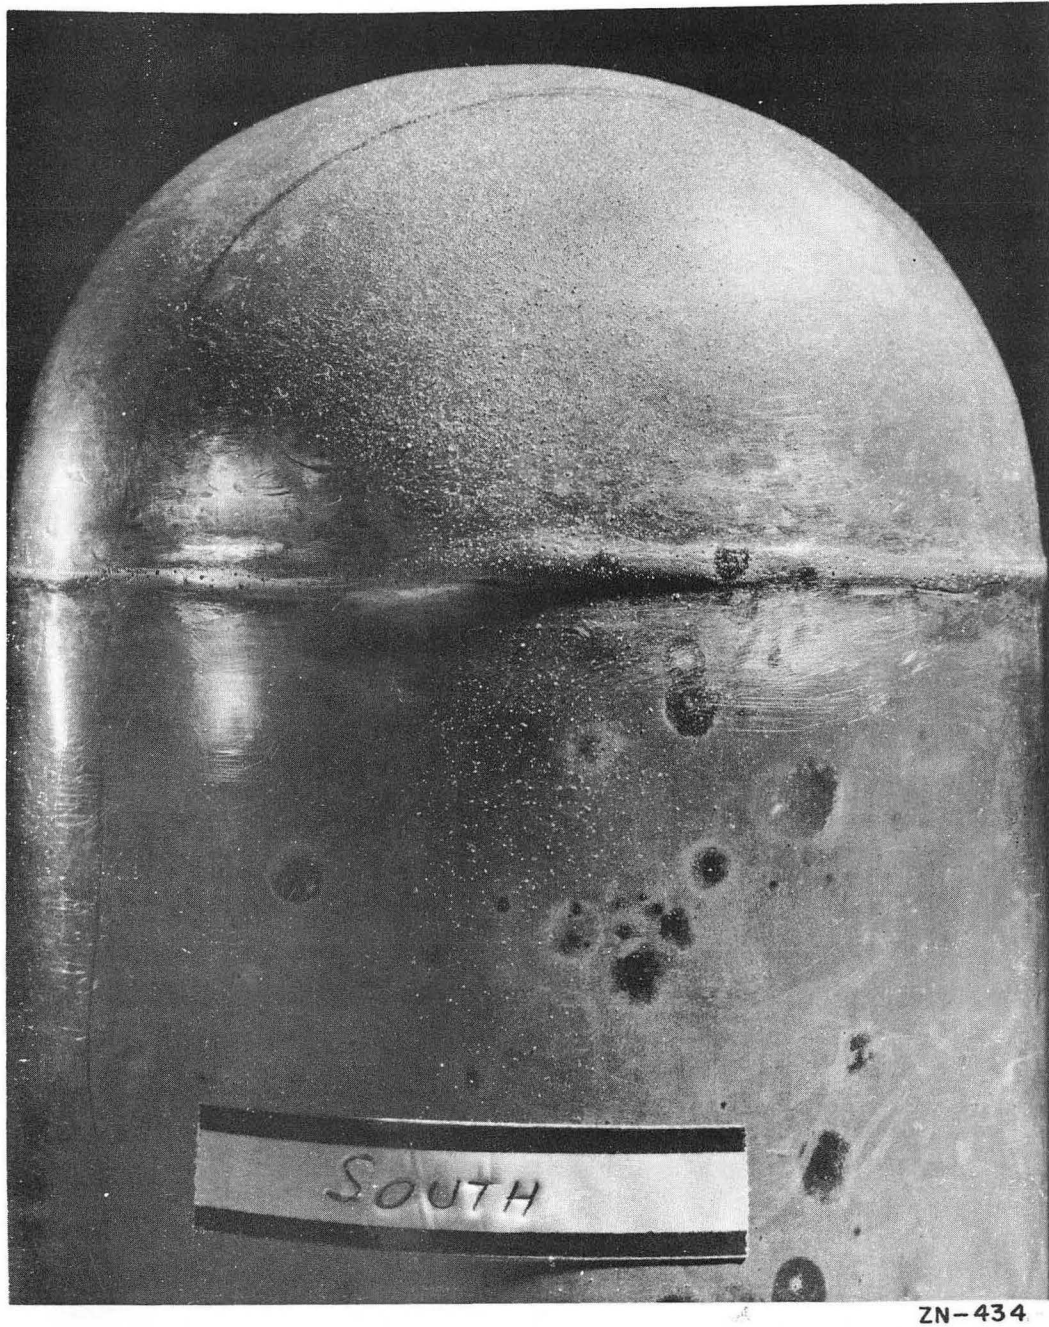
The spark damaged is illustrated in Figs. 12 and 13.

Fig. 12 - Tantalum Stem Electrode

Fig. 13 - Tantalum Side Electrode

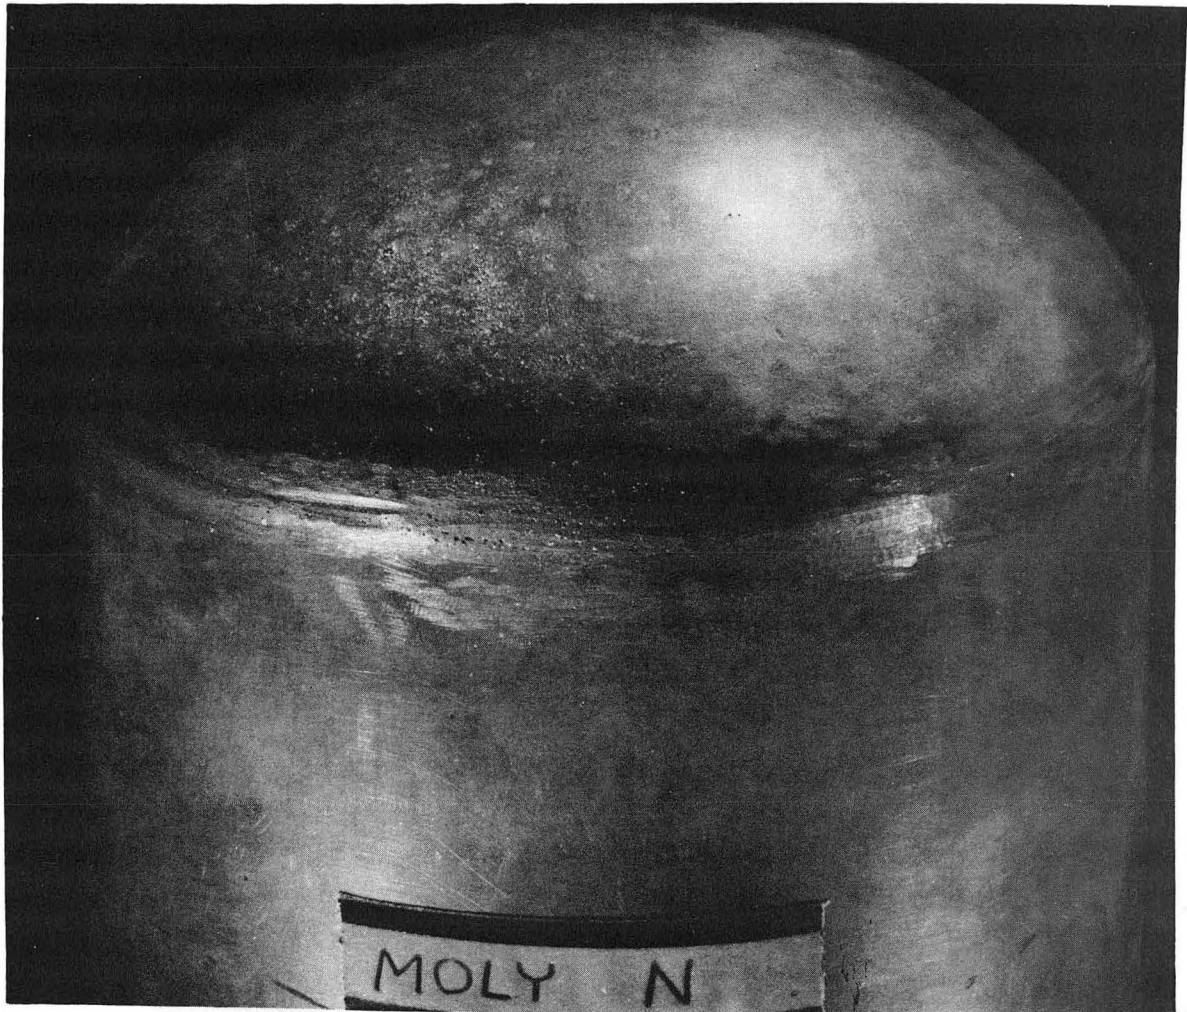
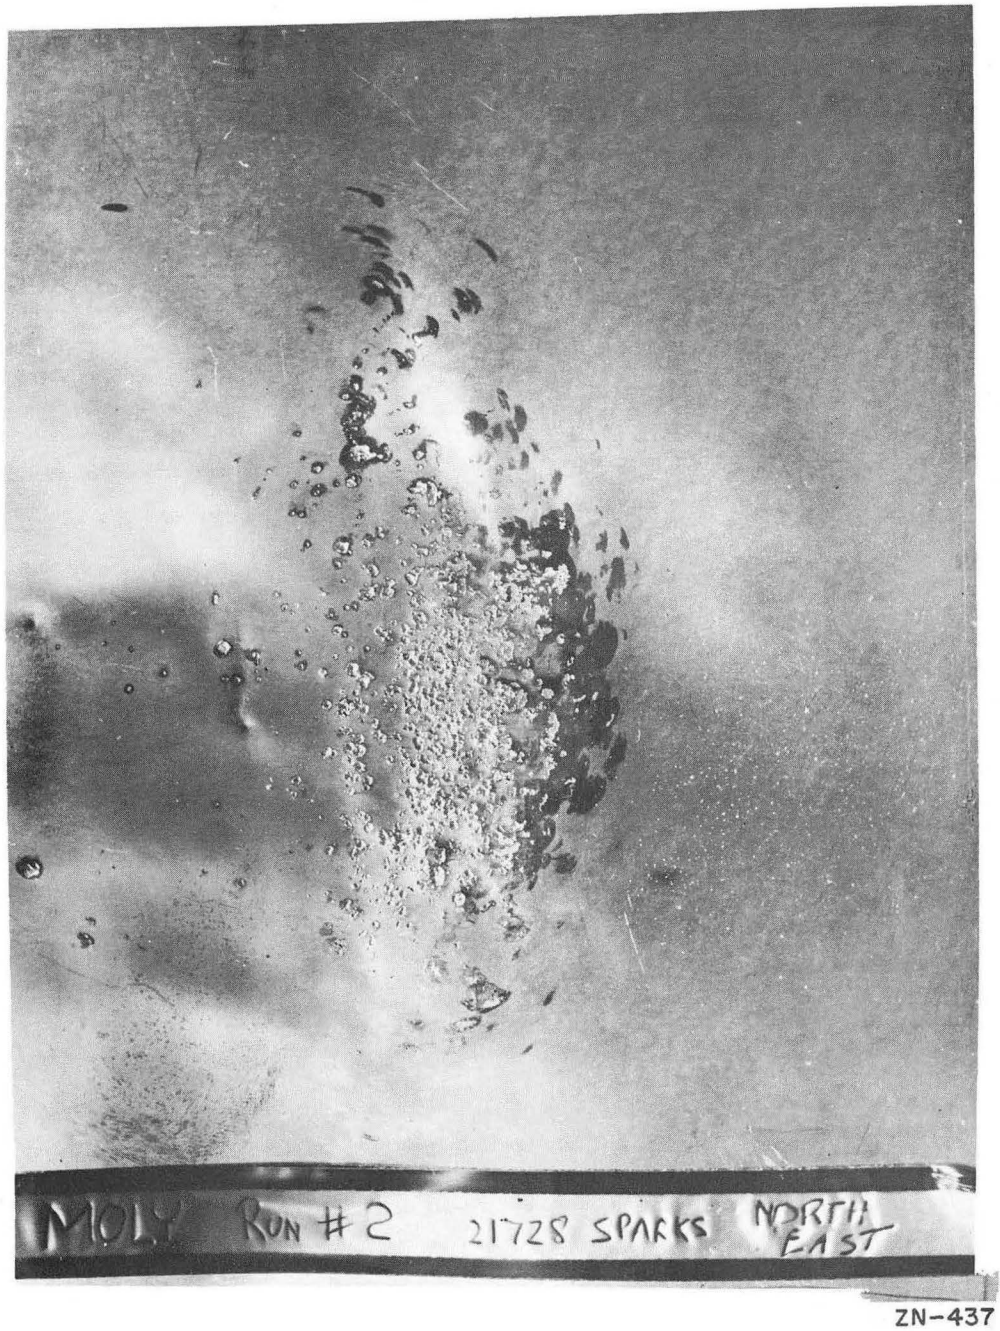
- (3) Resistance to damage from sparking is good (see Figs. 14 and 15)..

Fig. 14 - Molybdenum Stem Electrode

Fig. 15 - Molybdenum Side Electrode

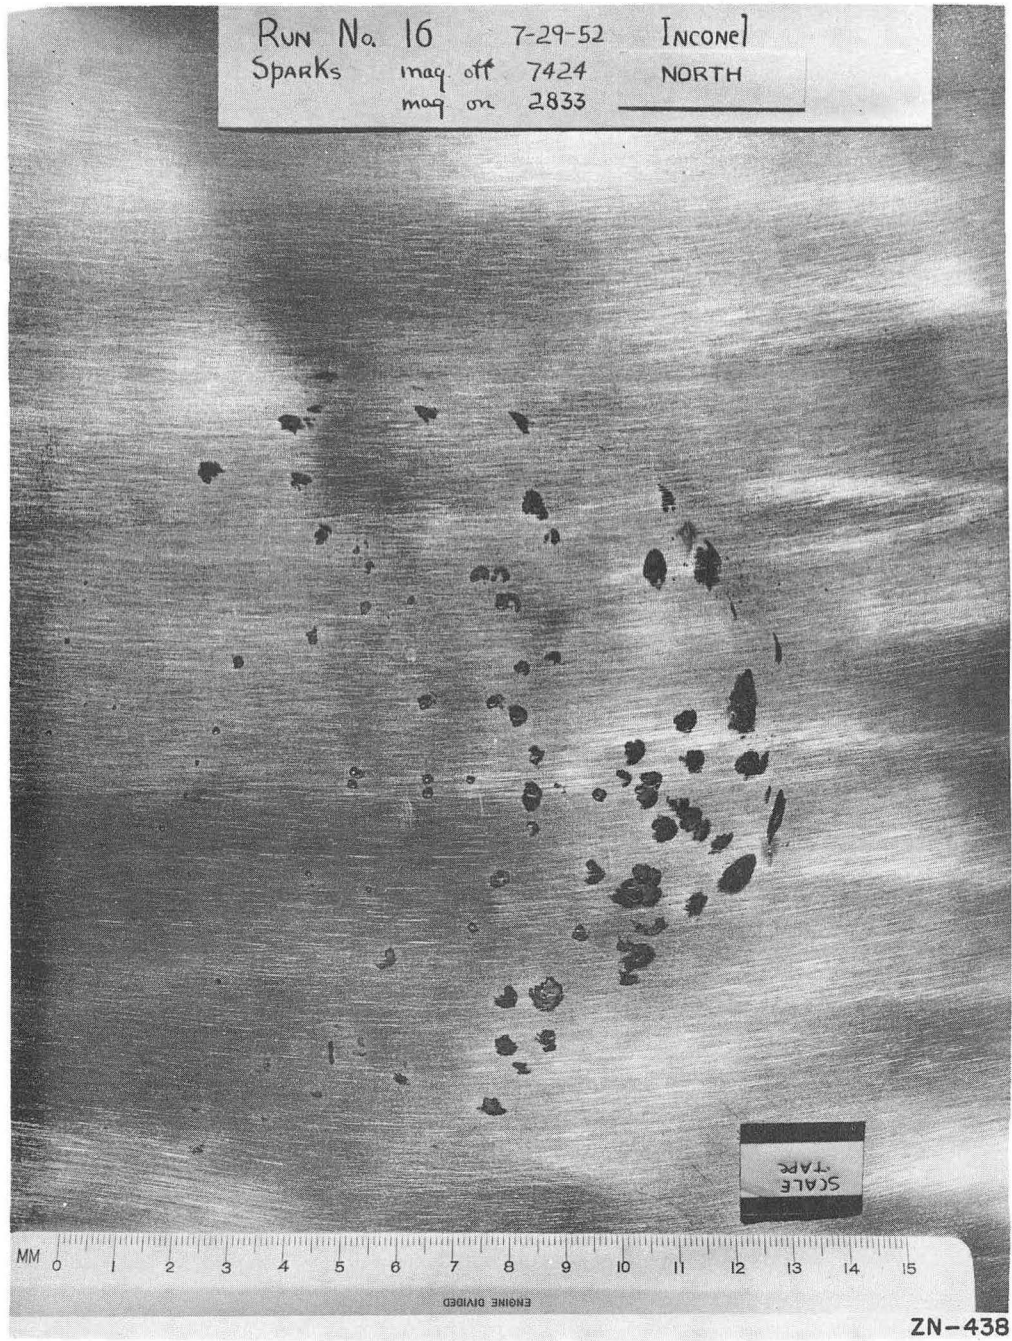
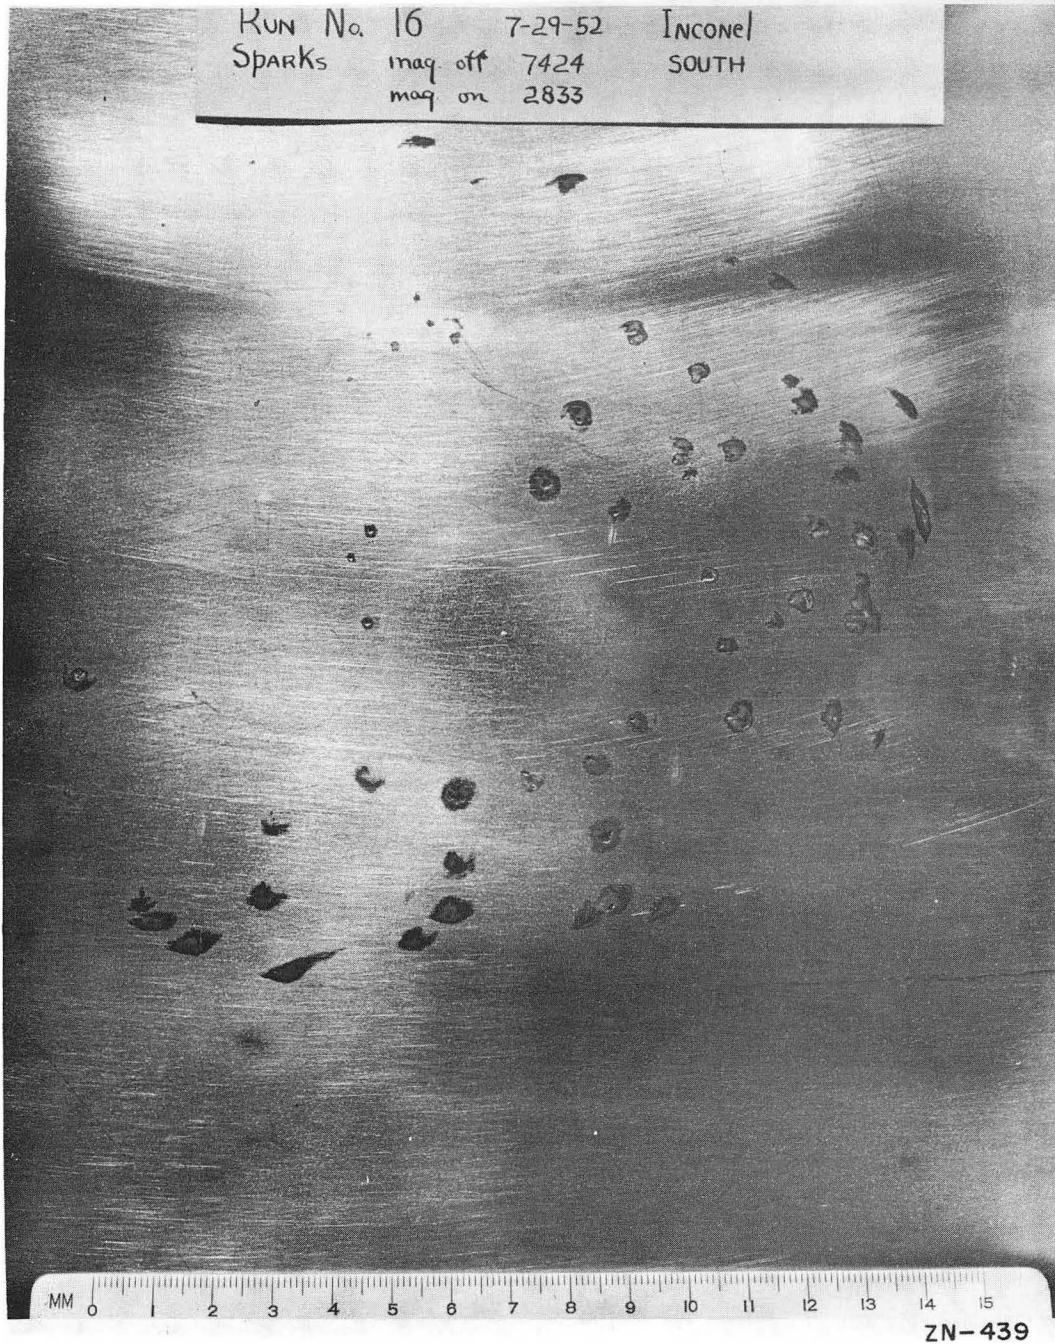
Spark craters and spark damage can be compared with coppers for the 5-3/8 inch gap. Inspection of the electrodes (see Figs. 16 and 17) shows the spark craters to be smaller and less numerous than found with any of the coppers for the same voltage.

Fig. 16 - Inconel Side Electrodes

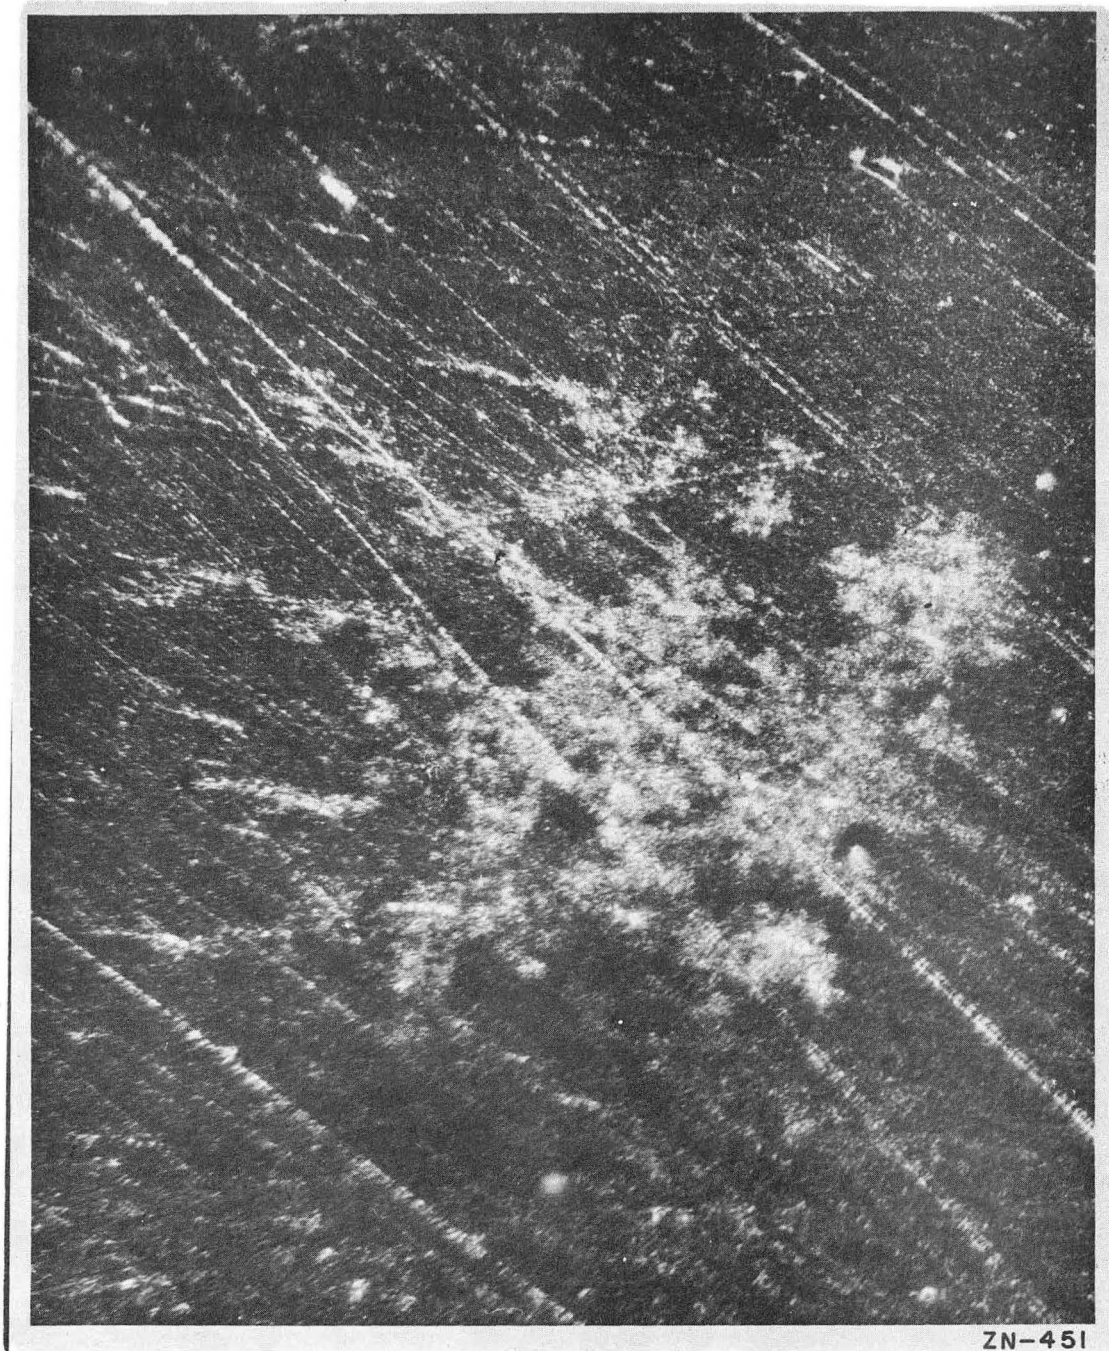
There is a striking difference between sparks which occur with and without the magnetic field. Sparks without the field always appear at the surface of the electrode of highest gradient. The visible ionization from these sparks usually extends approximately one inch from the electrode. Sparks without the magnetic field do not cause macroscopic damage to the electrodes. In one test without the magnetic field more than 10,000 sparks passed between the electrodes of which more than 5,000 occurred while at the breakdown threshold. When the system was opened for inspection no sensible macroscopic damage was found. In an extension of this test highly polished electrodes were sparked approximately 2700 times without the magnetic field at voltages from 500 to 1100 kv. Microscopic examination revealed no sparking damage to the side plates. There were microscopic marks on the stem (highest gradient) which corresponded to the areas where scintillations were observed. Typical photographs at 50 X magnification are Figs. 29 and 30.

Fig. 29 - Photomicrographs of Spark  
Marks on Center Electrode

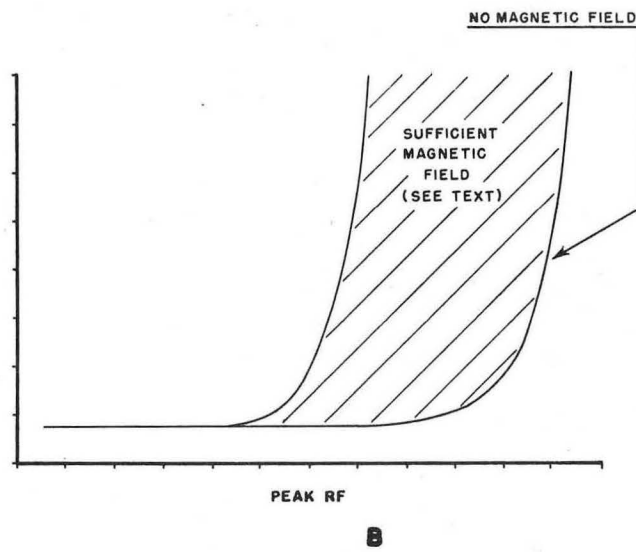
Fig. 32 - (a) Variation of Breakdown Voltage with Magnetic Field  
 (b) Variation of Sparking Rate with Magnetic Field

A test was performed to isolate and study the effect of the magnetic field on the observed breakdown voltage. In this test the sparking rate was measured as a function of voltage with magnetic field as the parameter. The variation in breakdown voltage with magnetic field is shown qualitatively in Fig. 32 (a) and (b).

It was found that the damaging sparks which occur in the presence of sufficient magnetic field cause the observed breakdown voltage to be lowered. The breakdown voltage is not affected by the magnetic field until the damaging sparks appear; it then drops discontinuously to a lower value. At all values of magnetic field above this the breakdown voltage remains constant at the value found when the damaging sparks first appeared. If the magnetic field is turned off after the sparking threshold has been reached with damaging sparks, there will be no instantaneous decrease in the sparking rate.

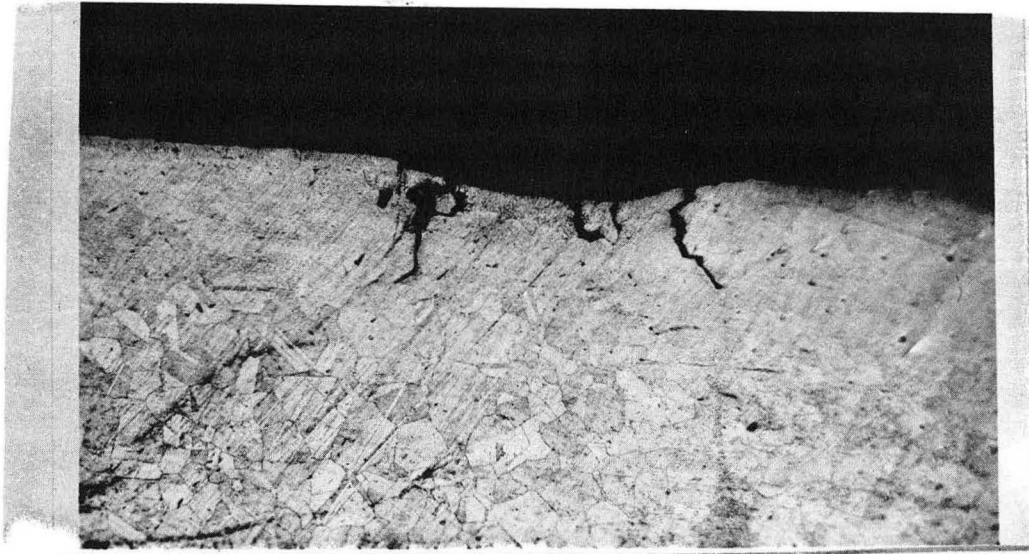
Photomicrographs (68 X) were made of the spark craters on the Inconel side plates. Fig. 40 shows a cross section of a typical crater .025 inches in diameter. Radial cracks resulting from stress concentration extend .002 to .008 inches from the crater surface. There is evidence of

Fig. 40 - Spark crater .025 in. in diameter. Inconel Electrodes. Note .002 - .008 in. radial cracks.

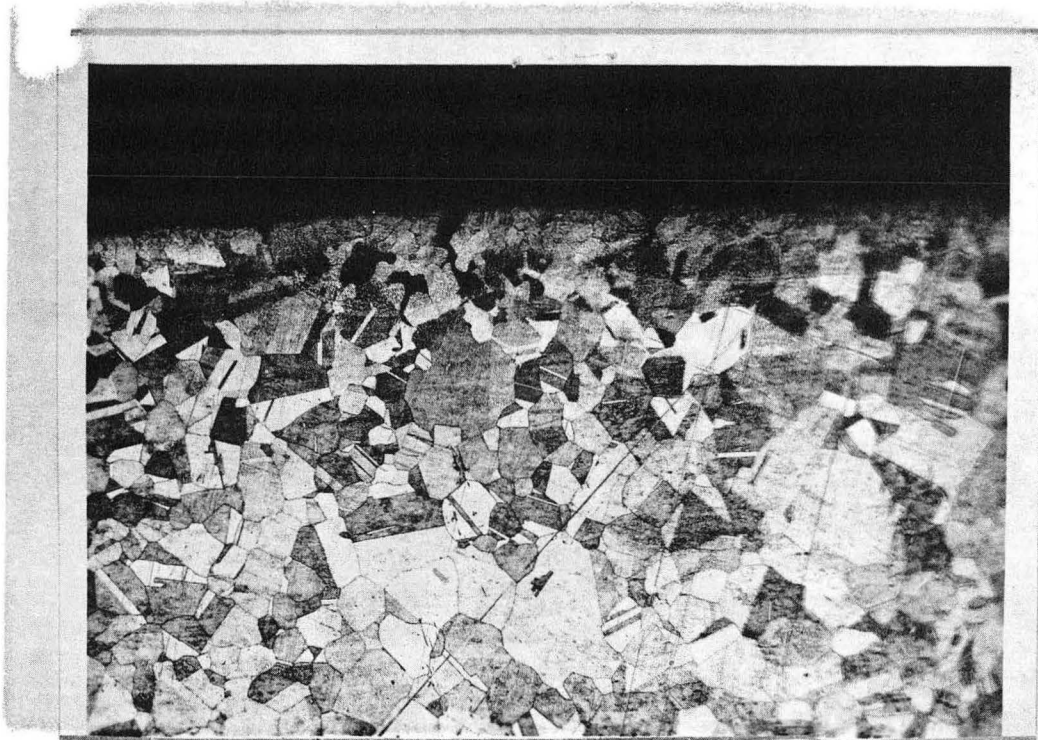
Fig. 41 - Extensive recrystallization .005 to .007 in. into the surface of Inconel electrodes.

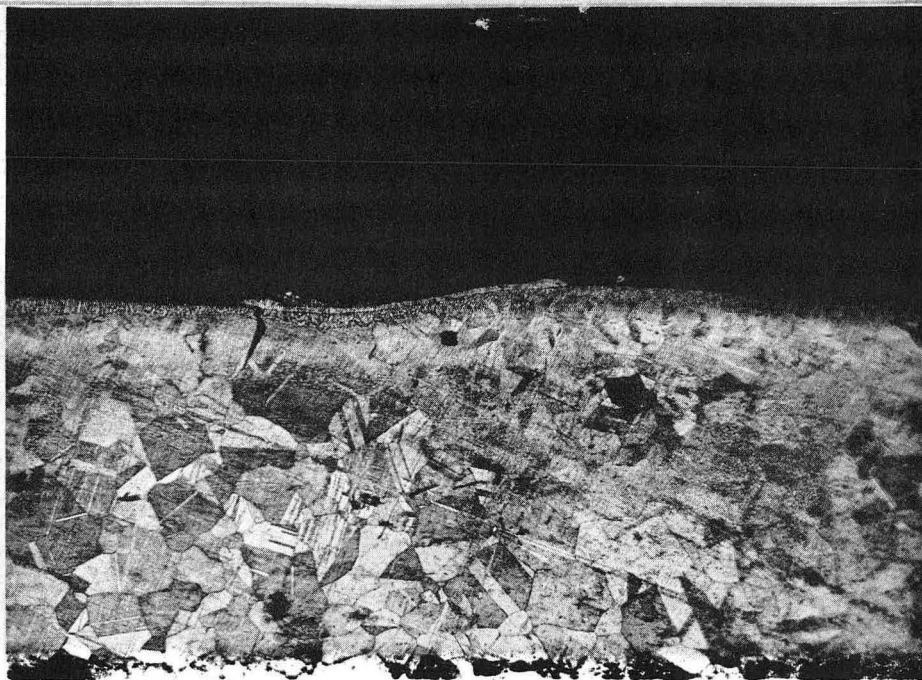
Fig. 43 - Mechanical bond of material transferred across the gap as a result of a spark. Inconel.
