Low Cost Upgrades to At-Grade Crossing Safety Devices

WP-2013-6

Douglas L. Cooper, David R. Ragland and
Grace Felschundneff, SafeTREC

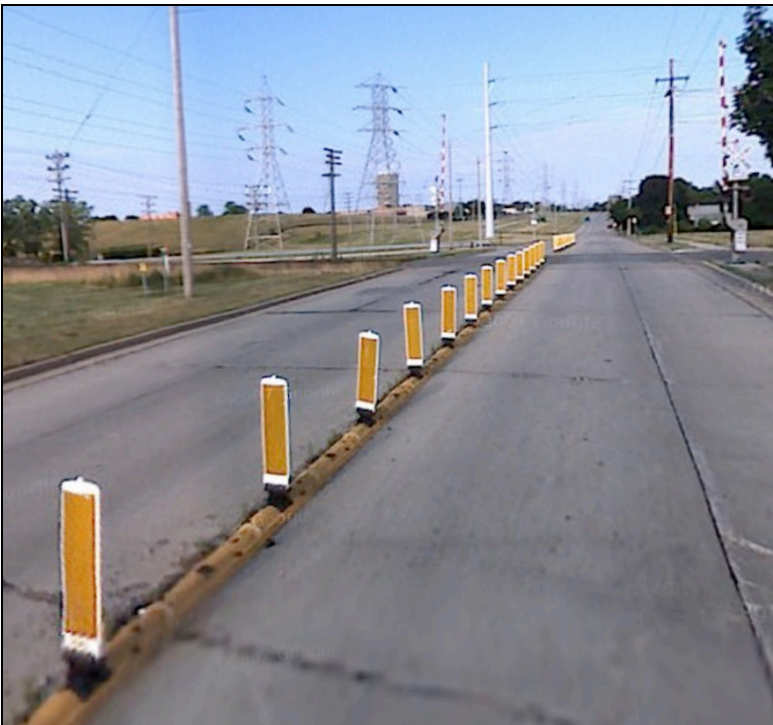
26
27 **FIGURE 1 Street Mounted Channelization**
28

44 For our purposes, channelization devices are defined as mountable centerline medians
45 with upright reflectors that can be applied directly to the existing roadway, as shown in
46

1 Figure 1, or be part of a more complex structure consisting of an island with the device
2 mounted on the top, as shown in Figure 2. Such systems present drivers with a visual cue
3 intended to impede crossing to the opposing traffic lane. The curbs are no more than six
4 inches in height, usually less than twelve inches in width, and built with a rounded design
5 to create minimal deflection upon impact. The reflectorized paddle delineators or tubes,
6 typically 24-36 inches high, are built to be able to bounce back up after being hit or run
7 over. These systems are designed to discourage drivers from circumventing the traffic
8 control devices at the crossing while allowing emergency vehicles to cross over
9 into opposing lanes to go back in the opposite direction (1). Usually, such a system can
10 be placed on existing roads without the need to widen them.

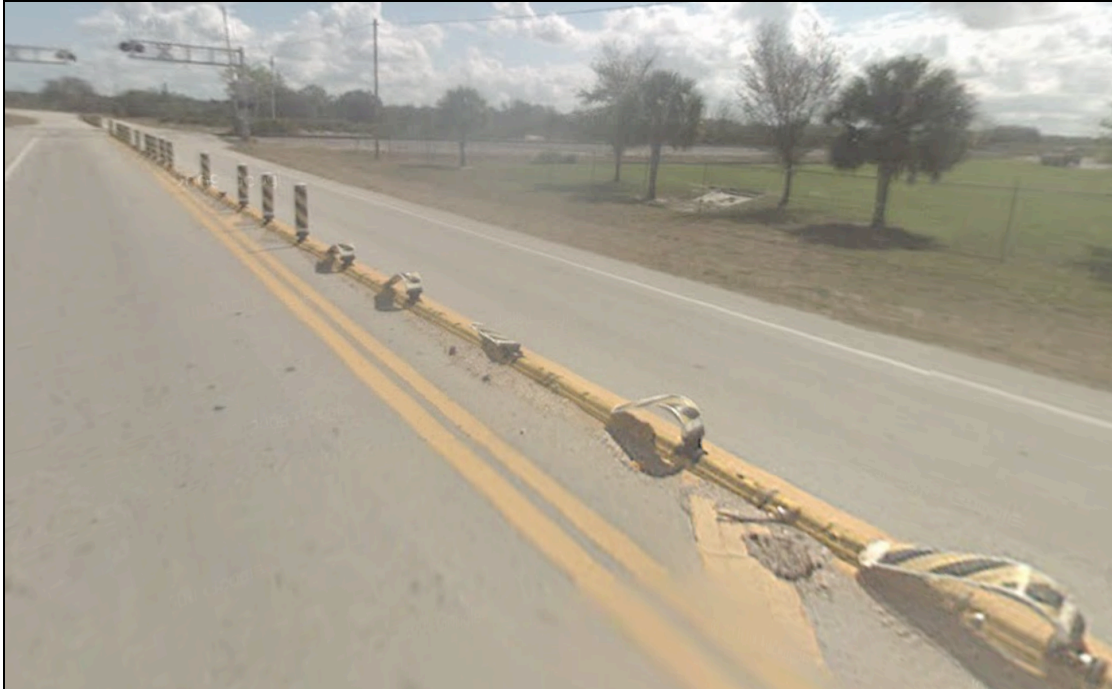
1
2 **FIGURE 4 Damage to Channelization Devices in Frostproof, Florida**
3

22 There was significant damage to a channelization installation at the US 98 site in
23 Frostproof, Florida. Nine consecutive markers were completely removed from the traffic
24 separator, apparently by the impact of a large motor vehicle such as a semi-trailer.
25 Factors that may have contributed to the collision include narrow lane width: 9.2 feet, and
26 the number of lanes: 2. With additional lanes, motorists have the ability to compensate
27 for the presence of the traffic separator and may be able to avoid collision with the
28 markers (7). Nearby, on State Route 17, there was also substantial damage to another
29 channelization device (Figure 4).
30

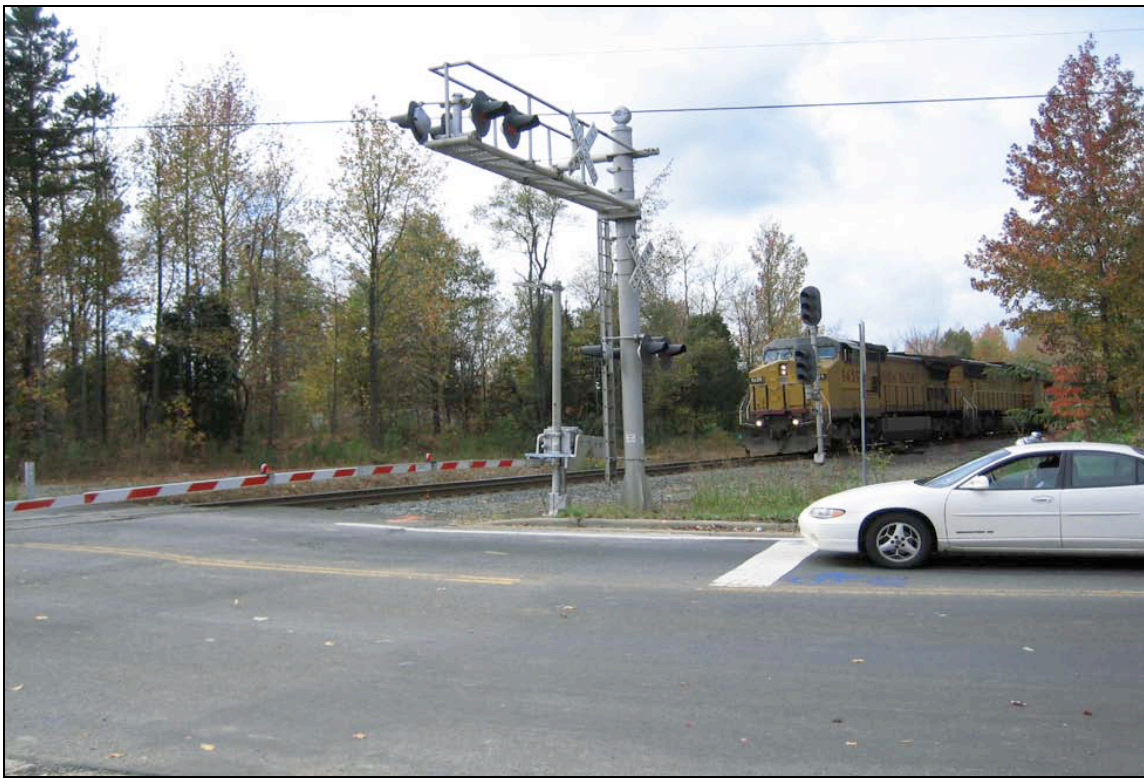
25 **FIGURE 7** Longer-Arm Gates at Orr Road, North Carolina
26

3 As reported in the North Carolina Sealed Corridor Phase I, II, and III Assessment
4 study, the longer-arm gate systems must cover at least three quarters of the roadway.
5 Tests at the Orr Road Crossing in Charlotte were conducted by the state's DOT to
6 evaluate the effectiveness of longer-arm gates to reduce drivers' ability to drive around
7 the gates (Figure 7).

10 A total of three tests were conducted with the first gathering driver violation data before
11 the gate was installed, the second test gathering post-treatment violation data which
12 showed a 67 percent reduction in crossing violations, and a third test which gathered
13 "after" data on long gate arms a year after the first test to determine whether long-arm
14 gates retain their effectiveness. The results from the third test showed an even higher
15 reduction in crossing violations of 84 percent compared with pretreatment "before"
16 numbers. Longer gate arms are used in conjunction with traffic channelization devices in
17 some locations, but not where they would block a street or driveway intersection close to
18 the crossing. The gates provide considerable discouragement to drivers who start to drive
19 around and then realize how great the distance is.
