PM PEM's On-Road Investigation - With and Without DPF Equipped Engines

PM PEM's On-Road Investigation — With and Without DPF Equipped Engines

Prepared for: Engine Manufacturers Association

July 2009

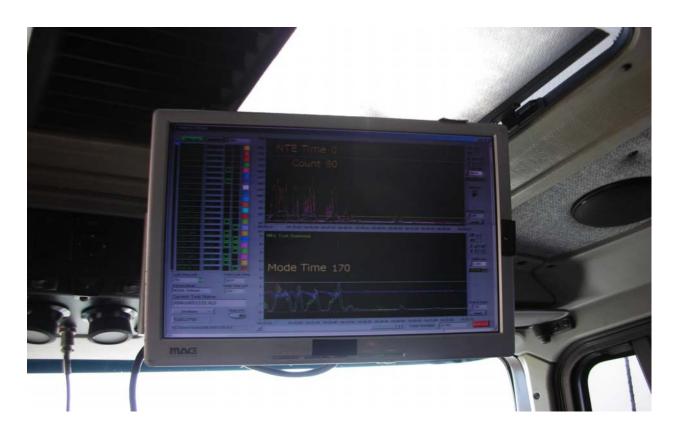
Figure 3-16. MEL Driver's Aid Interface
