Full-Depth Pavement Reclamation with Foamed Asphalt: First-Level Analysis Report on HVS Testing on State Route 89

Partnered Pavement Research Program (PPRC) Strategic Plan Element 4.12: Development of Improved Mix and Structural Design and Construction Guidelines for Full-Depth Reclamation with Foamed Asphalt

University of California
Pavement Research Center
UC Davis, UC Berkeley

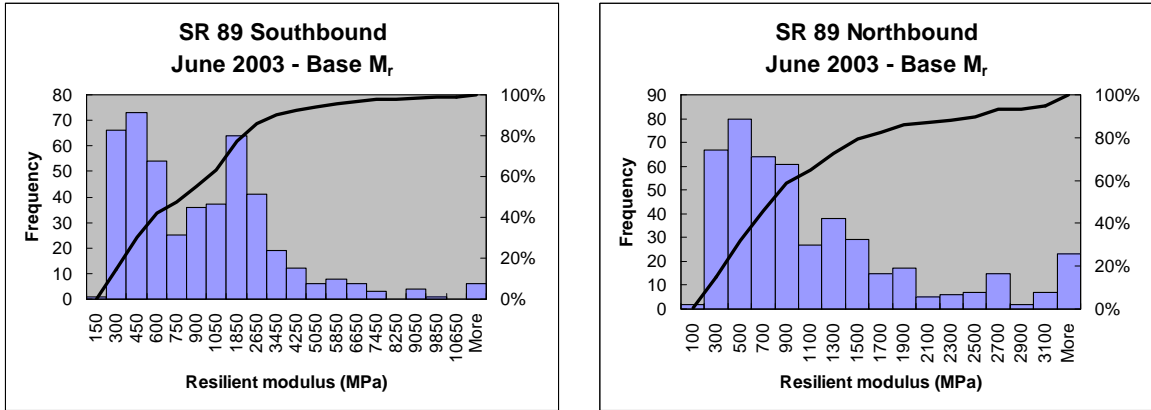
Figure 4.4: Backcalculated base resilient modulus, main roadway June 2003.

The backcalculated resilient moduli for the foamed asphalt treated RAP layer are shown in Figure 4.4 and Figure 4.5 for the mainline and HVS test lane. The range of resilient moduli on the main roadway was considerably higher than on the HVS test lane, but it should be noted that the sample size was significantly larger than for the HVS test lane because of the length of the mainline sections. The frequency histogram for the southbound lane shows two distinct distributions of resilient modulus values, one with a peak in the region of 300 MPa to 400 MPa and the other in the region 1,050 MPa to 1,850 MPa. This is a result of the distribution of deflections measured on the southbound lane. The frequency histogram for the northbound lane shows a much less prominent secondary peak at 1,300 MPa. The resilient modulus values for the secondary peaks of the frequency histograms, 1,050 MPa to 1,850 MPa for the southbound lane and 1,300 MPa for the northbound lane are typical of values expected for foamed asphalt treated material.

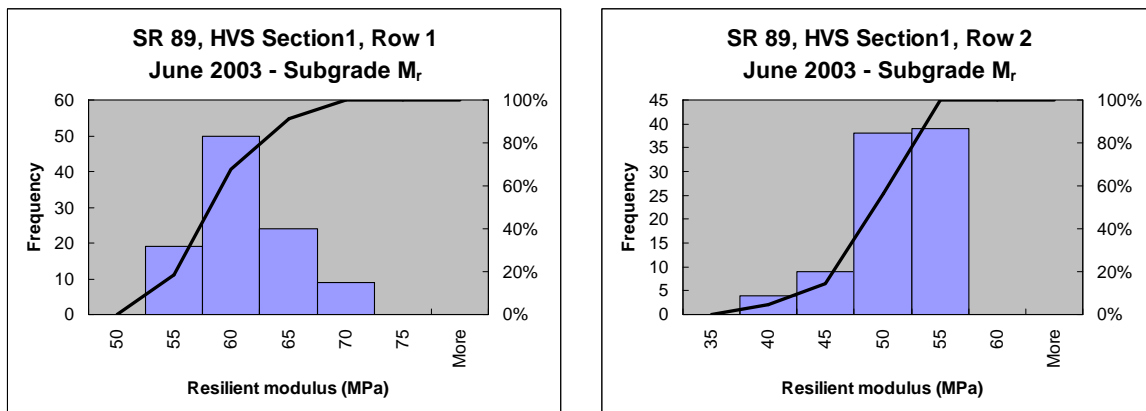
Figure 4.7: Backcalculated subgrade resilient modulus, HVS test lane June 2003.

The subgrade resilient moduli were slightly, but not unrealistically low for the decomposed granite subgrade. The support condition is fairly consistent for the main roadway and the HVS lane. The large differences in deflections discussed in the preceding section are therefore not due to differences in the support.

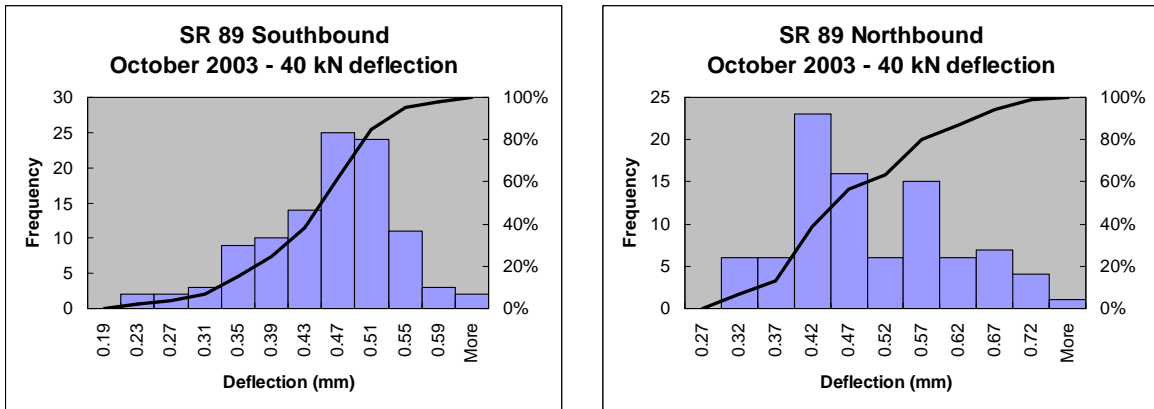
Figure 4.8: Peak FWD deflections for the main roadway during October 2003.

The peak deflections measured are illustrated in Figure 4.8 and Figure 4.9 for the two directions of the mainline and the HVS test lane.

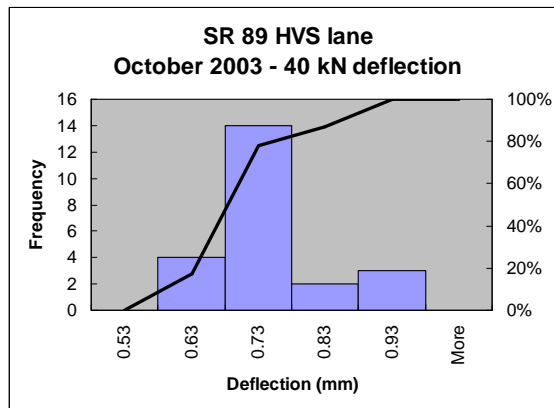
Figure 4.9: Peak FWD deflections on HVS Section 593FD during October 2003.

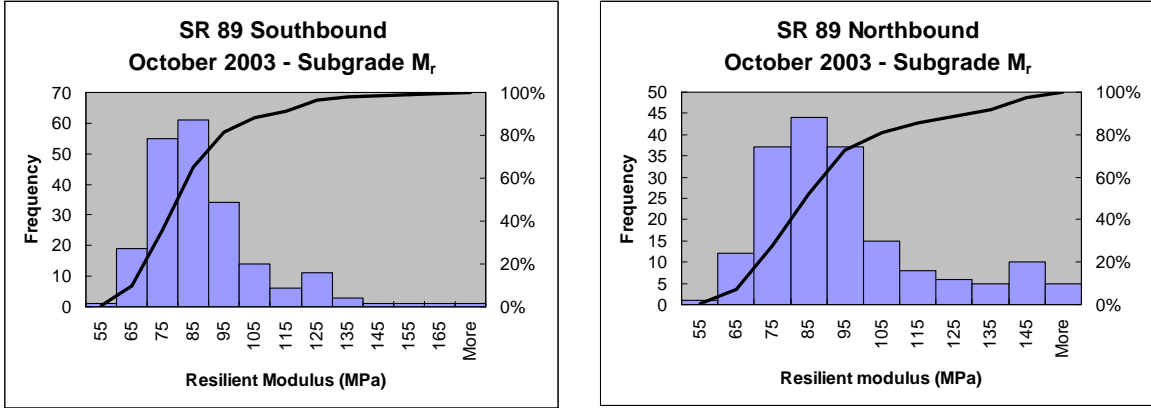
Figure 4.12: Backcalculated subgrade resilient modulus, main roadway, October 2003.

The subgrade resilient moduli determined from the October 2003 survey are illustrated in Figure 4.12 and Figure 4.13. The results indicate no significant differences between the support condition of the north and southbound lanes and the HVS test lane.

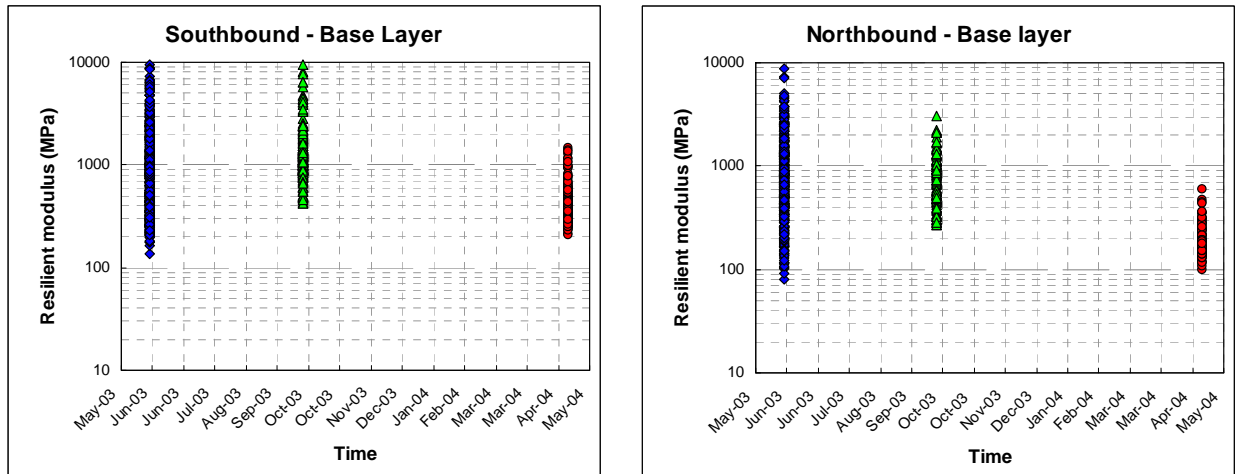
Figure 4.17: Comparison of the backcalculated base layer resilient modulus results.

The base layer resilient modulus results from the June 2003, October 2003 and May 2004 FWD surveys are plotted in Figure 4.17. The distribution of resilient modulus values for the southbound lane was consistently slightly higher than that of the northbound lane. The resilient modulus of the base layer of both lanes showed a significant reduction from October 2003 to May 2004. The subgrade resilient modulus did not differ substantially between the three survey periods as shown in Figure 4.18.

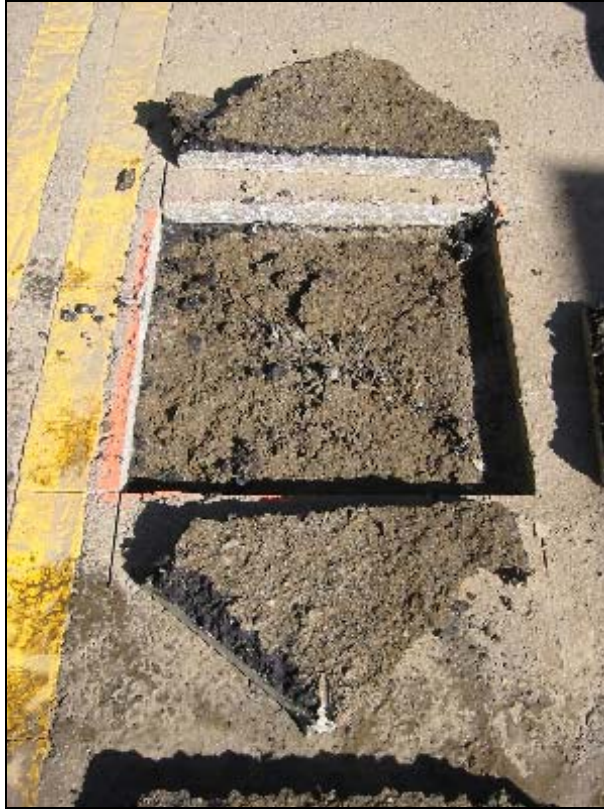
Figure 4.19: Asphalt concrete surfacing removed from the test pit on the mainline.

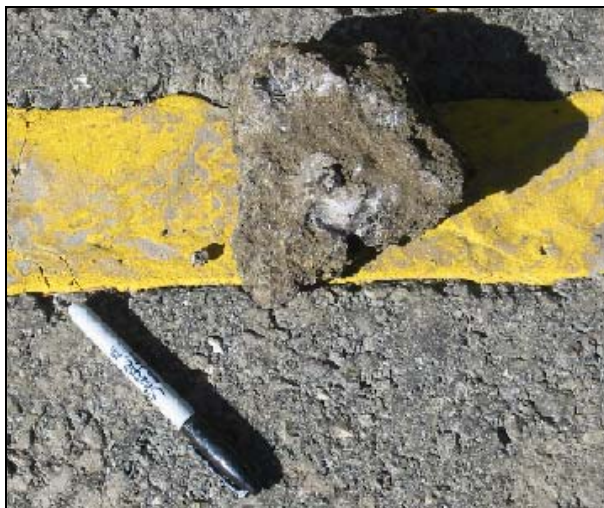
Figure 4.20: Intact piece of reclaimed asphalt concrete found in the mainline test pit.

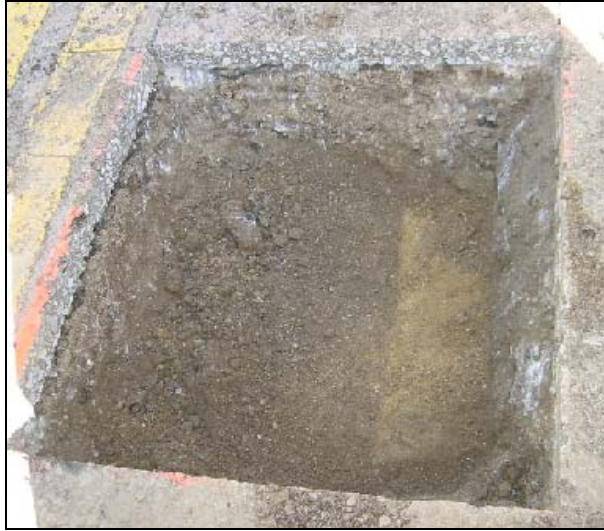
Figure 4.21: Bottom of mainline test pit showing old oil-based pavement.

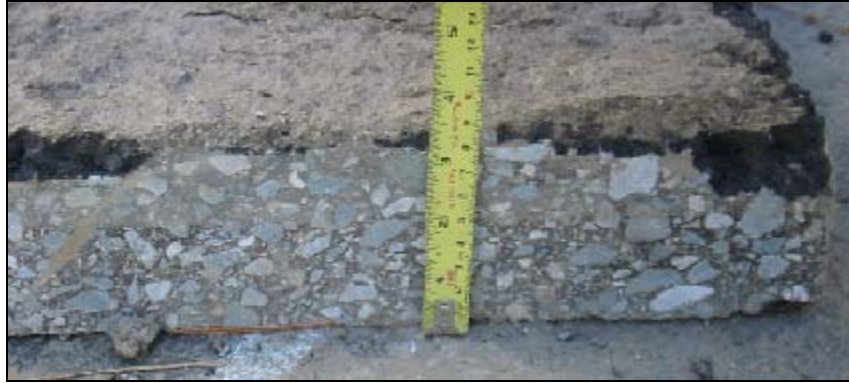
Figure 4.22: Good bond between asphalt concrete and foam asphalt base layer on Section 593FD.

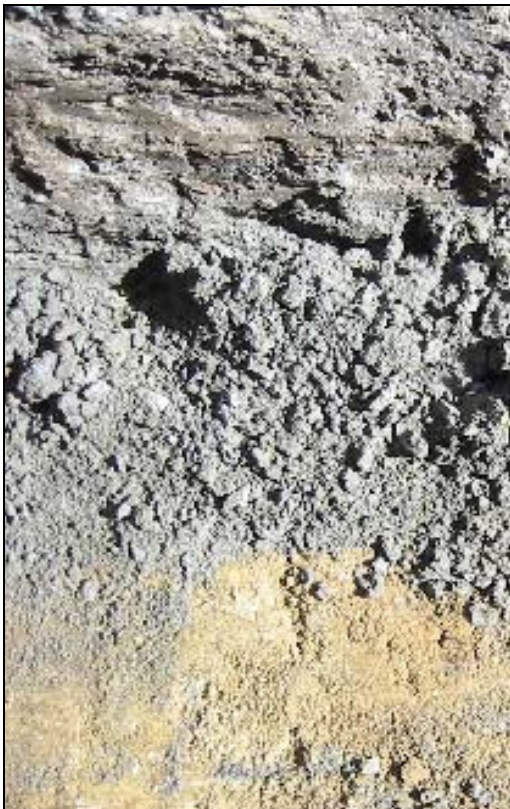
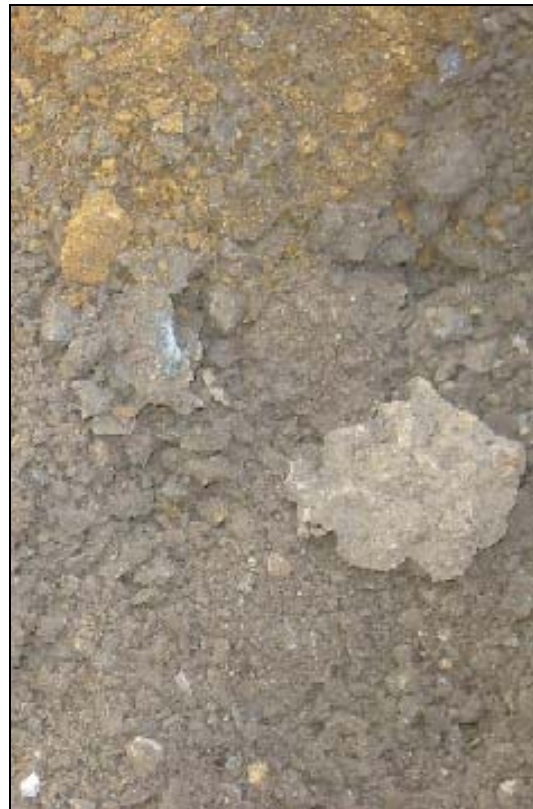
(a) Grey colored material found below the base layer on the HVS lane

(b) The material below the base layer broke out in flaky pieces

Figure 4.23: Grey, clay like material found below the base layer on Section 593FD.

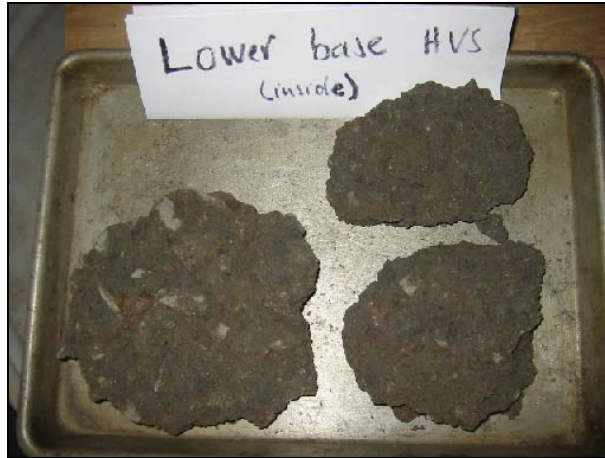
Figure 4.24: Flaky, clay like material from below the base layer on Section 593FD.

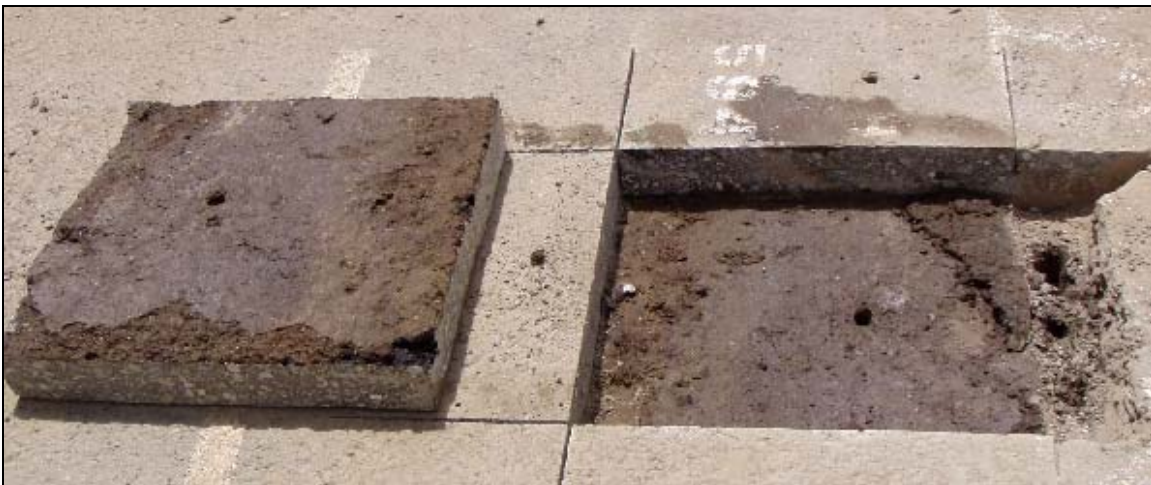
Figure 4.27: Bond between asphalt concrete surfacing and the treated base on Section 594FD.

The photograph in Figure 4.27 shows the asphalt concrete surfacing layer removed from the test pit in Section 594FD. Again, there appeared to be a good bond between the asphalt concrete surfacing and the foamed asphalt treated base layer. However, there did appear to be some lamination near the top of the foamed asphalt treated base layer.

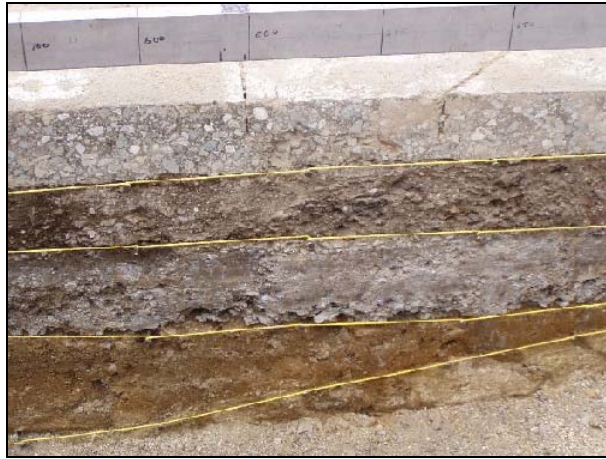
Figure 4.28: Test pit on Section 594FD after HVS trafficking.

A photograph of a section of the 594FD test pit with the layer interfaces marked with string is shown in Figure 4.28. Grey clay-like material layer was again found underneath the foamed asphalt layer. On this section, the subgrade appeared to comprise of two materials, somewhat randomly placed. The lighter material was sandy weathered granite, while the darker material appeared to have more clay particles. It is thought that the materials are essentially the same, but were procured from different areas when the turnout was constructed. This is discussed in Section 4.2.4.

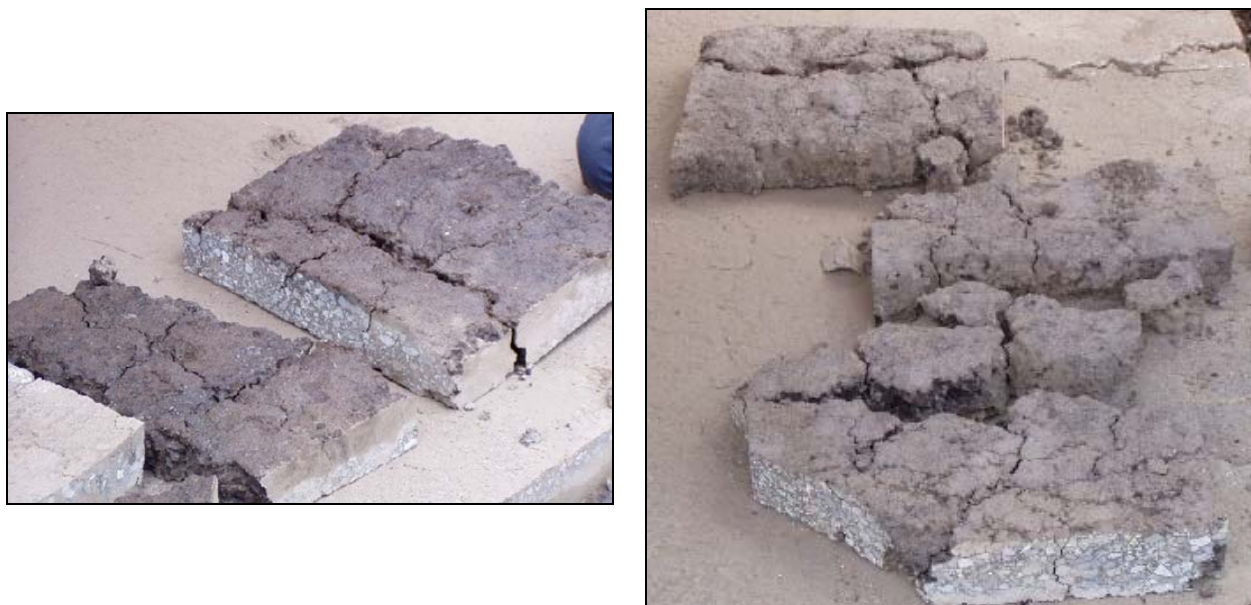
Figure 4.30: Asphalt surfacing from Section 595FD.

The photograph in Figure 4.30 shows the asphalt concrete surfacing layer removed from the test pit excavated on Section 595FD. This section was cracked through the slab, and the slabs broke up when lifted out of the test pit. The slabs from outside the trafficked area remained intact.

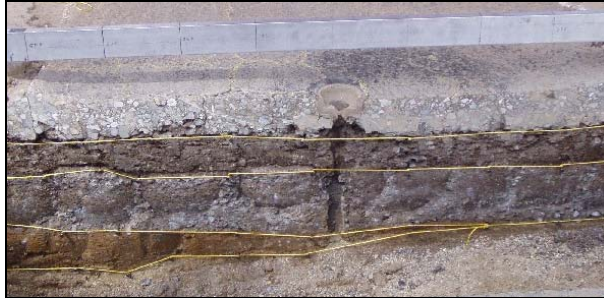
Figure 4.31: Test pit on Section 595FD after HVS trafficking.

A photograph of a section of the 595FD test pit with the layer interfaces marked with string is shown in Figure 4.31. The grey clay-like material layer was again found below the foamed asphalt layer and materials in the subgrade appear to have been mixed as shown in Figure 4.32.

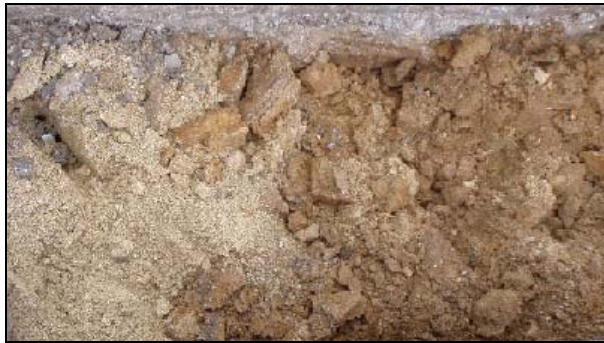
Figure 4.32: Two materials in subgrade on Section 595FD.

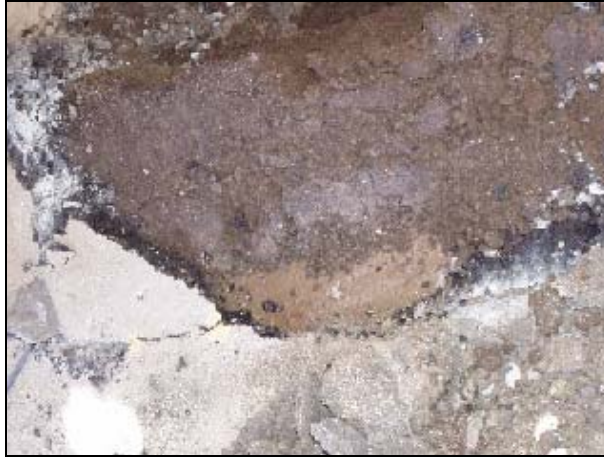
Figure 4.34: Mud between the AC surfacing and treated base, on the side of Section 596FD.

A test pit was opened on the part of Section 596FD that had severe cracking and upward movement on the sides of the test section. When the surfacing was removed, a mud puddle was observed on the side of the caravan side of the test section, illustrated in Figure 4.34. This demonstrates that the water applied to the surface reached the base layer. A large amount of the base material was pushed to the sides of the test section because of this water. This is shown in Figure 4.35 and in the profile in Figure 4.36. Deformation in the layers underneath the base is not evident from the profiles. Average layer thicknesses in the test pit are provided in Table 4.9.

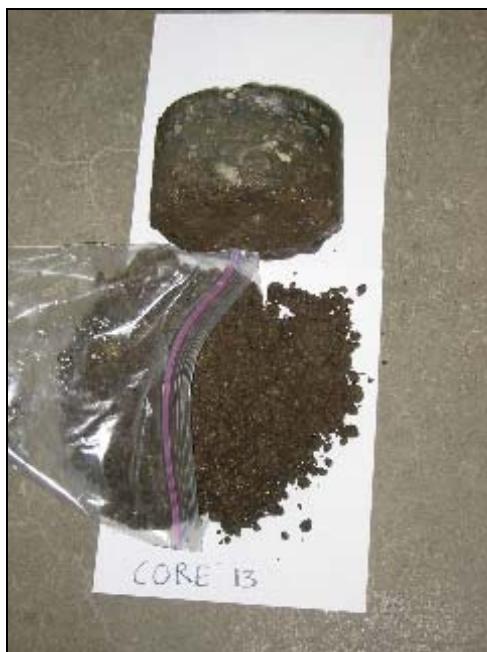
(a) Core 13 taken from the HVS test section

The photographs in Figure 4.41 show cores taken from inside Section 593FD and immediately next to section 593FD. The foamed asphalt treated base appears to have disintegrated under the effect of HVS trafficking as shown by the loose material from Core 13, taken inside the HVS test section. The thicknesses of the asphalt concrete layer were 85 mm on Core 13 and 86 mm on Core 14. The foamed asphalt treated base on Core 14, taken next to the HVS section, came out intact and bonded to the asphalt concrete surfacing layer, but the foamed asphalt treated portion was only 40 mm thick.

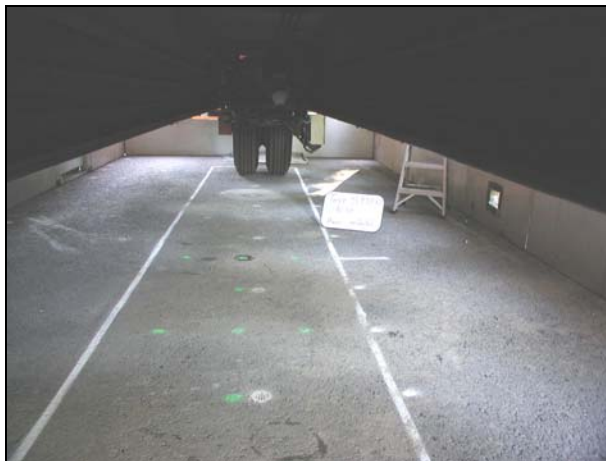
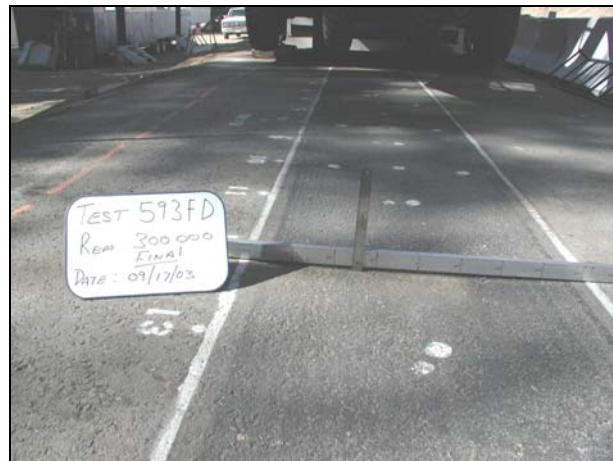
(a) Start of test after 10 repetitions at 60 kN

(b) End of test after 300,000 repetitions

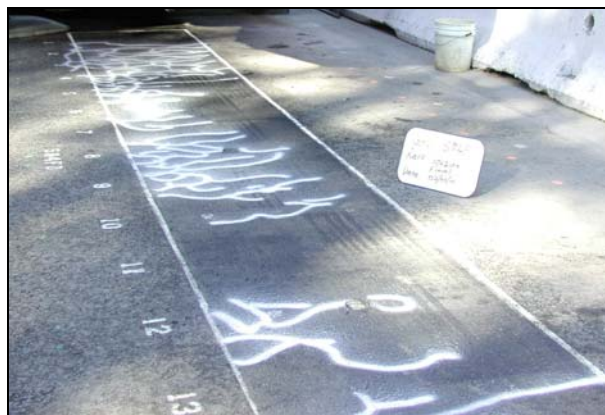
Figure 5.17: Visual condition of Section 594FD at the end of the test.

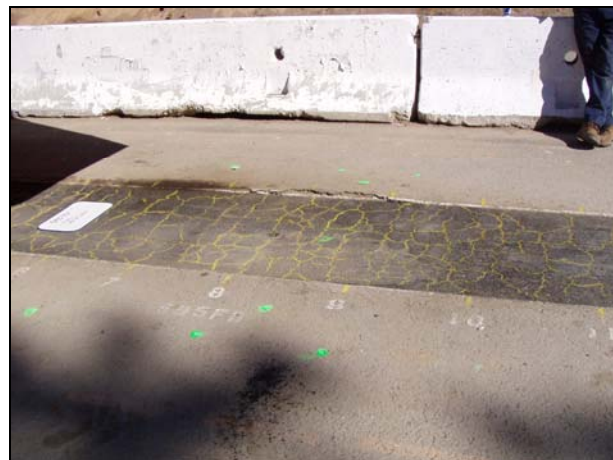
(b) Extensive fatigue of Section 595FD at end of test

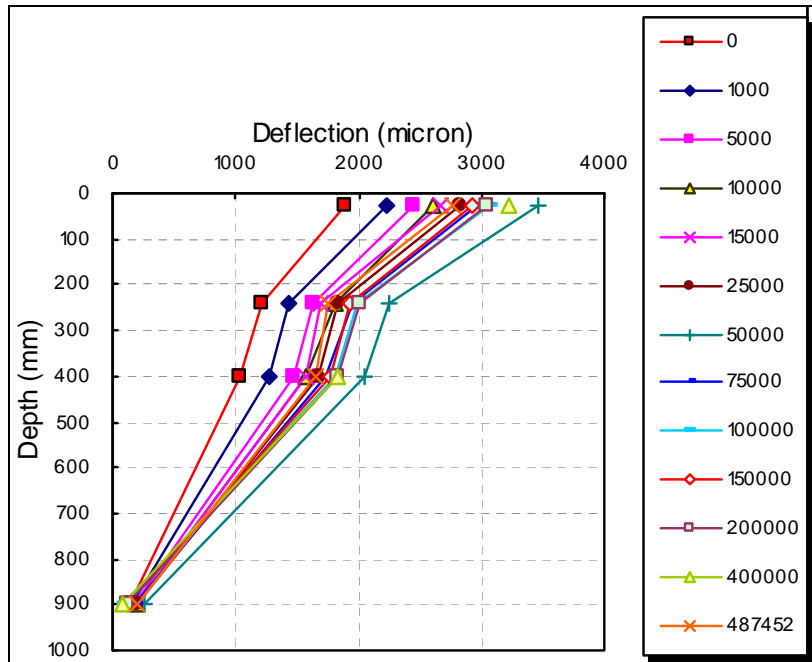
Figure 5.34: 60 kN MDD depth deflection profiles for Section 595FD.

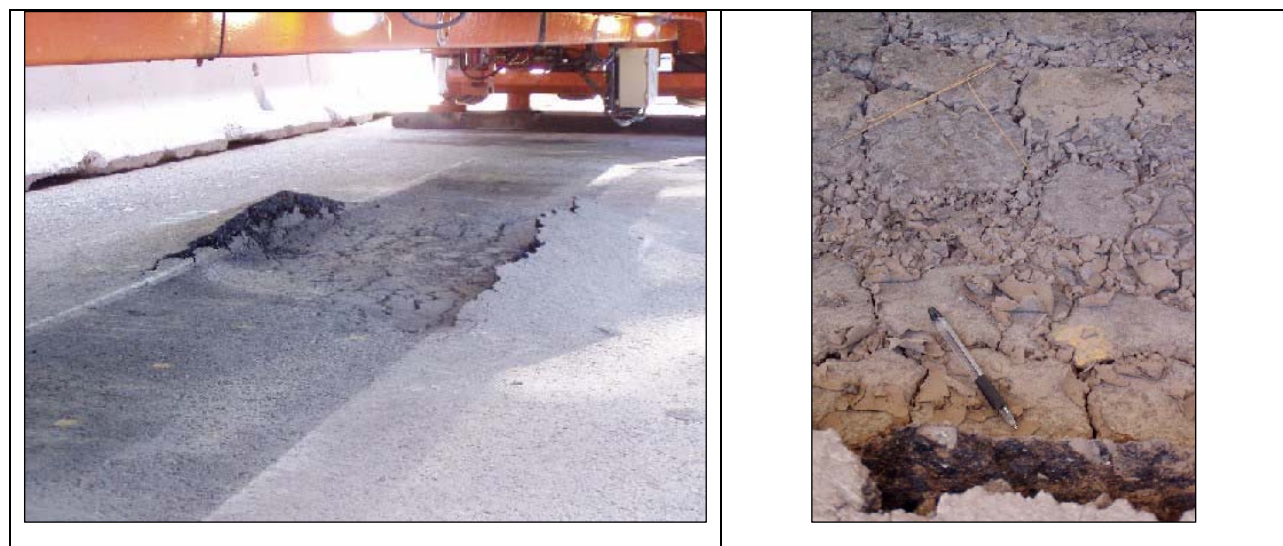
(a) Shear failure between Stations 7 and 8
