# **Longevity of Duct Tape in Residential Air Distribution Systems: 1-D, 2-D, and 3-D Joints**

**Bass Abushakra**

**Energy Performance of Buildings Group  
Indoor Environment Department  
Lawrence Berkeley National Laboratory  
One Cyclotron Road  
Berkeley, CA 94720**

**December 2002**

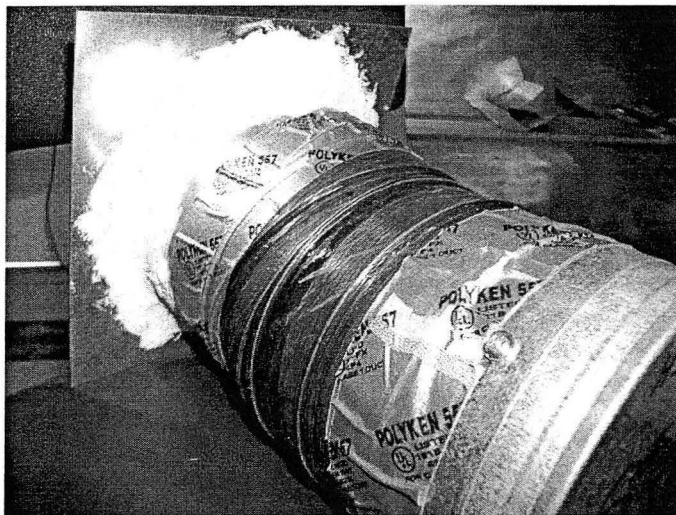
- shrinkage and delamination among the unclamped specimens (Figure 10)
- oozing of the adhesive layer in the foil-butyl tape (Tape 4) specimens (Figure 11)
- little shrinkage and delamination in the strapped specimens
- discoloration of the plastic strapping in the clamped specimens

**Figure 10. Shrinkage and delamination among the unclamped specimens (showing here result of 5 months of aging)**

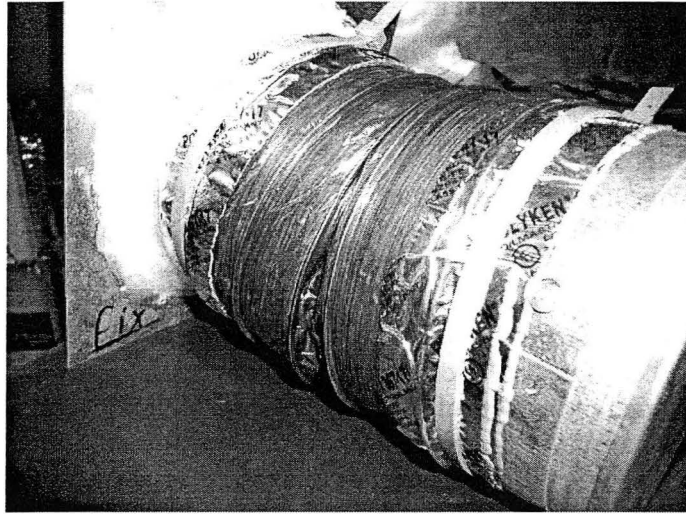
**Figure 11. Oozing of the adhesive layer in the foil-butyl tape (Tape 4) specimens (showing result of 5 months of aging).**

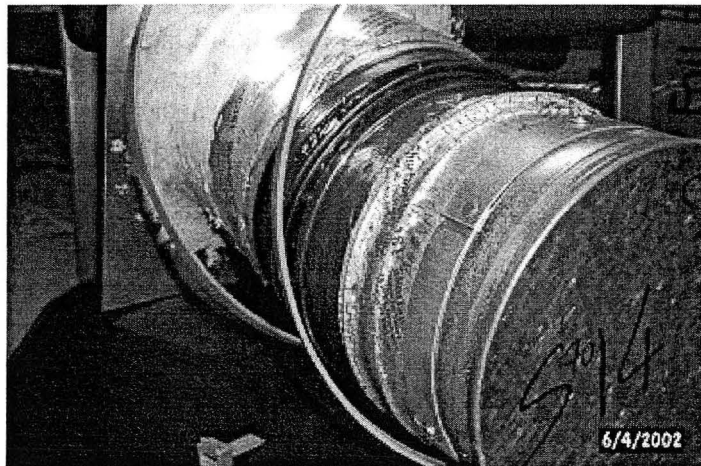
The discoloration of the plastic strapping was an indication of its deterioration which basically lead to a total failure afterward in one case (specimen S7014) after four months of aging. The plastic clamp cracked open due to the increased brittleness of the plastic (Figure 12).

**Figure 12. The failed plastic strapping on one of the flexible core to sheet metal collar specimens after four months of aging.**

Lastly, we found that plastic straps became discolored and brittle during the tests, and a couple of straps broke completely. Therefore, we recommend that clamping the duct-taped flexible core-to-collar joints should be done with metallic adjustable straps.

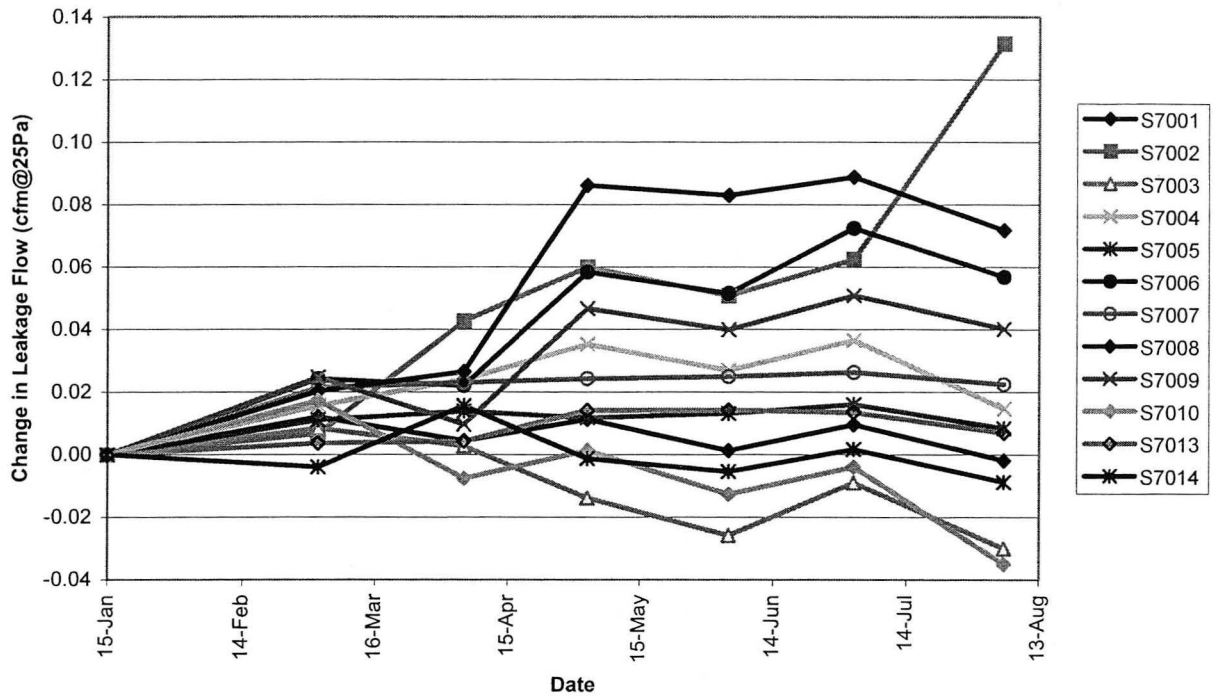
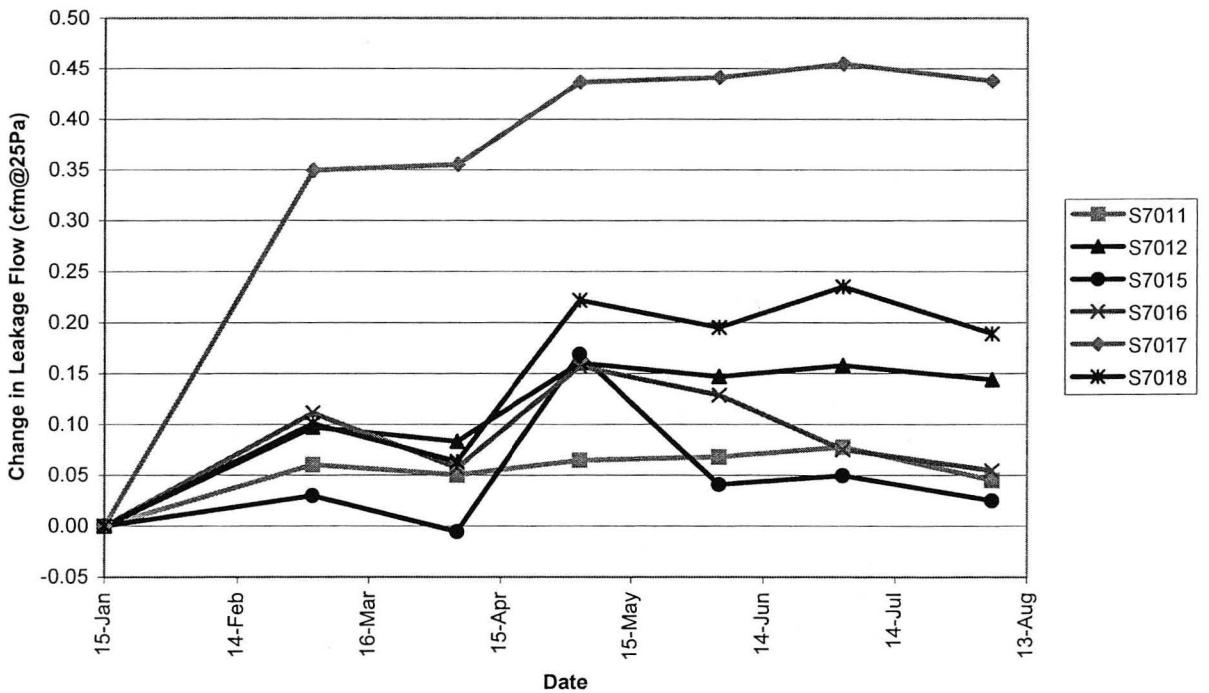
The results are separated in two figures (13 a and b) for clarity. These results show all but one of the samples having an increase in leakage after the first month of testing. After this first month there are no clear universal trends with both increases and decreases in leakage of different magnitudes for different samples. The cases of decreases in leakage illustrate some of the limitations of our test procedure in terms of the resolution of the leakage tests and other issues, such as the changes due to temperature of the test sample during leakage testing (discussed earlier). For example, for the most recent tests, we waited until the samples were cool before testing, which leads to lower measured leakage. In the earlier measurements we did not consider waiting for temperature

stabilization and tested the samples at some intermediate temperature, thus leading to higher measured leakage. The magnitude of the changes in leakage with time and therefore sample temperature shown in Figure 4 indicate that the negative leakage shown in Figures 13a and b is of a similar magnitude to this effect. In addition, a general observation of the core-to-collar joints undergoing an aging test is that the shrinkage of the duct tape can have a positive effect as it tightens up around the joint, unlike the case of a collar-to-plenum joint where the shrinkage of the duct tape makes it peel off and pull away from the surface it is applied to, thus exposing the leaks.

Figure 13 (a and b). The measured change in leakage flow of the flexible core to sheet metal collar joint specimens during the six-month period of the aging test.
