Evaluation of collapse resistance of reinforced masonry wall systems by shake-table tests

Earthquake Engineering & Structural Dynamics, 50(2)

Cheng, Jianyu  
Koutras, Andreas A  
Shing, P Benson

2021-02-01

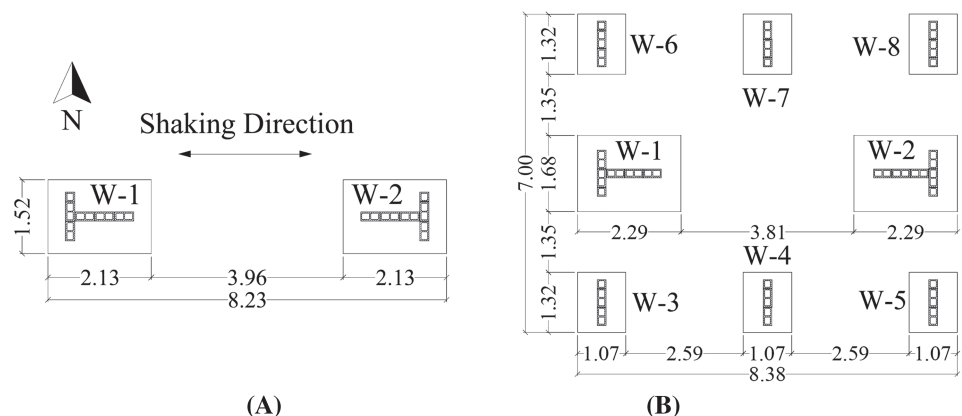
Figure 1 shows the plan layouts of the two RM shear wall systems designed and tested under unidirectional motions on the outdoor shake table in the NHERI (Natural Hazards Engineering Research Infrastructure) facility at the University of California, San Diego. Each specimen had two T-walls as the main seismic force-resisting system. Specimen 2 had six additional rectangular walls with their planes oriented perpendicular to the direction of the shake-table motion. They are referred to as the out-of-plane walls in this paper. One of the objectives of the tests was to investigate the influence of the out-of-plane walls on the seismic resistance of a wall system. To this end, the T-walls in the two specimens had the same design and carried the same gravity load, and the two specimens had the same effective seismic weight.

**FIGURE 1** Plan views of footing and wall layout (in meters): A, Specimen 1; B, Specimen 2

could be attributed to the higher initial stiffness of Specimen 2 because of the out-of-plane wall components. Observations for each specimen in the tests are described below with the wall numbers identified in Figure 1.

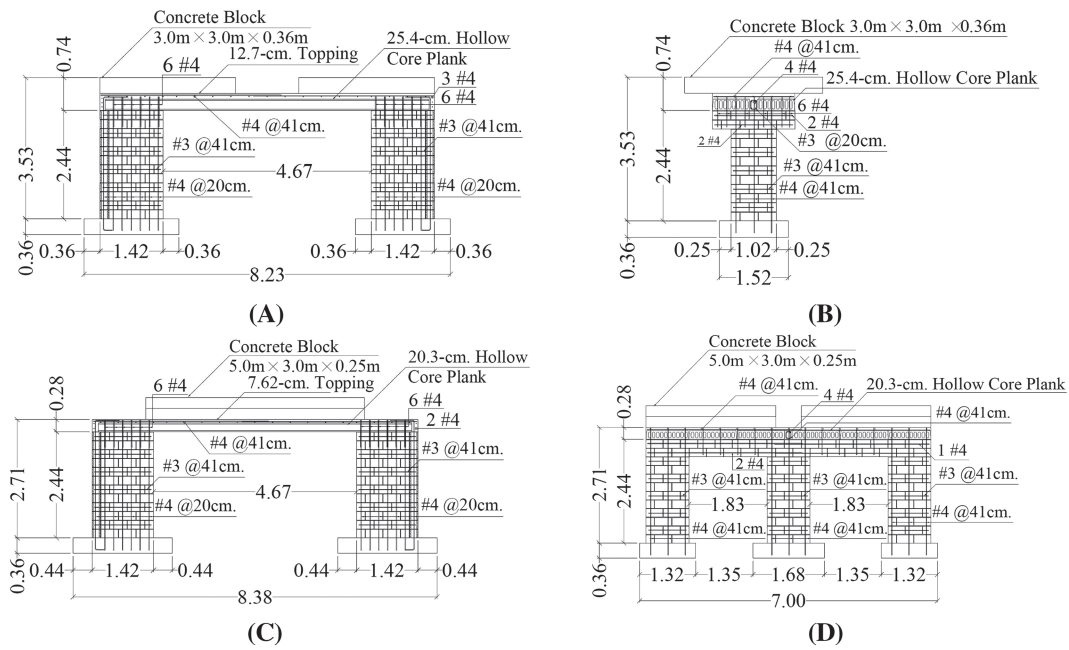
Figure 2 shows the reinforcement details for the two specimens. The reinforcing bars in the walls had a nominal yield strength of 414 MPa (Grade 60 in ASTM standard<sup>24</sup>). Each T-wall had six No. 4 (13 mm) vertical bars spaced at 20 cm (8 in.) on center in the web, and three No. 4 (13 mm) vertical bars spaced at 41 cm (16 in.) in the flange. The horizontal bars in the web and the flange were No. 3's (10 mm) spaced at 41 cm (16 in.) on center. In Specimen 2, each of the out-of-plane walls had No. 4 (13 mm) bars for the vertical reinforcement and No. 3 (10 mm) bars for the horizontal reinforcement, both spaced at 41 cm (16 in.) on the center. The reinforcement complied with the prescriptive requirements of TMS 402/602<sup>3</sup> for walls designed for high seismic areas, but the spacing of the reinforcing bars in the flanges of the T-walls slightly violated the maximum spacing requirement (which is no greater than one third of the wall length). The vertical reinforcement ran continuously from the walls into the footings, and each bar ended with a 90° standard hook in the footing conforming to the ACI 318-14 specification<sup>25</sup> for the development of reinforcement in tension. The surface of the concrete footing underneath each wall was intentionally roughened to increase the frictional resistance.

As shown in Figure 2, the roof slab of Specimen 1 consisted of 25-cm-thick (10-in.) precast prestressed hollow-core planks with a 13-cm-thick (5-in.) cast-in-place concrete topping. Two reinforced concrete slabs, each with dimensions of 3.0 × 3.0 × 0.36 m (10 ft × 10 ft × 14 in.), were secured on top of the roof slab to achieve the target roof mass. For Specimen 2, the roof slab consisted of 20-cm-thick (8-in.) hollow-core planks with a 7.6-cm (3-in.) concrete topping. It had four additional concrete slabs, each with dimensions of 5.0 × 3.0 × 0.25 m (16.5 ft × 10 ft × 10 in.), as added mass. The resulting roof weights of Specimens 1 and 2, including the added concrete slabs, were 245 kN (55.1 kips) and 601 kN (135 kips), respectively. The roof weights of the two specimens were so determined that the T-walls in the two specimens carried the same gravity load. Because the roof slabs were very stiff, the tributary roof load,  $P$ , on each wall was assumed to be proportional to the axial stiffness of the wall. The axial compressive load ratio,  $P/f_m A_g$ , for each T-wall was 0.016, where  $A_g$  is the cross-sectional area of the wall. The compressive strength of masonry,  $f_m$ , was specified to be 17 MPa (2.5 ksi). Including the weight of the masonry walls from the mid-height to the top, Specimen 1 had an

**FIGURE 2** Reinforcement details (in meters unless indicated): A, south elevation view of Specimen 1; B, west elevation view of Specimen 1; C, south elevation view of T-walls in Specimen 2; D, west elevation view of Specimen 2

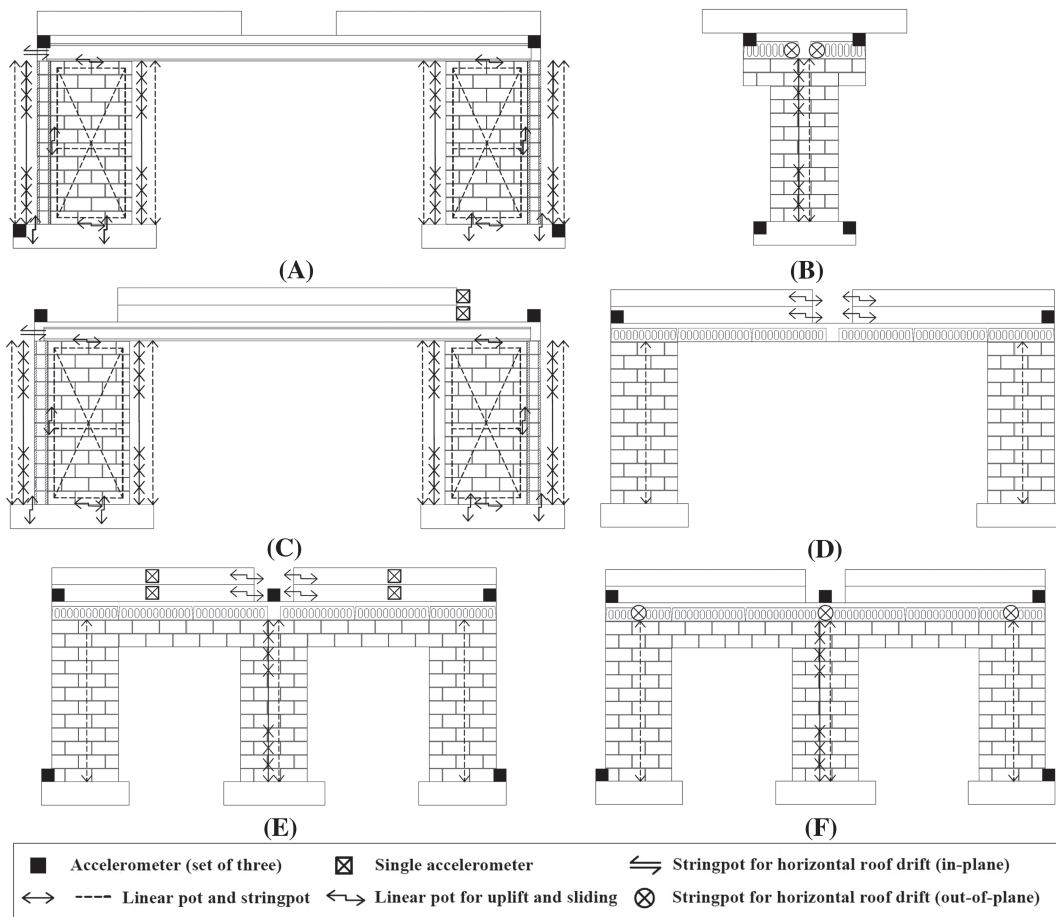
For both specimens, there were seven string potentiometers installed on the north face of the web of each T-wall to measure the wall deformation. As shown in Figure 3A,B, on the east and west sides of a T-wall, a string potentiometer was installed to measure the vertical displacement of the roof slab. For Specimen 2, one string potentiometer was installed along the center line of each out-of-plane wall to measure the vertical roof displacement, as shown in Figure 3D–F. The horizontal displacement of the roof relative to the table (the story drift) was measured by string potentiometers mounted along the east edge of the roof with the ends of the strings attached to a stiff reference frame, which was fixed on the table. As shown in Figure 3B,F, Specimen 1 had two string potentiometers to measure the relative roof displacement, and Specimen 2 had three. The multiple string potentiometers were to check if there was

**FIGURE 3** Instrumentation plans for Specimens 1 and 2: A, north view of Specimen 1; B, east view of Specimen 1; C, north view of two T-walls in Specimen 2; D, west view of two central out-of-plane walls in Specimen 2; E, west view of Specimen 2; F, east view of Specimen 2

horizontal rotation of the roof. Figure 3A,C also shows that 14 linear potentiometers were installed on the east and west sides of each T-wall to measure the flexural deformation (seven potentiometers on each side). The remaining linear potentiometers were used to measure the uplift and sliding of the base of each T-wall relative to the footing, the sliding between the top of each wall and the roof slab, and the sliding between the web and the flange if any.

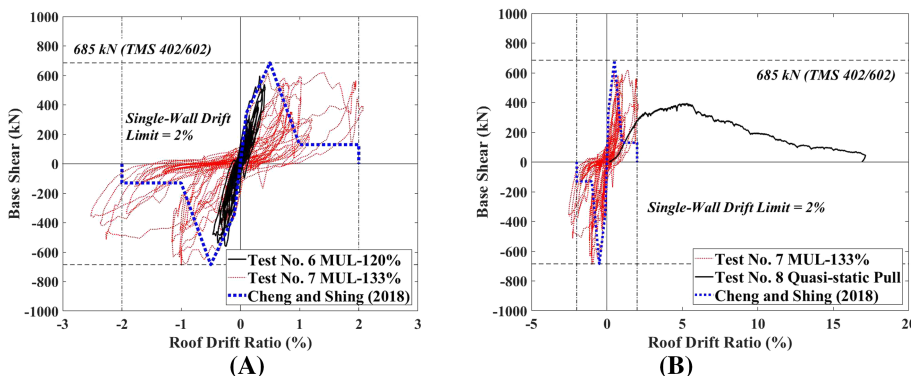
**FIGURE 8** Base shear–roof drift ratio curves for Specimen 1: A, responses from the ground motion tests; B, results from the quasi-static and last ground motion tests [Colour figure can be viewed at wileyonlinelibrary.com]

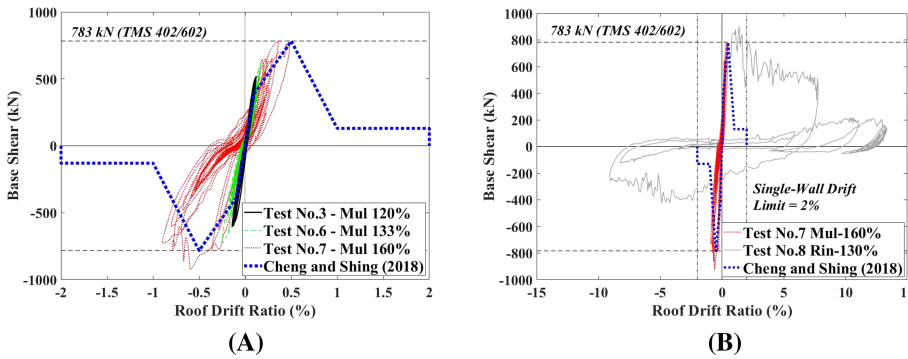
Figure 11A shows the base shear–roof drift ratio curves for the 120%- and 133%-level Mulholland motions applied to Specimen 2. During the test with MUL-120%, the specimen reached a maximum base shear of 598 kN (135 kips) at a drift ratio of 0.14%. The fundamental period increased to 0.121 s after this motion and remained unchanged after the following MUL-90%. Figure 11A also shows that the specimen developed nonlinearity during MUL-133%. The peak drift ratio reached in the test was 0.25%, whereas the maximum base shear developed was 726 kN (163 kips). The period of the specimen increased to 0.164 s, indicating some damage.

**FIGURE 11** Base shear–roof drift ratio curves for Specimen 2: A, Mulholland motions; B, last two motions [Colour figure can be viewed at [wileyonlinelibrary.com](http://wileyonlinelibrary.com)]

During MUL-160%, the period of the specimen elongated from 0.164 to 0.328 s. A maximum drift ratio of 0.90% was reached. As shown in Figure 11, the base shear capacity of 925 kN (208 kips) was reached at a roof drift ratio of 0.60% in the negative (west) direction. During the test, load degradation was relatively mild, about 22% with respect to the peak. Figure 12 shows the crack pattern obtained after MUL-160%. Flexural and diagonal shear cracks occurred in the webs of the T-walls. As shown in Figure 12A, in the web of Wall 1, a major diagonal crack extended from the top right corner to the wall flange above the fourth course of masonry units from the base and then propagated as a horizontal crack in the flange. On the same wall, a crack developed along the flange–web interface, propagating from the end of the major diagonal crack down to the wall base. In Wall 2, major diagonal cracks extended into the toe of the web at one end and to the flange at an approximately 60° angle with respect to the horizontal at the other, propagating vertically up along the web–flange interface. Similar to Wall 1, one diagonal crack extended into the wall flange and formed a horizontal crack on the flange. Furthermore, several flexural cracks initiated and propagated in the lower part of the wall webs. Toe crushing occurred in the web of Wall 2. As shown in Figure 12C,D, horizontal cracks developed at the top of the out-of-plane walls right below the lintel. For the two middle out-of-plane walls (Walls 4 and 7 as identified in Figure 1), no visible cracks were observed.

During RIN-130%, the T-walls developed severe damage. A maximum drift ratio of 13.4% was reached, but the structure did not collapse. The base shear–roof drift ratio curves in Figure 11B show that the maximum base shear reached 902 kN (203 kips) at a drift ratio of 1.39% in the positive (east) direction. The specimen developed a residual strength of 185 kN (41.6 kips), which was about 20% of the peak strength (208 kips) reached during MUL-160%. Figure 13 shows the damage of the specimen after the test. The diagonal cracks developed during MUL-160% extended further and were accompanied by the opening of new diagonal cracks in the webs of the T-walls. As in the quasi-static test of Specimen 1, severe masonry crushing occurred in the wall webs. The webs and flanges of the T-walls were practically separated. The failure of the 90° hooks connecting the flanges and webs was observed, along with the fracture of the horizontal bars crossing the flange–web interfaces. The flanges of the T-walls exhibited severe out-of-plane bending at the elevation of the horizontal cracks that developed in motion MUL-160%. Figure 13E shows that masonry spalling occurred on the east face of Specimen 2. Moreover, cracks radiated from the corners between the lintels and the out-of-plane rectangular walls, as shown in Figure 13B,F. However, the roof slab remained practically intact during the test.

masonry prism tests and the tensile tests of the bars, which are shown in Tables 1 and 2. For Specimen 1, the calculated shear strength is 685 kN (154 kips), which is almost identical to the peak strength of 689 kN (155 kips) reached in the test, as shown in Figure 8. For Specimen 2, the calculated strength is 783 kN (176 kips), which is 142 kN (32 kips) lower than the peak strength reached during MUL-160%, as shown in Figure 11.

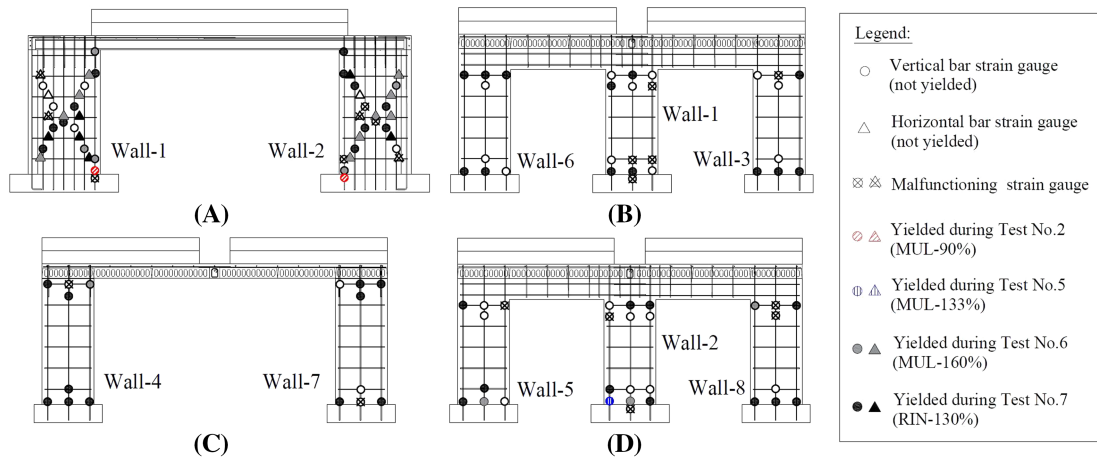
In Specimen 2, the vertical bar yielded in tension at the toe of the web of Wall 1 during test No. 2 (with MUL-90% motion), as shown in Figure 15A. In addition, the extreme vertical bar in the web of Wall 2 yielded in the region embedded in the concrete footing, indicating strain penetration. During MUL-133%, a vertical bar in the flange of Wall 2 yielded near the base. Yielding of the bars during these motions indicates that the walls were subjected to significant flexural deformation before the peak capacity was reached. During MUL-160%, with the initiation of diagonal cracks in the webs of the two T-walls, yielding occurred in the vertical and horizontal bars at locations intersected by diagonal shear cracks. Meanwhile, a few vertical bars in the wall flanges and the out-of-plane walls yielded. During the last test with RIN-130%, more bars in the webs of the T-walls yielded due to the opening of major diagonal cracks. After this test, most of the vertical bars at the top and bottom of each out-of-plane wall and T-wall flanges had yielded, showing that the walls were subjected to double-curvature bending.

**FIGURE 15** Yielding of reinforcing bars in Specimen 2: A, webs of T-walls; B, flange of Wall 1 and two west out-of-plane walls; C, two middle out-of-plane walls; D, flange of Wall 2 and two east out-of-plane walls [Colour figure can be viewed at wileyonlinelibrary.com]

The reinforcing bars in the two specimens had similar yielding sequences. Yielding first occurred in some of the vertical bars near the base of the two T-walls due to the flexural deformation. After the diagonal shear cracks opened, most of the horizontal and vertical bars in the webs of the T-walls yielded at the locations where the diagonal cracks passed. For Specimen 1, the opening of the diagonal shear cracks in the wall webs was accompanied by the yielding of the vertical bars near the top of the flange of Wall 2. For Specimen 2, yielding was detected in most of the vertical bars near the top and bottom of the T-wall flanges and the out-of-plane walls during the last ground motion test.
