High temperature degradation by erosion-corrosion in bubbling fluidized bed combustors

# High Temperature Degradation by Erosion-Corrosion in Bubbling Fluidized Bed Combustors

P. Y. Hou<sup>1</sup>, S. MacAdam<sup>2</sup>, Y. Niu<sup>3</sup> and J. Stringer<sup>4</sup>

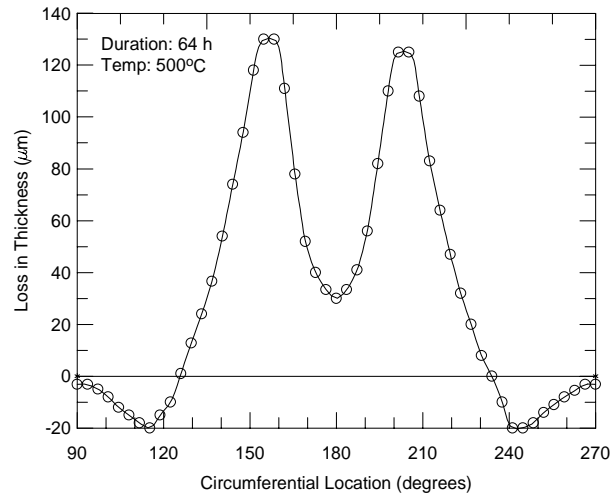
Fig. 2. Typical circumferential distribution of wastage over the bottom half of the specimen rods, where the bottom is at 180°.

The erosion behavior of 1018 mild steel at temperatures from ambient to 540°C was studied. A typical wastage distribution about the lower half of the specimen, measured in degrees that are referenced to 0° at the rod top, is shown in Figure 2. The maximum material loss is between 25° and 30° on either side of the bottom. Near the sides from the bottom, there was a thickness increase caused by the buildup of a

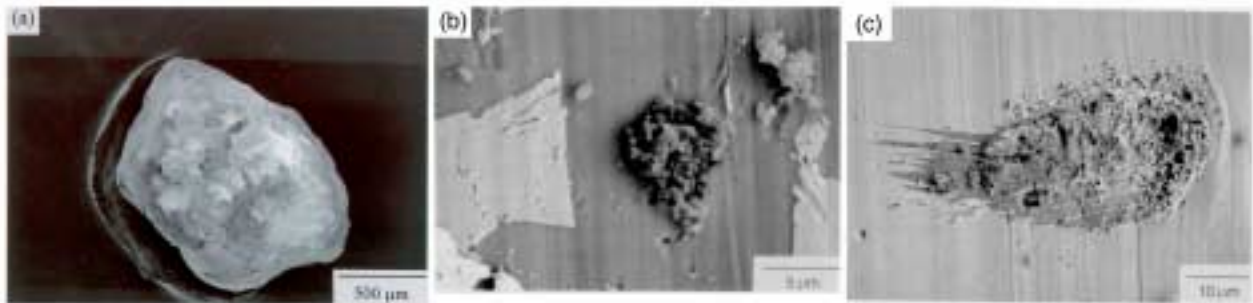
Fig. 6. (a) SEM image of a bed particle under high dust condition, (b) and (c) show depositions of fine bed particles on a gold-coated specimen tested for 30s at 300°C.

To better understand the process of deposit formation, bulk bed particles were first examined carefully under the SEM, then a specimen surface was observed in the earliest stage of deposition. Figure 6(a) shows a bed particle taken at the conclusion of a test that showed protective behavior. The particle is partially encased by a loosely adherent layer that spalled easily upon cooling. At higher magnifications, the encased layer was found to consist of fine bed particles that had agglomerated together to form micron sized clusters. Scoring marks on the encased layer suggest that it was formed and compacted by compression that probably resulted from impacts with the specimen or with other bulk bed particles. The encasement increased with temperature, and more obviously, with the dust concentration in the bed [24]. Although gross metal deformation was not essential for deposition to occur, as seen in (Fig. 6b), more deposition occurred at locations of significant impacts, as in (Fig. 6c). Protective deposit layer, therefore, is believed to have formed by the transfer of agglomerated layer segments that were first formed on the bulk bed particles. The transferred clumps when first deposited on the specimen are relatively loosely bonded, but are compacted with repeated impacts, and a dense continuous layer is formed. The fact that spallation of the deposit and oxide layer occurred at the oxide/metal interface, with the overlying deposit remaining attached to the oxide, suggests a relatively strong bond between the oxide and the deposit. It also implies that the initial interaction between the fine particles and the oxide layer may be important.

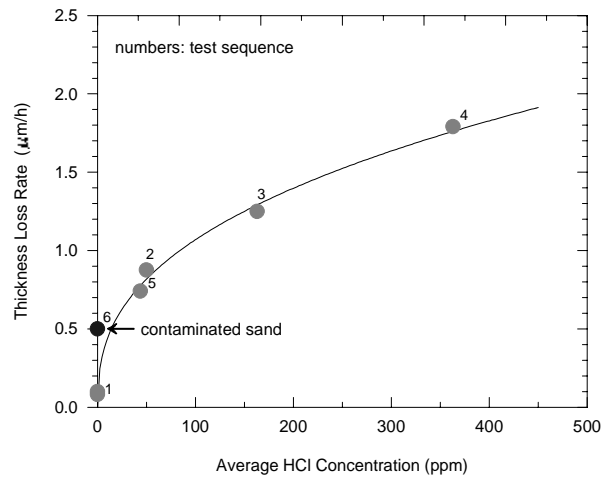
Fig. 8. Effect of HCl dosage on the maximum wastage rate at 300°C.

The maximum wastage clearly increased with higher HCl concentration. The increase was fast with initial increase in HCl, then became more gradual and slowly approached a steady state level. After testing in HCl, the bed material was apparently contaminated, because further testing in the bed without any flow of HCl gas resulted in an accelerated wastage rate. According to the dosage dependence shown in Fig. 8, this contamination is equivalent to an HCl concentration of about 20 ppm. The fact that HCl can remain in the bed and cause a noticeable increase in wastage raises some practical concerns, particularly with down time corrosion where HCl can react with moisture to cause severe pitting attack.

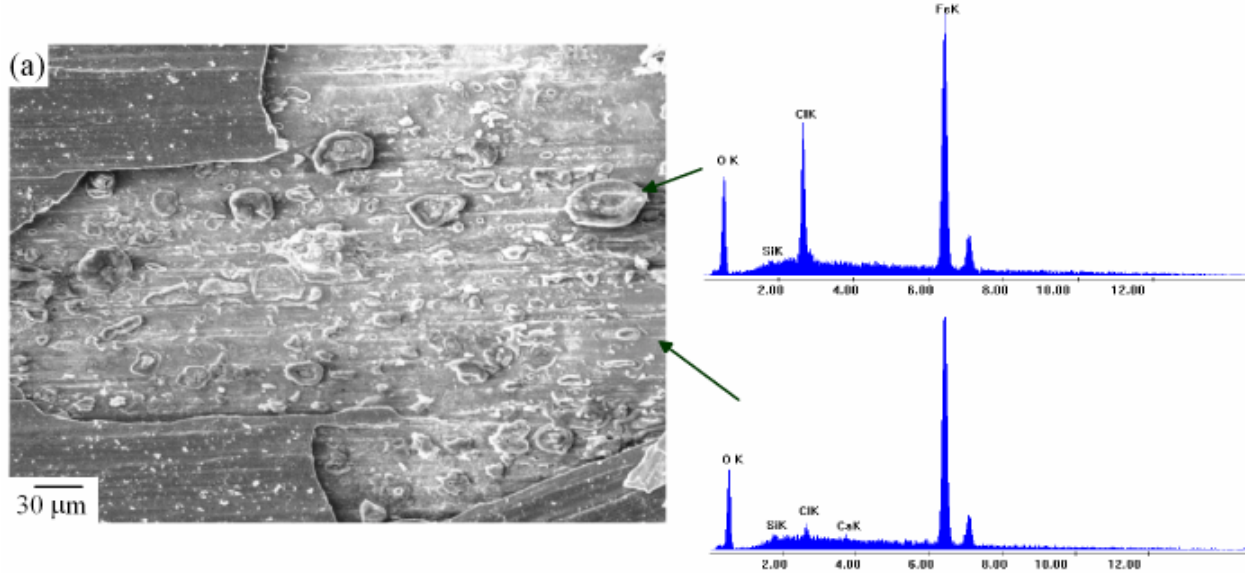
Fig. 9. SEM micrograph of the top surface (near  $0^\circ$ ) on a specimen tested at  $400^\circ\text{C}$  for 24h with 50 ppm HCl. EDS analyses show compositions of the nodule and the thin oxide on the alloy surface.

Microstructural and compositional characterization of the specimens showed that under all HCl containing test conditions, Cl was detected on the specimen surface and its concentration was higher near the scale/alloy interface. Specimens tested with HCl addition showed significantly greater scale spallation than those tested without. The phenomenon was more severe with higher testing temperatures and occurred only on the top half of the specimen where there was no impact. Figure 9 shows the top surface of a 400°C sample. Most of the scale had spalled leaving a thin layer of iron oxide on the metal. In this thin oxide layer a small amount of chlorine was detected. Cl-rich nodules 5-40 µm in size were
