North Campus Open Space Restoration Project First Year Monitoring Report (2018)

2019-02-22

**North Campus Open Space Restoration Project
First Year Monitoring Report (2018)**

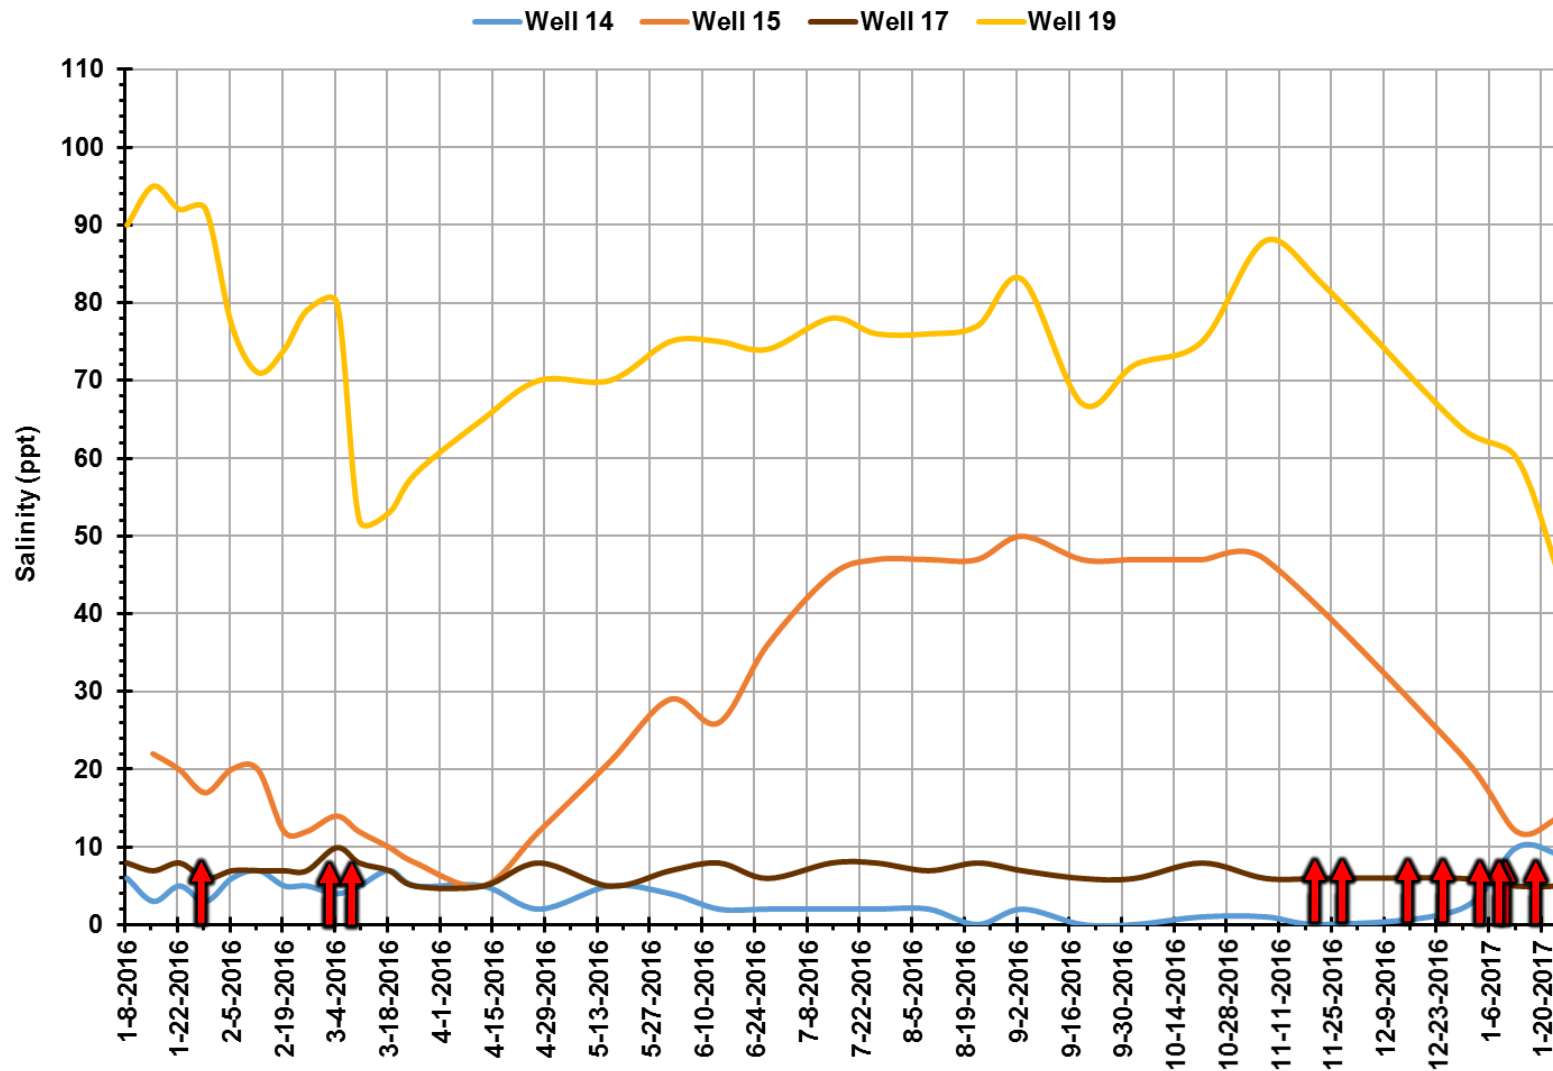
North Campus Open Space Groundwater Salinity in 2016

Figure 18. Groundwater salinity (in parts per thousand) measured in four index wells on North Campus Open Space in 2016, one year prior to the beginning of restoration. The red arrows represent rainfall amounts of 0.5 inches or greater in one day.

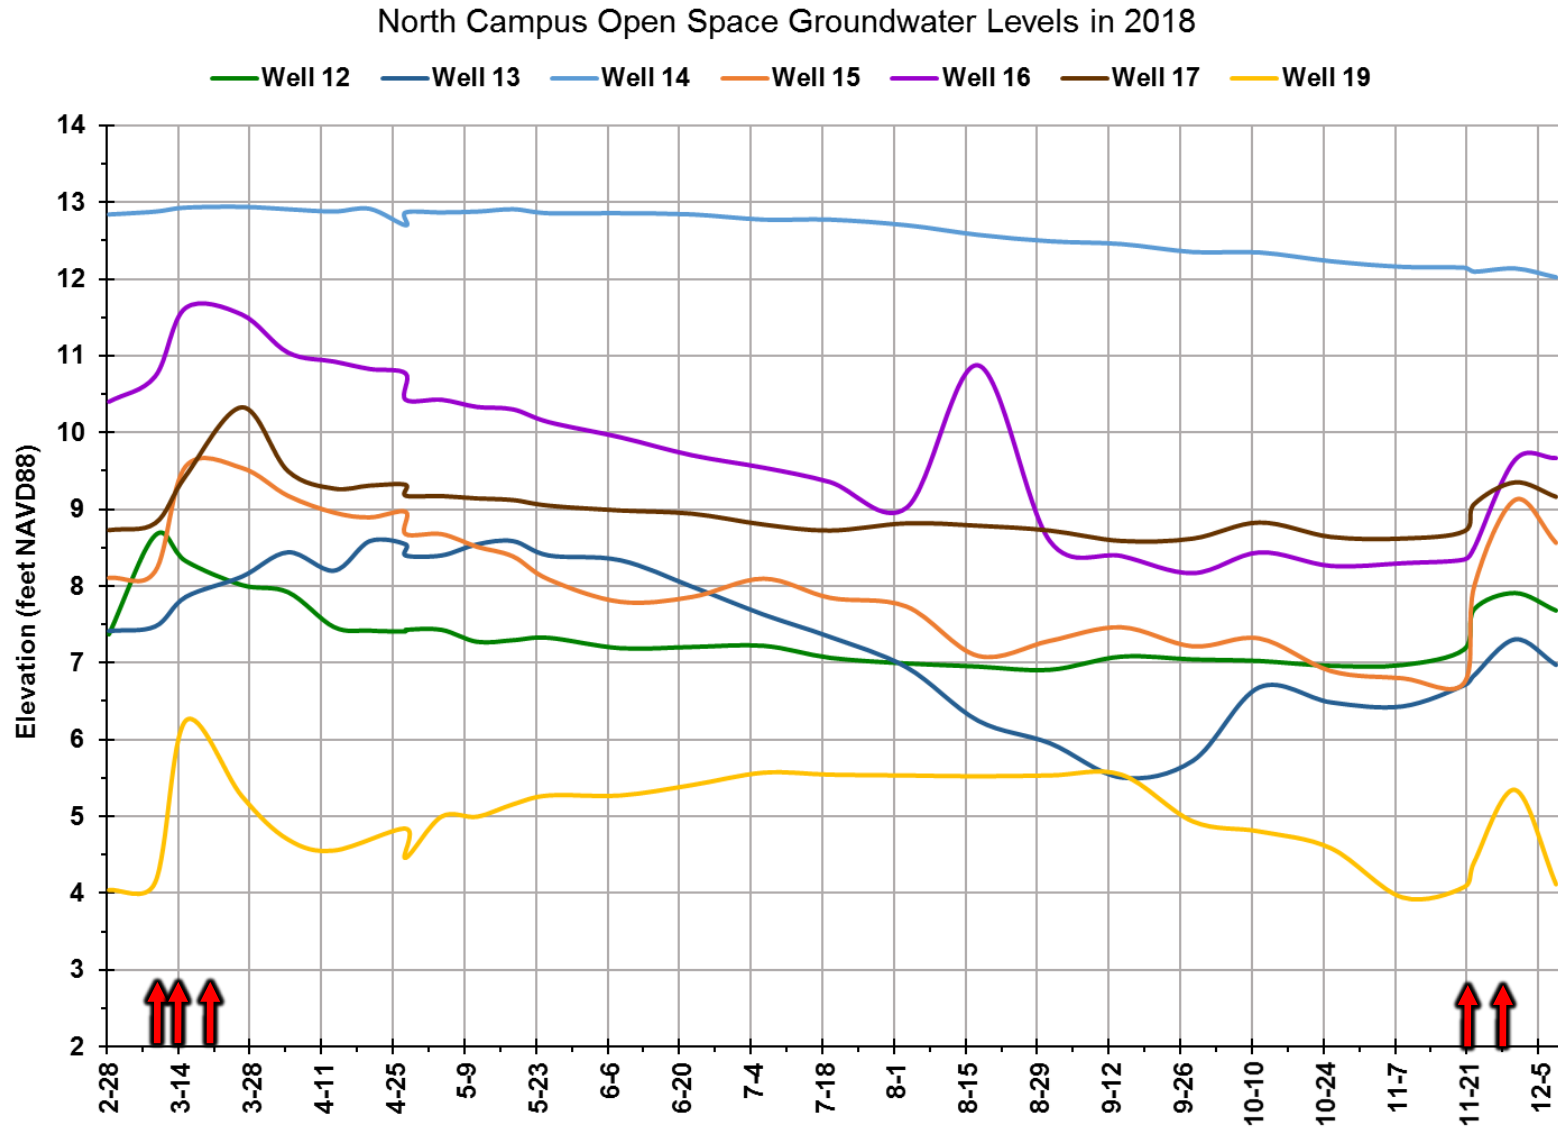
Figure 20. Groundwater elevation level (in feet NAVD88) measured in seven index wells on North Campus Open Space in 2018, the first year following the completion of the grading phase of restoration. The red arrows represent rainfall amounts of 0.5 inches or greater in one day.

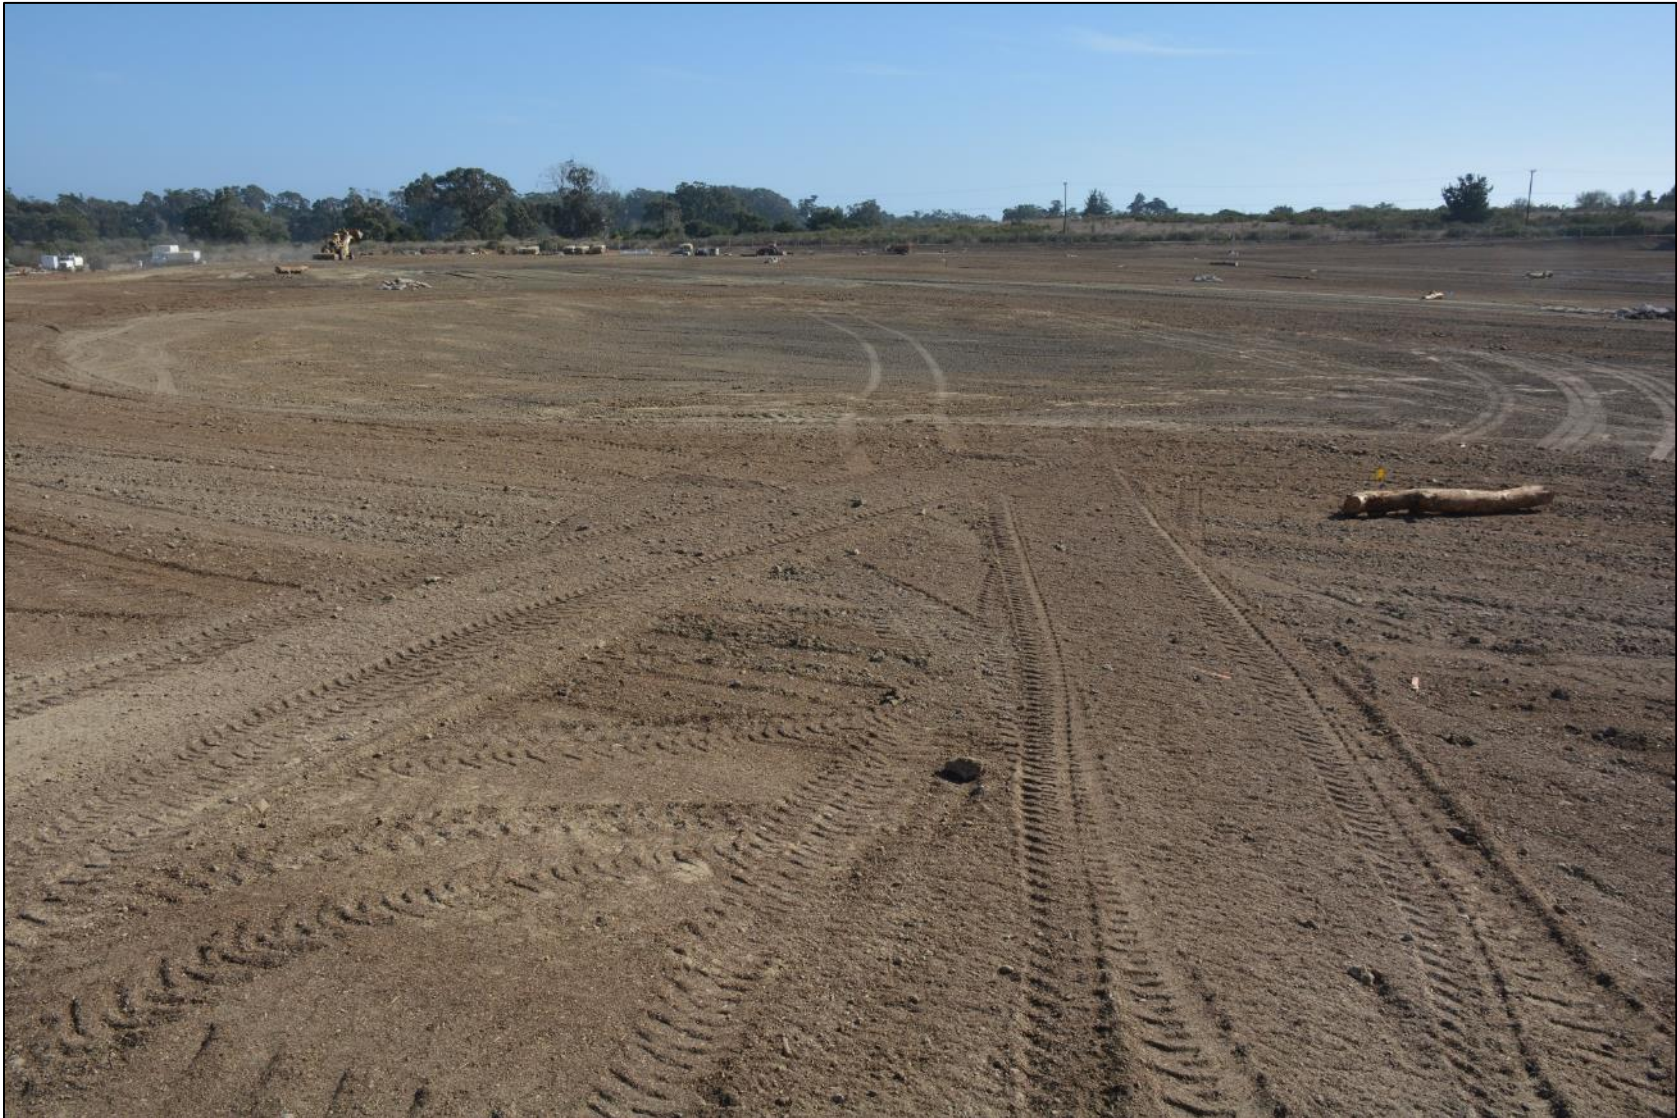
Photo point 15-SE – looking southeast from the Mesa trail, across the eastern-most vernal pool.

Baseline photo – post-grading, October 10, 2017.

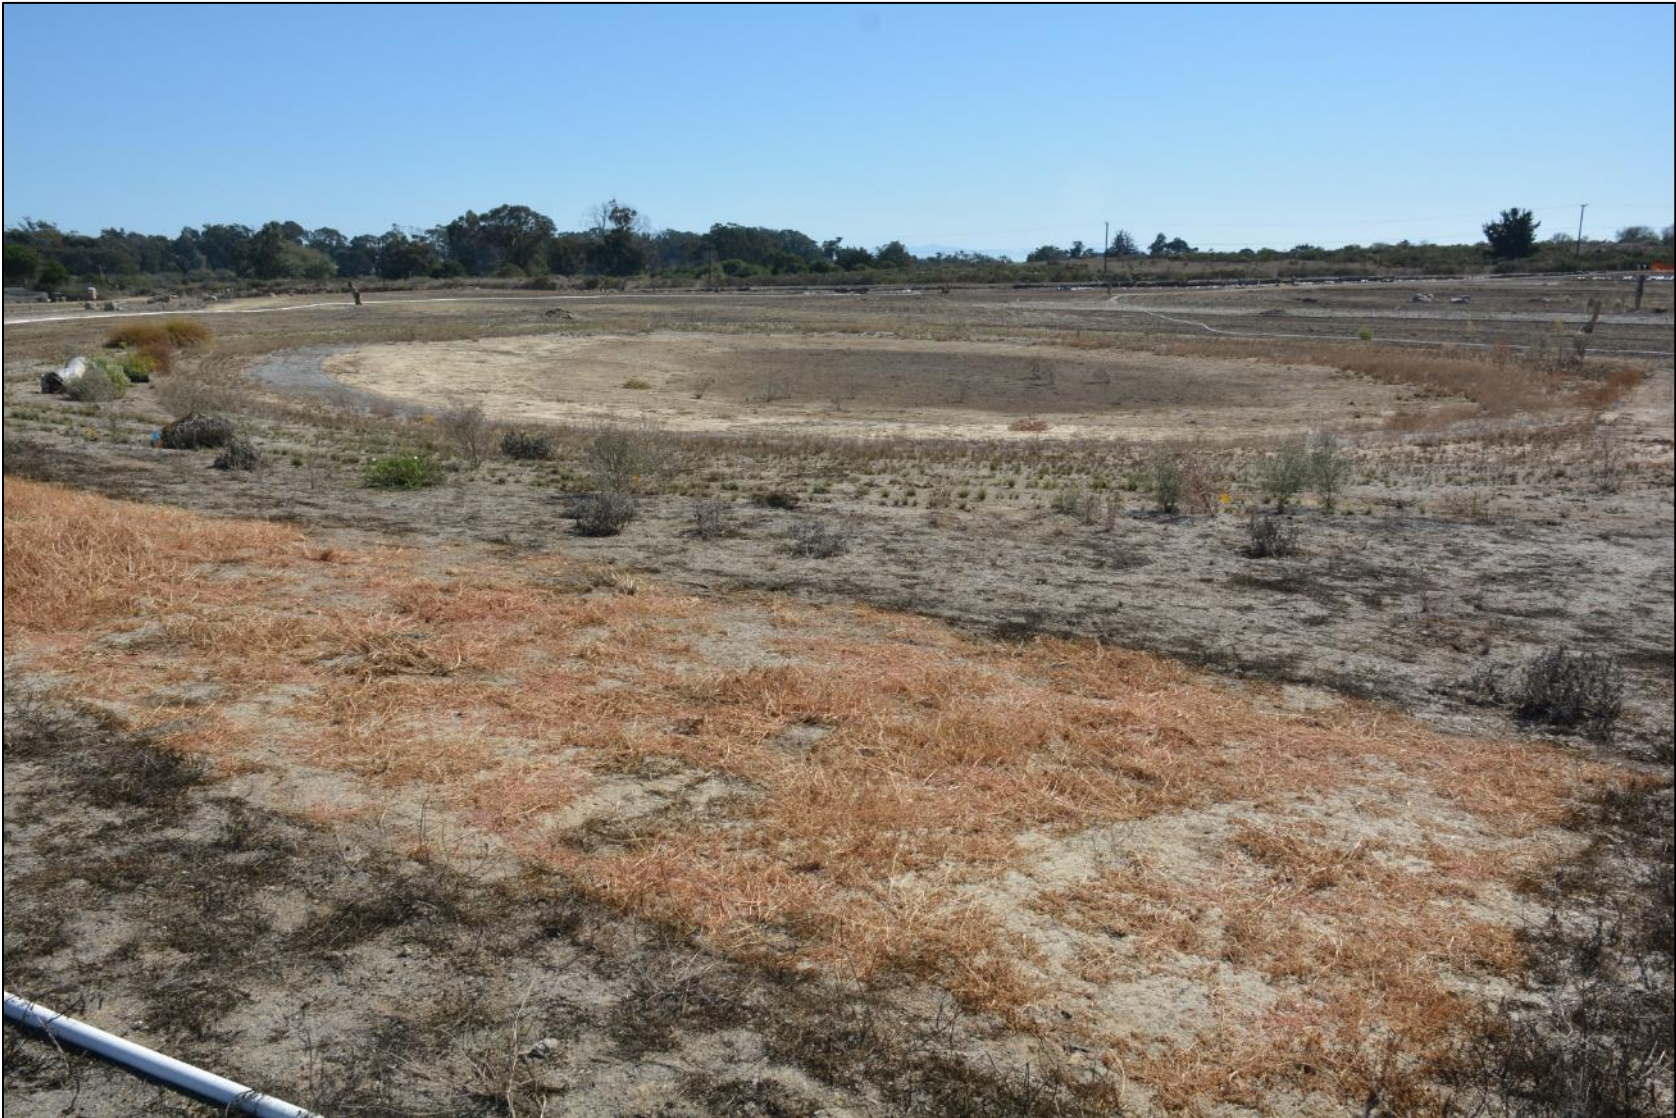
Photo point 15-SE – looking southeast from the Mesa trail, across the eastern-most vernal pool.

Year 1 photo – October 16, 2018.

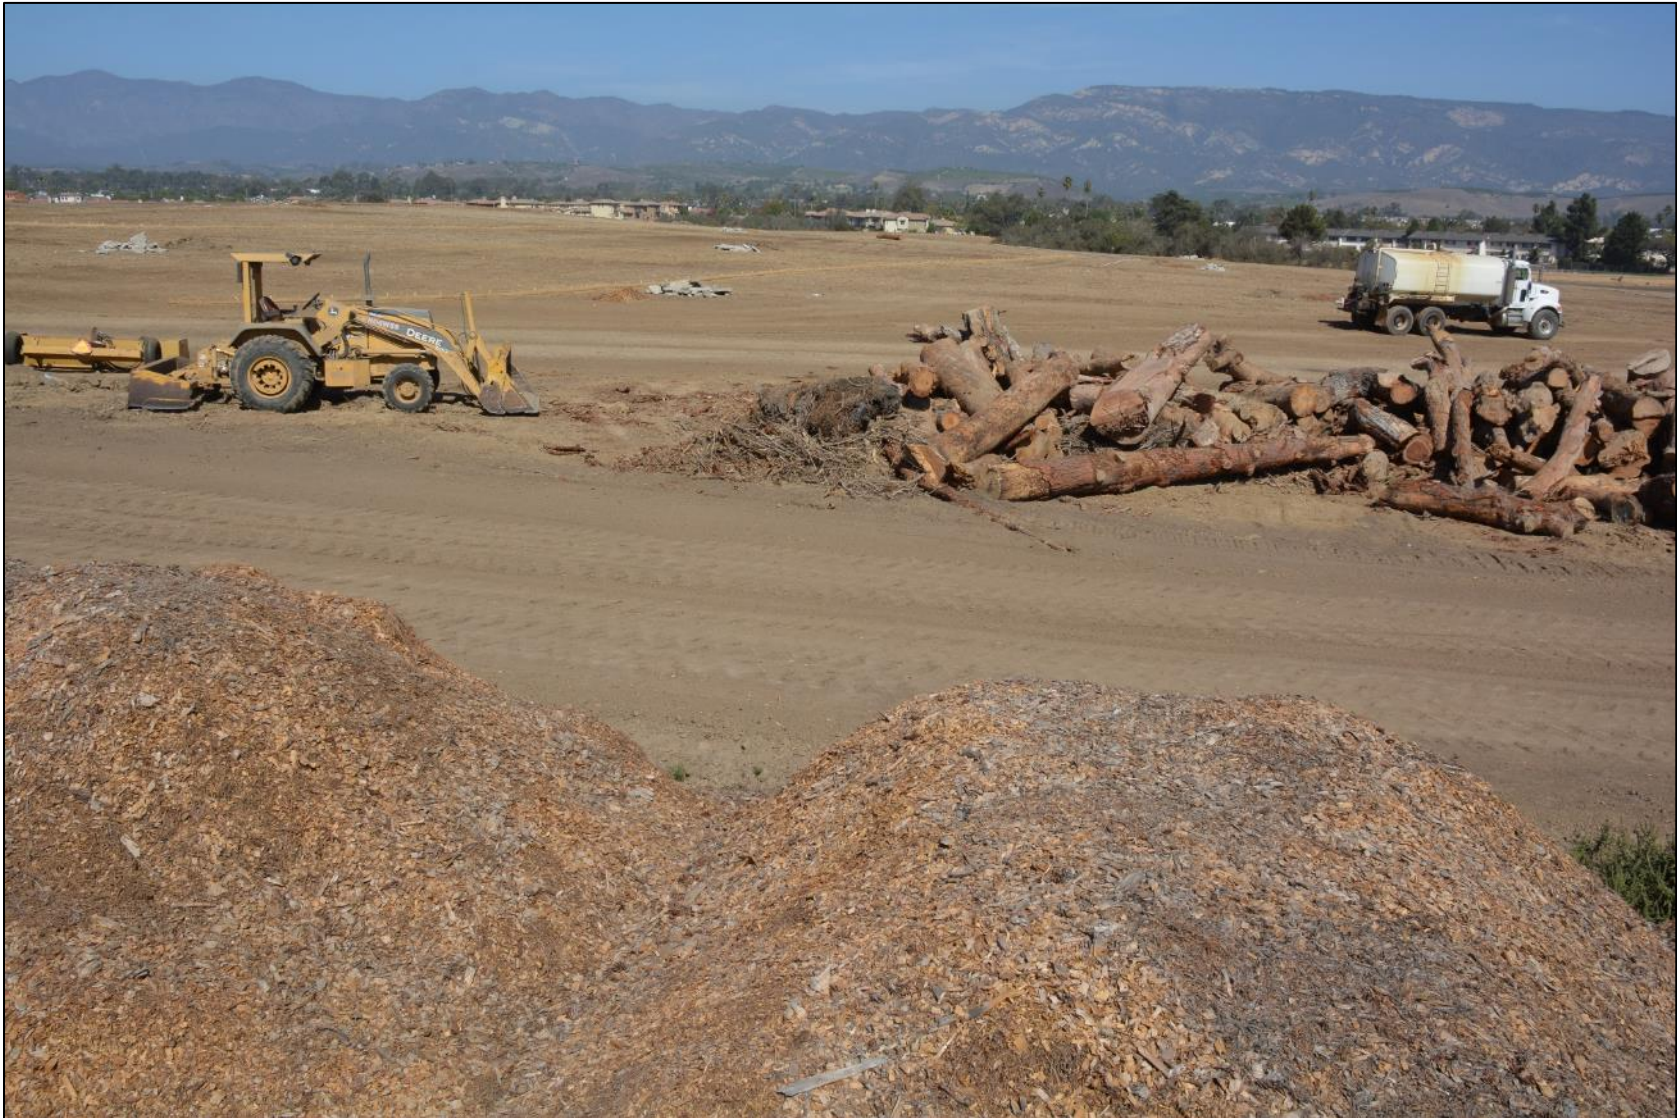
Photo point 16b-N – looking north from Venoco Road, across the drill-seeded grassland area.

Baseline photo – post-grading, October 10, 2017.

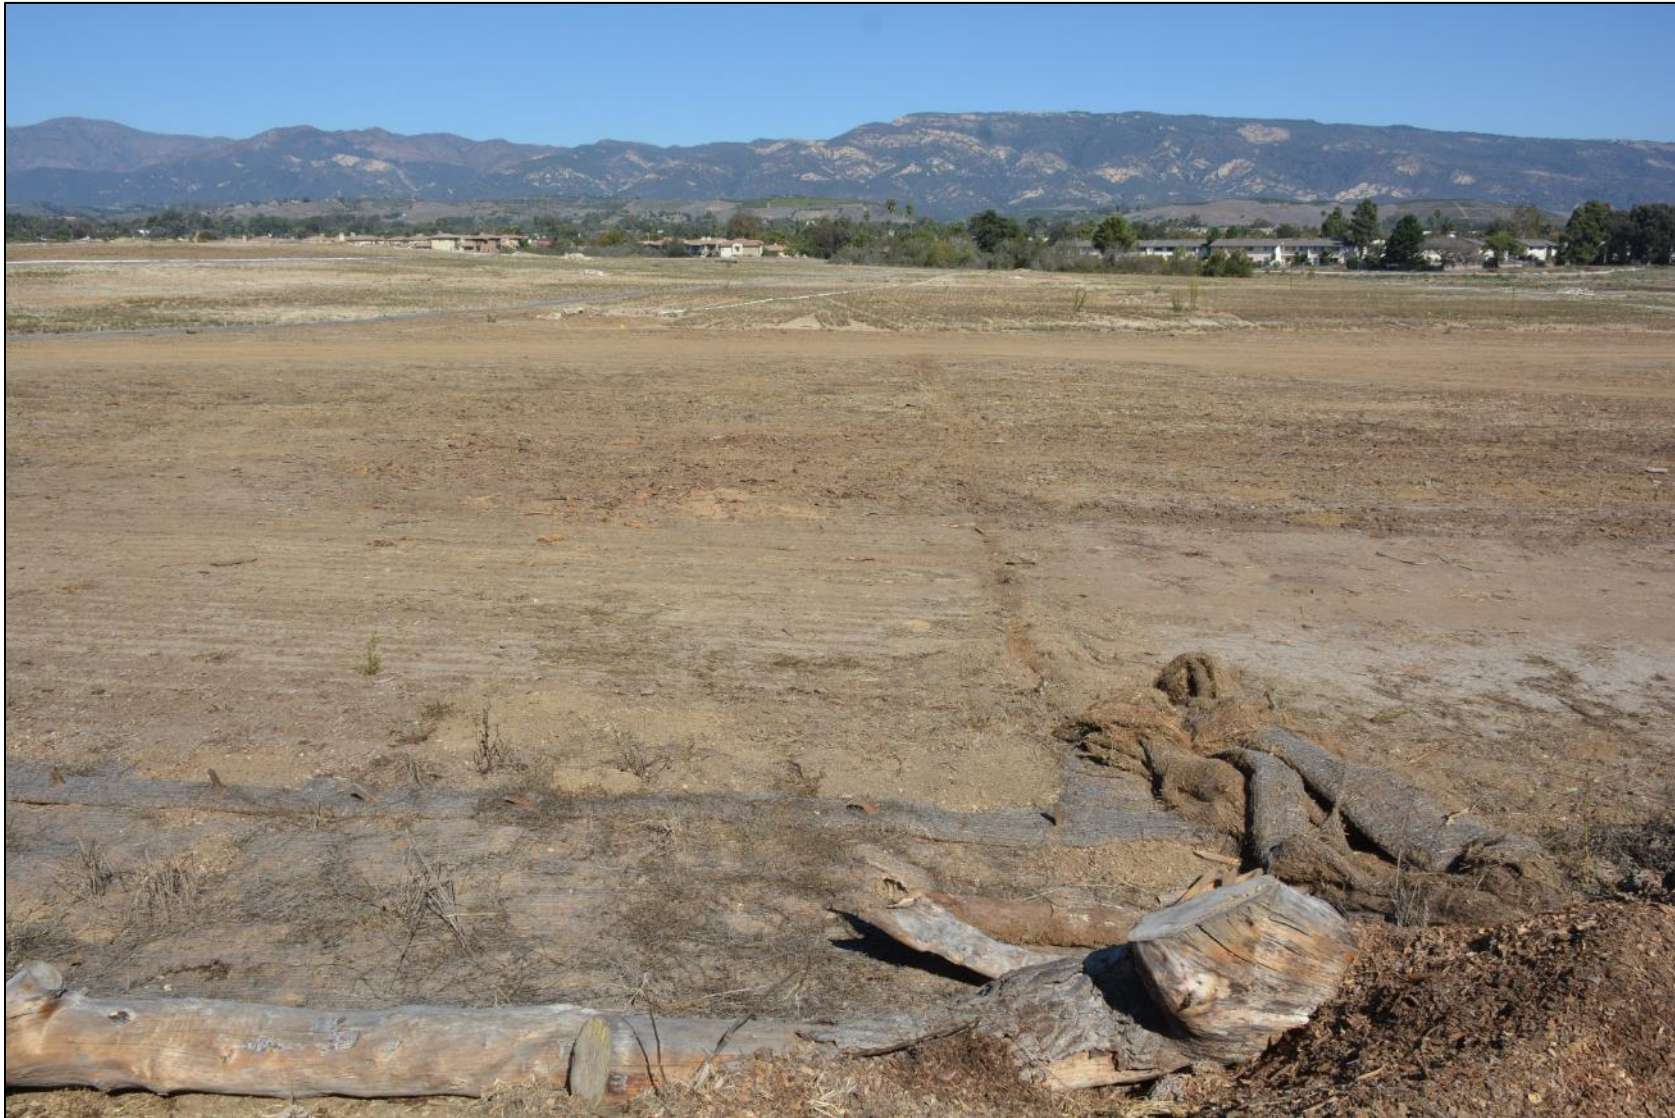
Photo point 16b-N – looking north from Venoco Road, across the drill-seeded grassland area.

Year 1 photo – October 16, 2018. Note the grass seedlings in the background and recent drill seeding in foreground.

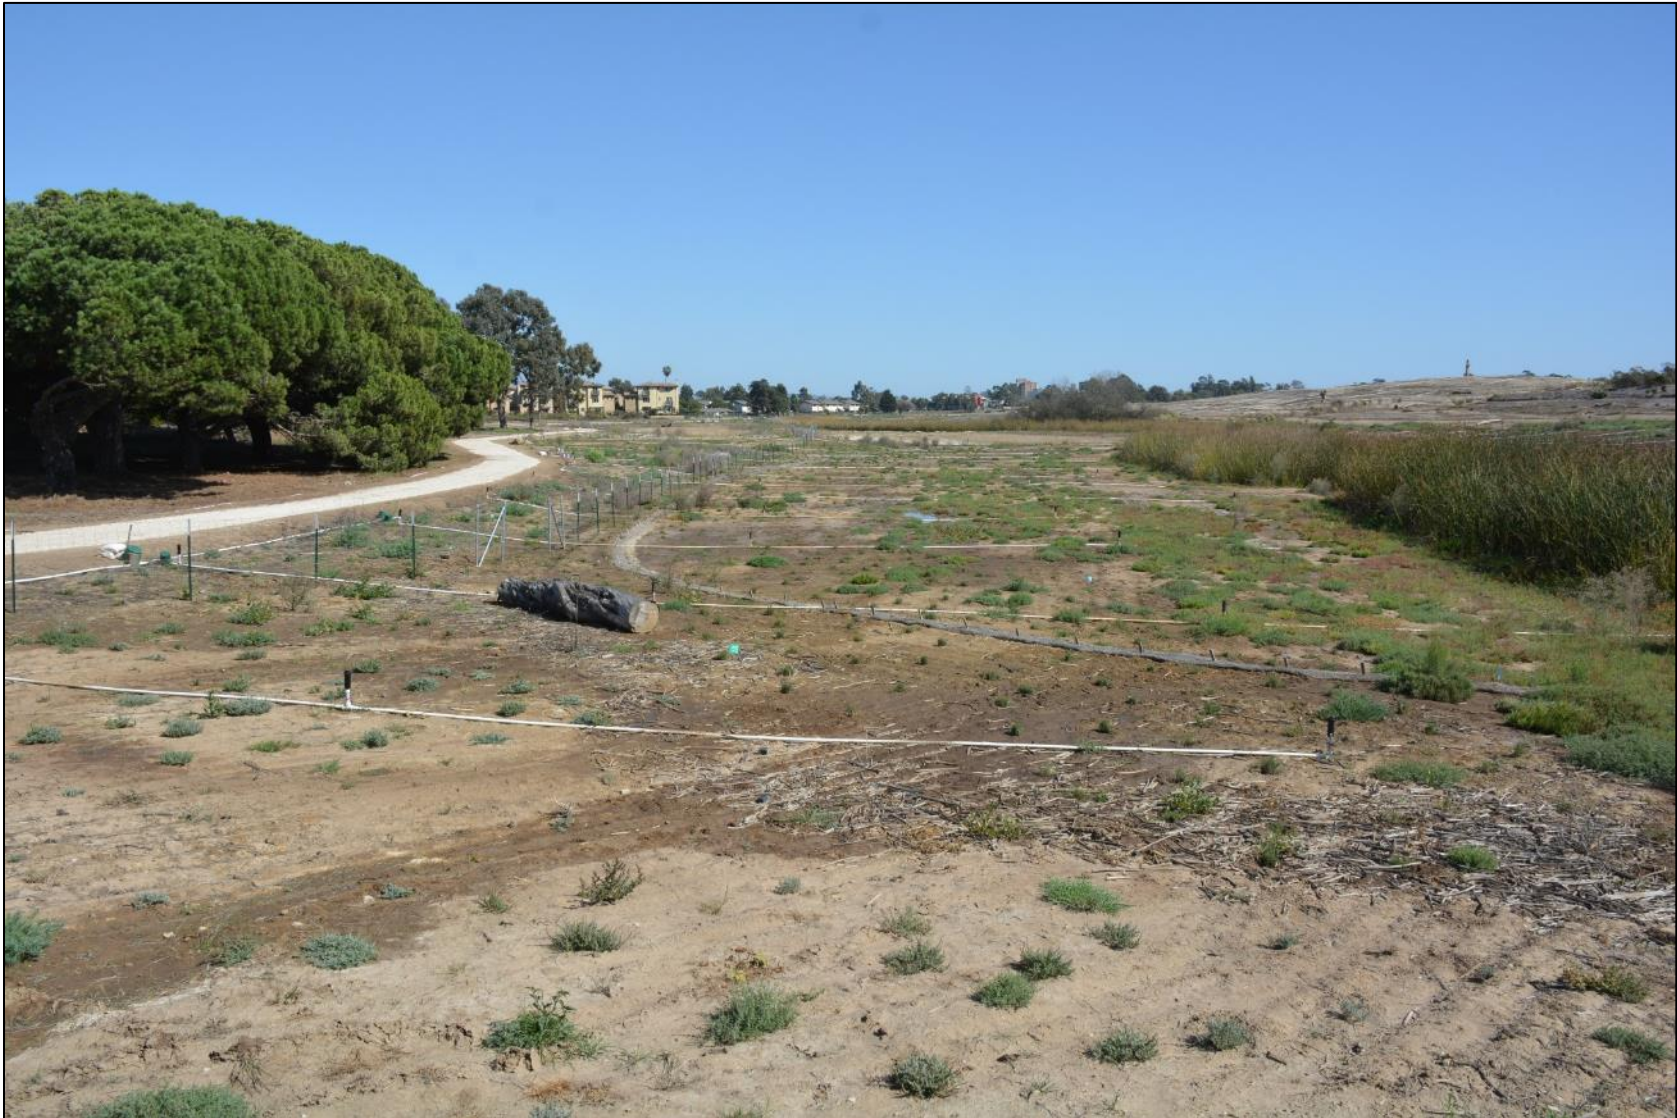
Photo point 27-E – looking east from near the northwest corner of NCOS.

Year 1 photo – October 15, 2018. Note the western end of the completed Marsh trail and the habitat protection fence.

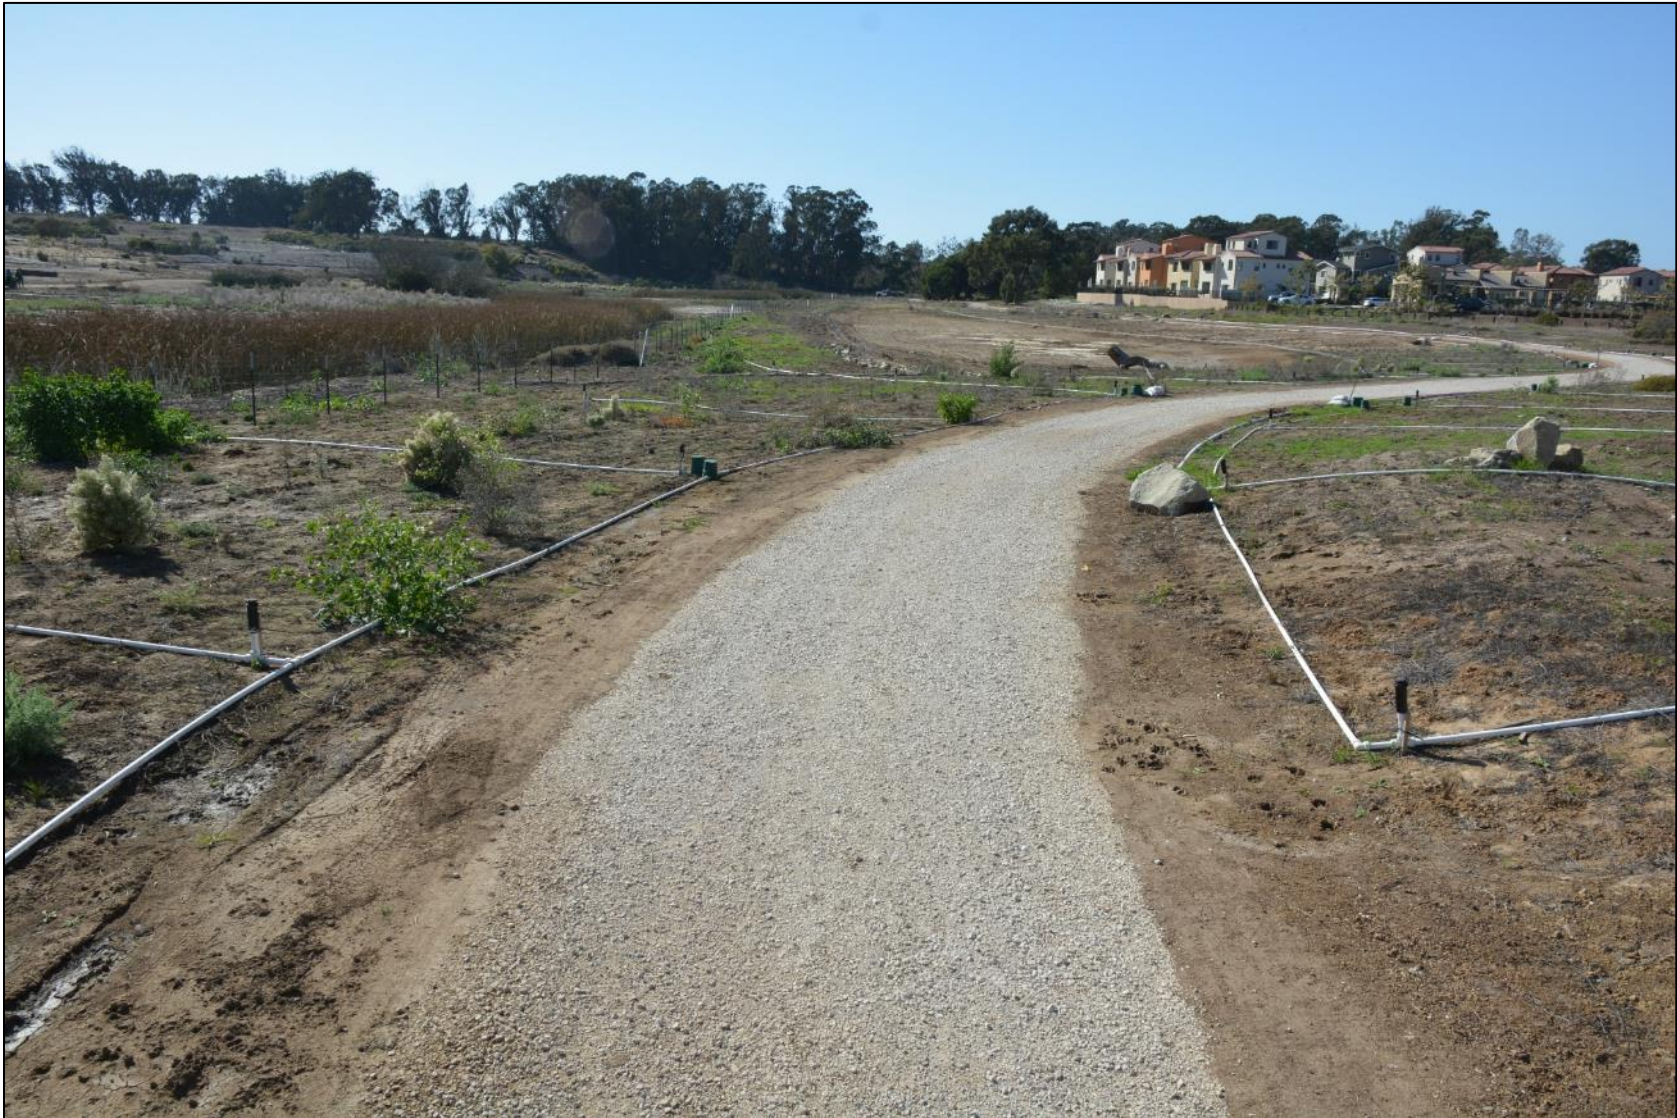
Photo point 29-W – looking west from the west side of the Phelps Creek Bridge.

Year 1 photo – October 15, 2018. Note completed Marsh trail and seasonal pond (dry).

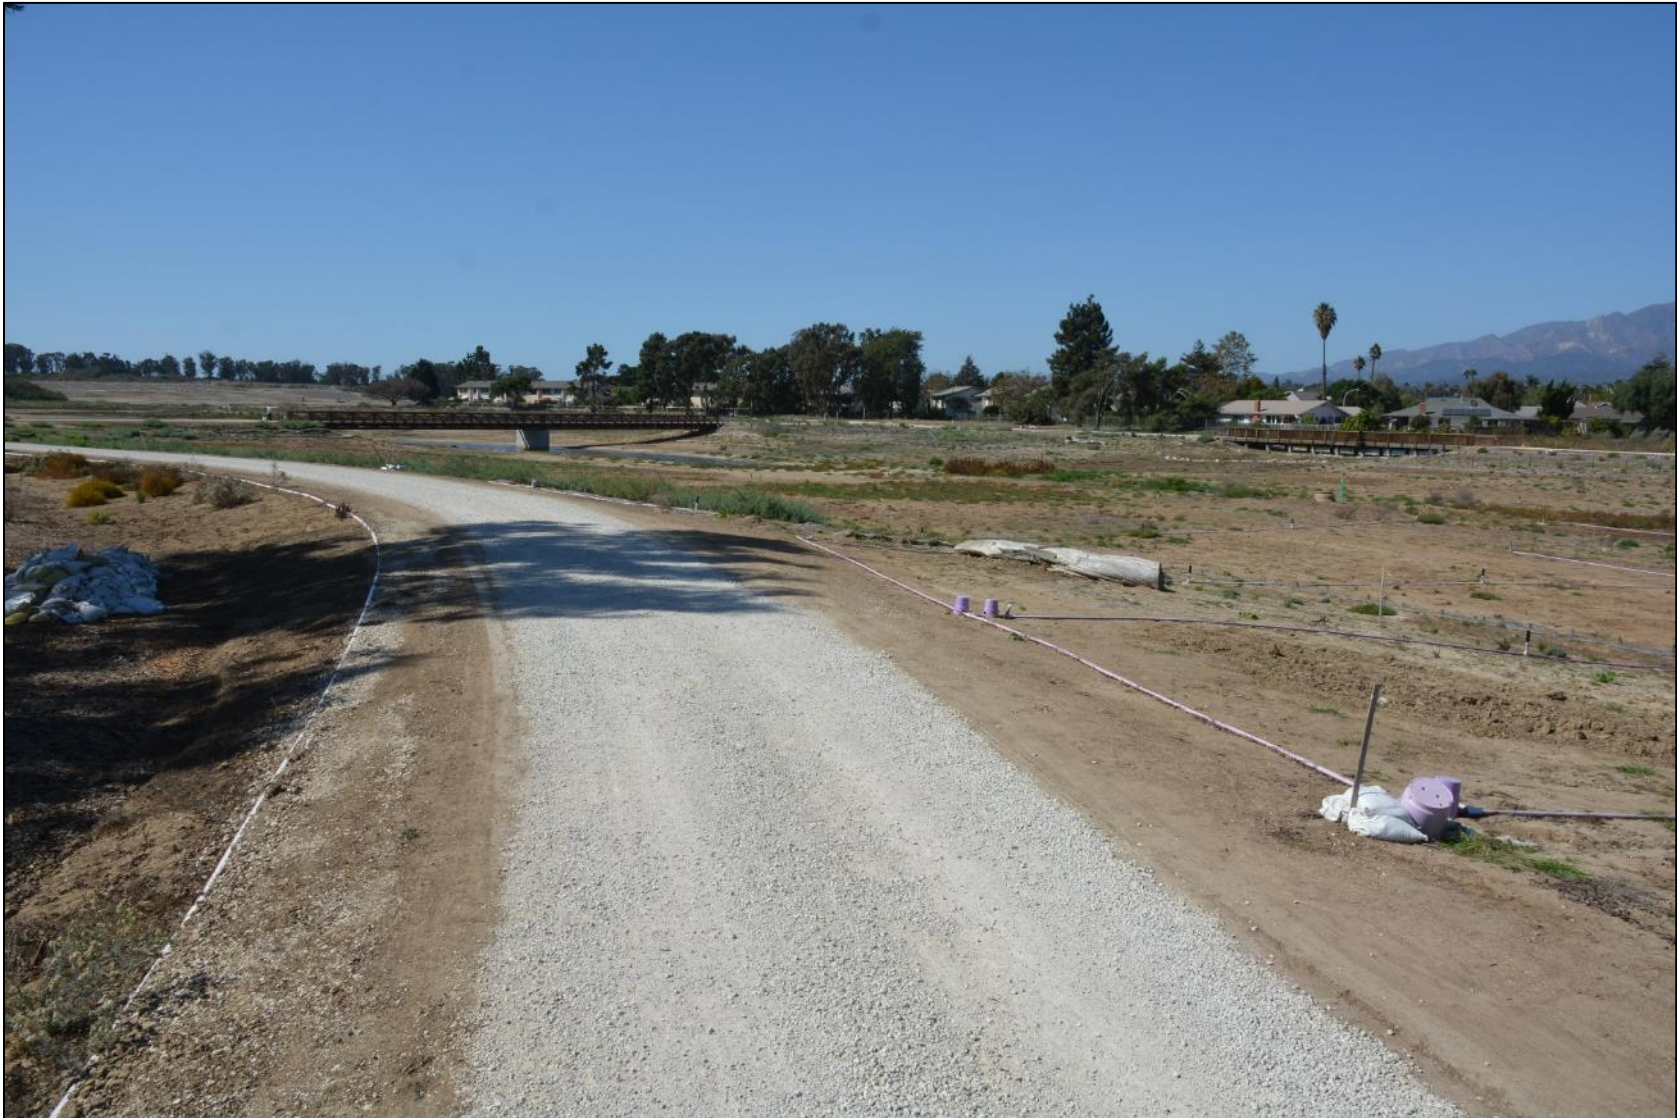
Year 1 photo – October 15, 2018. Note both the east arm bridge and Whittier crossing.

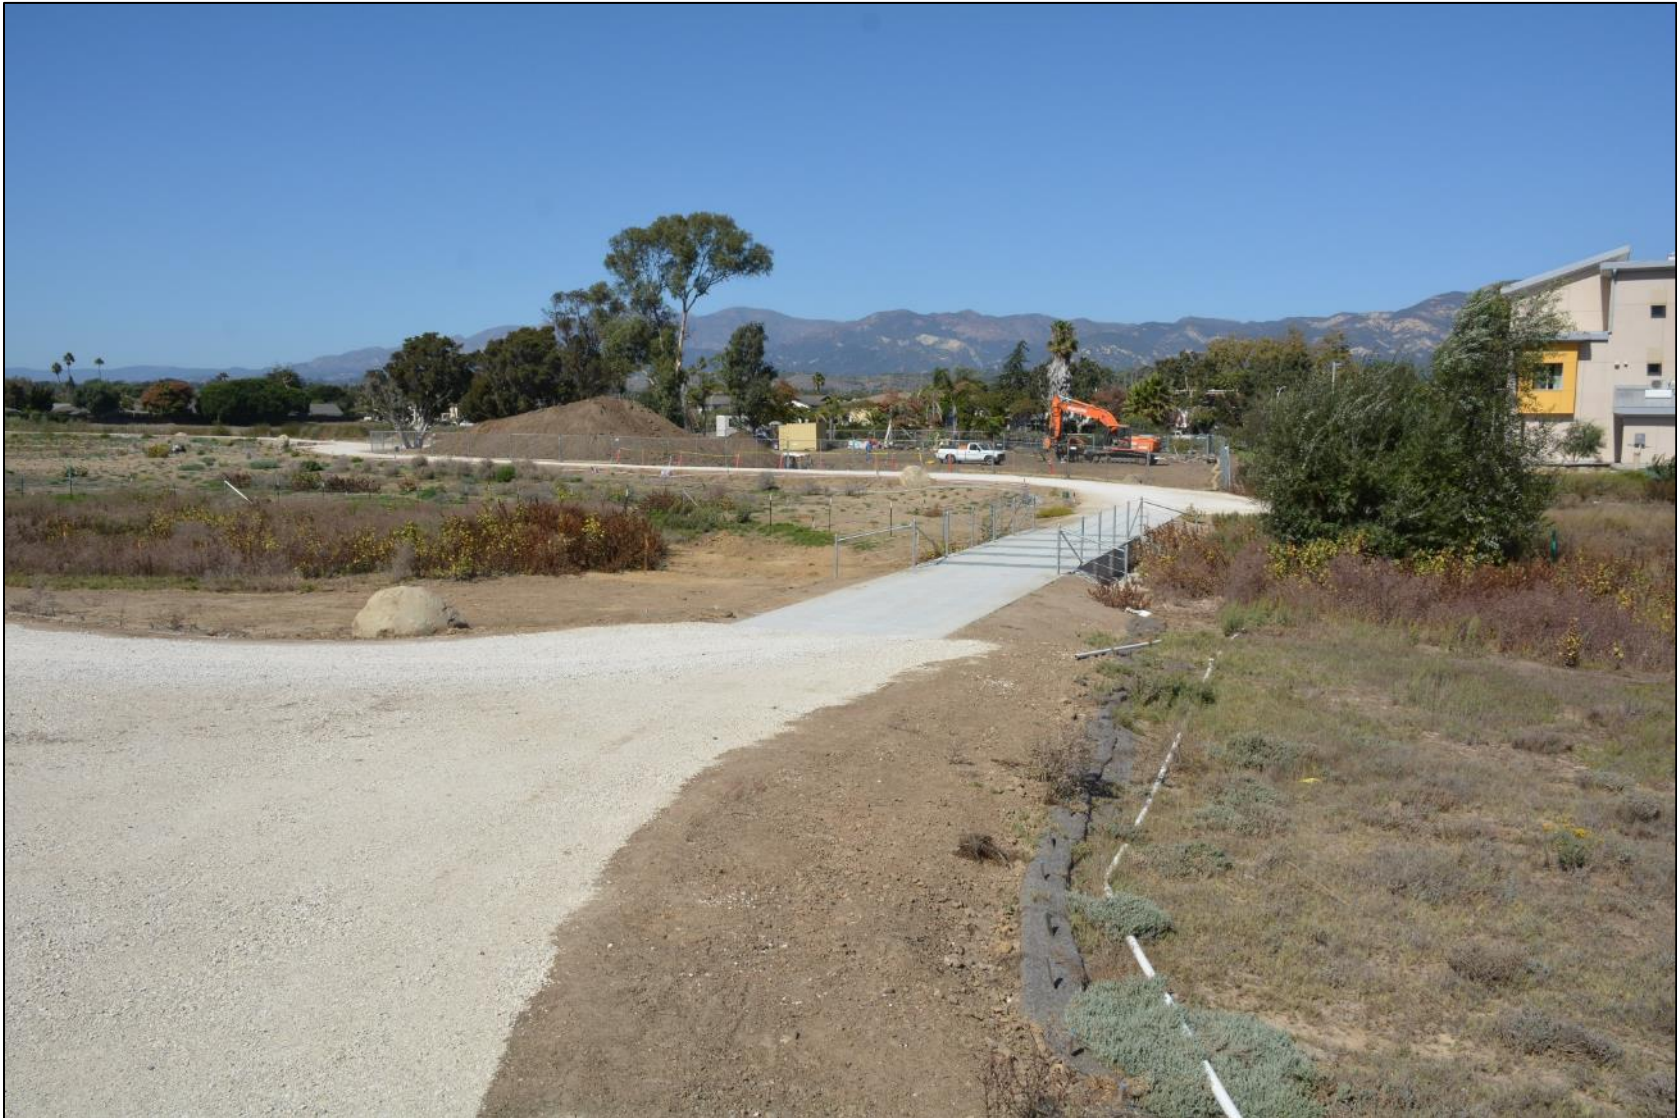
Year 1 photo – October 15, 2018. Note completion of culvert crossing and trail.
